**Land west of Cody Road,
Waterbeach, Cambridgeshire:**

**Archaeological Trial Trench
Evaluation**

October 2014

Pre-Construct Archaeology Ltd	
Project Number	K3761
Report Number	R11886

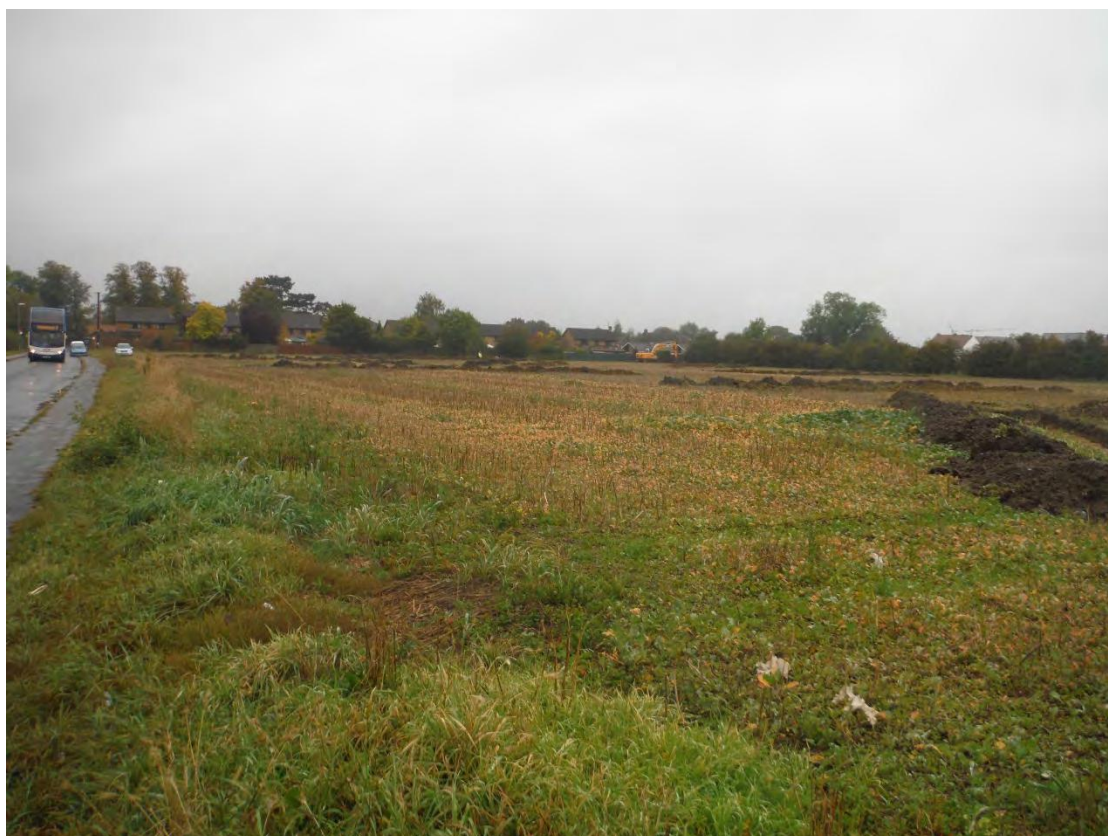
Plate 1: The site, view south-west

- 1.1 An archaeological trial trench evaluation was undertaken by Pre-Construct Archaeology Ltd (PCA) on land west of Cody Road, Waterbeach, Cambridgeshire, CB25 9LQ (centred on Ordnance Survey National Grid Reference (NGR) TL 49816 66018) on 13th October 2014 (Figure 1; Plate 1).

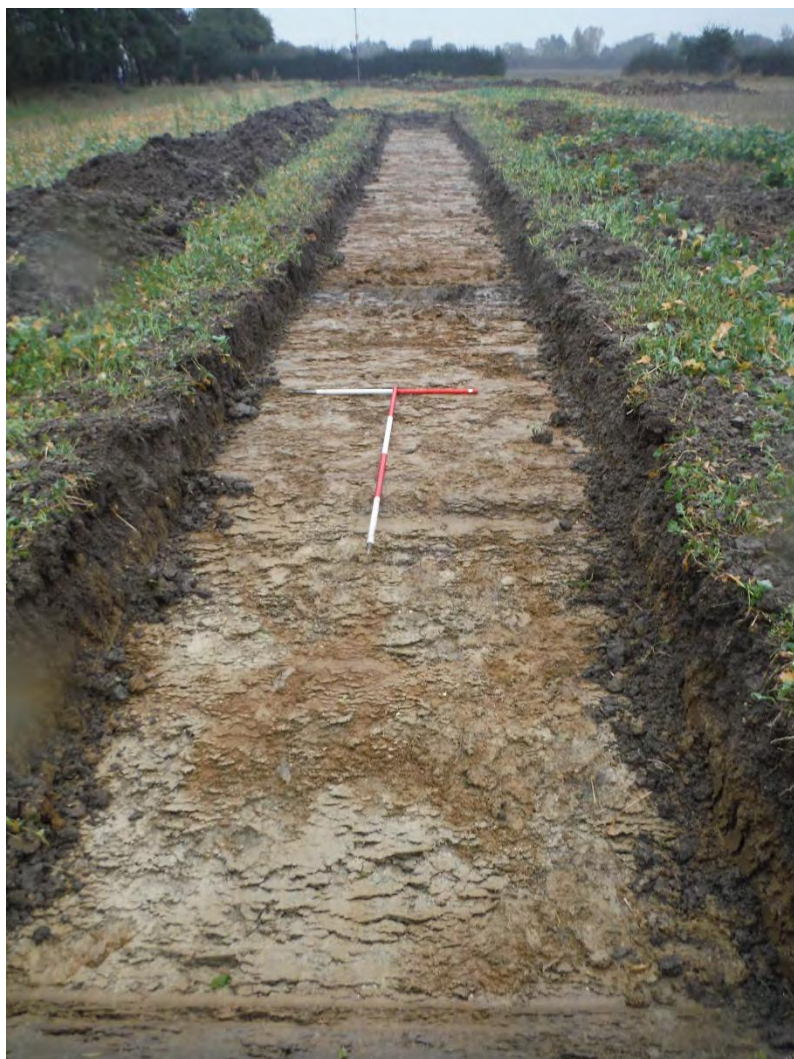
Plate 2: Trench 1, view east with modern pipe trench in middle ground

5.2.1 Trench 1 contained no archaeological features or finds. A modern pipe trench on a north to south alignment (Plate 3) corresponds with a linear anomaly identified by the geophysical survey.

TRENCH 1	Figure 2	Plates 2-3	
Trench Alignment: WNW-ESE	Length: 30m	Level of Natural (m OD): 5.36-5.63m	
Deposit	Context No.	Average Depth (m)	
		W End	E End
Topsoil	(11)	0.35m	0.30m
Natural Clay	(12)	0.35m+	0.30m+
Summary			
<p>Trench 1 was located close to the northern boundary of the site.</p> <p>No archaeological features or finds were present. A modern pipe trench on a north to south alignment was present in the centre of the trench and matches a linear anomaly identified by the geophysical survey.</p>

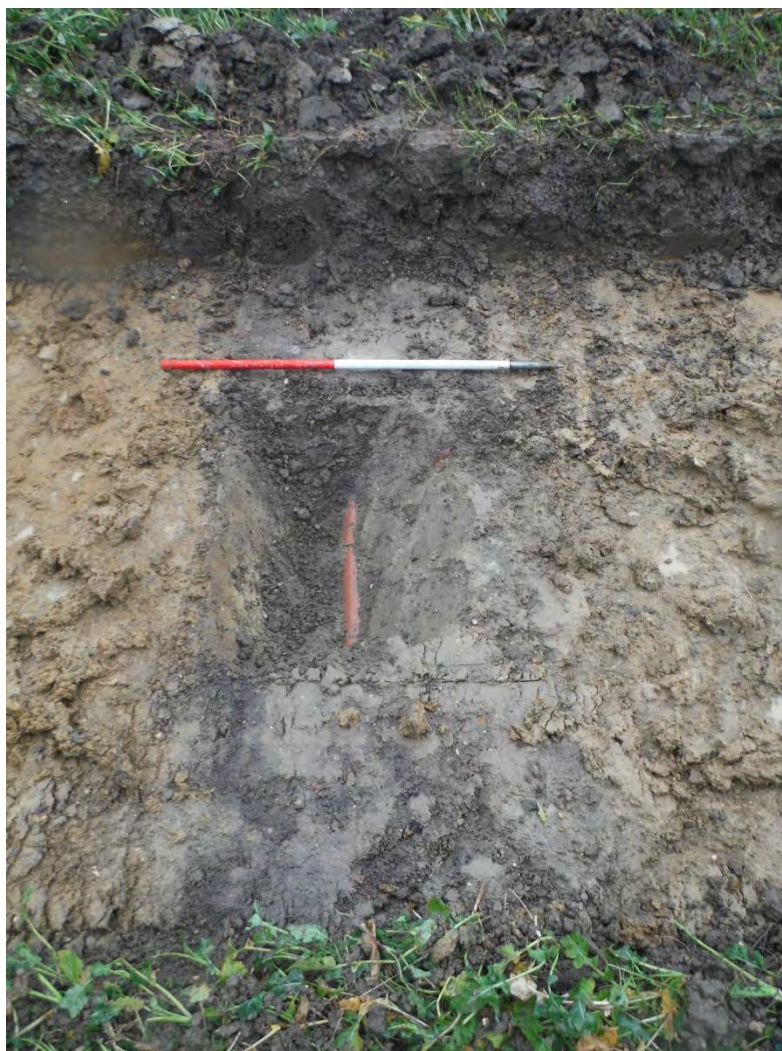
Plate 3: Trench 1, view south showing modern pipe trench (matches geophysical anomaly)

- 6.2 Trenches 1 and 6 contained a roughly north- to south-aligned modern pipe trench, which corresponds with a linear anomaly identified by the geophysical survey.

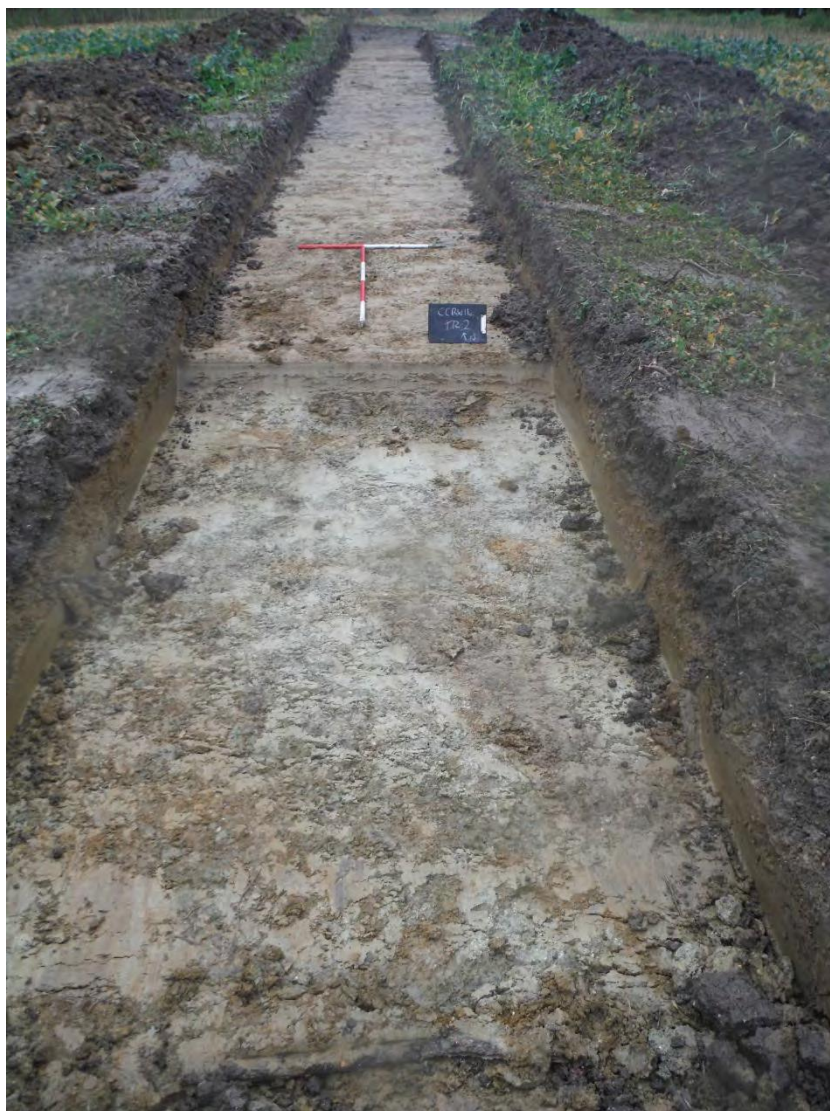
Plate 4: Trench 2, view north-east (machining was slightly deeper in foreground to test whether the natural geological horizon had been reached)

TRENCH 2	Figure 2	Plate 4	
Trench Alignment: SW-NE	Length: 30m	Level of Natural (m OD): 5.16-5.71m	
Deposit	Context No.	Average Depth (m)	
		SW End	NE End
Topsoil	(11)	0.25m	0.30m
Natural Clay	(12)	0.25m+	0.30m+
Summary			
Trench 2 was located in the north-east corner of the site. No archaeological features or finds were present.

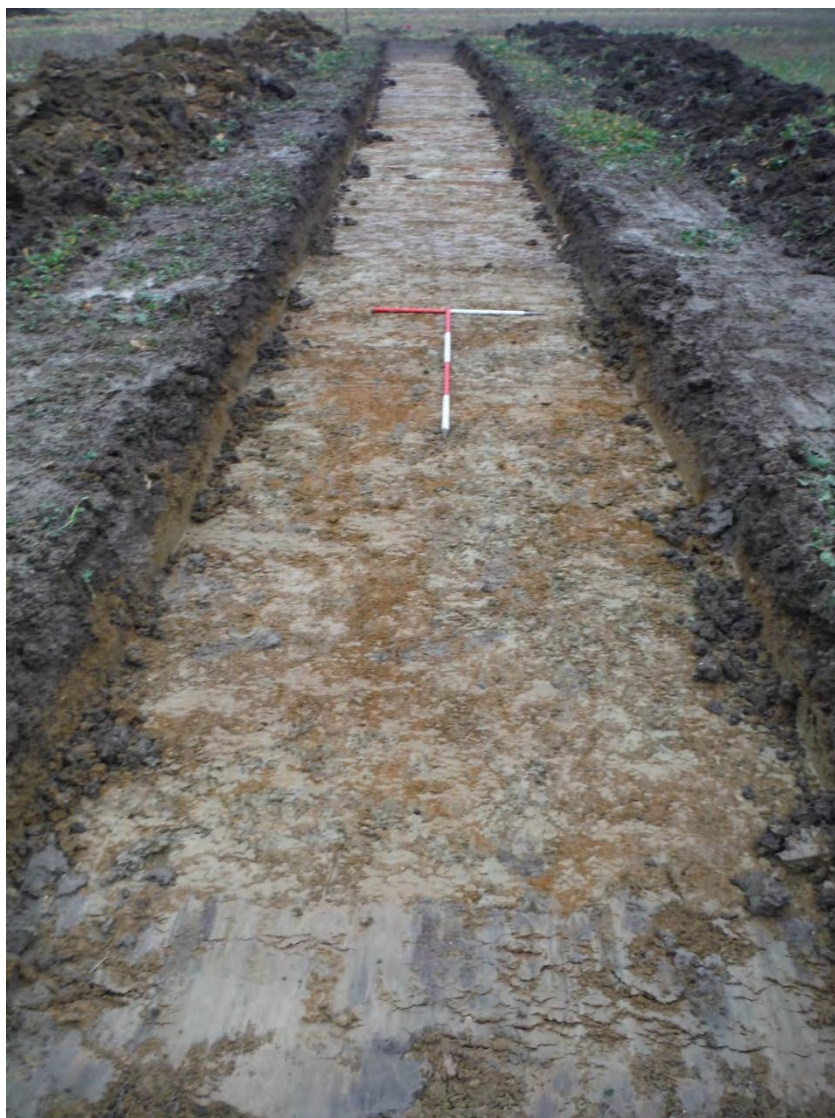
Plate 5: Trench 3, view south-east

TRENCH 3	Figure 2	Plate 5	
Trench Alignment: NW-SE	Length: 30m	Level of Natural (m OD): 5.34-5.79m	
Deposit	Context No.	Average Depth (m)	
		NW End	SE End
Topsoil	(11)	0.30m	0.25m
Natural Clay	(12)	0.30m+	0.25m+
Summary			
Trench 3 was located in the north-west of the site. No archaeological features or finds were present.

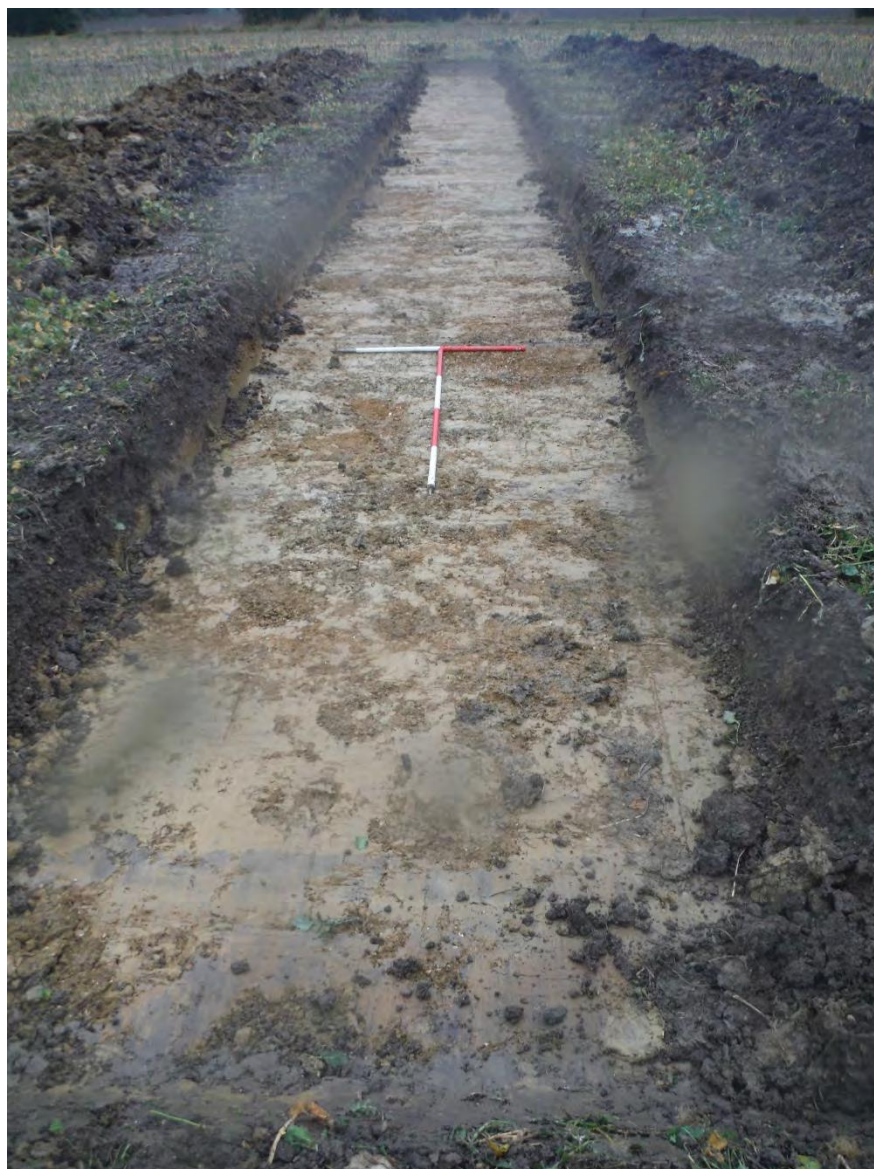
Plate 6: Trench 4, view east

TRENCH 4	Figure 2	Plate 6	
Trench Alignment: WNW-ESE	Length: 30m	Level of Natural (m OD): 5.07-5.66m	
Deposit	Context No.	Average Depth (m)	
		W End	E End
Topsoil	(11)	0.25m	0.25m
Natural Clay	(12)	0.25m+	0.25m+
Summary			
Trench 4 was located centrally in the north of the site. No archaeological features or finds were present.

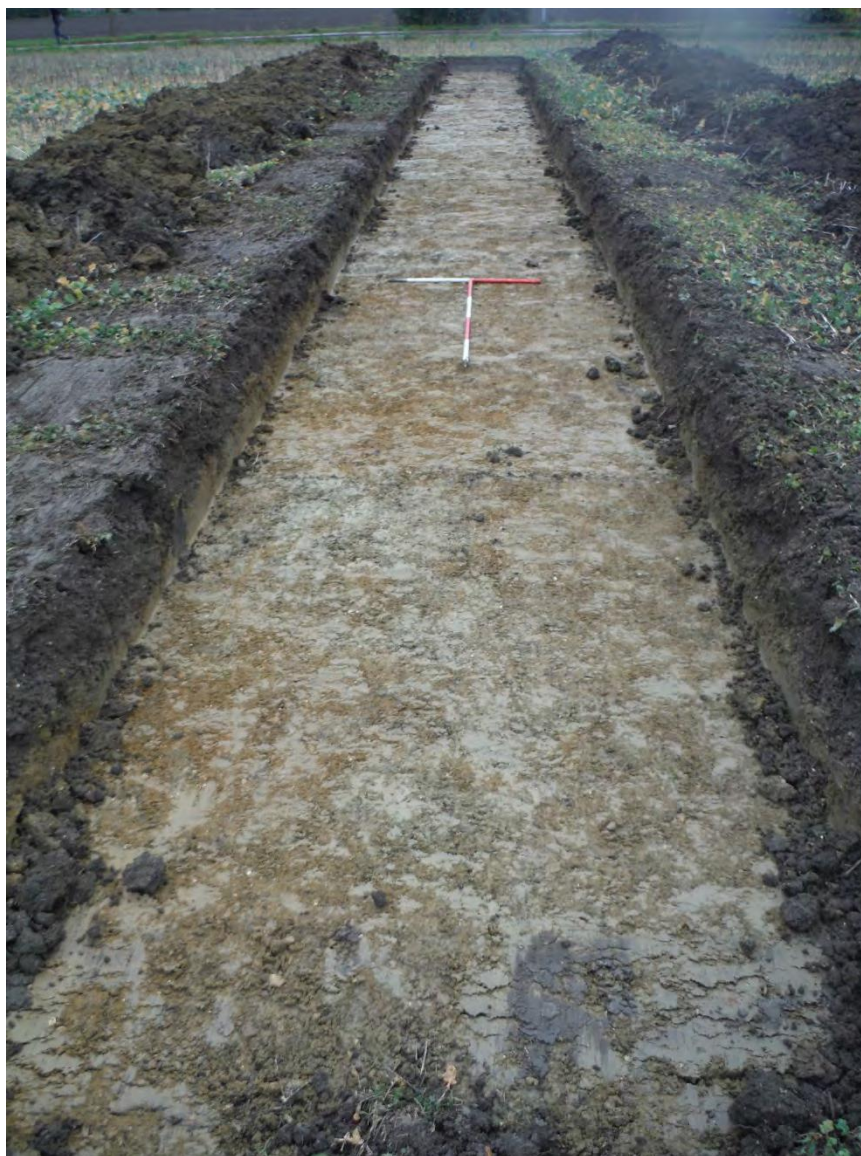
Plate 7: Trench 5, view east

TRENCH 5	Figure 2	Plate 7	
Trench Alignment: WNW-ESE	Length: 30m	Level of Natural (m OD): 5.03-5.50m	
Deposit	Context No.	Average Depth (m)	
		W End	E End
Topsoil	(11)	0.30m	0.30m
Natural Clay	(12)	0.30m+	0.30m+
Summary			
Trench 5 was located in the east of the site. No archaeological features or finds were present.

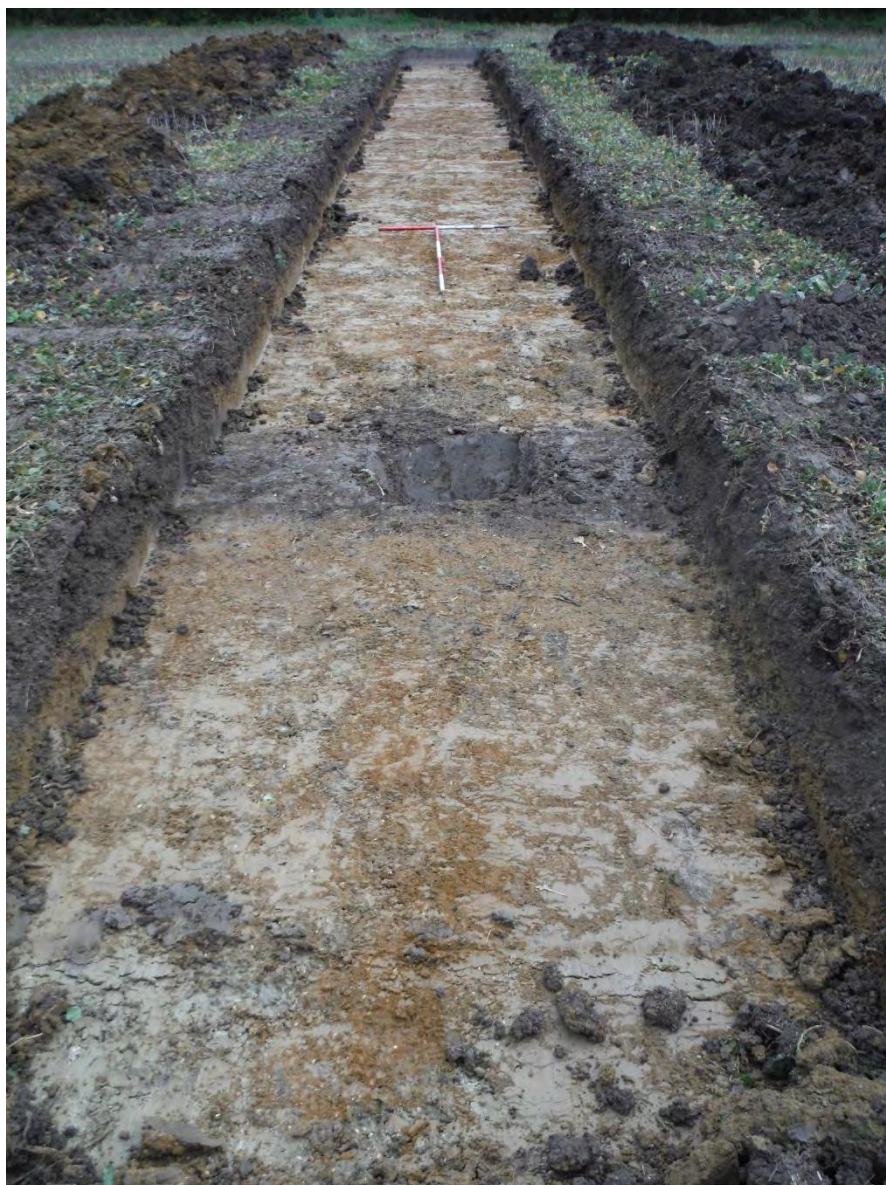
Plate 8: Trench 6, view west with modern pipe trench (matches geophysical anomaly) in foreground

5.7.1 Trench 6 contained no archaeological features or finds. A modern pipe trench on a north to south alignment corresponds with a linear anomaly identified by the geophysical survey. The same pipe trench extended through Trench 1.

TRENCH 6	Figure 2	Plate 8	
Trench Alignment: WNW-ESE	Length: 30m	Level of Natural (m OD): 5.11-5.60m	
Deposit	Context No.	Average Depth (m)	
		W End	E End
Topsoil	(11)	0.29m	0.29m
Natural	(12)	0.29m+	0.29m+
Summary			
<p>Trench 6 was located in the west of the site.</p> <p>No archaeological features or finds were present. A modern pipe trench on a north to south alignment was present in the east end of the trench and matches a linear anomaly identified by the geophysical survey.</p>

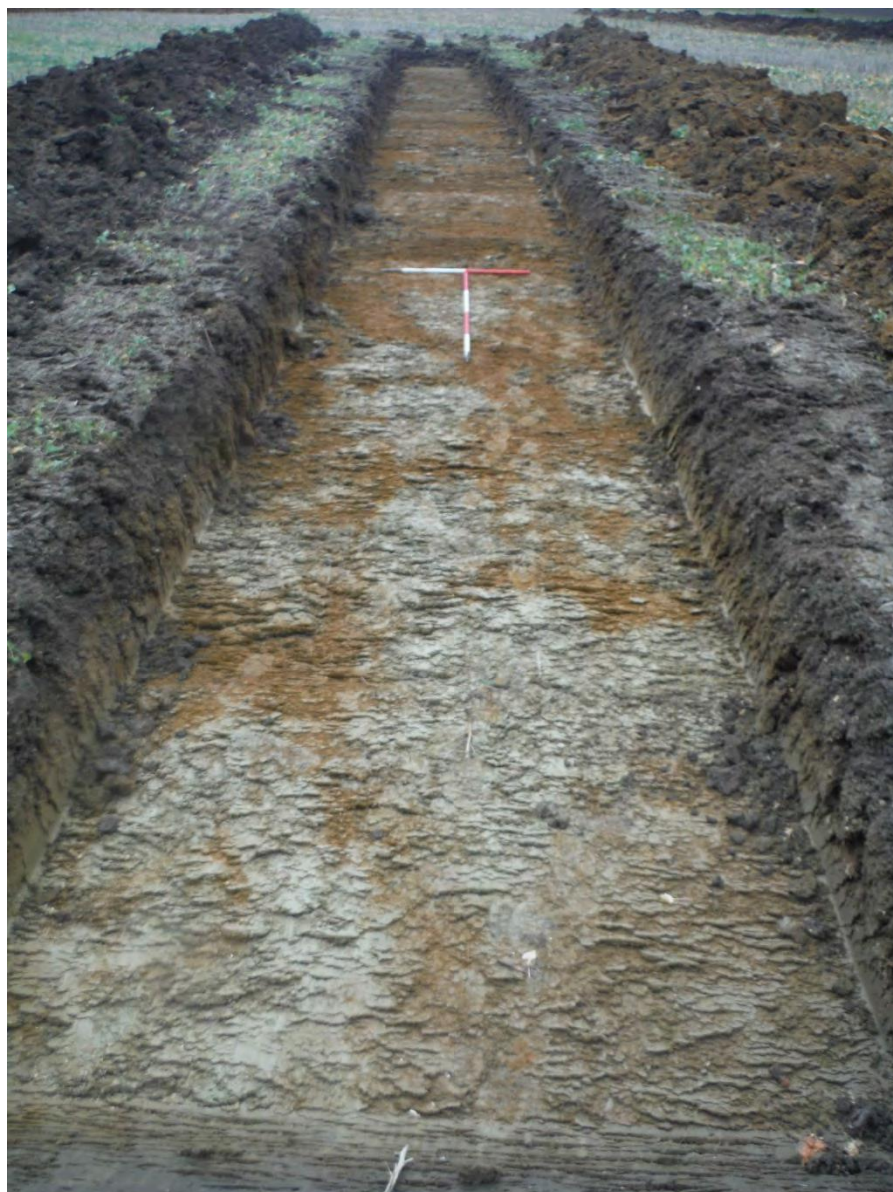
Plate 9: Trench 7, view north-east

TRENCH 7	Figure 2	Plate 9	
Trench Alignment: SW-NE	Length: 30m	Level of Natural (m OD): 4.81-5.94m	
Deposit	Context No.	Average Depth (m)	
		SW End	NE End
Topsoil	(11)	0.30m	0.20m
Natural Clay	(12)	0.30m+	0.20m+
Summary			
<p>Trench 7 was located in the south-west corner of the site.</p> <p>No archaeological features or finds were present.</p>

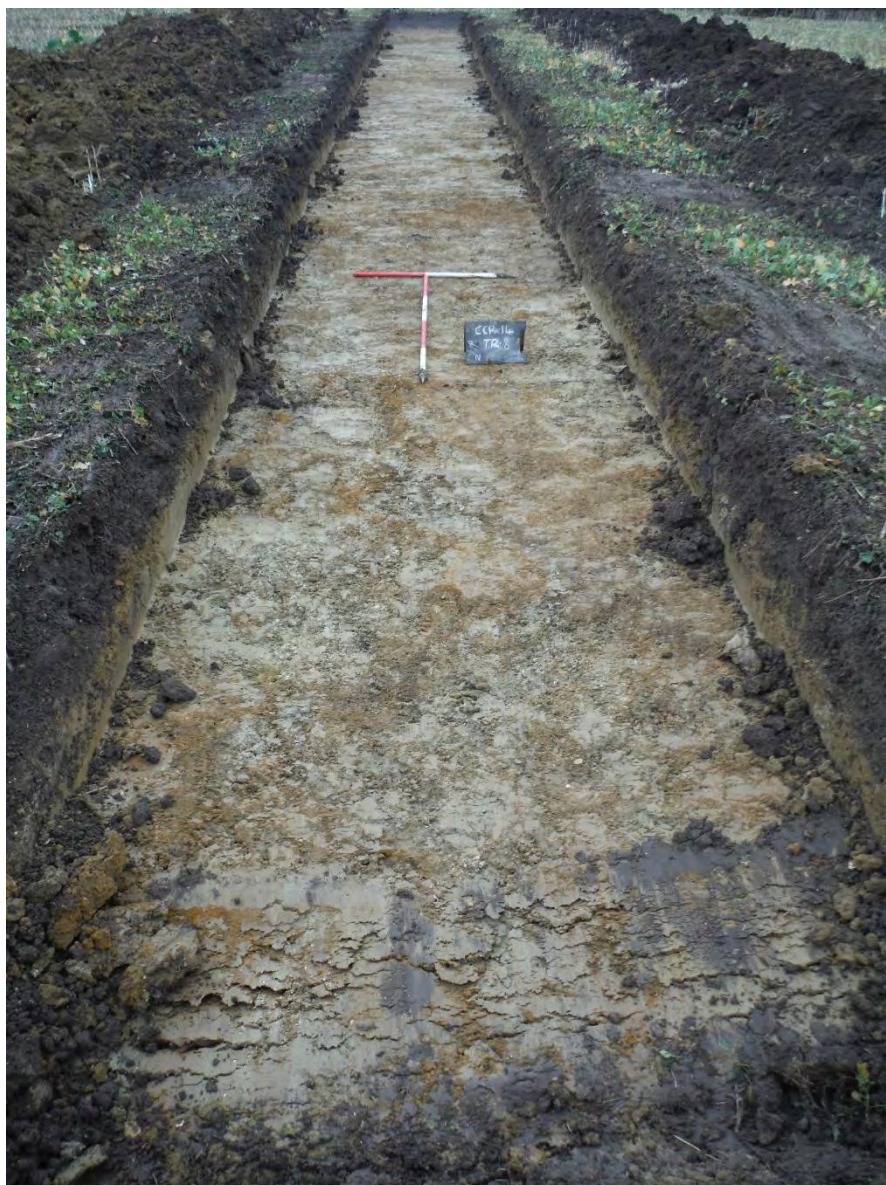
Plate 10: Trench 8, view north-east

TRENCH 8	Figure 2	Plate 10	
Trench Alignment: SW-NE	Length: 30m	Level of Natural (m OD): 5.03-5.56m	
Deposit	Context No.	Average Depth (m)	
		SW End	NE End
Topsoil	(11)	0.30m	0.20m
Natural Clay	(12)	0.30m+	0.20m+
Summary			
Trench 8 was located in the central southern part of the site. No archaeological features or finds were present.

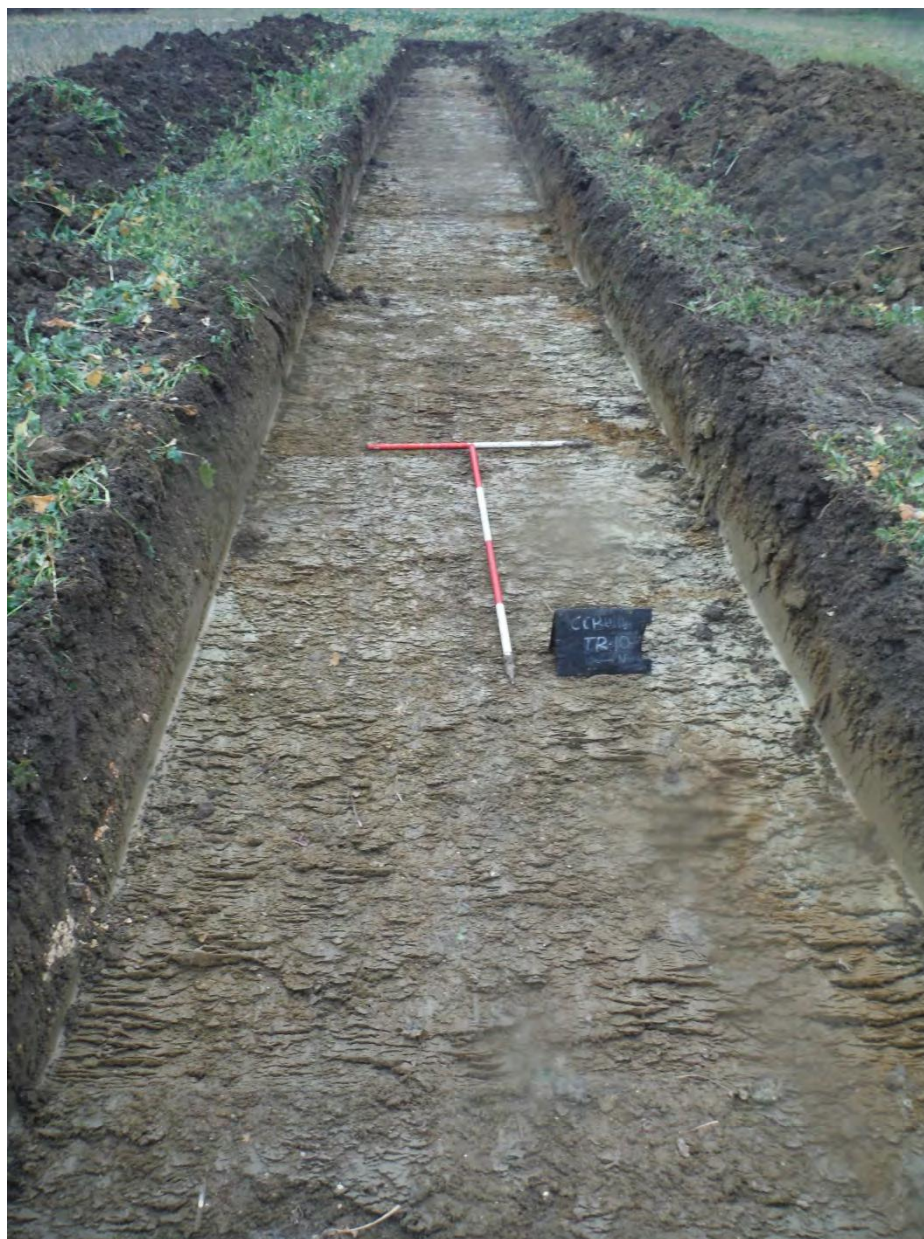
Plate 12: Trench 10, view east showing Ditch [13]=[15]

5.11.1 Trench 10 contained an east- to west-aligned ditch. Two 1m slots were excavated ([13] and [15]). The ditch extended along the length of the trench for 30m, continuing beyond the limits of excavation in both directions. It was 0.80-1.10m wide and extremely shallow, surviving to only 0.05m deep, with an irregular profile and base (Plates 12-13). It was filled with a compact mottled mid brown/ grey clay ((14)=(16)). Two small, abraded 'crumbs' of probable local medieval coarseware, including one partial rim sherd (c. late 12th-14th century) (<1g each) (Berni Sudds, pers. comm.), were found in Slot [13]. It is likely that this was only the base of the ditch, the upper portion of the feature having been ploughed away.

TRENCH 10	Figure 2	Plate 12	
Trench Alignment: WNW-ESE	Length: 30m	Level of Natural (m OD): 4.99-5.05m	
Deposit	Context No.	Average Depth (m)	
		W End	E End
Topsoil	(11)	0.40m	0.40m
Natural Clay	(12)	0.40m+	0.40m+
Summary			
<p>Trench 10 was located close to the southern boundary of the site. A single shallow east- to west-aligned medieval ditch was present.</p>

- 6.1 The evaluation identified a single ditch in Trench 10, adjacent to the southern boundary of the site. It has been truncated by ploughing and only the base survives. Two small pieces of abraded medieval (late 12th-14th century) pottery were found in one of the excavated slots. The ditch is aligned perpendicular to Cody Road and parallel with Bannold Road and is likely to be a field boundary or drainage ditch in agricultural land.

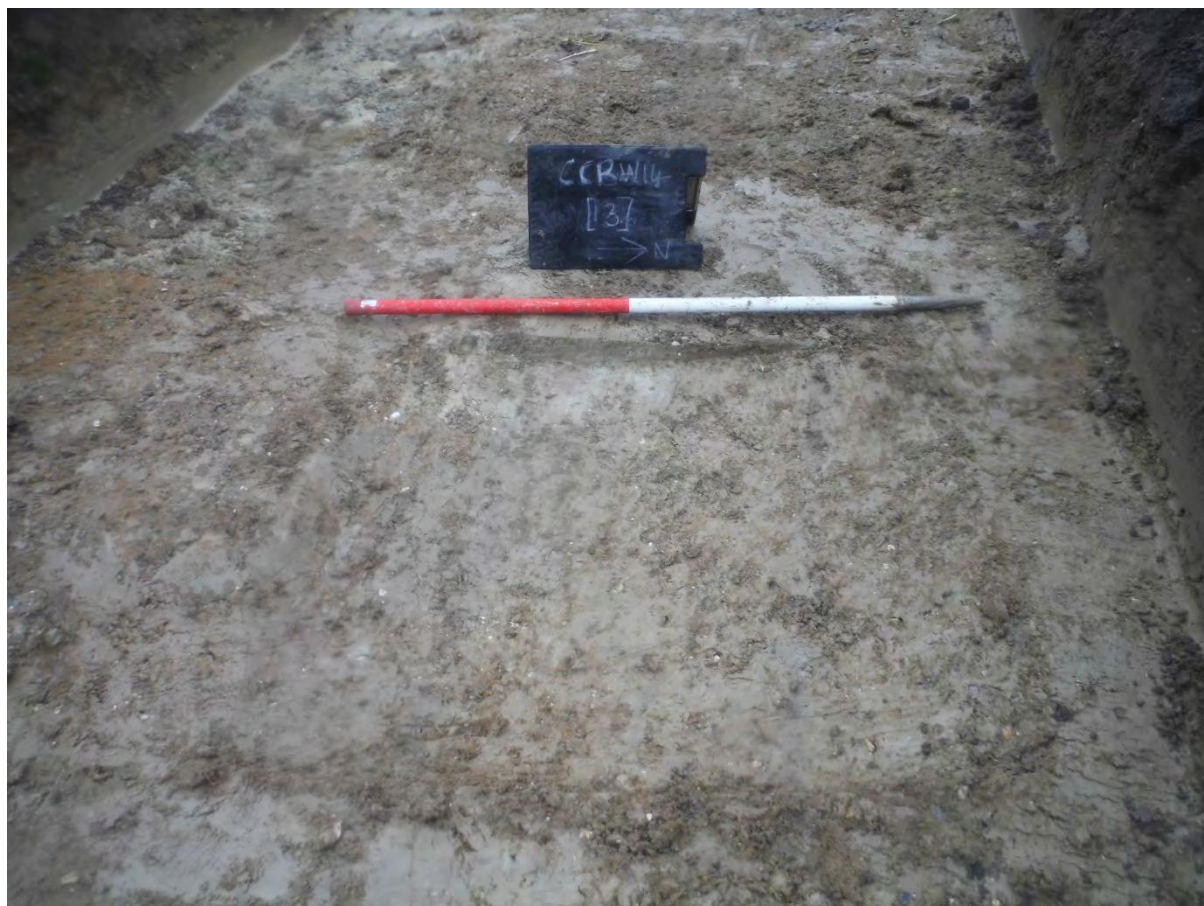
Plate 13: Ditch [13], view west (Trench 10)
