**ADAMS GATE WIDENING SCHEME,  
ADAMS GATE,  
HAMPTON COURT PALACE**

**SUMMARY REPORT OF AN  
ARCHAEOLOGICAL WATCHING  
BRIEF**

**PCA REPORT NO: 11891**

**OCTOBER 2014**

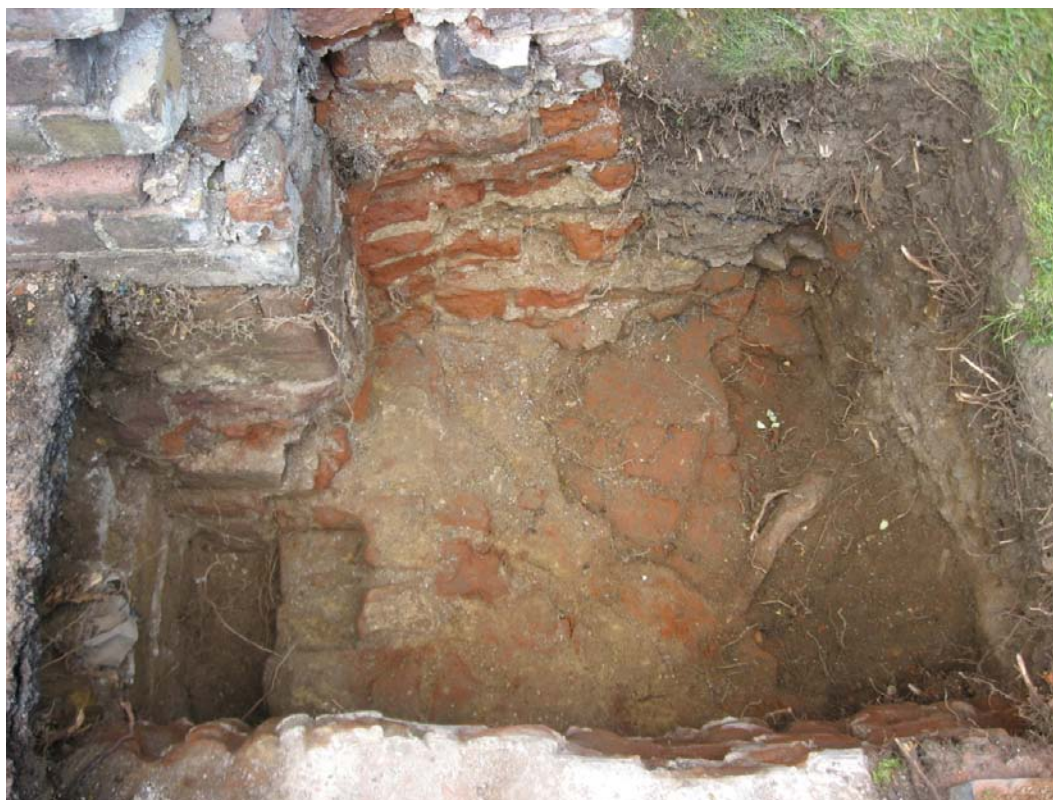
- 4.1.1 The earliest remains observed during the works date to the Tudor period. On the west side of the gate this is represented by the east to west aligned foundation [12]. It was composed of some whole, but mainly fragmentary, unfrogged red bricks bonded with hard lime mortar. The full thickness of the masonry was not seen as it extended below the necessary impact level of the works, but it was at least three courses high. In plan, it measured greater than 0.80m wide by 0.76m north to south. The top of the masonry was seen at approximately 9.92m OD.

*Plate 1: The western pillar, post-excavation, looking west*

- 4.1.2 Wall [2] measured between 0.30m and 0.40m wide and was greater than 100m in length, this being the wall enclosing the northern side of the palace and built c. 1515. It was built directly on top of foundation [12] and was seen to be greater than 47 courses high.

- 4.1.3 To the north of masonry [12] was backfill [6]. This appeared as a loose sandy deposit that abutted the northern side of the foundation. Towards the northwest corner of the trench, several bricks were seen against the foundation that at first glance appeared as potentially representing a northern turn of the foundation. However, this is thought to be unlikely and the bricks representative of either material dislodged and incorporated into the fills matrix from recent truncation to the wall, or an original component part of the foundations backfill. Also, these extended beyond the trenches limits and are therefore unlikely to be impacted upon during these works.

- 4.1.5 Backfill [11] was seen abutting the southern side of foundation [12] and unlike [6], is thought to be late post-medieval in date and related to building later masonry on top of the earlier foundation as seen by a wall extending at ninety-degrees to the south as well as a parallel brick feature associated with drainage.

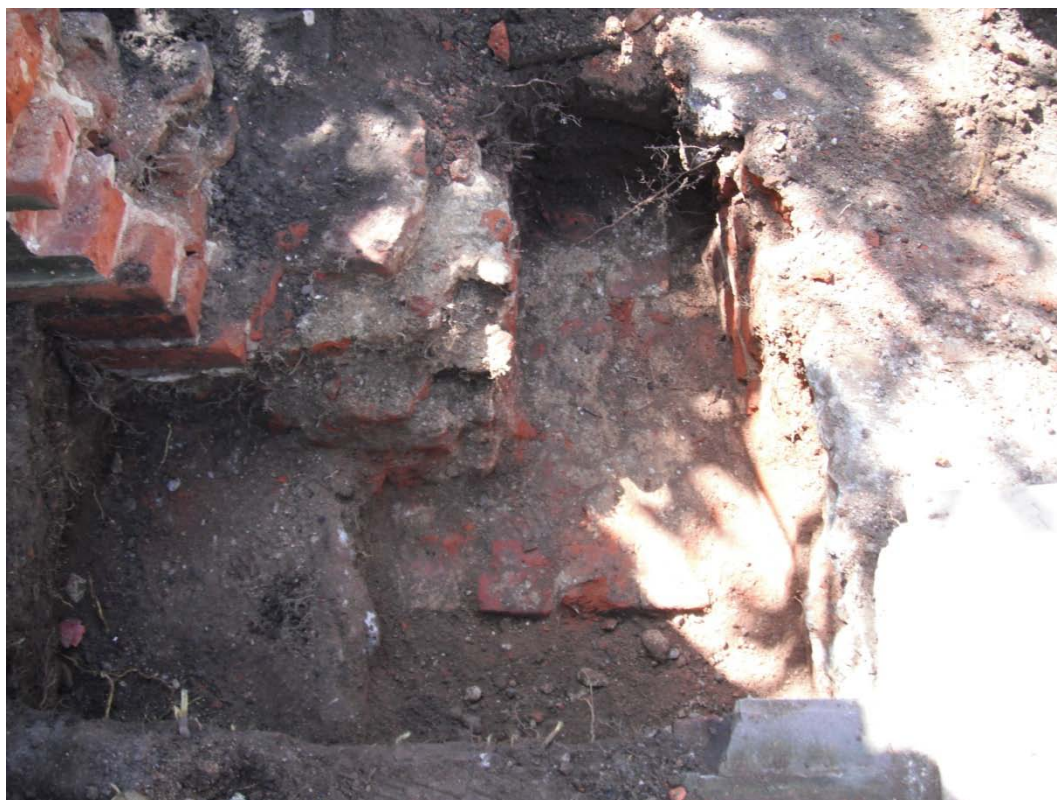
- 4.1.6 At the eastern side of the gate a Tudor stepped foundation [3] was observed on to which the later construction of the wall is directly built. It has maximum dimensions of 1.00m (E-W) by 0.80m (N-S) and was seen at a height of 9.97m OD. As with the brickwork discussed above it comprised of red and purple red unfrogged brick with typical brick dimensions of 23cms x 10.5cms x 5cms with a light yellow brown lime mortar.

*Plate 2: The eastern pillar, post-excavation*

- 4.1.7 To the north of footing [3] it was also possible to see deposit [6] running 0.60m (E-W) and 0.30m (N-S) at a height of 9.97m OD.
- 4.2 Phase 2: 17<sup>th</sup>-18<sup>th</sup> Century**
- 4.2.1 At the western side of the gate this phase is represented by the existing wall [2] that is still *in situ* today together with a pillar [7] on to which the 20<sup>th</sup> century reconstruction seems to have been directly built. As seen, it has dimensions of 0.90m (E-W) by 1.15m (N-S) with a depth of 0.50m at the limit of excavation and was seen at a height of 10.37m OD. It comprised of red unfrogged brick with a light grey lime mortar.

- 4.2.2 At the eastern side of the gate wall [2] is also still standing to its full extent. Once the 20<sup>th</sup> century pillar was removed, it became apparent that the pillar was originally located approximately 1.00m further west. In plan, just under the tarmac it was possible to see the line of the existing wall [4] extending to the west for a further 0.40m before it meets up with what must be assumed to be an earlier pillar [5].
- 4.2.3 As seen, pillar [5] had dimensions of 0.48m (E-W) by 1.00m (N-S) and was seen at a height of 10.32m OD.
