**HISTORIC BUILDING  
RECORDING OF  
NO. 29 TANNERS HILL,  
DEPTFORD, LONDON  
BOROUGH OF LEWISHAM,  
SE8 4PJ**

**SITE CODE: TAN14**

**PCA REPORT NO. R11895**

**DECEMBER 2014**

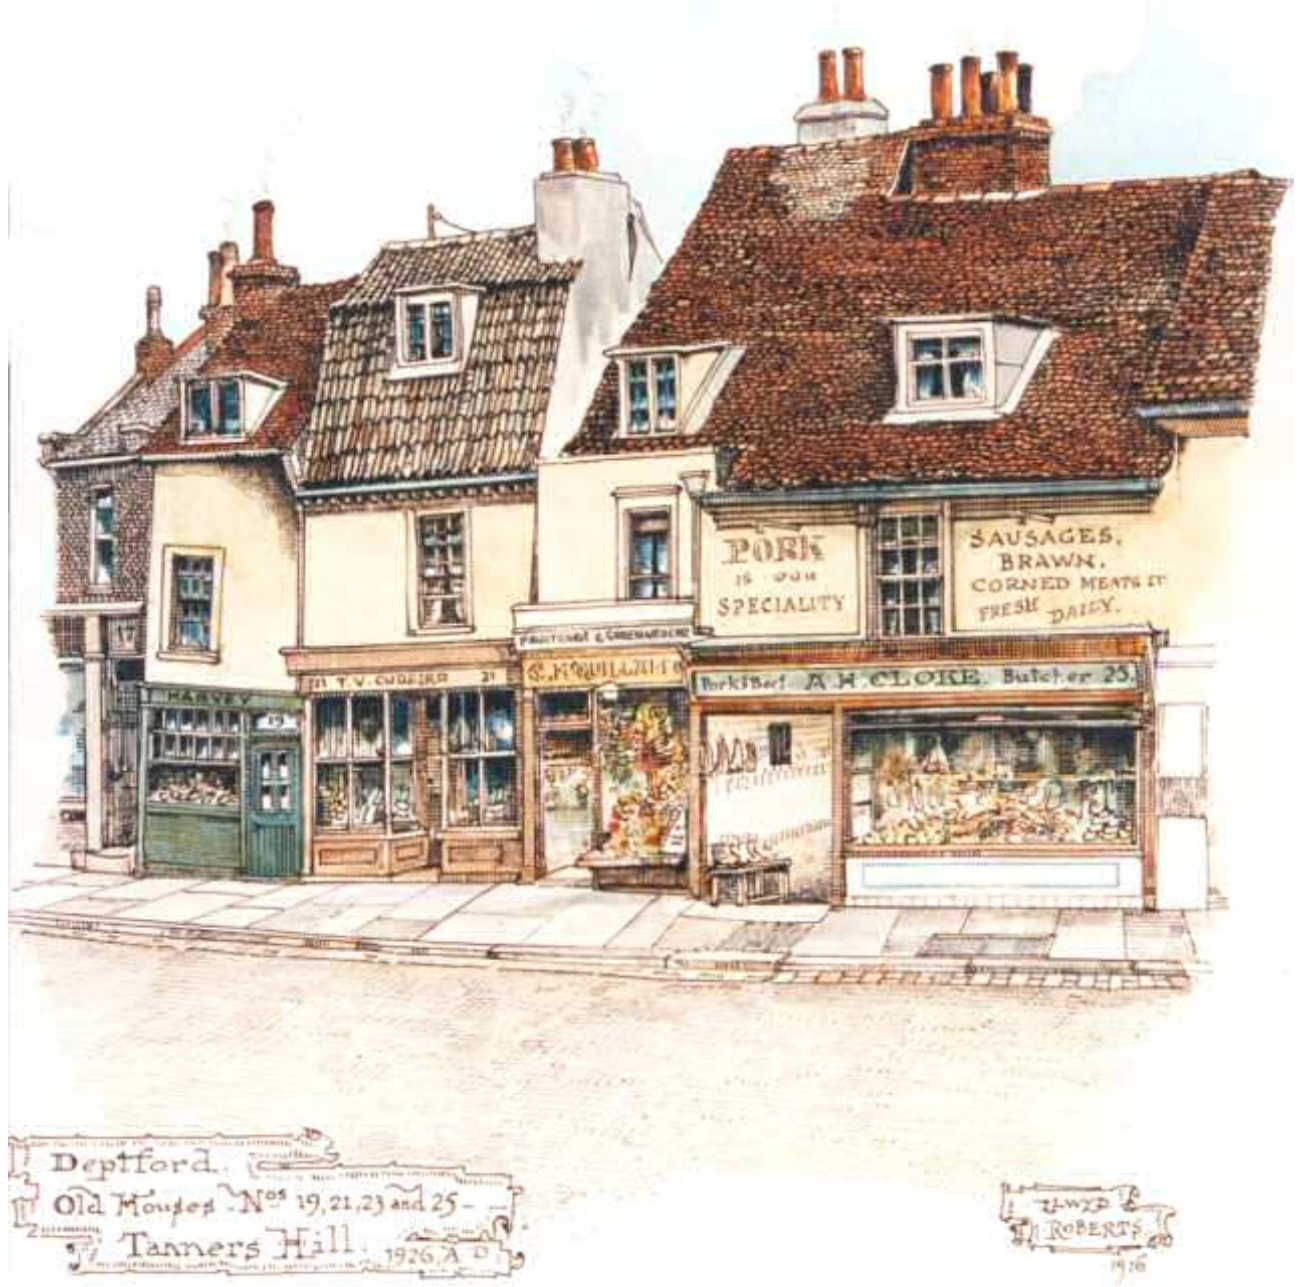
Historic Plate 1 Watercolour of Nos. 19-25 Tanners Hill painted in 1929

- 5.1.9 A watercolour of Tanners Hill (Nos 19, 21, 23 and 25) drawn in 1929 by John R. Llwyd Roberts (**Historic Plate 1**) gives some impression of the character of the area and the retail use of the buildings during this period.

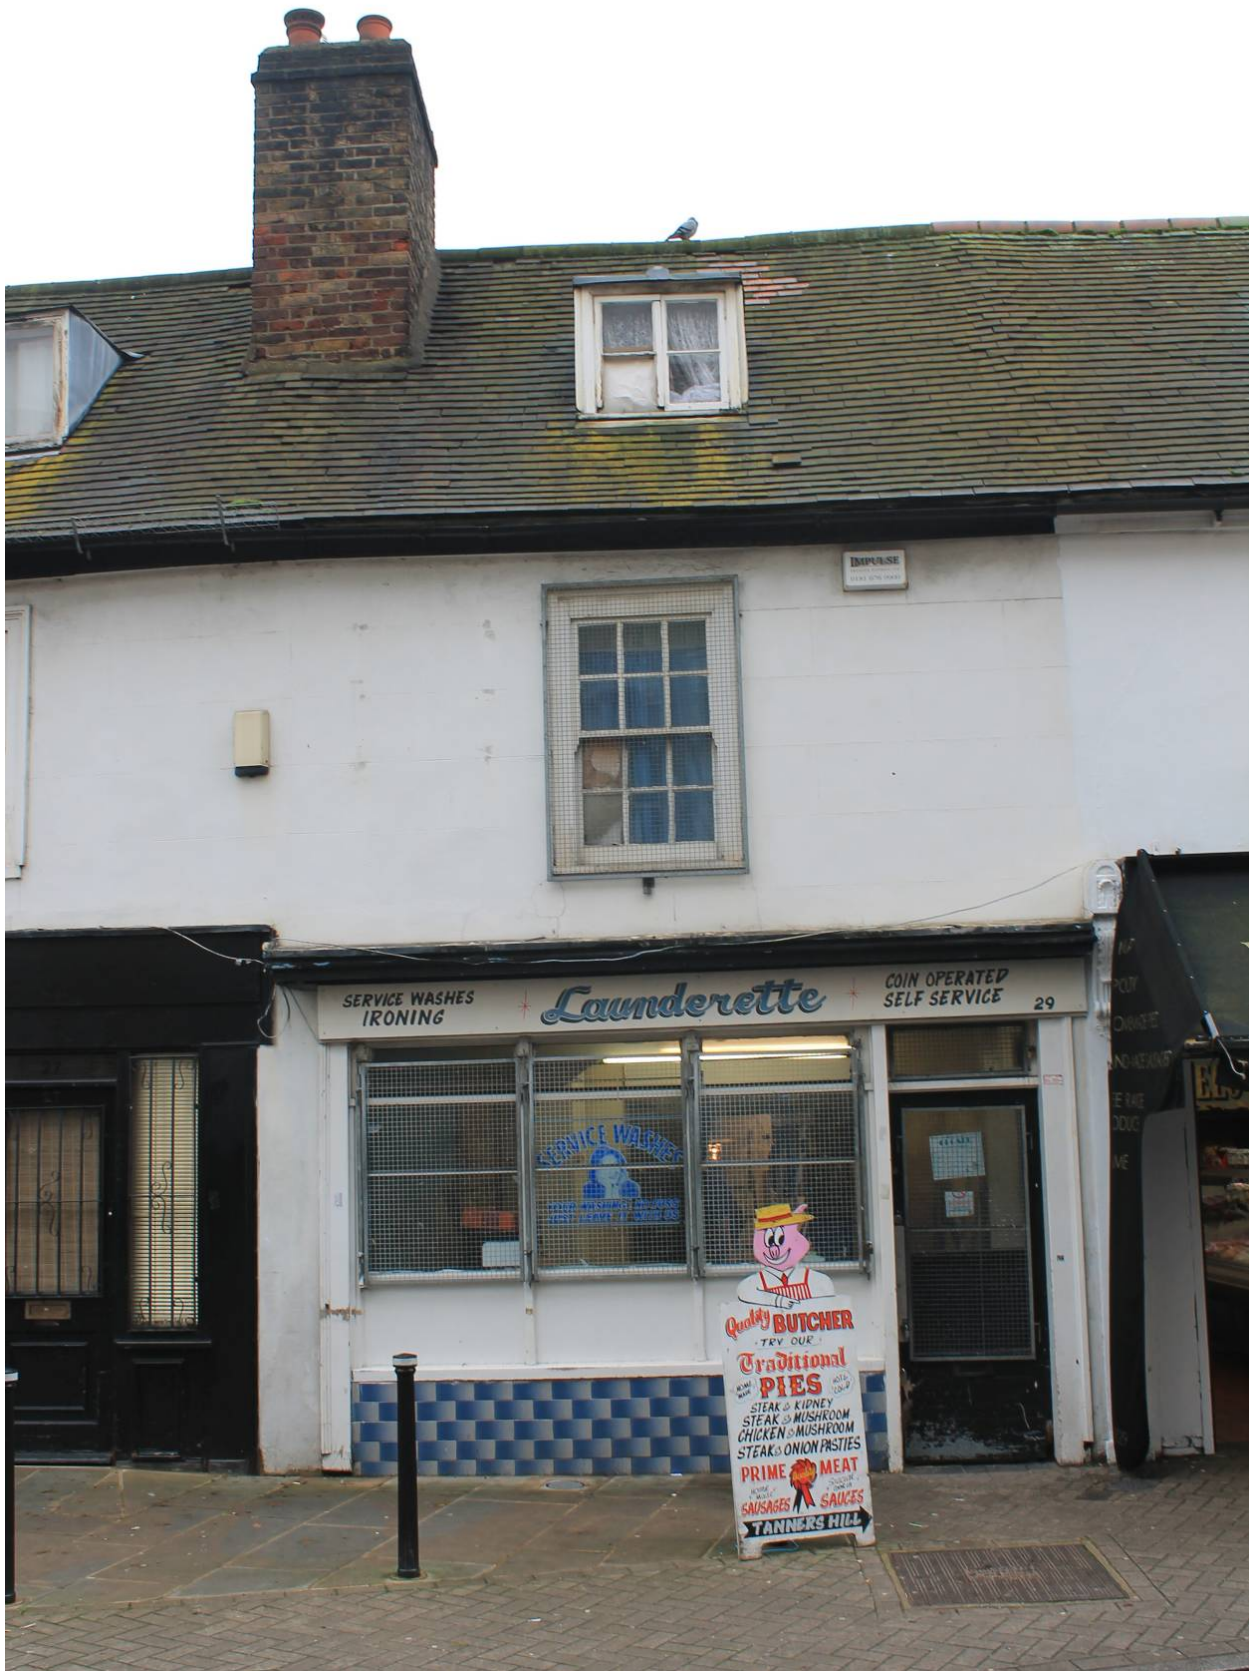
- 6.2.1 No. 29 forms one of a row of small two and half storey timber-framed cottages along the south-eastern side of Tanners Hill as it curves eastwards to meet Deptford Broadway. The row of cottages, through alterations and adaptations, present a mixture of facades and roofs to the streetscape. The cottages in this row have been converted to retail use and accordingly incorporate modern or remnants of 19<sup>th</sup> century shop fronts at ground floor level. The first floor level of these cottages incorporates a single central window opening, which lies directly below and in line with a flat roofed dormer window to the attic storey.

Plate 1 No. 29 facade fronting onto Tanners Hill/Clarence Place, looking south

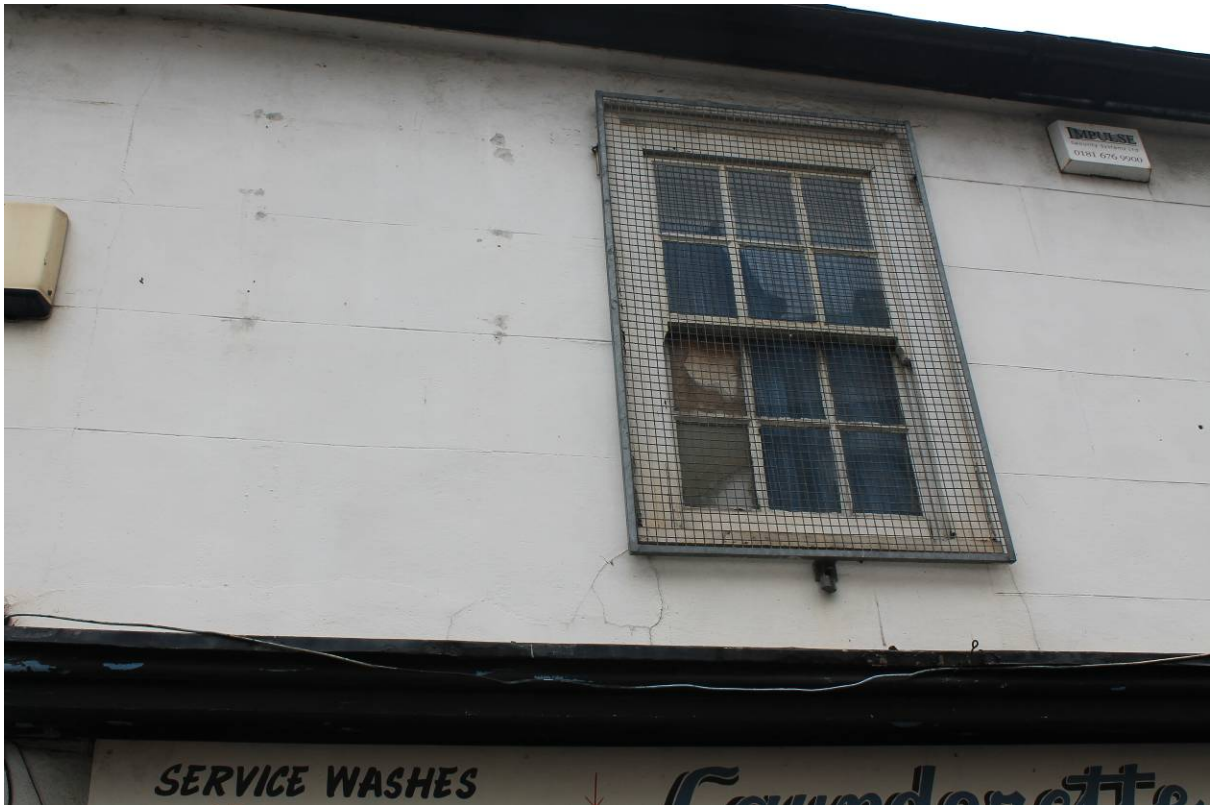
- 6.2.3 The wall above the shop front at first floor level has been rendered and subtly scored with incised lines to represent ashlar blocks (**Plates 1 and 2**). The first floor window opening lies centrally in the facade and includes a 19<sup>th</sup> century six over six horned sash window with glazing bars and recessed surround. The small dormer window above, has a small 19<sup>th</sup> or early 20<sup>th</sup> century casement window of four lights and a leaded flat roof with leaded side elevations. The roof of No. 29 was covered in machine-made red clay plain tiles. The through pitch stack, which was located along the party wall with No. 27 next door, was built in what appeared to be 18<sup>th</sup> or early 19<sup>th</sup> century stock bricks (**Plate 1**). It was built with a single over-sailing course and has a pair of terracotta pots. The flashings to the stack are cement render.

Plate 2 No. 29 facade with line out render and horned sash window at first floor level, looking south

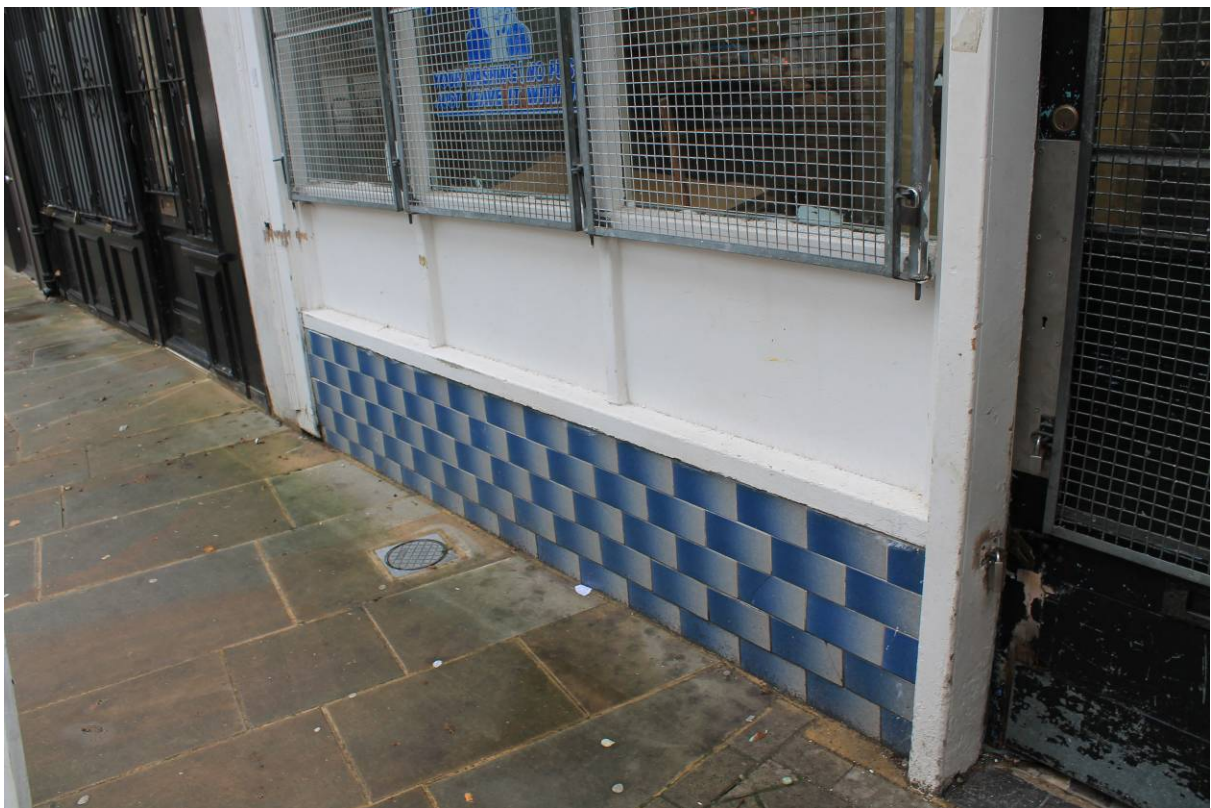
- 6.2.2 The shop front to No. 29 is a modern post-war addition, probably added when it was first in use as a Cafe during the mid 20<sup>th</sup> century and into the 1960s. The shop front is part-glazed, with a ceramic tile clad apron below a large, fixed, single glazed window of three equal lights and two timber mullions (**Plates 1 and 3**). This included a narrow light, with a louvred ventilating window below the window head, that aligned with a rectangular fixed light over the main entrance. The entrance door was also part glazed. The surround to the shop window, was also modern and lacked any architectural detail. A decorative consol bracket allied with a more ornate 19<sup>th</sup> century shop frontage to the adjacent butcher (No. 31) survives at the junction of the two cottages.

Plate 3 Detail of tiled apron and shop front, looking east

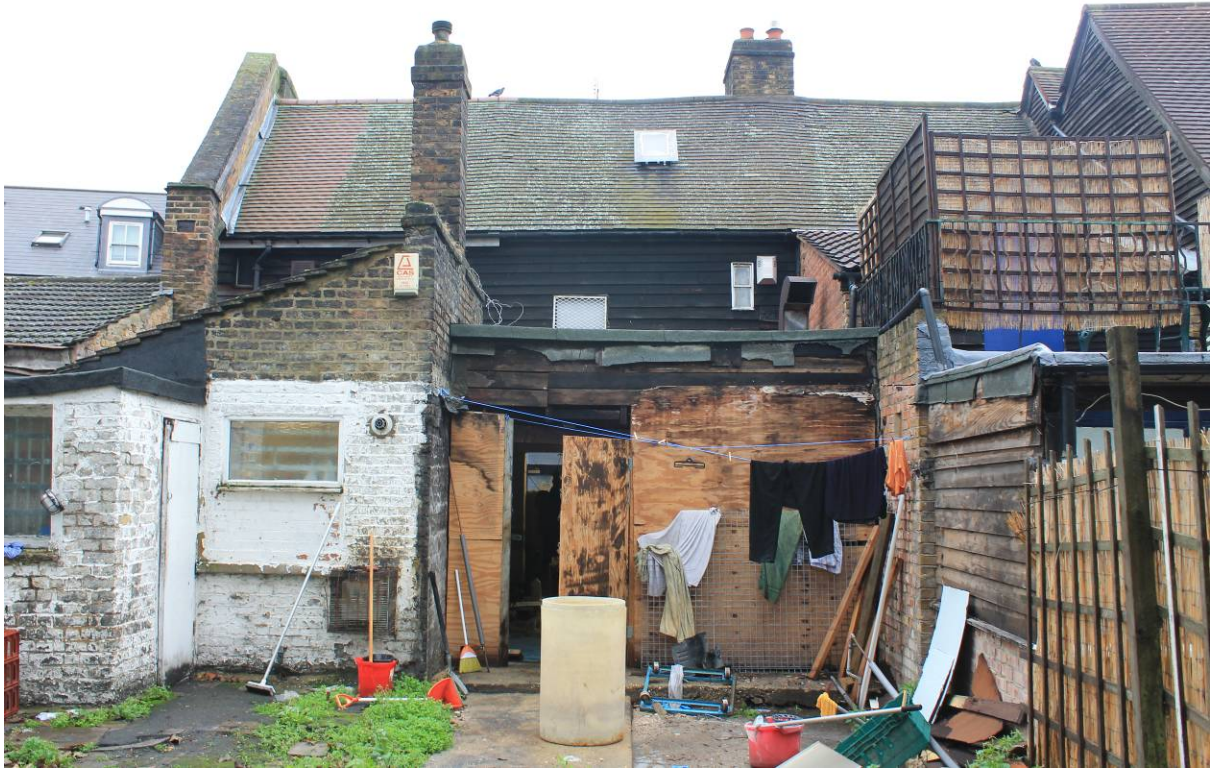
- 6.2.4 The rear (south-east) elevation was much plainer than the facade, the visible first floor was covered using modern black stained horizontal feather-edge weatherboarding, which included two openings, one to the first floor bedroom and a smaller casement window to the stairs (**Plate 4**). The ground floor was a modern low quality construction, built between and taking advantage of brick built rear extensions of the properties either side. It was also clad in weatherboard and was built with a felt covered flat, almost butterfly roof, which unusually drained to a valley situated along the line of an earlier out-shut or lean-to. A small flush roof light had been inserted into the rear roof pitch.

Plate 4 Nos 29 (centre) and 31 (left) rear (south-east) elevations, showing 'flat' roofed rear extension, looking north-west

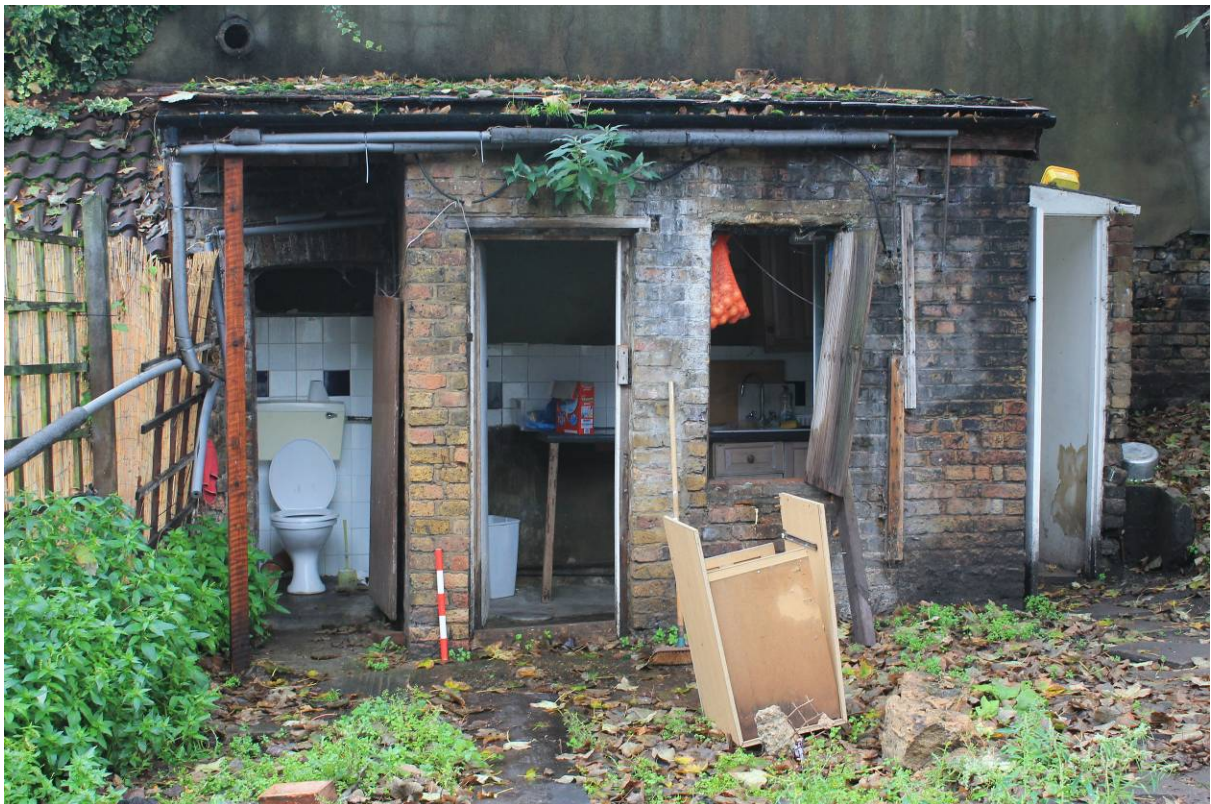
6.2.5 The small outbuildings were constructed up against and backing onto the rear (south-east) garden boundary wall. They were constructed using large 19<sup>th</sup> century yellow and red stock bricks, which were laid in no particular bond and had a shallow pitched lean-to roof covered in grey slate (**Plate 5**). The openings either used replacement lintels or rough brick arches. No original architraves, window frames or doors remained. Internally all fixtures, fittings and decorations were modern. The outbuildings were most likely originally built to provide a wash house and toilets, and latterly broadly continued in this use, used as outside toilets and as washing and shower facilities.

Plate 5 Outbuilding, looking south-east

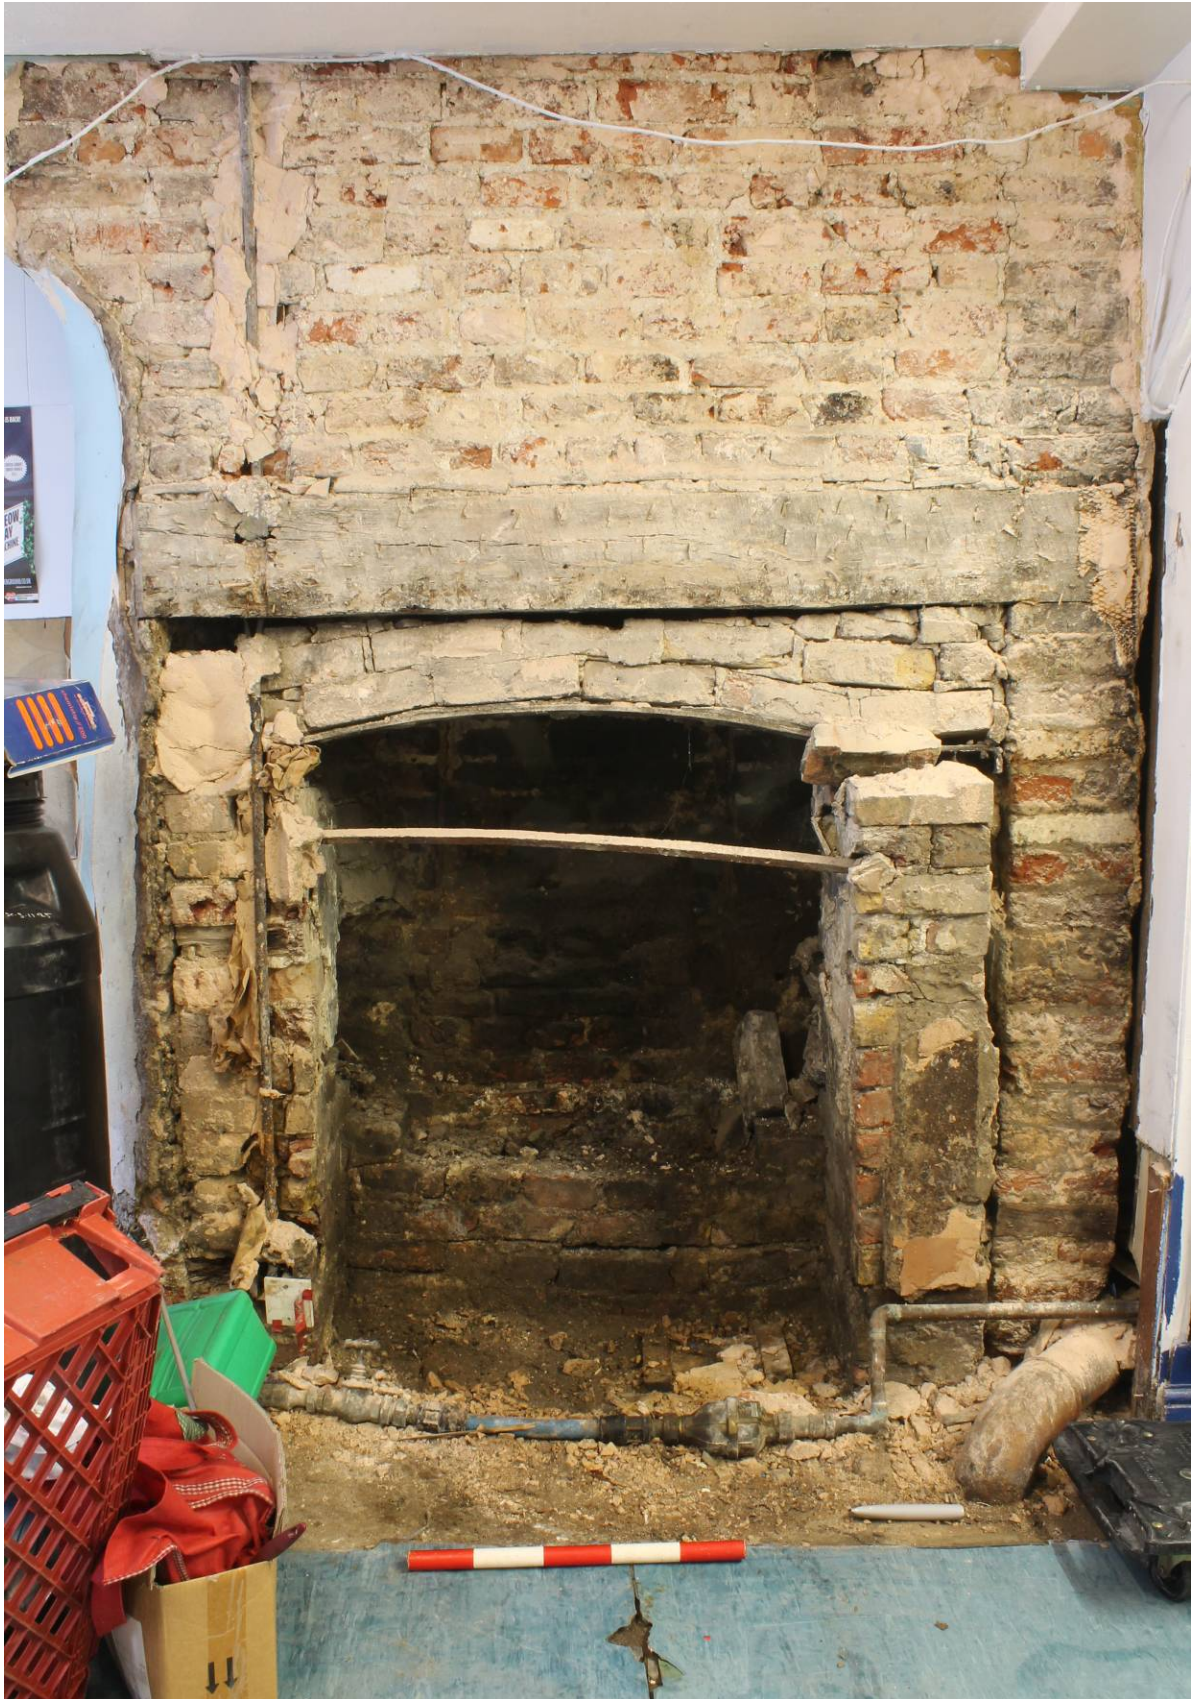
6.3.2 The principal feature of the front part (Area 1) is the fireplace and breast projecting into the room from the eastern party wall (with No. 27). This large fireplace, built using early 18<sup>th</sup> century brickwork was corbelled over to the north, presumably to ease access in this area, and was abutted to the south by a timber winder staircase to the first floor (**Figure 13**; **Plate 6**). The fireplace was constructed using long, but quite narrow red bricks (230 x 50 x 100-105mm), laid in an irregular bond with wide un-pointed mortar joints, suggesting that the fireplace was originally plastered. A remnant of horse-hair plaster was seen trapped between the fireplace and the adjacent staircase. The fireplace showed two clear phases of construction, the original build (bricks described above), which included a heavy oak lintel or bressumer that had been cut away at the rear to help the fire draw, and a later remodelling of the fireplace. This later alteration was built using larger mid 19<sup>th</sup> century or later brickwork (220 x 70 x 110mm). It decreased the size of the fireplace opening by adding a wrought iron lintel to support a new arch, added new jambs (1 course thick) to both sides of the opening, introduced splayed brickwork to the inner sides of fireplace to increase the up-draught and built a plinth (of brick courses) to the rear of the hearth to heighten the fire basket.

Plate 6 Fireplace with corbelled angle within front part of the building (Area 1), looking east.

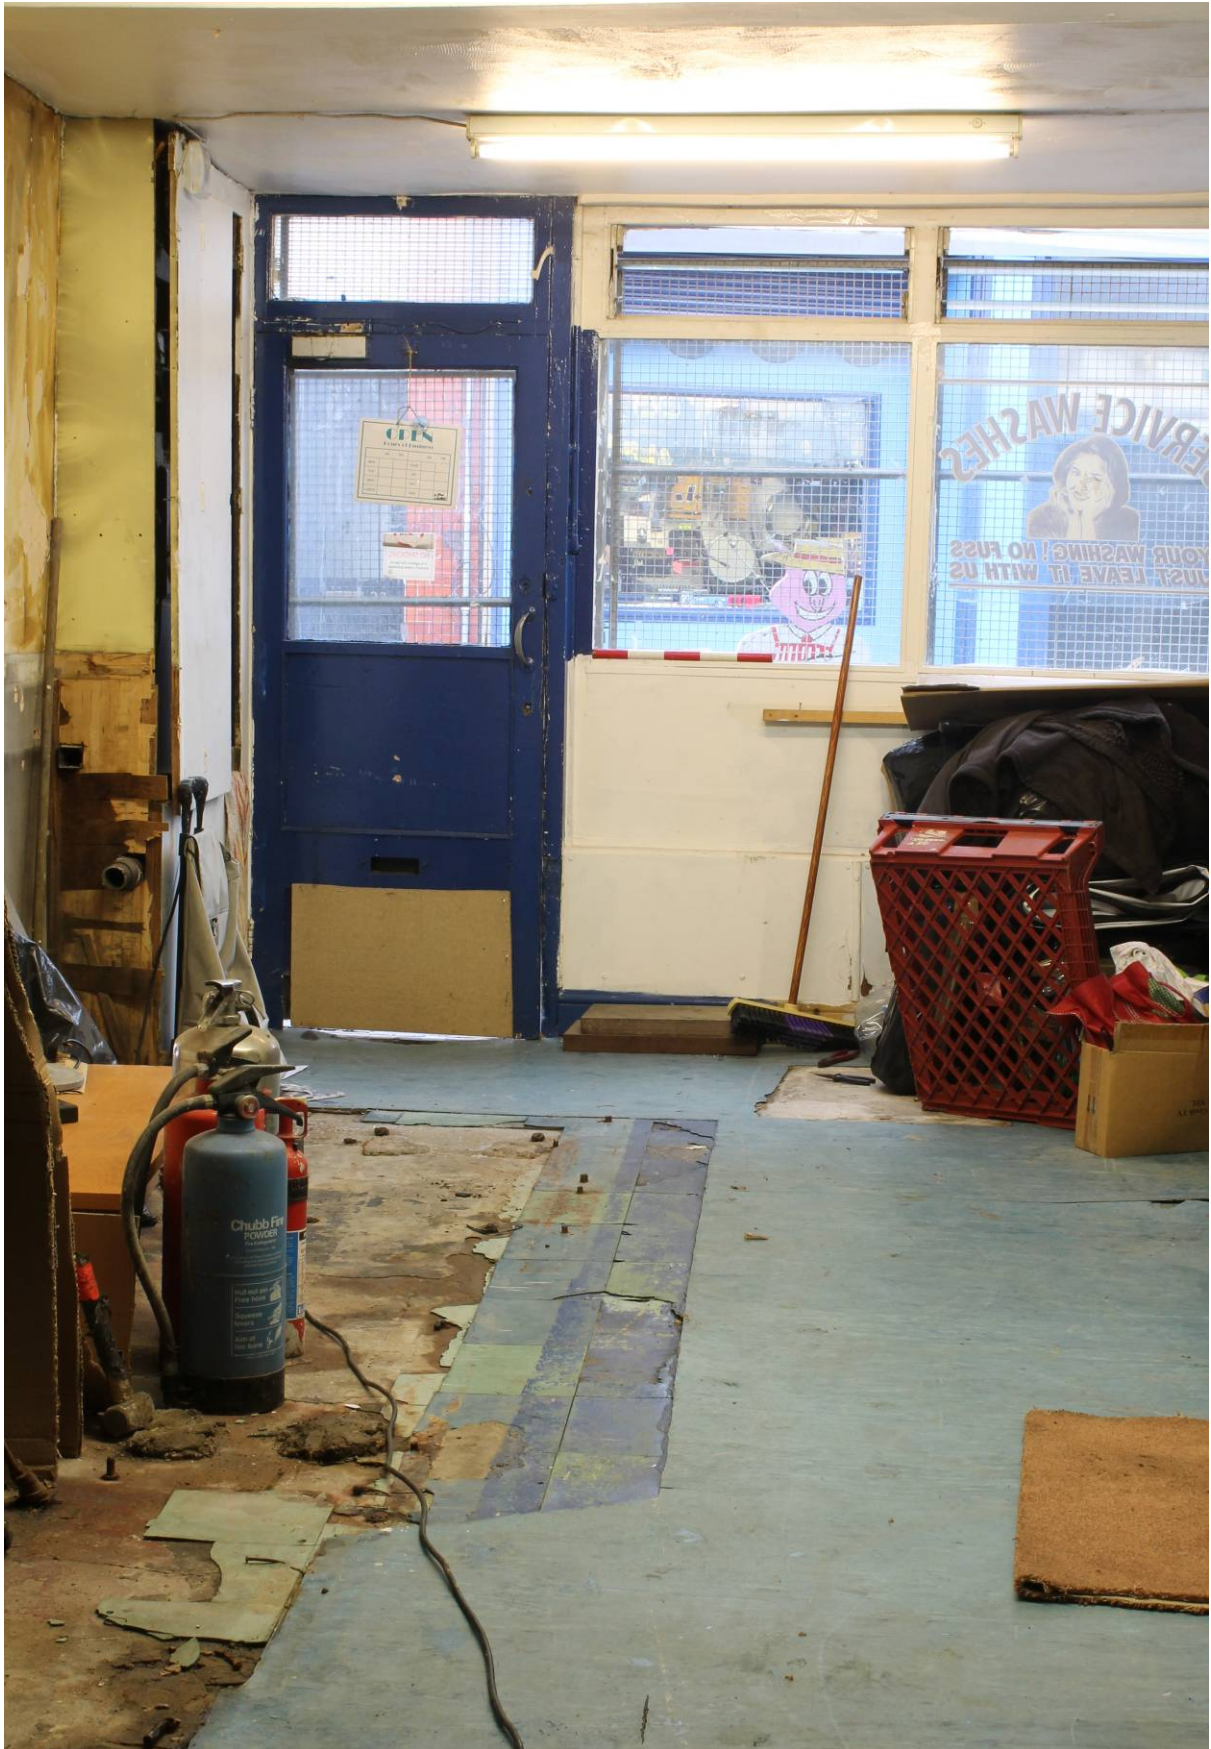
Plate 7 Front part (Area 1) and shop front, looking north

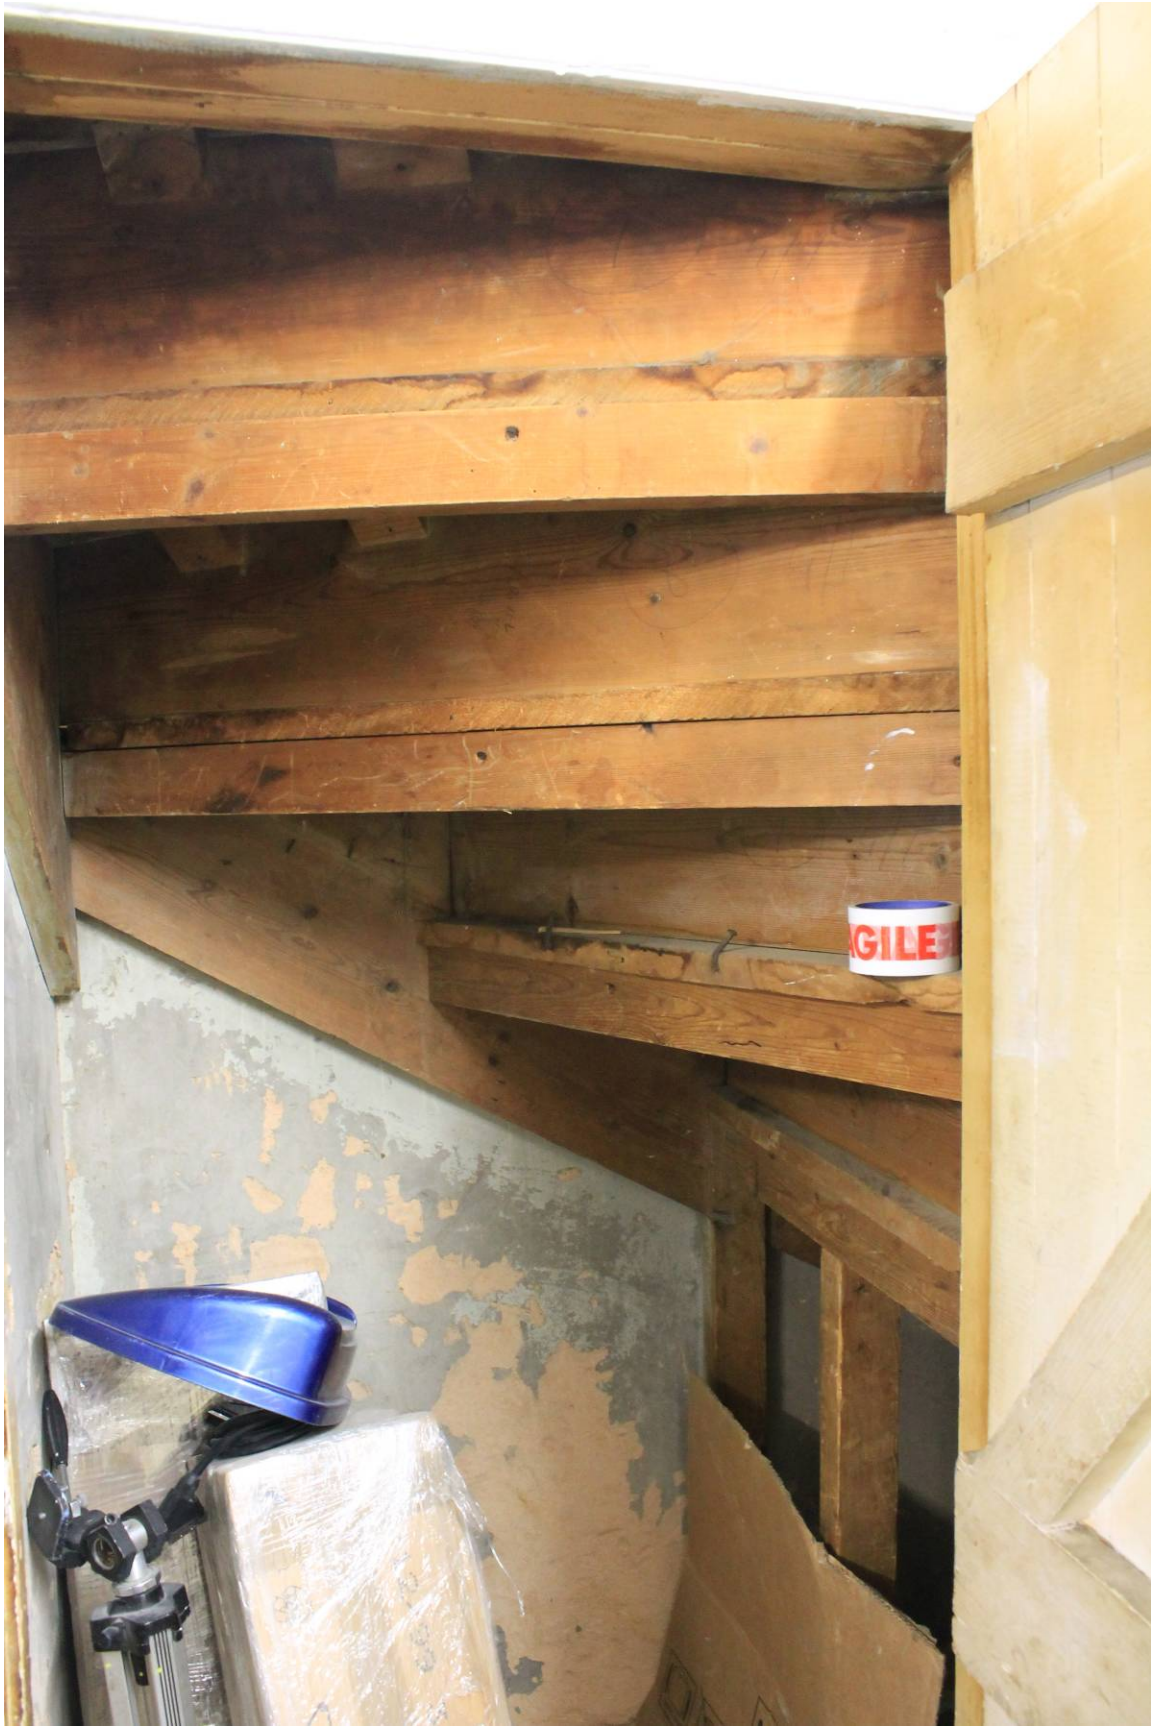
6.3.3 The timber winder staircase to the first floor is a closed riser stair built into a small constricted space to the rear (south) of the fireplace. It is accessed via a simple plank and batten door which had latterly been boarded over on its room facing elevation. Analysis of the present stair, via an under-stairs cupboard built into the space adjacent to the fireplace, revealed that the stairs (from ground to first floor at least), though probably adopting the form of an original, was a later rebuild (**Plate 8**). It was constructed from very regular machine-cut and planed softwood timber which had been screwed together using slotted screws. The timber suggests a relatively modern rebuilding, possibly reworked as a consequence of the reported fire, the damage of which was apparent in the rear part of the building (Area 2) just south of the stair.

Plate 8 Under-stairs cupboard revealing the structure of the narrow winder stairs, looking east

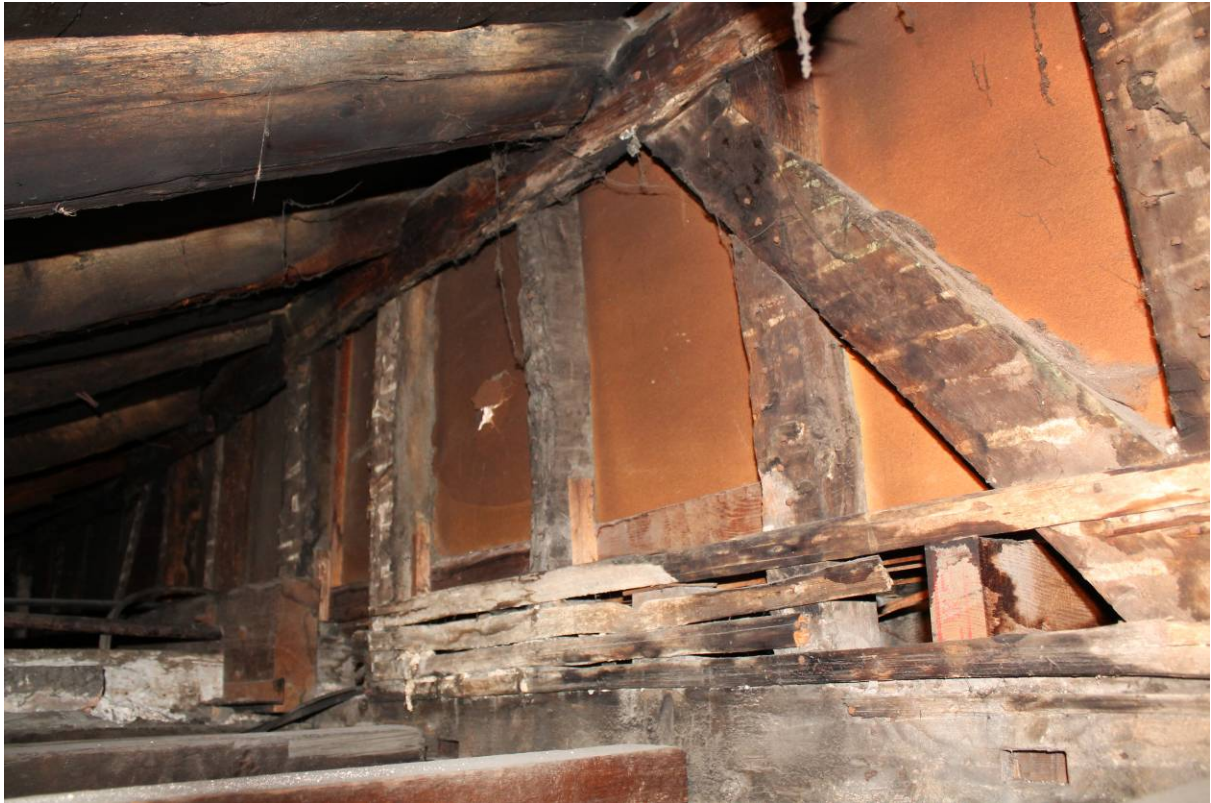
6.3.4 The western wall in Area 1 had been plastered in recent years and so analysis was limited. The original timber-framed rear wall to the cottage at the junction of Areas 1 and 2 and just south of the stairwell, had been removed at ground floor level to unite the two spaces. This involved the insertion of a 4½ inch I-section RSJ, supported on two brick piers, along the line of the rear wall and directly below and supporting the timber mid-rail or girt of the first floor and upper register (**Plates 9 to 12**).

6.3.5 The mid-rail and the lower section of the upper register (wall-frame) were visible above the ceiling joists of the modern rear extension and below the mono-pitch roof of a much earlier lean-to extension, built up against the original rear elevation. The visible timber-framing (upper register) comprised typical primary bracing, using diagonal tension braces, which interrupt the studs (**Plates 9 and 10**). The latter were cut and nailed into the diagonal braces. All the wall-framing was built using pit-sawn softwood, with relatively light scantling studs and braces of between 4 x 3 inch or more typically 3 x 3 inch. The mid-rail was of a heavier scantling (5 x 3½ inch) and showed evidence of a series of empty mortices cut into its outer (rear) face (**Plates 9**

- and **11**). These small mortices (1 x 2 inch) were regularly spaced along the length of the mid-rail (at 19 inch centres) and most likely held the ceiling joists of the earlier lean-to extension.

Plate 9 Primary braced upper register and mid rail, below lean-to roof, to the rear of No. 29 and 31

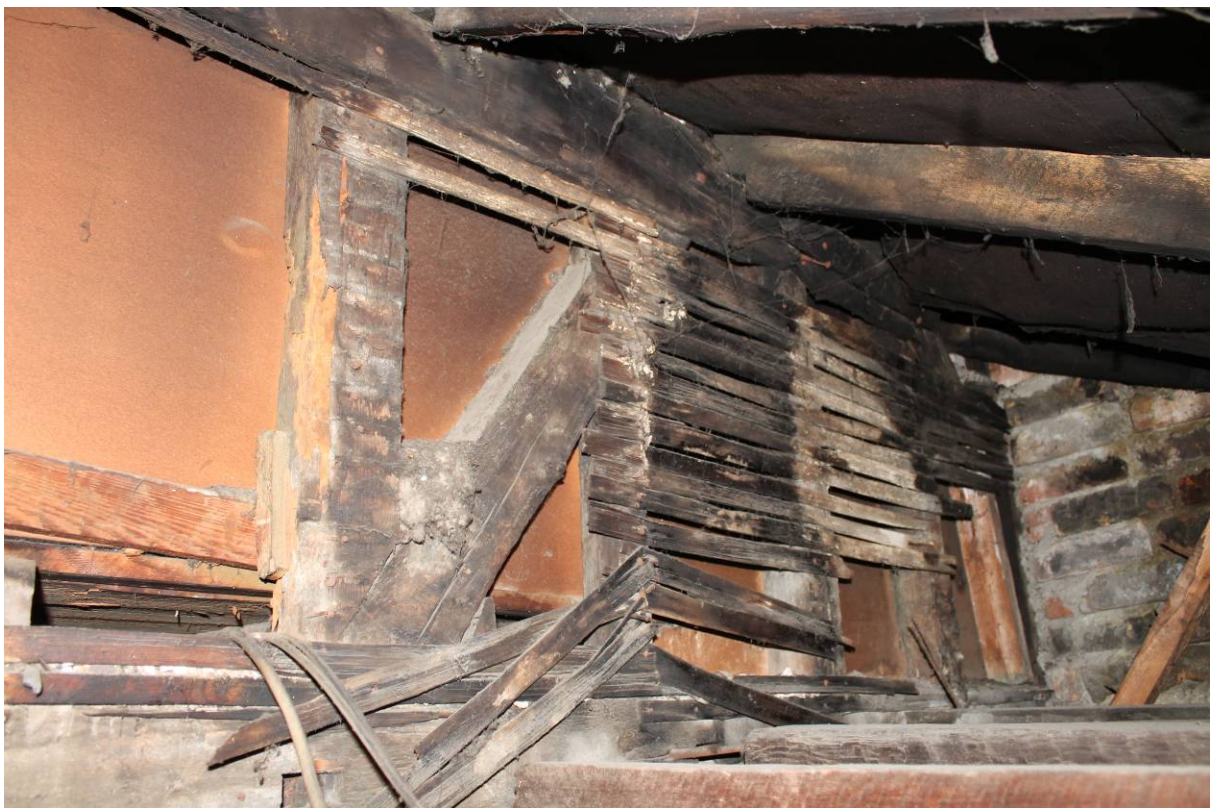
- 6.3.6 The roof structure of this earlier lean-to, which extended the length of No. 29 and the adjacent No. 31 and may have extended to encompass No. 27 also, was built using roughly sawn softwood rafters, some halved and still partly in the round (**Plates 9, 10 and 12**). The rafters were notched over a softwood ledge that had been nailed onto the lower wall-frame (**Plate 12**). This ledge or batten also extended the full width of the two buildings (Nos 29 and 31). The rafters, particularly to the east were distinctly discoloured and some slightly burnt, as a consequence of the fire of 1964 (**Plate 10**).

- 6.3.7 The wall-frame between the modern ceiling and the lean-to roof structure was clearly previously plastered prior to the addition of the lean-to roof as remnants of laths, nailed onto the studding, still survived within this roof space (**Plate 10**).

Plate 10 Primary braced upper register looking east toward No. 25, showing lathes and lean-to roof

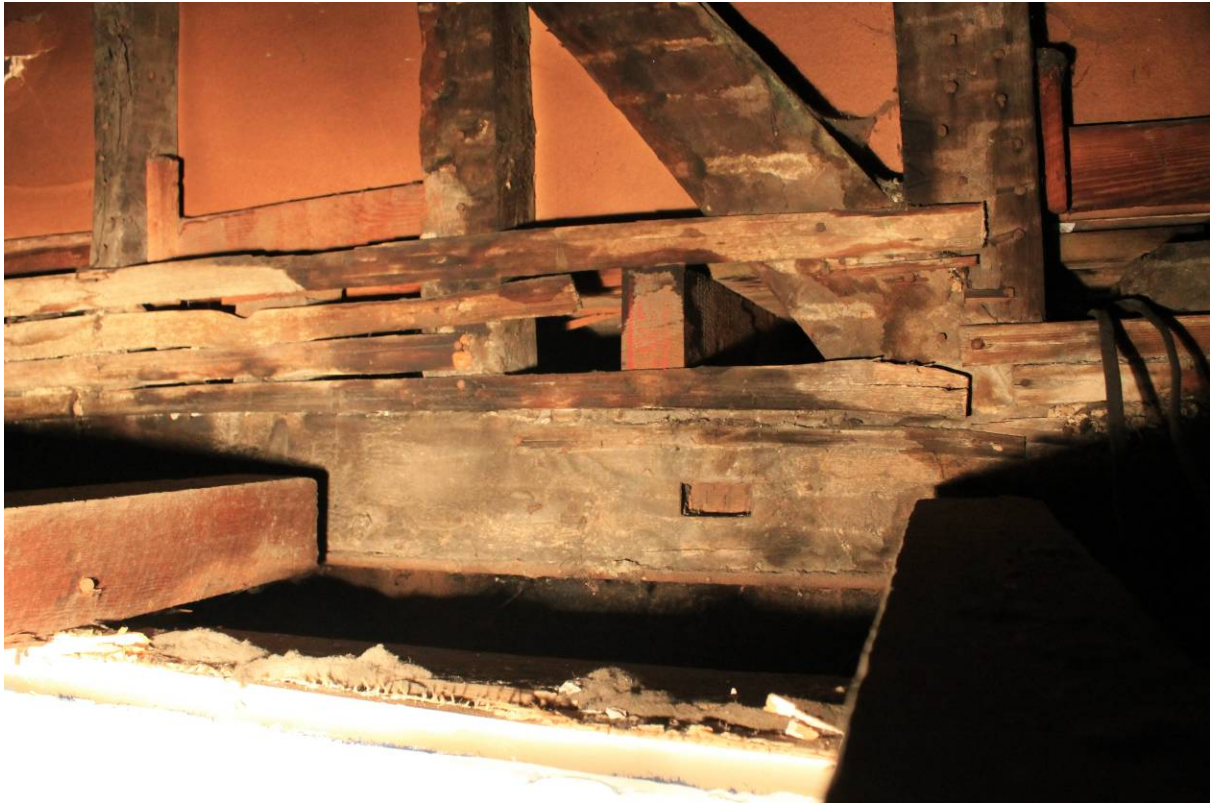
Plate 11 Detail of empty mortise in mid-rail (for ceiling joist)

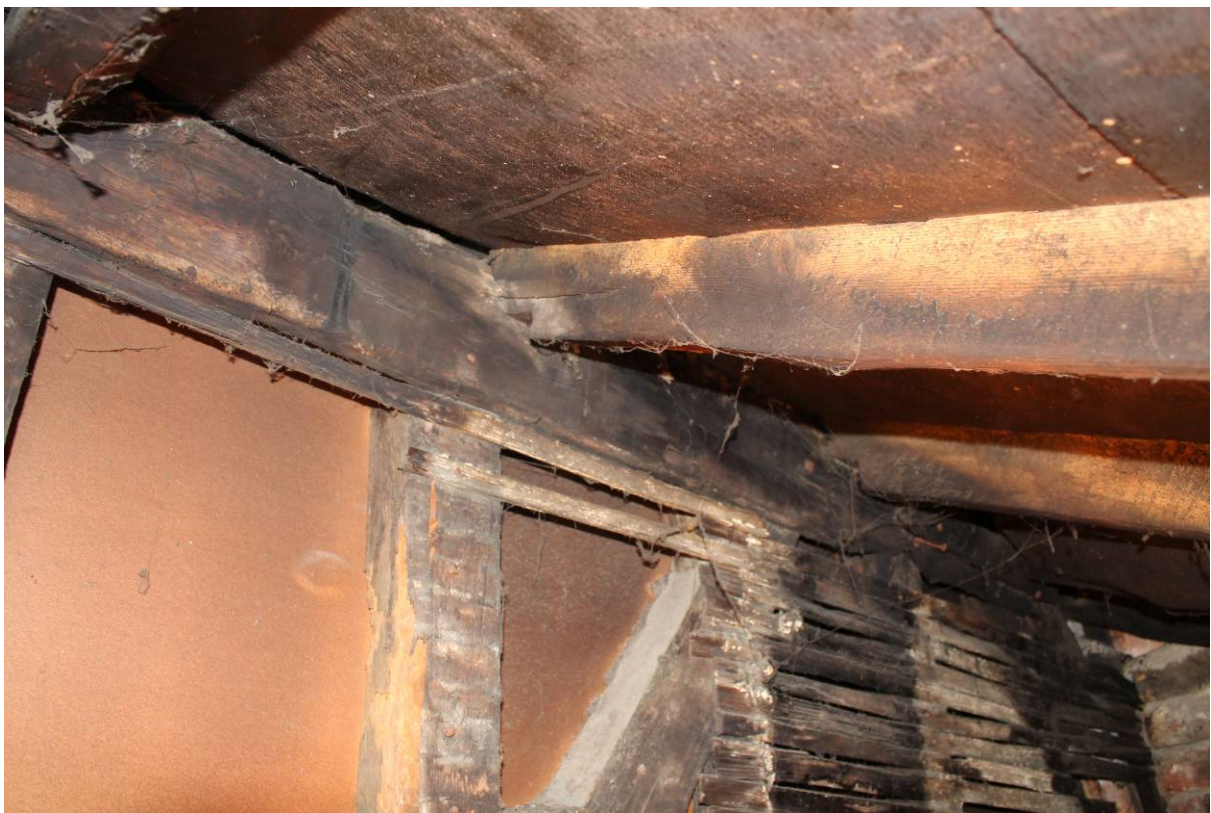
Plate 12 Detail of nailed-on batten/ledge supporting lean-to roof rafters

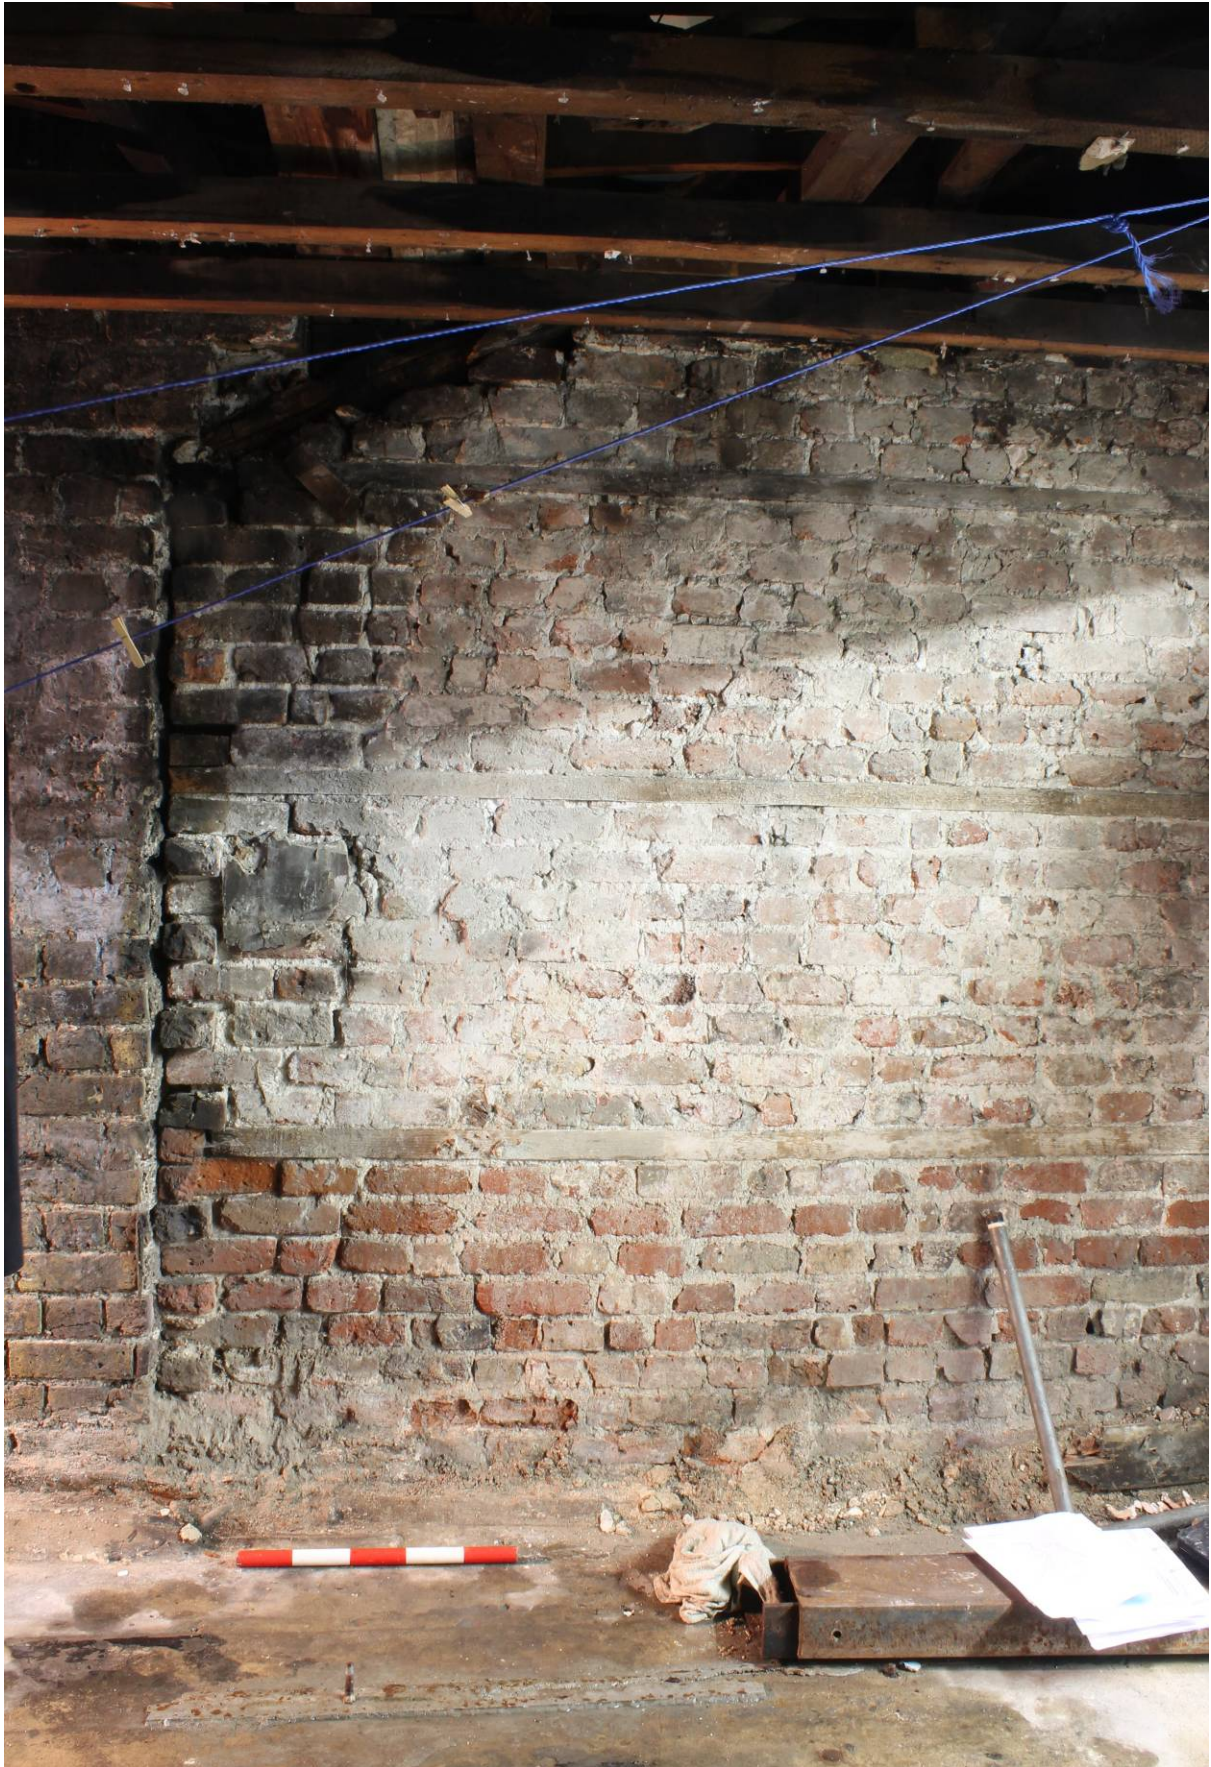
- 6.3.8 Whilst most of the structural evidence of the earlier lean-to had been removed at ground floor level, particularly its southern end wall, the eastern and western flank walls still partly remained intact. The western wall (brickwork A) of this initial extension was built using red bricks, measuring 210-220 x 60-65 x 100mm) laid in an irregular English bond (**Figure 13; Plate 13**). The brickwork comprised many three-quarter and half bricks held in a lime rich mortar and also included three 2 inch softwood bearers, every c.7 to 8 courses and 9 courses from the floor. This wall rises only to the level of the ceiling leaving the roof space open between Nos 29 and 31 (**Plate 9**). The style and dimensions of the brickwork and the rough none machine-cut joists would suggest a late 18<sup>th</sup> or early 19<sup>th</sup> date for the addition of this lean-to.

Plate 13 Brickwork A of lean-to extension showing timber bearers
