**HISTORIC BUILDING  
RECORDING OF  
NO. 29 TANNERS HILL,  
DEPTFORD, LONDON  
BOROUGH OF LEWISHAM,  
SE8 4PJ**

**SITE CODE: TAN14**

**PCA REPORT NO. R11895**

**DECEMBER 2014**

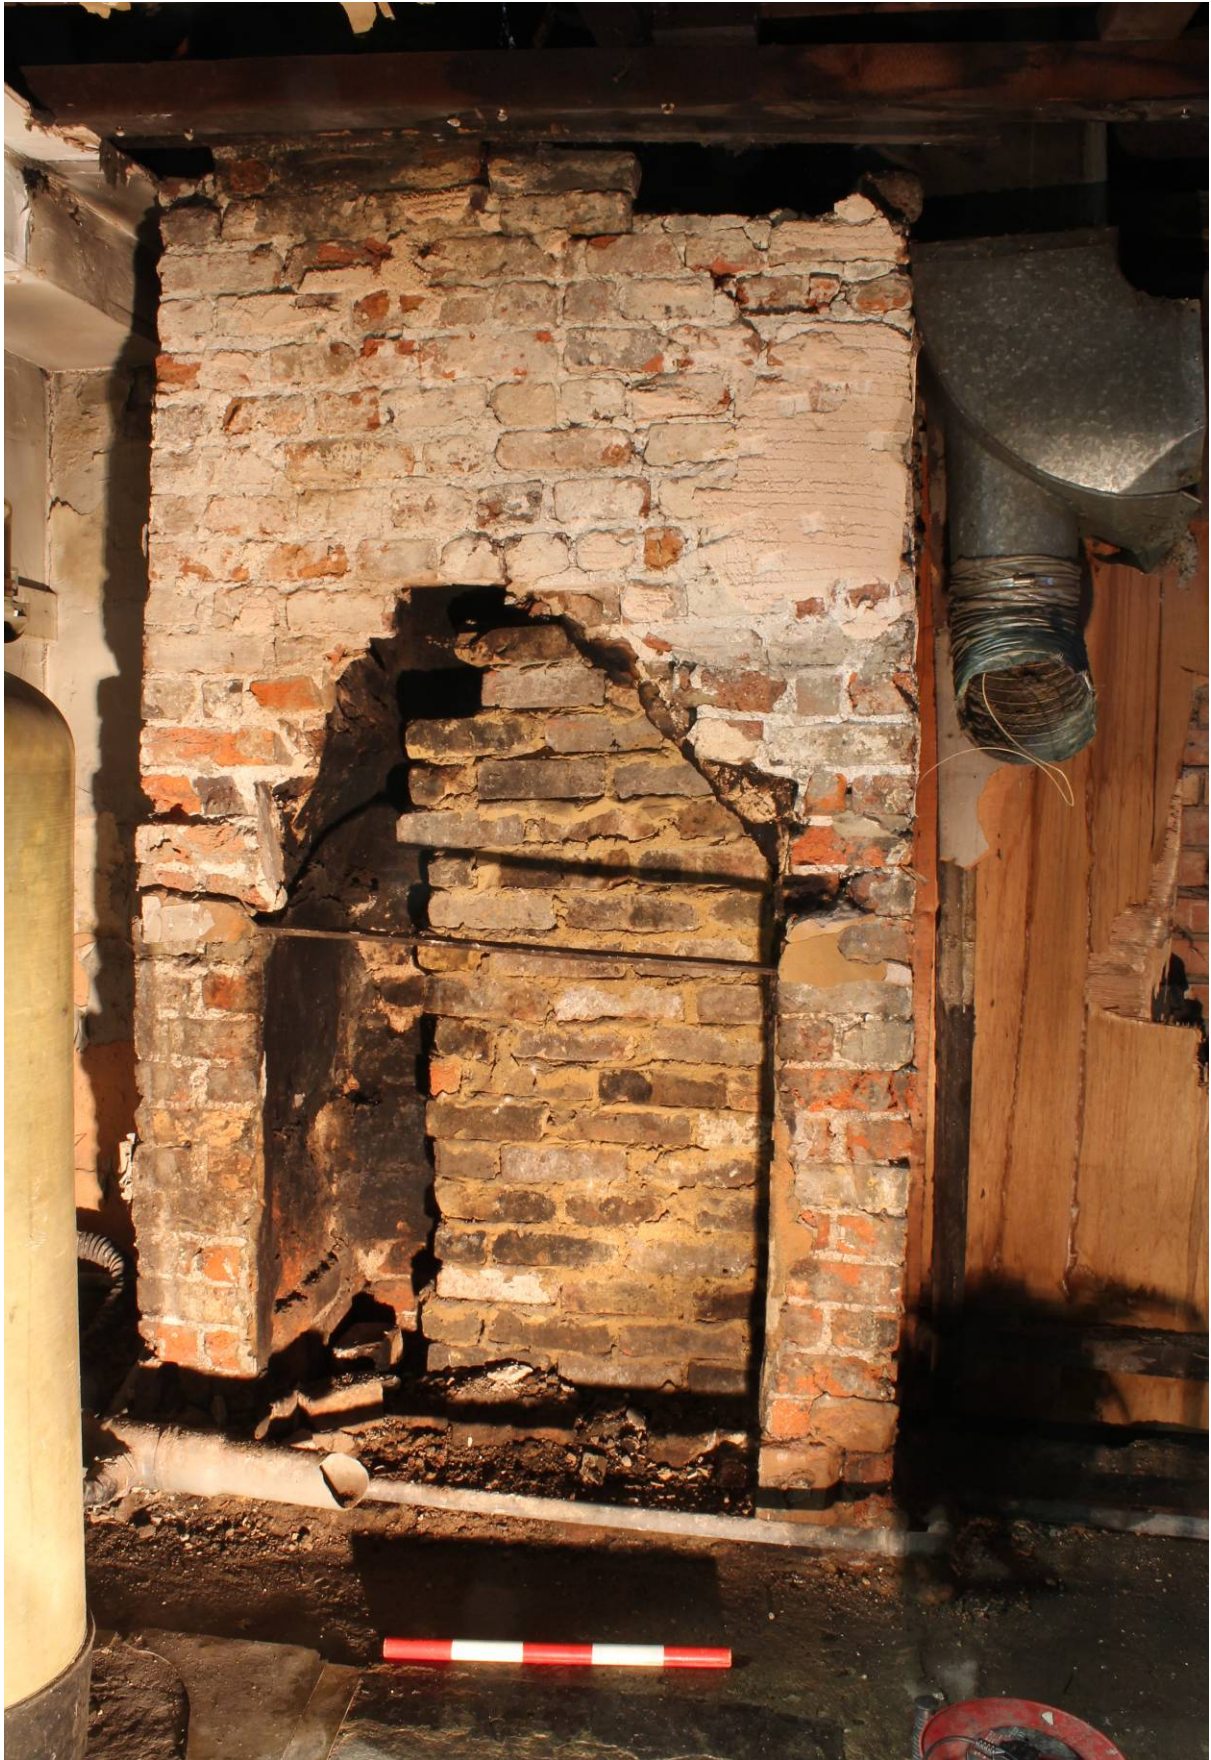
- 6.3.9 The surviving section of east wall was built in similar brickwork and incorporated a roughly central brick fireplace (**Plate 14**). It was built using the same brickwork as brickwork A in the opposite (west) wall, utilising and re-using many three-quarter and half bricks. The fireplace opening included a wrought bar, used as a lintel, which supported the brickwork above, latterly collapsed. No evidence of the fire surround survived. A brick flue opening into the adjacent property (No. 27) to the east had been inserted into the back of the fireplace. The flank wall to the south of the fireplace had been demolished and latterly rebuilt using a light-weight timber-frame of re-used and fire damaged timbers obviously recovered from the fire in the rear part of the building (Area 2) (**Plate 15**). This wall extended the full length of the rear part of the building (Area 2) and was previously clad with vertical match-boarding (recently mainly removed). This wall also covered a Fletton brick party wall, belonging to the adjacent property.

Plate 14 Fireplace within rear part (Area 2) of the building, east wall.

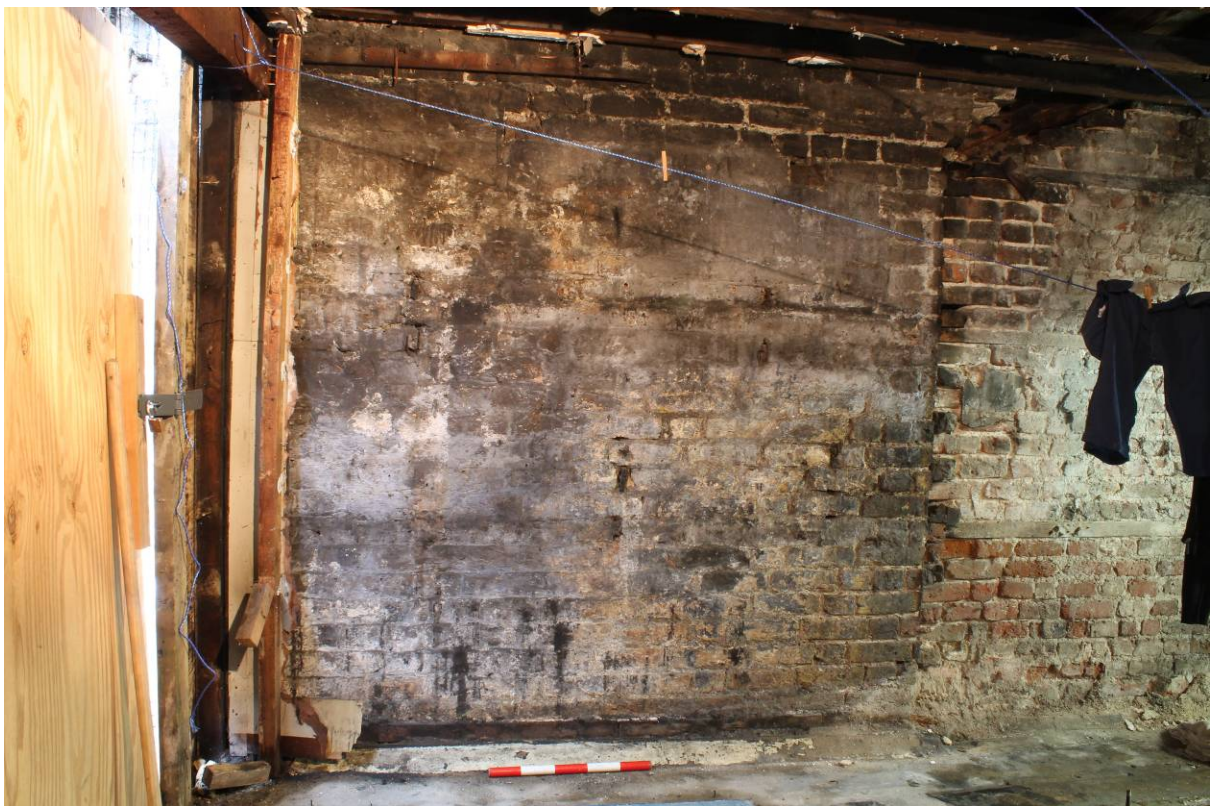
- 6.3.10 The flank wall of a mid to late 19<sup>th</sup> century extension added to No. 31 along the property boundary, was visible to the south of and abutting brickwork A (**Plate 16**). This wall (brickwork B) was constructed using typical yellow London stock bricks (225-230 x 70 x 105mm) in Flemish Bond. This small extension is first recorded on the Ordnance Survey map of 1869-71, so a mid to late 19<sup>th</sup> century date seems appropriate.

Plate 16 Flank wall of mid to late 19<sup>th</sup> century extension to adjacent butchers (No. 31), looking west
