**An Archaeological Evaluation on  
Land at the former Radwinter  
Mushroom Farm, Roman Road,  
Radwinter, Essex.**

**PRE-CONSTRUCT ARCHAEOLOGY  
R11898**

AN ARCHAEOLOGICAL EVALUATION

Pre-Construct Archaeology Ltd	
Project Number	K3717
Report Number	R11898

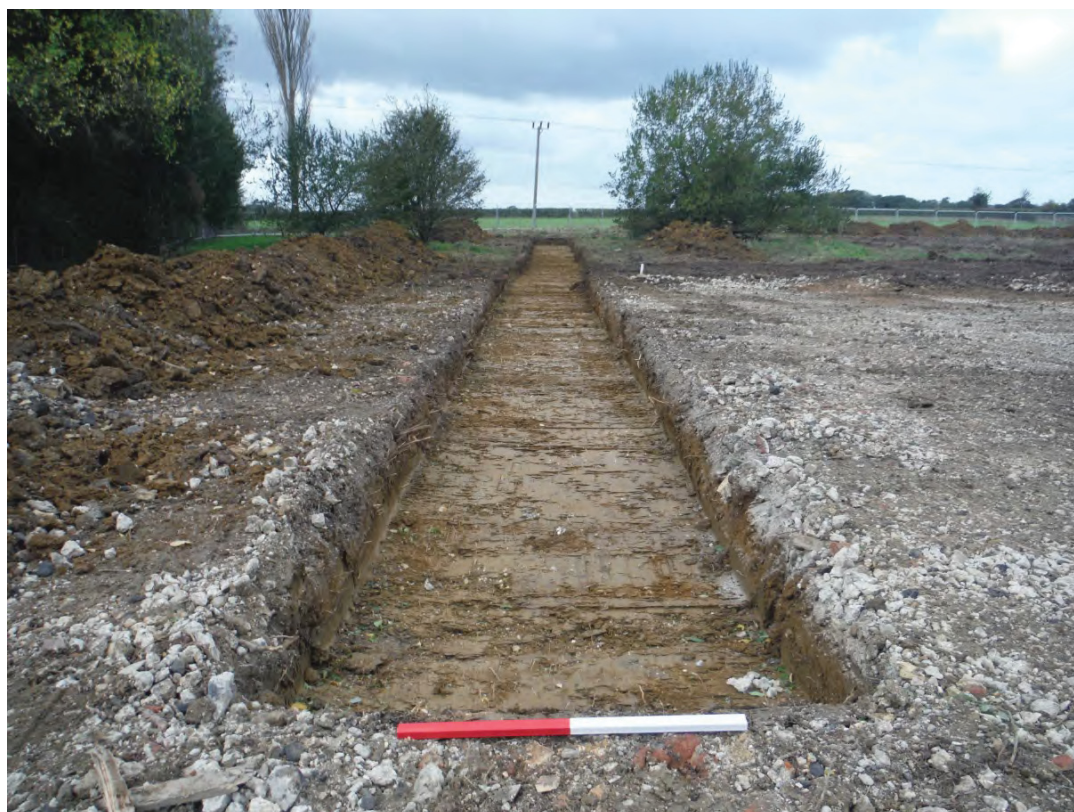
5.2.1 The eastern half of the trench was located in an area which had been levelled, with some disturbance to the overburden deposits through recent demolition activity. The underlying natural deposits remained undisturbed, with little or no impact from recent demolition activity.

TRENCH 1	Figure 2	Plates 1	
Trench Alignment: E-W	Trench Length: 49.5m		
Deposit	Context No.	Average Depth (m)	
		E End	W End
Demolition (Recent)	102	0.15	-
Topsoil	100	0.1	0.18
Subsoil	101	0.19	0.21
<b>Summary</b>			
Trench 1 was located in the southern end of the site, parallel to the southern site boundary.			
No archaeological features or deposits.

Plate 1: Trench 1, taken from the east.

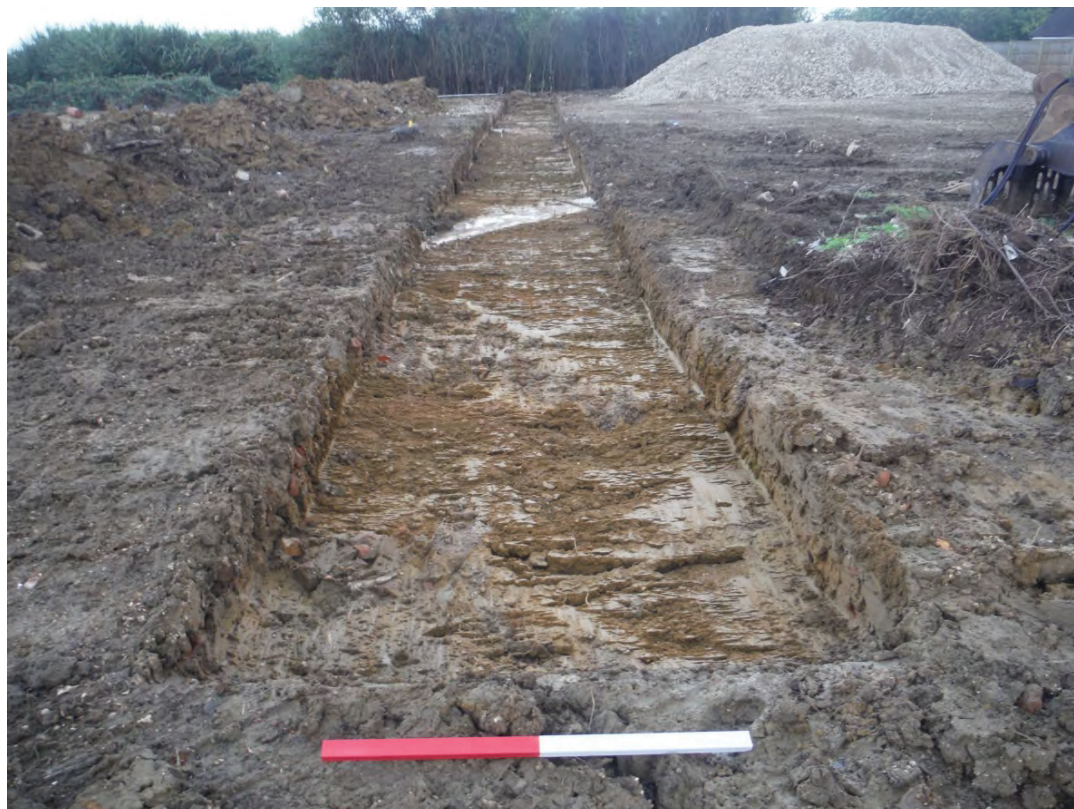
5.3.1 The north-western end of the trench was partially truncated by modern demolition, with modern demolition material pressed into the natural clay. Two linear concrete pads were also present within the trench, the majority of the trench was however undisturbed natural. The trench was located the closest to the known course of the Roman road, however no evidence was seen in the south-eastern end of the trench for the ancient road or any possibly associated road side ditch.

<b>TRENCH 2</b>	<b>Figure 2</b>	<b>Plates 2</b>	
Trench Alignment: NW-SE	Trench Length: 38.5		
<b>Deposit</b>	<b>Context No.</b>	<b>Average Depth (m)</b>	
		<b>SE End</b>	<b>NW End</b>
Demolition (Recent)	102	0.11	-
Topsoil	100	-	0.19
Subsoil	101	0.26	0.17
<b>Summary</b>			
Trench 2 was located centrally within the site.			
No archaeological features or deposits.

Plate 2: Trench 2, taken from the south-east.

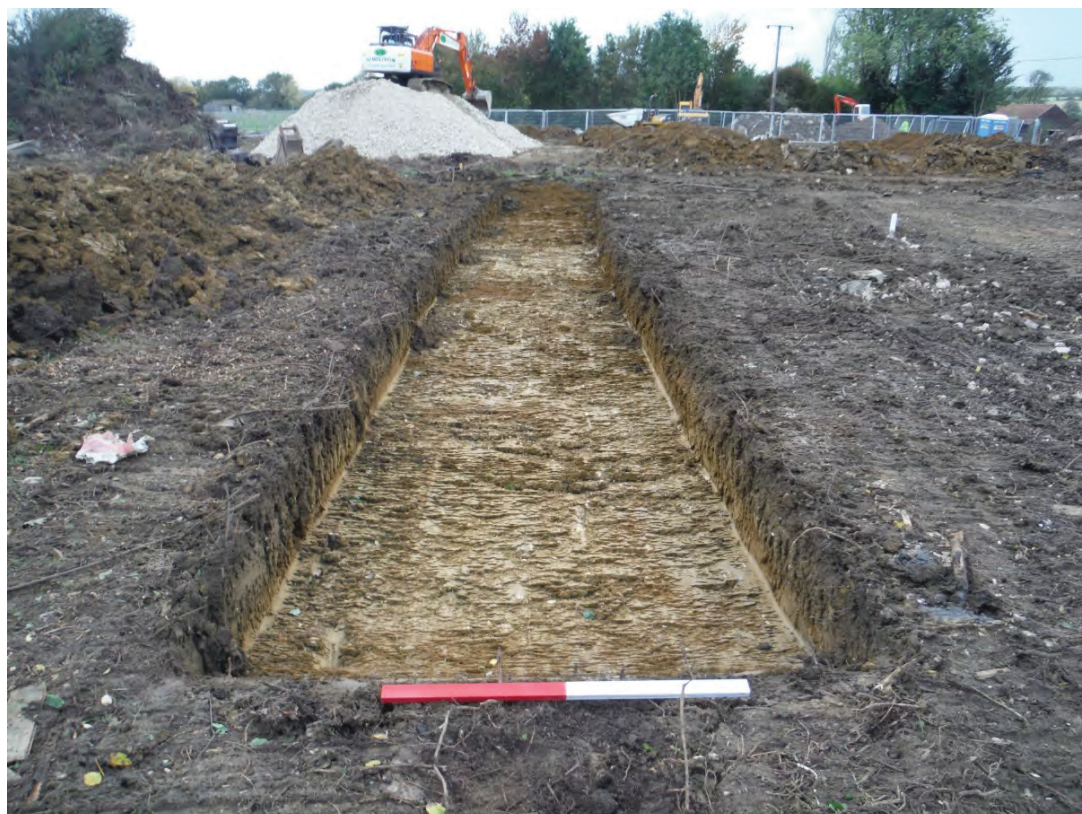
5.4.1 The trench contained no modern truncation, or disturbance.

<b>TRENCH 3</b>	<b>Figure 2</b>	<b>Plates 3</b>	
Trench Alignment: N-S	Trench Length: 19m		
<b>Deposit</b>	<b>Context No.</b>	<b>Average Depth (m)</b>	
		<b>N End</b>	<b>S End</b>
Topsoil	100	0.22	0.17
Subsoil	101	0.36	0.26
<b>Summary</b>			
Trench 3 was located centrally within the southern half of the site.			
No archaeological features or deposits.

Plate 3: Trench 3, taken from the south.

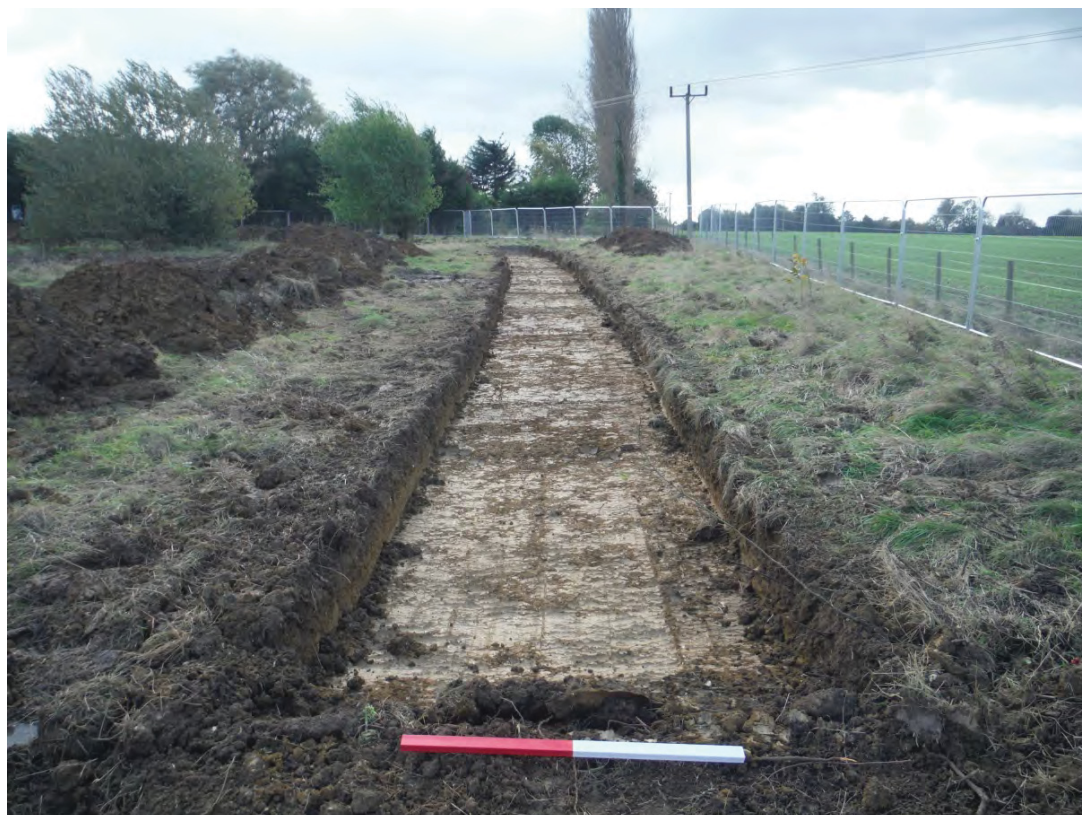
5.5.1 The trench contained no modern truncation, or disturbance.

<b>TRENCH 4</b>	<b>Figure 2</b>	<b>Plates 4</b>	
Trench Alignment: N-S	Trench Length: 45m		
<b>Deposit</b>	<b>Context No.</b>	<b>Average Depth (m)</b>	
		<b>N End</b>	<b>S End</b>
Topsoil	100	0.2	0.25

Subsoil	101	0.19	0.29
<b>Summary</b>			
Trench 4 was located at the western edge of the site, parallel to the western site boundary.			
No archaeological features or deposits.			
The trench was shortened due to overhead power lines present at the south-west corner of the site.

Plate 4: Trench 4, taken from the north.

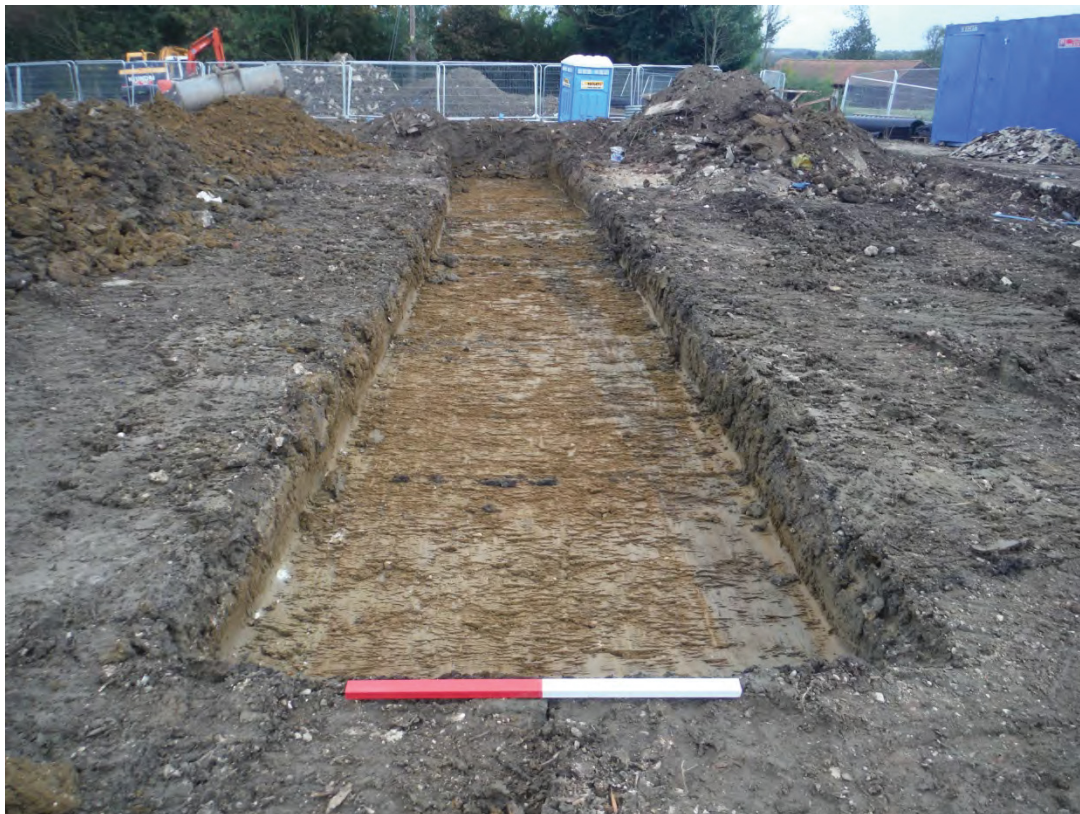
- 5.6.1 Modern intrusions were present within the trench, the intrusions were services uncovered below the archaeological grade and did not affect the machining levels.

<b>TRENCH 5</b>	<b>Figure 2</b>	<b>Plates 5</b>	
Trench Alignment: N-S	Trench Length: 18m		
Deposit	Context No.	Average Depth (m)	
		N End	S End
Topsoil	100	0.15	0.13
Subsoil	101	0.34	0.17
<b>Summary</b>			
Trench 1 was located on the eastern side of the site, parallel to the eastern site boundary.			
No archaeological features or deposits.

Plate 5: Trench 5, taken from the south.

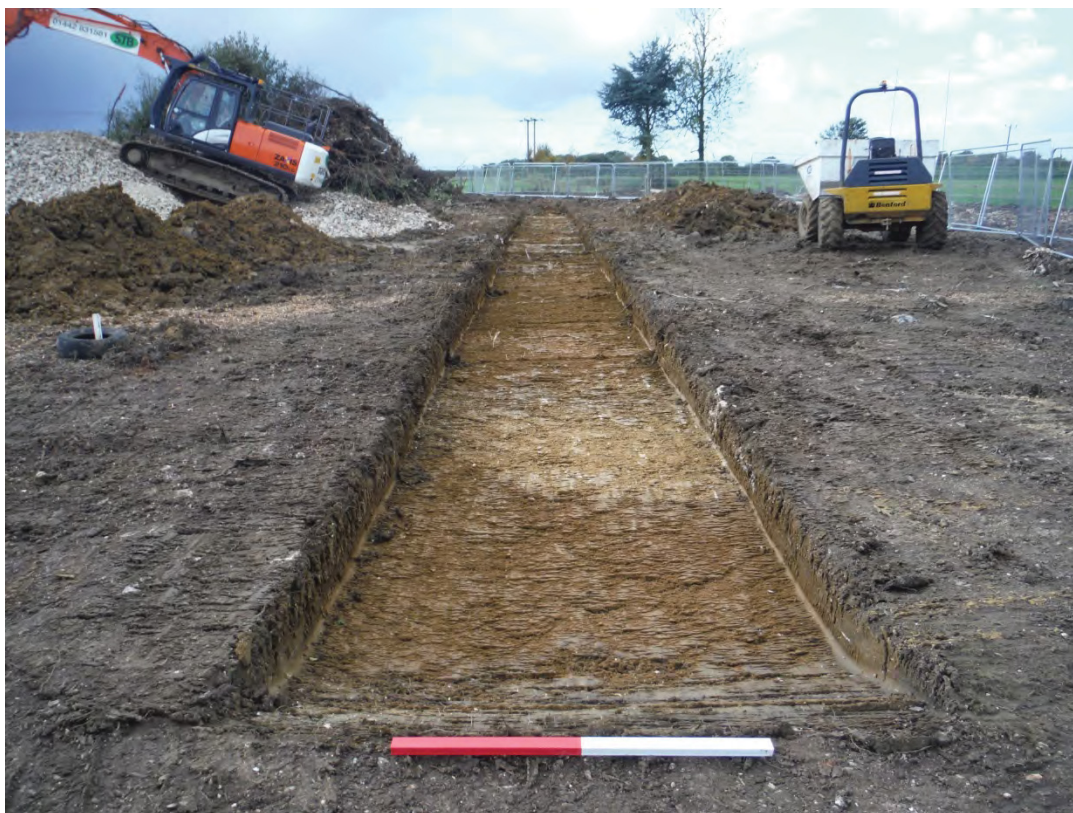
- 5.7.1 The trench contained a small amount of modern disturbance at the western end, and a single defunct electric cable.

<b>TRENCH 6</b>	<b>Figure 2</b>	<b>Plates 6</b>	
Trench Alignment: E-W	Trench Length: 41m		
Deposit	Context No.	Average Depth (m)	
		E End	W End
Topsoil	100	0.12	0.13

Subsoil	101	0.24	0.21
<b>Summary</b>			
<p>Trench 1 was located in the northern half of the site.</p> <p>No archaeological features or deposits.</p> <p>The trench was shortened due to the presence of a public footpath.</p>

Plate 6: Trench 1, taken from the east.
