**AN ARCHAEOLOGICAL WATCHING BRIEF:  
MARKET SQUARE, SOUTH SHIELDS,  
TYNE AND WEAR**

**WATCHING BRIEF REPORT**

**National Grid Reference: NZ 436060 567100**

**Site Code: SSM 14**

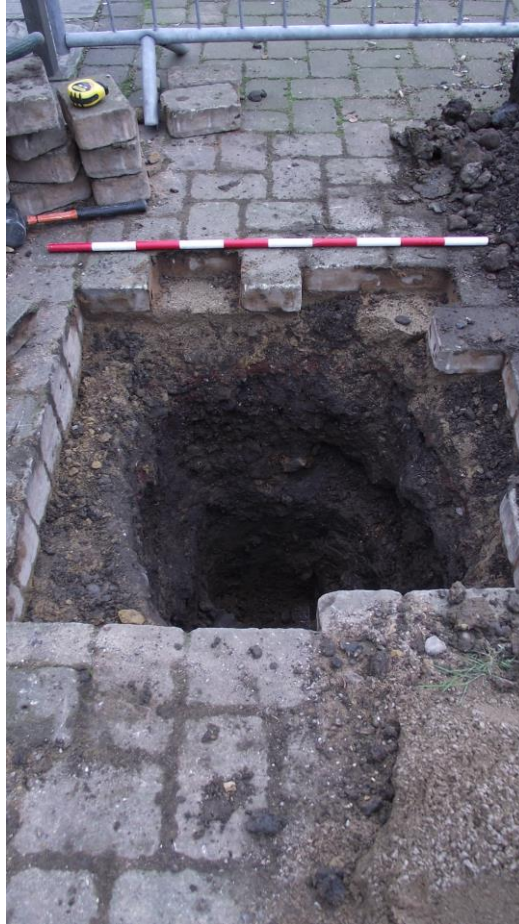
Plate 1: Test Pit 1 west facing section (scale 1m)

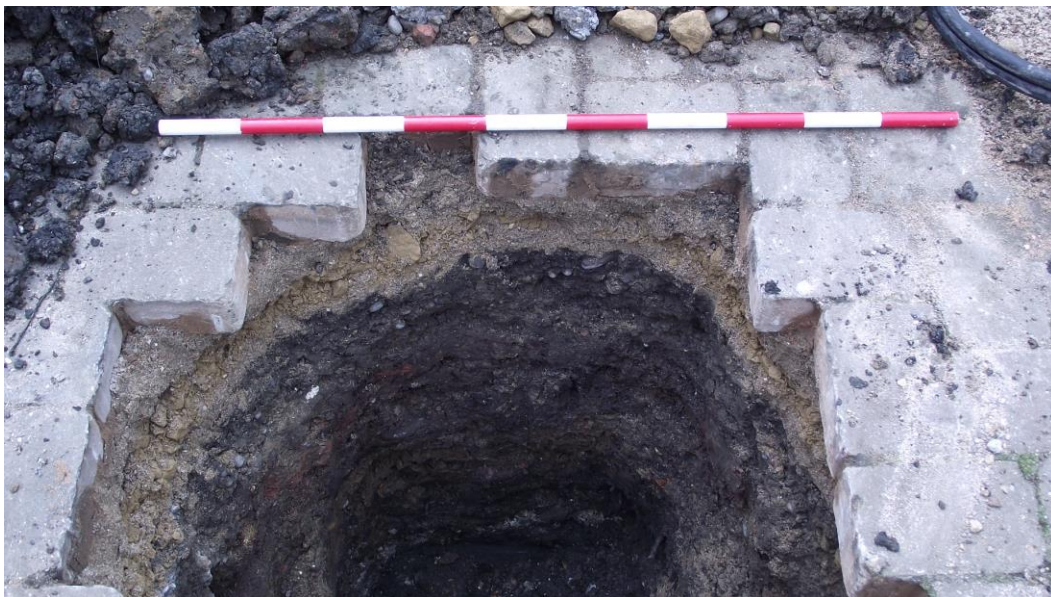
Plate 3: Test Pit 2 north facing section (scale 1m)

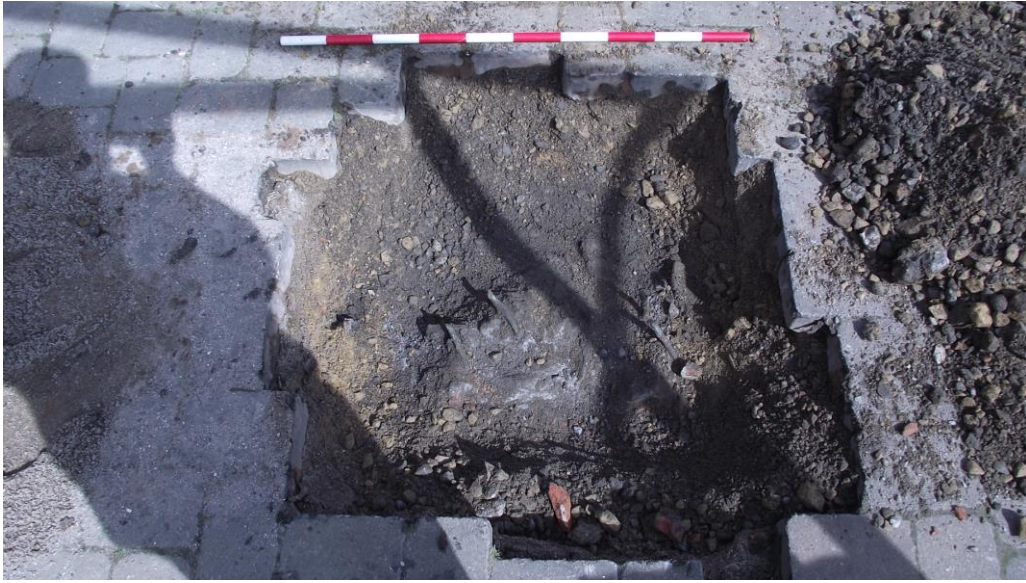
- 5.3.1 A reinforced concrete pile capping, [9], which measured 0.95m north-south by 0.78m east-west was encountered at a depth of 0.22m below present ground level at a height of 10.08m OD (Plate 4). Excavation ceased at this level. With such a small area exposed, interpretation of this structure is not possible.
- 5.3.2 The concrete pile was overlain by the same sequence of deposits as encountered within the uppermost part of Test Pit 1; bedding deposits [3] and [2] for the current surface [1] which in this area lay at a height of (10.11m OD)

Plate 4: Test Pit 3 concrete pile capping [9], facing east (scale 1m)

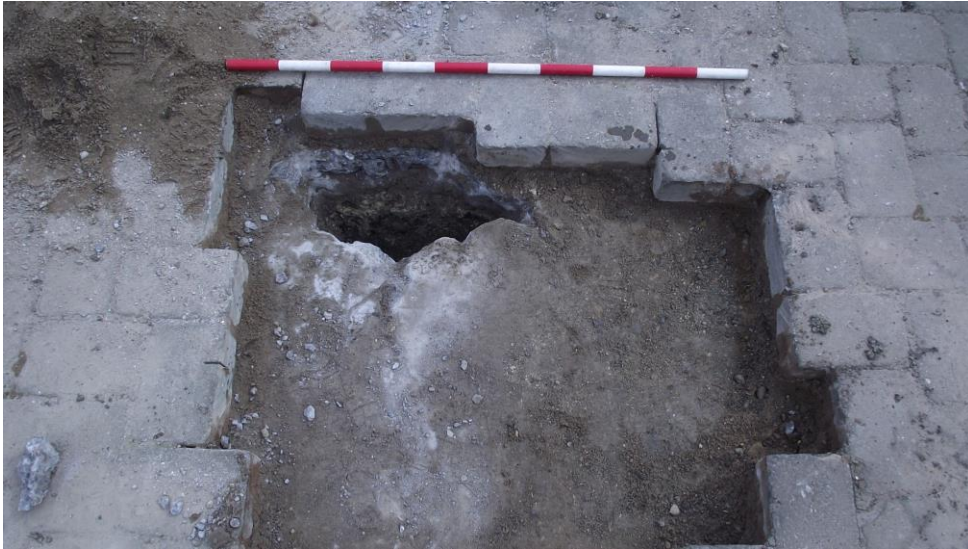
- 5.4.2 Levelling deposit [5] was overlain by a 70mm thick deposit of crushed dolomite, [11], which was the bedding layer for a very hard 0.14m thick concrete deposit, [10] (Plate 7). This was encountered at a height of 10.07m OD at a depth of 0.11m below the existing ground level.
- 5.4.3 As in all other test pits the uppermost deposits comprised the bedding deposit, [2], for the brick paving, [1], which in this area lay at 10.18m OD.

Plate 6: Test Pit 4 sondage cut through concrete surface [10], facing south (scale 1m)

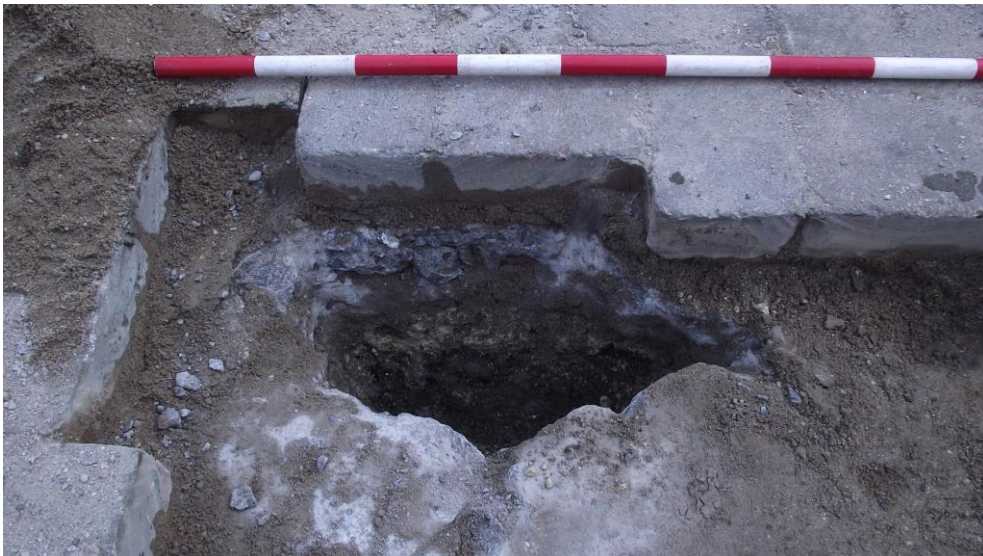
- 5.4.1 The lowermost exposed deposit within Test Pit [4] comprised levelling deposit [5]. This deposit was only exposed within a small area in the south-eastern corner of the test pit due to the presence of an indurated concrete surface which proved difficult to excavate (Plate 6). In this test pit, deposit [5] was exposed for a maximum thickness of 0.10m and encountered at height of 9.87m OD.

Plate 7: Test Pit 4 north facing section (scale 1m)
