**HISTORIC BUILDING  
RECORDING OF  
BALANCE HOUSE,  
NO. 16 BALANCE STREET,  
UTTOXETER,  
STAFFORDSHIRE,  
ST14 8JE**

**PCA REPORT NO. R11957**

HISTORICAL BUILDING RECORDING

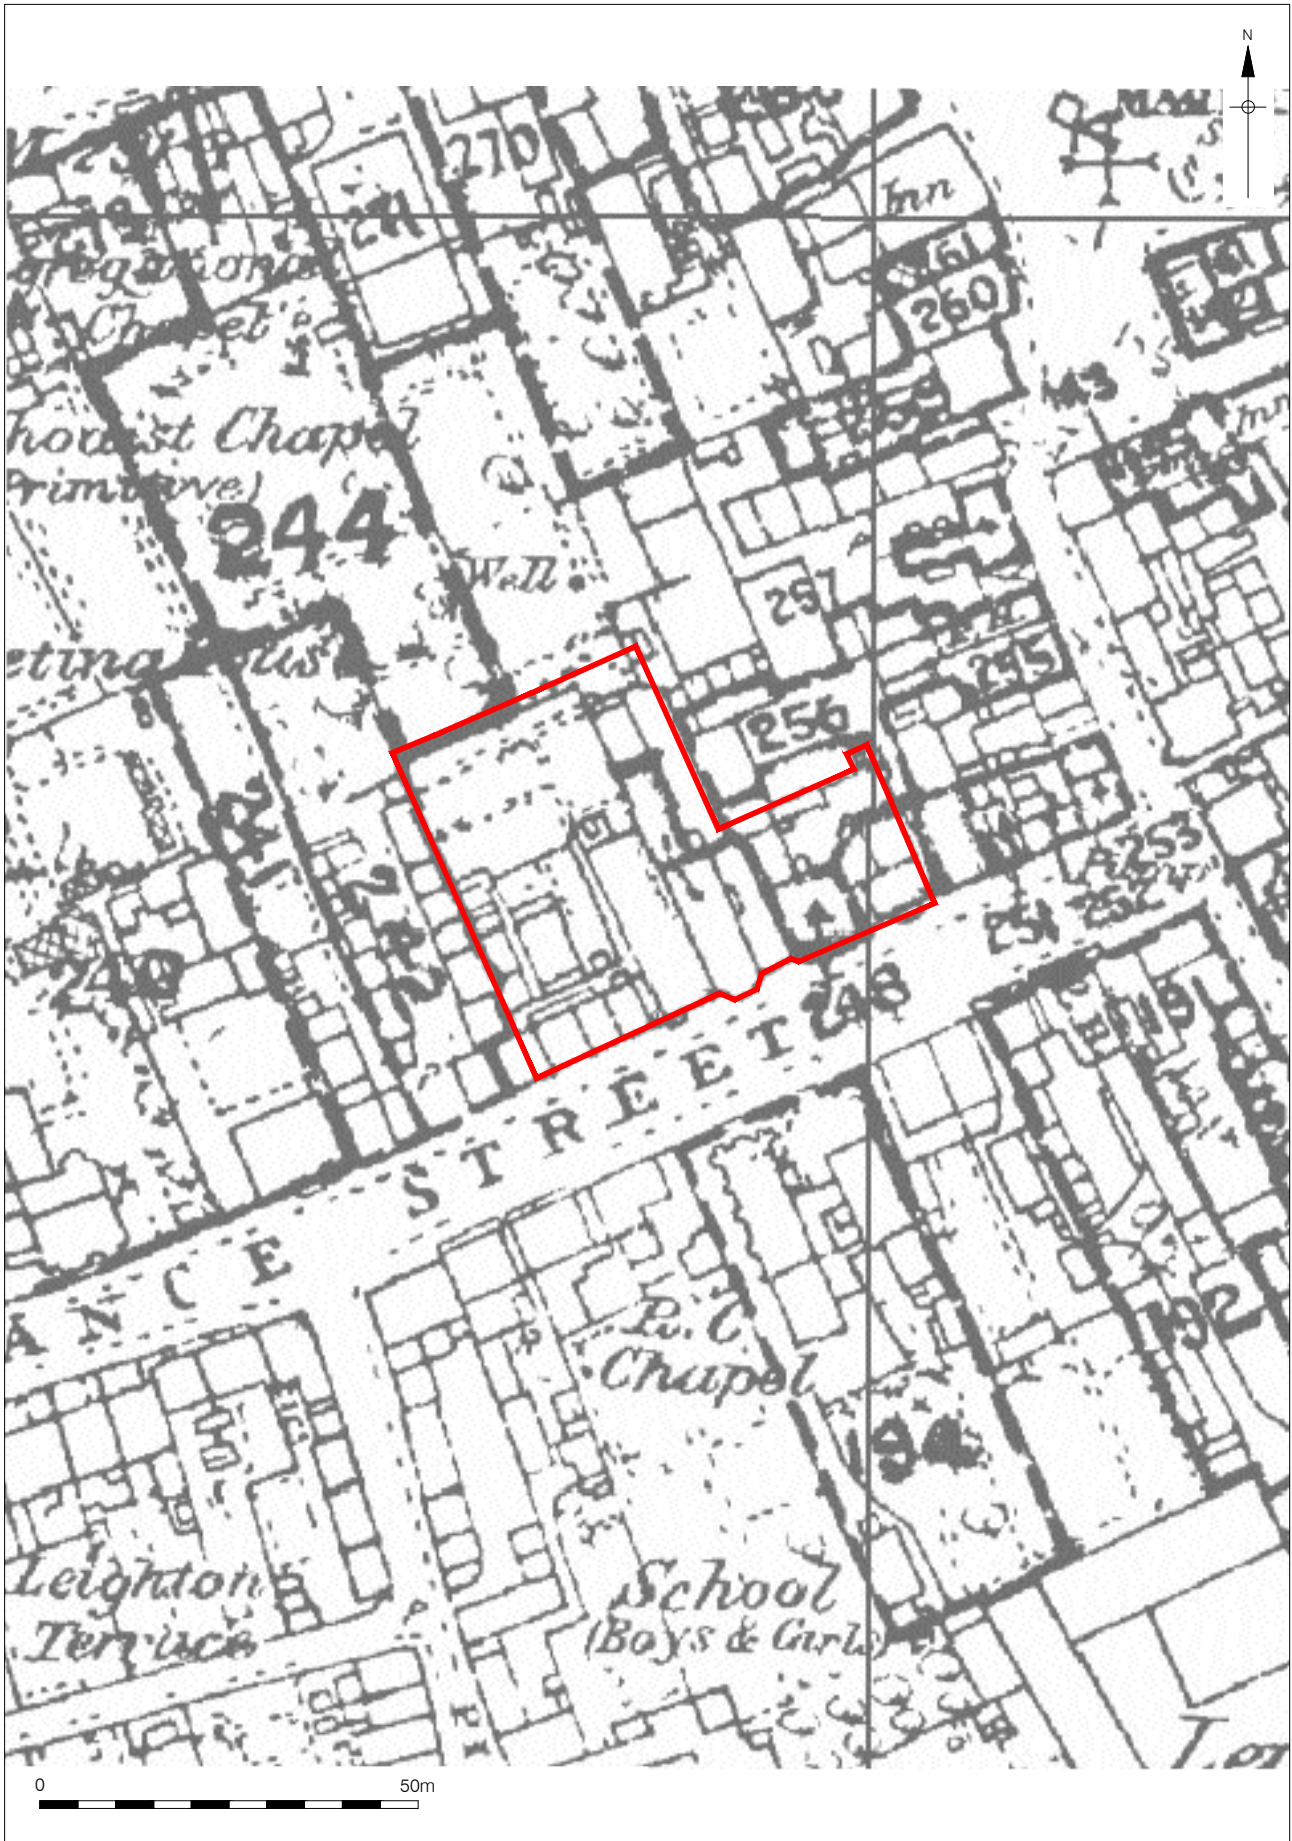
Figure 5  
First Edition Ordnance Survey 25" map 1883  
1:1,000 at A4

- 5.1.8 The first edition Ordnance Survey map of 1883 (**Figure 5**) shows Balance House with its distinctive canted window bay to Balance Street and adjoining outbuildings to the north. The general layout of the building is much the same as that seen on the 1845 Tithe copy and the conveyance plan of 1830. Notably it is not identified as a 'club', seen on later extracts and therefore remained in domestic use until its conversion to a club house, sometime between 1883 and 1900.

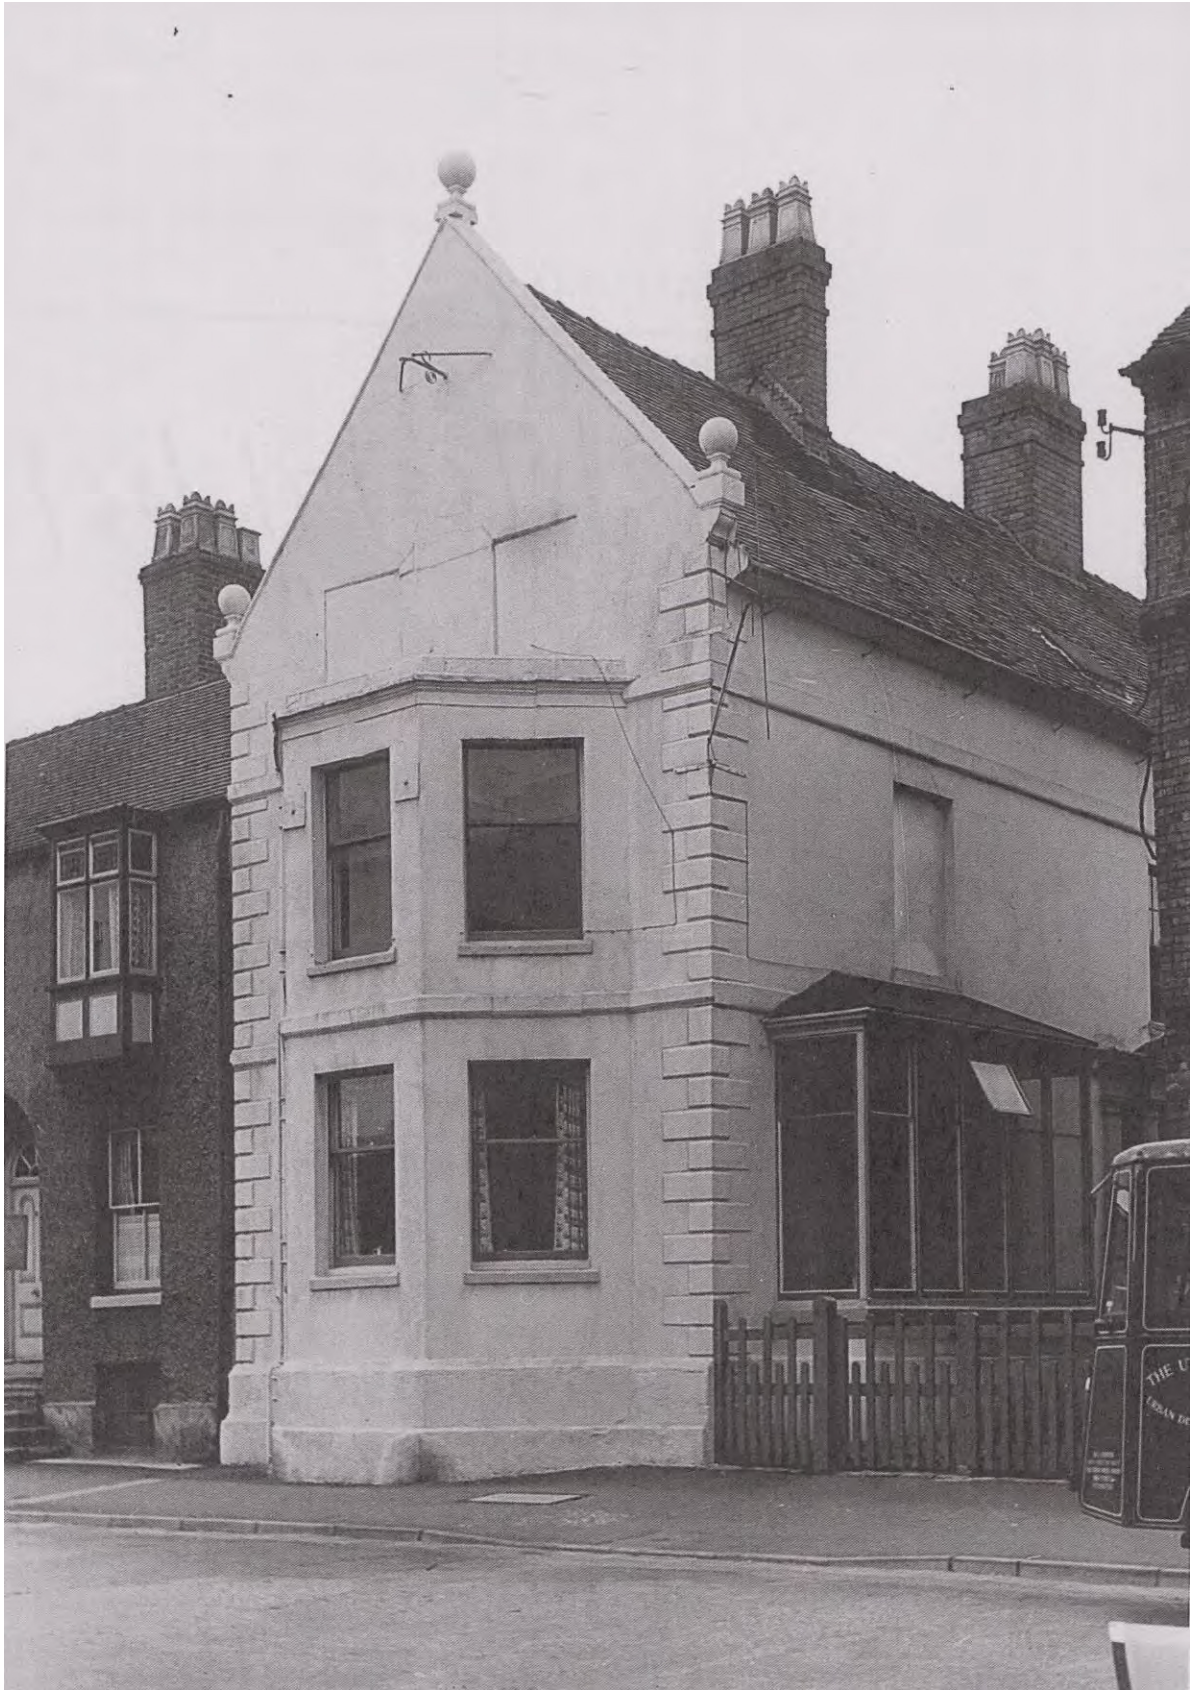
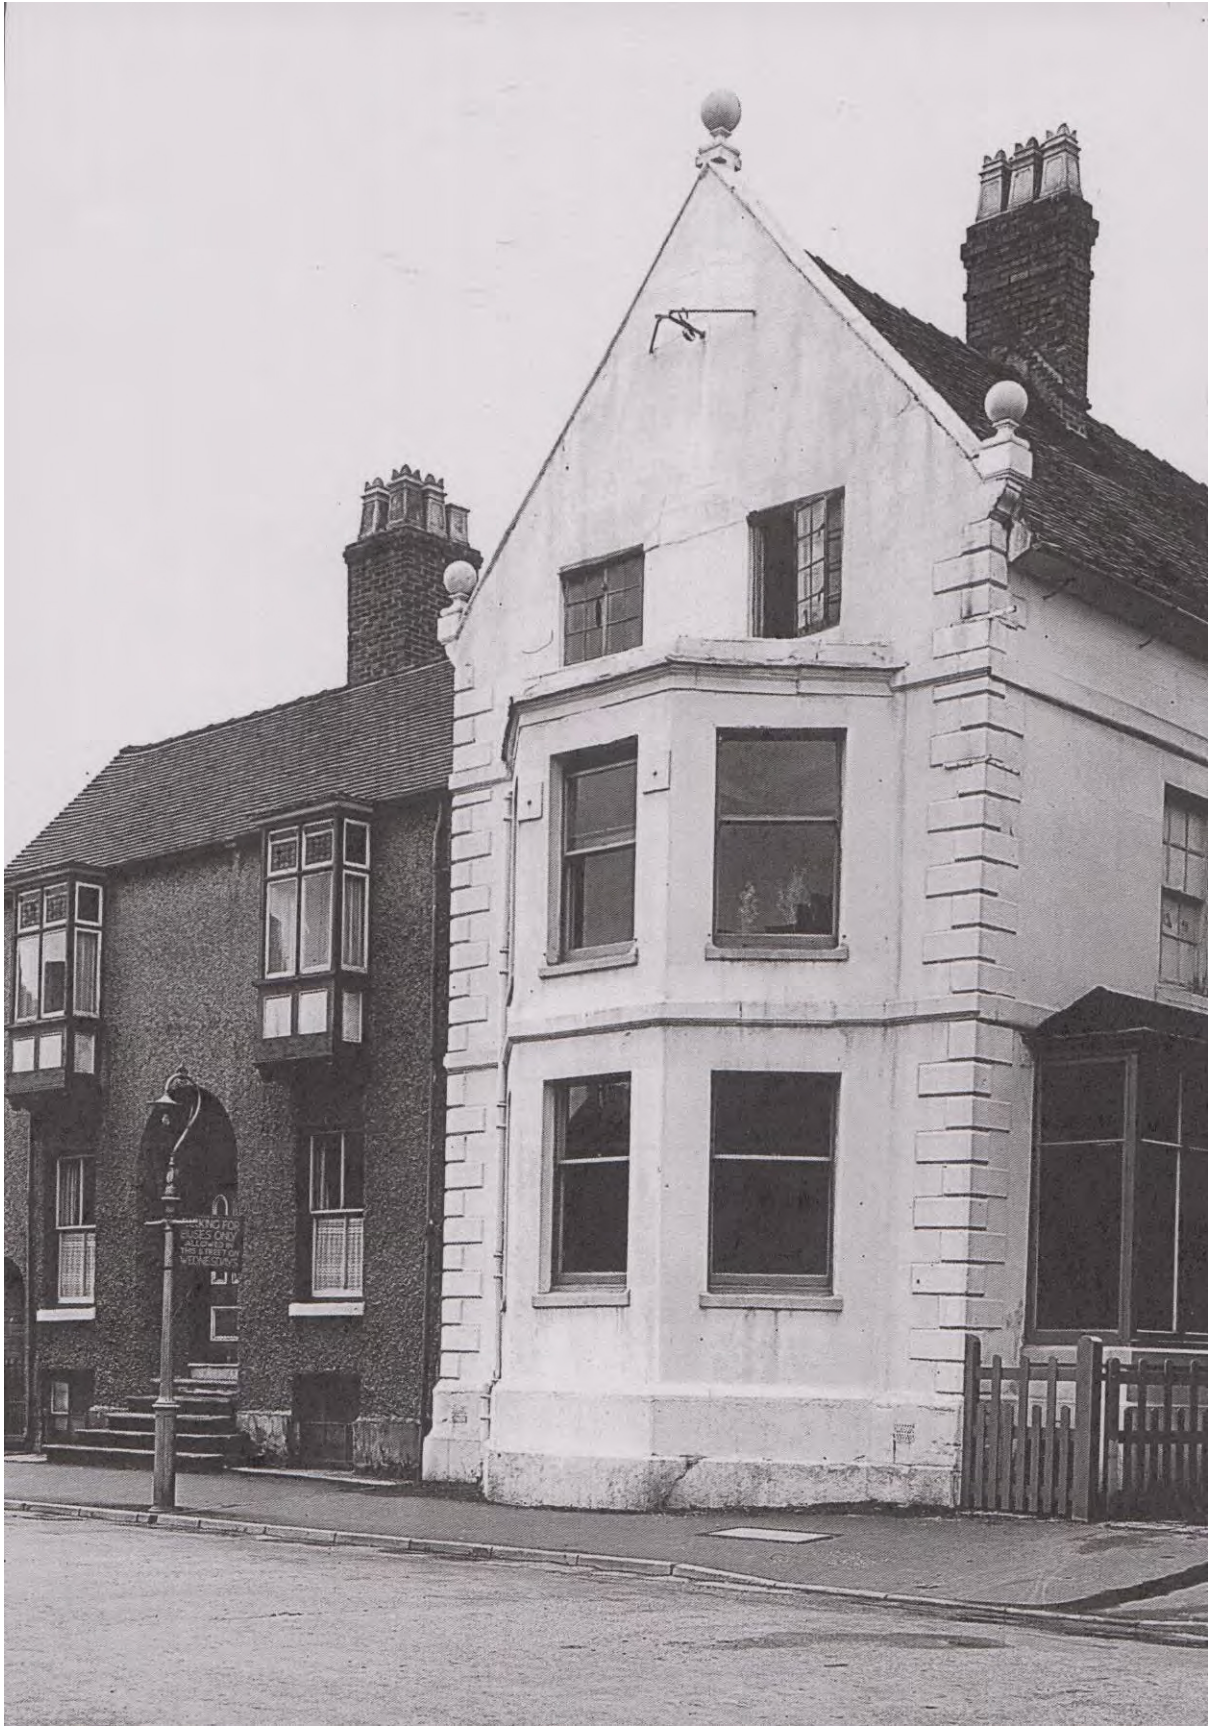
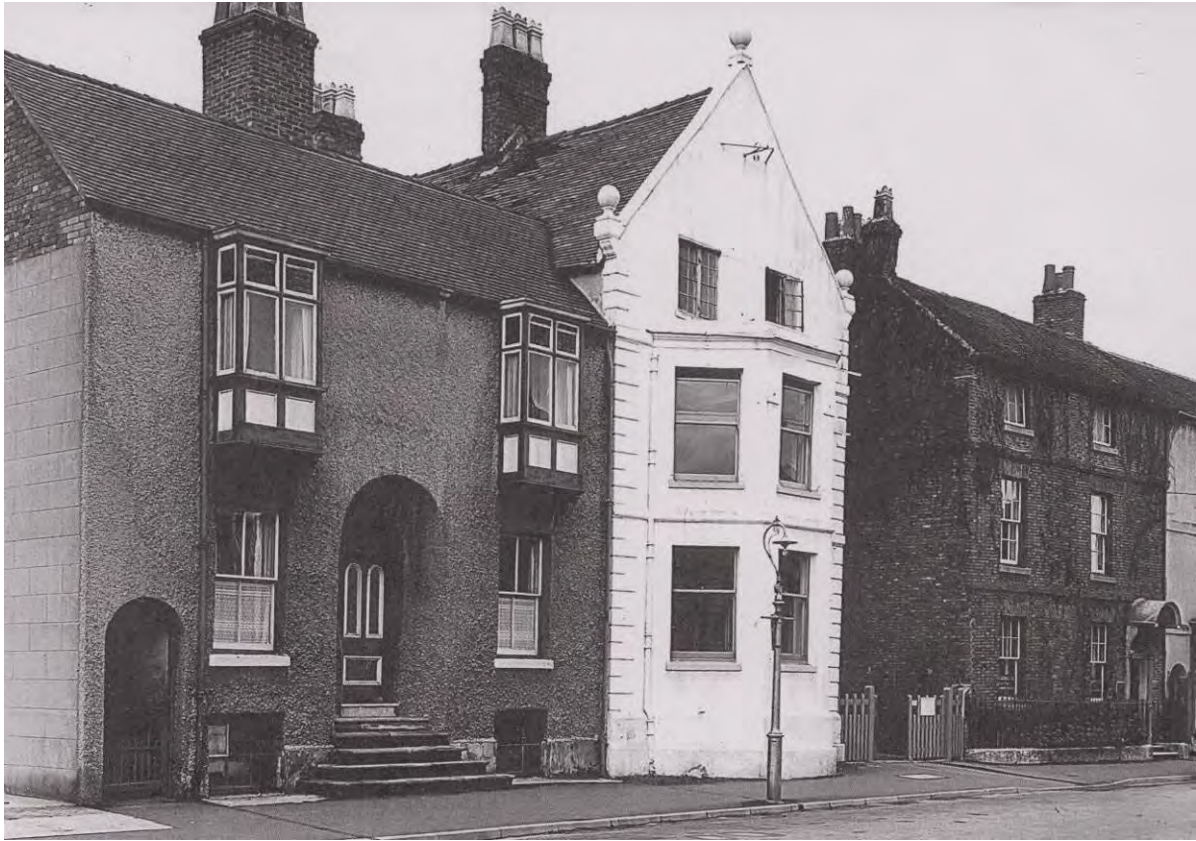
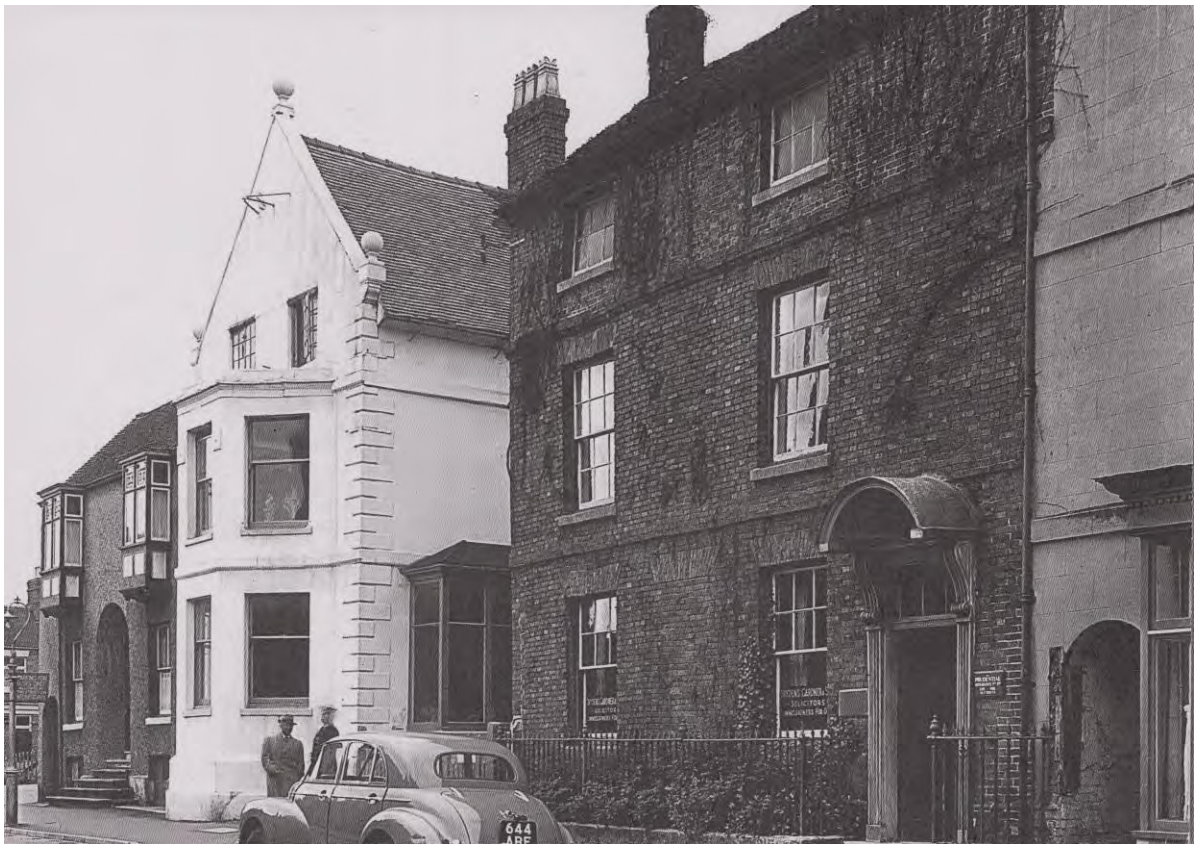
5.1.12 A number of historical but undated photographs of Balance Street, thought to have taken just before World War II, are shown as **Historic Plates 1 to 4**. They show the extent to which Balance House has changed in recent years, particularly the loss of two ridgeline chimney stacks and to a lesser extent, three ball finials from the gable parapet. They also depict the extent of re-fenestration; the present windows to the ground floor canted bay, the side bay window, the first floor window of the southern bedroom, east side, and the windows to the attic storey are all replacement windows post-dating the photographs. The attic windows, which are blind in **Historic Plate 1** appear to be fenestrated using iron-framed multi-light casements in the subsequent photographs (**Historic Plates 2 to 4**). These casement windows have, in turn, since been replaced. The photographs also show that the southern (east) side bay window was originally built with a shallow hipped and tiled roof and not the present flat roof. The same treatment may be implied for the corresponding bay window to the north. A wrought iron bracket, attached to the gable wall, most likely held a pendant sign for the club. These photos also show the size and character of Nos 14 and 18 Balance Street. The former was a typical Georgian fronted town house with an ornate door surround with shell canopy. The latter was clearly a substantial dwelling with oriel windows to the first floor, a side passage and a large basement to the roadside.

Historic Plate 1 Balance House, looking north-west (note blocked attic and first floor windows)

Historic Plate 2 Balance House and No. 18 Balance Street, looking north-west

Historic Plate 3 Balance House, Nos. 14 (right) and 18 (left) Balance Street, looking north-east

Historic Plate 4 Balance House, Nos 14 and 18 Balance Street, looking north-west

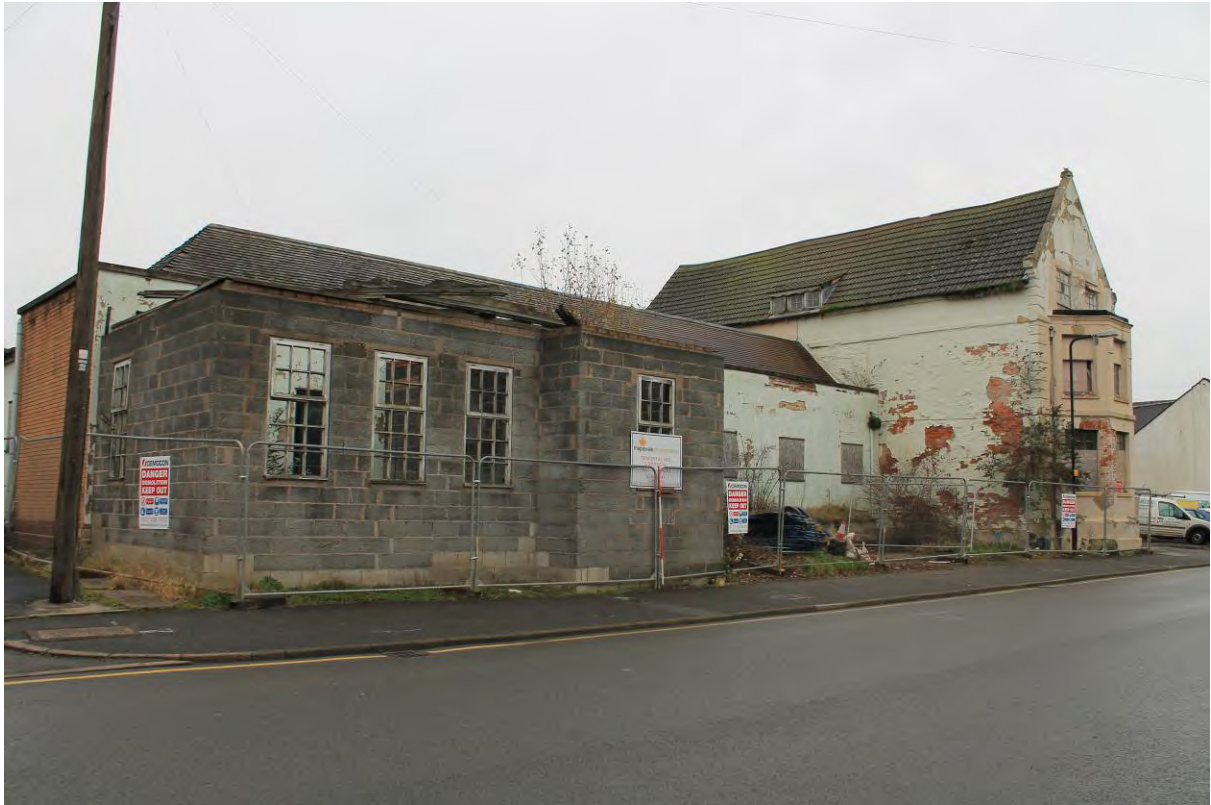
6.1.2 Balance House is a 2½ storey and basemented, brick and rendered, gable ended, former house, broadly orientated on a north-south alignment, presenting its principal facade to the east and principal gable elevation to the south and towards Balance Street. A single storey, predominantly flat roofed modern building, constructed during the 1980s as part of the Ladywood Care Home, but incorporating the facade of the former club house (built c.1950-60), extends to the rear (north) and west. The roofline of Balance House is pitched at c.45 degrees (more suitable for a plain tile or traditional stone slate) and covered with modern replacement interlocking tiles (**Plates 1 and 2**). The two through-ridge chimney stacks, shown on **Historic Plates 1 to 4**, have been truncated above the ridgeline, the southern one recently failing above the southern part of the building, allowing ingress of both weather and pigeons (**Plates 1 and 2**).

Plate 1 Modern Care Home buildings and Balance House, looking north-east

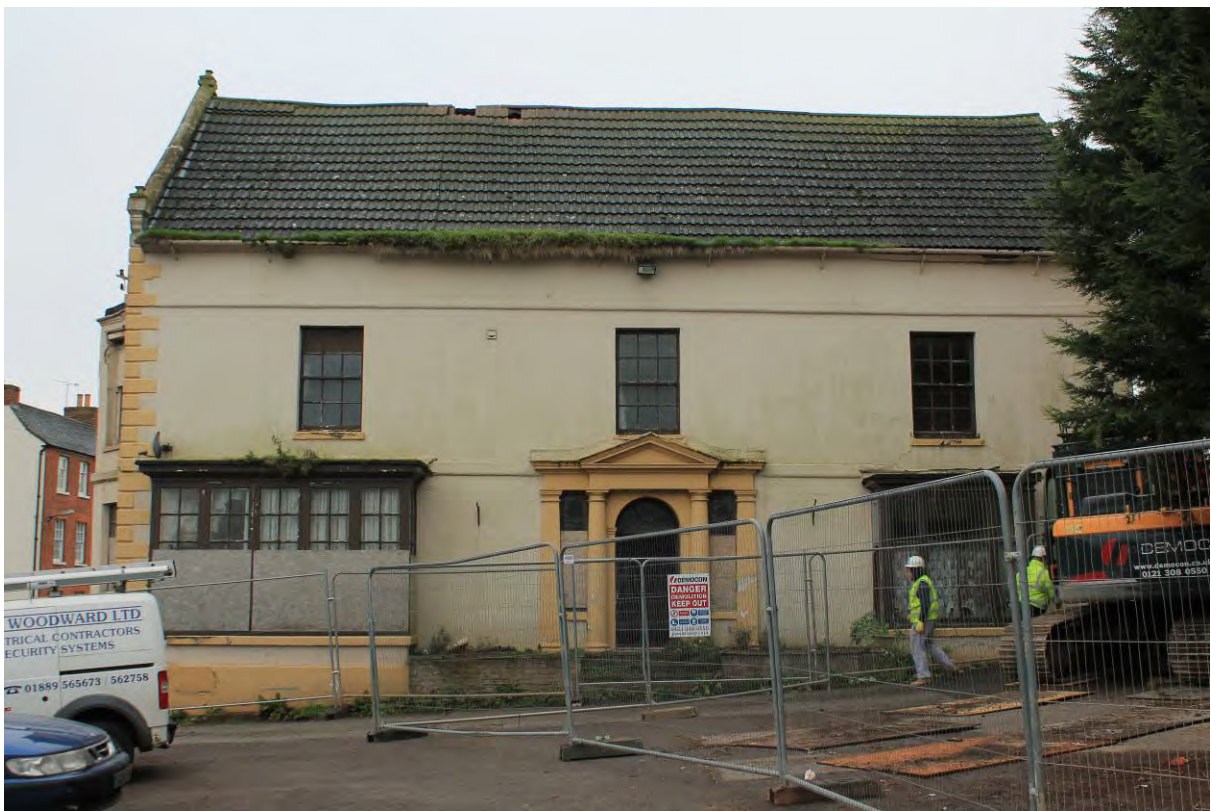
6.2.1 The eastern elevation is laid out over two storeys, with three symmetrically arranged first floor windows and a pair of large, flat-roofed ground floor bay windows, set on each side of a central front door (**Plate 2**). The elevation is covered in modern rough-cast render, which overlies an earlier render lined out in imitation of ashlar, still partially visible. Rusticated quoining is present along the south-eastern corner but is not used on the corresponding and less visible north-eastern corner (**Plates 2, 4 and 5**).

Plate 2 Eastern principal elevation, looking west

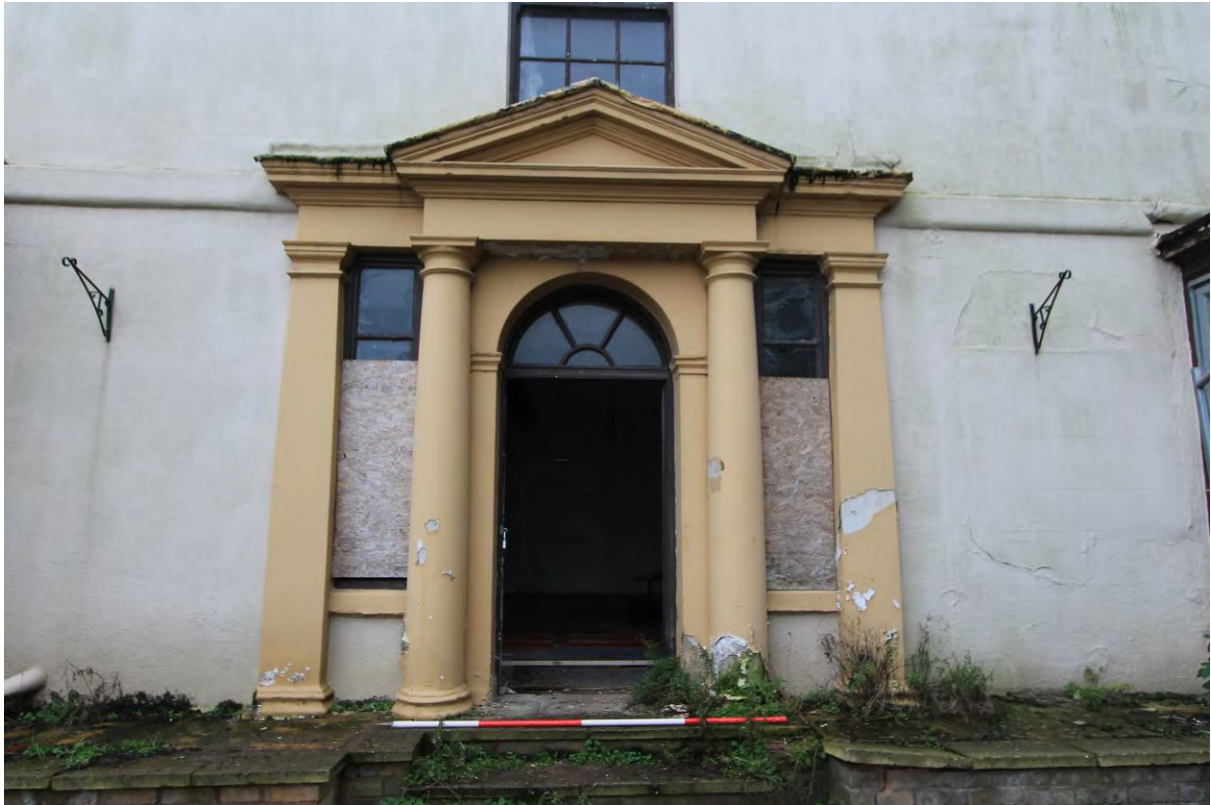
6.2.2 The principal feature of the elevation is the centrally placed main entrance (**Plate 3**). This is built with a classical surround adopting a Palladian motif with a central semi-circular arch flanked by narrower flat side openings. The central arch is flanked by half round columns with simple capitals and bases, and the sides, by rectangular section pilasters, using a similar capital and base design. The columns/pilasters typically in classical form, rise to support a plain entablature with a moulded cornice and a central triangular unbroken pediment over the arched door opening. The central arched door opening includes an impost and a fixed glazed fanlight window over the door. The narrow sides incorporate a pair of vertical two over two sash windows with plain sills. The classical door surround, including the pilasters/columns and sills to the windows appear to be masonry in construction. The door architrave, though plain, is original. The softwood raised panel front door, may be a later replacement. The main front door is reached via a short flight of steps, built or rebuilt quite recently. The eastern elevation also includes reserved decoration in the form of a plain (now rendered) first floor band, set at the height of the top of the bay windows and the entablature, and a similar floor band above the first floor windows (**Plate 2**). These three windows are six over six vertical sliding sashes recessed back from the wall line with undecorated reveals.

Plate 3 Detail of classical door surround in the eastern elevation, looking west

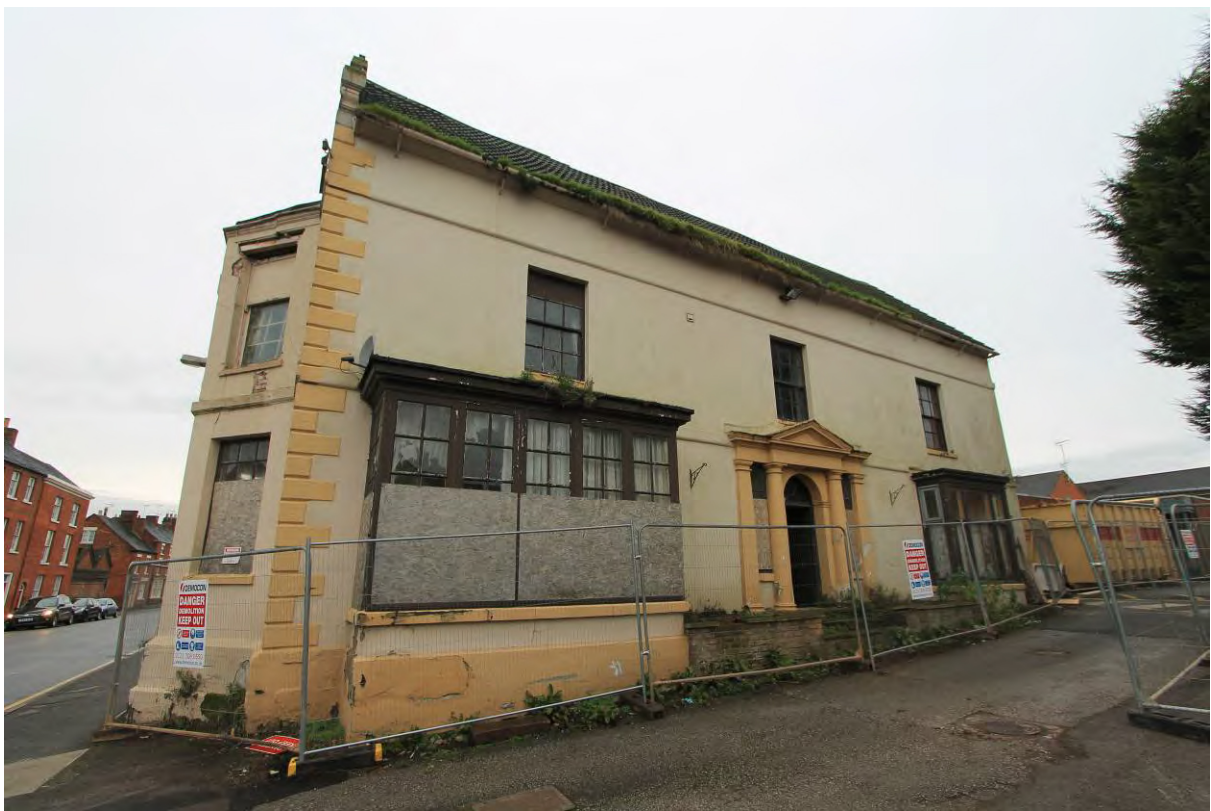
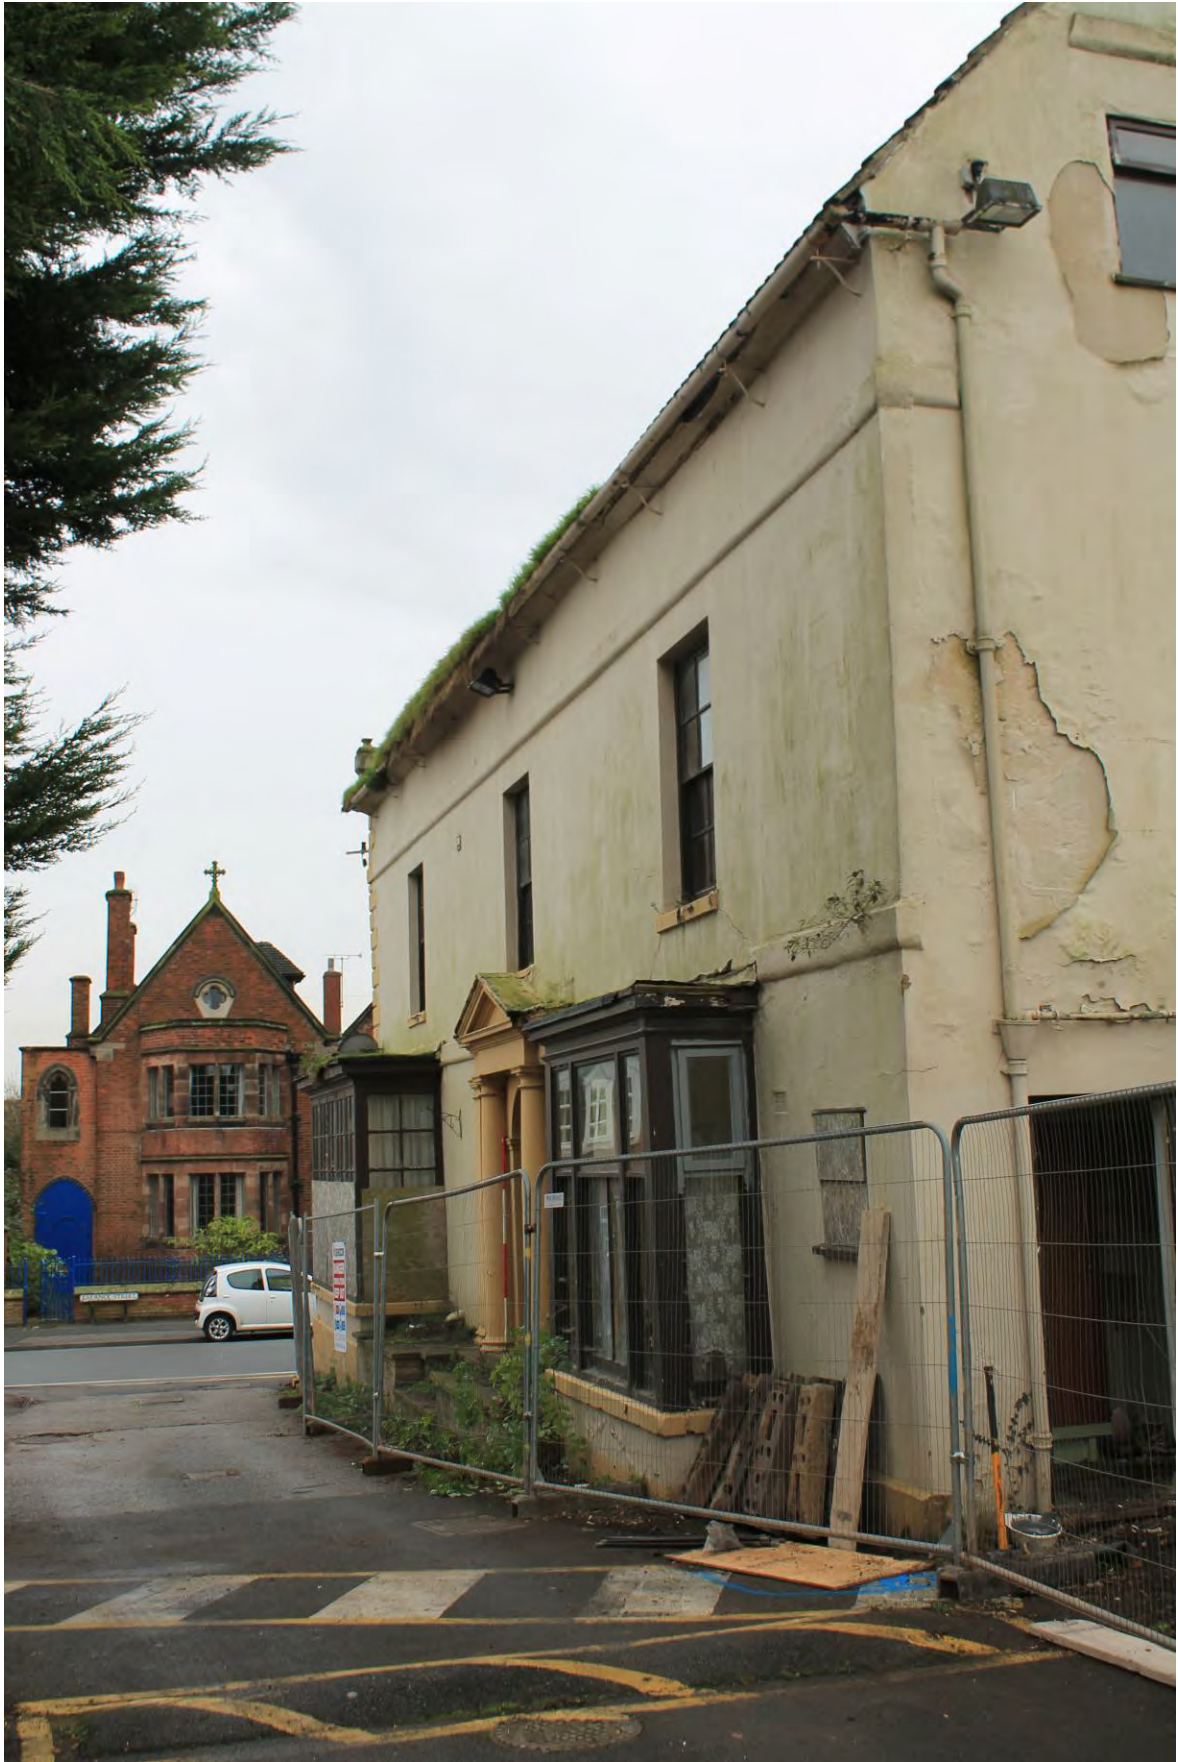
Plate 4 Oblique view of the eastern elevation, looking north-west

Plate 5 Eastern elevation looking south toward St Marys Catholic Church

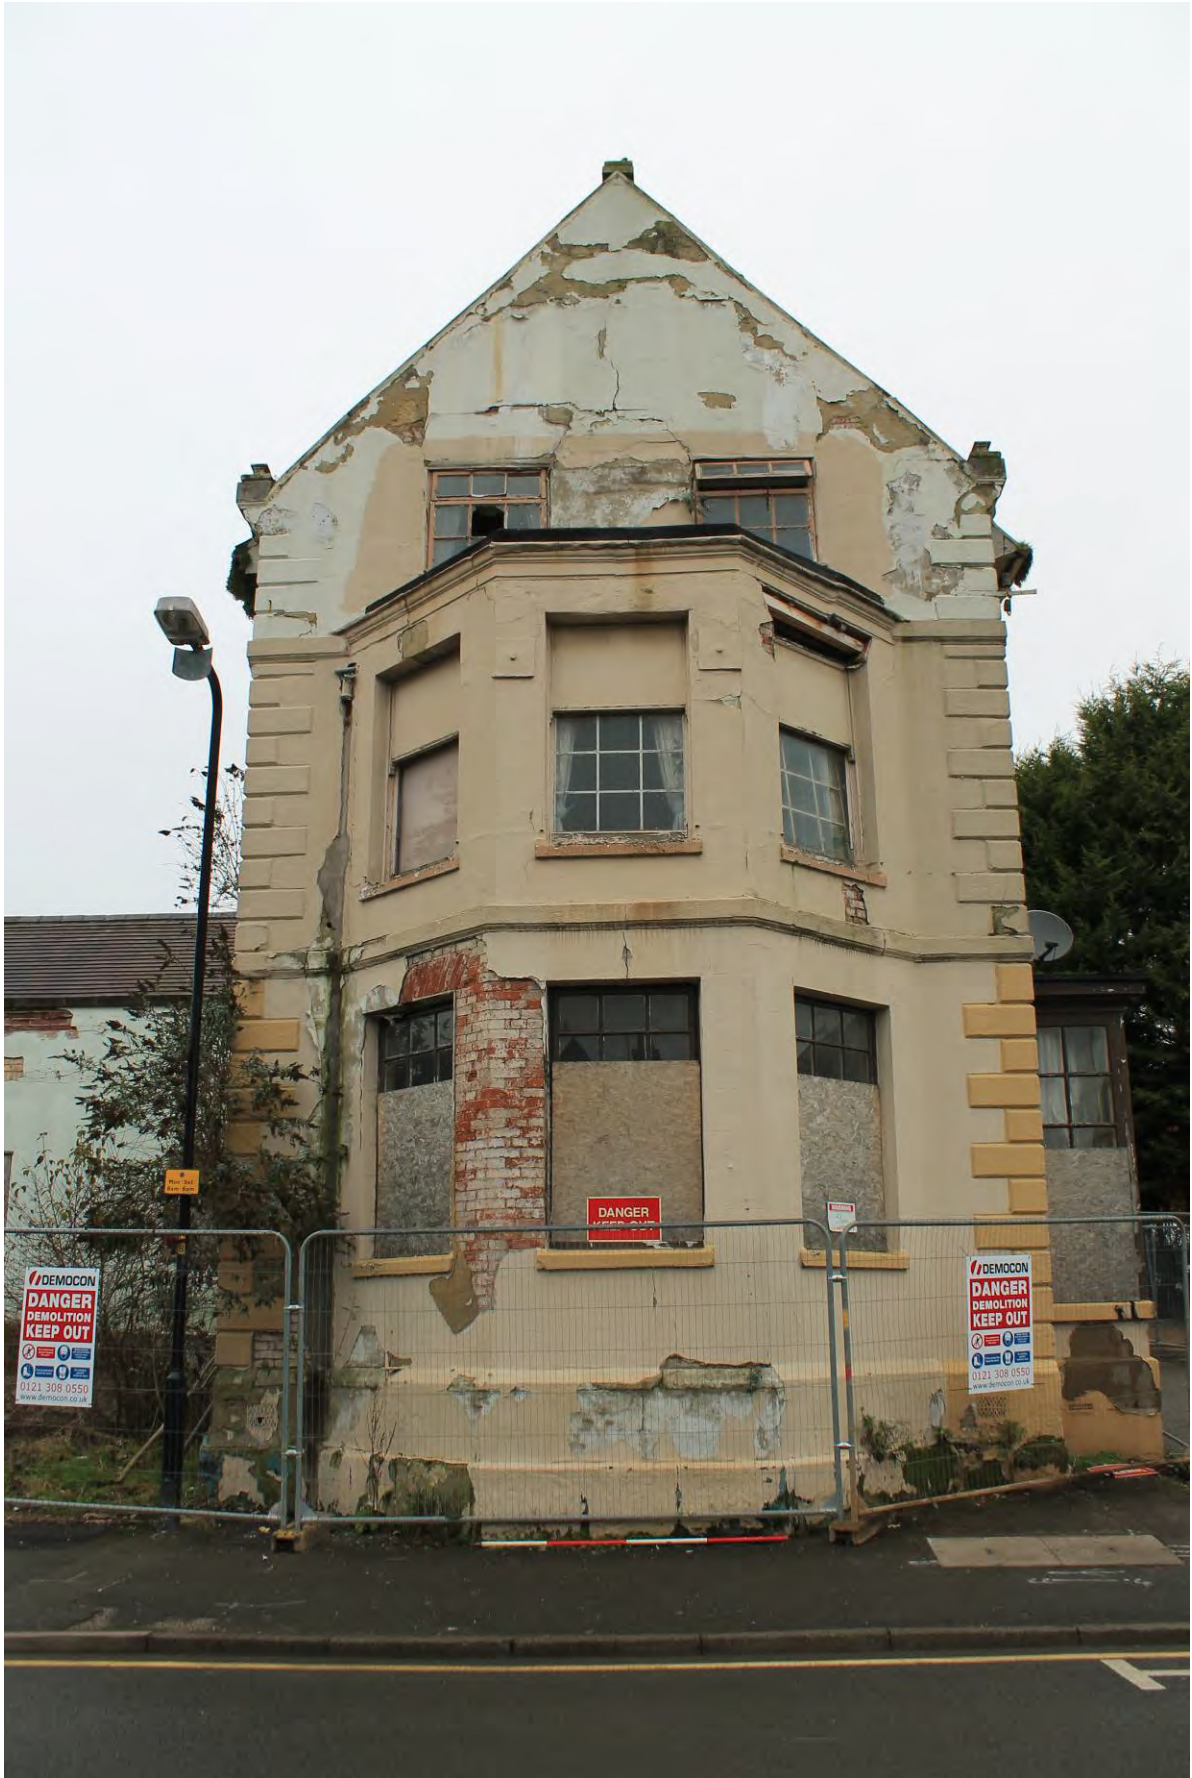
- 6.3.1 The southern gable elevation is built over 2½ storeys with a canted two storey bay central to the elevation and two small symmetrically placed attic windows to the second floor, above (Plate 6). Both the south-eastern and south-western corners are accentuated by the use of rusticated stone quoins, which rise to over-sailing shaped masonry kneelers and a gable parapet with plain saddleback copings. **Historic Plates 1 to 4** all show that the stone plinths, projecting from the top the kneelers and at the apex of the gable parapet, formerly held ball finials. The projecting two storey canted bay was brick-built with a moulded cornice to a flat felted roof. This cornice coincides with the upper (second) floor band present on the adjacent eastern elevation, while the lower first floor band continues around the canted bay, between the ground and first floor windows. It is built off a stepped-out plinth wall, constructed using large masonry blocks, and built in red brick with rubbed and gauged brick voussoirs to the ground floor window openings. Similar treatment was used for the first floor and second floor windows, although the former had been much altered in line with modern structural works added to consolidate the bay at first floor level. The canted bay was built using 'specials' for the angles and queen closers to the openings. The use of gaugework, along with contrasting stone quoining, stone floor bands and stone wall plinth, suggests that the house was not originally externally rendered. The lined-out (ashlar) render, also present across this elevation, a later, but historic, adaptation.

- 6.3.2 The ground floor fenestration comprised replacement 20<sup>th</sup> century, six over nine casements, using similar glazing bars to those in the southern bay window of the eastern elevation, and plain one over one horned sashes at first floor. The smaller windows to the attic floor were a pair of modern casements with nine (3x3) small panes.

Plate 6 Southern elevation, looking north
