# **AN ARCHAEOLOGICAL EVALUATION: OLE ANCHOR POSITIONS, YORK ENGINEERS' TRIANGLE, CINDER LANE, OFF LEEMAN ROAD, YORK RAILWAY STATION, YORK**

# AN ARCHAEOLOGICAL EVALUATION: OLE ANCHOR POSITIONS, YORK ENGINEERS' TRIANGLE

**An Archaeological Evaluation:  
York Engineers Triangle, Cinder Lane, off Leeman Road,  
York Railway Station, York:**

**Site Code:** YET 14

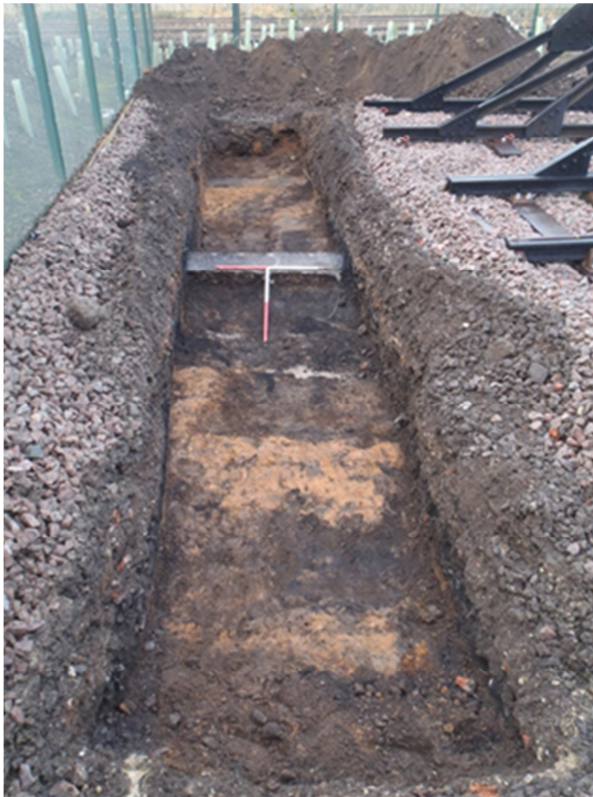
- 2.2.3 At the time of the present evaluation, the new buildings had been constructed across the areas subject to archaeological exposure, excavation and recording in 2012–2013, including the eastern side of RH3. The evaluation trench was located in the western part of the site, at National Grid Reference SE 59282 51534. At the time of the evaluation, the rail track running south-eastwards from the north-west (east of the curving link line of Holgate Junction), which can be seen on Figure 2, had been extended to the south-east (Plate 1). Trench 1 was situated at the south-eastern terminal of this new track within an area of ballast, immediately beyond the buffer stops (Plate 2).

**Plate 2: Trench 1, including two modern services, looking south-west (scales 2 x 1m)**

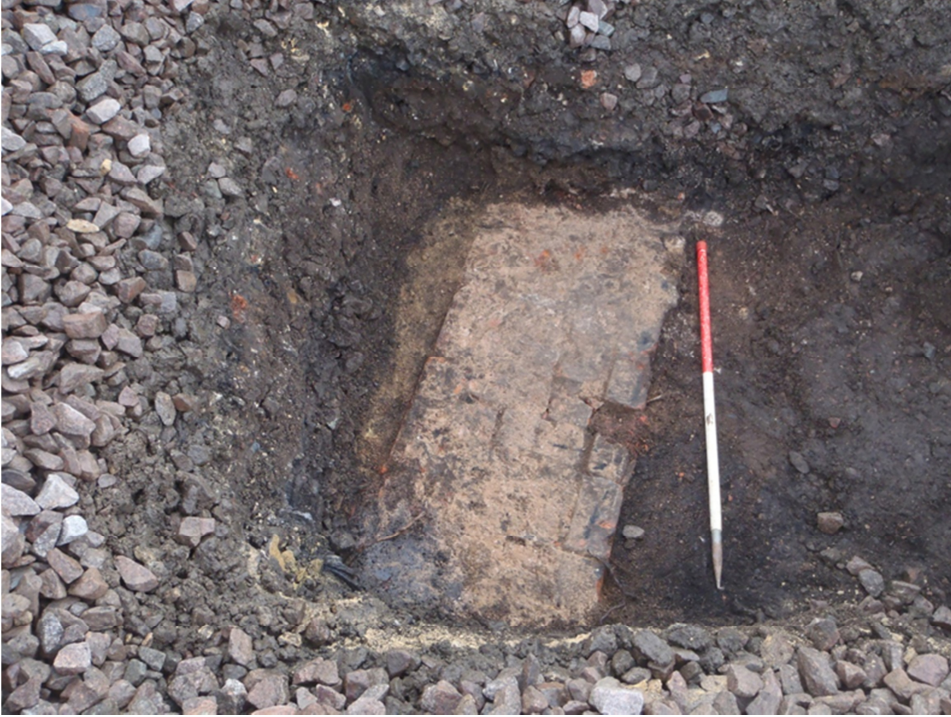
- 5.2 A 0.62m wide north-south aligned wall [008] (Plate 3; Figure 3) was located at the north-eastern end of the trench, truncated horizontally by modern activity, at a depth of 0.96m below present ground level. It was recorded for a distance of 1.60m, continuing beyond the limits of the trench, and was exposed for a height of 60mm. A single course of red bricks, each measuring 240mm long, 120mm wide and 60mm high, was exposed. This had been placed on bed and bonded with a pale greyish white sandy mortar, which had common chalk inclusions.

- 5.4 A 60mm-thick robbed out floor surface [009] (Plate 3; Figure 3) was exposed for a distance of 1.56m by 0.56m immediately to the east of wall [008], extending beyond the edges of the trench. This comprised a compact yellowish grey sandy mortar, with chalk flecks.

Plate 3 Trench 1, wall [8] with robbed-out floor surface [9] to east, looking south (scale 1m)

- 6.1 The truncated remains of part of the external brick wall of the south-western segment of Roundhouse 3 were recorded at the north-eastern end of Trench 1 at a depth of c. 1m below present ground level. This roundhouse was designed by Thomas Prosser and was built in 1863-64. Contemporary design plans show a polygonal structure, with 18 sides, constructed in terracotta-coloured brick with 18 roads radiating from a 45ft (c. 13.70m) turntable. As designed, the base of the turntable pit was concrete with retaining walls built in terracotta brick with sandstone coping. The ground level floor of the shed comprised stone cobbles and the inspection pit stairs were of terracotta-coloured brick. There were four internal chimney stacks placed symmetrically; two on the north and two on the south side of the building. Externally, Roundhouse 3 was architecturally distinct from the two earlier roundhouses on the site and more decorative in character. Each of the enclosed 18 bays had a separate gable end with decorative brickwork in the classical style. Most had three-arched iron-framed windows, above which a string course acted as the base of a pediment, reminiscent of a classical temple, within which was a semi-circular opening. The main entrances for rail traffic were square, with classical style 'columns' in brick either side. Between each gable the wall was recessed, thereby emphasising the gable.
