**AN ARCHAEOLOGICAL EVALUATION:
MARKET SQUARE, SOUTH SHIELDS, TYNE AND WEAR
EVALUATION REPORT**

Pre-Construct Archaeology Limited Quality Control	
<i>Project Number</i>	K3856
<i>Site Code</i>	SSM15
<i>Report Number</i>	RN11055

**An Archaeological Evaluation:
Market Square, South Shields, Tyne and Wear**

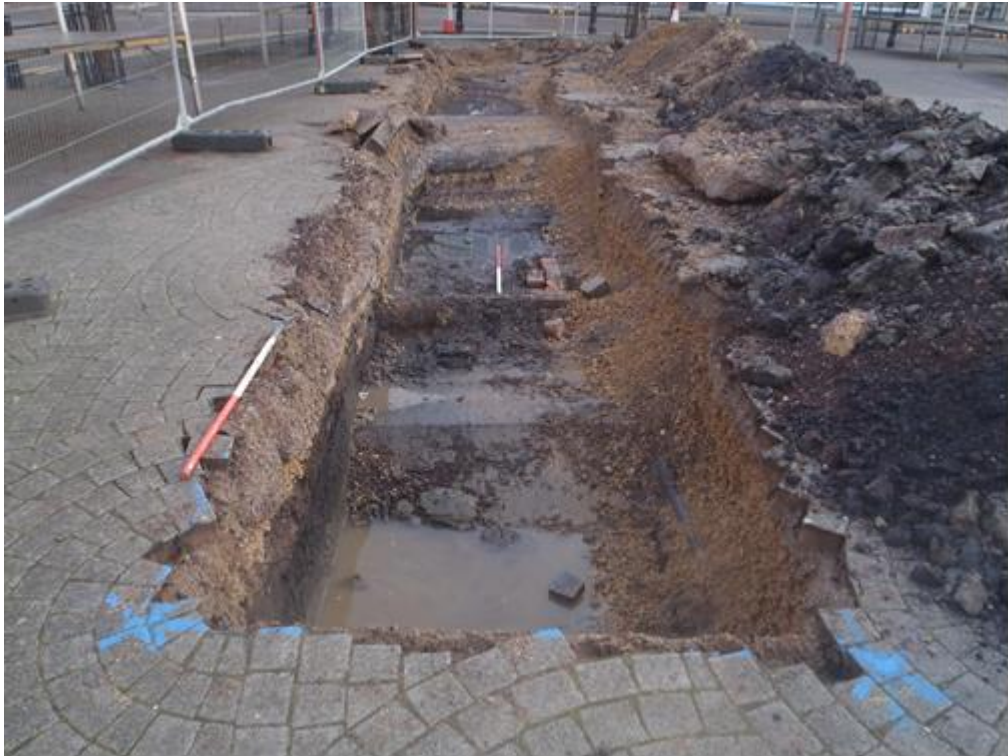
Plate 1. Trench 1, looking north-east (*scales 2 and 1m*)

5.2 Trench 1 (Plate 1; Figure 2)

5.2.1 No features or deposits of archaeological significance were encountered within Trench 1.

TRENCH 1	Figure 2		Plate 1	
Trench Alignment: NE-SW	Length: 17.50m	Depth: 1.74m		
Deposit	Context No.	Average Depth (m)		
		Section 1	Section 5	
Paving	[100]	0.08m	0.08m	
Concrete	[101]	0.16m	0.16m	
Made Ground	[105]	0.14m	0.14m	
Made Ground	[106]	0.10m	0.14m	
Made Ground	[107]	0.28m	0.46m	
Made Ground	[103]	0.20m	-	
Made Ground	[104]	0.40m+	0.64m+	
Made Ground	[113]	-	0.28m+	
Summary				
Trench 1 was located in the north-eastern corner of the Market Place.				
No archaeological features or deposits of significance were encountered in the trench. The natural geology could not be reached due to the significant amount of made ground present throughout the trench.				
Deposits of made ground were excavated to a maximum thickness of 1.50m. Natural geology was not present at this depth.				
Modern intrusions, including modern services, were present in the trench.

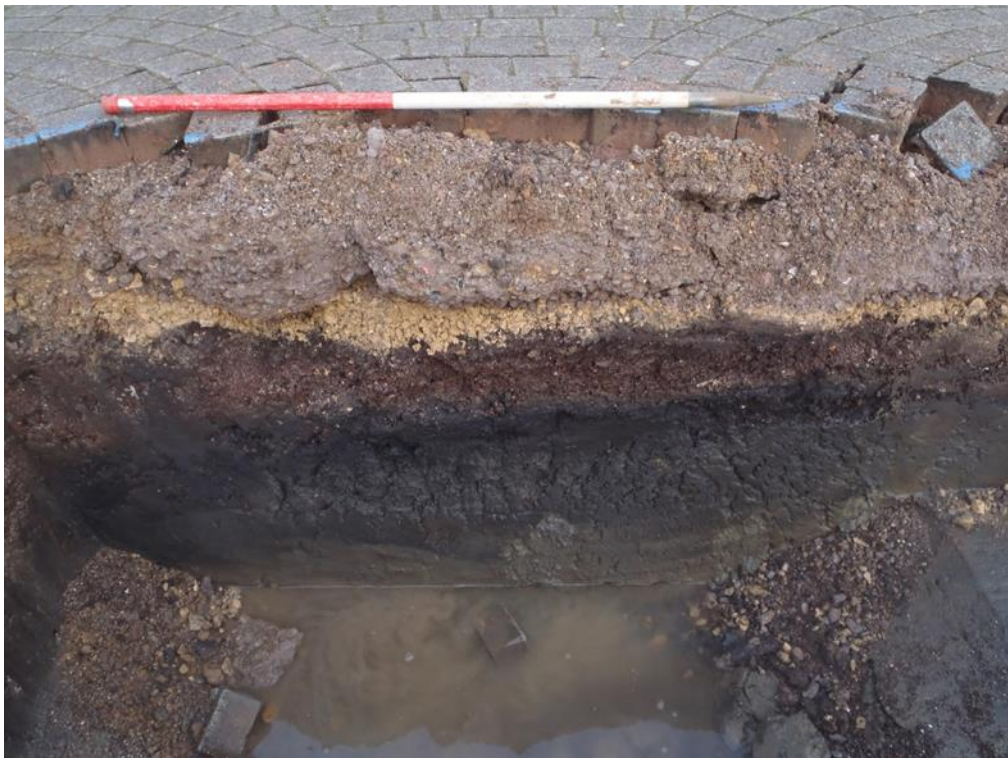
Plate 2. Trench 1, Section 1 (south-east facing section), looking north-west (*scale 2m*)

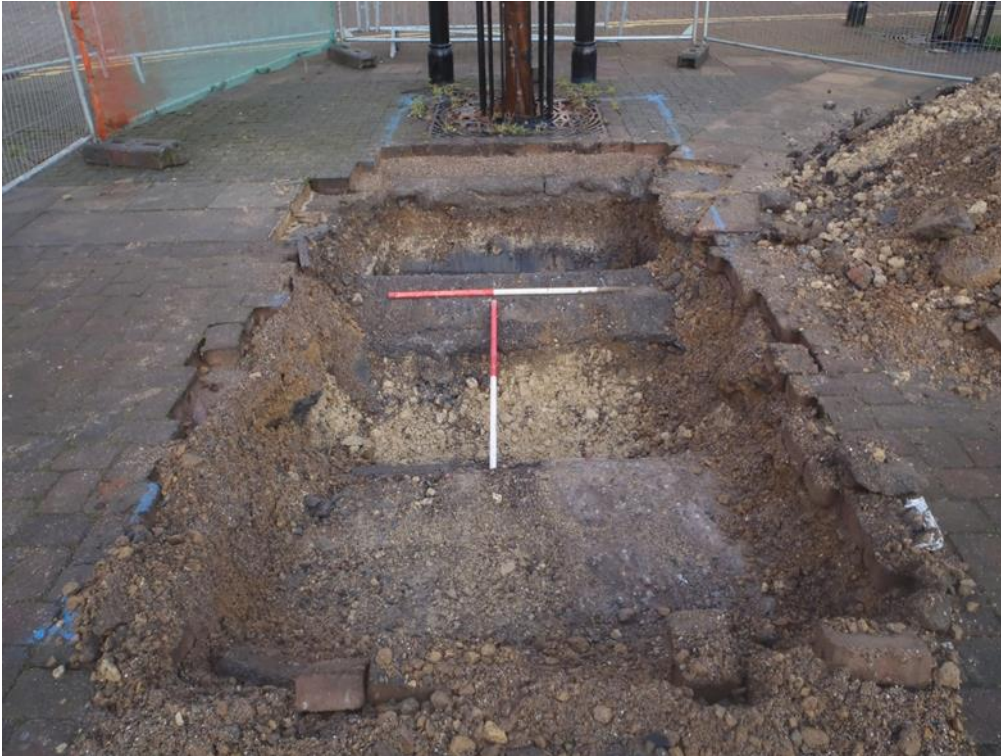
Plate 3. Trench 2, showing services, looking north-west (*scales 2m and 1m*)

5.3 Trench 2 Plate 3 (Plate 3; Figure 2)

5.3.1 No features or deposits of archaeological significance were encountered within Trench 2.

TRENCH 2	Figure 2		Plate 3
Trench Alignment: NW–SE	Length: 5.75m	Depth: 0.68m	
Deposit	Context No.	Average Depth (m)	
		Section 2	
Paving	[100]	0.08m	
Concrete	[101]	0.06m	
Made Ground	[102]	0.36m	
Made Ground	[103]	0.24m	
Made Ground	[104]	0.12m+	
Summary			
Trench 2 was located in the north-west corner of the Market Place.			
No archaeological features or deposits of significance were encountered in the trench.			
Modern services and the presence of a tree at the northern end of the trench meant that a maximum depth of only 0.68m could be reached. Natural geology was not identified at this depth.

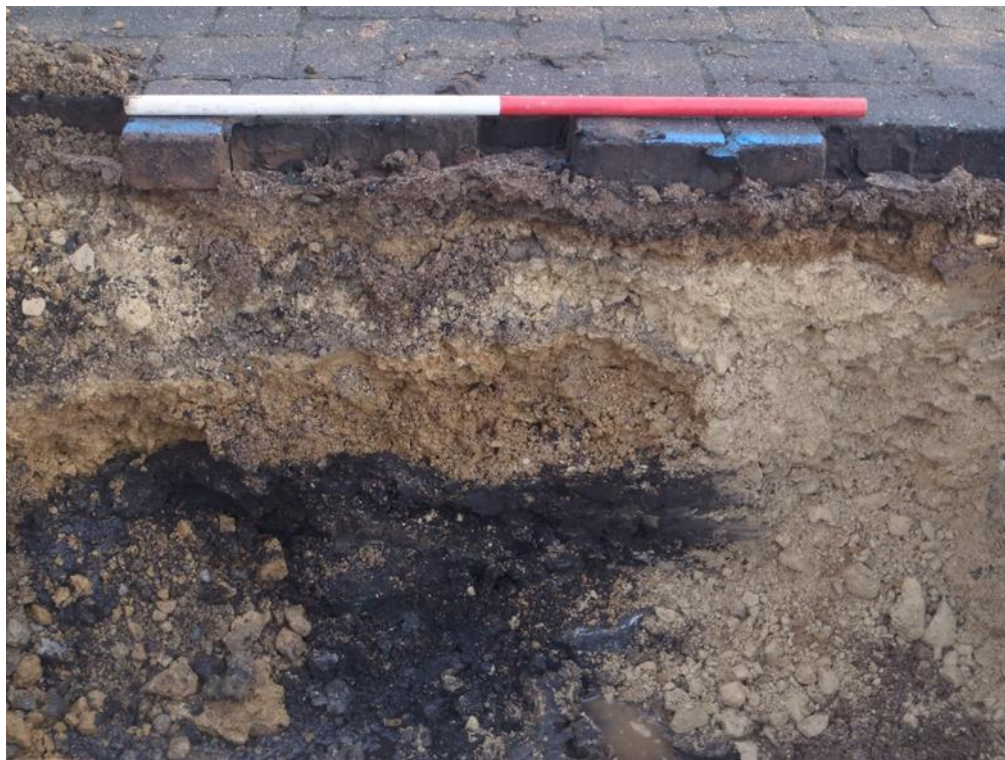
5.3.2 A cut for a modern electricity cable [112] (Plate 4) heavily truncated areas of Trench 3.

Plate 4. Trench 3, showing electricity cable trench [112], looking north-east (*scale 1m*)

5.3 Trench 3 (Plate 4; Figure 2)

5.3.1 No features or deposits of archaeological significance were encountered within Trench 3.

TRENCH 3	Figure 2		Plate 4
Trench Alignment: NW–SE	Length: 2m ²	Depth: 0.88m	
Deposit	Context No.	Average Depth (m)	
		Section 3	
Paving	[100]	0.08m	
Concrete	[101]	0.12m	
Made Ground	[102]	0.18m	
Made Ground	[107]	0.24m	
Made Ground	[110]	0.18m+	
Summary			
Trench 3 was located in the south-west corner of the Market Place.			
No archaeological features or deposits of significance were encountered in the trench.			
A modern electricity cable crossed the trench; as such a maximum depth of 0.88m could be reached. Natural geology was not identified at this depth.

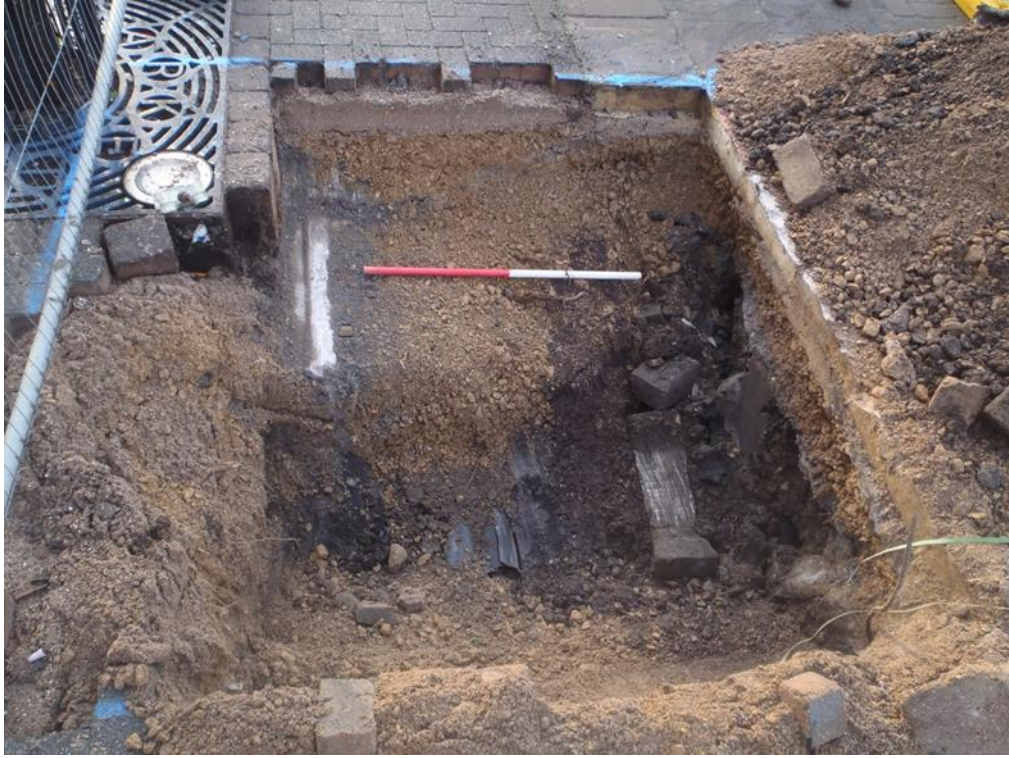
Plate 5. Trench 4, showing modern services, looking south-east (*scale 2m*)

5.4 Trench 4 (Plate 5; Figure 2)

5.4.1 No features or deposits of archaeological significance were encountered within Trench 4.

TRENCH 4	Figure 2	Plate 5
Trench Alignment: NW–SE	Length: 2m ²	Depth: 1.22m
Deposit	Context No.	Average Depth (m)
		Section 4
Paving	[100]	0.08m
Concrete	[101]	0.10m
Made Ground	[105]	0.14m
Concrete	[109]	0.16m
Made Ground	[110]	0.82m+
Summary		
<p>Trench 4 was located in the south-eastern corner of the Market Place.</p> <p>No archaeological features or deposits of significance were encountered in the trench.</p> <p>Two modern services were located in the trench and the presence of a tree also limited investigation in this area; a maximum depth of 1.22m could be reached and natural geology was not present at this depth.</p>
