**THE DERWENT CENTRE
PRINCESS ALEXANDRA HOSPITAL
HAMSTEL ROAD, HARLOW
ESSEX CM20 1QX**

**AN ARCHAEOLOGICAL
MONITORING EXERCISE**

PCA REPORT NO: R12024

SITE CODE: HADC15

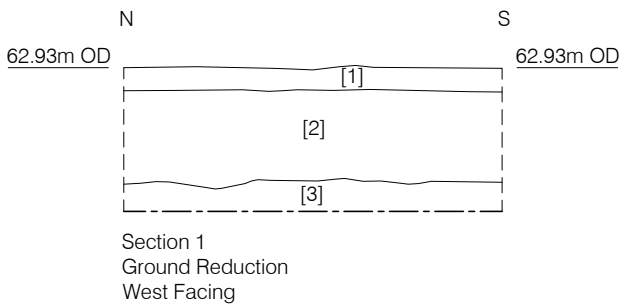
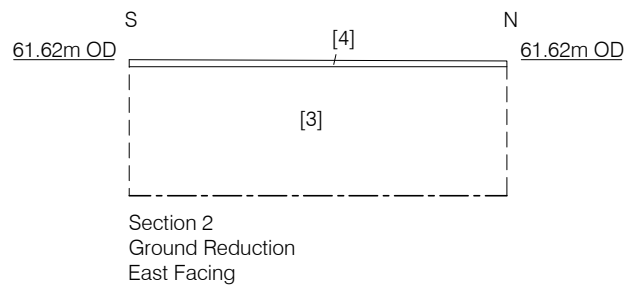
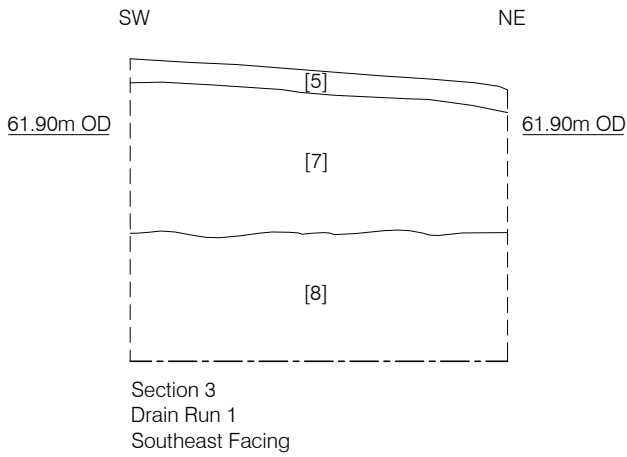
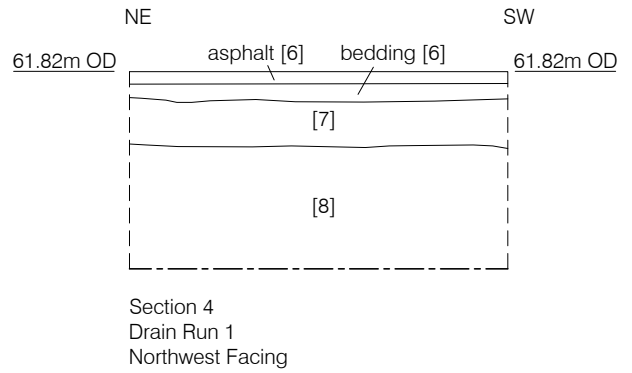
Figure 3
Sections 1 - 4
1:50 at A4

7.2.3 The stratigraphic sequence in Area 1 was completed by a layer of turf-covered topsoil [1] across much of the area. This material was up to 0.19m thick and recorded at an upper elevation of 63.63m AOD. At the foot of the slope towards the western end of the area, a north to south aligned path comprised of concrete paving slabs [4] had been laid directly over the exposed and truncated natural sands and gravels. This was recorded at an upper elevation of 61.86m AOD (Figure 5, Section 2).

7.3.2 The natural sands and gravels were overlain by mixed made ground comprising redeposited natural materials and recent demolition rubble [7] (Figure 5, Section 4; Plate 5). This was of a negligible thickness at the north-west corner of Shannon House but increased to a thickness of approximately 1m at the south-western end of

the monitored drainage run (Figure 5, Section 3; Plate 6), where it formed an artificial bank, which had been grassed over.

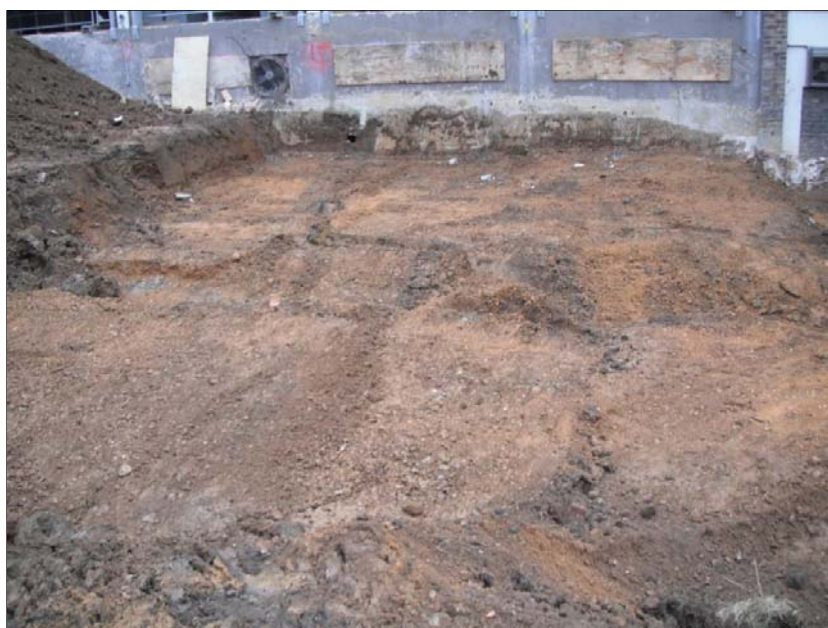
Plate 3: Truncated Natural Deposits in Area 1, Looking South

7.2.1 Basal deposits recorded across the site comprised Pleistocene sands and gravels. In Area 1 at the north of the building the upper natural deposit was soft, light reddish brown sand [3], recorded at an upper elevation of 62.93m AOD (Figure 5, Section 1). Below this were varying deposits of sand and gravel extending to at least the excavated formation level of c. 60.4m AOD (Plate 3).

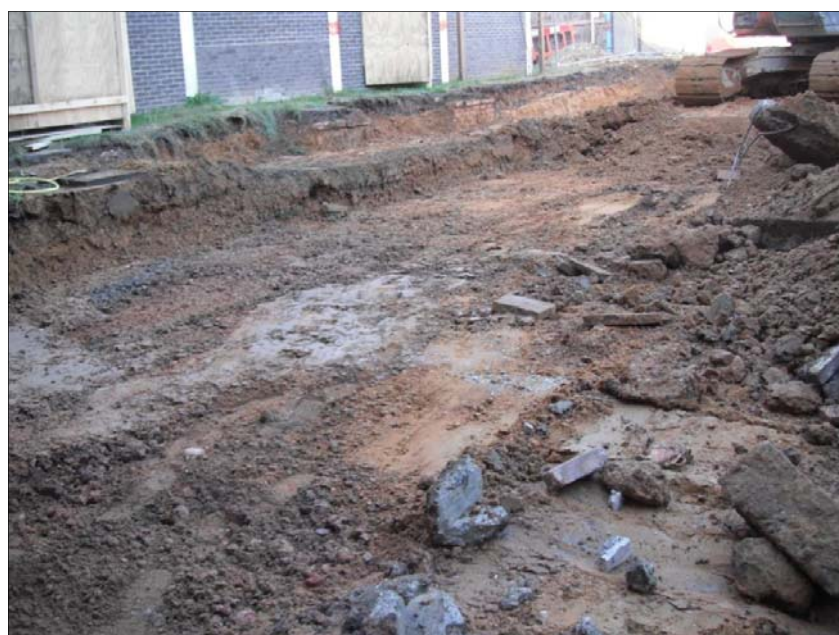
Plate 4: Heavily Truncated Natural and Made Ground Deposits, Western End of Area 1, Looking North-West

7.2.2 In Area 1 natural sands and gravels had been significantly truncated, particularly to the west, where there had been terracing of the natural slope and excavation for the lower foundations of the secure unit (Shannon House) at the north-west corner of The Derwent Centre (Plate 4). The sands and gravels were directly overlain by up to 0.62m of mixed made ground [2] comprising reworked natural deposits, demolition rubble of recent date and other materials, recorded at an upper elevation of 63.51m AOD. Adjacent to the building the same material filled the extensive foundation trenches, which extended up to 2m from the structure and more than 3m bgl. The made ground was also truncated by numerous services, particularly drainage runs.
