**HISTORIC BUILDING
RECORDING OF NOS 3-5
VALENTINE PLACE AND
NOS 17-19 VALENTINE
PLACE/NO. 21 WEBBER
STREET,
LONDON BOROUGH OF
SOUTHWARK,
SE1 8QH**

PCA REPORT NO. R11992

FEBRUARY 2015

HISTORICAL BUILDING RECORDING

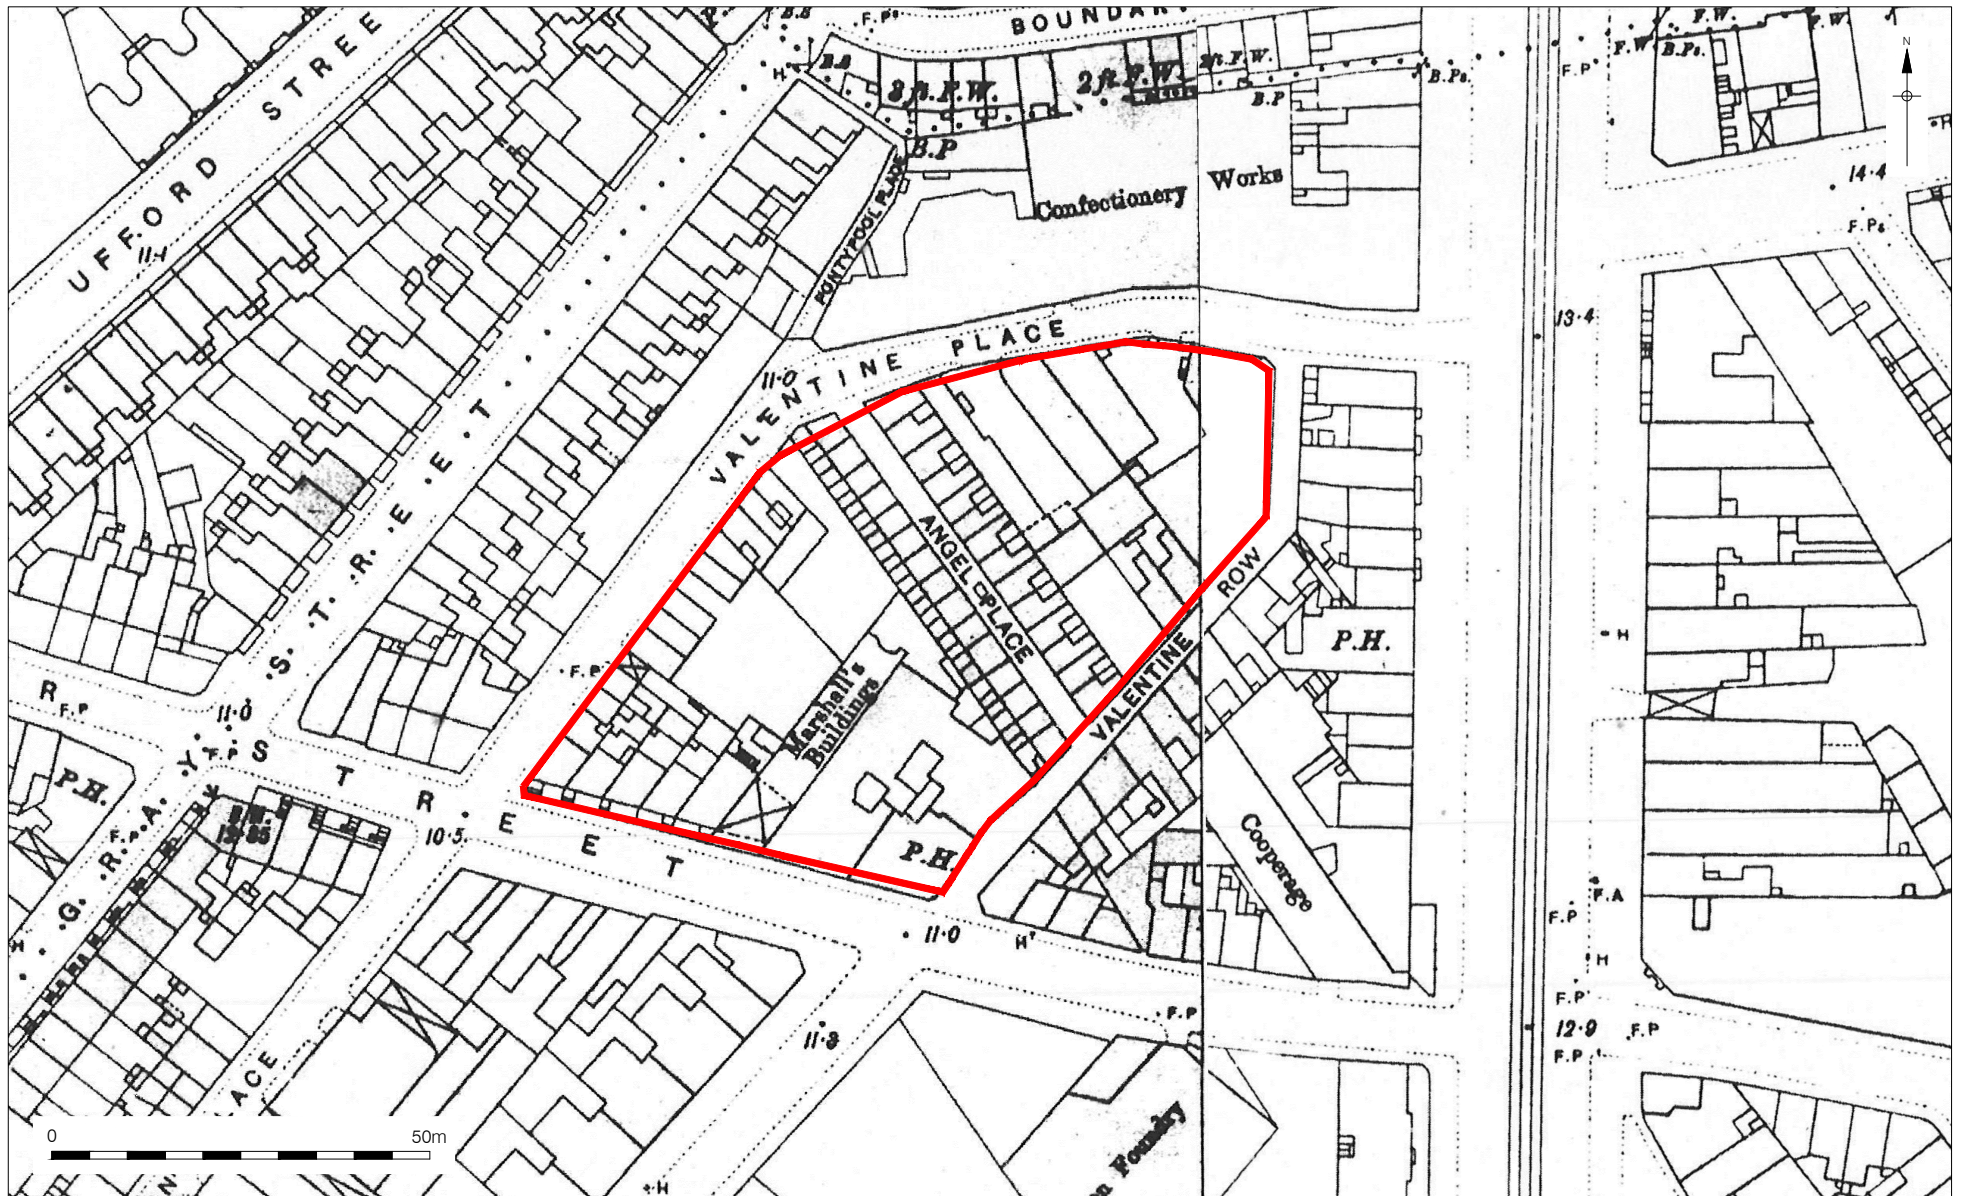
Figure 8
 1907 Ordnance Survey
 1:1,000 at A4

- 5.4.1 The period between 1896 and 1916 saw significant changes take place in the Valentine Place area. The terraced houses of Angel Place although present in the 1907 Ordnance Survey Map (**Figure 8**) had been cleared away and replaced with large buildings by the time of the following 1916 map (**Figure 9**).

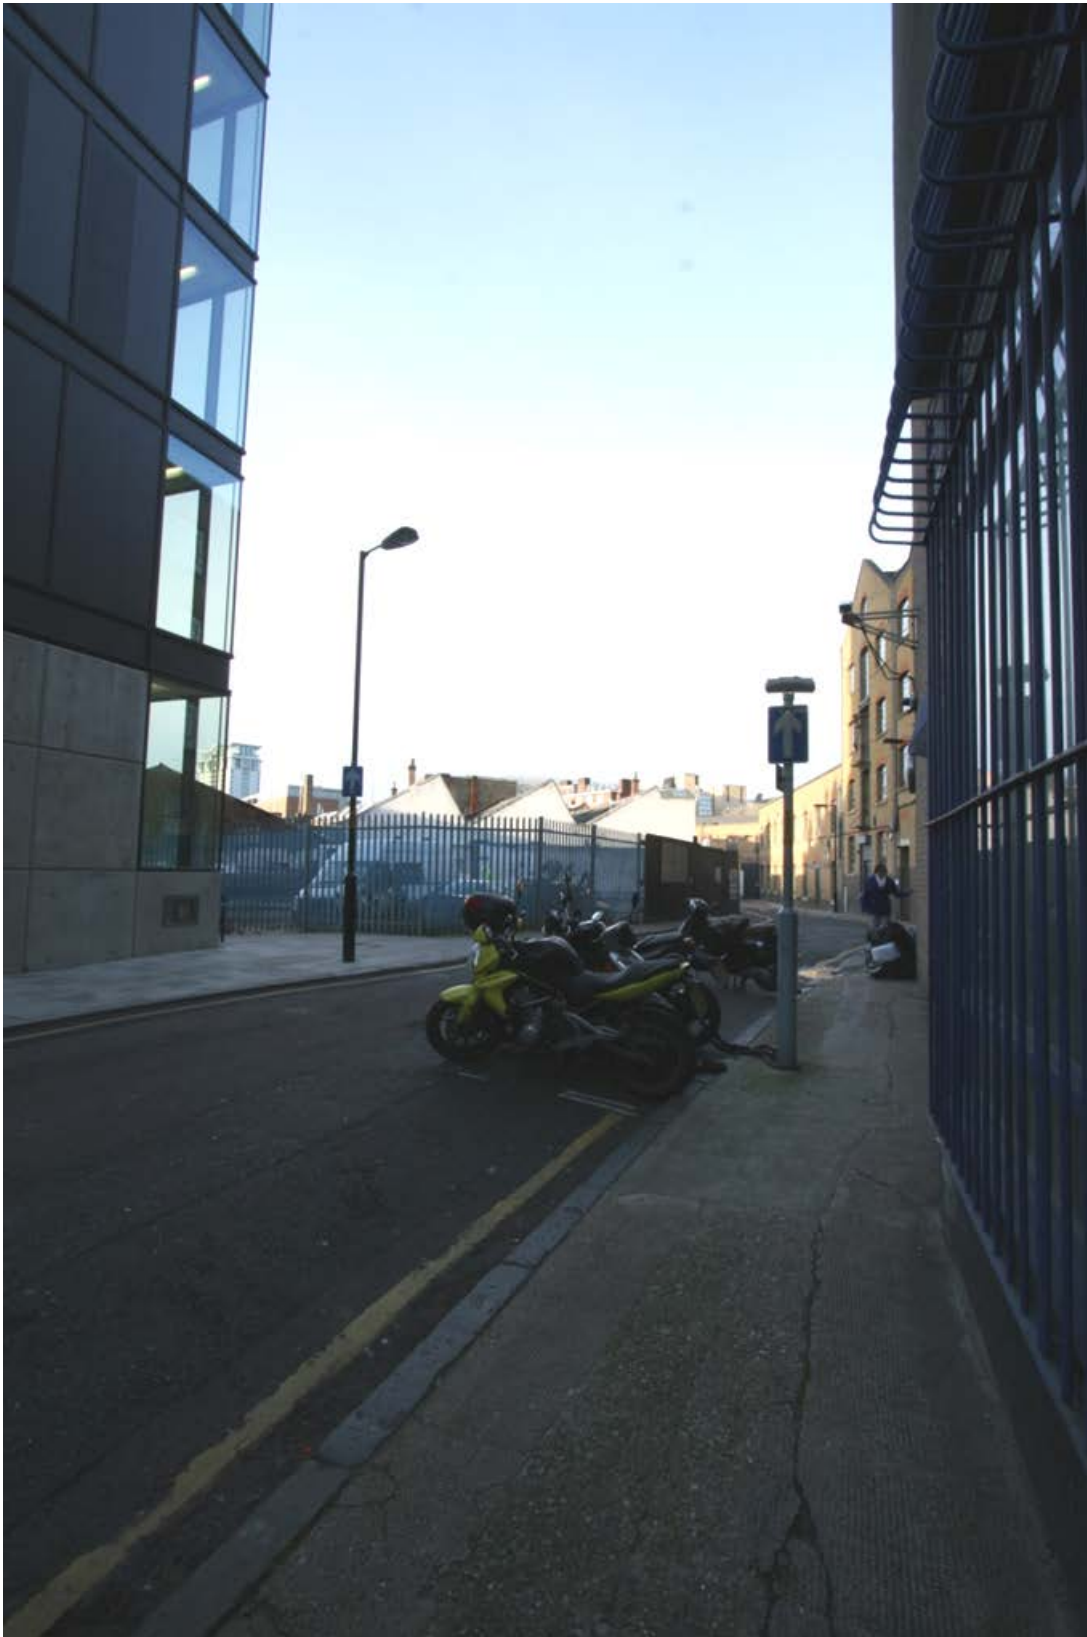
Plate 1: Distinctive saw-tooth roof of nos 3-5 Valentine Place, looking south (VAL14 D100 (1))

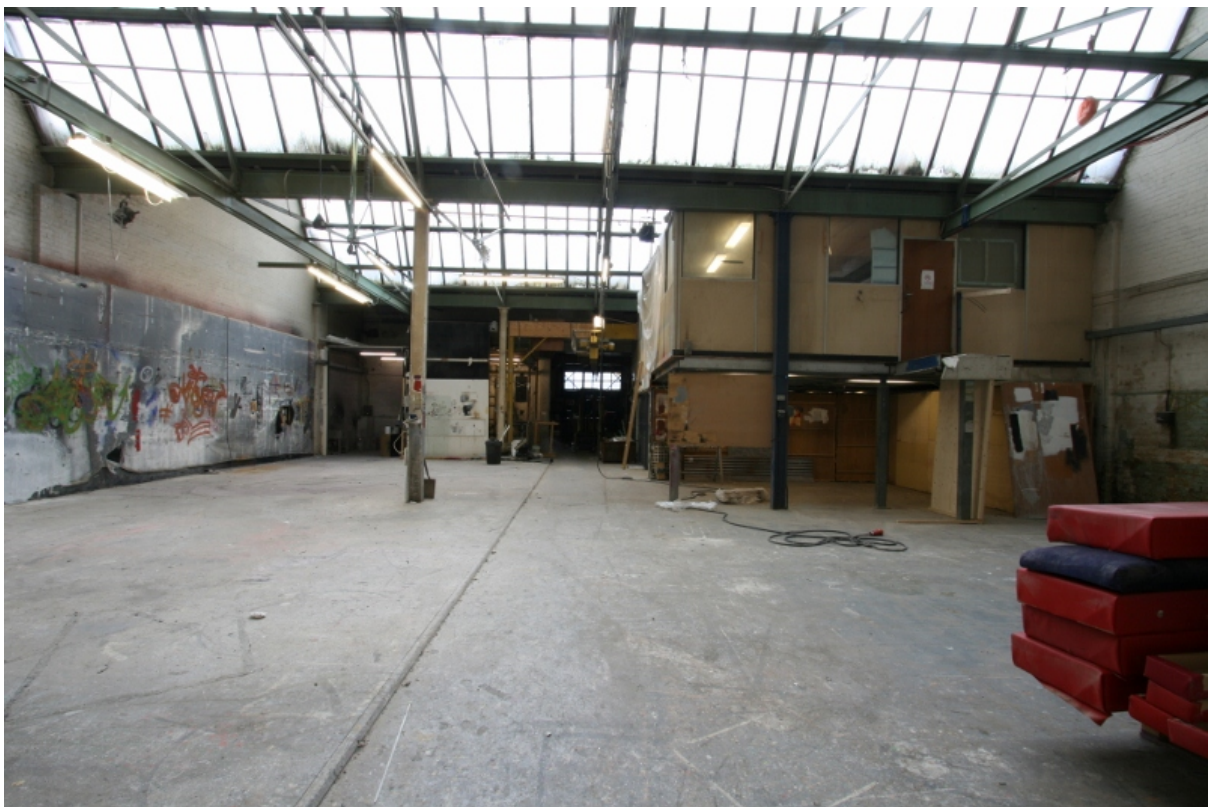
Plate 15: Room B1G1 with inserted mezzanine level (right), looking west (VAL14 D100 (128))

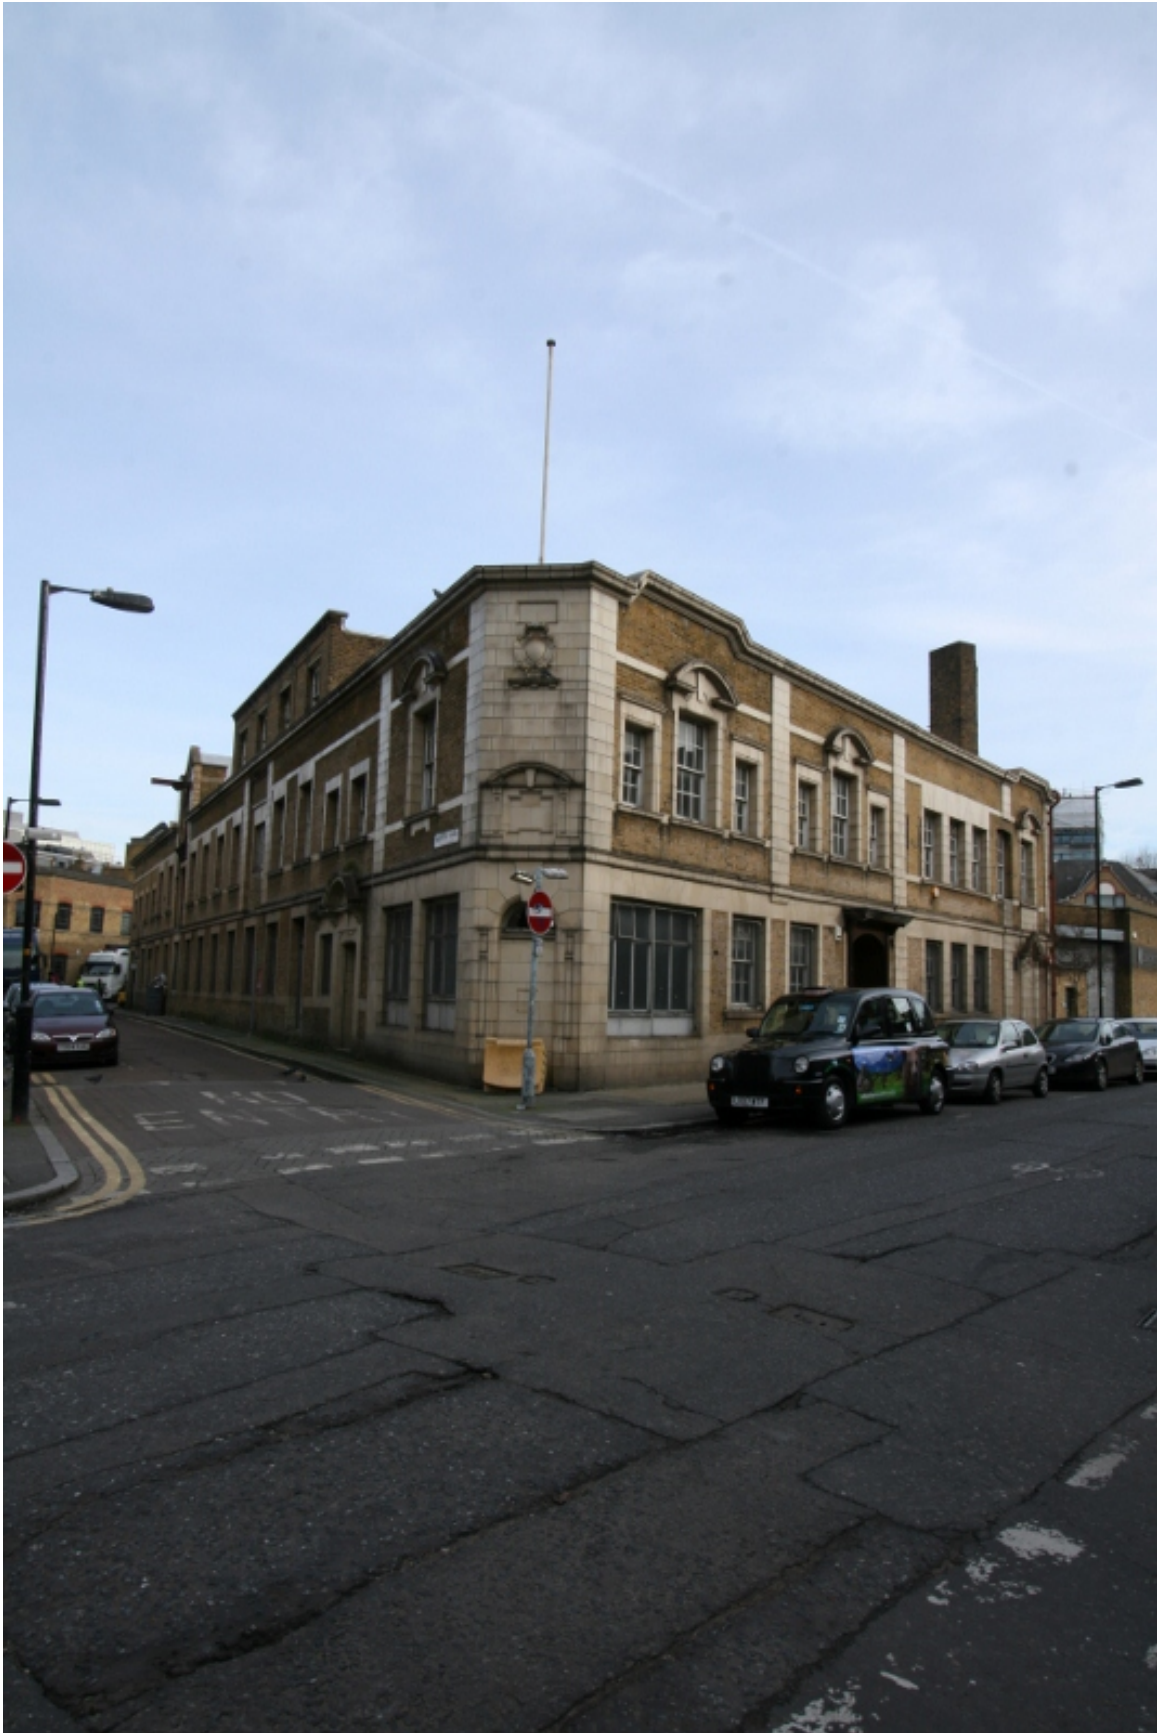
Plate 34: South-west corner of nos 17-19 Valentine Place/no. 21 Webber Street decorated with terracotta detailing (faience), looking north-east from Webber Street (VAL14 D100 (11))

6.4.2 The building contrasts in architectural style with the majority of the utilitarian industrial buildings that surround it. The elevations along Valentine Place and Webber Street are in an Edwardian neo-classical style and is constructed from London yellow stock brick with faience (golden terracotta) dressings (**Plates 32a to 36**). The west elevation along Valentine Place has four ground floor doorways and fifteen windows (**Plates 32a, 33 and 34**). Some of the windows have been replaced and most of the doorways have been altered. Above at first floor level, the west elevation has sixteen windows and one loading bay door. One of the windows appears to have been altered from another loading bay door and the part of the doorway has been infilled with brickwork. One of the other windows may also have been altered from a

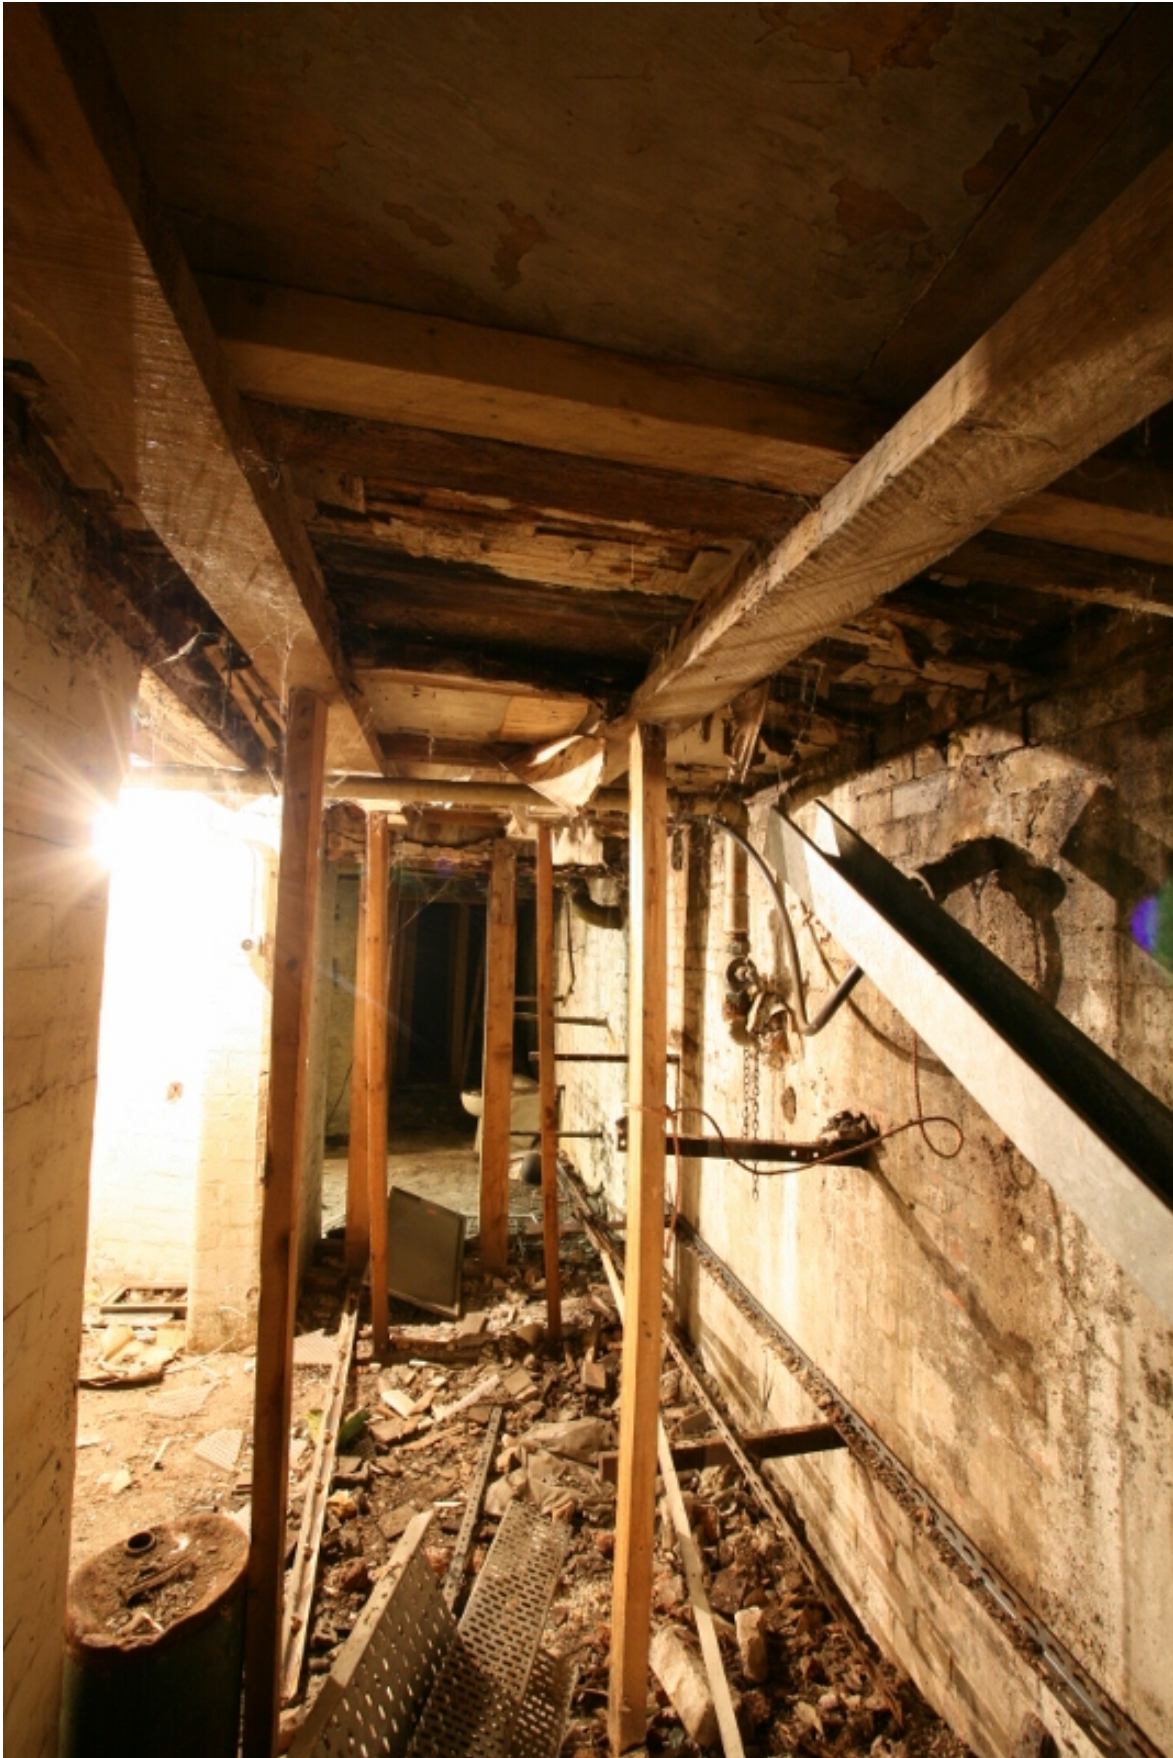
Plate 51: Pavement vault area of basement, looking west (VAL14 D100 (61))

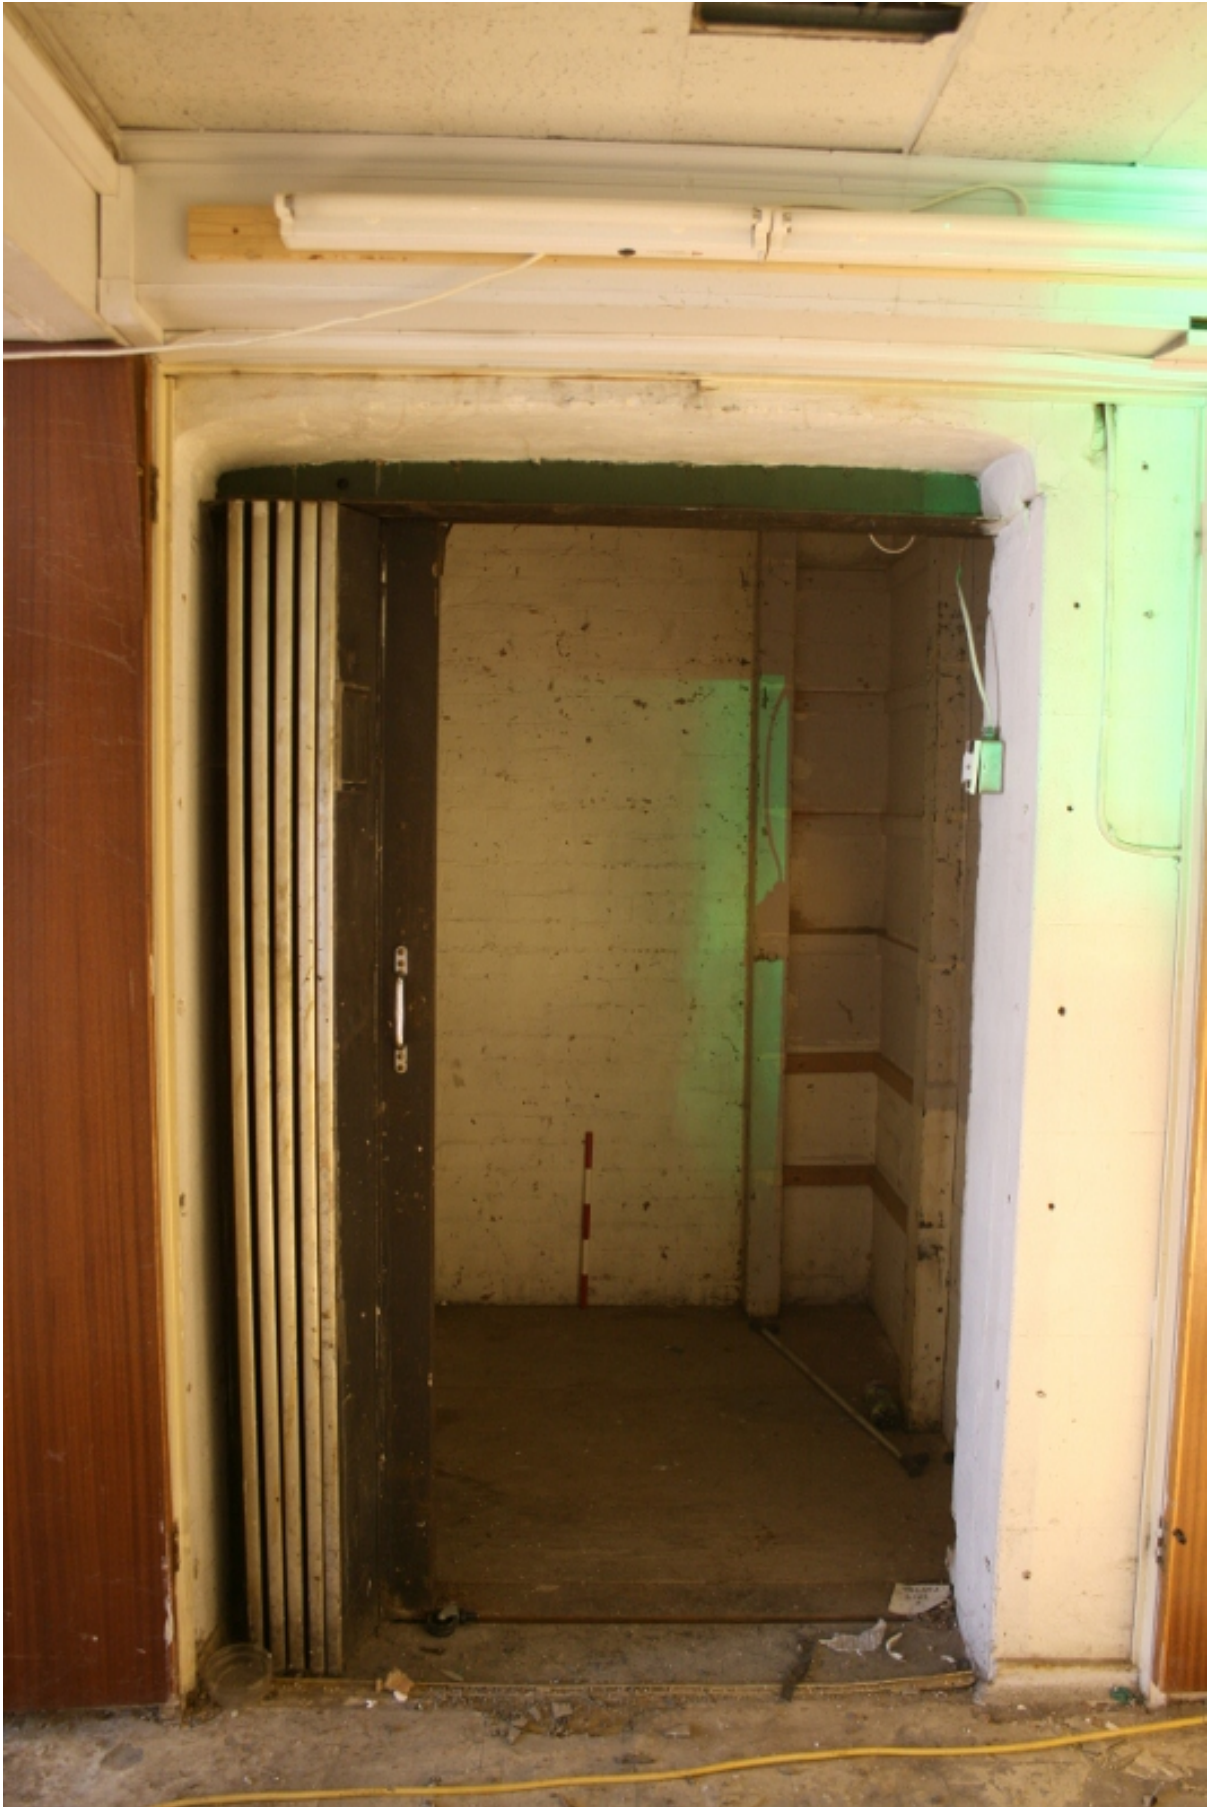
Plate 60: Converted lift shaft in corridor 3 at ground floor level, looking west (VAL14 D100 (40))

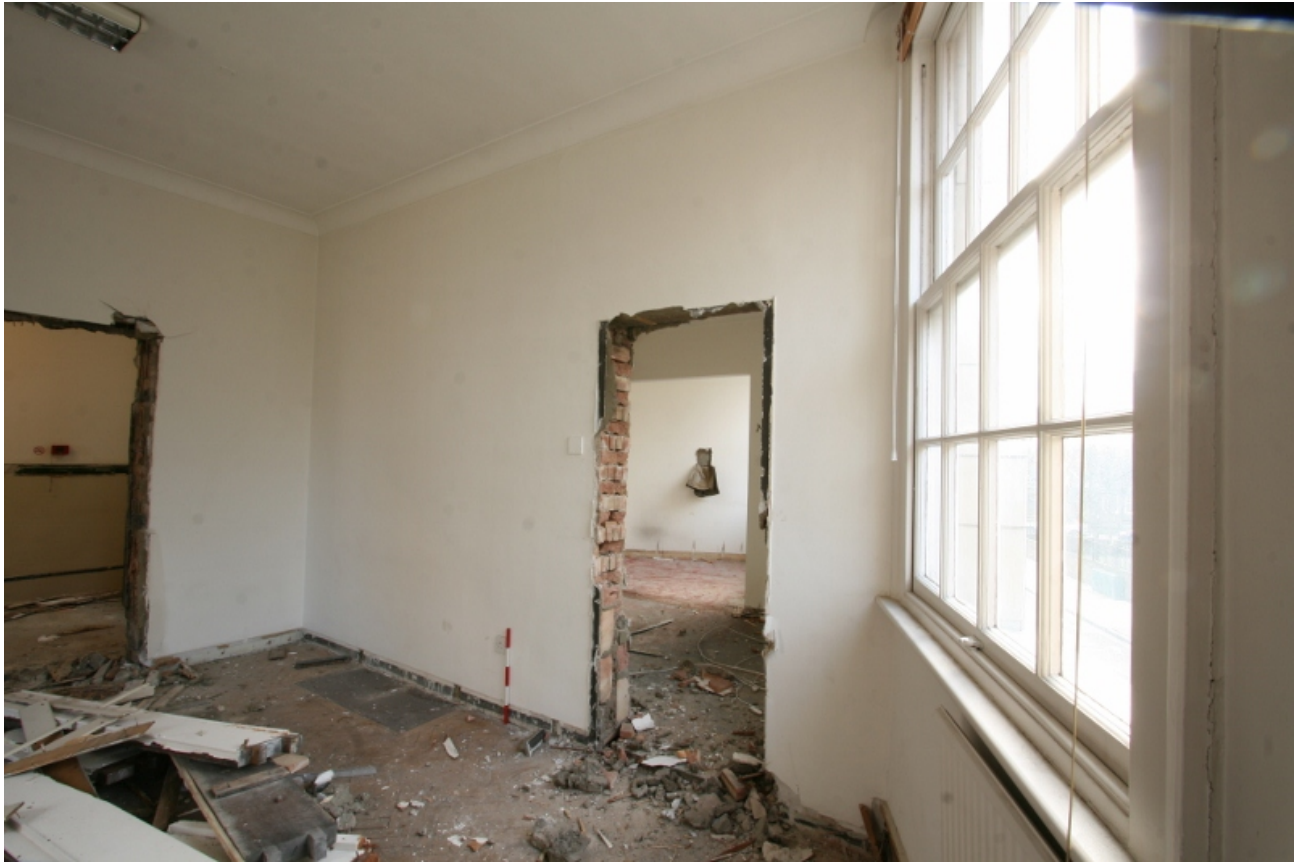
Plate 70: Removed fireplace indicated by original hearth stone in first floor room B2F4, looking north-east (VAL14 D100 (80))

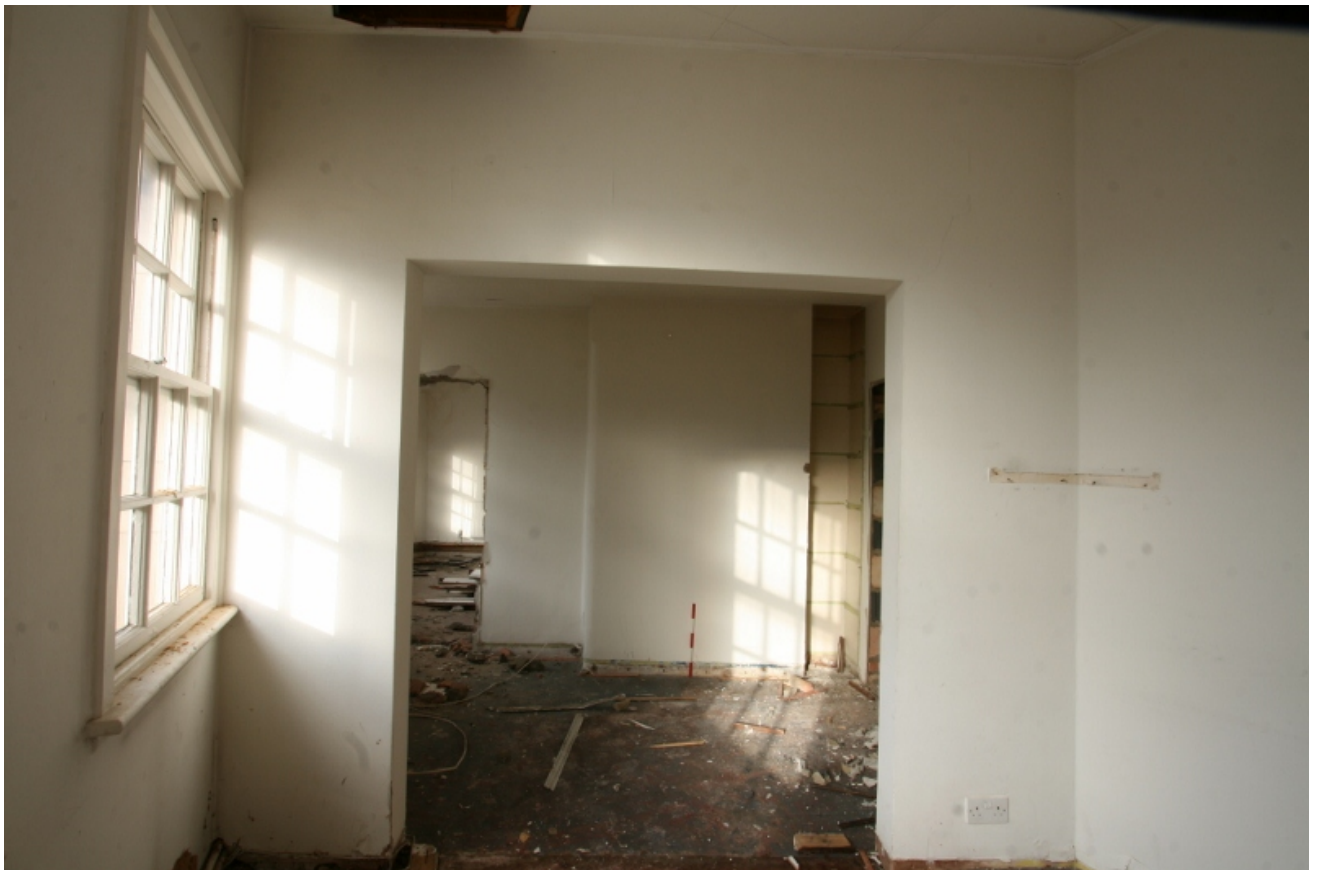
Plate 71: Chimney-breast in first floor room B2F5, looking west (VAL14 D100 (81))

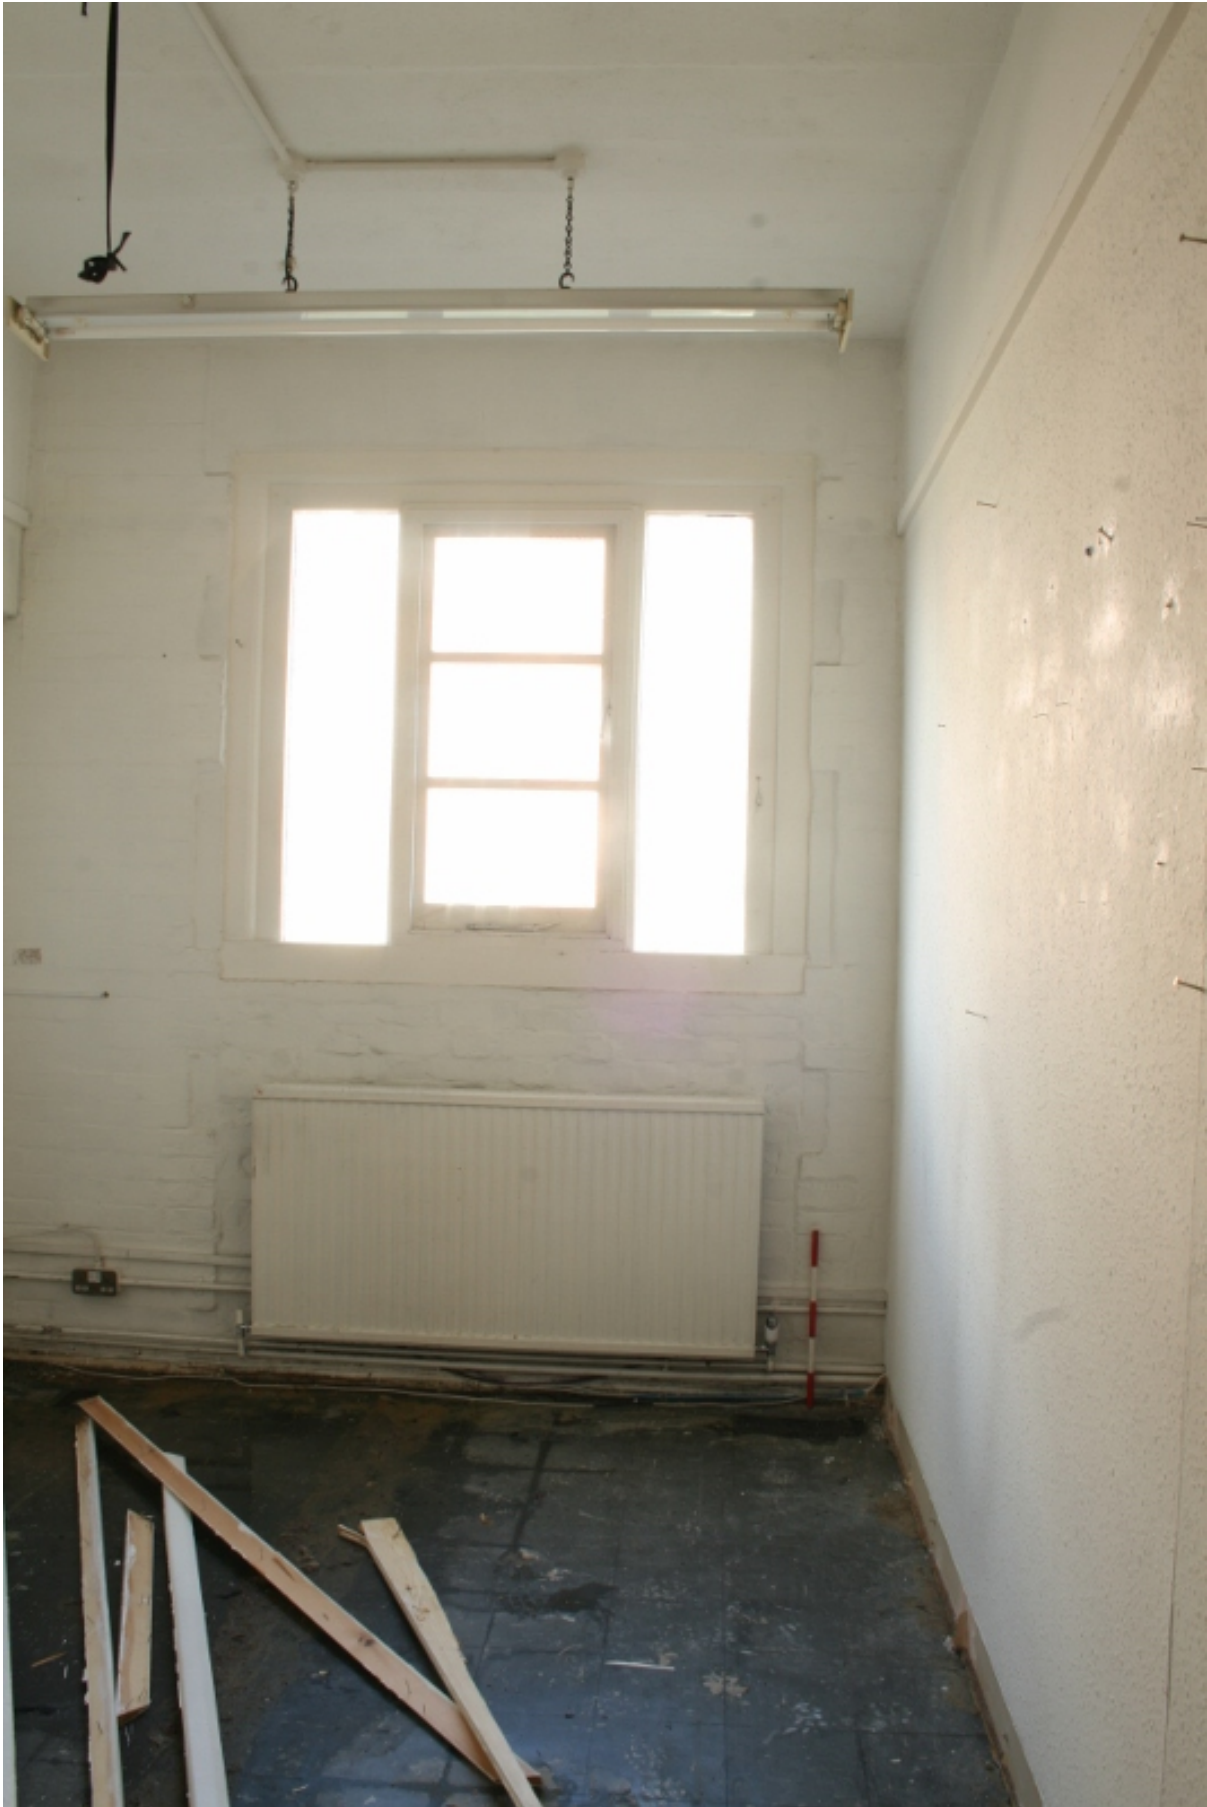
Plate 78: Replacement window in first floor room B2F2, looking west (VAL14 D100 (96))

6.4.18 The first floor rooms on the west side of the building had been further divided to create smaller rooms (**Figure 19**). In one of these rooms (B2F2) the window facing Valentine Place had been replaced (**Figure 19; Plate 78**). In addition, a new set of stairs (staircase 3) had been added from the first to the second floor, and were presumably added when this part of the second floor was added (**Figure 19; Plates 76 and 77**). A photograph of the building taken in 1977 shows that this second floor addition was in place by that time (Grehs, 2013, 43).

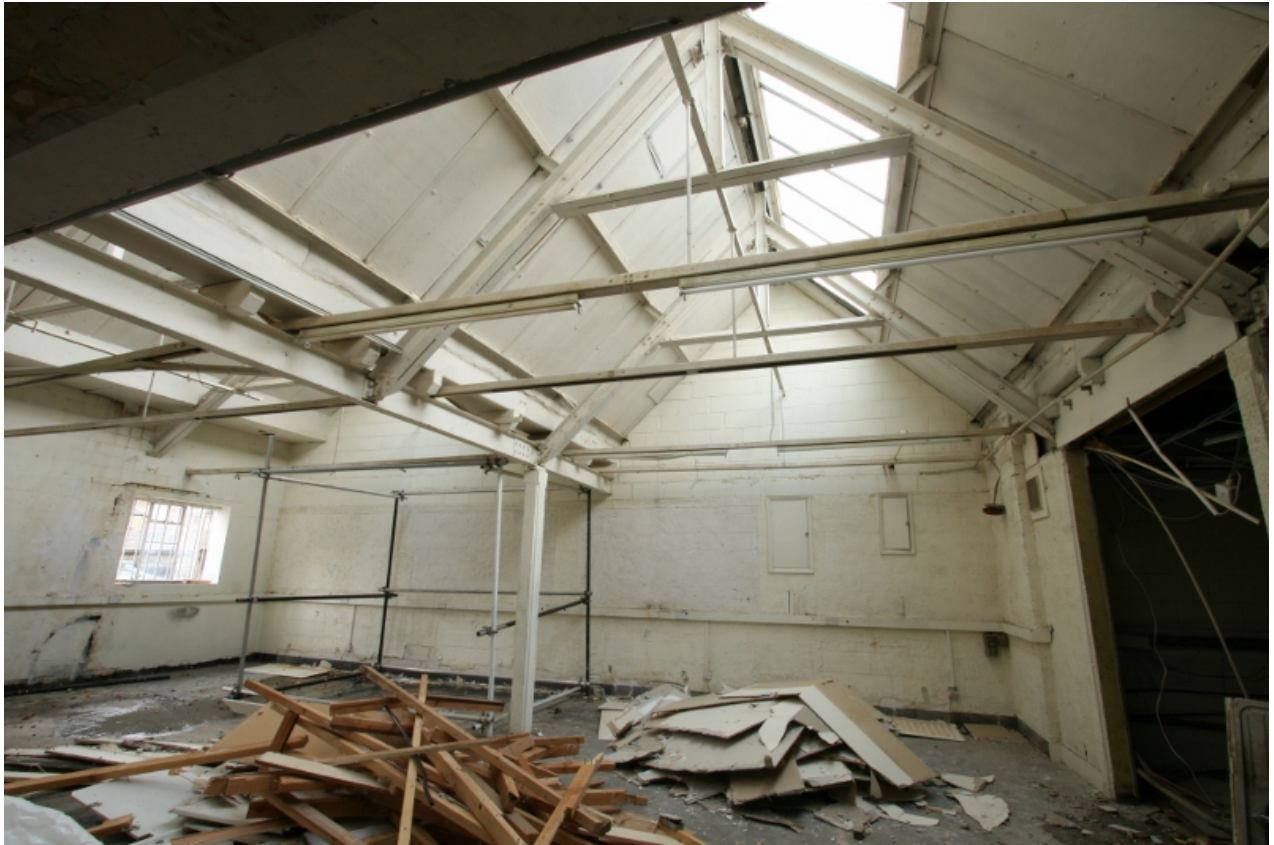
Plate 79: Exposed metal trusses of saw-tooth roof in room B2F10, looking south-east (VAL14 D100 (110))

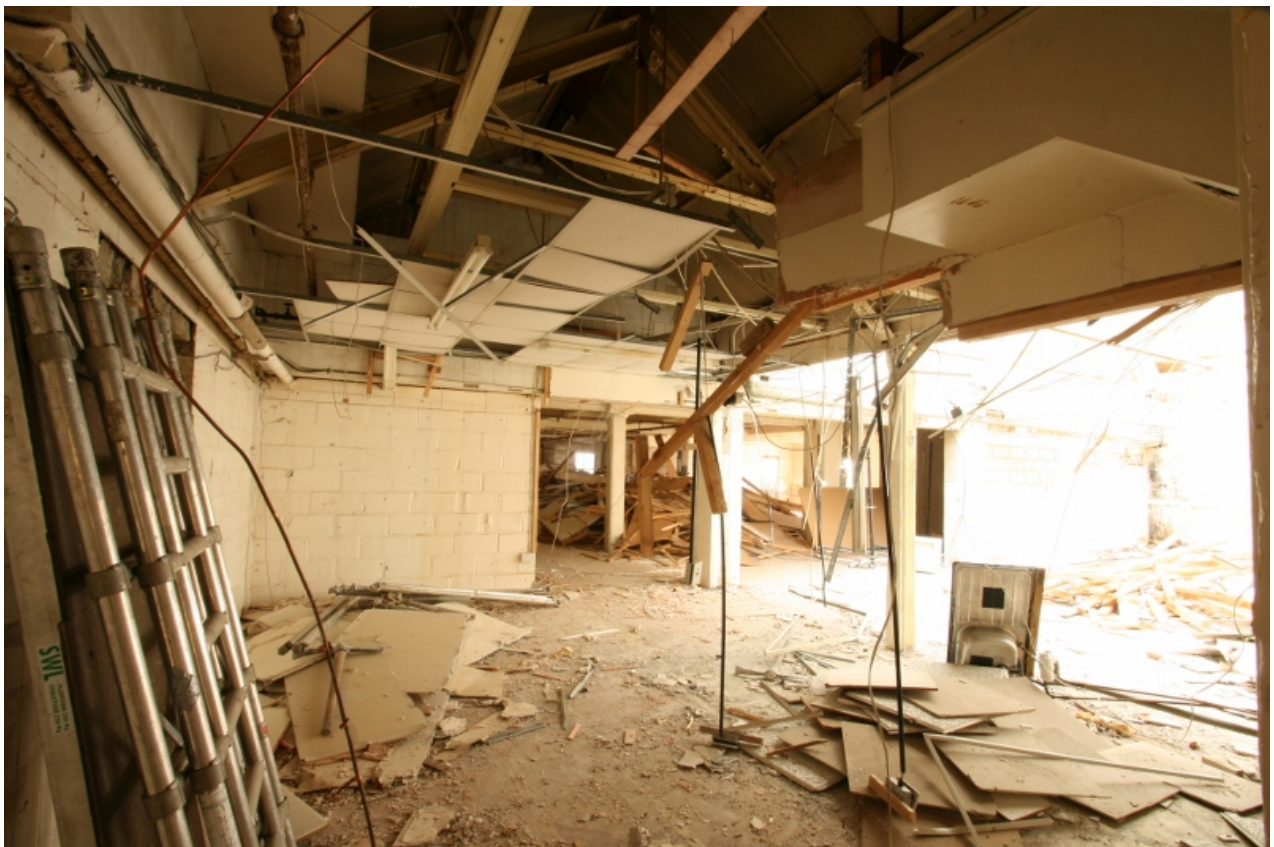
Plate 80: Exposed roof truss structure in first floor room B2F9 following partial soft strip, looking north-east (VAL14 D100 (107))
