**HISTORIC BUILDING
RECORDING AT
WOLSINGHAM SCHOOL
AND COMMUNITY
COLLEGE, WOLSINGHAM,
COUNTY DURHAM**

SITE CODE: WSD 15

PCA REPORT NO. R12005

FEBRUARY 2015

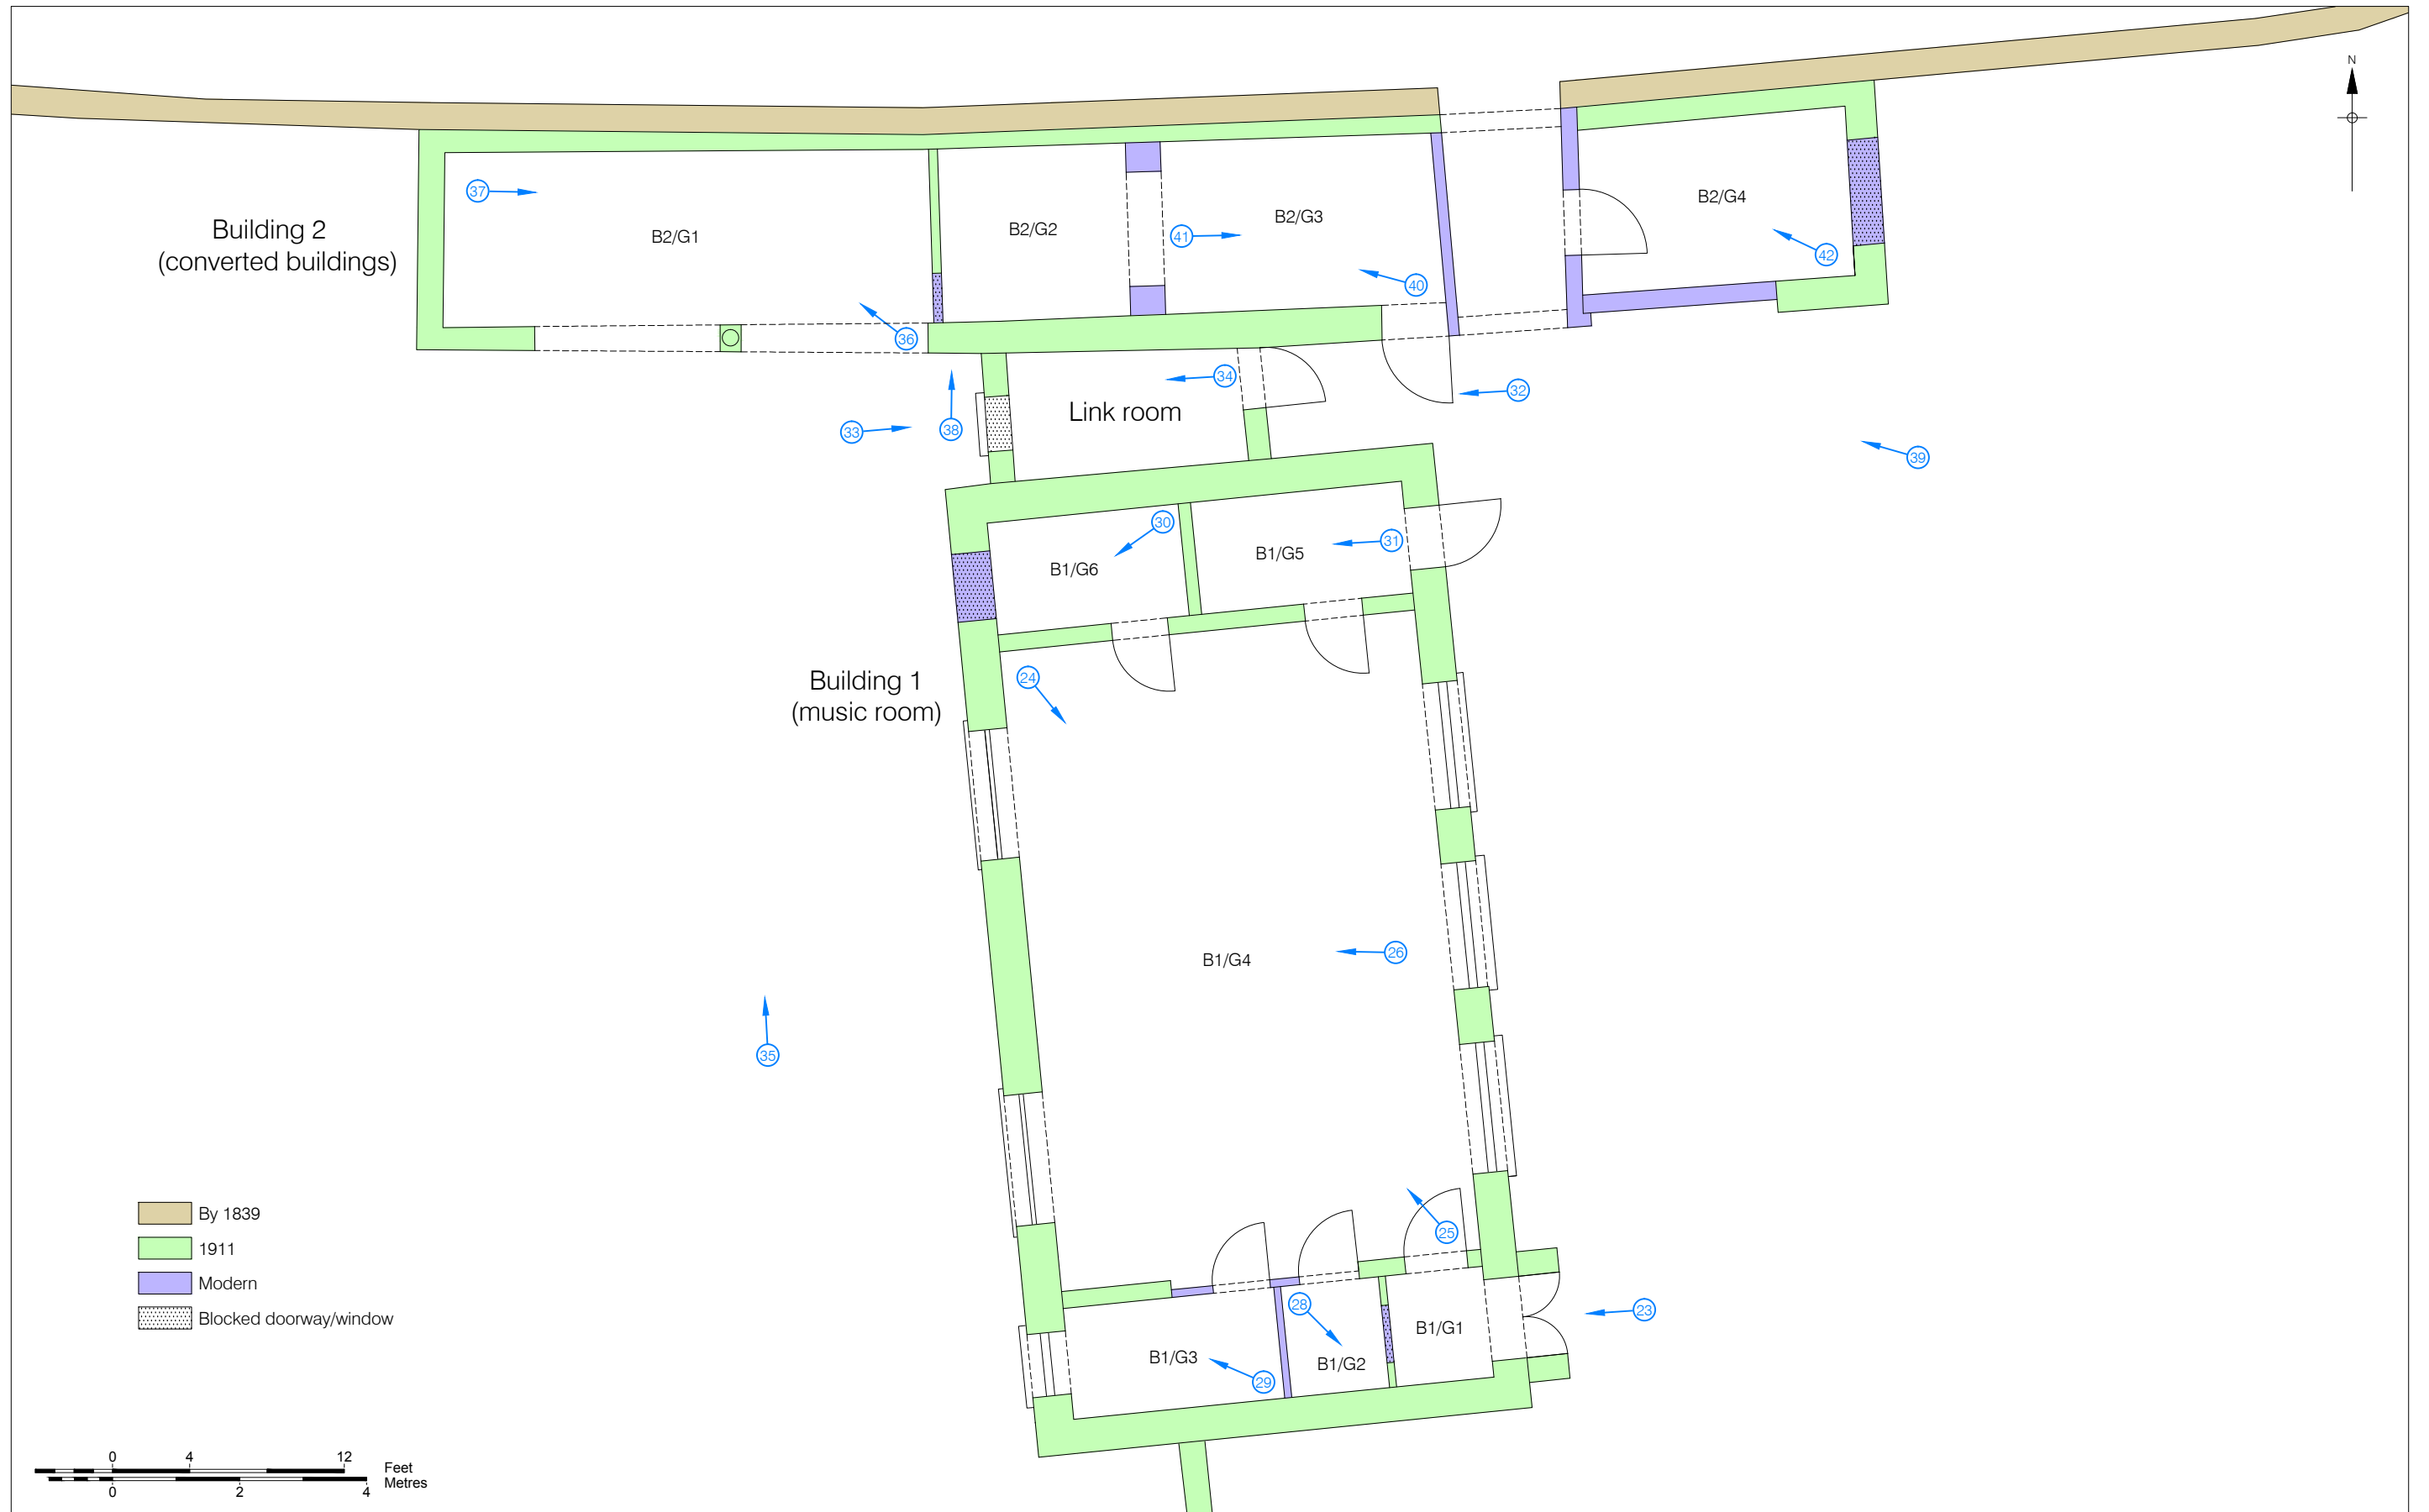
Figure 11
Existing Ground Floor Plan Showing Plate Directions
1:100 at A3

- 6.1.1 At the time of recording, the T-shaped pavilion building occupied the northern part of the site, while the former low east-west boundary wall, the north-south playground dividing wall, the Music Room and converted outbuildings lay to the south of the pavilion and to the north of the main Grammar School building (**Figures 2, 10 and 11**).
- 6.1.2 To facilitate recording, rooms and spaces in the investigated buildings were each assigned a unique alphanumeric code, for example Music Room (B1) or Converted Outbuilding Building (B2) followed by a number to indicate a specific room (**Figure 11**).

6.5.4 The music room outbuilding has a simple internal layout (**Figure 11**). A large classroom (B1G4) occupies the central part of the building (**Figure 11; Plates 24 and 25**), which is open to the roof. Four timber king post trusses support the roof over the classroom. Set within the apex of the roof are two octagonal chutes associated with air vents observed externally on the ridge of the roof (**Plates 26 and 27**). The walls of the large classroom are covered with original brown tiles to dado height and the south and north walls are built of brick (**Plates 24 and 25**). The doorway at the east end of the south wall is original; all the other doorways appear to have been inserted and are fitted with late 20th century plain flush doors (**Figure 11**).

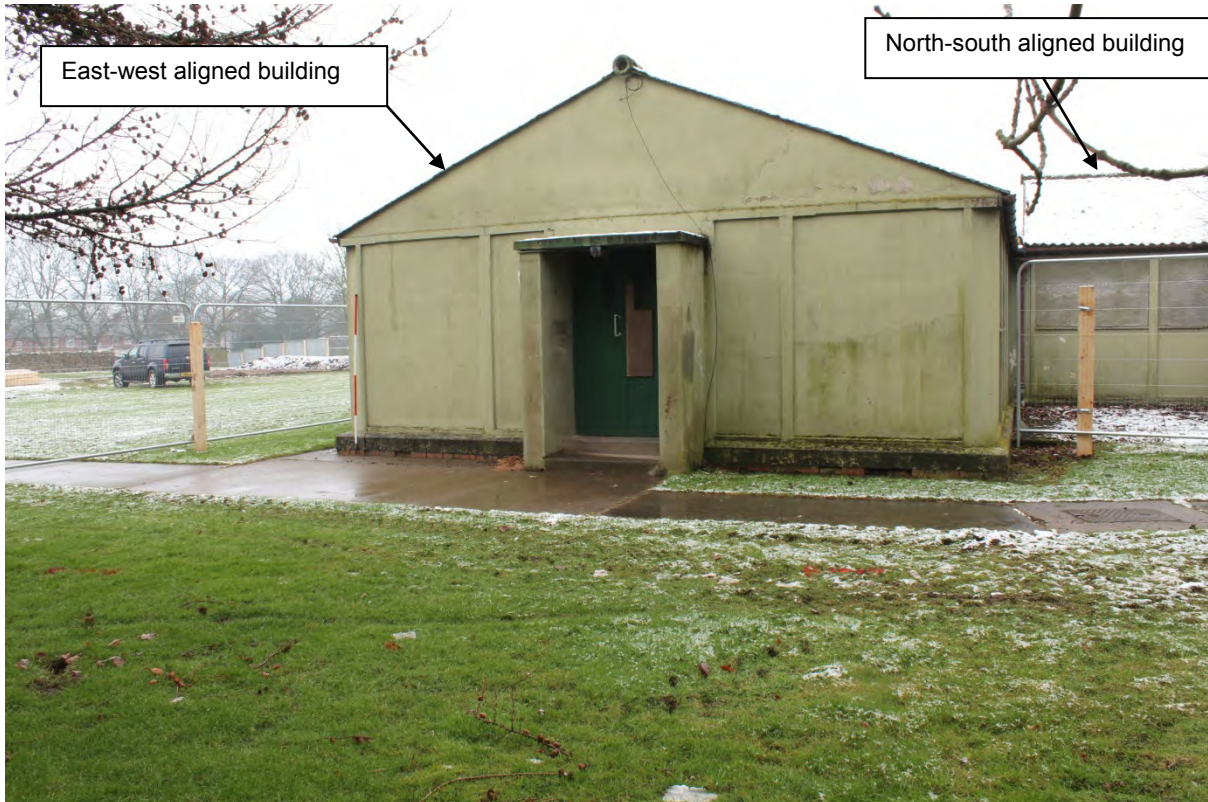
- 6.2.3 Although the interiors were not accessed for this English Heritage Level 1 recording, three access doorways were noted in the front (east) elevation (**Plates 1 and 2**). Two of these had porches. The elevation was painted a light olive green colour.

Plate 1: Front entrance into the Pavilion, looking west (WDS15 D1 (7))

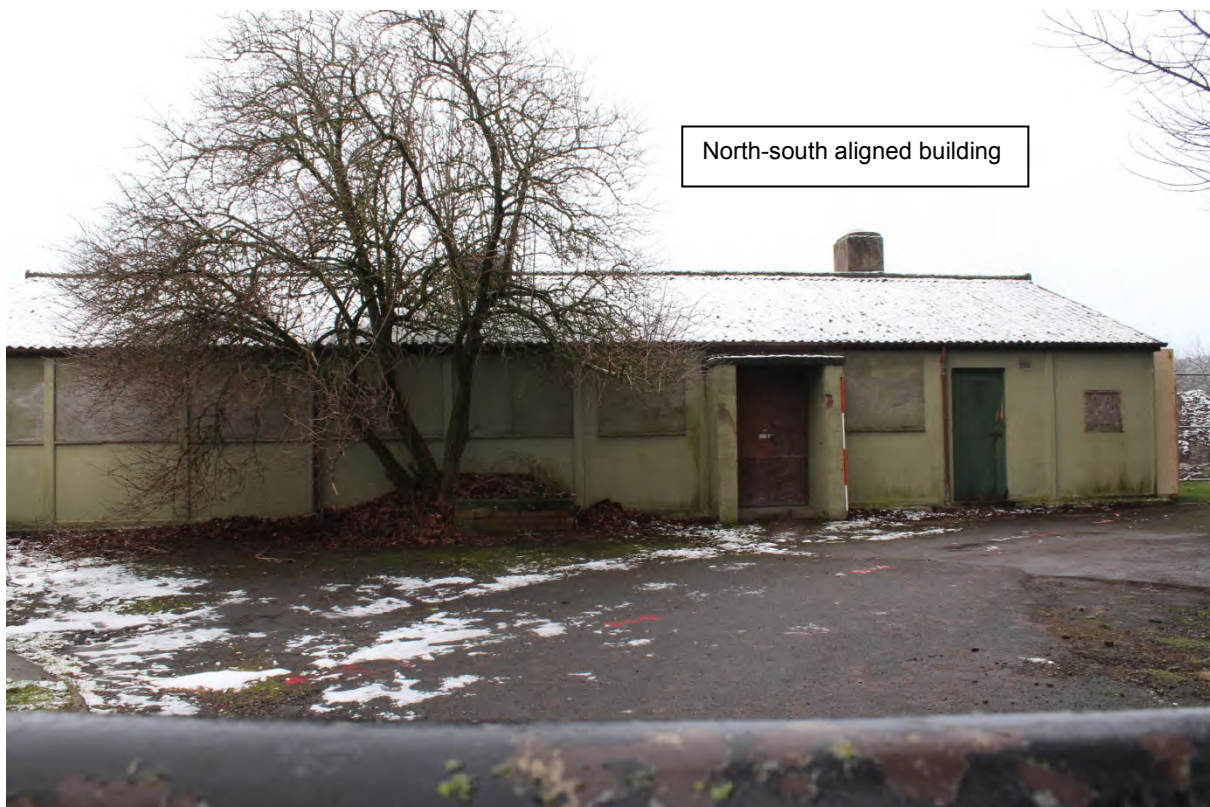
Plate 2: Side entrance in east elevation of the Pavilion, looking west (WDS15 D1 (8))

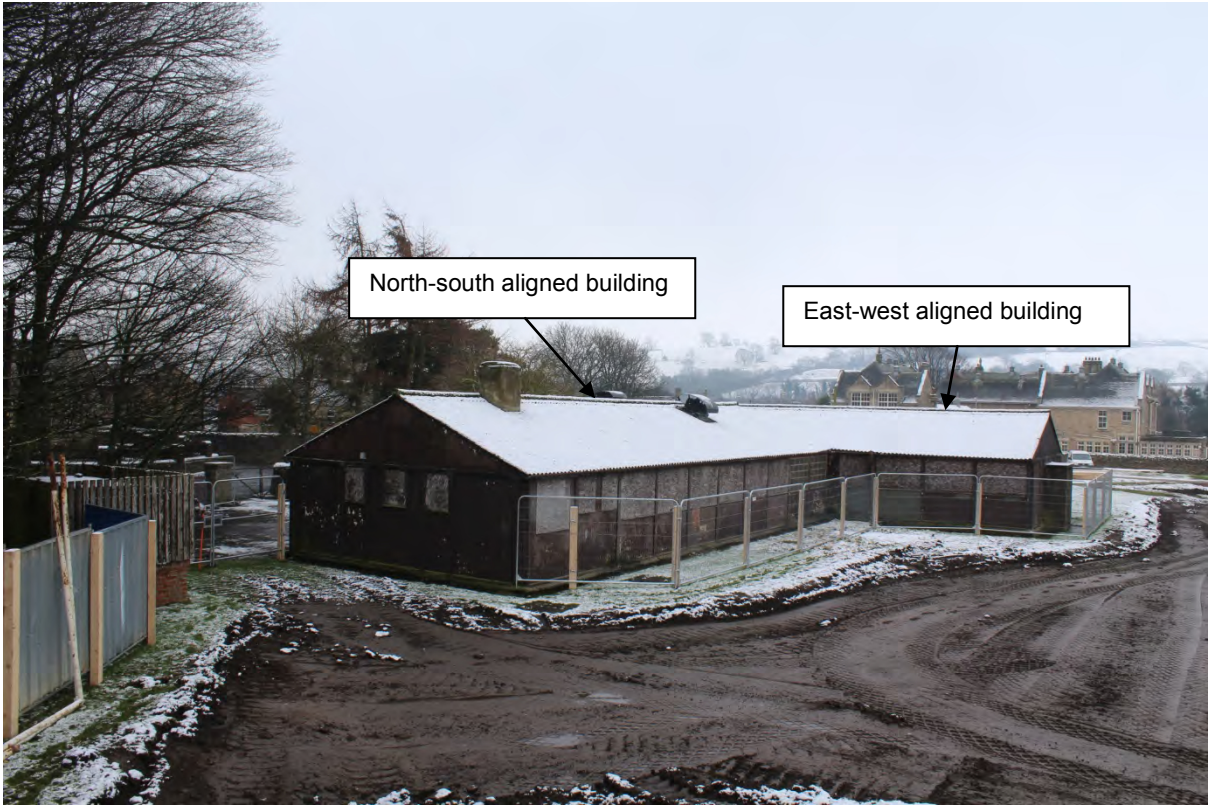
- 6.2.5 Unlike the front, the rear (west) elevation was mostly painted a dark brown colour (**Plates 3 to 6**), with the exception of two panels located at the south end of the north-south building (**Plate 5**). A squat cement rendered chimney was noted at the north end of the roof (**Plates 2, 3 and 5**). The (rear) west elevation had two access doorways in the same locations as the front elevation, although only the south doorway was set within a porch (**Plate 6**).

Plate 3: Rear elevations of the Pavilion, looking south-east, (WDS15 D1 (1))

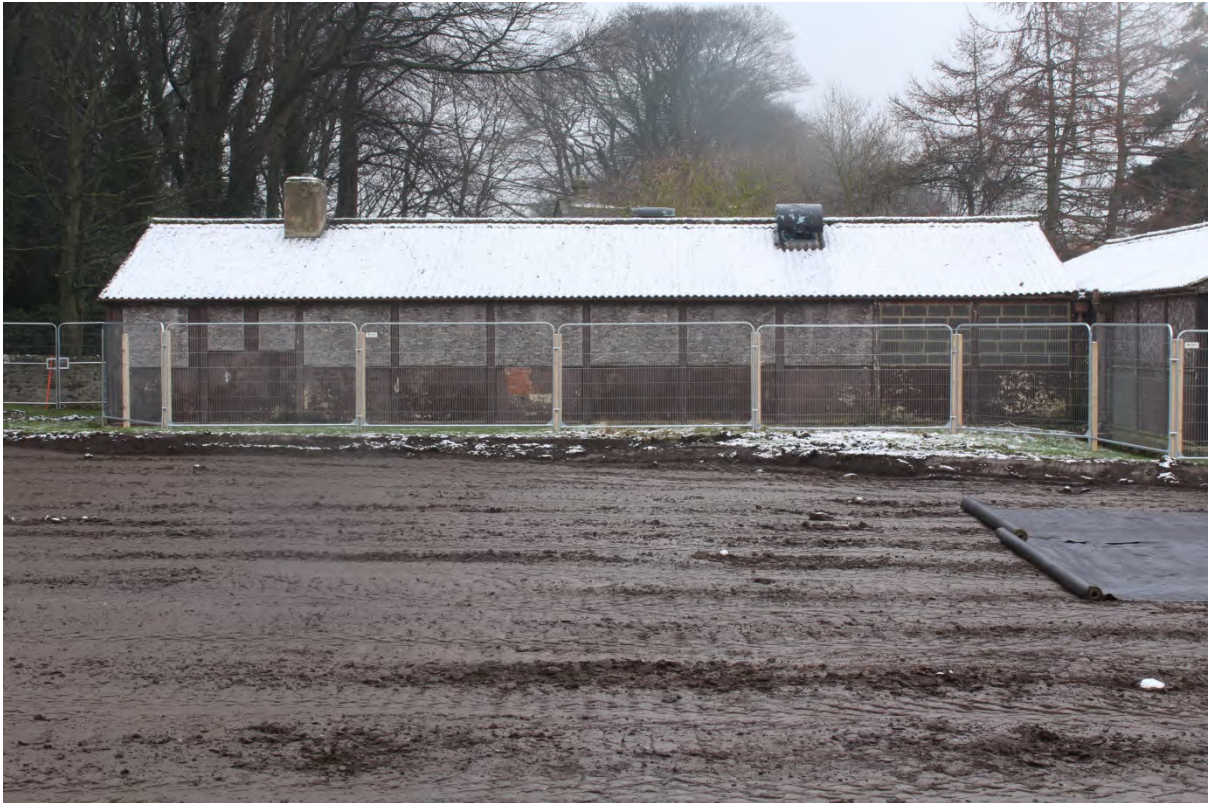
Plate 5: Rear west elevation (long) of the Pavilion, looking east (WDS15 D1 (4))

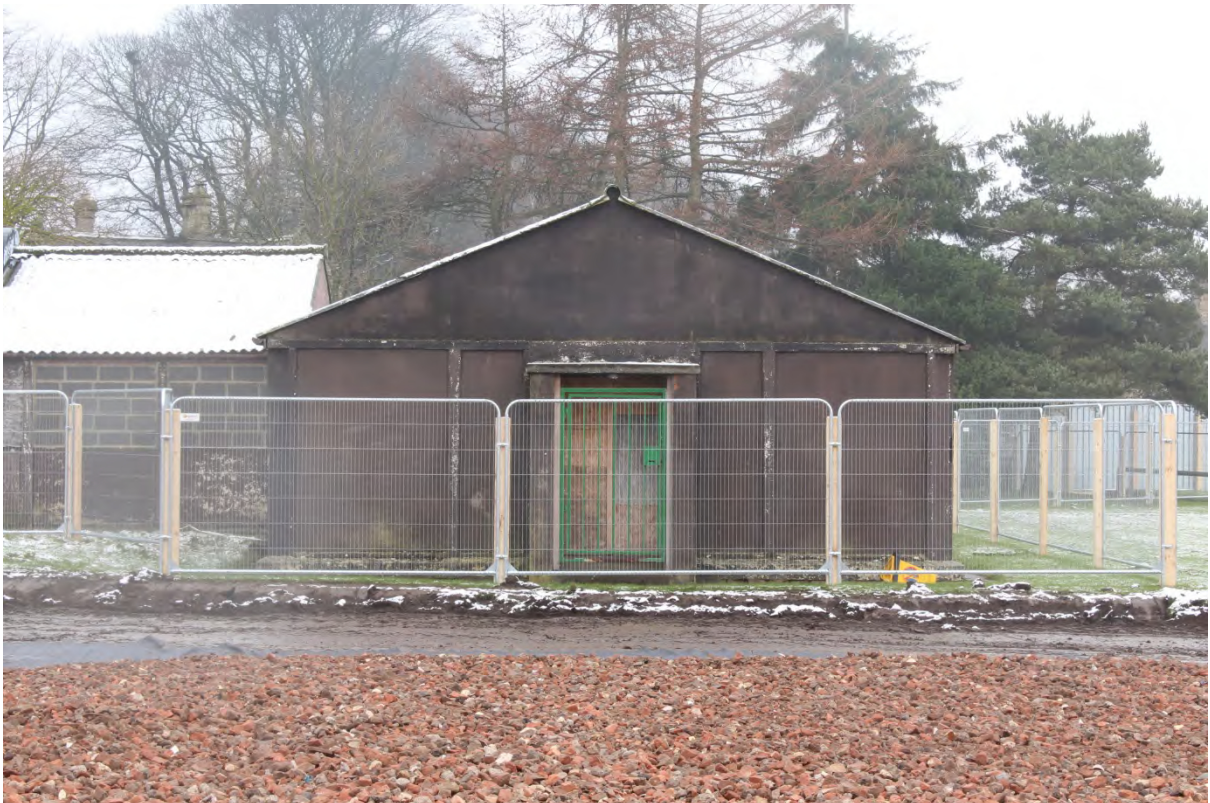
Plate 6: Rear west elevation (gable end) of the Pavilion, looking east (WDS15 D1 (5))

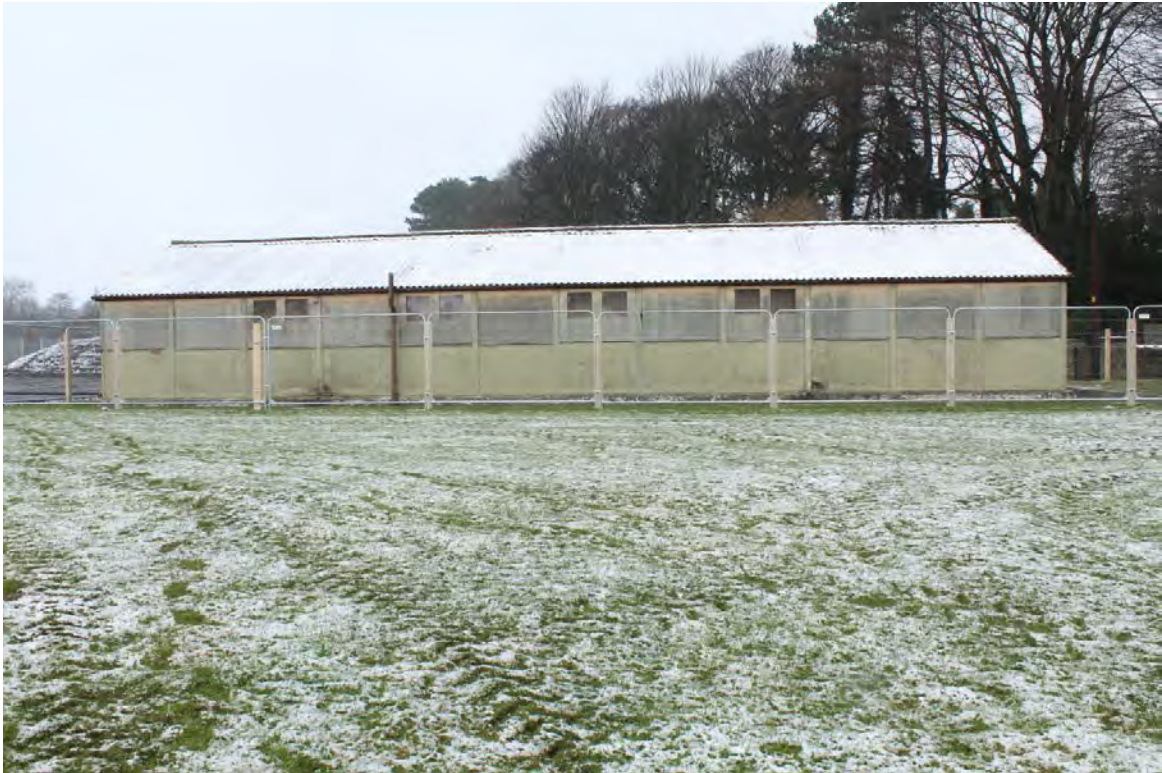
- 6.2.4 The side (south) elevation was also painted in a light olive colour with thirteen equally spaced posts, with window openings set between these posts (**Plate 7**). Most of the windows apart from three were boarded over; these three partially open window openings had modern metal windows.

Plate 7: South elevation of the Pavilion, looking north WDS15 D1 (6)

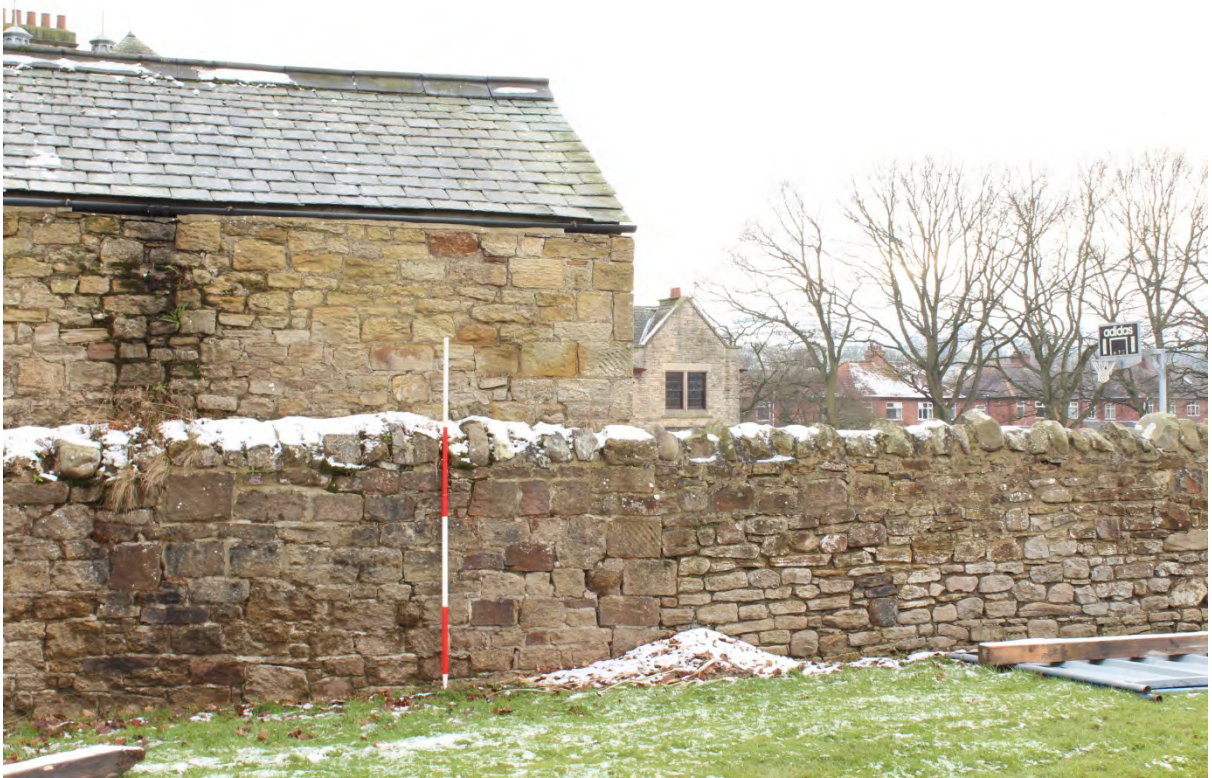
- 6.3.2 The eastern part of the wall is constructed with larger ashlar (some with tooling marks), while the western part is built from smaller stone (**Plate 9**). The wall is capped with roughly semi-circular stones (**Plates 8 to 15**). The eastern half, upper part of the west half of the wall and western end of the wall appear to have been rebuilt, presumably when the school was constructed and the wall changed in use from an agricultural field boundary to a playground perimeter (**Plates 9 and 12**).

Plate 9: Detail of low perimeter wall showing change in stone size, looking south-west (WDS15 D1 (30))

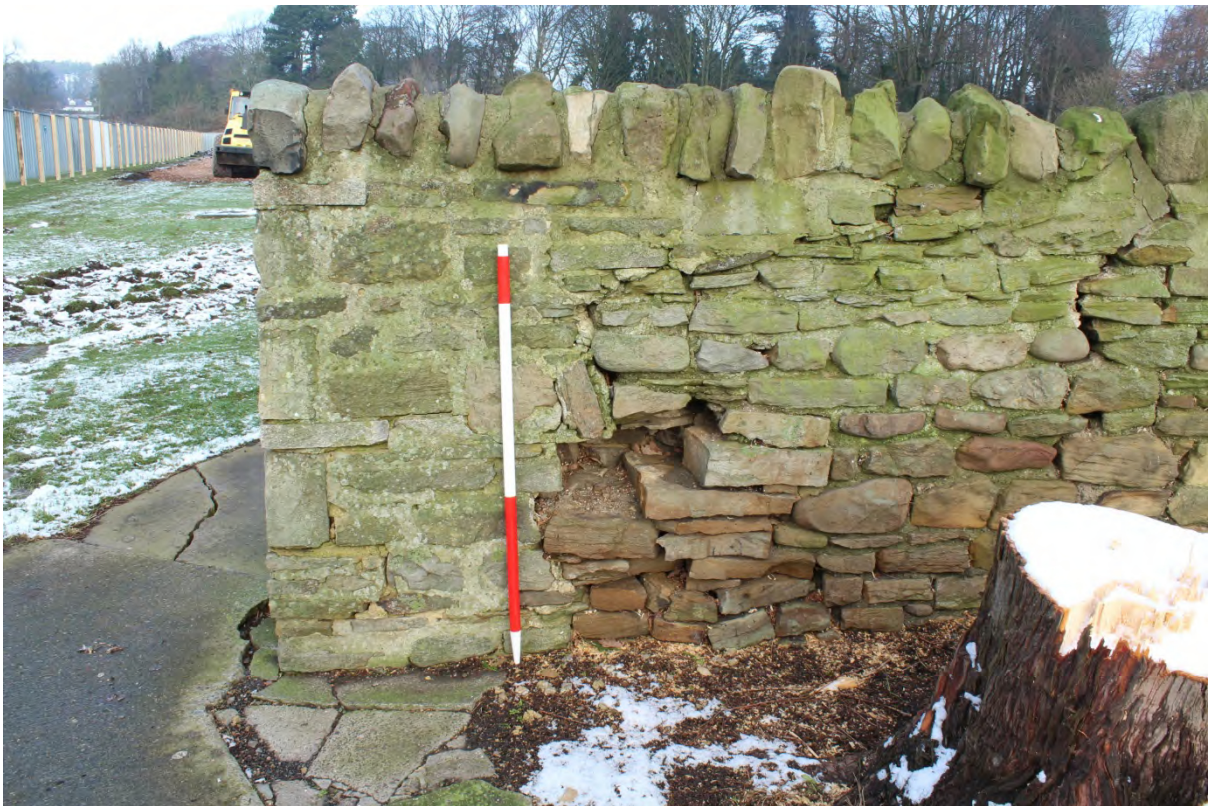
Plate 12: Western end of the low perimeter wall's, looking east (WDS15 D1 (19))

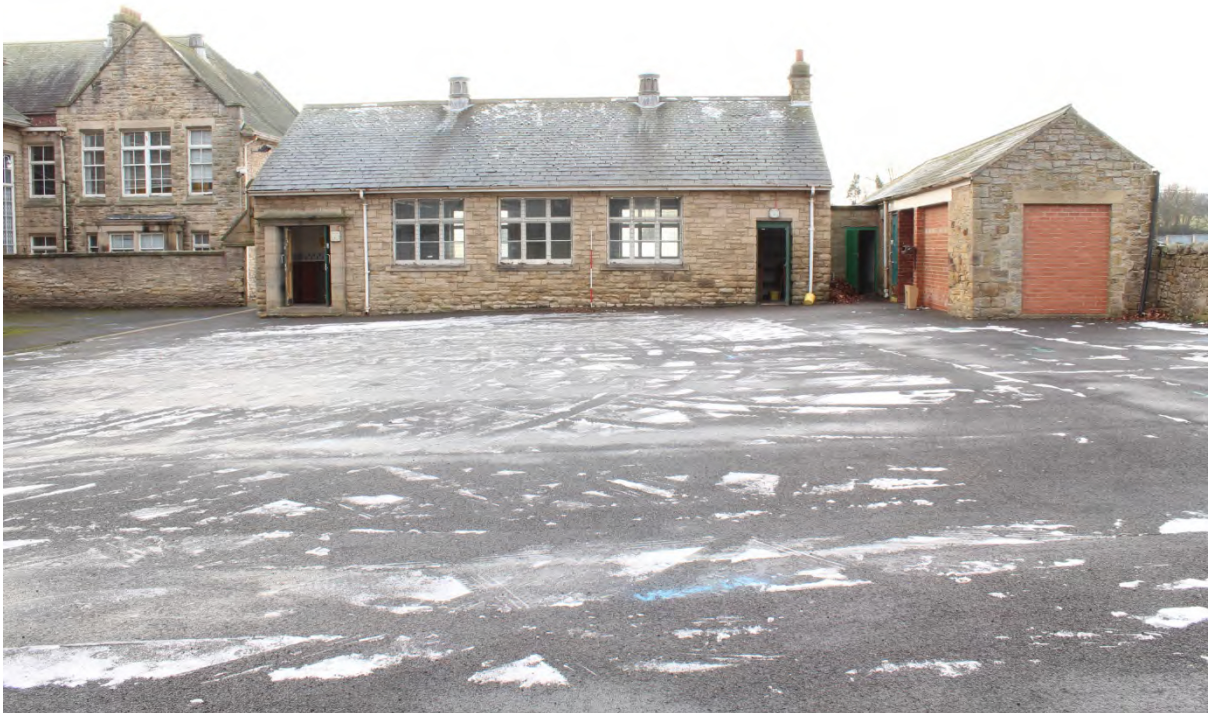
- 6.5.1 The music room for the school is currently housed in what may have been a former outbuilding (**Plates 20 to 31**), which is located to the north of the main school building. The outbuilding has a rectangular plan containing six rooms (**Figure 11**). It has a pitched roof, which is covered with slate, with a stone and terracotta chimney at the northern end (**Plates 20 and 22**). A small converted link room butts the north elevation of the building (**Plates 20, 22, 32 and 33**).

- 6.5.2 The building has two doorways in its front (east) elevation (**Plate 20**). The main entrance doorway is located at the south end of this elevation and is set within a carved stone porch giving access into a small entrance hall (B1G1) (**Figure 11; Plates 20, 21 and 23**). The other doorway is located at the north end of the elevation and gives access to a small storeroom (B1G5) (**Figure 11; Plates 20 and 31**). The elevation has three large classroom windows with chamfered stone lintels and stone sills between the two doorways (**Plate 20**).

Plate 20: East elevation of music room outbuilding, looking west (WDS15 D1 (32))

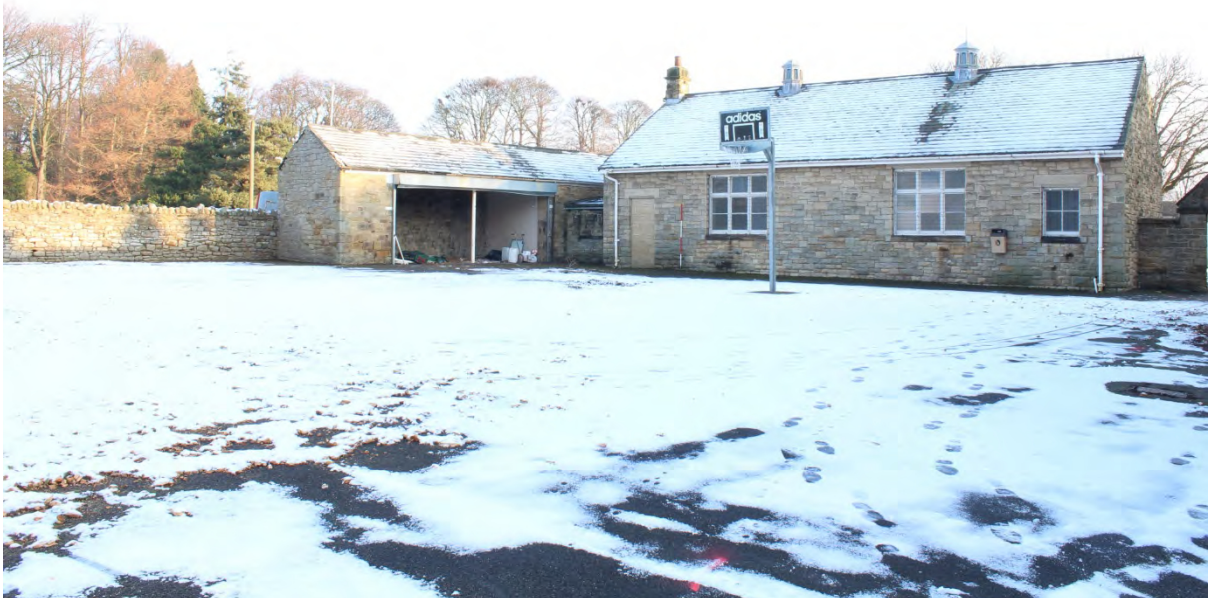
- 6.5.3 A doorway at the north end the rear (west) elevation has been blocked with concrete block

internally and stone externally (**Plates 22 and 30**). It originally gave access to another small room which until recently was used for storage (B1G6) (**Figure 11**). The west elevation has two large classroom windows again with chamfered stone lintels and stone sills (**Plate 22**). A smaller window at the south end of the elevation matches the size of the door at the other end. Both window and doorway have chamfered stone lintels.

Plate 22: West elevation of music room outbuilding and south elevation of converted outbuilding, looking west (WDS15 D1 (16))

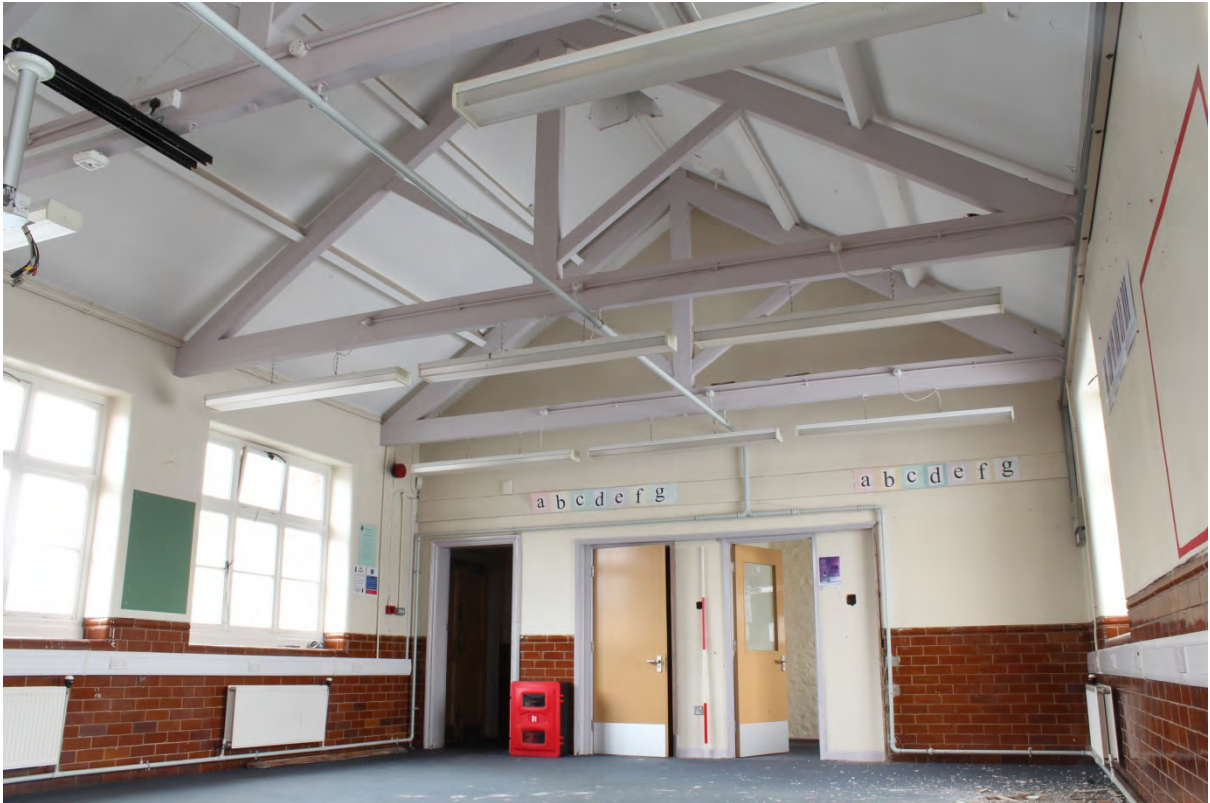
Plate 24: South end of large classroom B1G4 in the music room outbuilding, looking south-east (WDS15 D1 (38))

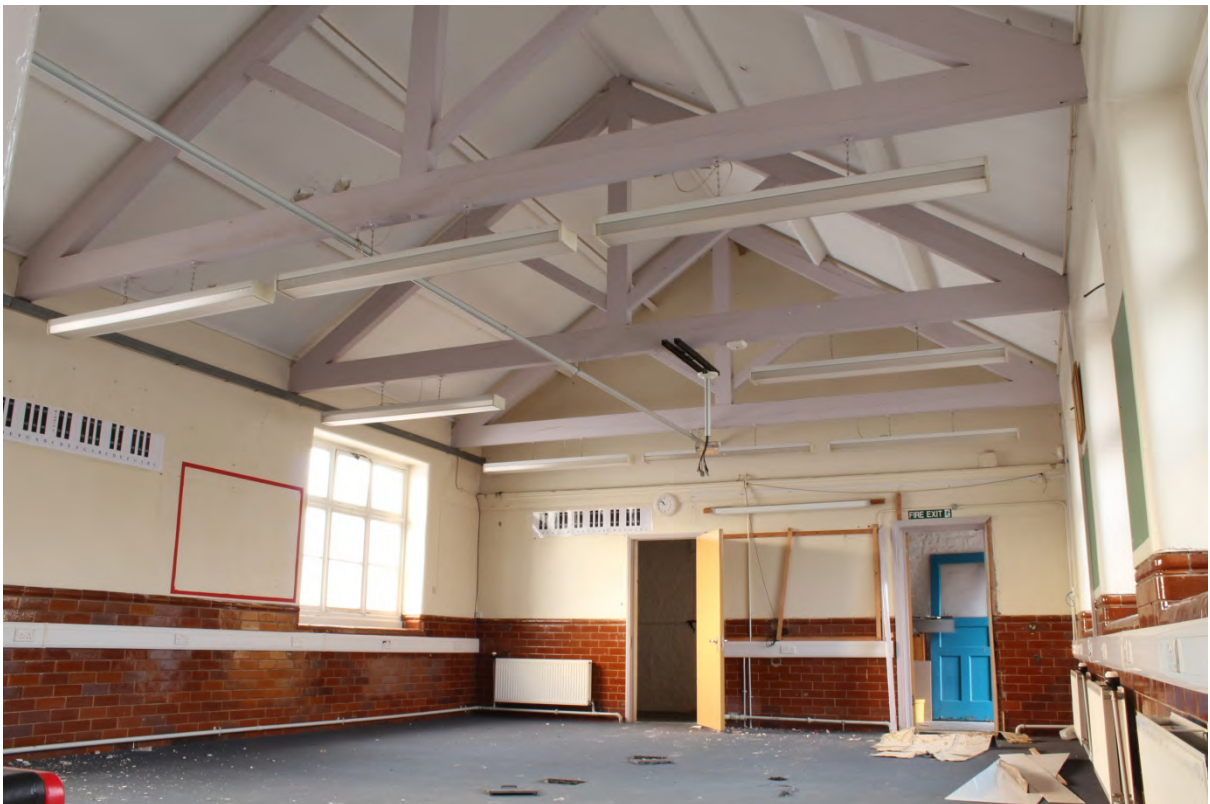
Plate 25: North end of large classroom B1G4 in the music room outbuilding, looking north-west (WDS15 D1 (37))

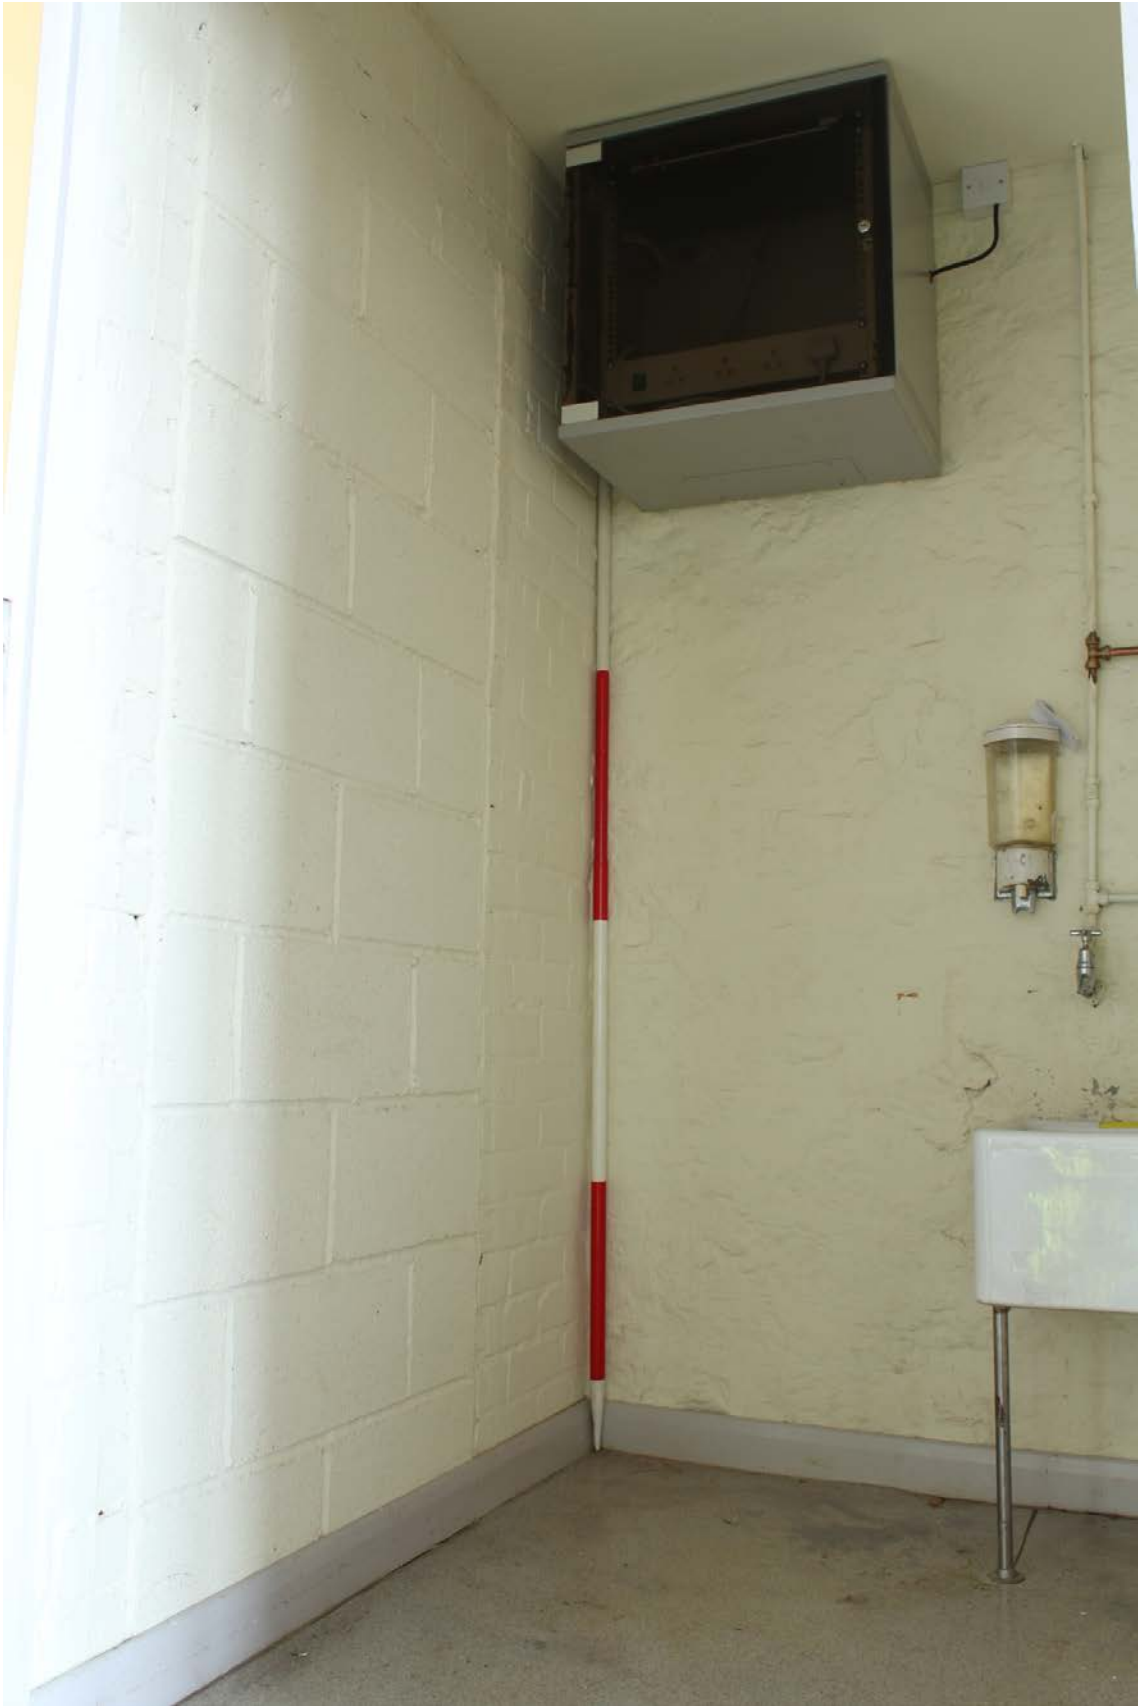
6.5.5 The building currently has three rooms (B1G1 to B1G3) at the south end (**Figure 11; Plates 23, 28 and 29**) and two rooms (B1G5 and B1G 6) at the north end (**Plates 30 and 31**). The latter were originally only accessible externally. The former were originally two rooms which have since been subdivided to create three rooms. An original doorway between B1G1 and B1G2 has been blocked with concrete block (**Plates 23 and 28**). Scarring on the north wall of room B1G5 may suggest that this room was originally a boiler room (**Plate 31**). This end of the building has a chimney (**Plates 20 and 22**).

Plate 28: Blocked doorway in room B1G2, looking south-east (WDS15 D1 (39))

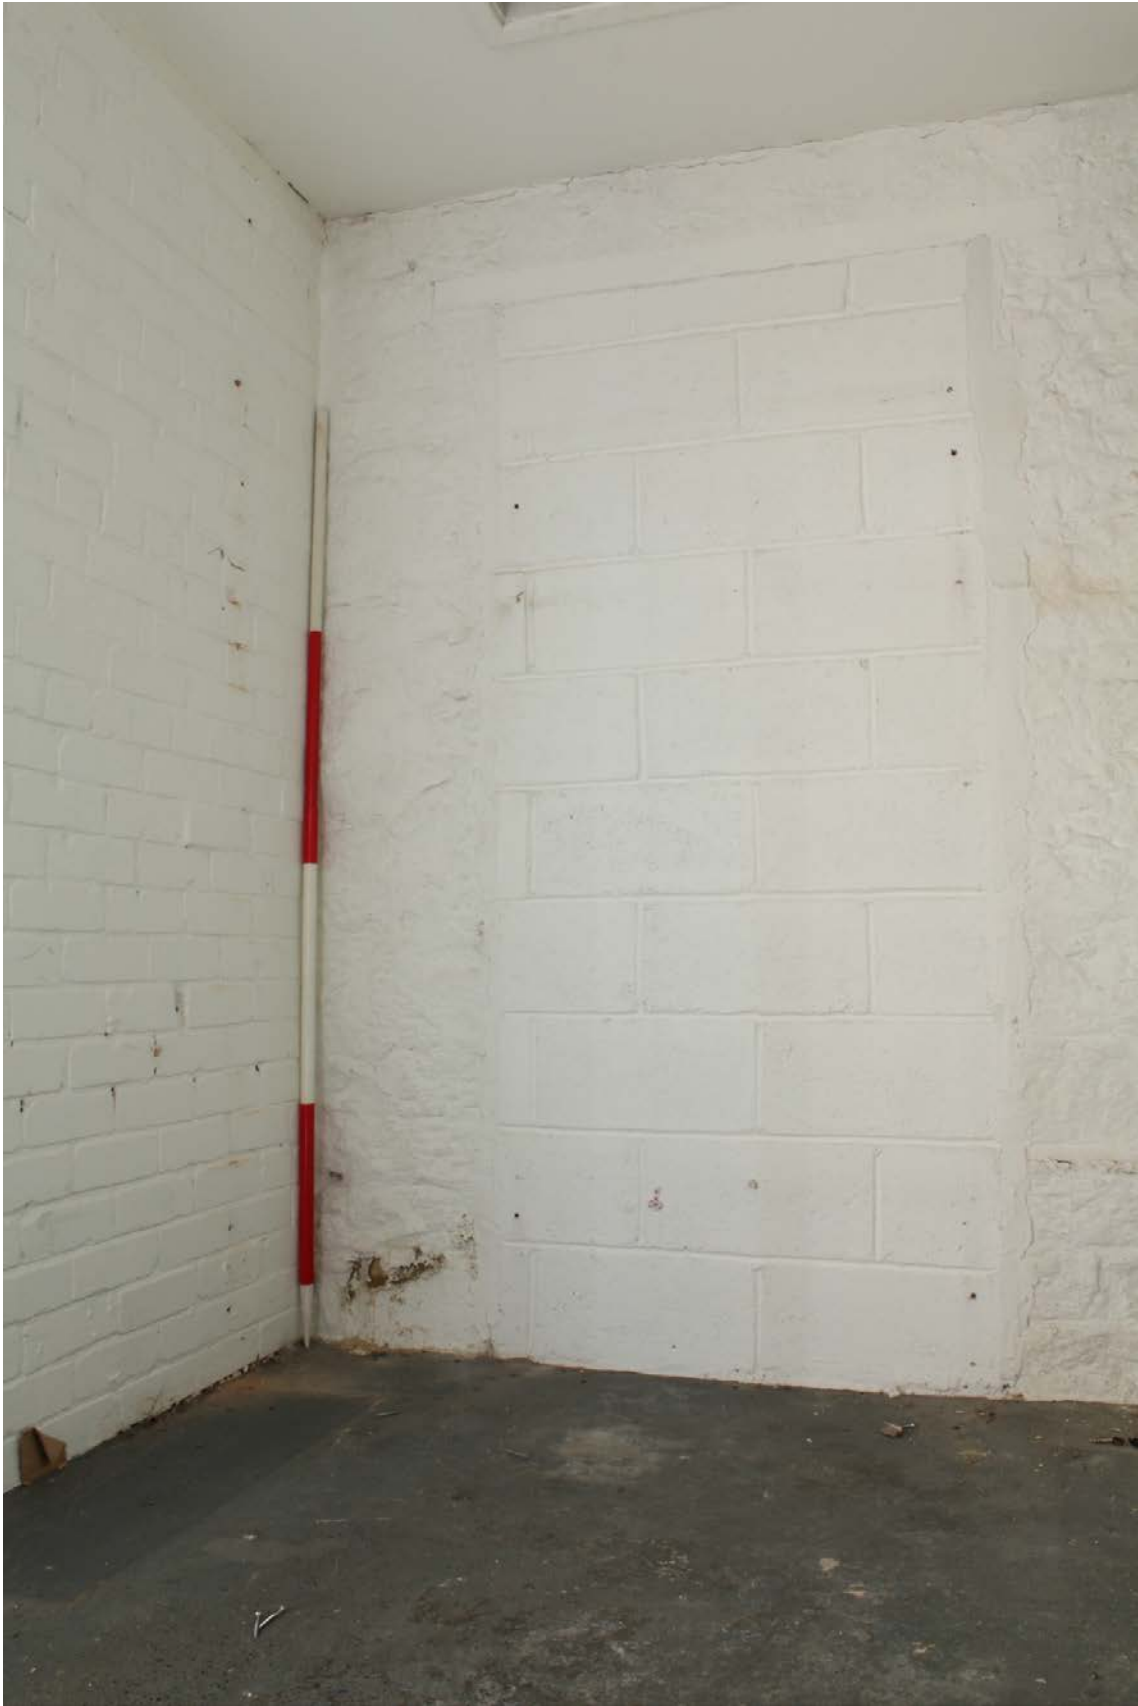
Plate 30: Blocked doorway and inserted brick wall in room B1G6, looking west (WDS15 D1 (42))

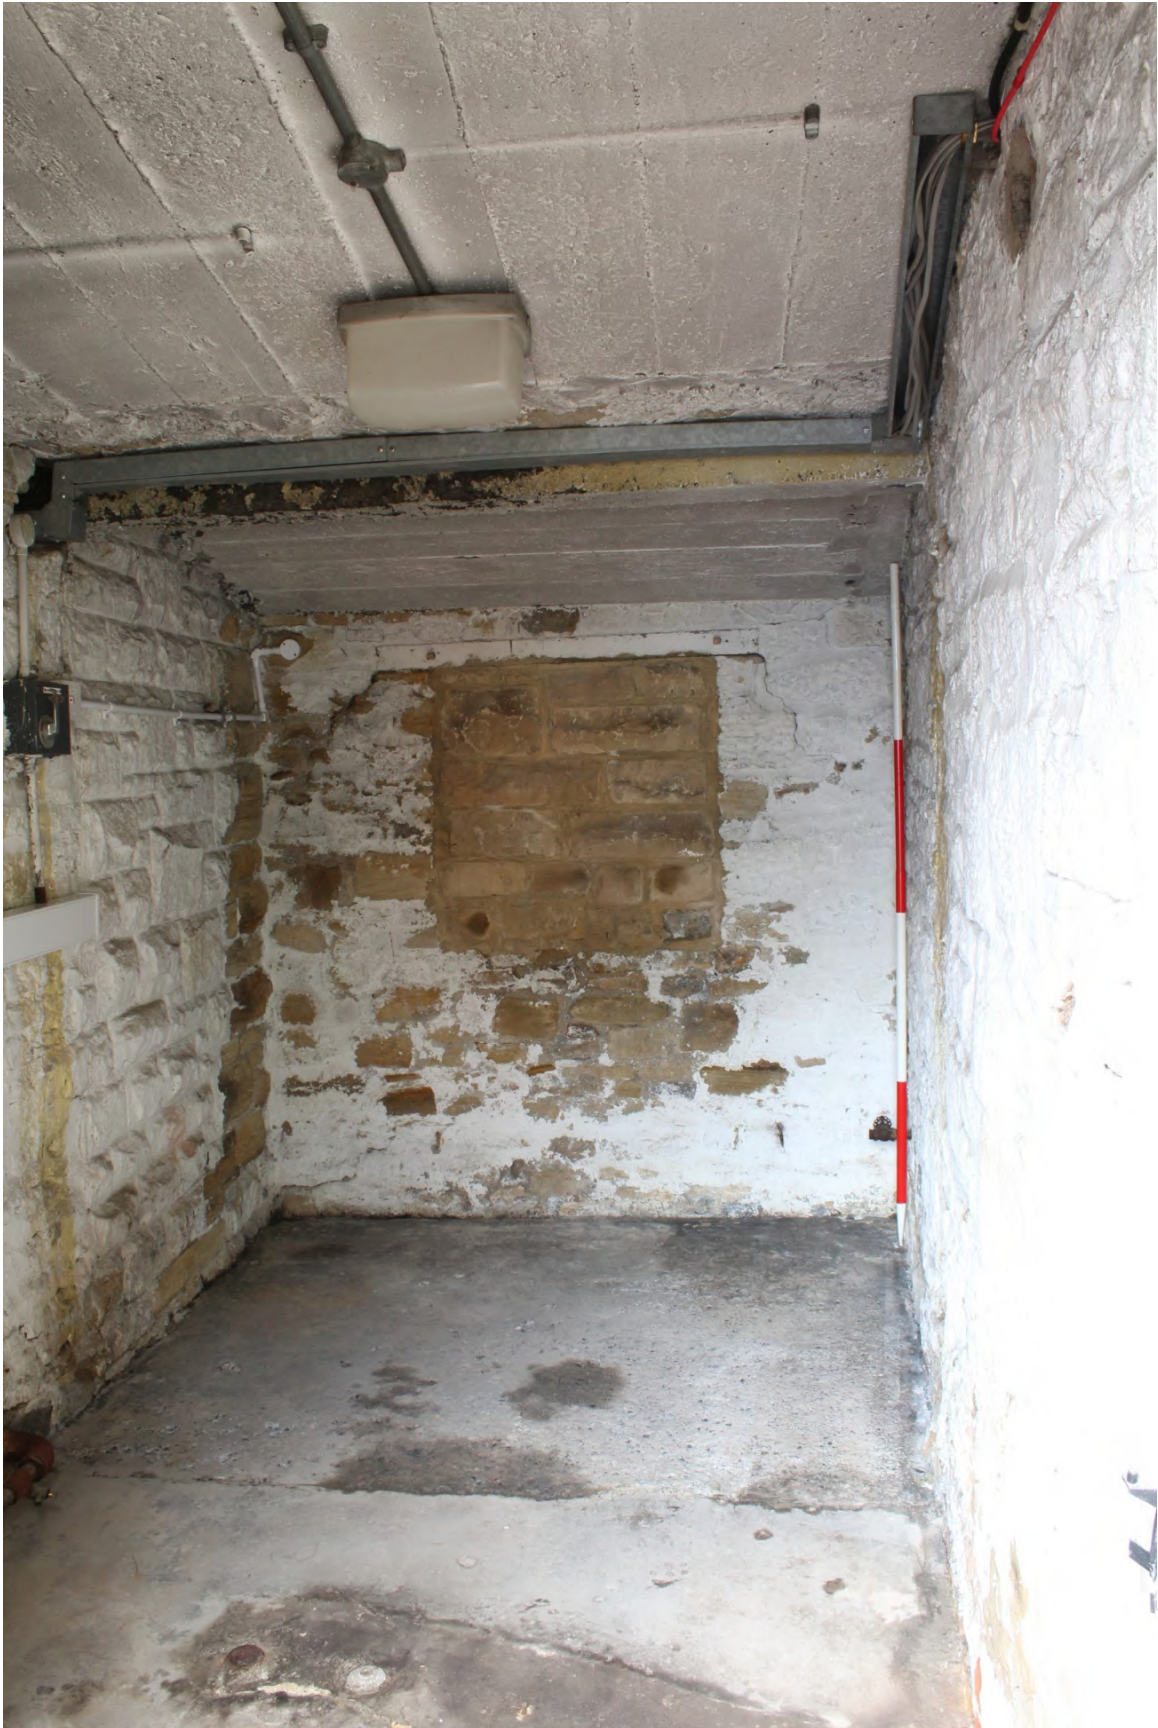
6.6.1 The link room butts the music room outbuilding to the south and the converted outbuildings to the north (**Figure 11**). It is constructed in regular mid-yellow/grey sandstone ashlar (**Plates 32 and 33**). It consists of one room and has a single low set doorway in the east (front) side (**Plate 32**). A single window in its rear (west) elevation has been infilled with sandstone blocks (**Plates 33 and 34**). The room has a concrete shuttered ceiling (**Plate 34**).

Plate 34: Interior of link room, looking west (WDS15 D1 (44))
