**HISTORIC BUILDING
RECORDING AT
WOLSINGHAM SCHOOL
AND COMMUNITY
COLLEGE, WOLSINGHAM,
COUNTY DURHAM**

SITE CODE: WSD 15

PCA REPORT NO. R12005

FEBRUARY 2015

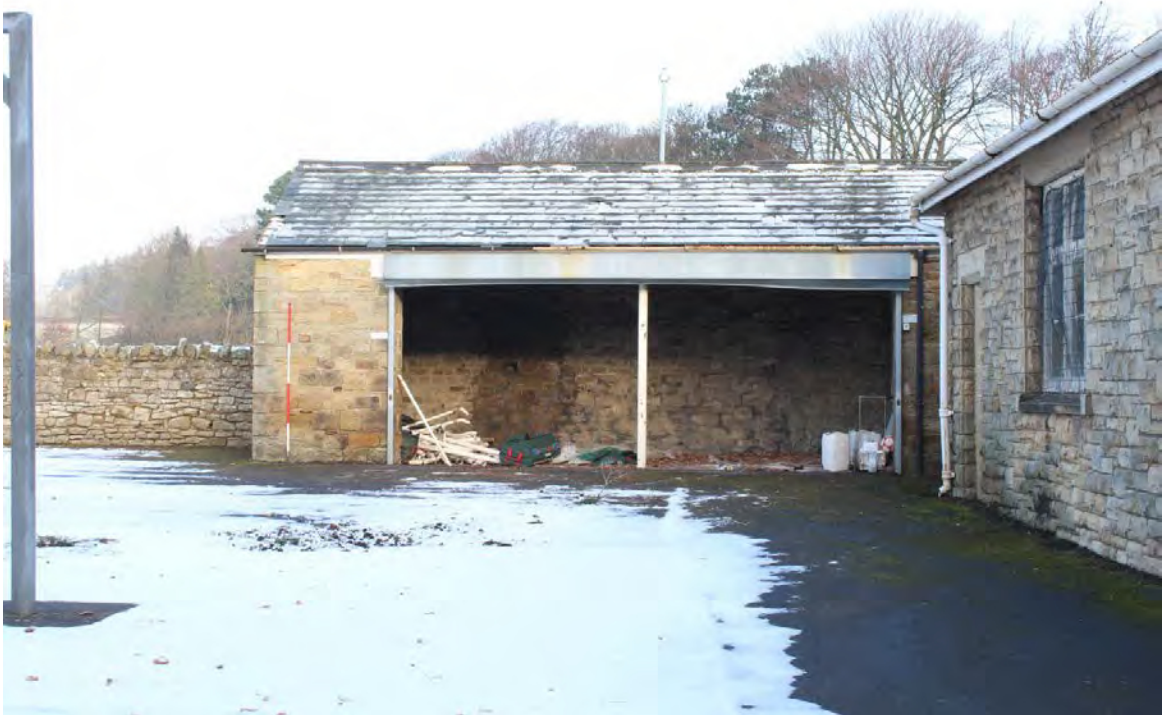
for the storage of outdoor games equipment. The large opening in its south elevation has a timber lintel, which is supported by a cast iron column (**Plates 35 to 37**). Regularly spaced sockets in the rear (north) wall of this building have been infilled with small purpose-cut sandstone blocks (**Plate 36**). These sockets possibly suggest that the building's former use was a stable with six stalls. Three timber king post trusses are visible over the space as well as common timber rafters supporting roof boards (**Plates 36 and 37**). Scars of lath and plaster are visible on some of the rafters suggesting that the room once had a plastered pitched ceiling.

Plate 35: West end of converted outbuildings used for storage space, looking north (WDS15 D1 (17))

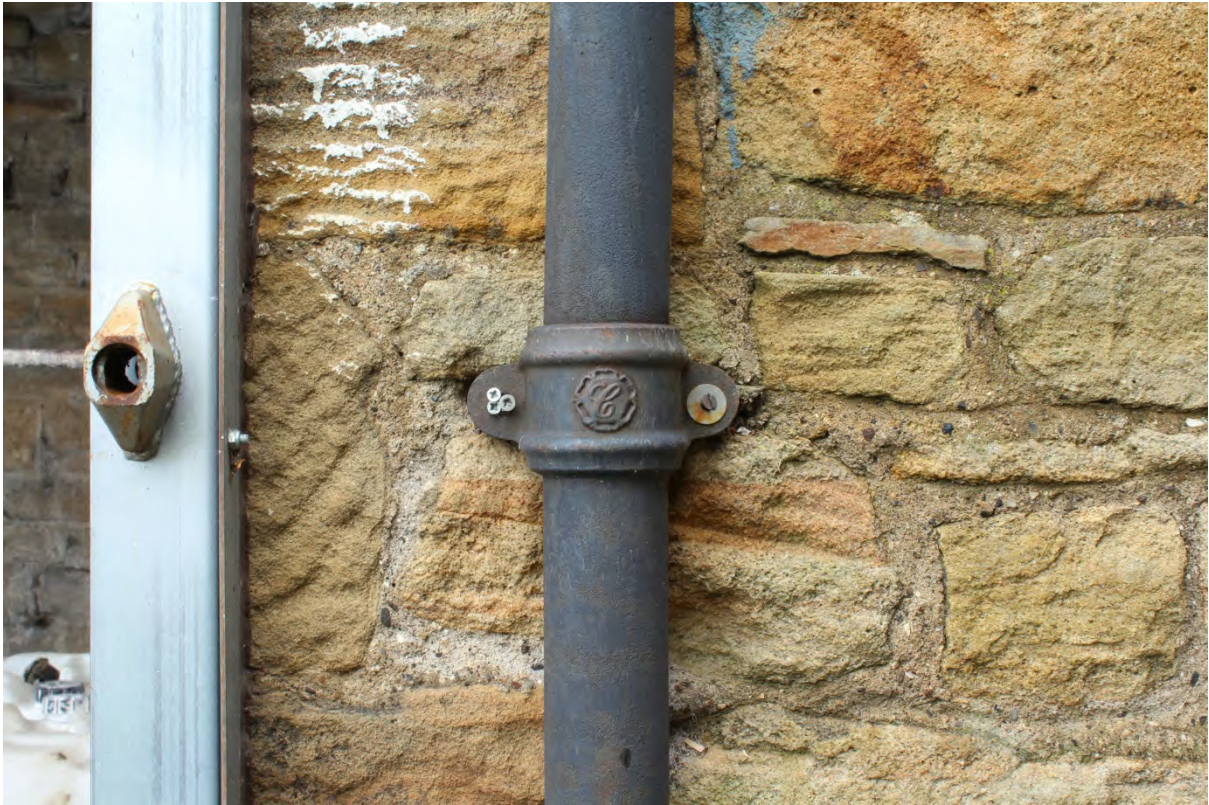
6.7.1 The converted outbuilding lies to the north of the music room outbuilding and is aligned east-west (**Figure 11**). It has been divided into two halves and has four rooms in total. The eastern side has an inserted through north-south walkway. This outbuilding is constructed in regular mid-yellow/grey sandstone and has a pitched roof covered with slate (**Figures 2, 10 and 11; Plates 35 to 39**). An original cast iron down pipe still survives against the south wall (**Plate 38**).

Plate 38: Detail of iron downpipe on exterior of converted outbuilding, looking north (WDS15 D1 (25))
