**BUILT HERITAGE SURVEY OF
OUTBUILDINGS ADJACENT TO
WESTGATE HOUSE, WESTGATE
STREET, BURY ST EDMUNDS,
SUFFOLK IP33 1QS**

**FEBRUARY 2015
REPORT NO.12007**

**Built Heritage Survey of Outbuildings Adjacent to Westgate House, Westgate Street,
Bury St Edmunds, Suffolk IP33 1QS**

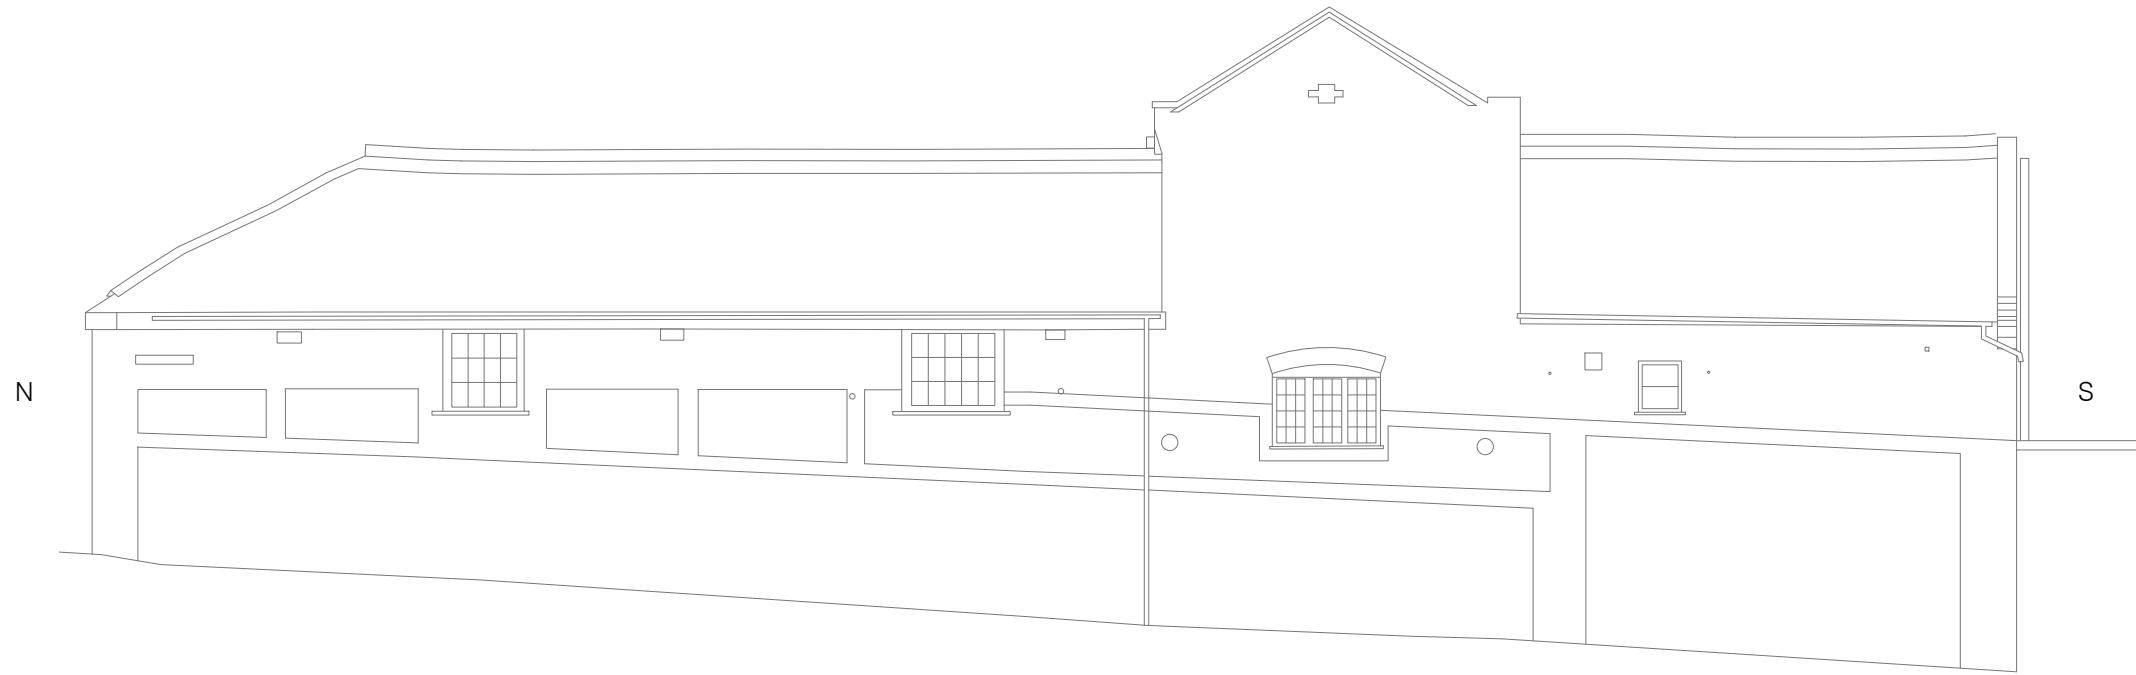
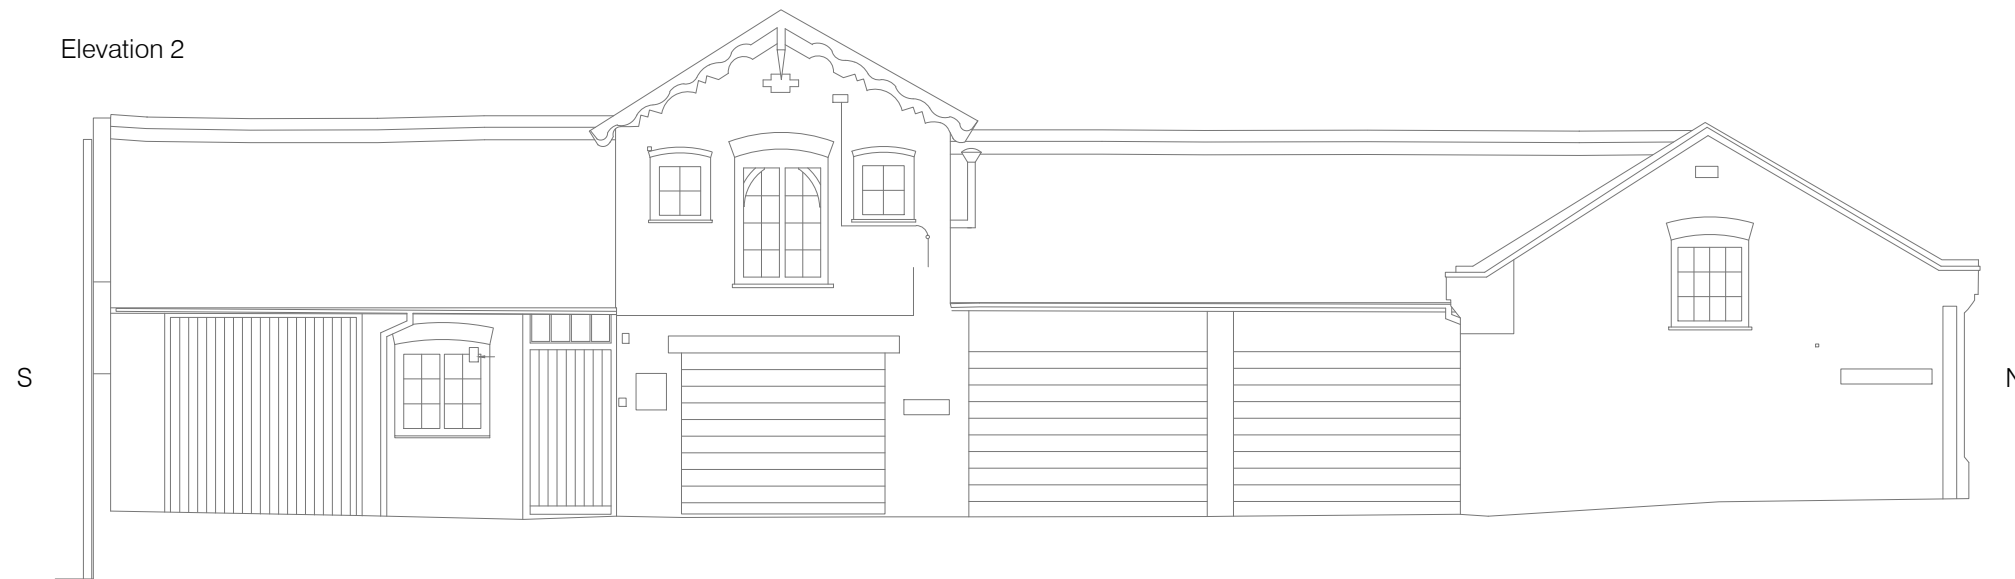
Elevation 1

Elevation 2
