**The Old Library, Ely Cathedral,
Ely, Cambridgeshire:
Archaeological Monitoring**

ARCHAEOLOGICAL MONITORING

Pre-Construct Archaeology Ltd	
Project Number	K3914
Report Number	R12004

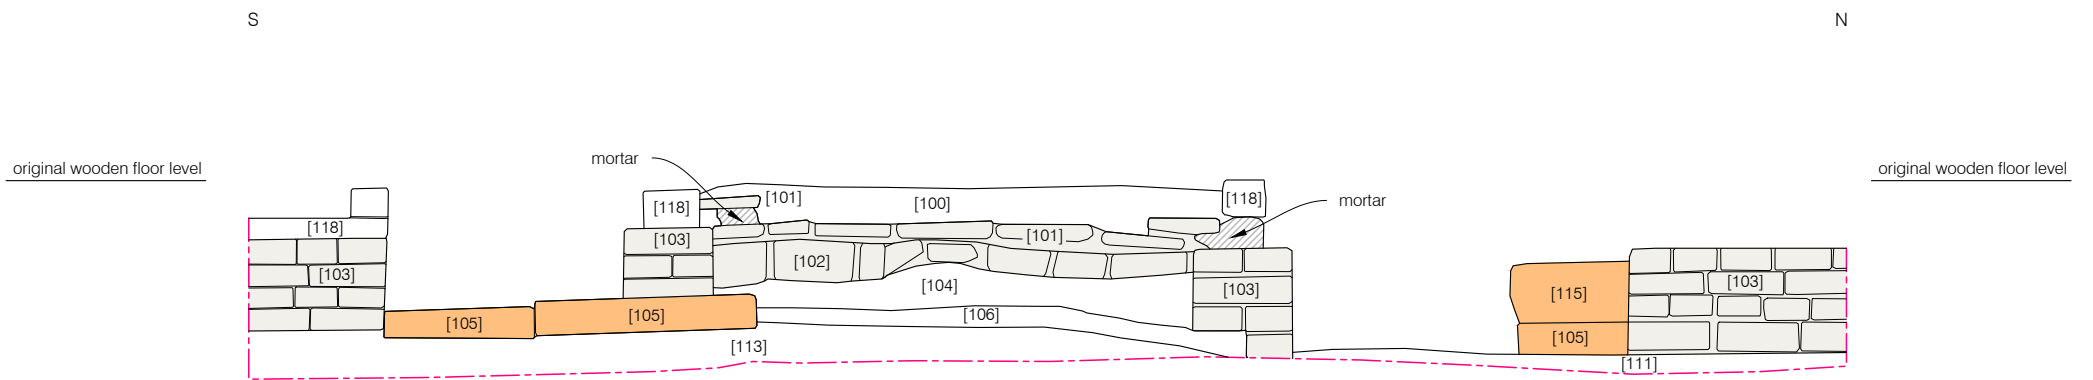
Figure 5
Section along west wall of Old Library
1:20 at A4

Section 1
South facing

- 19th Century bricks/tiles
- Medieval masonry

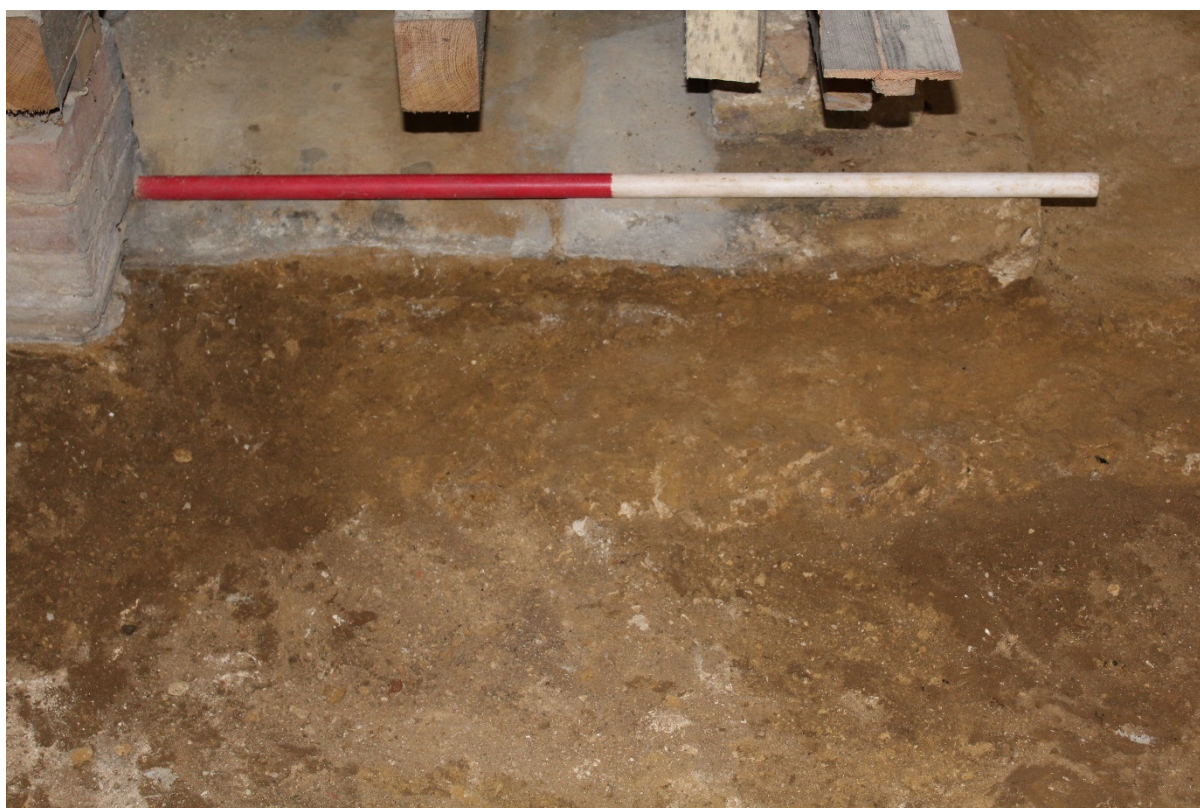
Plate 2: Foundations 113 and 105, view west

5.2.2 Two layers of mortar (111) and (113) measuring 0.95m and 1.9m long and 1.3m and 0.33m wide were seen along the southern half of the west wall (Plate 2). The mortar consisted of a mid-whitish yellow chalky sand, which appeared to be an extremely compacted foundation layer for the limestone foundation for the building. This limestone foundation, Structure 105, extended c.10.4m along the length of the west wall and measured 1.15m wide and 0.07m (as seen) deep (Plates 2-4, 8). It was truncated in the area of the 19th/20th century hearth, Structure 102, presumably for the flue which extended east from the west wall (removed prior to monitoring). The stones forming Structure 105 were finished with flat, straight faces, and were bonded with mortar.

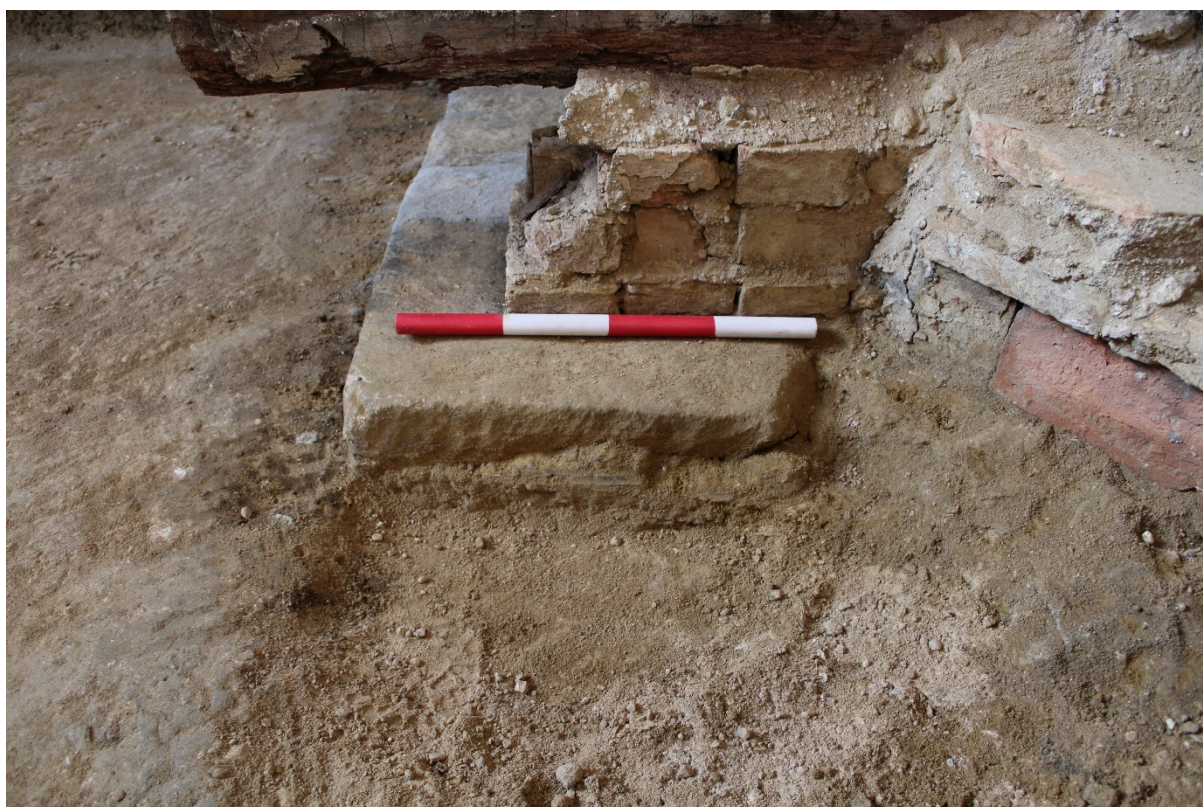
Plate 3: Foundation 105 showing relationship with dwarf sleeper wall 103 and hearth 102, view south

- 5.4.4 Structure 103 consisted of a series of dwarf sleeper walls, constructed in brick, observed against the walls of the Old Library and inset from the two central columns 115 and 117 (Plates 3, 8). These varied in length and width and were built to support the raised timber joists and floor, Structure 118, which was built in the late 19th or early 20th century.

- 5.4.5 In the same phase of works a brick hearth, Structure 102, was constructed in the west wall, measuring 1.6m long, 0.1m wide and 0.12m deep (Plate 3, 8). It consisted of a single recessed course of bricks with a flue extending east (flue removed prior to monitoring). The hearth was capped with three courses of terracotta tiles, Structure 101. The full extent of these structures was not seen as they were mainly seen in section and were not excavated. Overlying the hearth was a layer of rubble (100) which consisted of light yellowish brown chalk dust and sand.

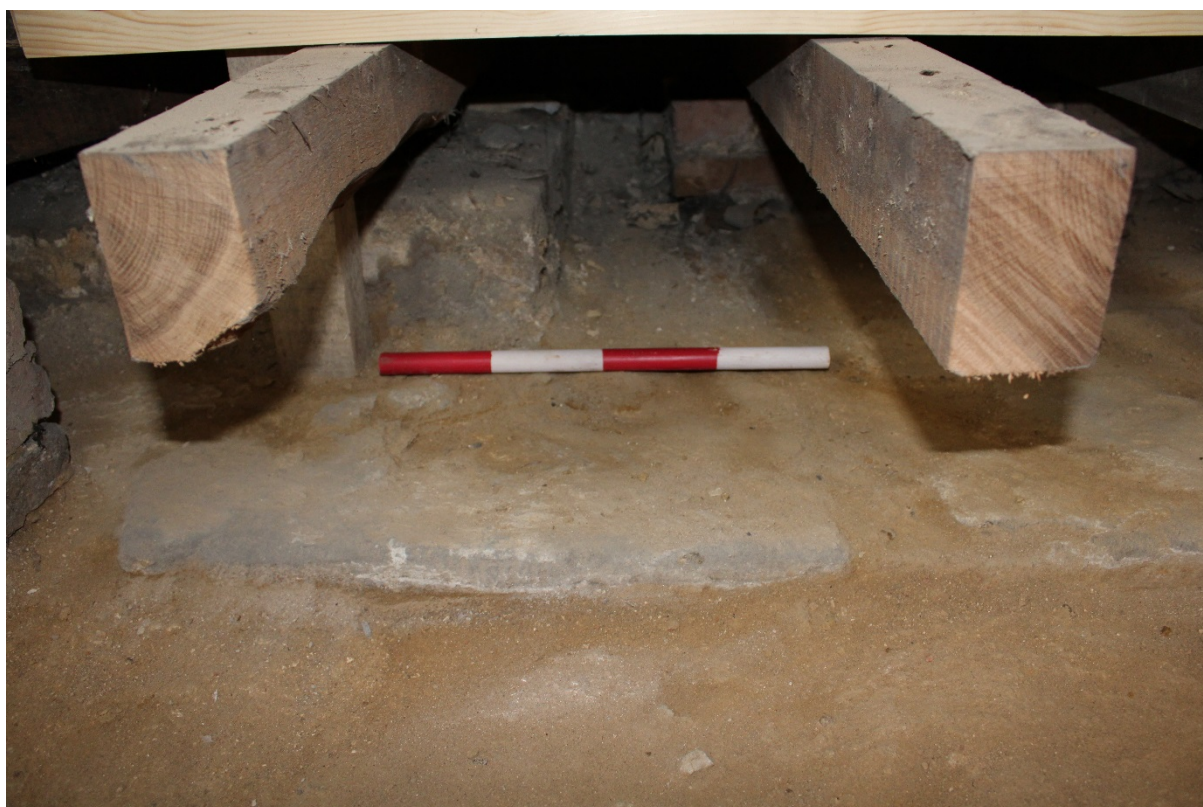
Plate 4: Foundation 105 and column base 115, view west

5.2.4 Structure 105 supported the bases for columns 114, 115 and 116 in the west wall, the foundations for column 117 in the east wall were not seen during

monitoring (Plate 4).

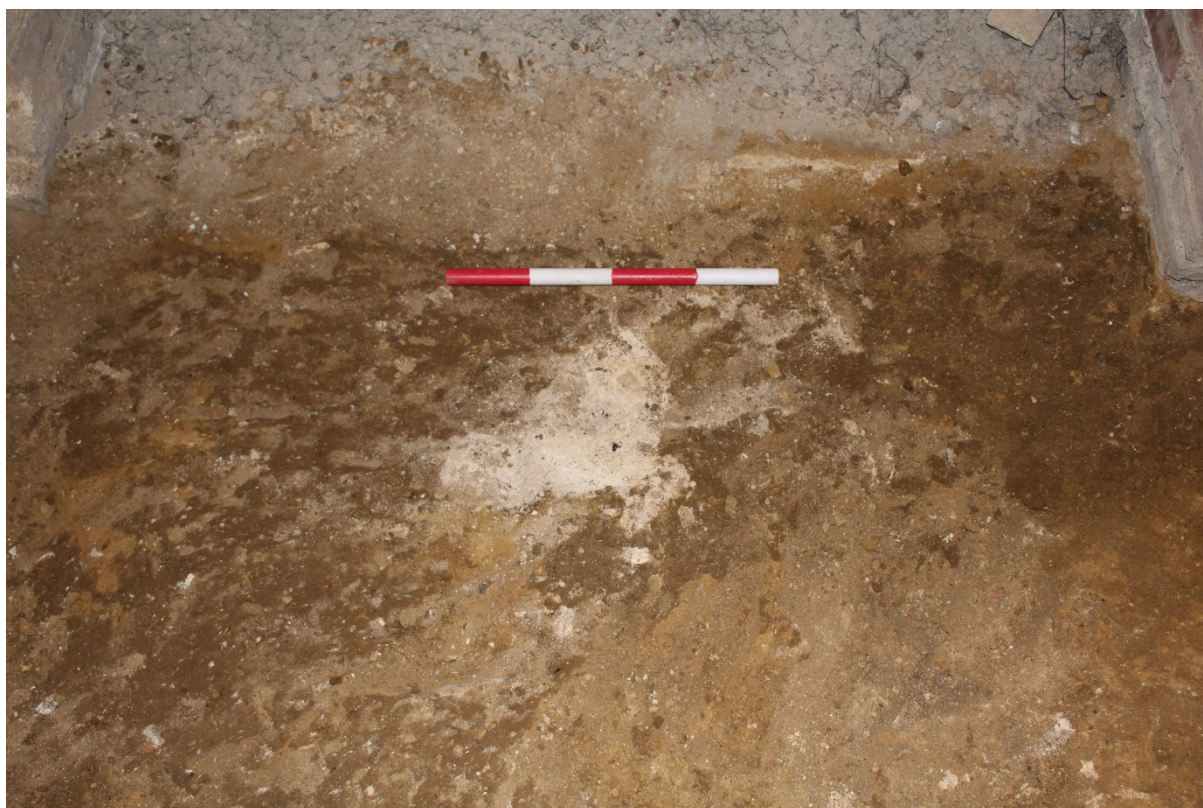
Plate 5: Limewash screed layer (112) above compacted floor (108), view south

5.3.3 Made ground layer (108) was seen in the northern and southern halves of the Old Library and consisted of a compacted layer of mid-orangey brown clayey sand containing small fragments of chalk (Plate 5). Fragments of plain blue window glass were retrieved from this layer.

5.3.4 Patches of a thin layer of limewash (112) were observed towards the southern wall and in the northern half of the Old Library and consisted of a light yellowish white chalky layer, which may suggest that there was originally a paved or tiled floor which was removed prior to the insertion of the timber floor (118) in the later 19th century (Plate 5).

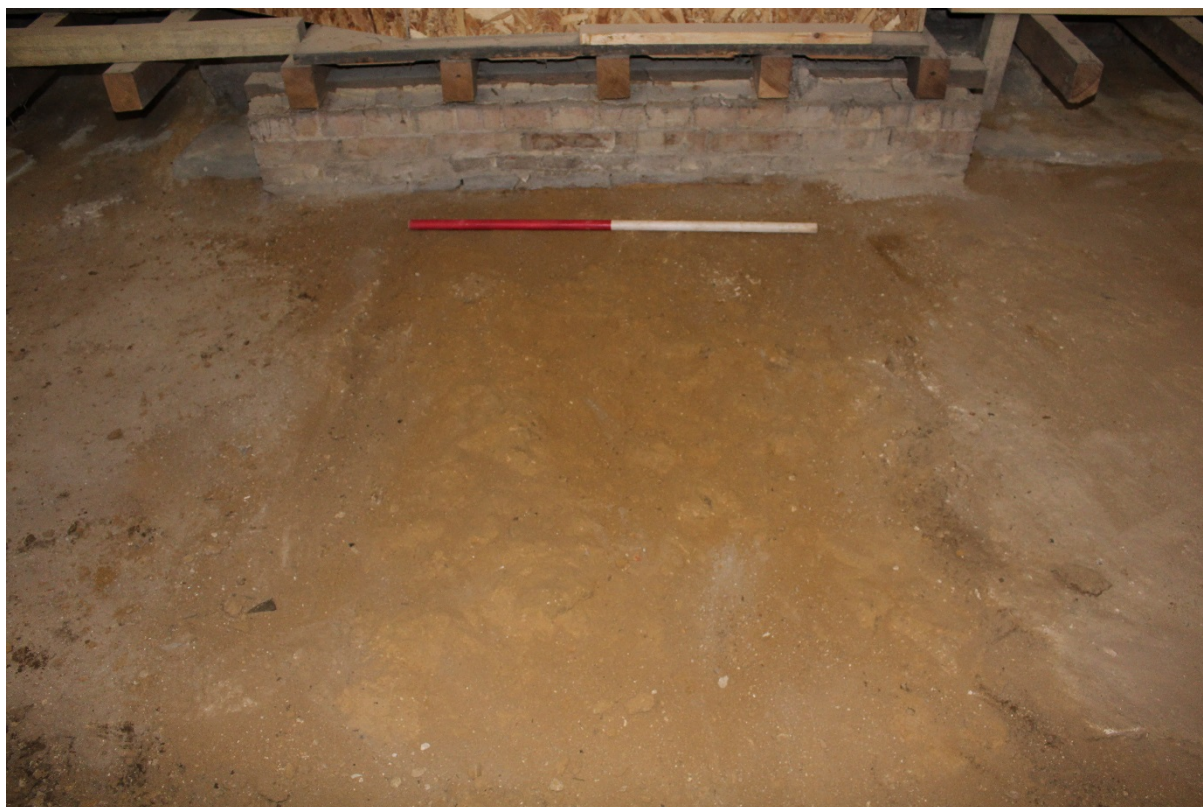
Plate 6: Demolition rubble (109) of dividing partition, view west

- 5.4.2 Layer (109) appeared to be one of the earliest phases of alterations within this period. It was seen in the centre of the room, aligned east-west, between the two central columns 115 and 117 and measured 3.15m+ long and 1.3m wide (Plate 6). (109) was a layer of rubble consisting of very large stone blocks mixed with light yellowish brown sandy mortar. The largest of the blocks measured 0.4m x 0.35m x 0.2m (Plate 7). This appears to be the demolition of the central division between the first two bays which is thought to have occurred in the late 19th or early 20th century.
