**ROYAL GARRISON CHURCH
OF ST GEORGE,
GRAND DEPOT ROAD,
WOOLWICH,
ROYAL BOROUGH OF
GREENWICH:
AN ARCHAEOLOGICAL
WATCHING BRIEF**

SITE CODE: SGE14

PCA REPORT NO. R12012

MARCH 2015

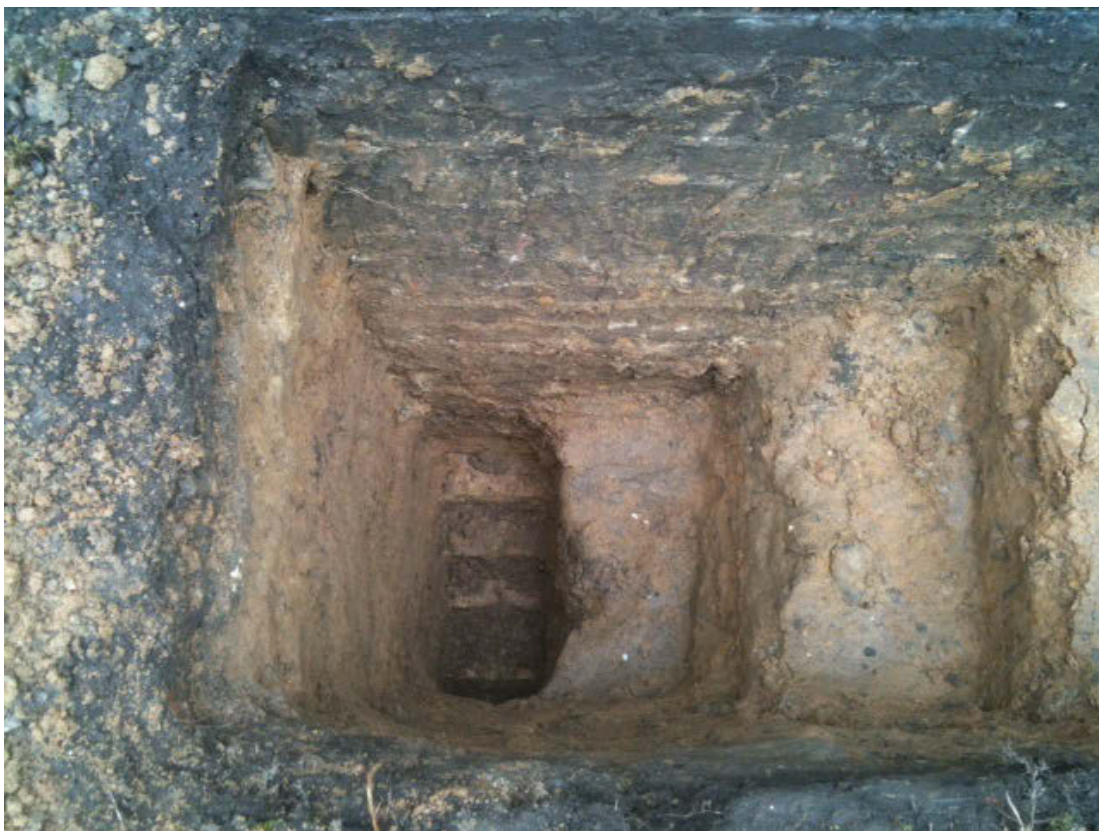
- 7.2.1 In May 2014 a single test pit (TP1) was excavated against the south face of the south wall of the Nave (**Figure 6**). It revealed the stepped foundation brick courses of the church at its base c.0.85m below the current ground surface (**Plate 4**). The section recorded a turf layer (1) and a made ground layer (2) which were subsequently found to extend across the southern part of the site. It was concluded that both belonged to a phase of levelling and landscaping of the area after the construction of the church.

Plate 4: TP 1 Stepped foundations of the south elevation of the Garrison Church of St George, looking north

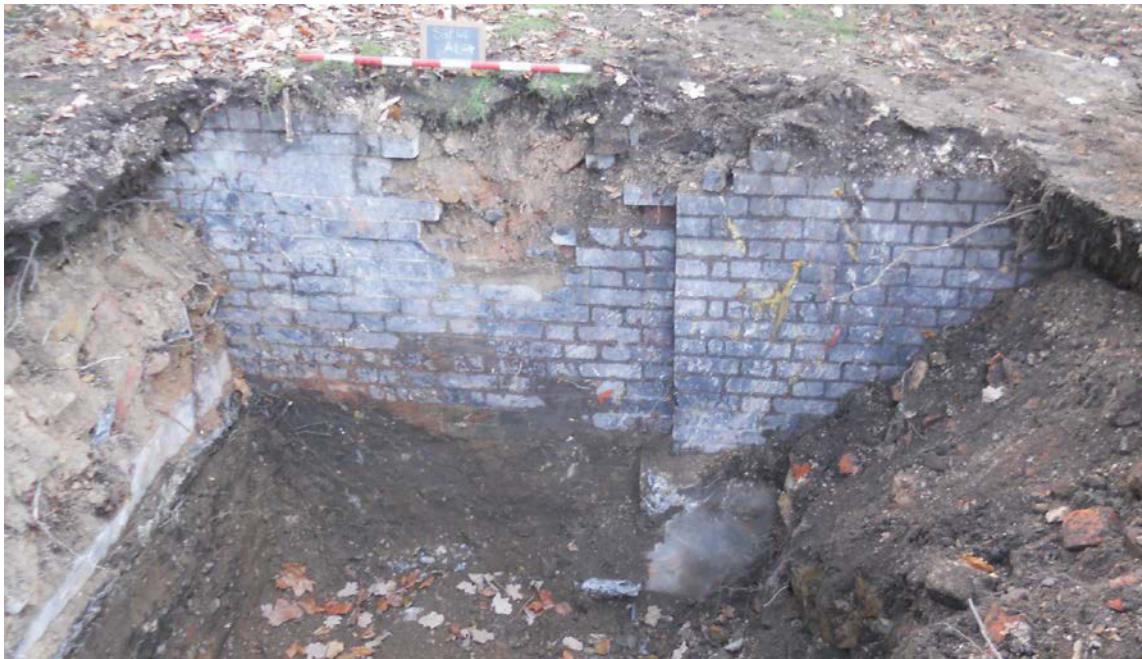
- 8.3.3 Wall [31]/[32]/[33] is the west wall of the 'outbuilding' and was observed in the east-facing section of Foundation Pile Pit A1 (**Figure 8; Plate 5**). In this instance 15 courses of blue-grey engineering bricks in Flemish bond were laid upon 8 horizontal courses of yellow frogged brick. At the bottom of these, two courses were stepped out by 60mm to create a foundation bed [33] with one course of stretchers laid upon a course of headers. The structure was exposed sufficiently to see a length of

Plate 5: Wall [31] and [32] of north ancillary building to the church in Foundation Pile Pit A1, looking west

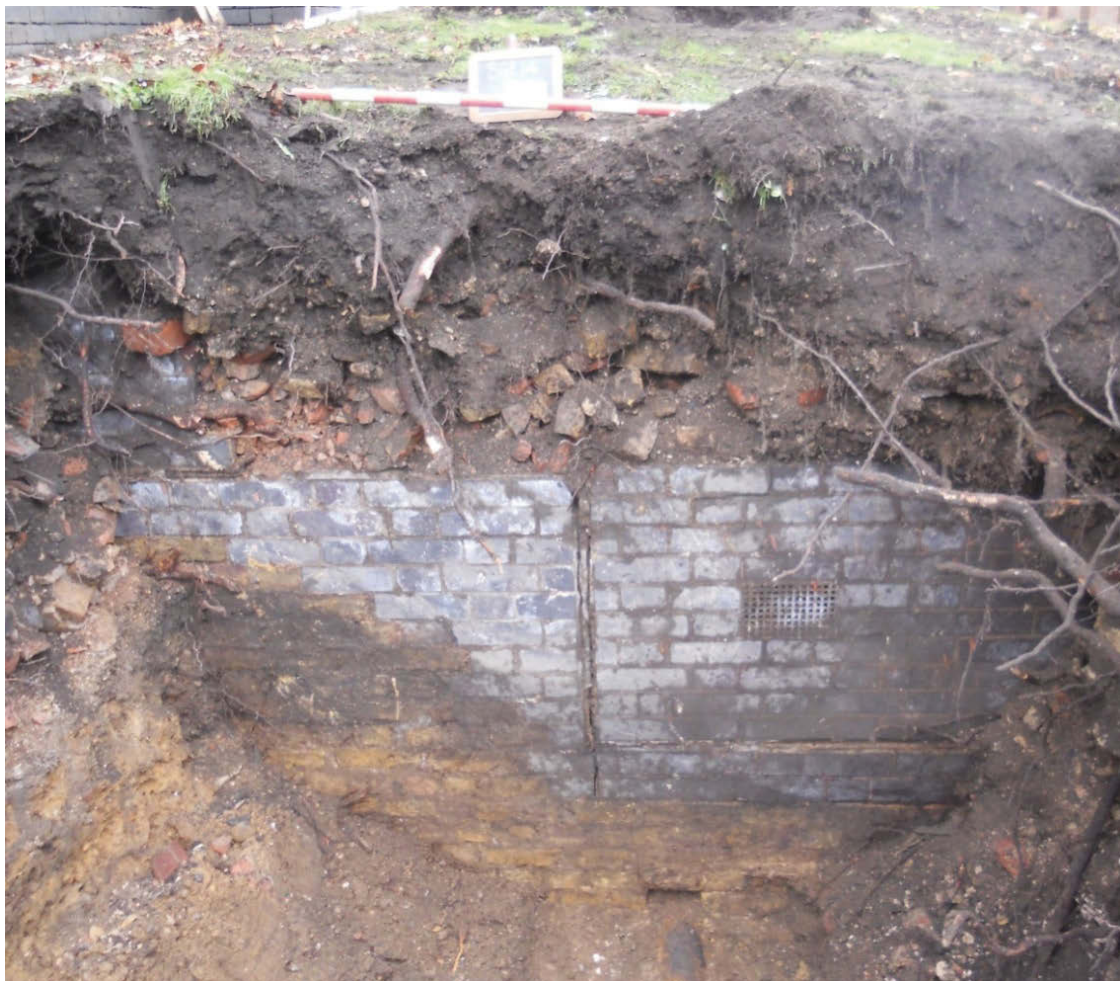
- 8.3.2 Wall [29]/[30], oriented north-south, is the eastern wall of this outbuilding and consisted of 12 courses of blue-grey engineering bricks in Flemish bond separated by a central straight construction joint; thus the lines of the courses are slightly misaligned (**Plate 6**). These courses had been laid upon 15 courses of yellow frogged bricks in stretcher coursing resting on a two-course step foundation bed of the same brick. However, [29] has been built upon [30] tying-in diagonally as opposed to being set on horizontal beds or courses. The cast iron pipe emerges from the step foundation courses at the bottom of the trench at a depth of 2.24m below present ground level.

Plate 6: Wall [29] and [30] of north ancillary building to the church in Foundation Pile Pit B1, looking west

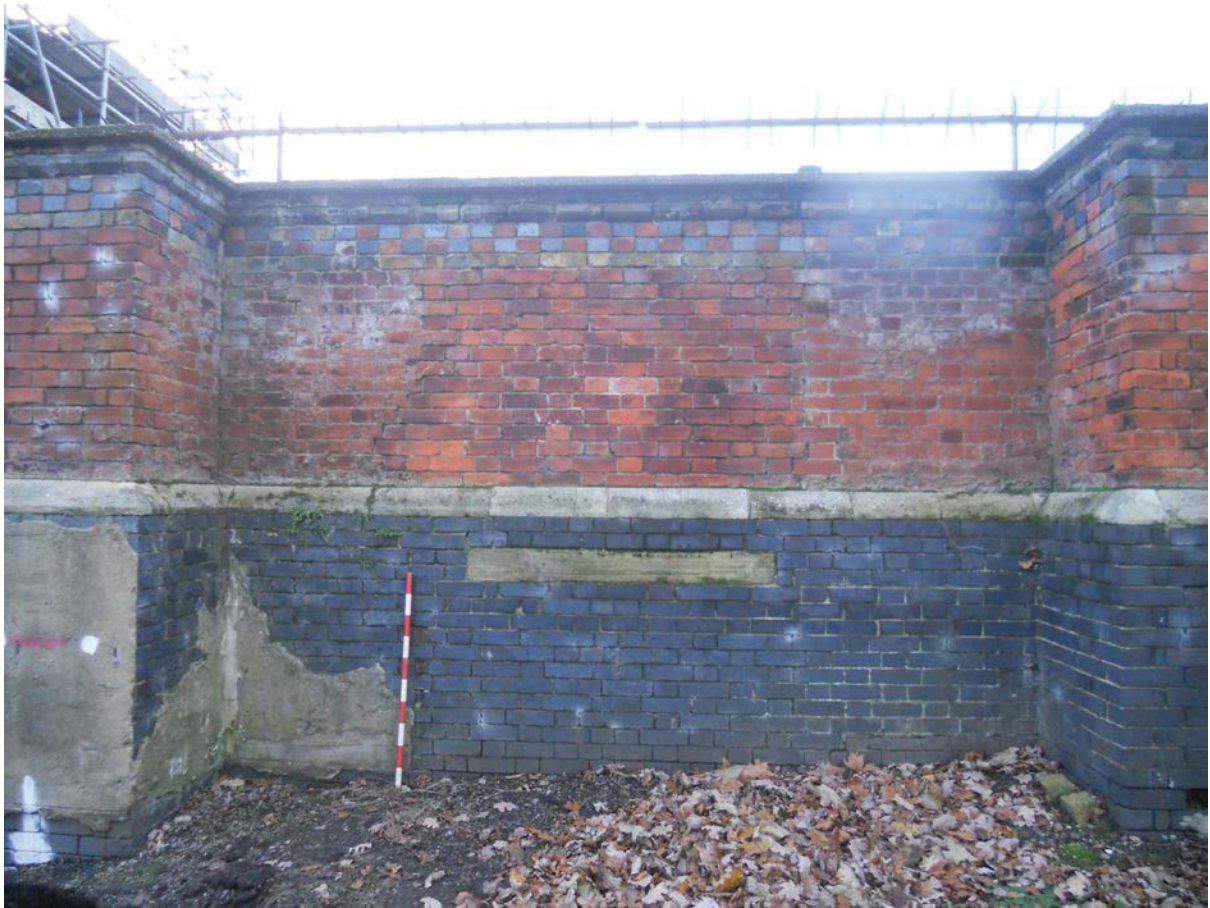
Plate 7: Blocked doorway in the north elevation of the church between buttresses 5 and 6, looking south

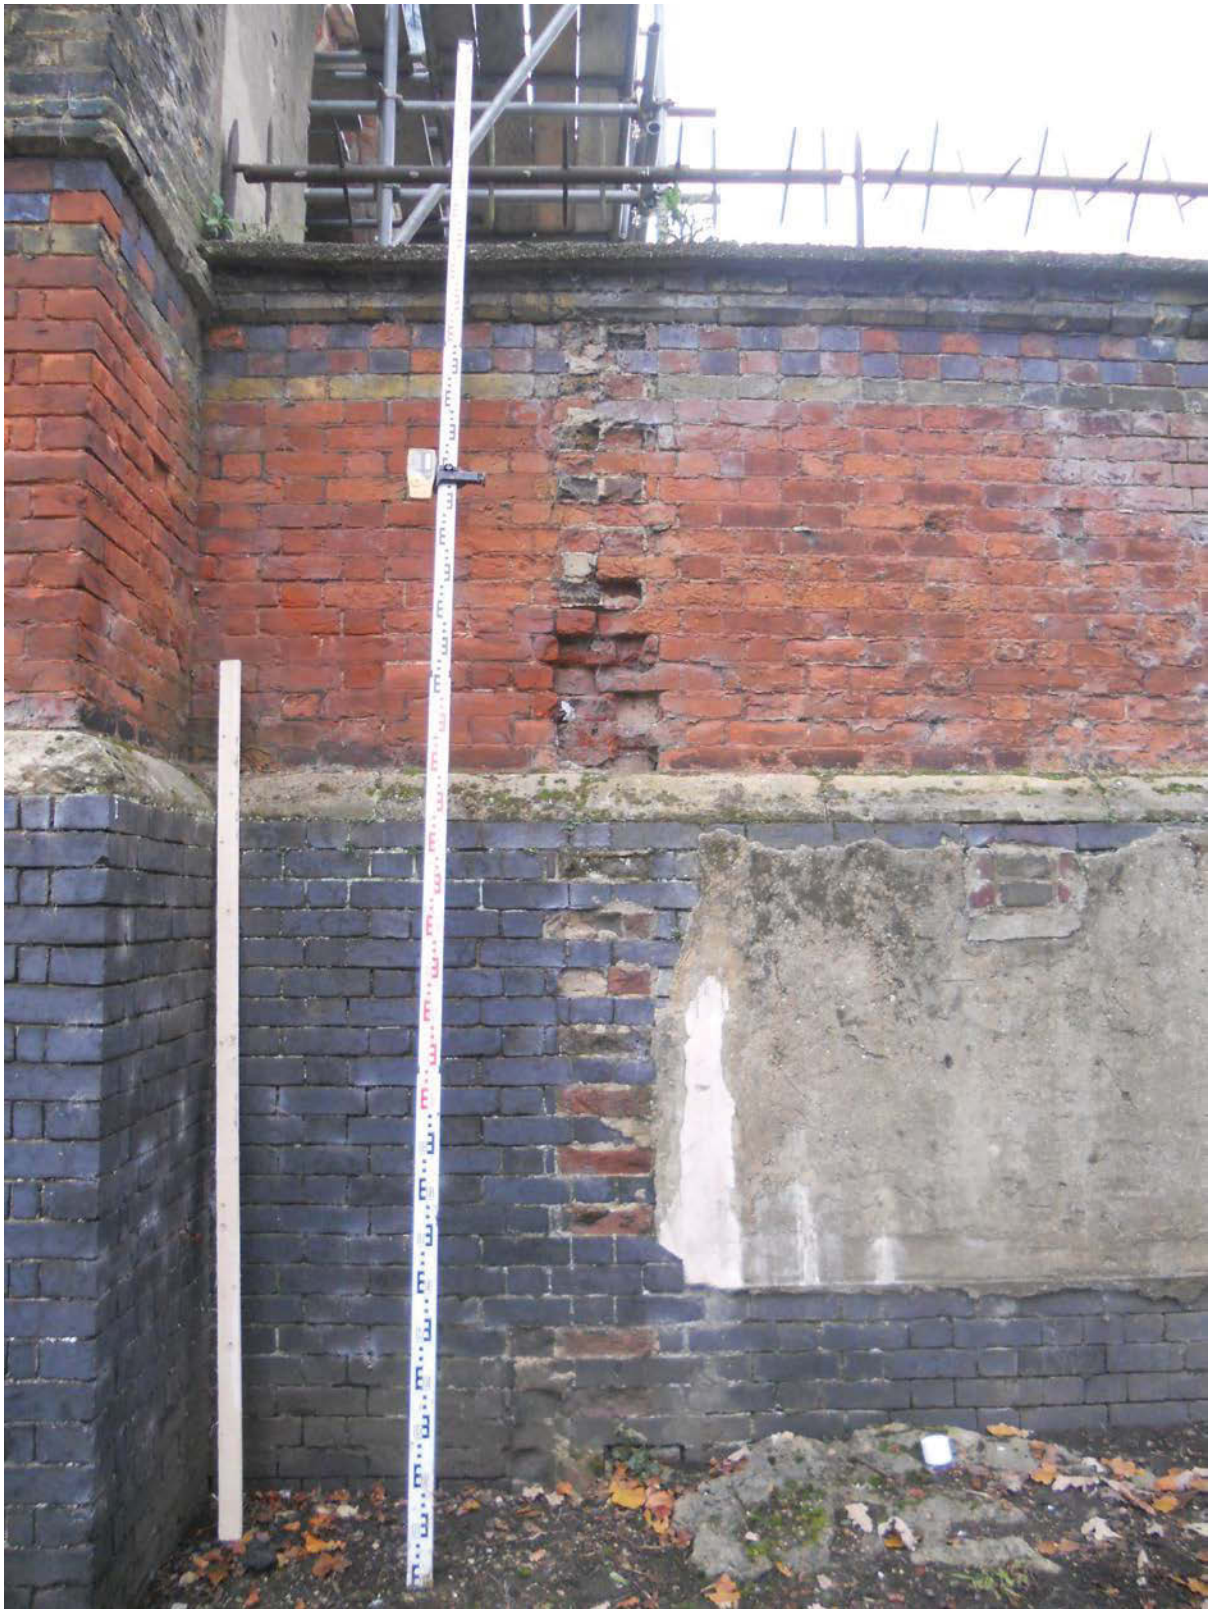
Plate 8: Wall scar in the north elevation of the church to the west of buttress 7 (right), looking south

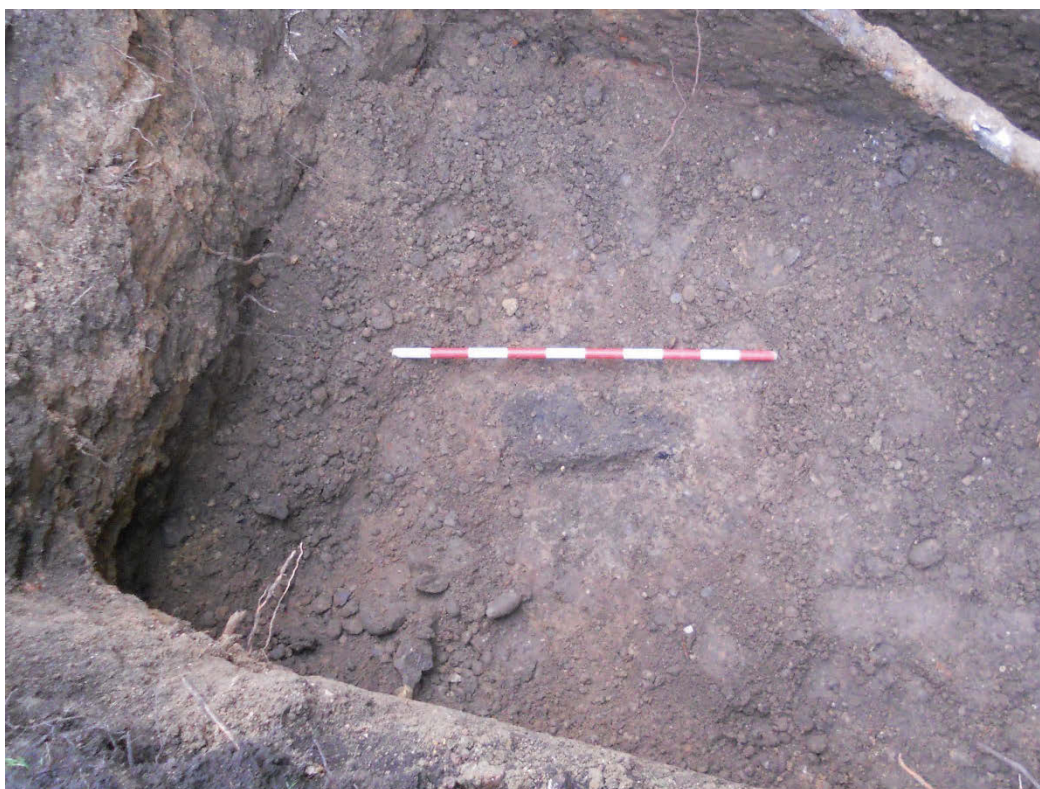
- 8.2.1 At the base of Foundation Pile C2 a small, sub-oval pit [19] was discovered which had been sealed by an overlying layer of mid-brown-yellowish clayey-sand (12) (**Plate 9**). It had not been possible to view it in section as it was almost central to the base of the Foundation Pile Pit and obscured by the digger bucket during excavation. It was barely 0.06m deep. Four sherds of London-type ware (LOND) were recovered from its fill (18) which were dated to between AD1225 - 1350. The pit is likely to be contemporary with the activities relating to the kiln [37] less than 6m to the south-west. It is possible that the sherd of baluster jug found in the fill is earlier in date than the rest of the pottery found in the other medieval features on this site.

Plate 9: Medieval Pit [19] in Foundation Pile Pit C2, looking north-west

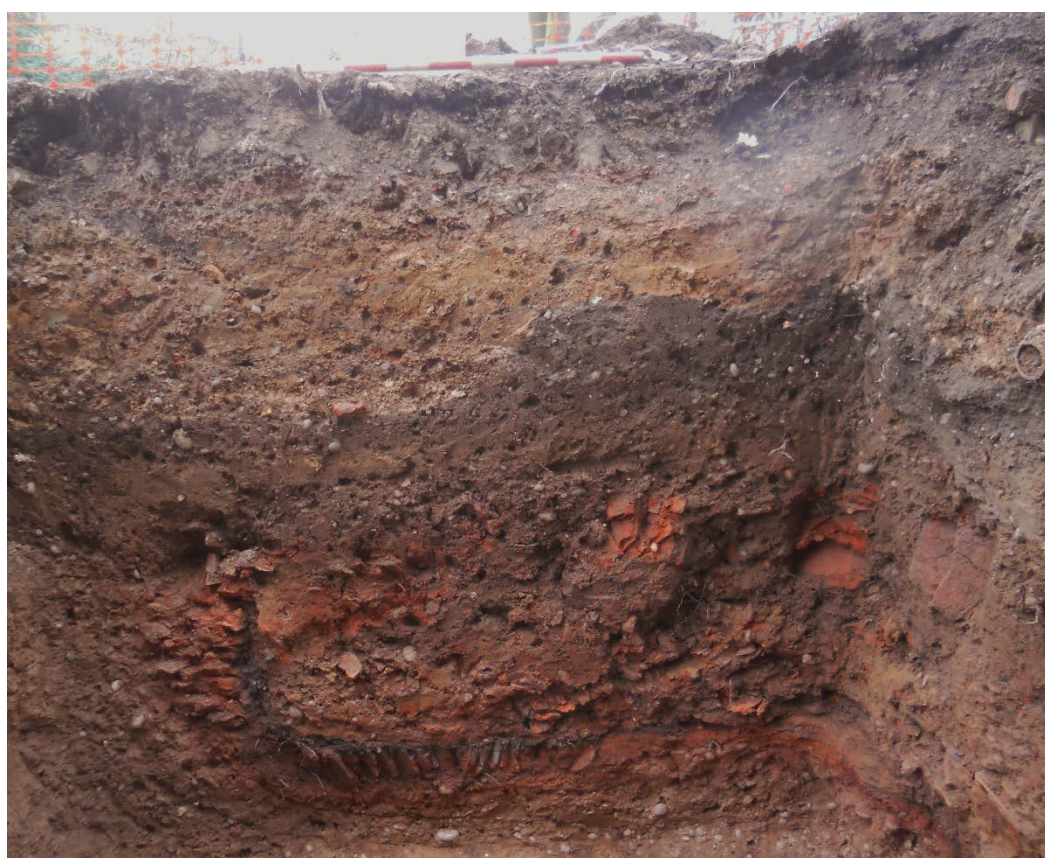
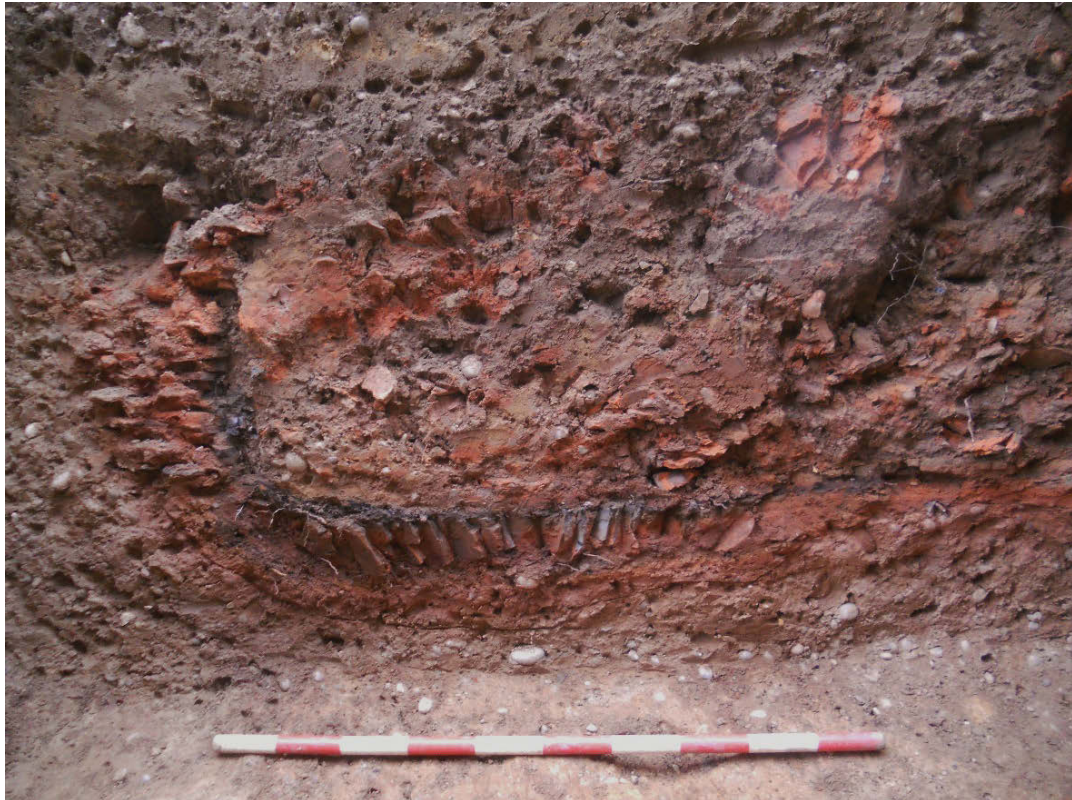
- 7.3.13 The tile-built kiln was revealed in the south and west section of Foundation Pile Pit B2 (**Figure 7; Plates 10 to 12**). The construction cut for the kiln had cut two natural geological deposits (17) and (42) below. Within the kiln cut itself could be seen a reddened layer (38) which appears to have been the result of heat radiating outwards from the centre of the kiln. The wall of the kiln was comprised tiles [37] laid without any mortar and arranged either vertically, 'on edge,' for the base of the structure or stacked horizontally for the walls. Their inner surfaces carried a layer of black soot or ash [36] which was testament to the use of the structure. Roughly three fills within the kiln could be ascertained and all to some degree were a result of the collapse of the structure itself. At the base of kiln, fill (35) contained tile and cbm fragments (25%) in a matrix of mid-brown sandy silt. Both fills (21) and (34) were a dark brown sandy silt, although higher layer 21 contained a high proportion of tile fragments (30%) which suggests it constituted the collapsed roof of the kiln itself.

Plate 10: Medieval Kiln [37] in Foundation Pile B2, looking south

Plate 11: Medieval Kiln [37] in Foundation Pile B2, looking south

- 8.2.2 During the excavation of Foundation Pile Pit B2 a tile-built structure was discovered and exposed in its south and west sections (**Figure 7; Plates 10 to 12**). As it was only partially revealed its exact dimensions were not ascertained but the principal chamber (or oven) appears to have been oval in plan, roughly 3.2m across. It had survived to a height of 1.6m although the roof had collapsed. The flue entered from the north-west. Although the total length of the flue is not known, it was recorded as being 0.94mm wide when it was observed in the ring-beam trench excavated between Foundation Piles A2 and B2 (**Figure 7; Plates 13 and 14**).

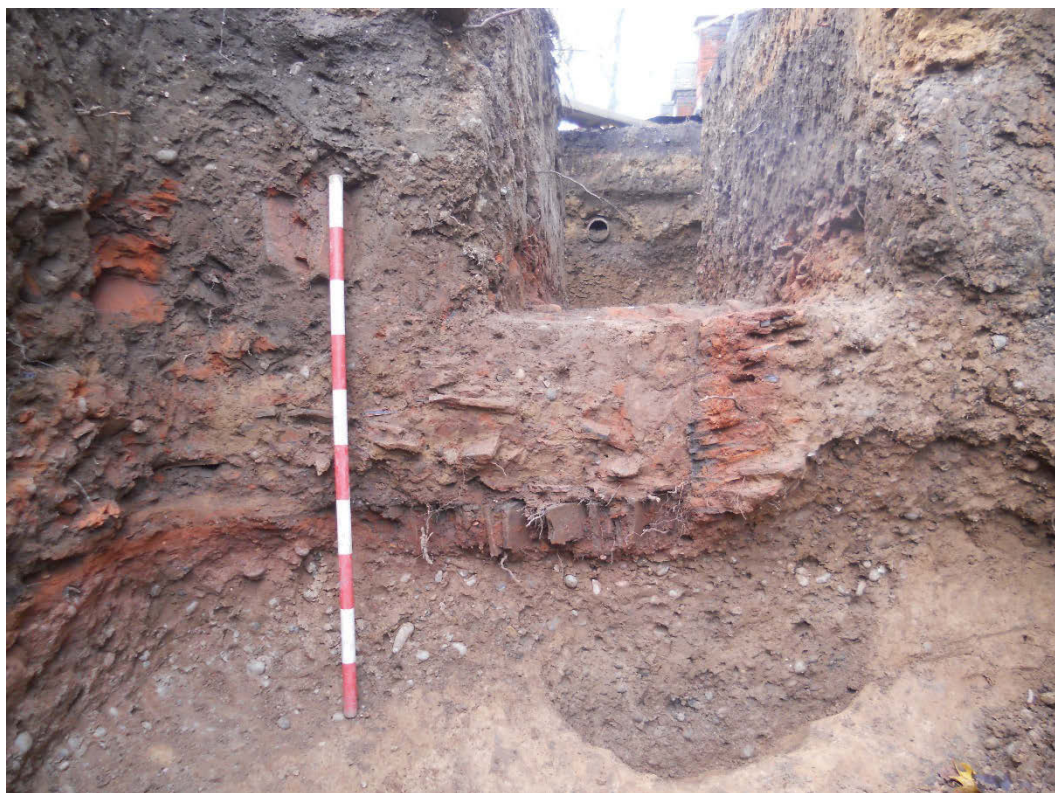
- 8.2.6 The north-west to south-east oriented flue was observed in plan within the confines of the ring-beam trench and therefore access was restricted (**Figure 7; Plates 12 to 14**). However, it appeared that two parallel walls had been created with a void between them and that the tiles had then been laid to overlap one another in a kind of 'barrel-vault' fashion. The kiln may have had the appearance of an 'igloo,' with a linear flue serving a cylindrical chamber although it is unknown as to whether the roof (or dome) had been corbelled or roofed in another fashion. An environmental sample taken of the flue fill (40) also produced two sherds of London-type ware of the highly decorated style (LOND HD) known to have been made around AD 1080-1350.

Plate 12: Medieval Kiln [37] Flue, Foundation Pile B2 looking west

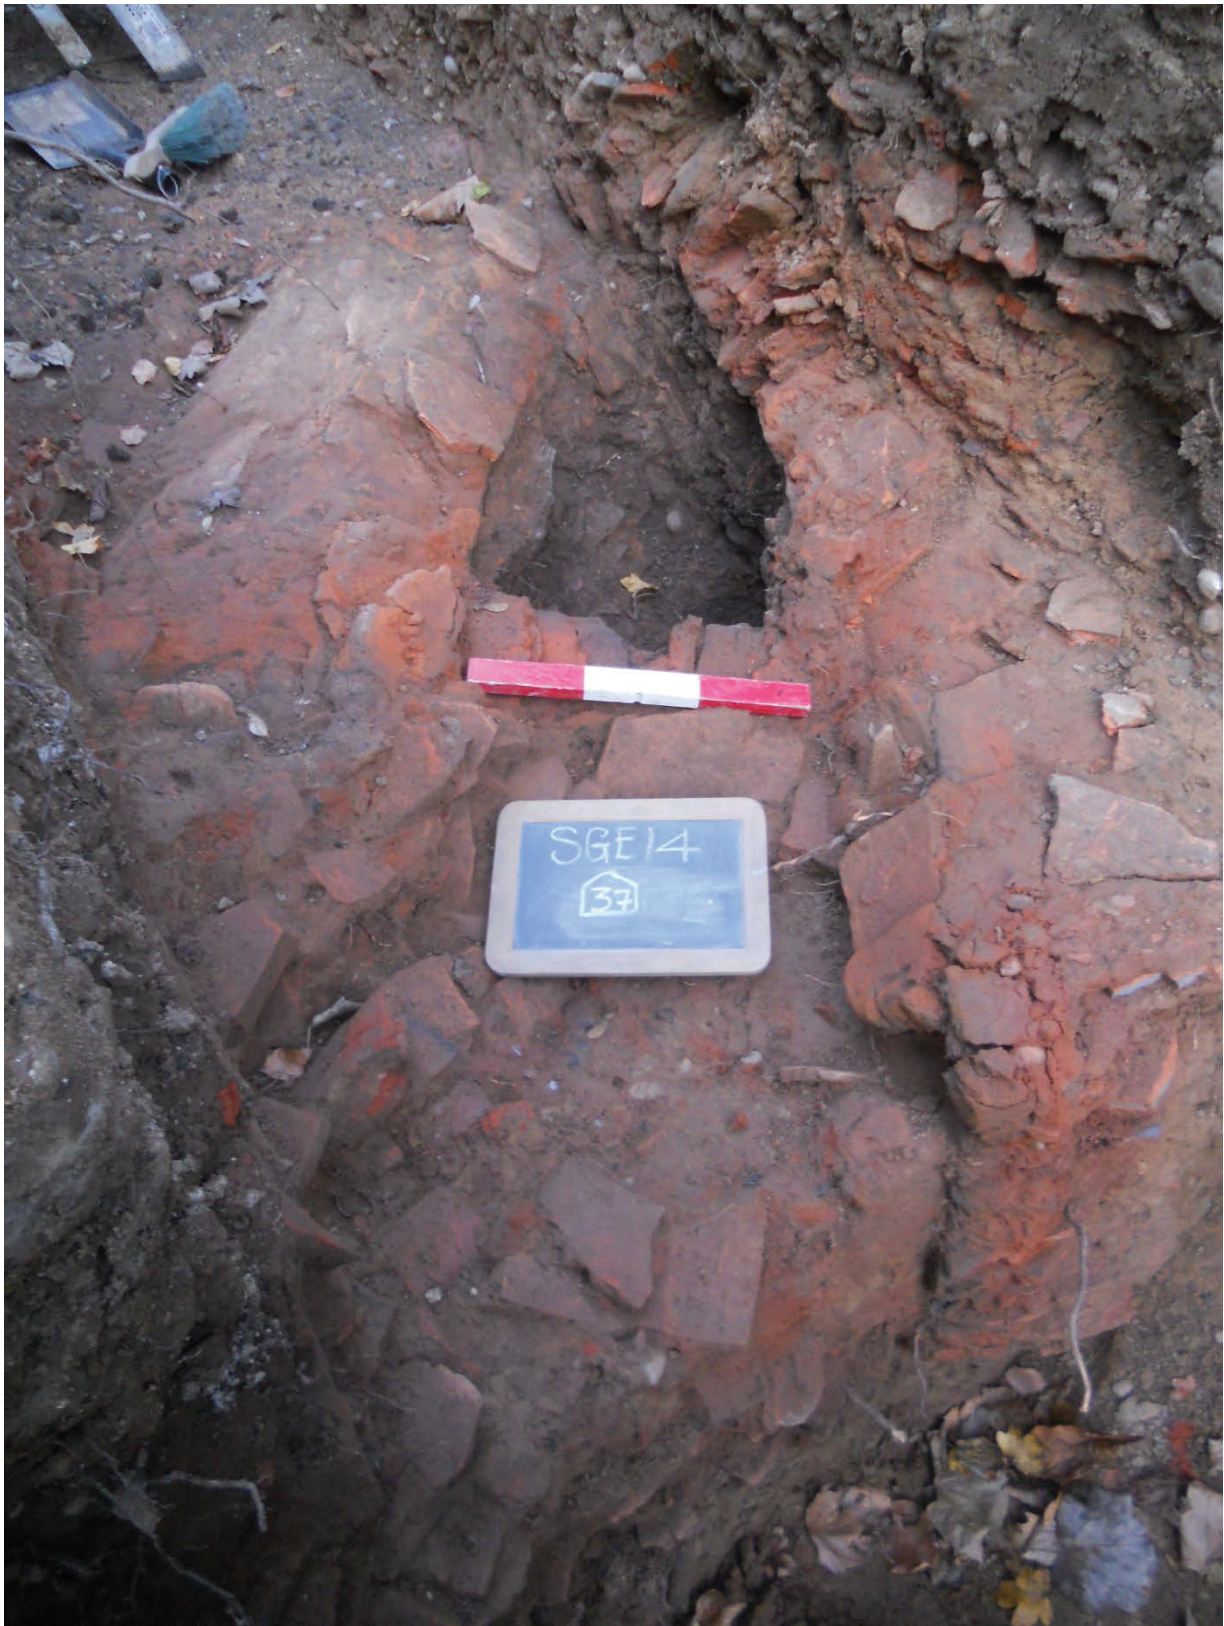
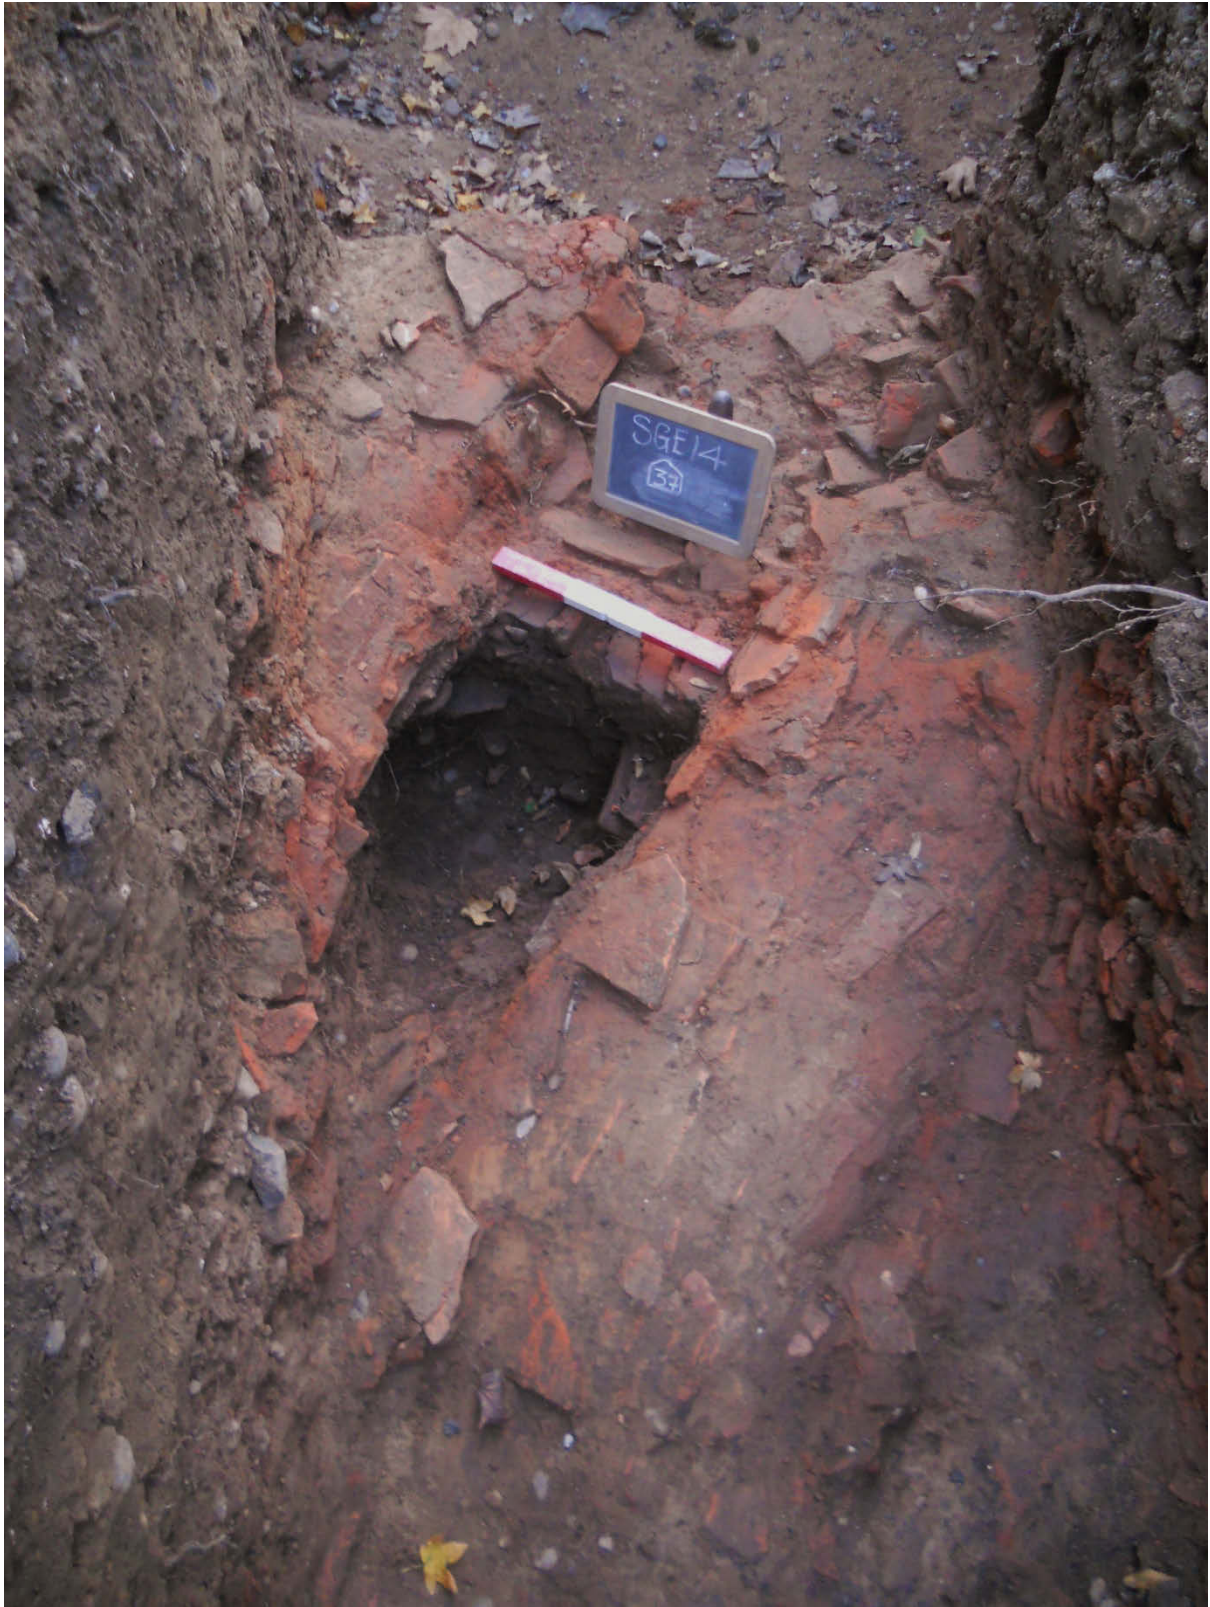
- 7.3.14 The flue [40] of the kiln was exposed in the ring beam trench to the west of Foundation Pile Pit B2 (**Figure 7; Plates 13 and 14**). Another flue-like structure [39] was observed less than a metre to the west in the ring-beam trench. It was oriented north-south.

Plate 13: Flue [40] of medieval kiln [37] in ring beam trench to the west of Foundation Pile Pit B2, looking north-west (Scale 30cm)

Plate 14: Flue [40] of medieval kiln [37] in ring beam trench to the west of Foundation Pile Pit B2, looking east (Scale 30cm)

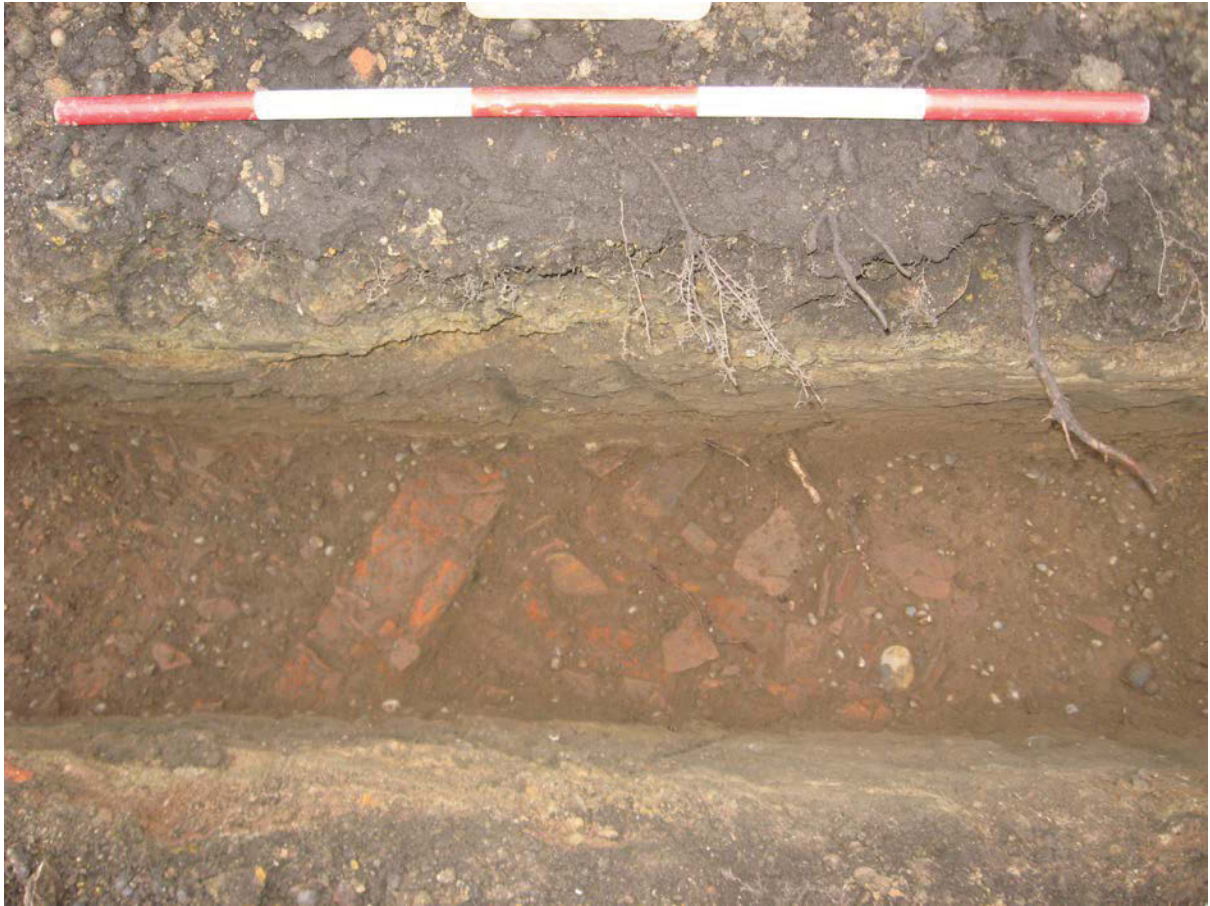
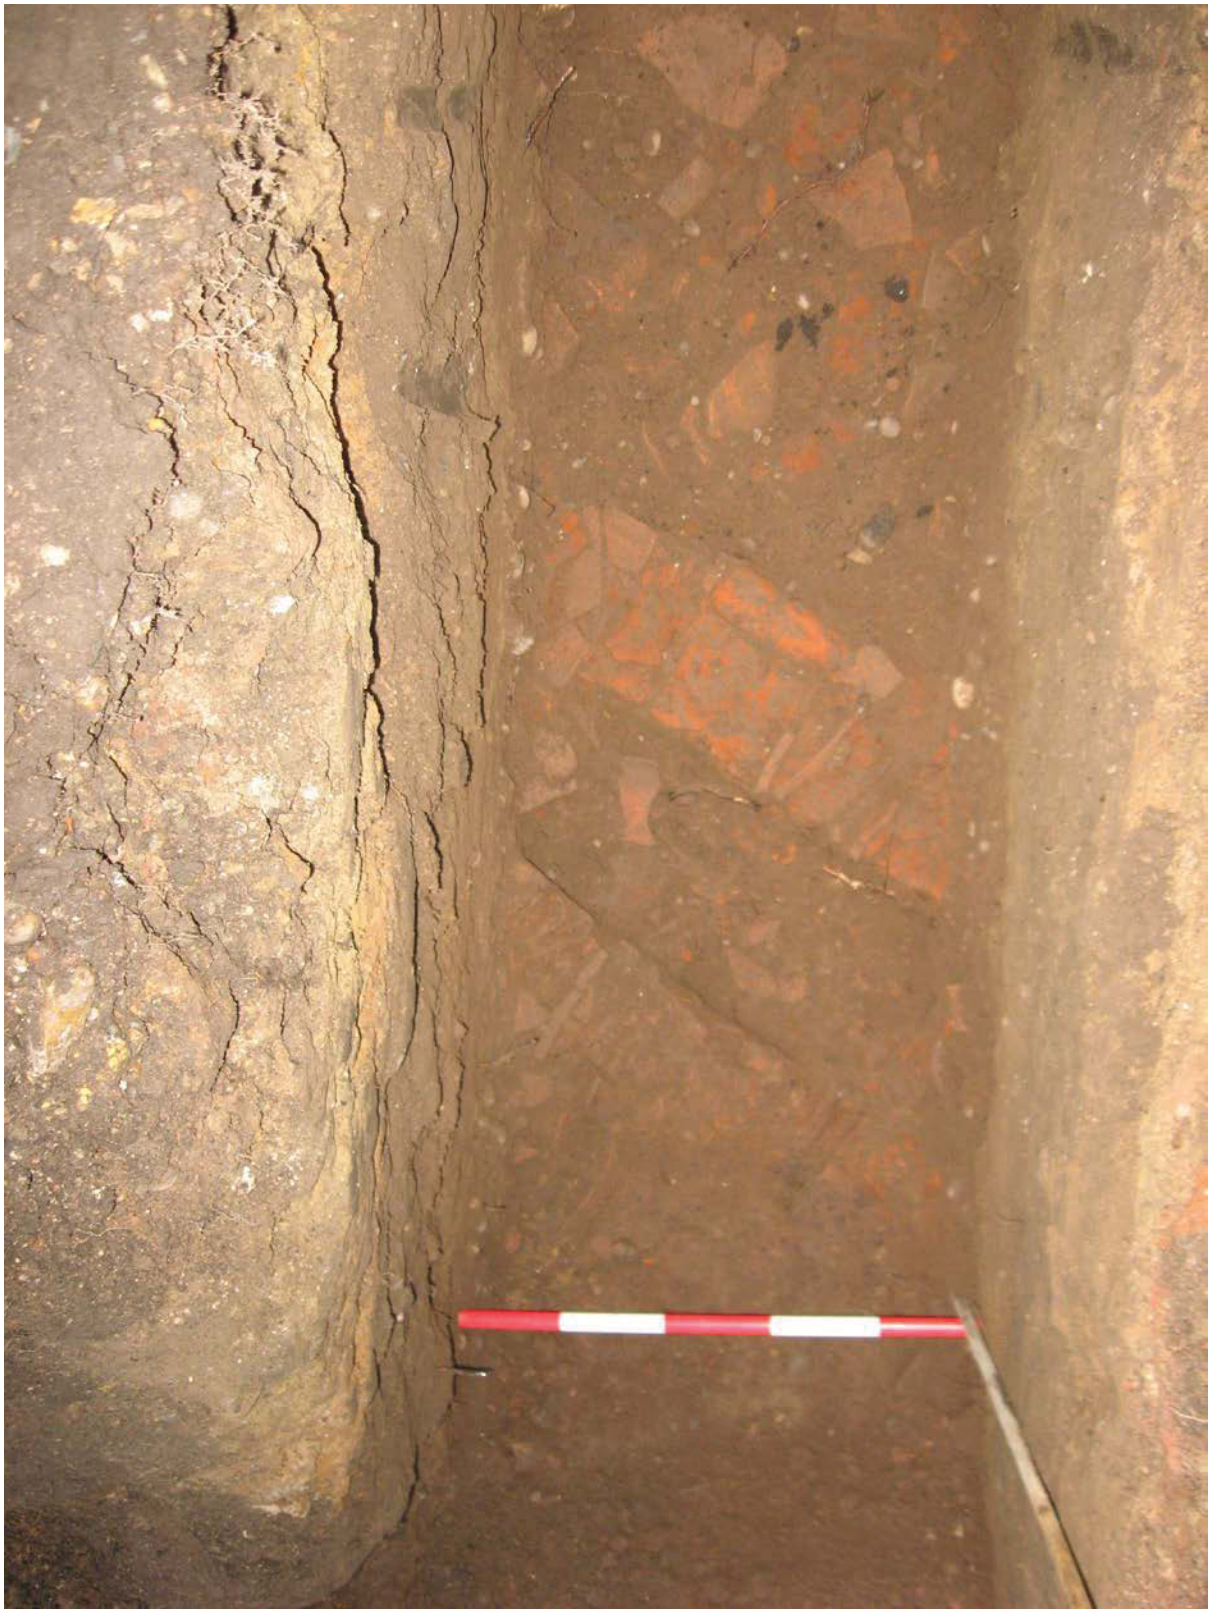
- 7.4.2 The storm drain on the south side of the church was excavated at a distance of no more than 0.75m south of Pile Foundation Pits A2 and B2 (**Figure 6**).
- 7.4.3 The storm trench, which was only 0.7m deep, passed over the tile-built kiln observed in Foundation Pile Pit B2. The roof or structure of the kiln [37] and its construction cut [22] were exposed in the base of the trench (**Figure 7; Plates 15 and 16**). This suggested that the kiln may have been round to oval in plan with the flue aligned to the north-west.

Plate 15: Medieval kiln [37] in storm drain trench to the south of Foundation Pile Pit B2, looking north (Scale 50cm)

Plate 16: Medieval kiln [37] in storm drain trench to the south of Foundation Pile Pit B2, looking east (Scale 50cm)

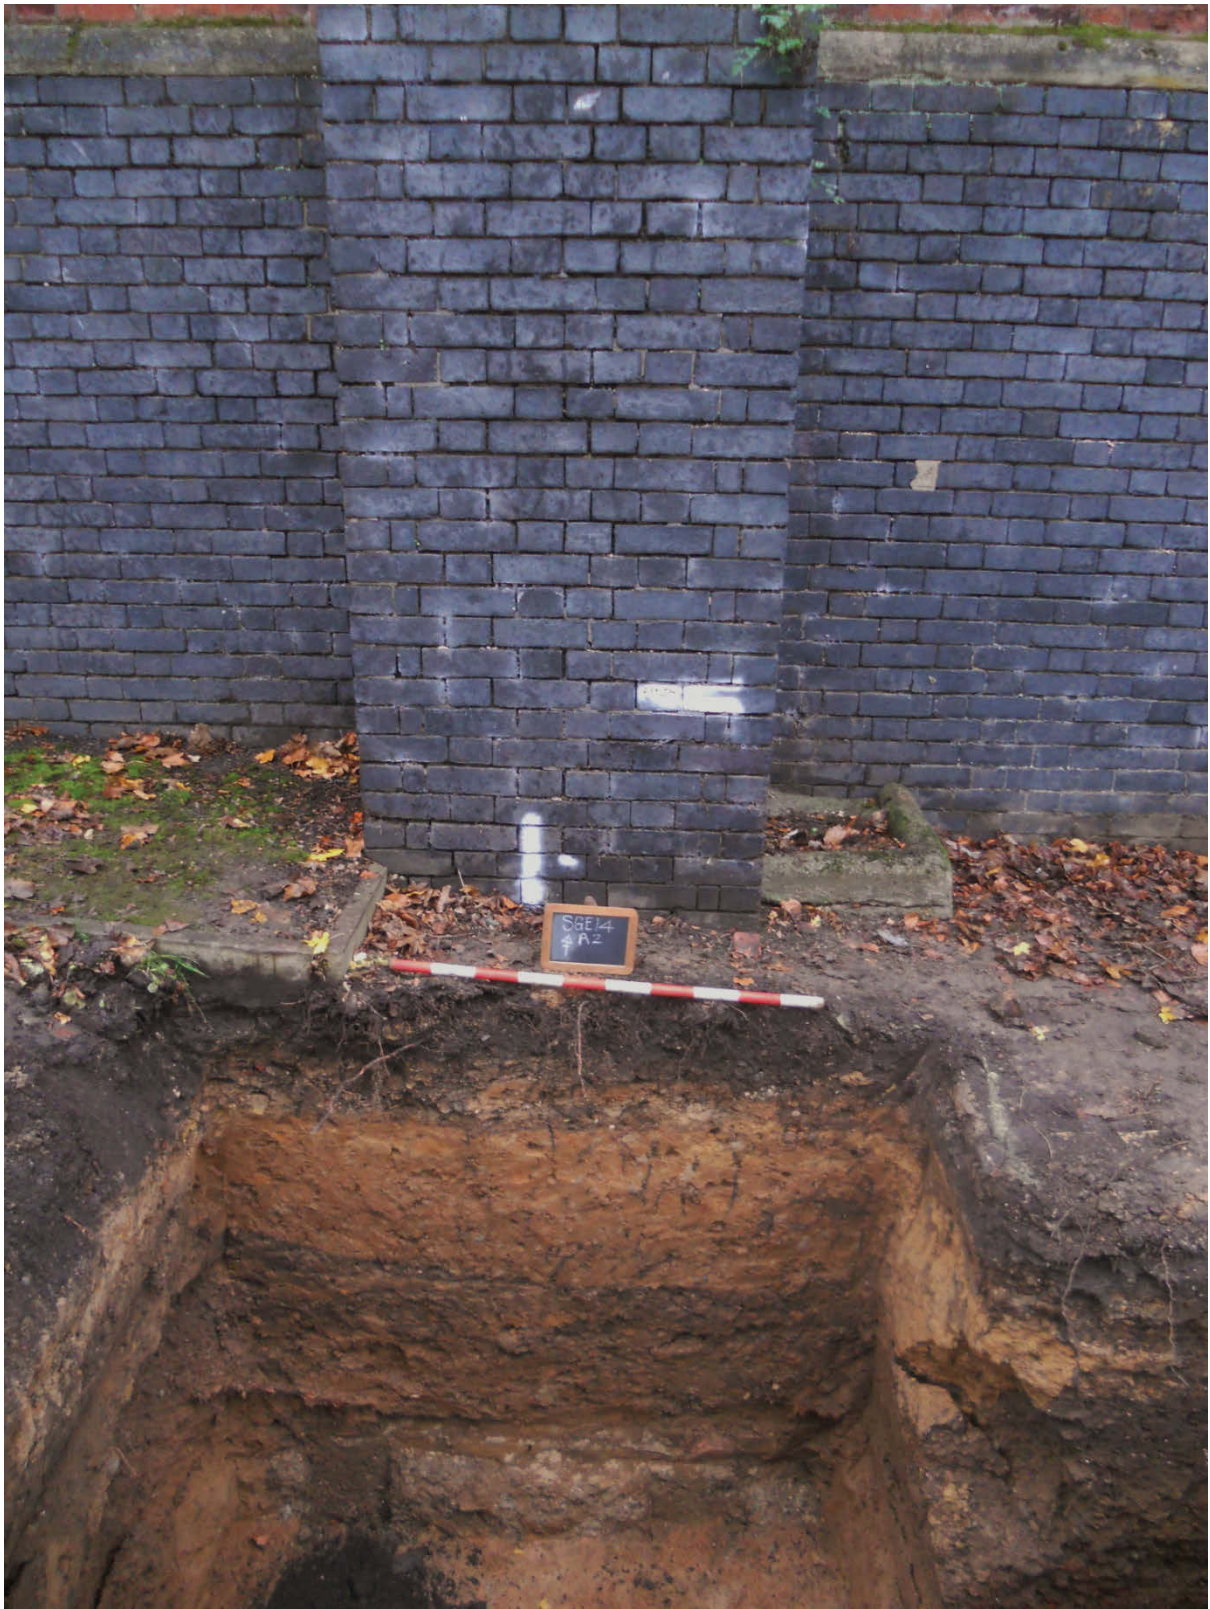
foundations [25] of one of the church's buttresses protruded into the section (**Plate 17**). It was built on a bed of mortar (26) that was so thick that it obscured the building materials evident within it. Structure [25] was two courses of yellow, frogged brick and constituted the foundation courses of the buttress against the main south elevation, which was built in blue-grey engineering bricks.

Plate 17: Foundation Pile A2, looking north

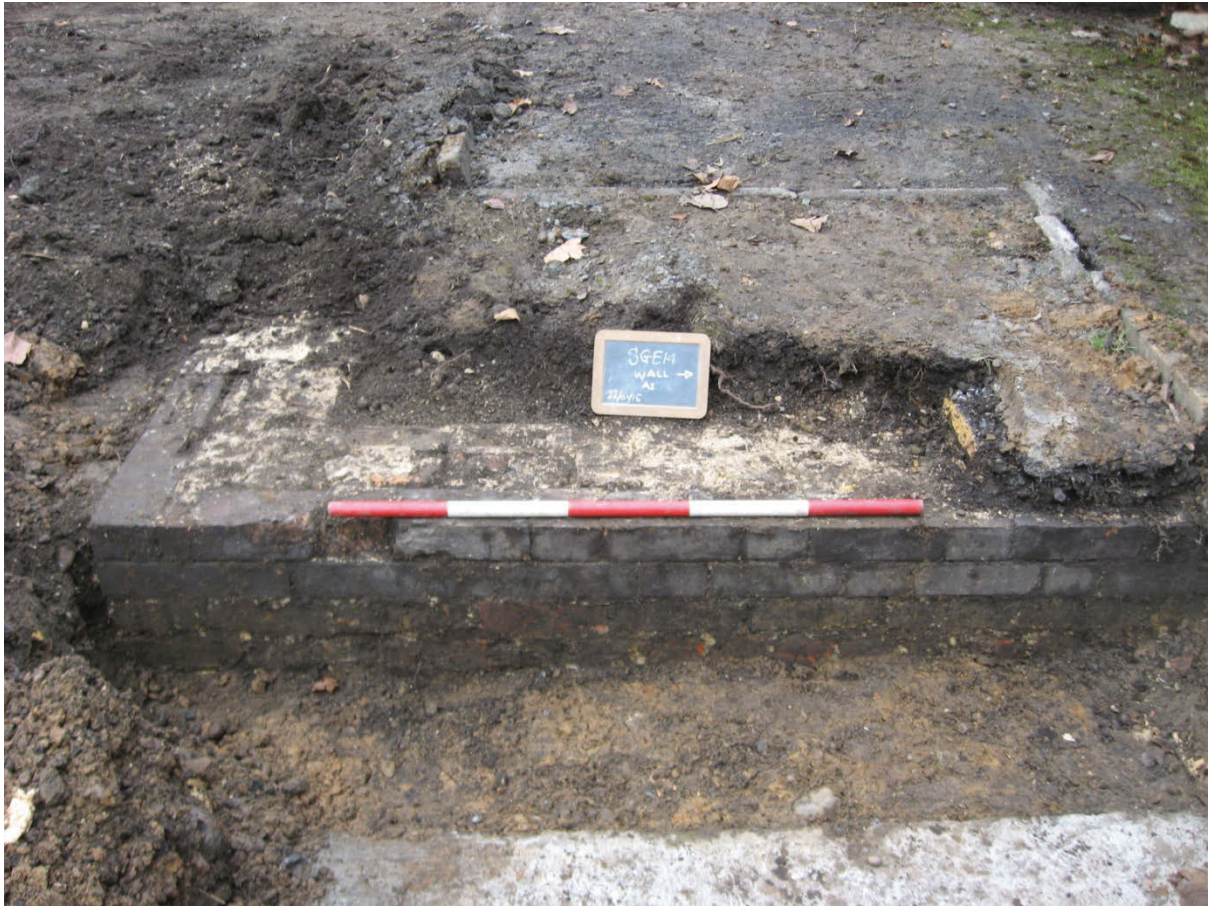
- 7.3.16 During the works, the upper part of the west section of Foundation Pile Pit A2 was extended to the west revealing a wall perpendicular to the south elevation of the church (**Figure 6; Plates 18 and 19**). It was aligned with a blocked former raised doorway in the south elevation (**Plates 19 and 20**). The wall comprised two courses of blue-grey engineering bricks in Flemish bond [48] laid on two (visible) courses of yellow, frogged bricks [49]. The latter two courses were laid in English bond.

Plate 18: Wall 48 in the area to the west of Foundation Pile Pit A2, looking west
