**ROYAL GARRISON CHURCH
OF ST GEORGE,
GRAND DEPOT ROAD,
WOOLWICH,
ROYAL BOROUGH OF
GREENWICH:
AN ARCHAEOLOGICAL
WATCHING BRIEF**

SITE CODE: SGE14

PCA REPORT NO. R12012

MARCH 2015

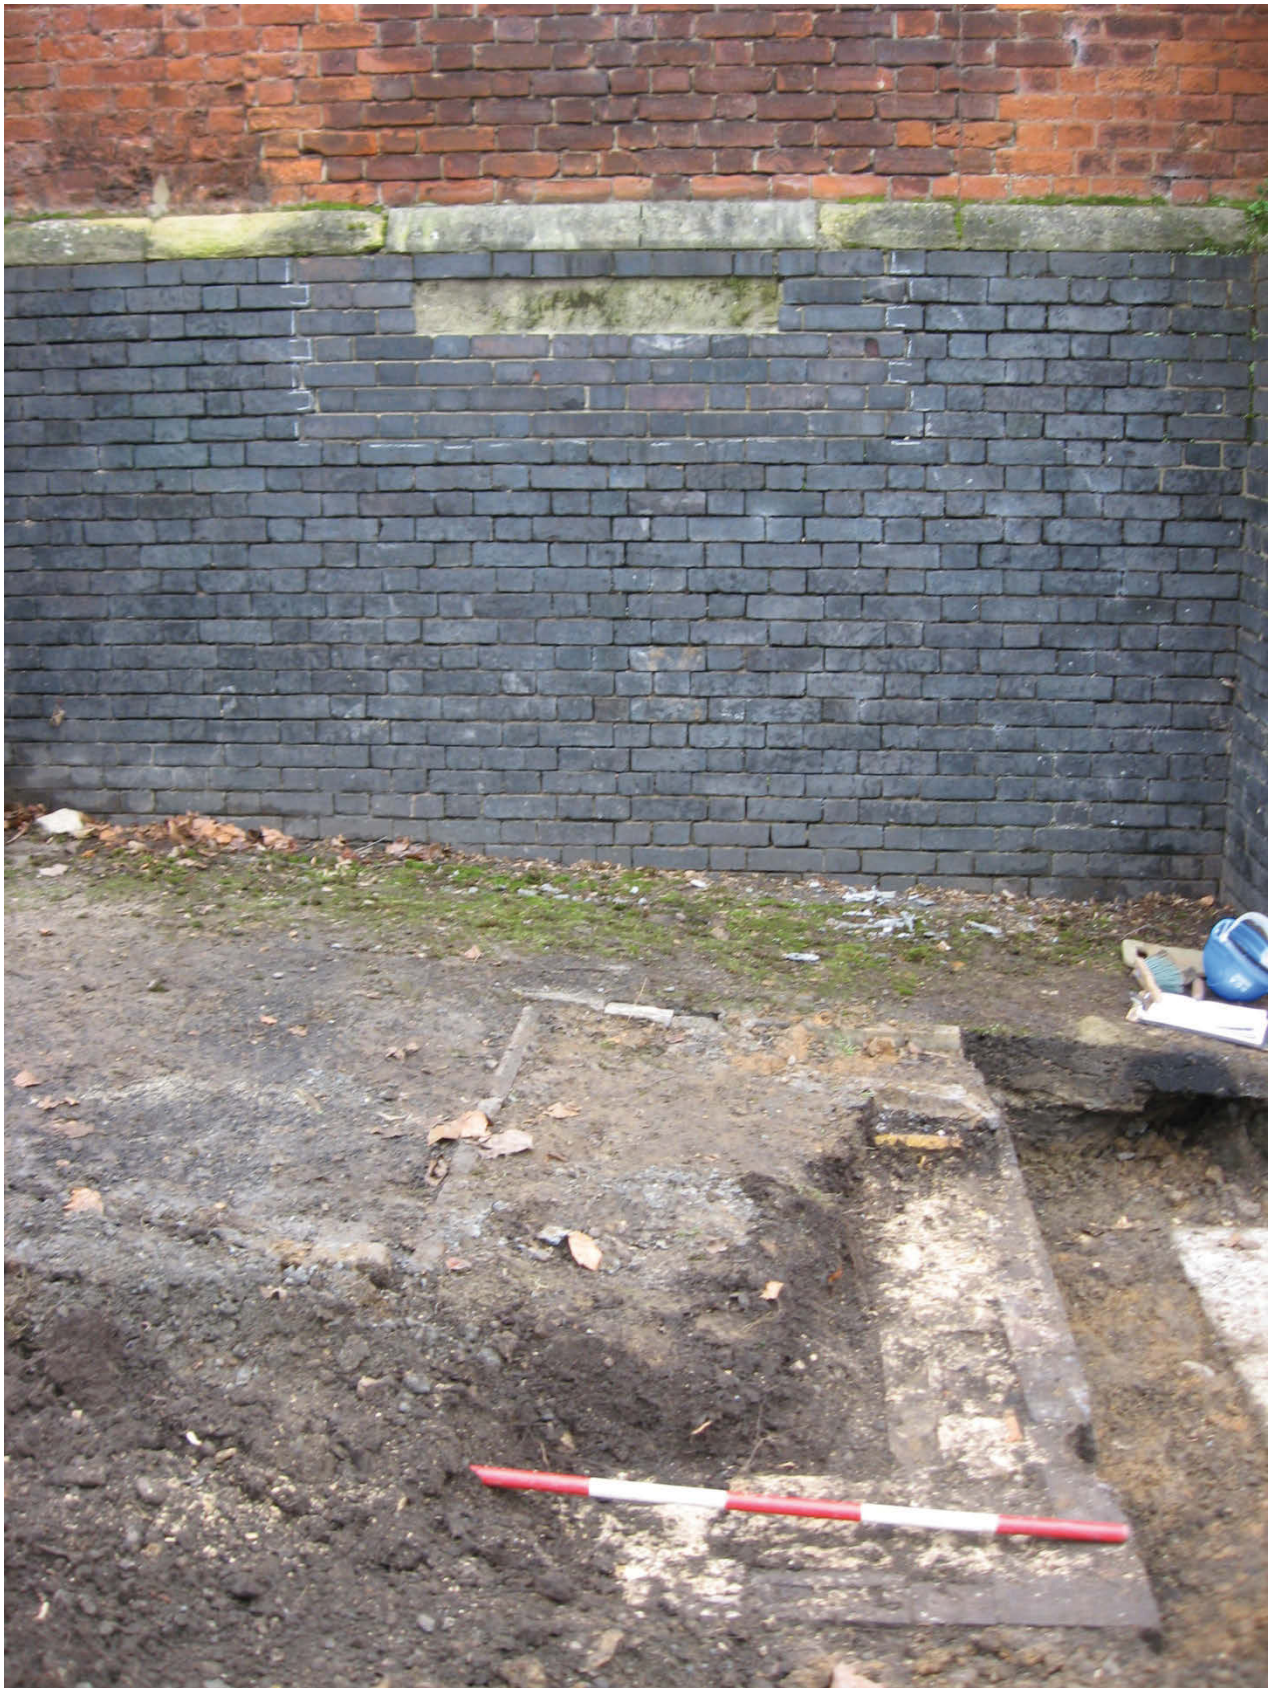
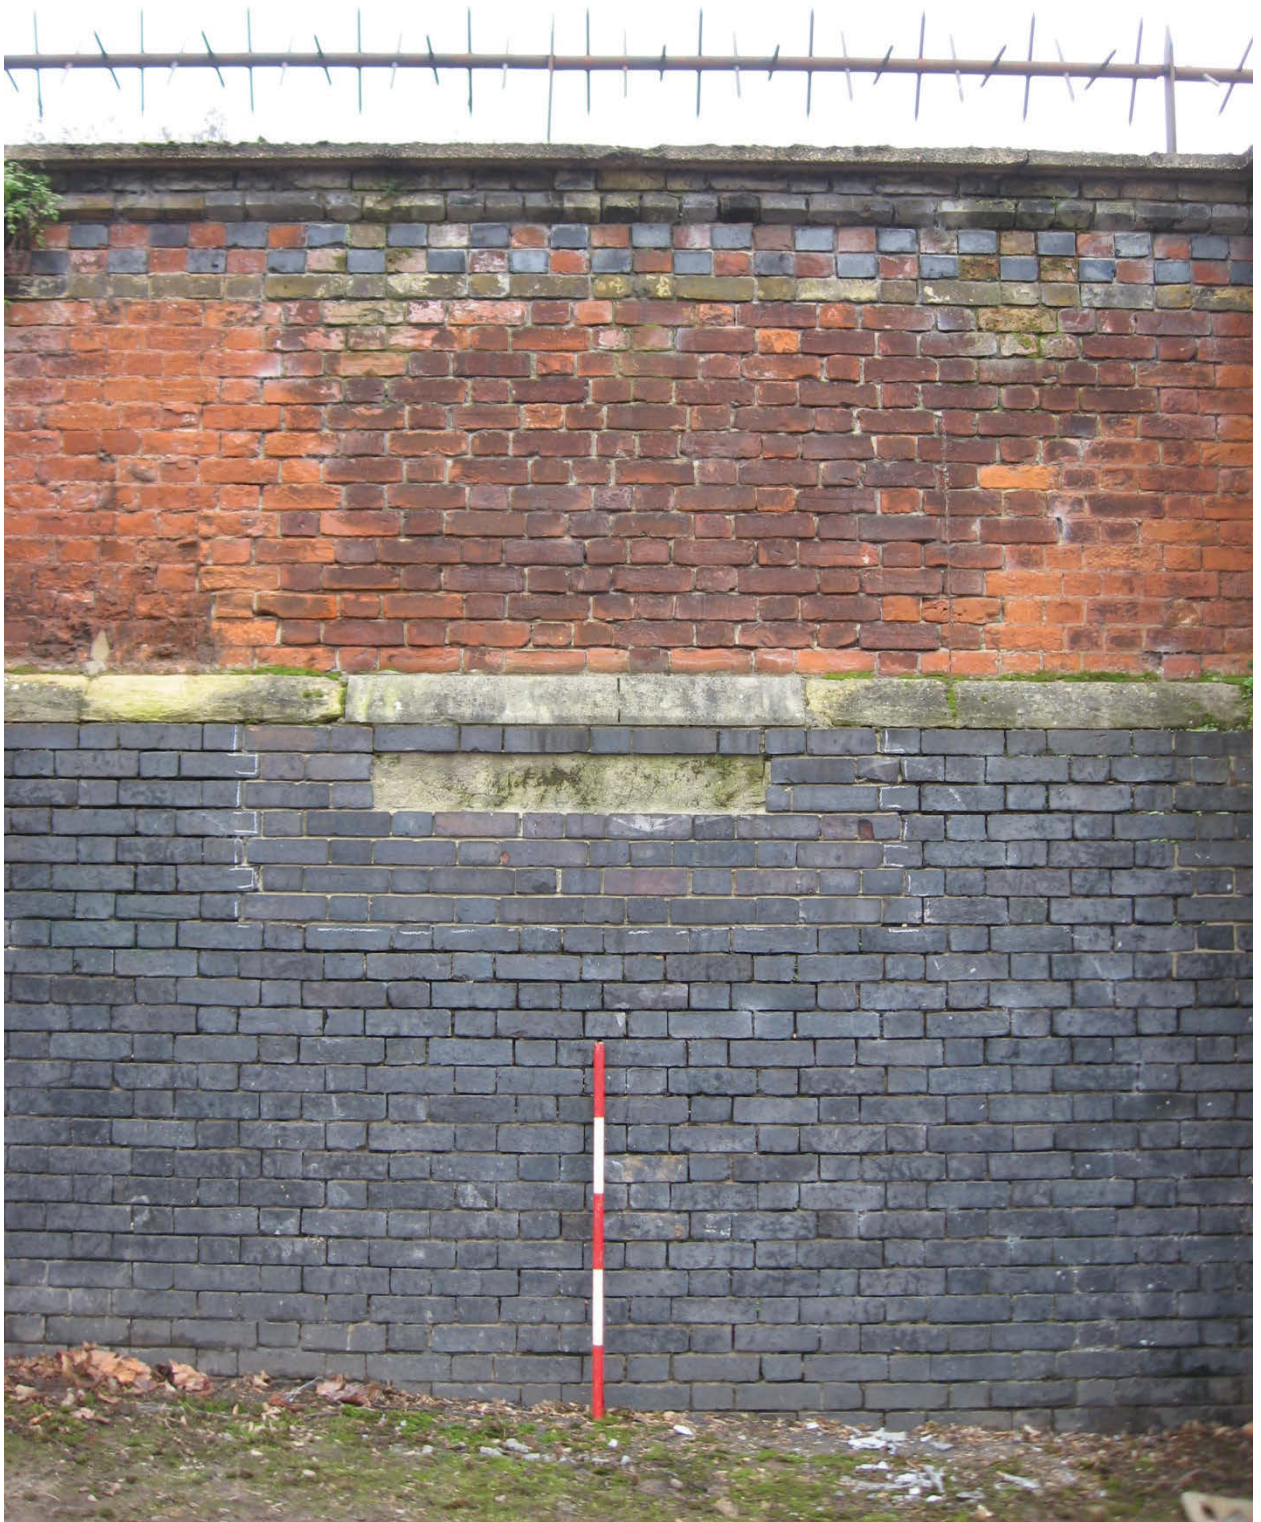
Plate 19: Blocked opening in the south elevation of the church to the north of wall 48, looking north

Plate 20: Blocked opening in the south elevation of the church to the north of wall 48, looking north
