**SOUTH FRONT LAWN LIGHTING,
KENSINGTON PALACE,
KENSINGTON GARDENS,
LONDON W8 4PX**

**AN ARCHAEOLOGICAL WATCHING
BRIEF**

PCA REPORT NO: R12060

SITE CODE: KEN26

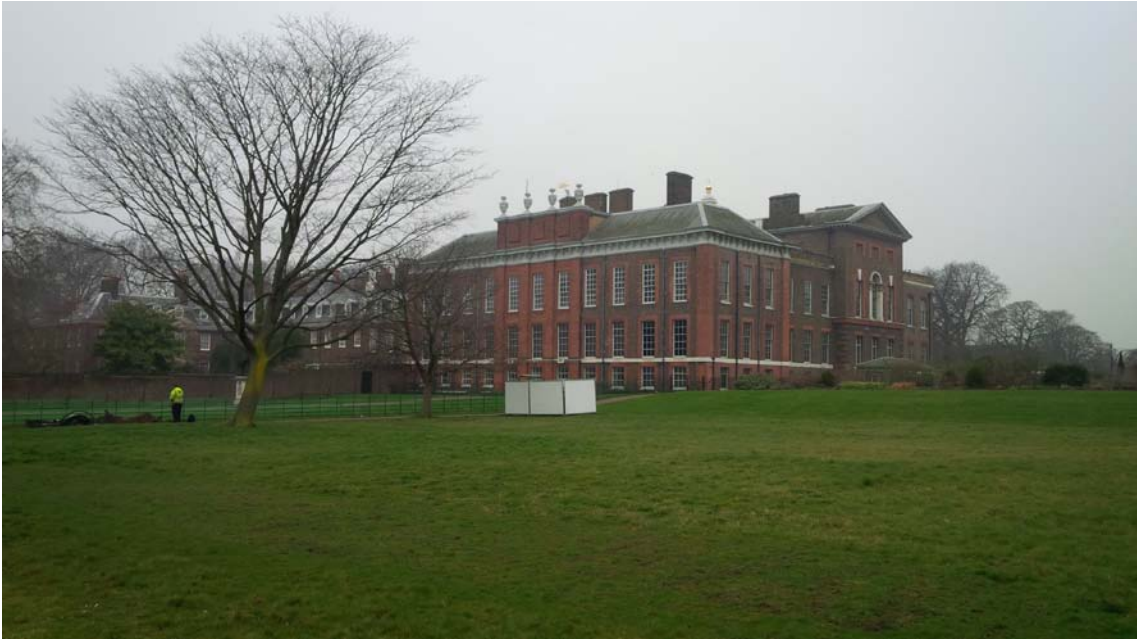
Plate 1: View northeast of South Front Lawn; the author is shown standing halfway along the cable trench

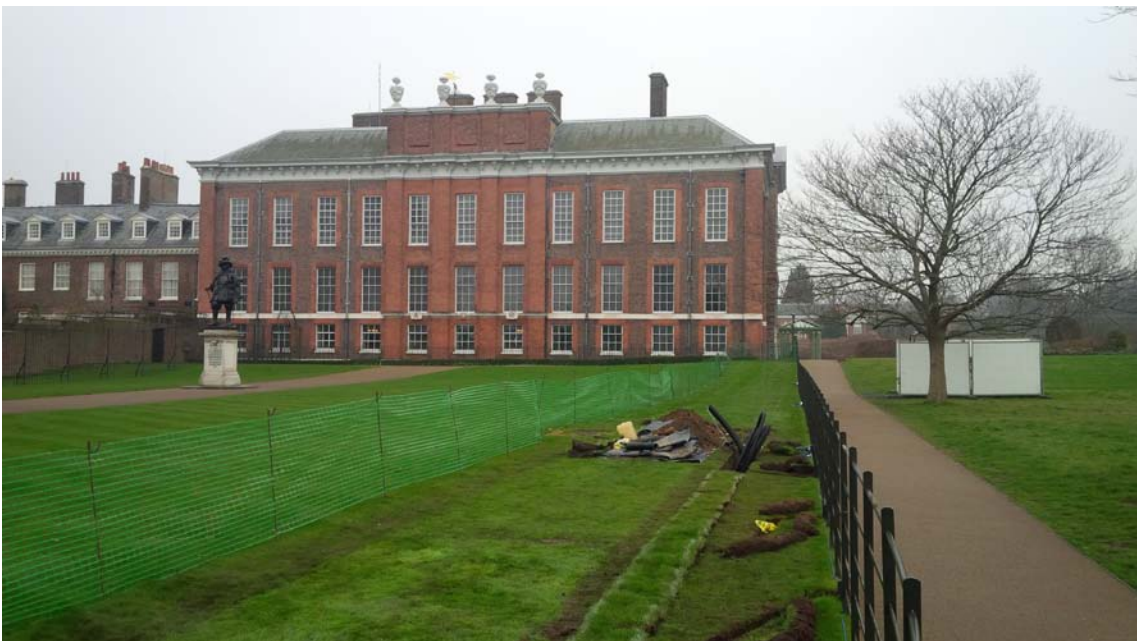
Plate 2: View north of cable trench

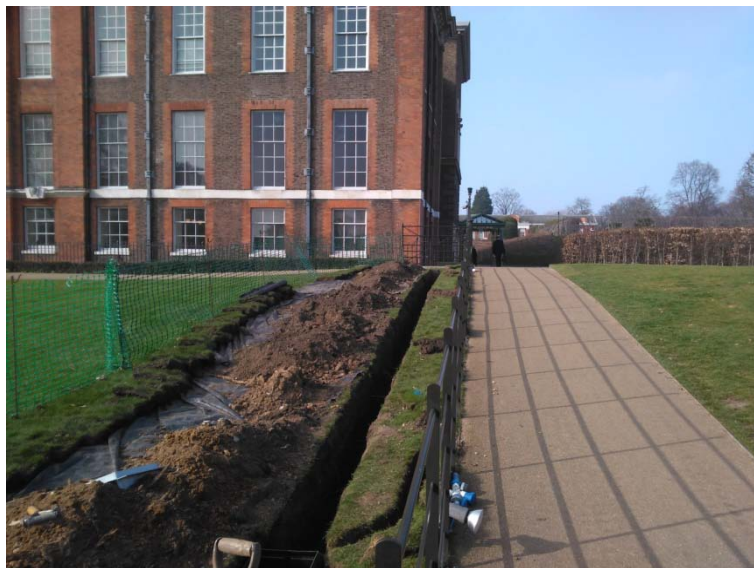
Plate 3: Northern length of cable trench –view north

- 5.9 For the main length of the cable trench the area was de-turfed and then excavated using a combination of hand tools and a 1.5 tonne machine using a 9-inch ditching bucket. The trench was dug in spits to allow the archaeologist to ensure no archaeological remains were disturbed without being recorded. This part of the trench was 55m long and ran parallel to Meadow Walk north-south along the South Lawn; the trench was 0.4m wide and 0.6m deep apart from in those places where archaeological remains were observed. As can be seen from Plate 3 the trench was located directly to the south-east of the current building.

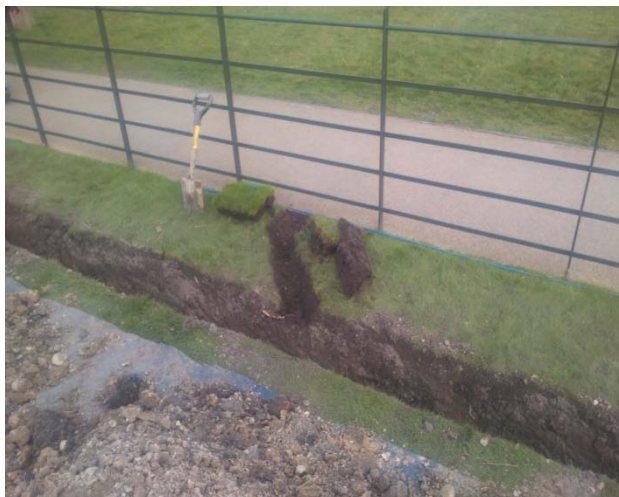
Plate 5: Side spurs –view east

- 5.11 In addition to the main trench, small spurs approximately 0.15m x 1m in size were dug towards the fence line to a depth of around 0.3m. They were excavated by hand to encompass smaller ducts that the lights were to be sat upon. There were a total of nineteen of these.

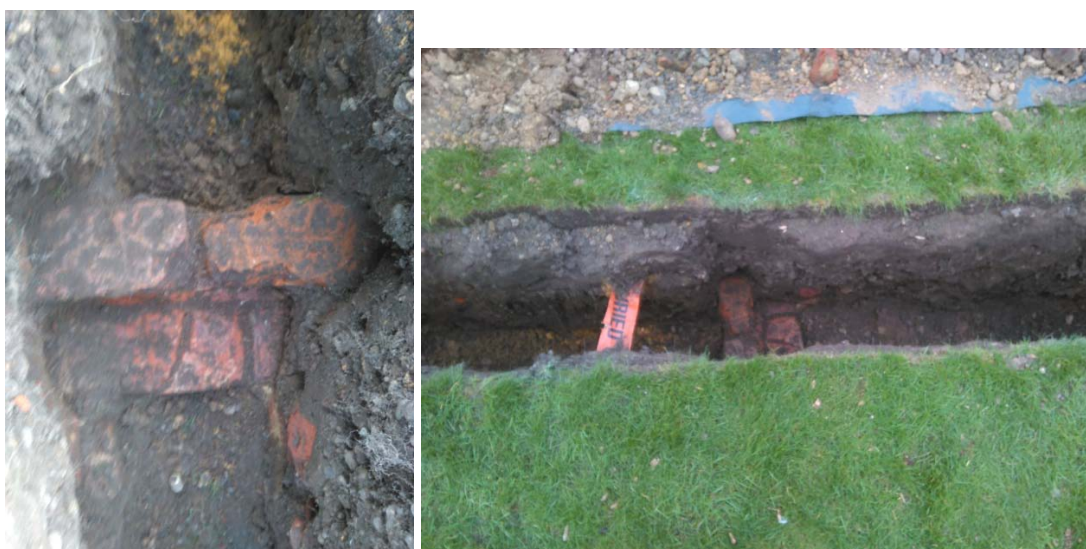
- 6.3.1 Within the study area four 18th century brick features were observed. From south to north within the trench, the first [6] was a well preserved wall, at least two courses high by two courses wide. It was orientated east-west and spanned the whole width of the trench as shown in Plates 6 and 7. The wall was at least 0.4m long by 0.2m wide and 0.18m high. It was built using red unfrogged brick, fabric 3032/3033, dating from the 18th century (B.Seddon pers.comm.). It was trench-built within construction cut [15], and the top of the wall was recorded at 21.52m OD.

Plates 6 and 7: South and west views of wall [6]

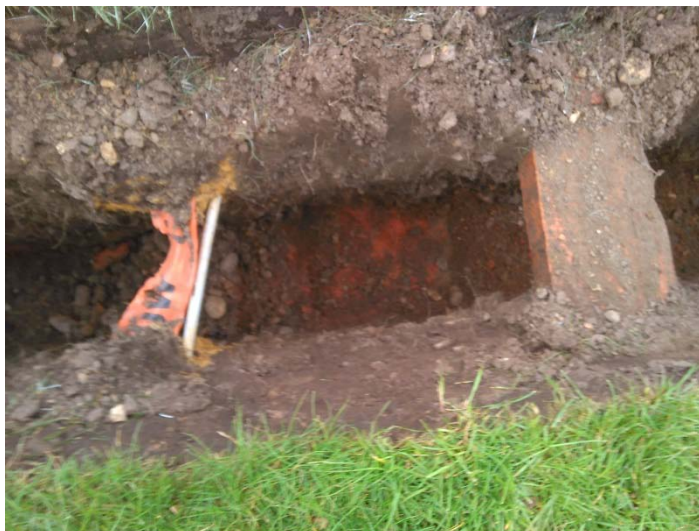
- 6.3.2 The second of these brick features [7] was probably a wall also running east-west; however as can be seen in Plate 8, it was very degraded and was obscured by modern security cables, the excavation for which may have impacted upon the wall. It was constructed of red unfrogged brick, and measured at least 0.4m long by 0.2m wide. It was recorded at approximately 21.42m OD.

Plate 8: Truncated wall [7] and location of modern security cables

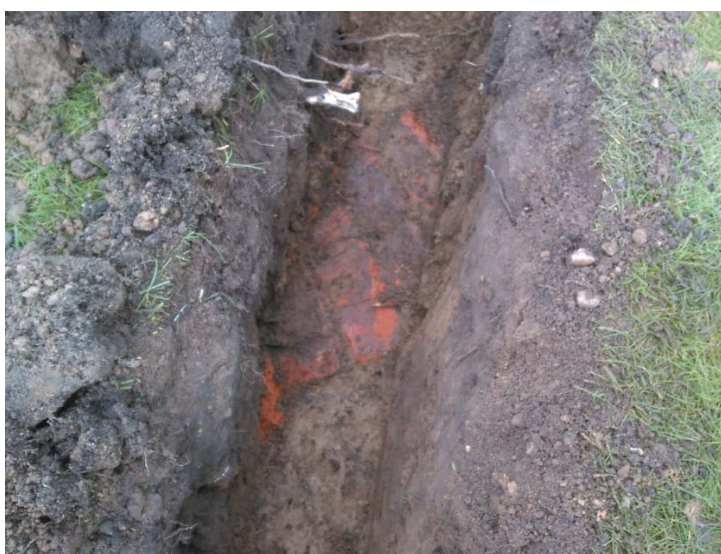
- 6.3.3 The third brick feature [9] was aligned NE-SW and had dimensions of 0.4m E-W and 0.6m N-S with an unknown thickness, shown in Plate 9. A brick sample from this feature is described as red unfrogged brick, fabric 3032/3033, with the shape of the edges indicating an 18th century date (B.Seddon pers. comm.). The top of the feature, which may be a garden wall, was recorded at approximately 20.55m OD. It was trench built within construction cut [17].

Plate 9: View north of brick feature [9]

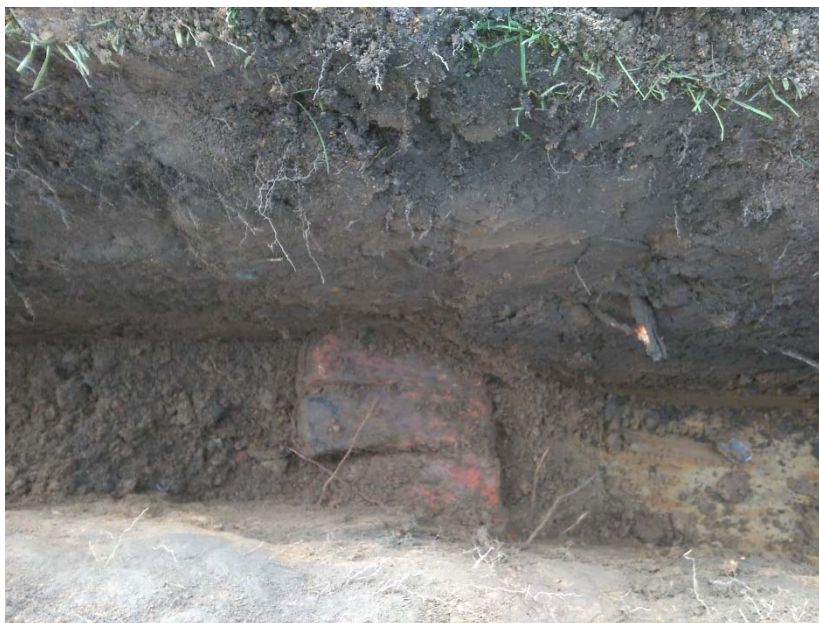
- 6.3.4 The fourth brick feature [12] was an E-W aligned wall, built in header courses and one brick thick (0.2m). It spanned the trench (>0.4m) and was at least 0.1m high from an upper height of approximately 22.05m OD. It was built with unfrogged 18th century red brick (Plate 10) within construction cut [18].

Plate 10 West view of wall [12]
