**ST. PAUL'S CHURCHYARD,  
CITY OF LONDON, EC2**

**AN ARCHAEOLOGICAL WATCHING  
BRIEF DURING GAS MAIN  
REPLACEMENT WORKS**

**PCA REPORT NO: 12044**

**SITE CODE: PLD15**

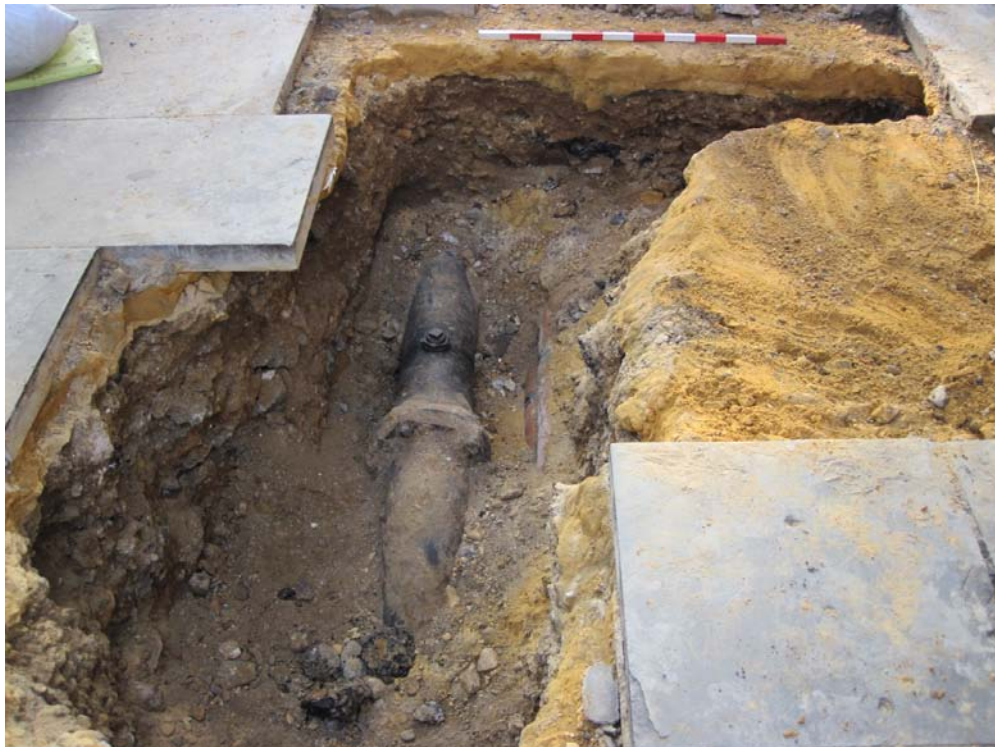
*Plate 1: Trench 1 facing west, scale 1m*

- 7.1.1 The largest intervention undertaken consisted of the excavation of Trench 1 which measured a maximum of 2.27m north-south by east-west, and was excavated to a maximum depth of 1.40m (Figure 3, Plates 1-2). This trench was located in St Paul's Churchyard, next to the south-east corner of Paternoster House. The trench was irregular in shape and excavated to varying depths across its extent due to initial problems locating the gas main and decisions involving the precise length of gas pipe that required exposure for replacement works.

- 7.1.2 A layer of modern paving slabs (approximately 0.07m thick) was found to lie above a thick layer of modern sand (approximately 0.12m thick). This sand overlay modern deposits of mixed sand, rubble and stones within which the gas pipe and other modern services were found. These mixed deposits extended down to the excavation depth and thus had a maximum observed thickness of 1.21m. In the very north of the trench, these deposits appeared to be truncated by an even more modern cut, perhaps relating to the construction of Paternoster House to the north.

- 7.1.3 No archaeological or natural deposits were observed within the trench. All deposits were modern and related to the laying of the existing gas main and other modern services (of which there were many) and, to a lesser extent, possibly also the recent construction of Paternoster House.

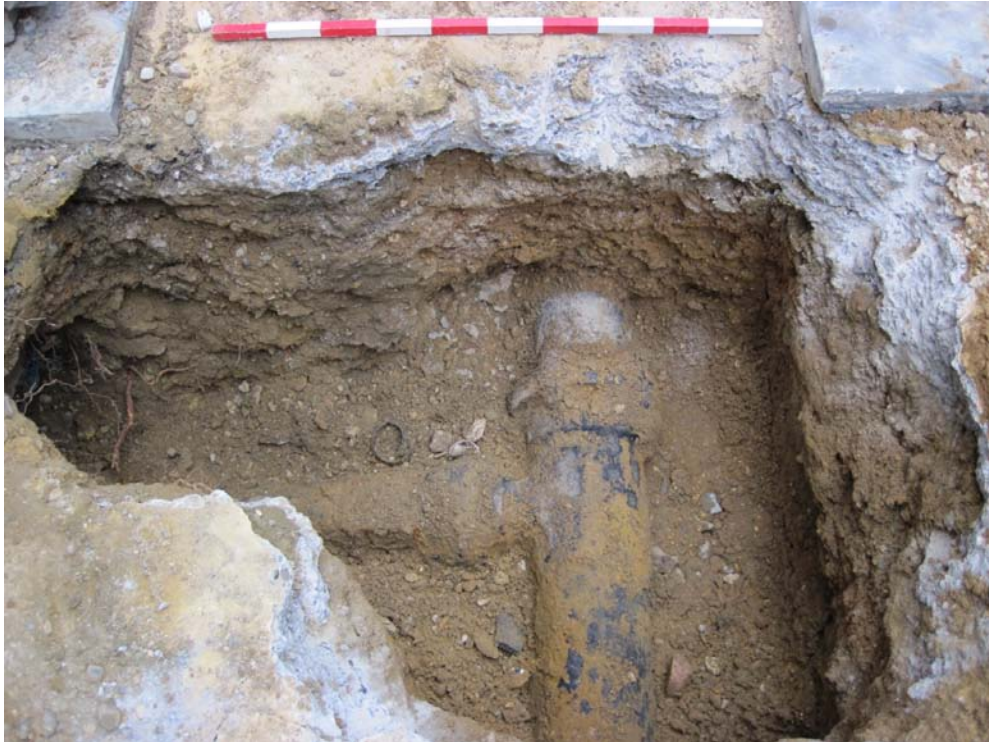
*Plate 3: Trench 2A facing east, scale 1m*

- 7.2.1 Trench 2A measured a maximum of 1.52m north-south by 0.92m east-west and was excavated to a maximum depth of 0.97m. It was located in St Paul's Churchyard next to the south-east corner of the building immediately west of Paternoster House (Plate 3).

- 7.2.2 Modern paving slabs were again discovered to overlay a deposit of sand, below which was a layer of concrete which became thicker to the south, where it reached a maximum thickness of 0.22m. Below this concrete were mixed deposits of sand, stone and rubble in which the gas pipe was found. These deposits varied somewhat across the extent of the trench but all were definitely modern and relating to the laying of the gas pipe. These deposits extended down to the excavation depth.

- 7.2.3 No archaeological or natural deposits were observed within the trench. All deposits were modern and related to the laying of the existing gas main.

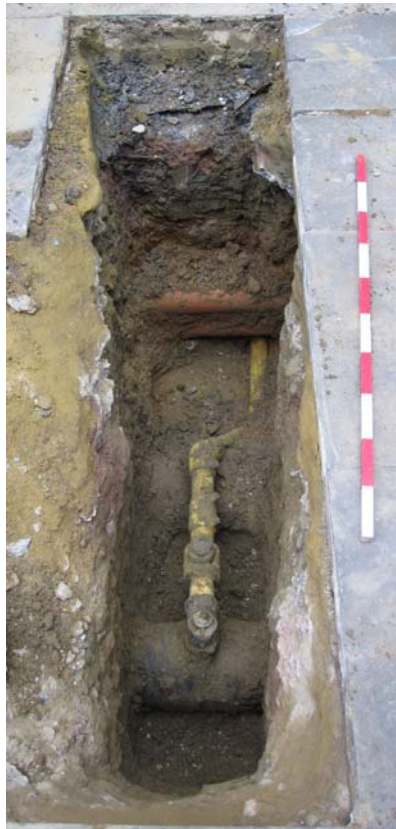
*Plate 4: Trench 2B facing north, scale 1m*

- 7.3.1 Trench 2B measured a maximum of 2.14m north-south by 0.59m east-west and was excavated to a maximum depth of 0.97m. It was located in St Paul's Churchyard just to the east of Trench 2A. The excavation of this trench was not originally planned, however it became necessary when the branch of the gas main found in Trench 2A was found to have been capped off and exposure of a further, live, branch of this main was thus required (Plate 4).

- 7.3.2 The general sequence revealed in Trench 2B was the same as that observed in Trench 2A; paving slabs overlying sand, overlying concrete, which sat above modern sand rubble and stone deposits containing the gas main and other services. The end of a concrete wall was also revealed in the north of this trench truncating all deposits below the sand layer; it may relate to the construction of the underground garage in this area. Modern deposits extended down to the excavation depth.

- 7.3.3 No archaeological or natural deposits were observed within the trench. All deposits were modern and related to the laying of the existing gas main and other services, and possibly also to the construction of the 1970s underground garage in the area.

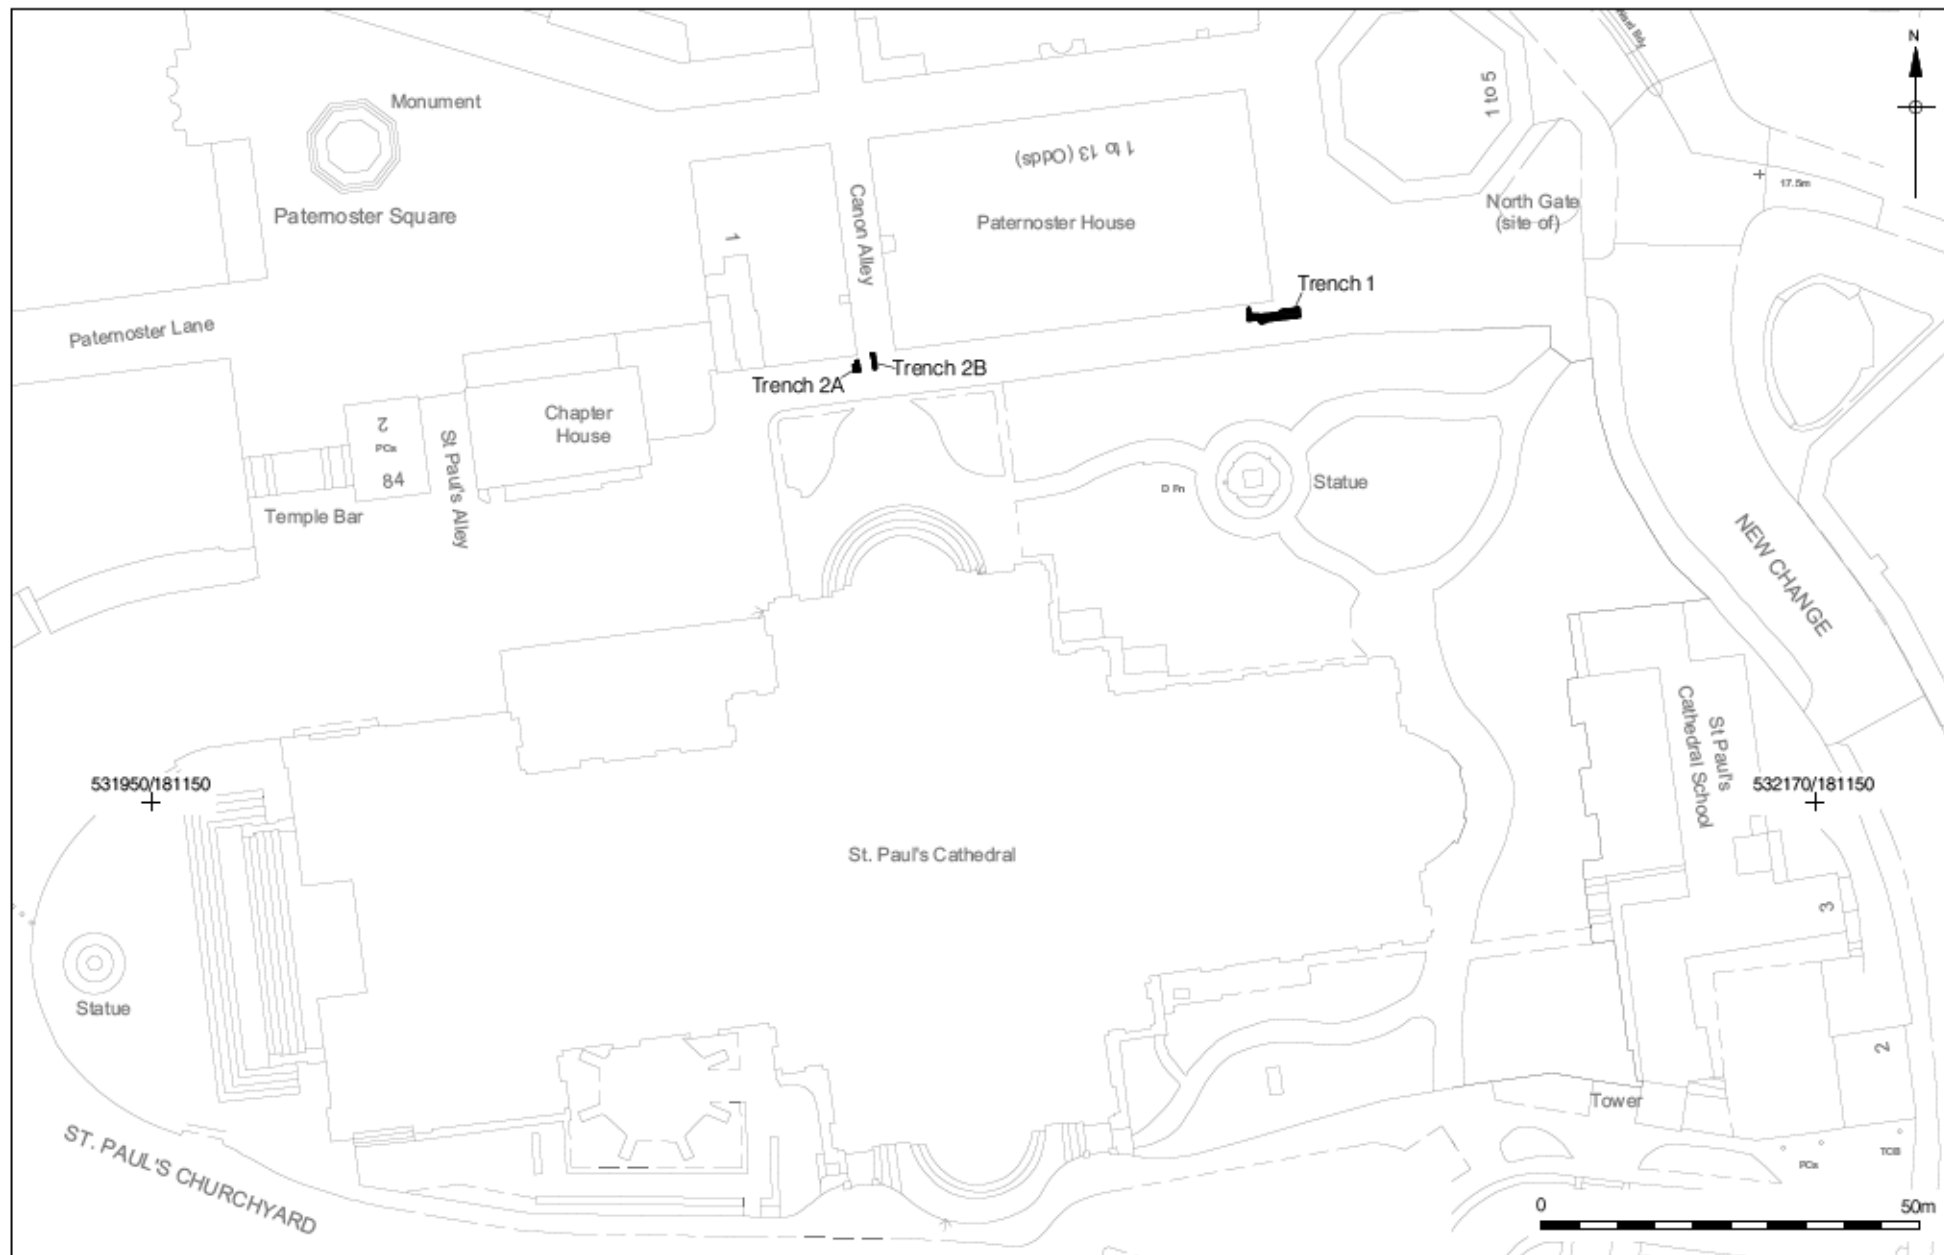
Figure 2  
 Detailed Site Location  
 1:1,000 at A4

- 2.3 Three trenches were excavated; Trench 1 was located in the east of St Paul's Churchyard next to the south-east corner of Paternoster House, and Trenches 2A and 2B were located at the south-east corner of the next building to the west, across Canon Alley (Figure 2). The purpose of monitoring the excavations was to establish whether any archaeological remains – including potential burials - survived below and around recent disturbance from the modern gas main.
