HISTORIC BUILDING
RECORDING OF
NO. 13 WATTS GROVE,
LONDON BOROUGH OF
TOWER HAMLETS,
E3 3RH

PCA REPORT NO. R12094

HISTORIC BUILDING RECORDING

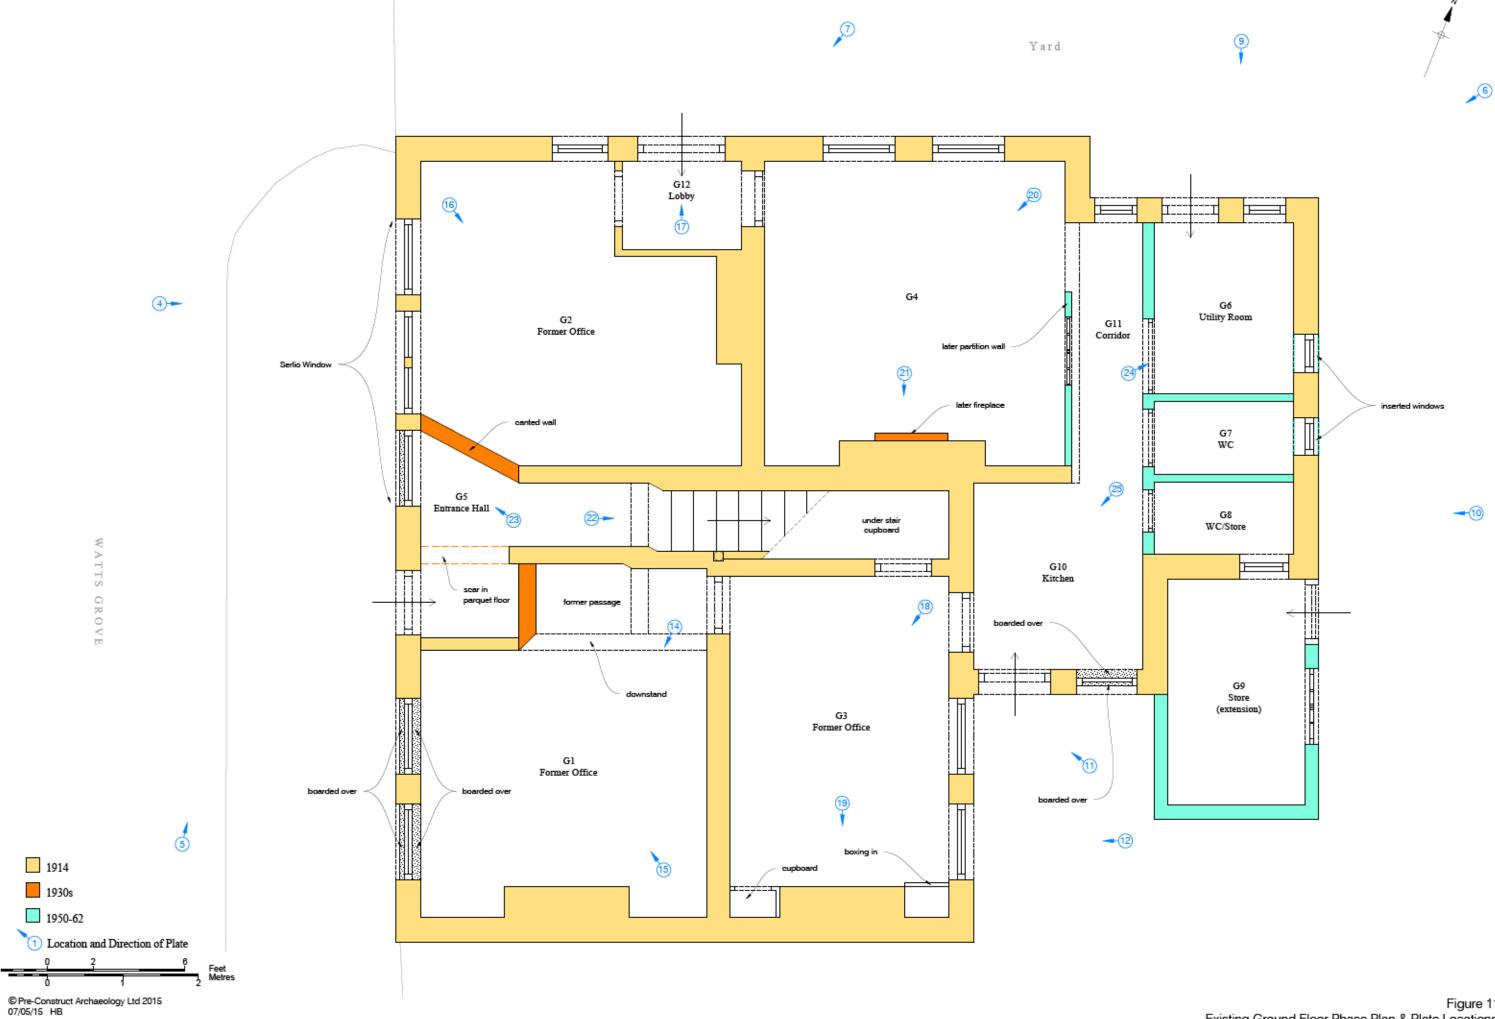
Figure 11 Existing Ground Floor Phase Plan & Plate Locations 1:50 at A3

- 6.2.28 Rooms G6 to G8 were a series of three utility rooms within the flat roofed rear (east) section of the building (Figure 11). All had wall plastered walls (internal partition walls were half brick thick) with no decorative treatment and hard wearing diamond pattern quarry tiled floors. Room G6 included three openings, an original door and window opening to the north wall, the latter with an ornate architrave, and a much plainer inserted metal framed window to the east (Plate 24). The adjacent room G7 was used as a toilet, again lit by an inserted metal framed window, while room G8, probably a store or a former toilet, was lit by a small original casement in its south wall. The panelled door and architrave to room G8 were also original features.

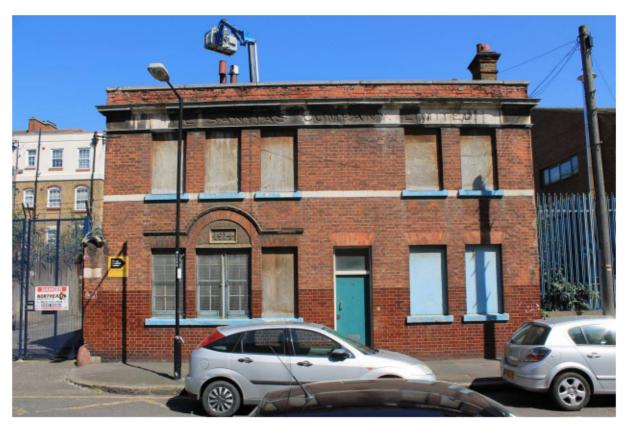
- 6.2.3 The western elevation is laid out over two storeys and a 3:2 window range on both floors (Plates 1 and 2). The elevation is relatively symmetrical, with larger window openings of three lights or paired window openings, set in line in both the vertical and horizontal axis. The only entrance from Watts Grove is positioned off-centre to the facade, probably as a consequence of the larger fenestration lighting the northern part.

Plate 1 Western principal elevation, looking east

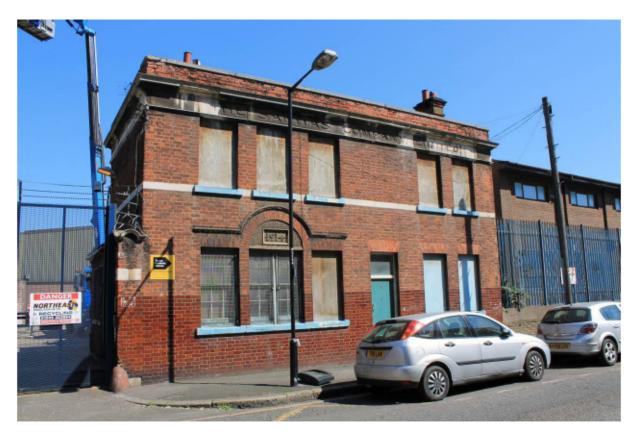
Plate 2 Western principal elevation, looking south-east

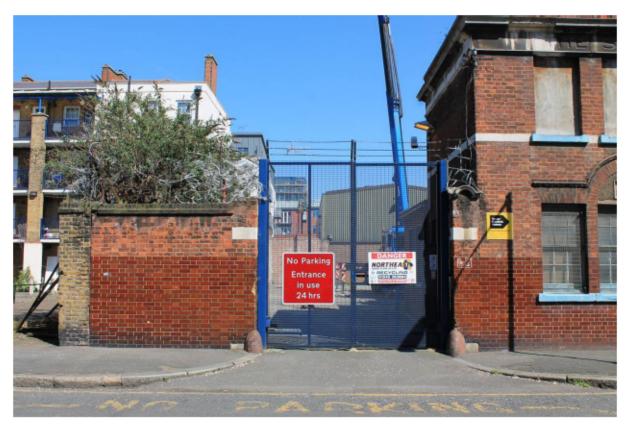
6.2.5 The brickwork of contrasting glazed and red brick is also present within the adjoining gated entry and depot compound wall to the north (**Plate 3**). The latter includes a decorative stone coping to the southern post (northern coping missing) and a stylobate, to protect the north-western angle, at the base of the wall.

Plate 3 Gated entrance and compound wall, looking east

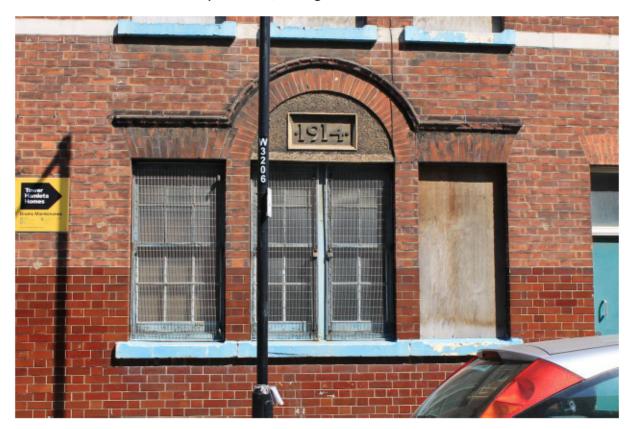
- 5.1.1 The building is primarily dated by the date plaque of 1914 set in relief within the tympanum of the ground floor window to the facade (**Plates 1** to **4**). This date concurs with the cartographic evidence, as the building is first shown on the map extract of 1921 (**Figure 4**) and not on the previous Ordnance Survey map of 1893 (**Figure 3**).

Plate 4 Serlio window and date plaque of '1914', looking east

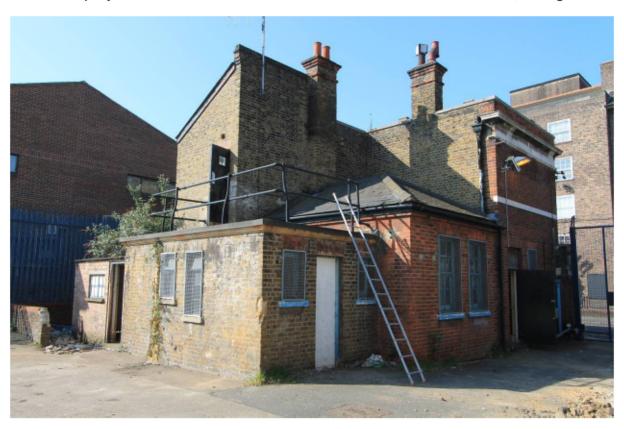
Plate 6 Northern elevations, looking south-west

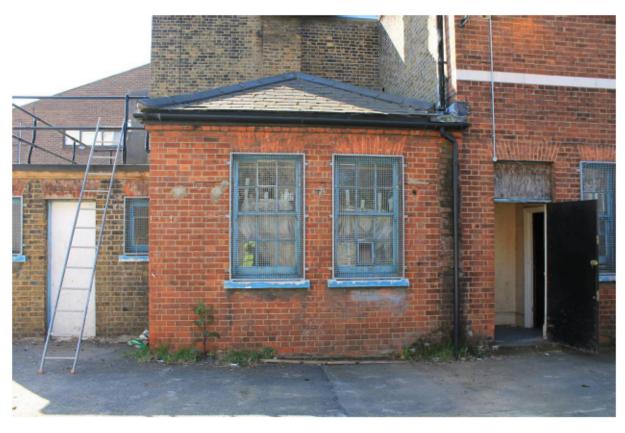
Plate 8 Contemporary hipped roof rear range looking south

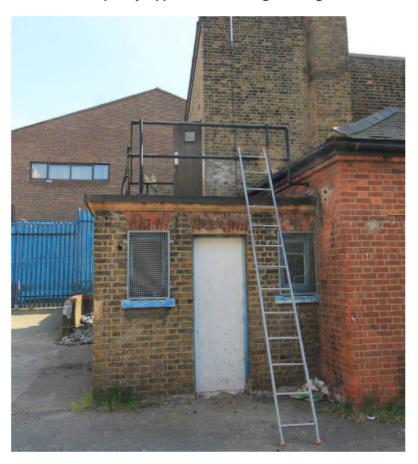
- 6.2.7 A flat roofed, single storey, yellow stock brick range adjoins the hipped roof part along its eastern wall (Plate 9) and was built at the same time as the front two storey building. This more utilitarian building includes a pair of window openings flanking a central door opening, all using flat gauged red brick heads, along its northern elevation. The yellow stock brick of the walls corresponds in size (225mm x 65mm x 105mm) to the red brick used elsewhere and is built using the same hard cement mortar in Flemish bond. A moulded (cyma-recta) edge or cornice to the concrete roof slab projects out over the wall line and above the voussoirs of the three openings. The latter all have later replacement joinery.

Plate 9 Flat roofed rear projection, looking south

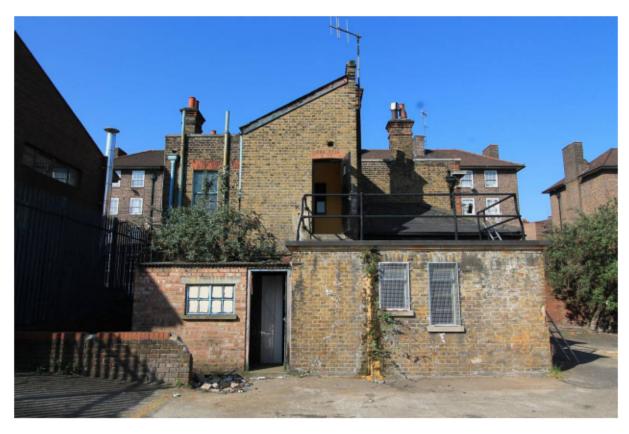
- 6.2.8 The eastern rear elevations comprised a composite of single and two storey ranges with a mixture of flat, hipped and pent roofs (Plate 10). The rear elevations of the two-storey front range were built using lower quality yellow stock brick, but included contrasting red brick gauged heads for the window and door openings. Red brick was also used as a decorative feature in banding and over-sailing courses to the chimney stacks. The chimneys projected as in-wall stacks through the parapets of the south and east walls. The use of yellow brick extended to the rear (easternmost) flat roof range, the roof of which was latterly re-used as a garden or sun terrace (with safety balustrade) to the first floor accommodation. The openings within this flat roofed unit were, unlike those of the main building, later insertions, created using simple rough brick heads in matching yellow stock brick. The fenestration comprised simple metal framed windows with reinforced obscure glazing (Georgian wire twist) and top hung ventilators.

Plate 10 Eastern rear elevations, looking west

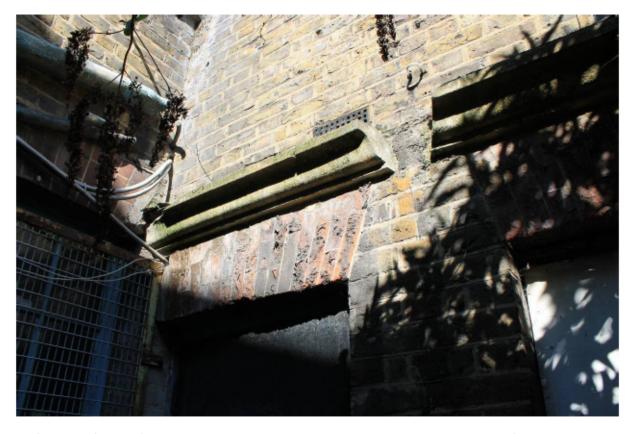
Plate 11 South elevation of rooms G10 and F7 showing moulding of original single storey building, looking north-west

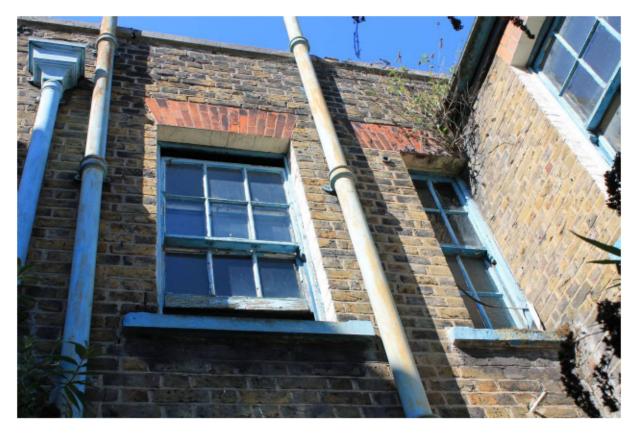
Plate 12 Partly blocked first floor window overbuilt by kitchen K7, looking north-east

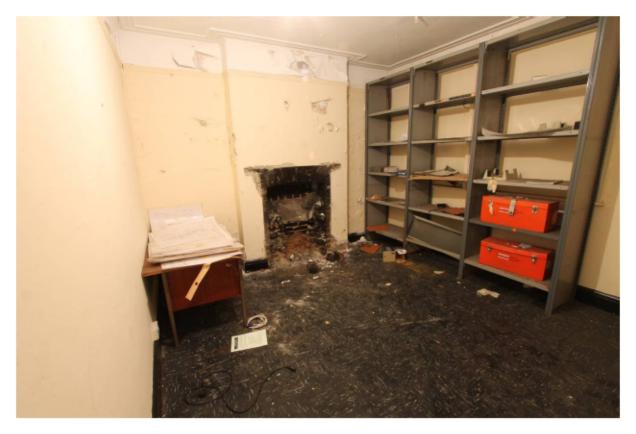
- 6.2.15 A chimney breast lies central to and projects out from the southern wall (Plate 14). A paint scar shows that until recently, a cast-iron fireplace, probably identical to the example still extant in room G3 (Plates 18 and 19), was also present. Analysis of the opening to the fireplace suggests that this fireplace may have been a later introduction as the large opening had been rebuilt in brick to improve draught and to receive the cast-iron surround.

Plate 14 Office G1, looking south west

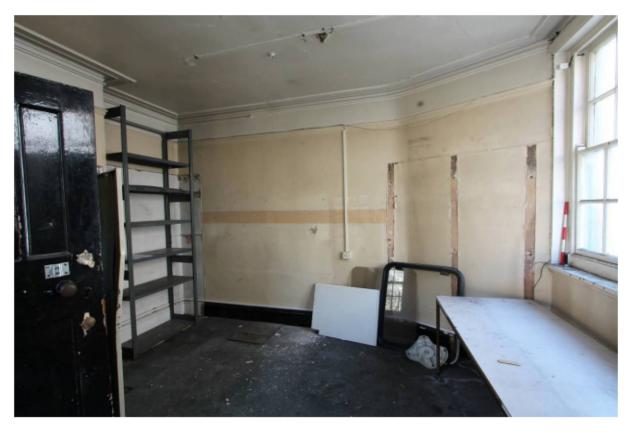
6.2.17 Room G2, latterly used by the Local Authority Drainage Department as a locker/mess room, occupied the opposite space to room G1 but to the north of entrance hall G5. Whilst it is broadly of similar dimension, alterations to the access from Watts Grove, entailed the addition of a section of north-west canted wall along its southern side (**Figure 11**). This canted wall abuts the western flank wall and the southernmost mullion of the large Serlio window, central to the west wall. This wall cuts off room G2 from entrance hall G5 and provides light, via the southernmost light of the Serlio window into entrance hall G5.

Plate 16 Office G2, looking south-east

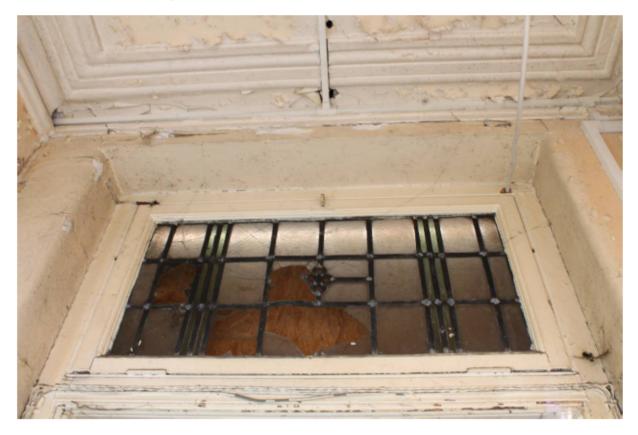
6.2.20 A small lobby G12 adjacent to the side entrance was built at the same time as the rest of the building, as evidenced by the use of the same style of skirting boards, similar moulded decoration to the ceiling and typical door architraves. This area also included short lengths of moulded dado rail to the walls and an ornate Arts and Craft style stained glass panel to the door light (Plate 17).

Plate 17 Glass door light to small lobby G12, looking north

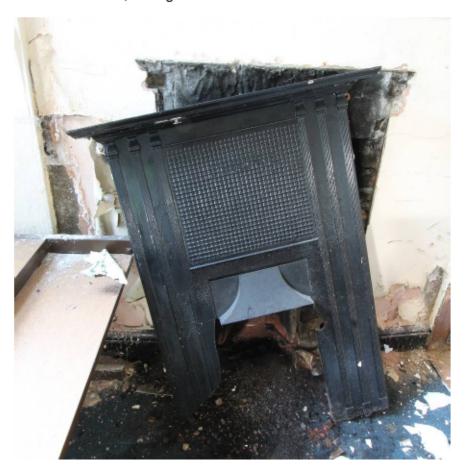
Plate 19 Detail of fire surround in office G3

- 6.2.22 The chimney breast and fireplace, as in room G1 were set against the southern flank wall (Plate 18). The recesses to each side of the chimney breast were either boxed in (east) or re-used for a tall built-in cupboard (west). The latter used plain panelled softwood doors and was internally shelved. The cast-iron surround to the fireplace in part survived (although detached from the wall). It was adorned with a simple relatively plain design of vertical fluted bands and a plain basket-weave panel (Plate 19).

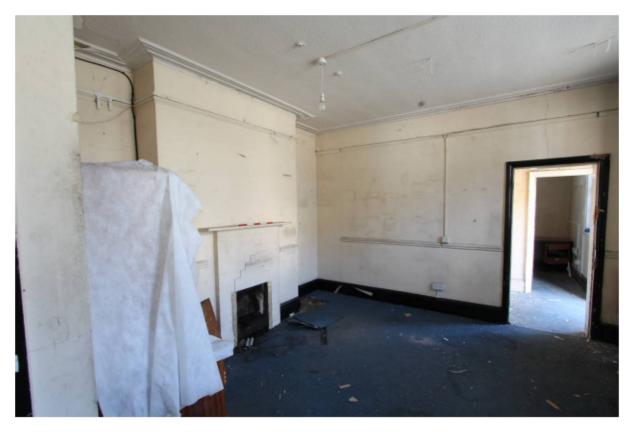
6.2.23 Room G4 lay outside the two storey range and within the single storey hipped roof unit to the east. It could be accessed directly via small lobby G12 (Plate 20) or indirectly from the rear utility range. The room decor was typical of that already described with a standard plaster cornice, skirting, picture rail and a dado rail. Sections of the picture rail and dado were missing, although neither survived along the eastern wall (to room G11). This is because the bulk of this wall had been removed and replaced with a much lighter half brick thick partition wall with a metal-framed fixed glazed window, providing borrowed light to room G11. This lighter wall is characteristically similar to those internal partition walls to rooms G6 to G8 suggesting that this more functional less ornate, insertion marks a change to a more utilitarian function for this area.

Plate 20 Office G4, looking south-west

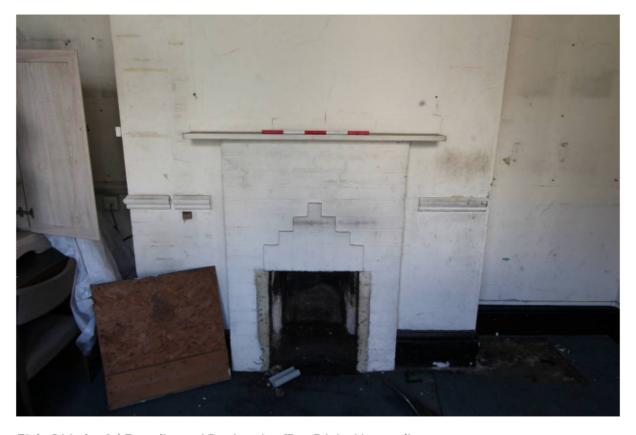
Plate 21 Later Art Deco themed fireplace in office G4, looking south

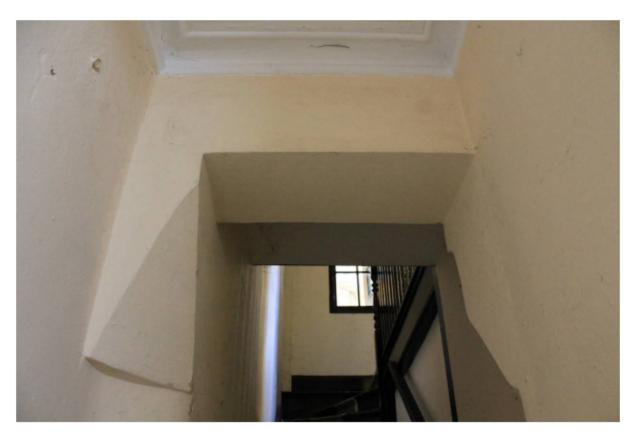
Plate 22 Constrained stopped and chamfered opening to stair G5, looking east

- 6.2.26 Lit by the southernmost light of the Serlio, which comprised a typical 6 over 6 sash window, hall G5 was an awkward space that was rather constrained toward the foot of the stairs, where the lobby walls 'chamfered' southward to meet the staircase. Decorative plaster stops adorned this narrow opening to the staircase (Plate 22). The latter was a straight, closed riser stair with a quarter-winder to the landing. Built in softwood with prominent nosings to the treads, the stair also incorporated two storey height newel posts, one towards the base and one at the fulcrum of the quarter winder.

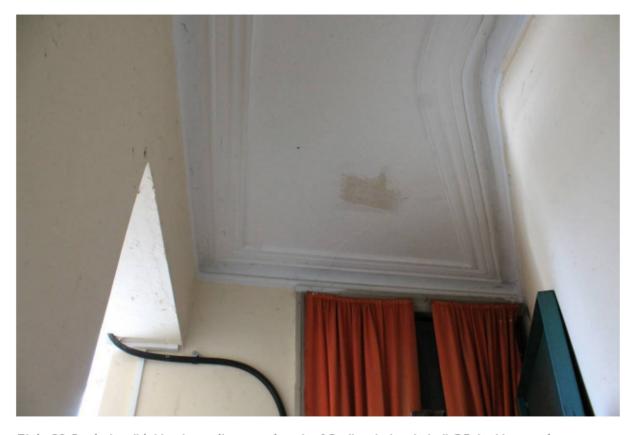
- 6.2.27 The ceilings to hall G5 employed the typical cornice treatment, although this appeared to have been reworked along the line of the canted wall (Plate 23). This was also the case with the 7 inch skirting boards, which were not totally consistent. The floor to the entrance hall comprised hard wearing oak parquet (as in room G3), interrupted along the line of a removed wall central to hall G5. The original door to the main entrance had latterly been replaced with a security door and the door light above, with plain clear security glass.

Plate 23 Canted wall taking in southernmost sash of Serlio window in hall G5, looking west

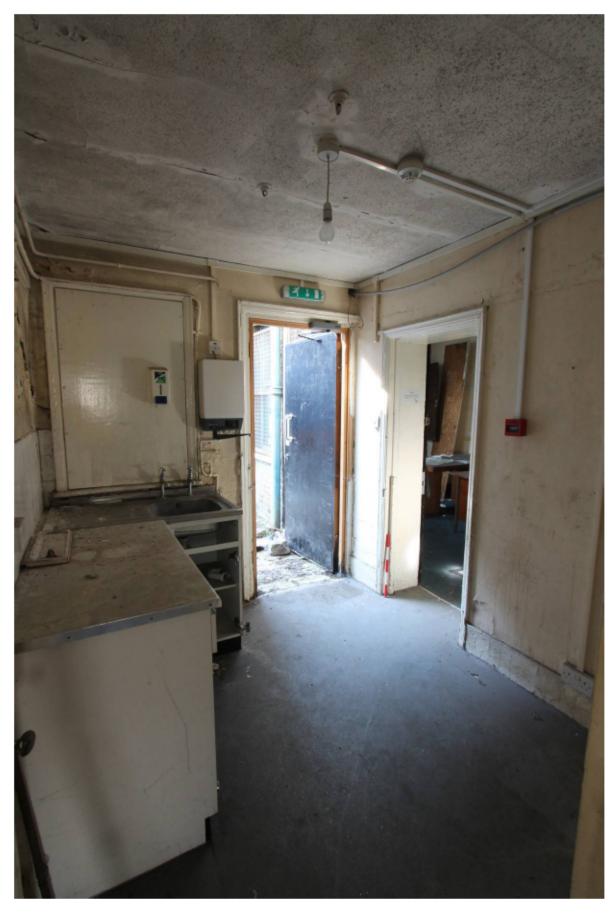
Plate 25 Kitchen G10, looking south

- 6.2.29 The decorative treatment to the present kitchen area G10 was also very plain, with unadorned walls and simple plank-like skirting boards. The ceiling was rough cast 'artex' and the floor covered in modern linoleum. Whilst the sash window to the south wall had latterly been blocked the window architrave and door architraves to the yard and door to room G3 were all original (Plate 25). A modern 'flat pack' kitchen unit with sink was present along the eastern and southern walls.

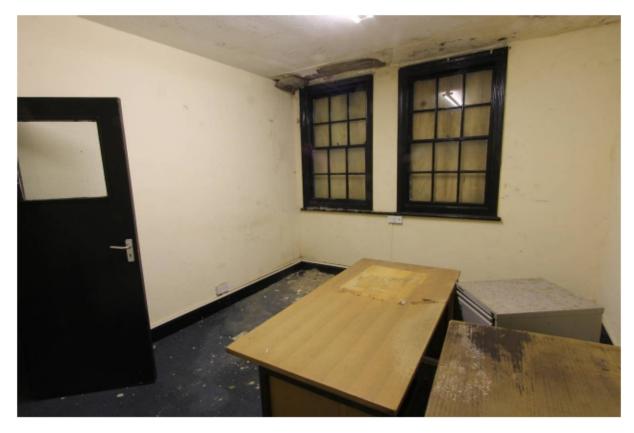
- 6.2.31 Room F1 was located within the northern part of the building and accessed directly from the landing F6. It is lit by a pair of 6 over 6 horned sash windows of typical design in the western front wall (**Plate 26**) and was heated by a fireplace in the opposite eastern wall. Whilst the breast remains the fireplace had been removed and blocked, replaced latterly with an electric storage heater. The ceiling was lath and plaster and exhibited no evidence of a cornice or ceiling decoration. The walls were also plain but did include a typical moulded 7 inch skirting board to the floor junction. The floors comprised softwood boards nailed to softwood deep section floor joists of 8 x 2½ inch scantling. The architraves to both the door opening and the two windows were original, the latter also incorporating a continuous sill below both windows. Examination of the internal walls between rooms F1, F2 and F3 showed that they were all lightweight stud walling.

Plate 26 Room F1, looking south-west

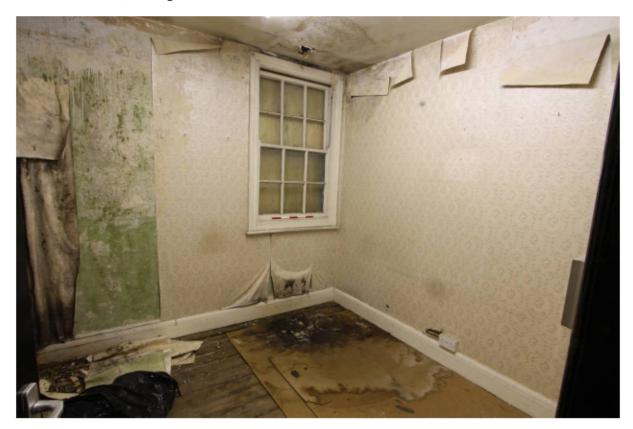
6.2.33 Room F2 was the central one of the three western rooms. It was a small unheated room lit by a single 6 over 6 sash window set off centre and against the internal partition wall to room F1 (Plate 27). In common with room F1, the window and door architraves remained as did the standard 7 inch skirting. The door to room F2 was a modern fire door. No evidence of ceiling or wall decoration was observed.

Plate 27 Room F2, looking west

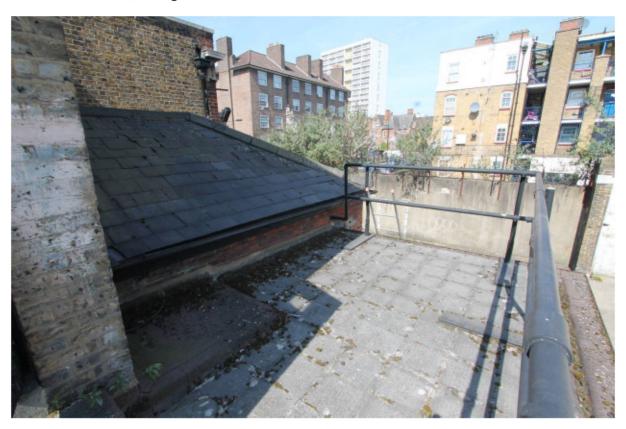
6.2.38 Kitchen F7 was a later addition built off the roof slab and walls of the original single storey rear part of the building (room G10). The door from landing F6 into kitchen F7 was also a later insertion, broken through the rear (east) wall to integrate the kitchen into first floor accommodation (Plate 31). This included a modern door flanked to the north by a smaller fixed glazed window. The window to the south wall was a 6 over 6 sash of the same design seen elsewhere (Plate 33). This raises the possibility that either the standard window was sourced from the same manufacturer or that the the window was reused from perhaps the original east wall of landing G6 before teh kitchen was added. Otherwise the kitchen, which included modern kitchen base units along its south wall, was unadorned. A door opening in the east wall led out via a short flight of steps onto the flat roof of the rear (north-east) projection, used as a terrace garden or sun terrace to the flat (Plate 34).

Plate 34 Garden terrace looking north, showing hipped roof over room G4
