Archaeological Monitoring at
Castle Farm, Church Lane,
Castle Camps, Cambridgeshire,
CB21 4TH

ARCHAEOLOGICAL MONITORING

Pre-Construct Archaeology Ltd	
Project Number	K3937
Report Number	R12095

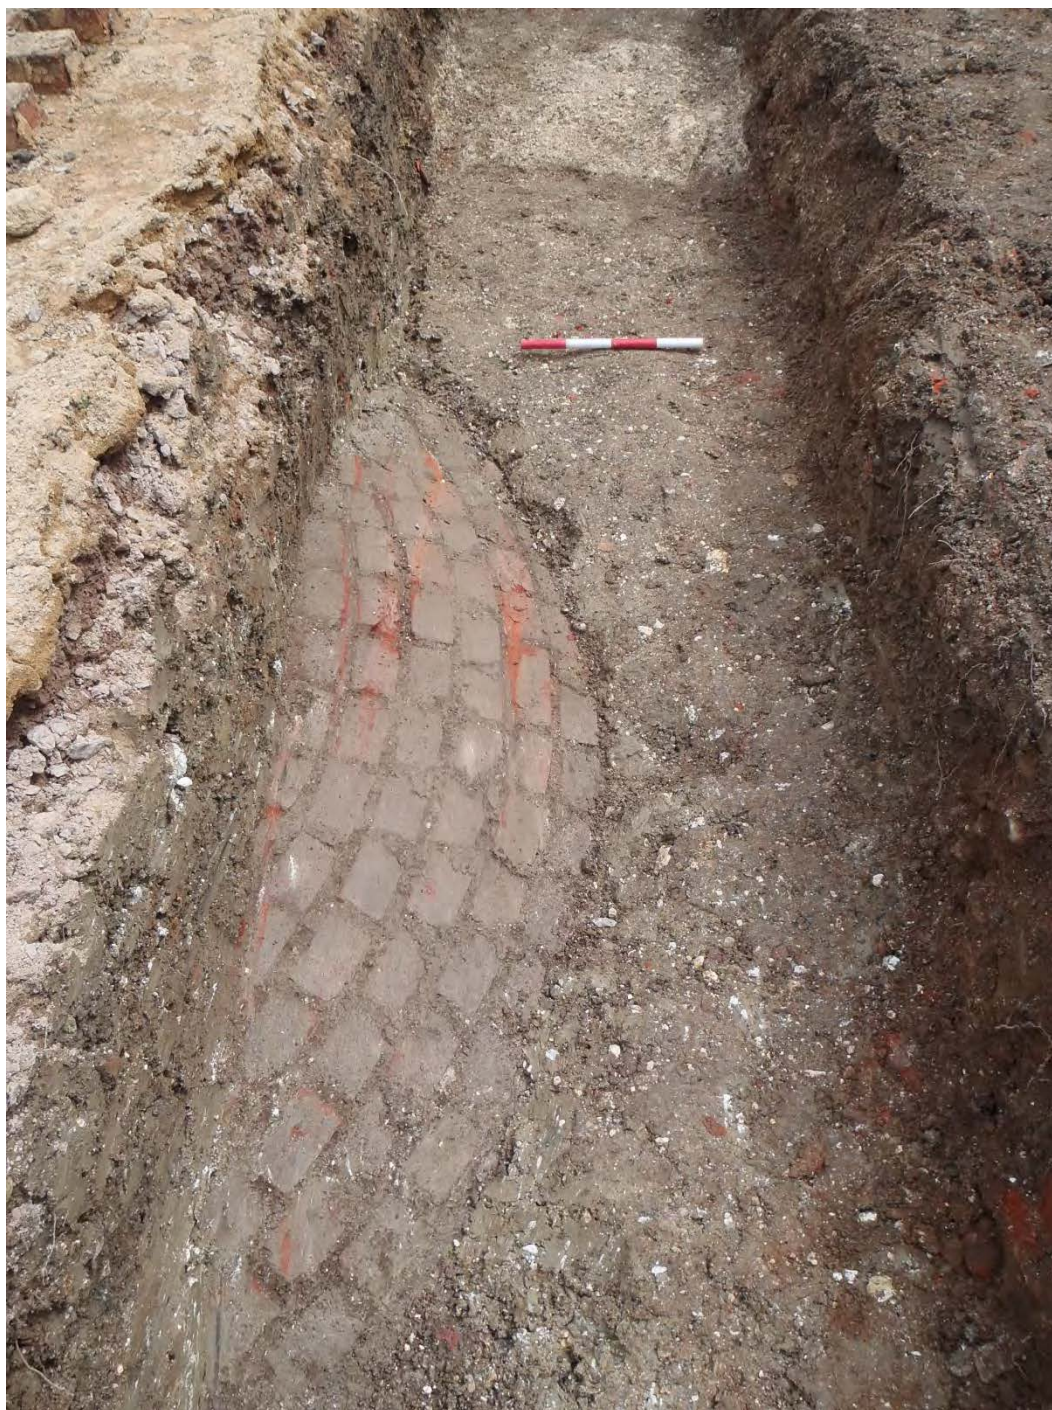
Plate 3: Structure 104 and wall 103, view south-east

5.1.1 The principal result of the fieldwork was the discovery of a demolished chalk rubble and mortar wall line [103] and a domed brick built structure [104], possibly an 18th or 19th century cellar or ice-house. Underlying these were layers of made ground/demolition (105), (107) and (109). Overlying the structures were layers of 18th-19th century made ground (102) and (108).

- 7.1.1 The archaeological monitoring identified features and deposits relating to post-medieval activity on the site. The made ground layers are thought to represent activity associated with the demolition of the Castle after it collapsed around 1738 and the construction of the current Castle Farm house in the mid-18th century. The chalk rubble wall foundation may relate to an earlier phase of building on the site between the 15th and 18th centuries while the domed brick structure is possibly an ice-house or cellar relating to 18-19th century activity associated with the current house.

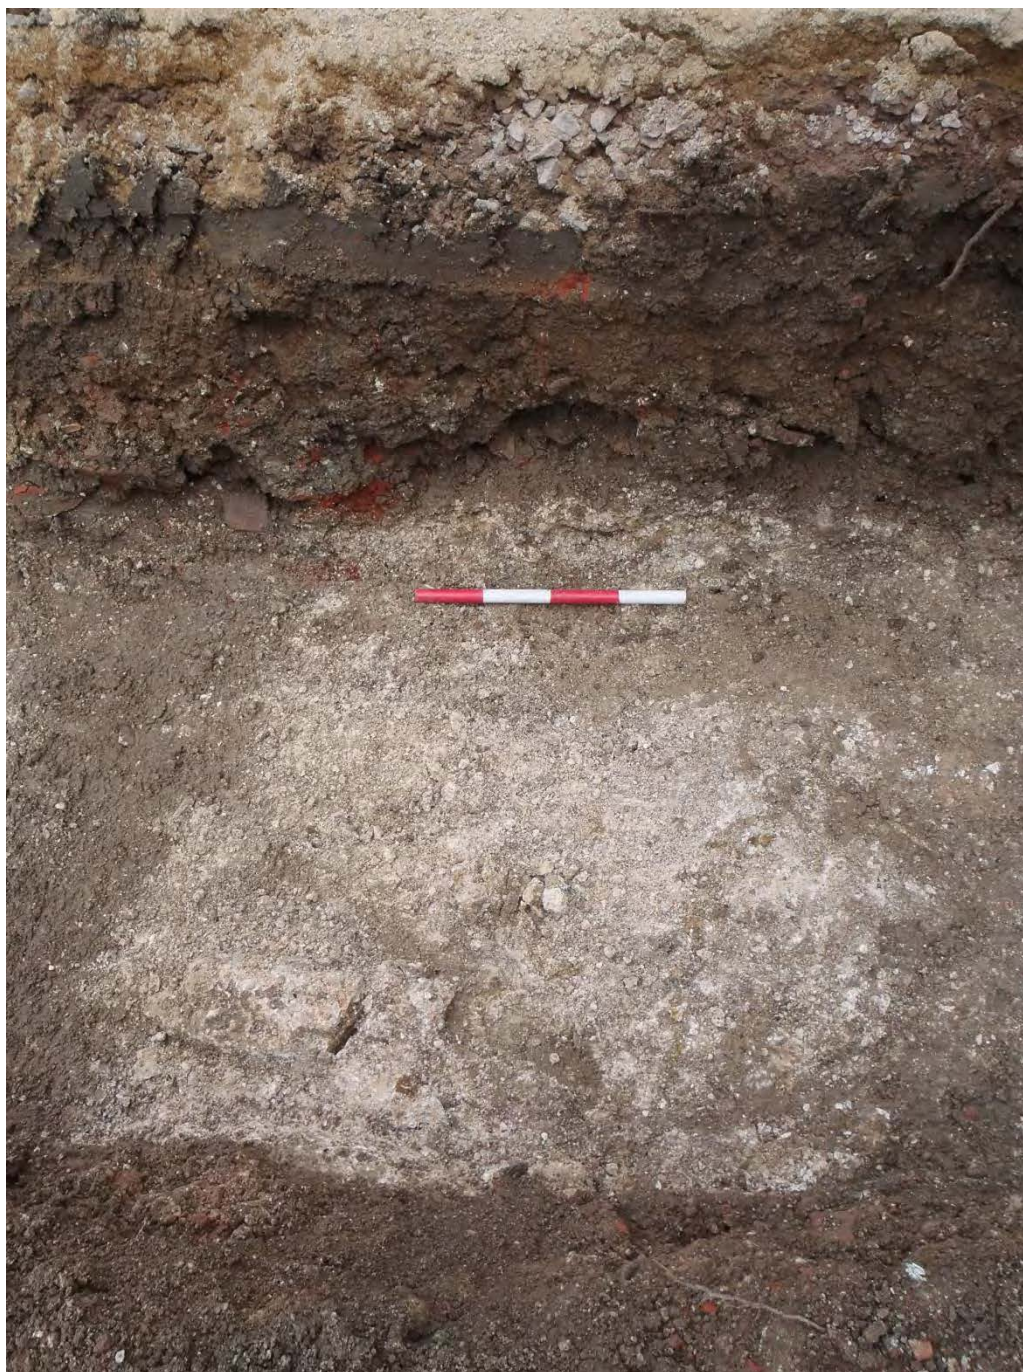
Plate 4: Wall 103, view north-east

5.2.4 Structure 103 (Figures 2-3, Section 100) was located in the north-eastern foundation footing, almost parallel to the current Castle Farm. It was 0.85m+ long, 0.9m wide and 0.13m+ deep. It consisted of light whitish yellow chalk rubble and mortar. No finds were seen.

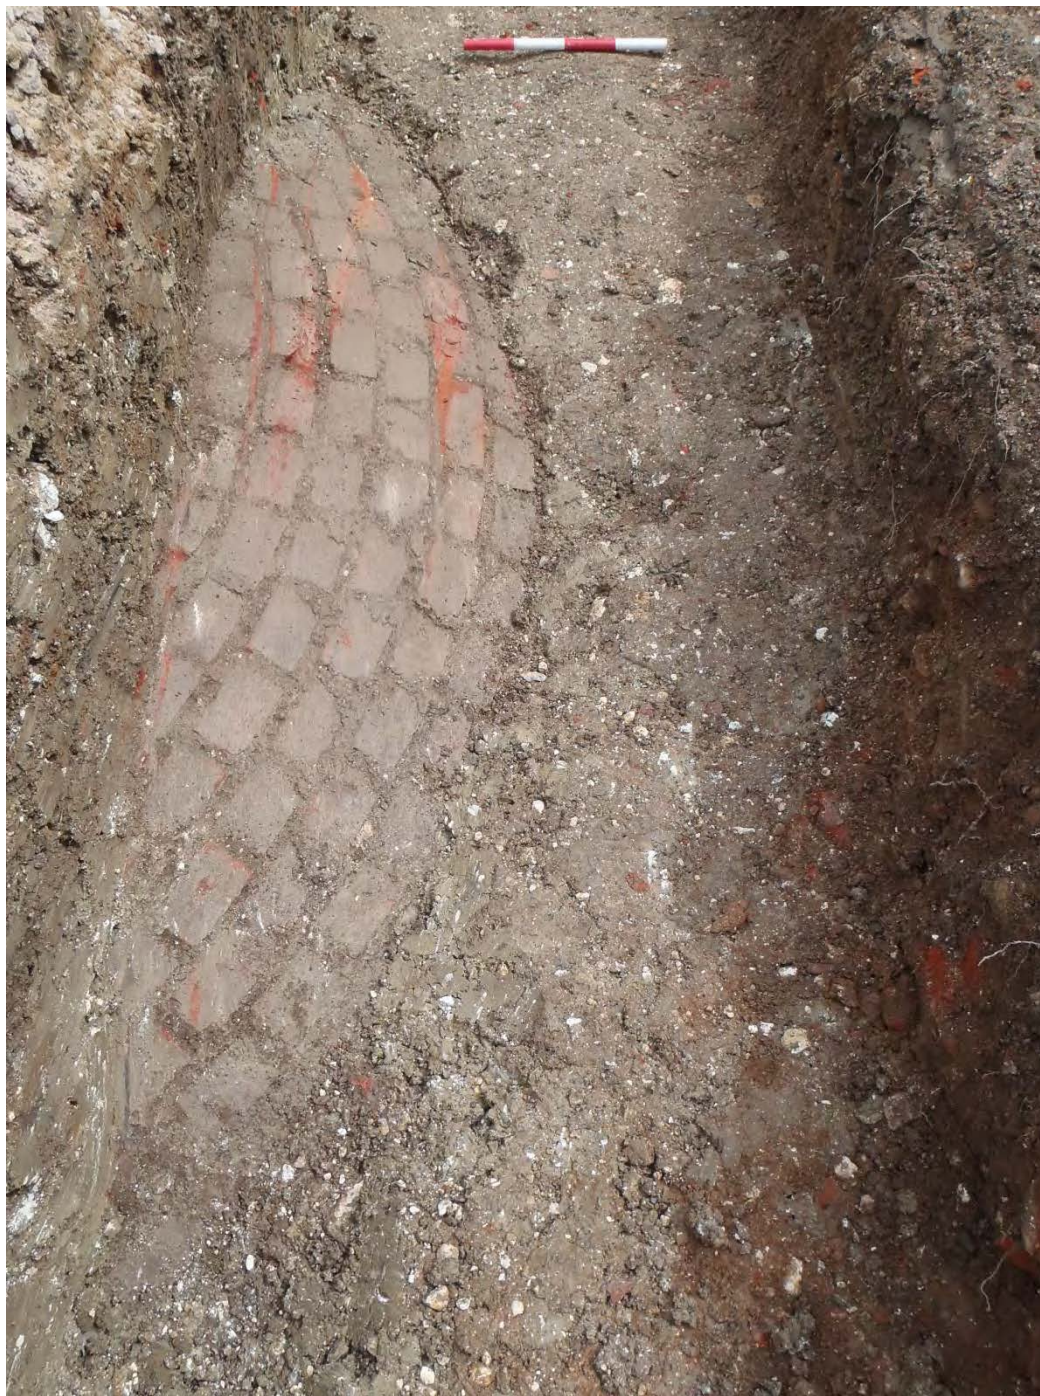
Plate 5: Structure 104, view south-east

5.2.5 Structure 104 (Figure 2) was located in the north-eastern foundation footing. It was 2.05m+ long, 0.45m+ wide and 0.2m+ deep. It was a brick built domed structure, circular in plan. Six courses of bricks were seen. The feature was not excavated and was left in situ.

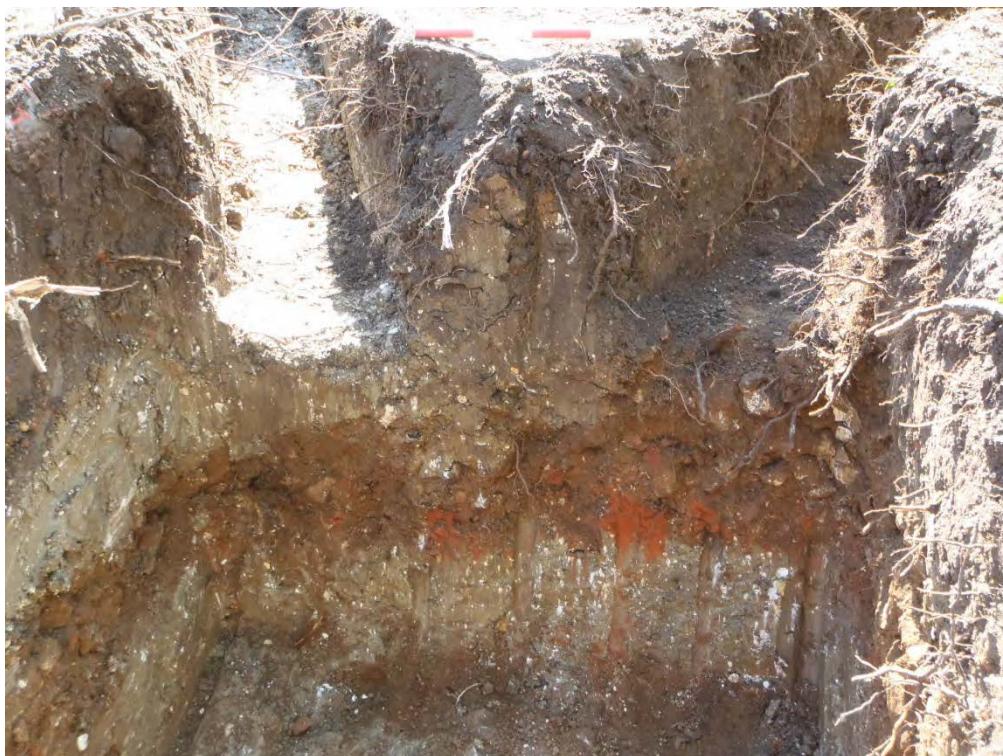
Plate 9: Section 103, view south-east
