**MILTON ABBEY SCHOOL,
MILTON ABBAS, NR
BLANDFORD FORUM,
DORSET**

**REPORT ON
ARCHAEOLOGICAL
WATCHING BRIEF**

REPORT NO: R12105

MAY 2015

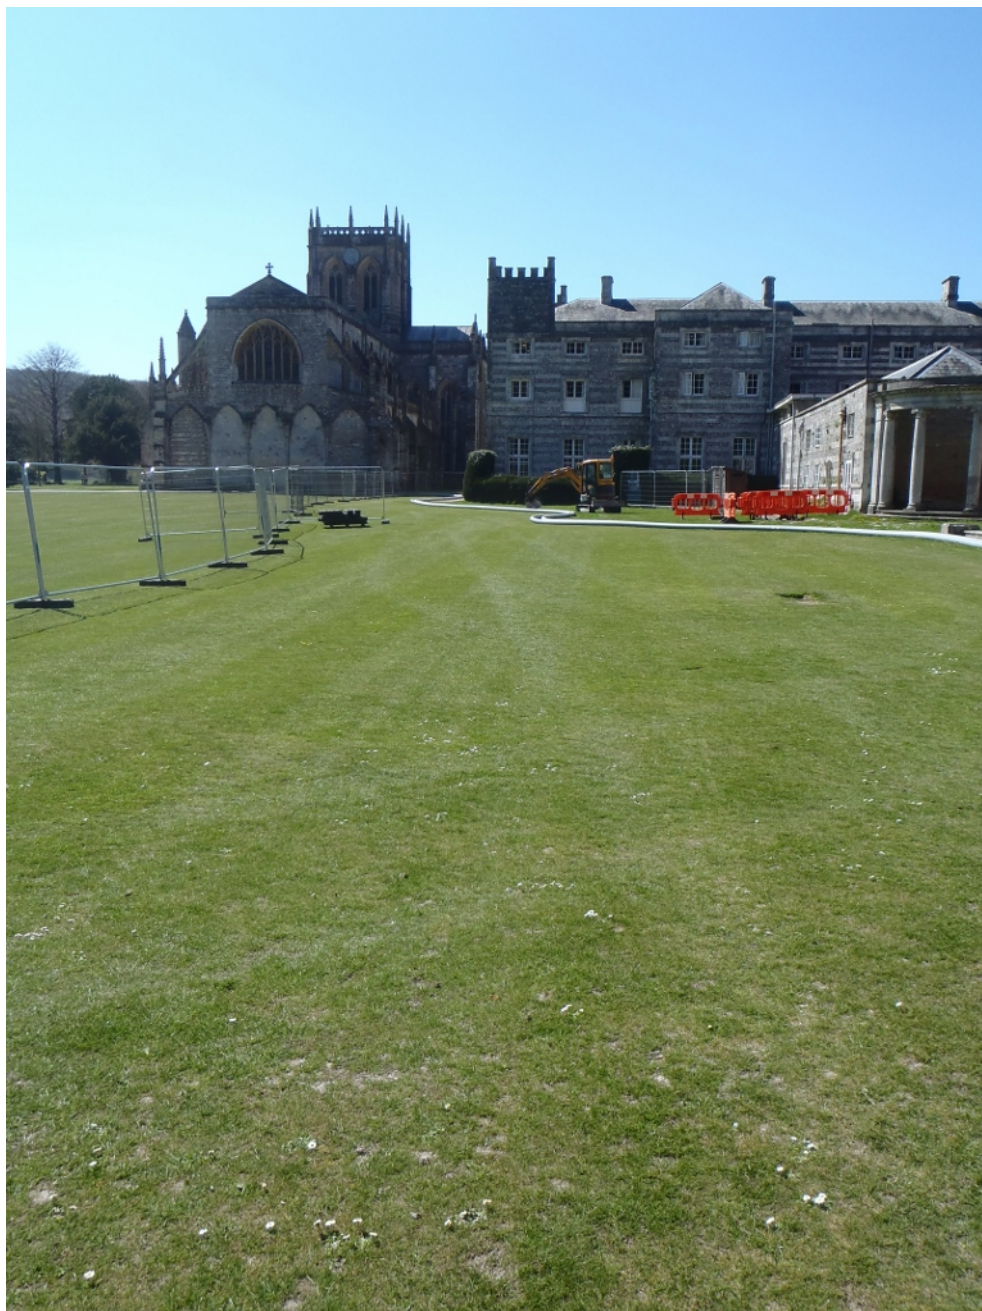
Plate 1: D10 General view of site, view to west

4.2.1 Mechanical excavation forming the length of the service trench crossing the playing field south of the school was monitored (**Figure 2, Plate 1**). It was excavated to a general depth of 1m below the ground surface and was 0.5m wide. The course of the trench followed the planned route. Arisings were heaped to the side and used to backfill the trench.

4.2.2 The trench revealed previous disturbance throughout of relatively modern date and including earlier service trenches and deposits of modern debris including brick rubble, sand, ceramic drain pipe, wood, modern glass and animal bone.

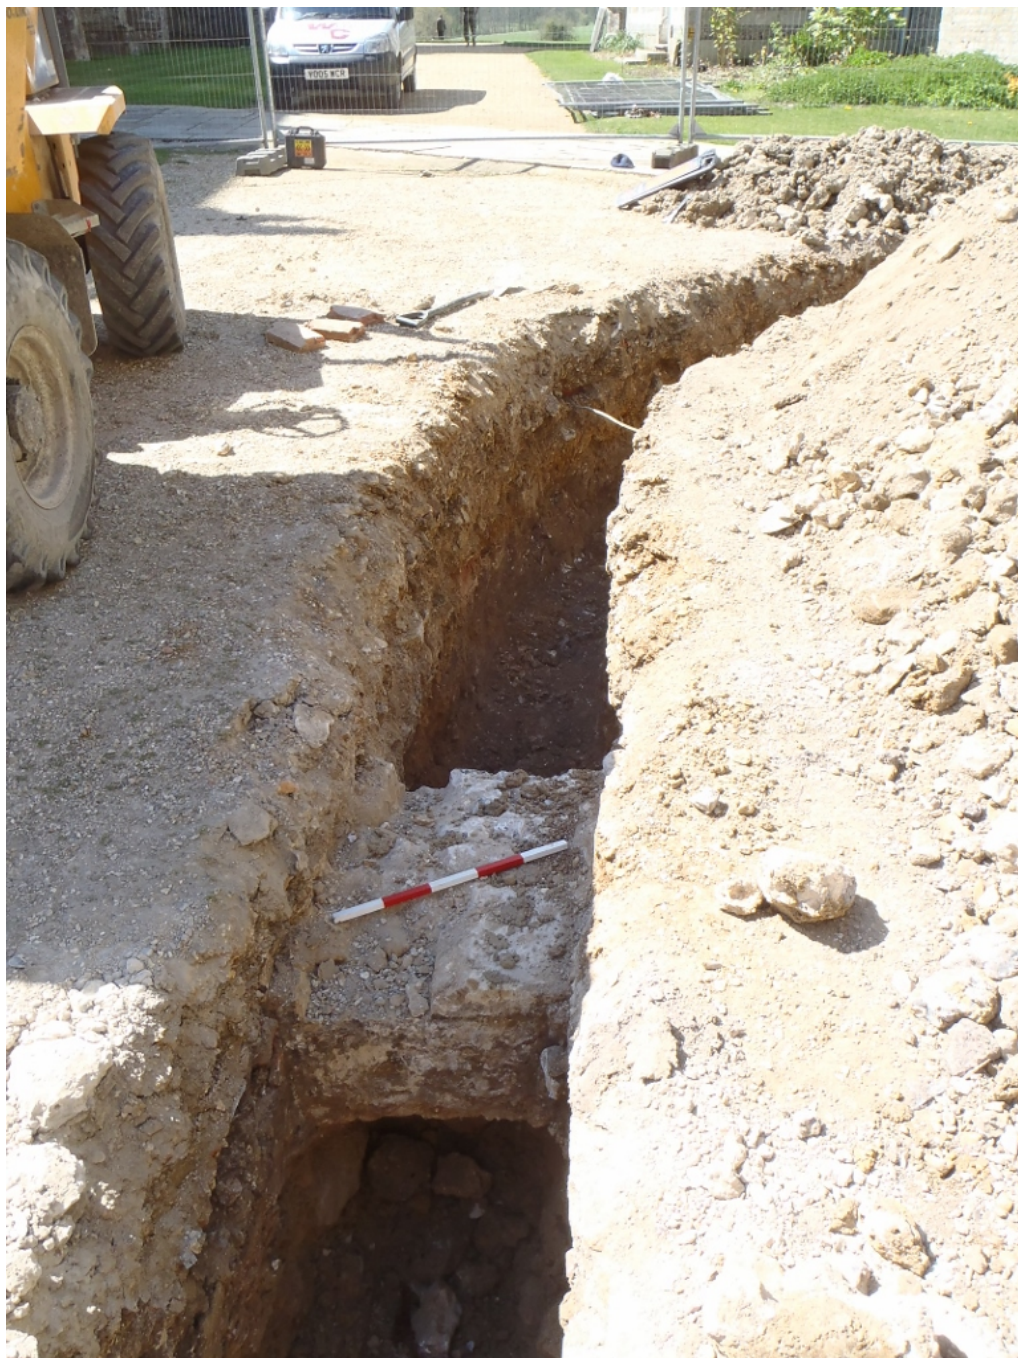
Plate 2: D21 Wall [002/3] View to west. Scale 0.5m.

4.4.1 A wall was revealed by the service trench toward its western end (**Figures 2 & 3, Plate 2**). The wall [002] ran north-south, on an alignment similar to the existing historic school buildings lying just 6m to the north (Mansion House), and appeared to consist of two courses, together some 0.3m thick and 0.5m wide. The upper part of the wall fabric [002] was mainly mortared flint rubble and included one dressed sandstone block. The mortar was whitish-yellow and included charcoal. The lower part of the wall [003] consisted of larger, coarser flint bonded by a more sandy mortar. The two elements of the wall may represent separate phases of construction or distinguish a foundation course from higher fabric.

4.4.2 Below the wall was a coarse sandy layer (Context 004), thought to be associated with the wall, perhaps having served as a bedding layer. No foundation 'cut' could be discerned and the relationship between the wall and adjacent deposits was not clear, although it is assumed the adjacent deposits ran up against it, suggesting the area of the trench has been heavily disturbed. The date of the wall is unclear although it seems likely that it formed part of a building within Milton Abbey and may be assumed to be late Medieval. The wall was left in situ and the new pipework laid beneath it.
