**HOLY ROOD CHURCH,
OLD SCHOOL LANE,
BAGWORTH,
LEICESTERSHIRE**

**AN ARCHAEOLOGICAL
OBSERVATION**

June 2015

**PRE-CONSTRUCT ARCHAEOLOGY LTD
R12135**

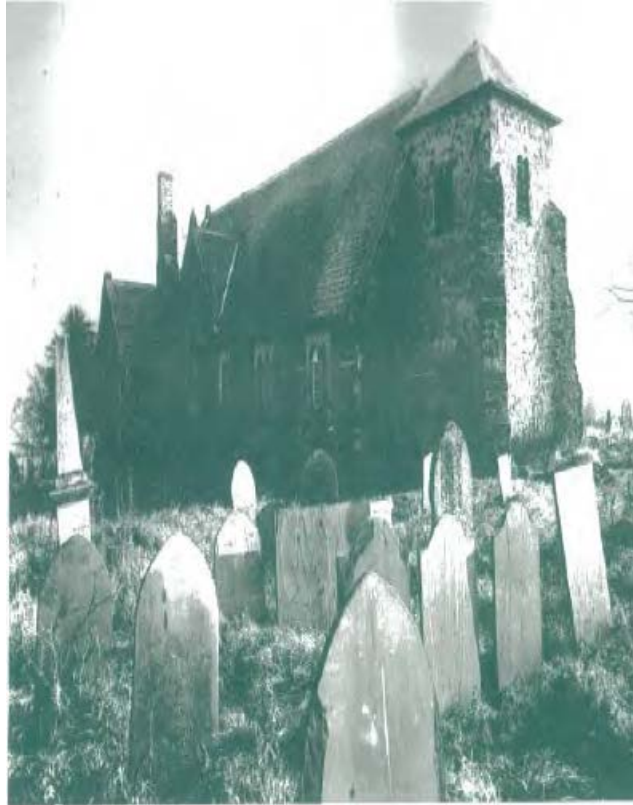
Plate 1: Holy Rood church of 1873 showing medieval tower

- 1.4.5 The squat medieval church tower (see Plate 1) formed the principal remains of the preceding medieval church to be incorporated into Victorian renovations of 1872-3 by Millican and Smith (Plate 1). The new church incorporated a large nave and chancel with a northern transept and a un-porched entrance toward the south-western angle. It was built with granite walls and used limestone for all window and door dressings. A First World War memorial was built adjacent to the east end window and next to the path leading to the church entrance on the south side (Garwood 2014). This church was damaged by subsidence and was demolished to be replaced by the 1968 CLASP building which has now also been demolished and is the subject of this report.

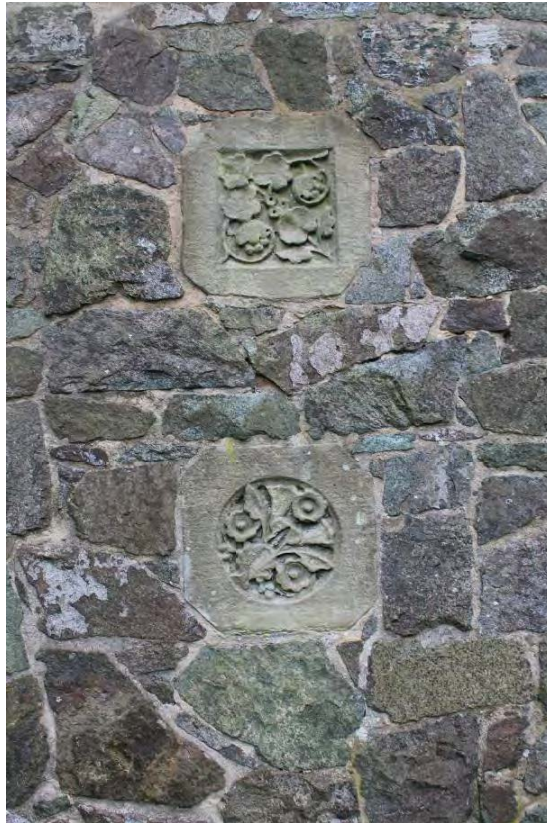
Plate 3: Re-used Fleuron blocks

- 5.2 Due to the nature of the work, no natural deposits were reached or recorded during the archaeological observation.
- 5.3 No evidence of any Prehistoric, Roman and Post-Roman activity was present on this site. The incorporation of elements of the medieval church into elements of the 1968 construction (Plates 3 and 4) represent the only visible archaeology from this period and these were left *in situ*.

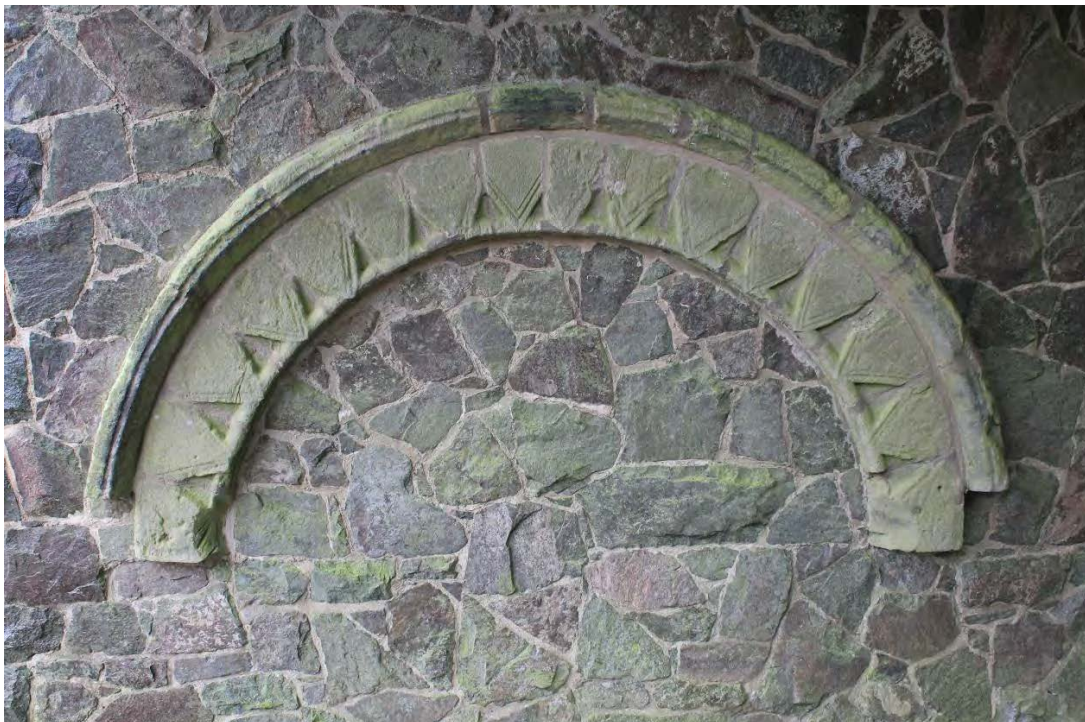
Plate 4: Re-sited Norman arch in utility range of 1968 church

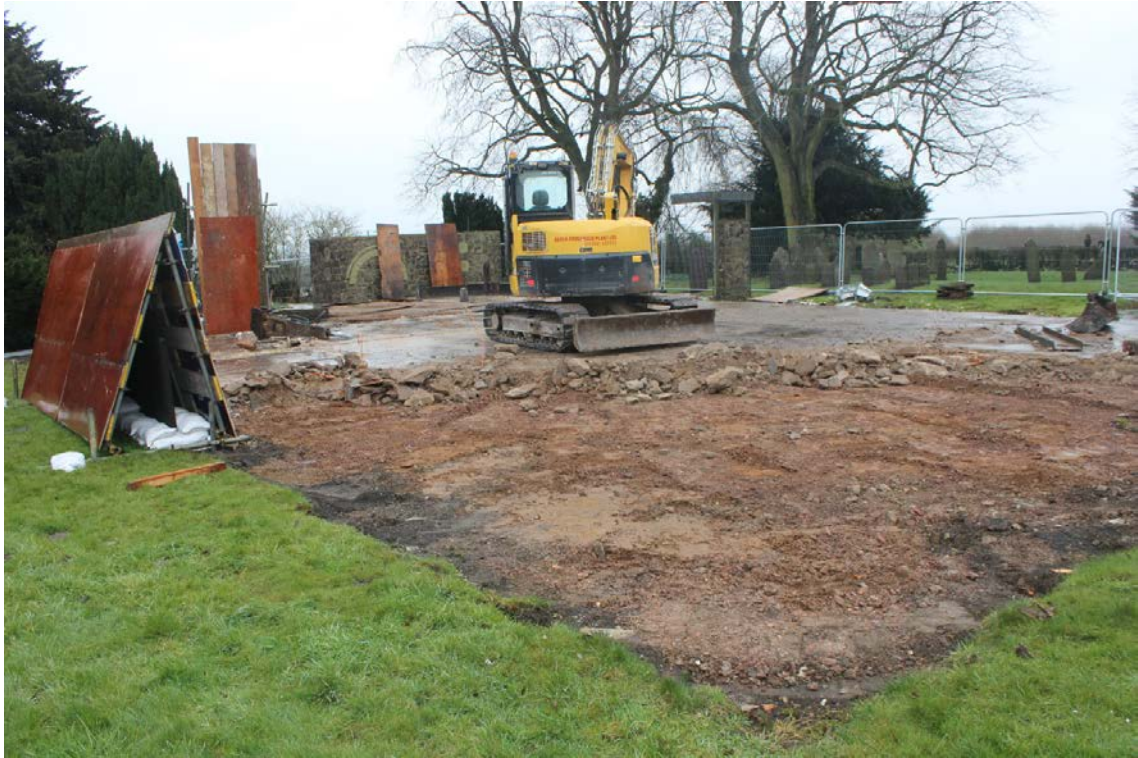
Plate 5: Study Area under demolition. From SE; context **101** exposed.

- 3.1.1 A layer of slabs and concrete forming the main floor of the church and surrounding the church tower (See Plates 5 and 6) were removed by demolition company Pro-Dem using a breaker. The removal of 75% of this layer was done under constant archaeological supervision however, the remaining 25% was not as the underlying surface was truncated by visible modern service drains (see **Figure 2**).

4.2.2 Context number **101** was a demolition/levelling layer beneath the concrete floor of the church. There were no visible features of finds within this layer although there were occasional burnt stone and brick fragments; the layer was only exposed to be covered with topsoil and turf so an in depth exploration of it did not take place.

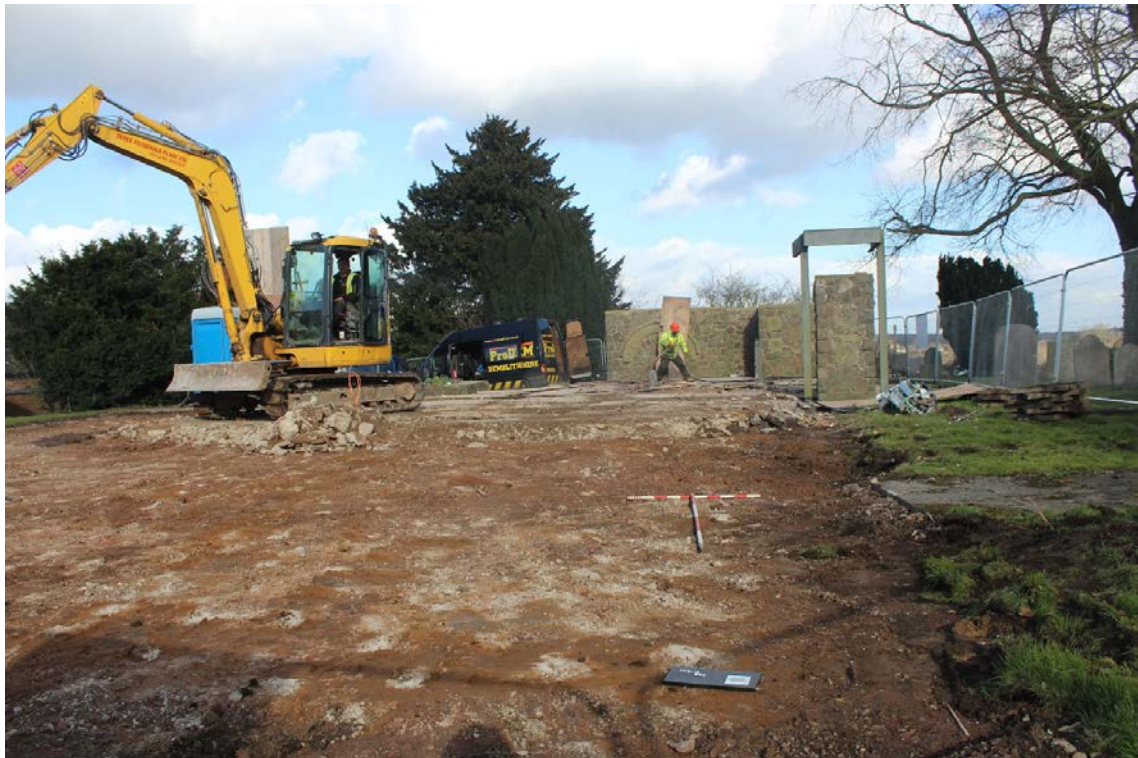
Plate 6: Additional working shot of demolition with the elements of the church left *in situ* visible. From E; contexts **101**, **103** and **105** are visible.

4.2.3 The remaining upstanding structure of the church was left *in situ* due to the fact that material from the original medieval church had been incorporated into the modern walls. This remaining structure was allocated the following context numbers: **103** and **105** for the remaining *in situ* structure and **104** for the surviving war memorial.
