**THE SITE OF BRIDGE 62,
ASHBY CANAL,
OFF QUARRY LANE,
SNARESTONE,
LEICESTERSHIRE**

**AN ARCHAEOLOGICAL
MONITORING**

July 2015

**PRE-CONSTRUCT ARCHAEOLOGY LTD
R12141**

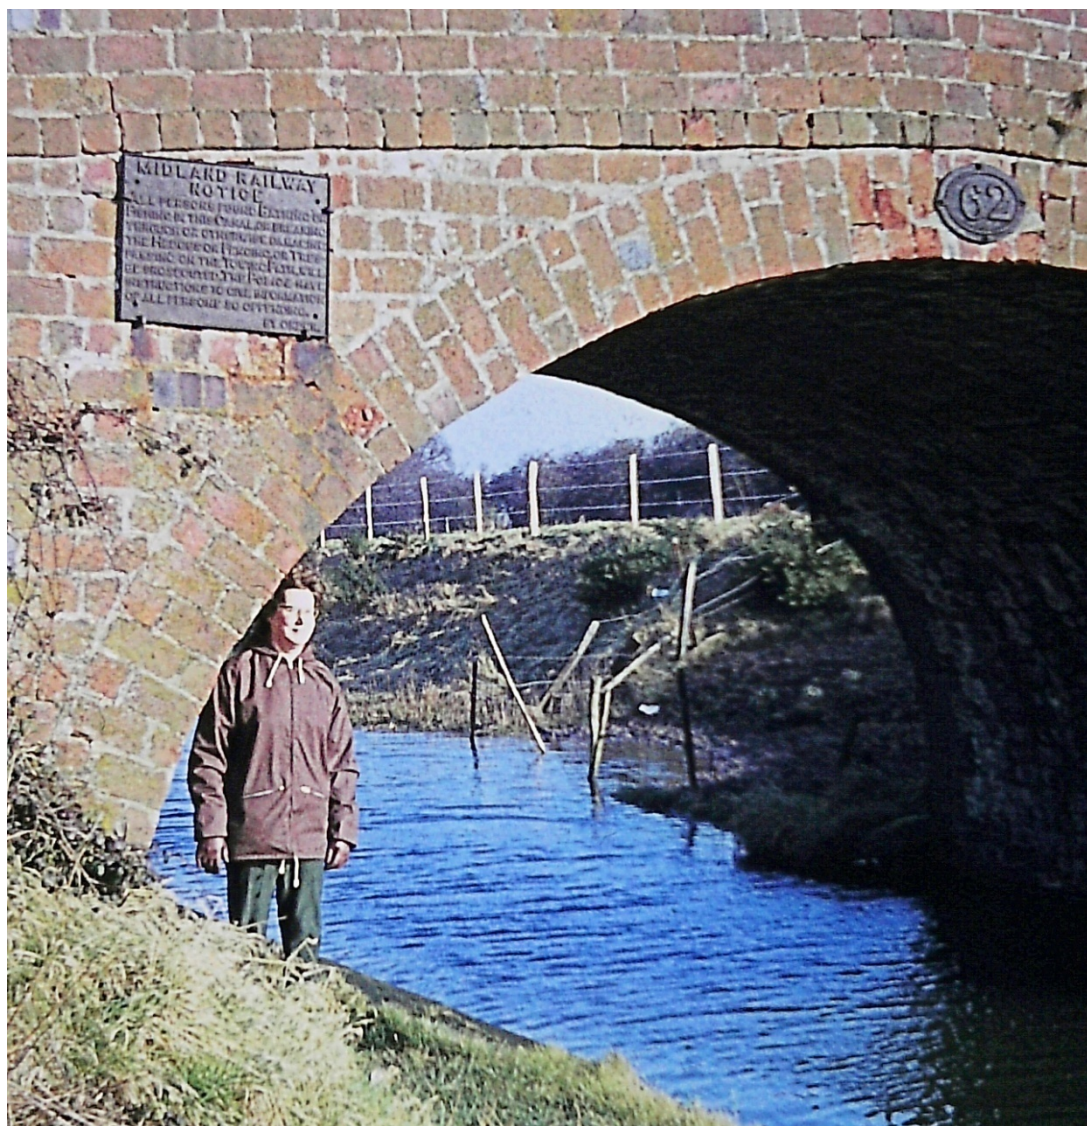
Plate 1: Bridge 62 showing number and Midland Railway plaques

- 3.1.6 Bridge 62, demolished following the closure of the canal in 1966, was typical of the many accommodation bridges built along the length of the canal. Photographic evidence shows that it was a single span bridge built in red brick, with a one and half brick wide arch, flanked by splayed brick abutments and over-sailed by a slightly cambered parapet wall. The bridge sat within a cutting, with moderately steep sloping banks to the east and west, and spanned the canal and a tow path, the latter present along the west side only.
- 3.1.7 During excavation work to restore the canal channel, a large number of bricks and the original elliptical cast iron number plate from Bridge 62 were recovered. The name plate has been restored ready to go on the new bridge.

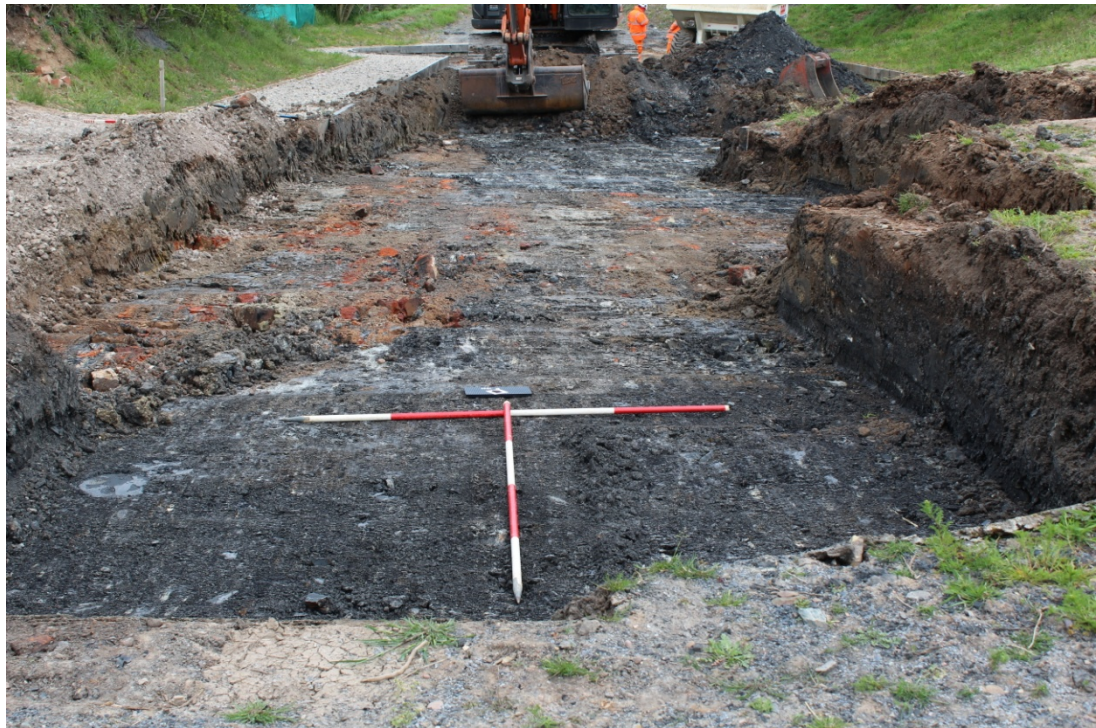
Plate 2: Site stripping, exposing coal waste back-filled canal looking N

5.1.1 The over-site, comprising a topsoil (001), sub soil (002) and a considerable deposit of largely mixed coal waste backfill (005), measuring up to 0.65m of compacted dark grey/black coal waste, was removed to a level which coincided with the upper surface of the tow path (west side) and to where the foundations walls of the bridge abutments were first recognised (east side). Context (005) was also used to back-fill the canal waterway, as its extent clearly defined the width of the canal, recorded as cut [004].

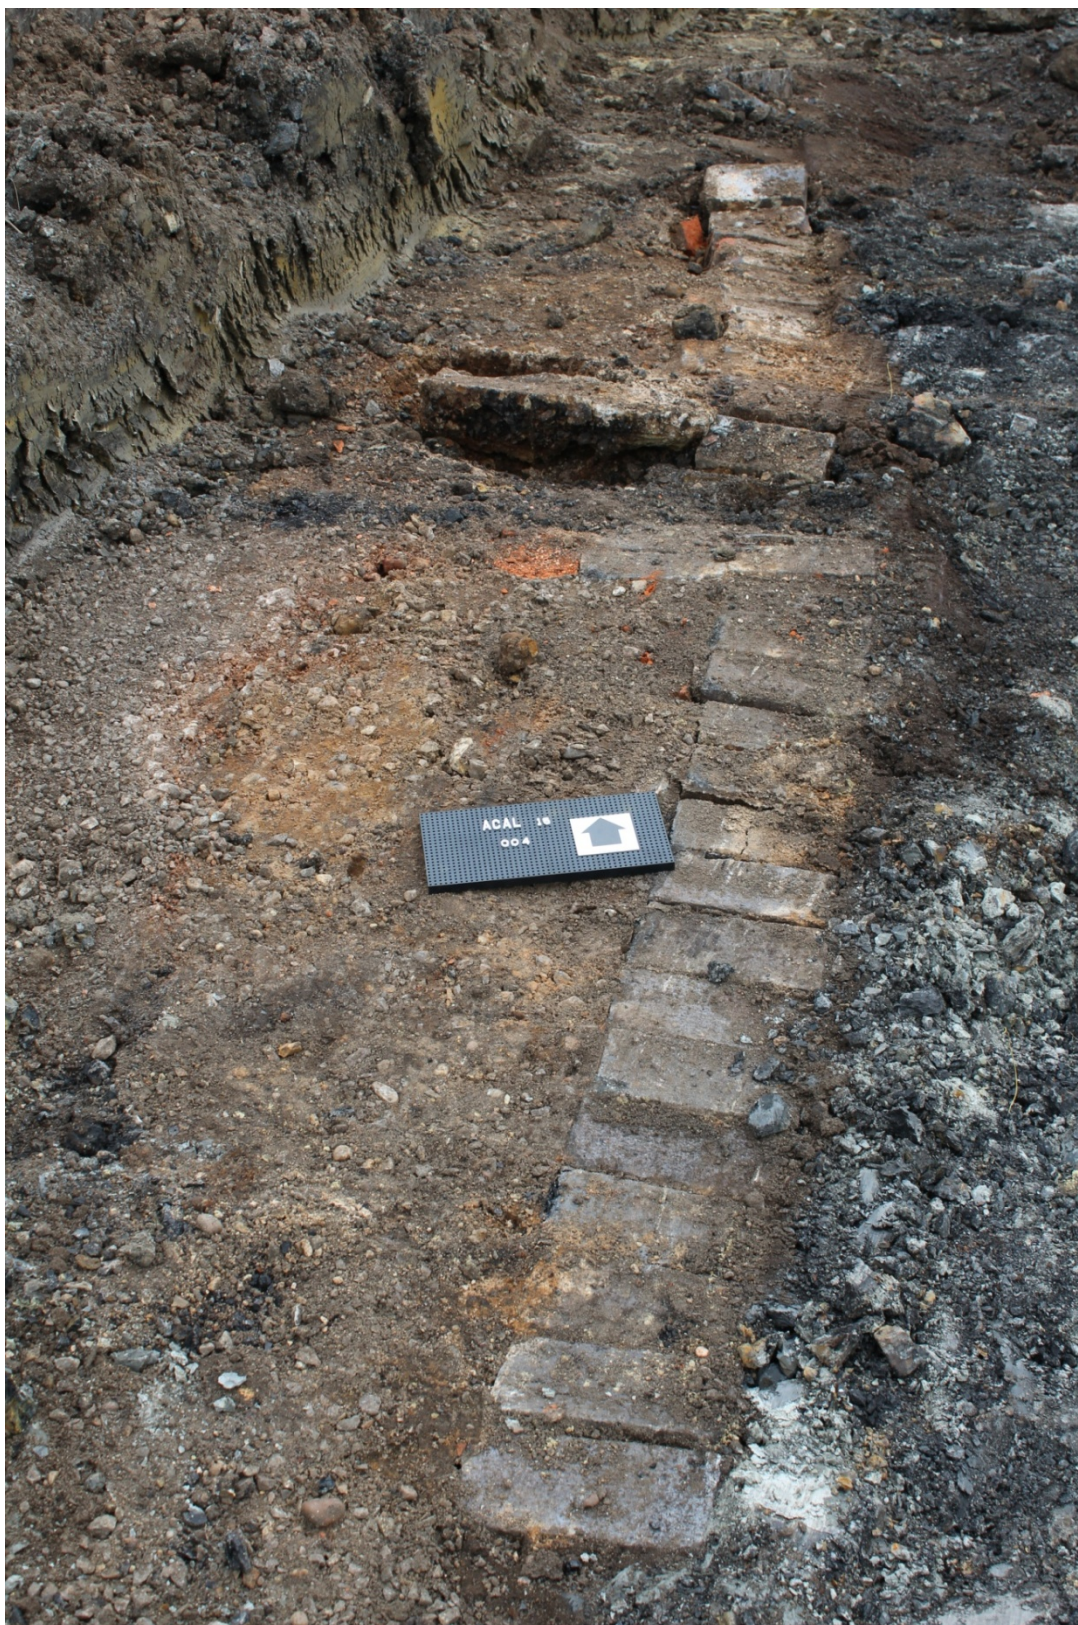
Plate 4: Blue brick edging to tow path, looking N

5.2.1 The canal cut [004] was flanked on its western side by the remains of the original tow path and canal bank. This comprised a single blue brick edging or coping course laid on bed and perpendicular to the canal edge and a replacement section of concrete copings (015), possibly used as a repair or later renovation of the canal edge, to the south. The blue engineering brick edging (008) to the canal used bricks measuring 230mm x 100mm that were fixed using a hard lime mortar. They were abutted to the north, and within the canal cut, by lengths of timber sleeper (010), later inserted (re-used from the parent company) to protect the edges of the canal from strike damage. Context (011), a foundation layer, immediately west of the edging course coping, comprised of brick rubble was abutted further to the west by an un-coursed and unbonded brick rubble layer (context 007) extending for c. 5m and interpreted as representing a demolition deposit associated with Bridge 62. Removal of this layer revealed the disturbed, but partly bonded, structural remains of a single foundation wall of the bridge, context (016). The brickwork used for this wall was characteristically similar to the abutment walls (012 and 013) recorded on the opposite side of the canal.

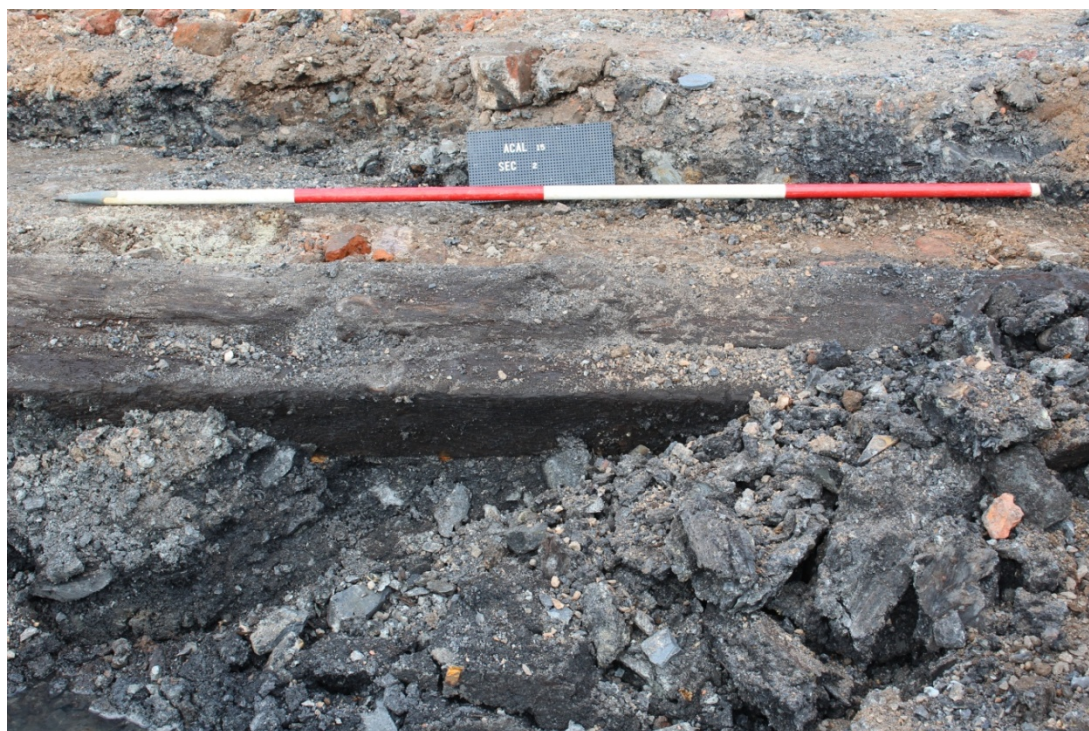
Plate 5: Re-used timber sleeper (010) along edge of canal

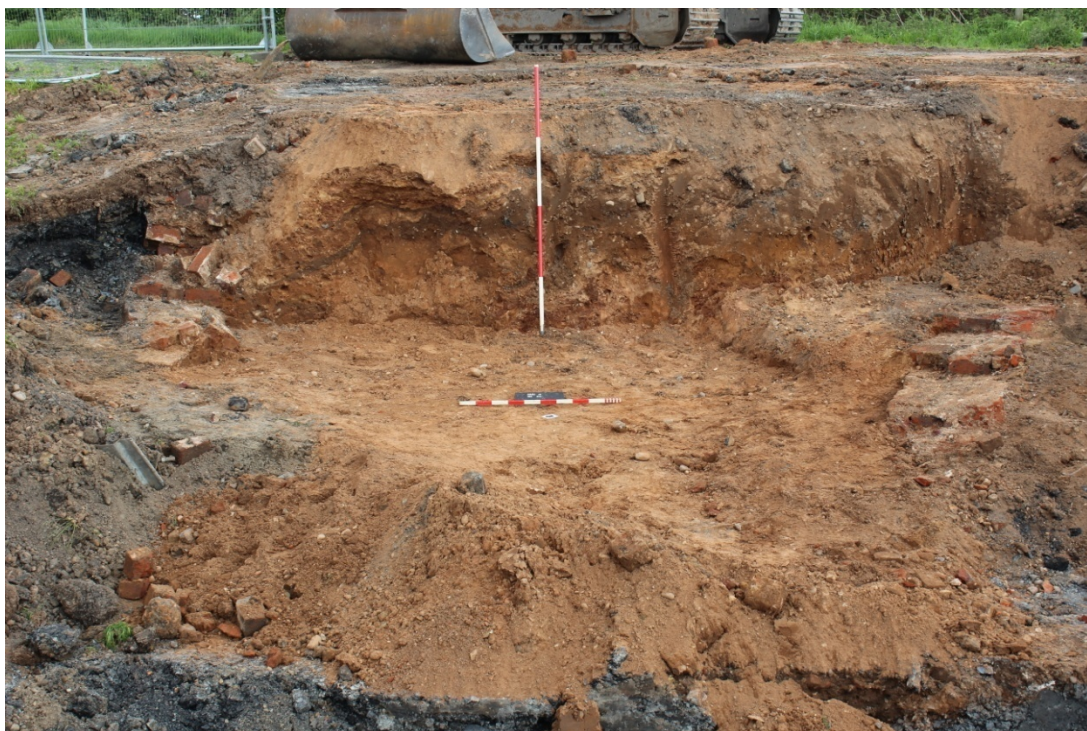
Plate 6: Site of Bridge 62, on the eastern side of canal, showing foundation walls, looking E

5.3.1 The canal edging recorded on the western side of the canal was not as clearly visible on the eastern side of the canal. This was mainly due of an extensive spread of moderately compacted light brown silty sand material (context 014) interpreted as part of the bridge construction, spread across this area. This re-deposited soil was present between and in part overlay the structural remains of the bridge, surviving in the form of two foundation walls (contexts 012 and 013) of the former abutments. The exposed wall foundation, context (012), projected westward from the eastern site baulk and measured 3.1m in length and 0.75m in width. It survived to a maximum depth of four brick courses (exposed) and was constructed using oversized sized,

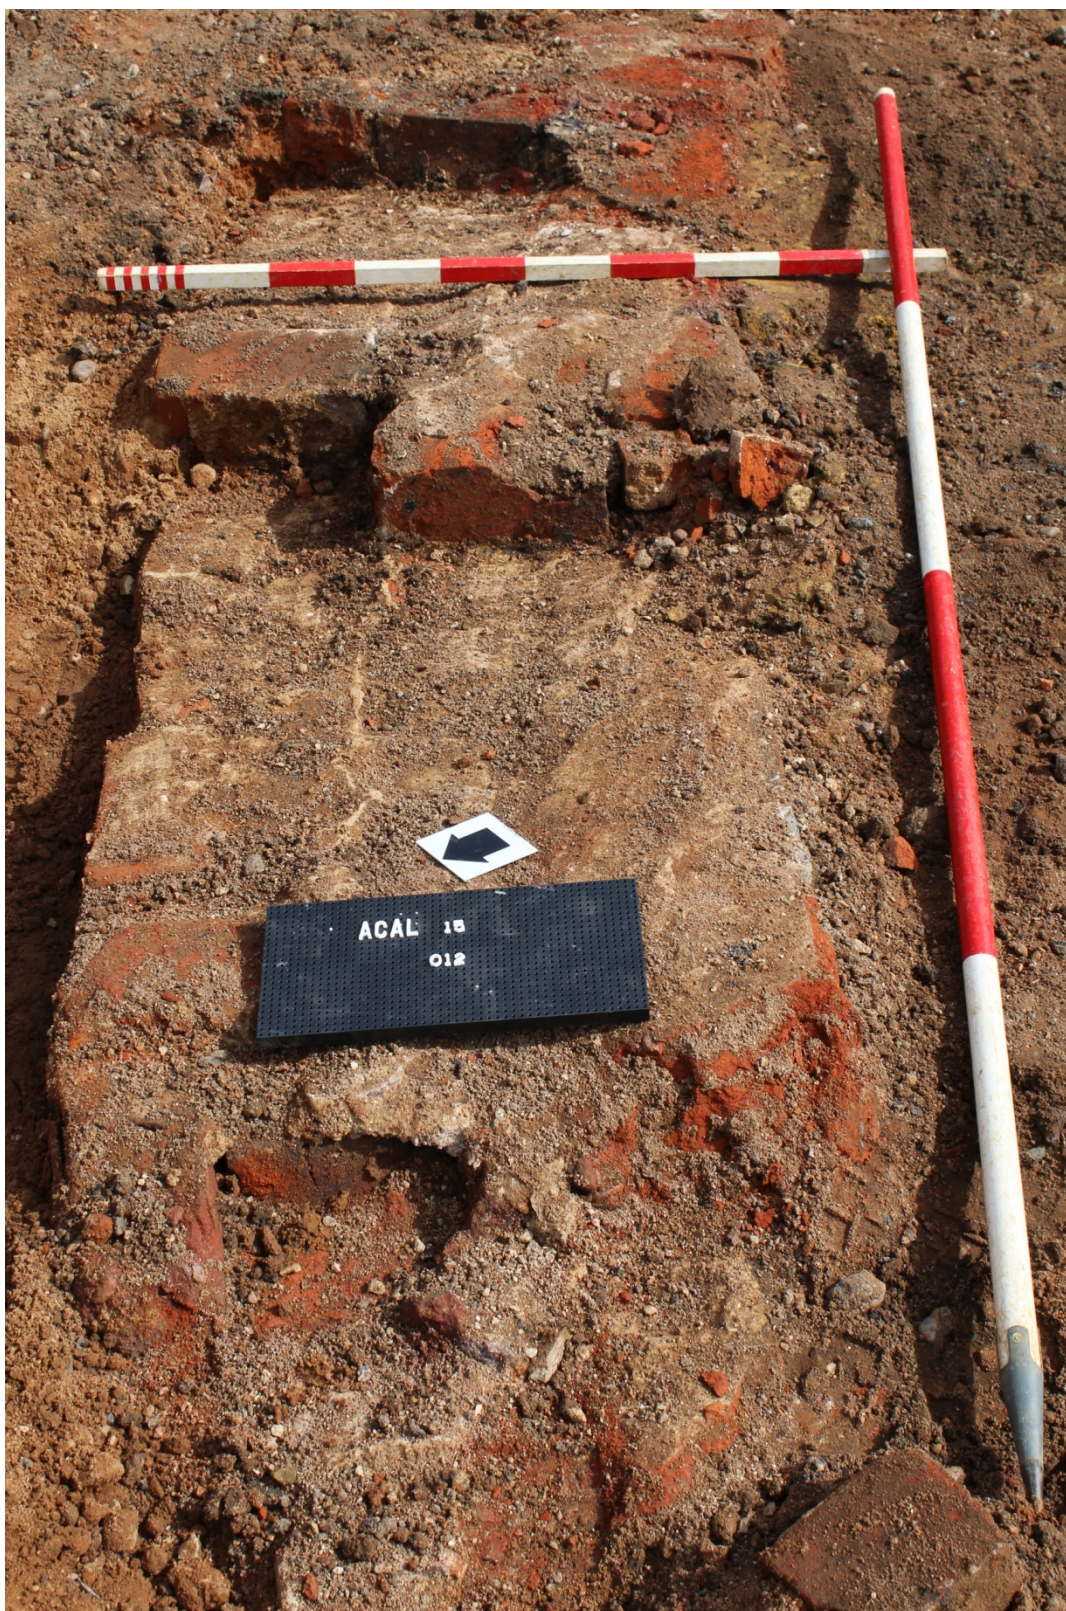
Plate 7: Surviving brick courses of the southern wall foundation (012) to Bridge 62, looking E

- 5.3.2 Context (012) lay to the south of the northern abutment foundation wall (013). This wall and context (012) were built broadly parallel but were also clearly splayed in plan, narrowing together as the walls progressed westward. Whilst context (013) was built using the same brickwork as recorded for (012) and to the same height (in courses), only 2.2m of wall projected into the site area from the baulk. It was however noticeable that up to another four courses of principally disturbed brickwork, associated with the northern abutment wall, were seen in the baulk section. It was abutted to the north by the coal waste backfill (005) and to the south by the sandy construction deposit, context (014). The stratigraphy confirms that the bridge was deconstructed prior to the infilling of the canal cut.

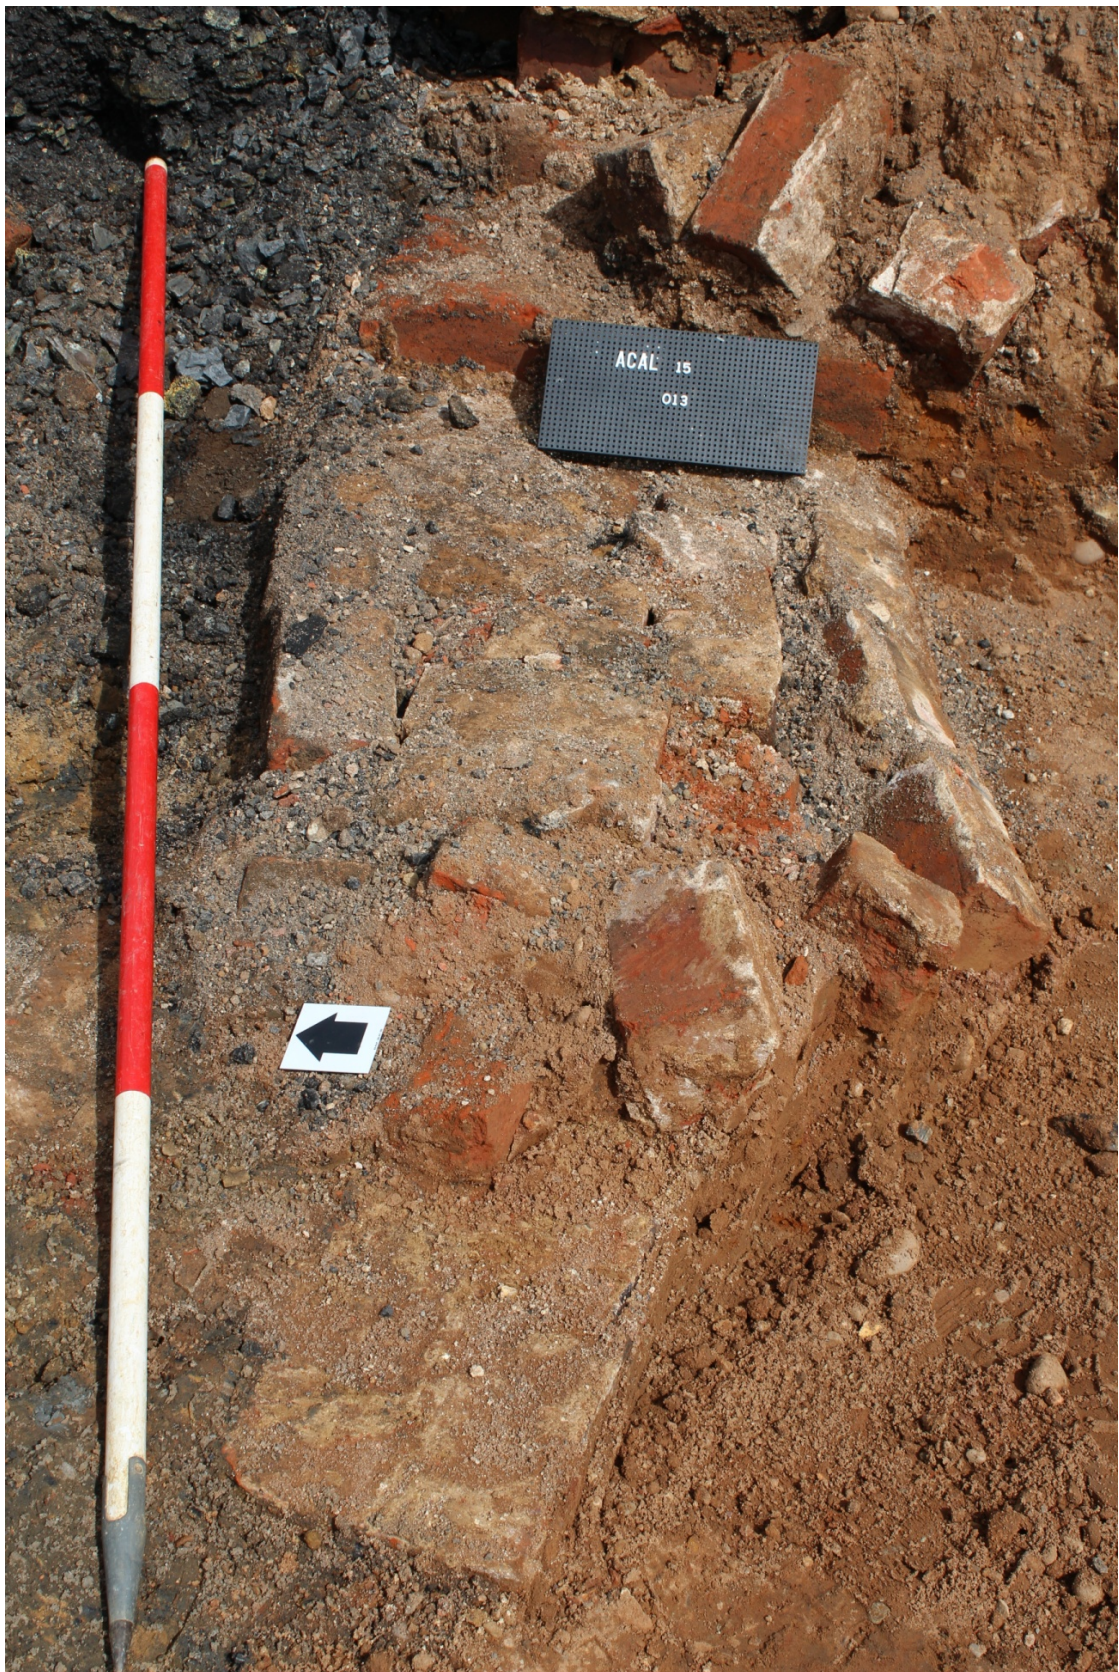
Plate 8: Surviving brick courses of the northern wall foundation (013) to Bridge 62, looking E
