Land at Cantley Lane, Cringleford, Norfolk, NR4 6TA: An Archaeological Evaluation

An Archaeological Trial Trench Evaluation

Local Planning Authority:	South Norfolk Council
Planning Reference:	2015/0346
Central National Grid Refer	ence: TG 1917 0561
Site Code:	ENF138280
Report No.	R12145
Written and researched by:	Mary-Anne Slater
	Pre-Construct Archaeology Ltd
Project Manager:	Mark Hinman
Commissioning Client:	Cripps Developments Ltd
Contractor:	Pre-Construct Archaeology Ltd
	Central Office
	The Granary
	Rectory Farm
	Brewery Road
	Pampisford
	Cambridgeshire
	CB22 3EN
Tel:	01223 845522
E-mail:	mhinman@pre-construct.com
Website:	www.pre-construct.com
	©Pre-Construct Archaeology Ltd

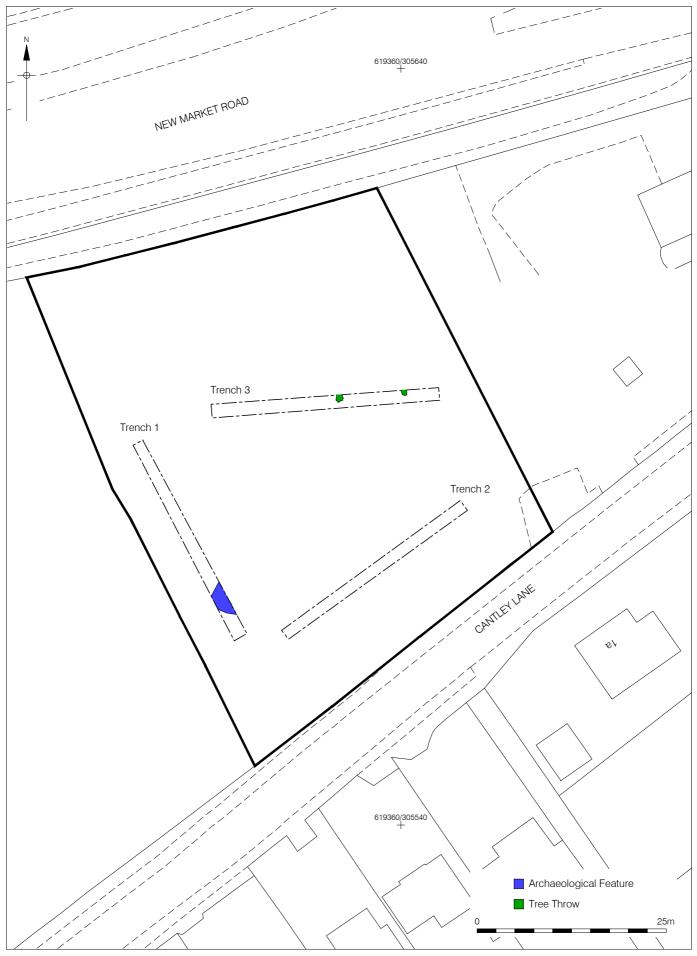
- 4.1.1 The Written Scheme of Investigation for the evaluation proposed the excavation of three 30m trial trenches (Figure 2).
- 4.1.2 Ground reduction was carried out under archaeological supervision using a 6-ton tracked mechanical excavator fitted with a 1.8m-wide toothless ditching bucket. Topsoil and subsoil deposits were removed in spits down to the level of the undisturbed natural geological deposits where potential archaeological features could be observed and recorded. Exposed surfaces were cleaned by trowel and hoe as appropriate and all further excavation was undertaken manually using hand tools. Overburden deposits were set aside beside each trench and examined visually and with a metal-detector for finds retrieval.

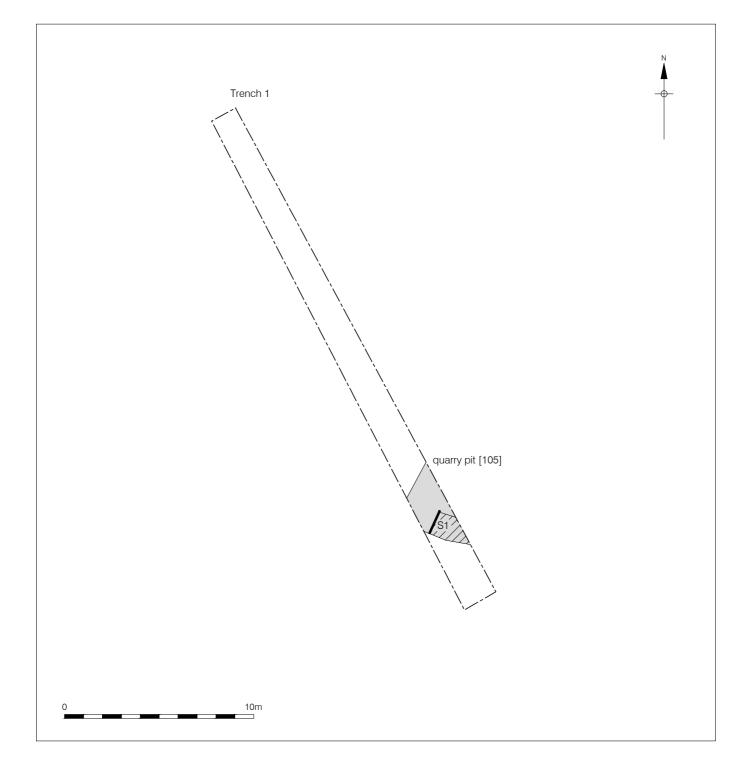
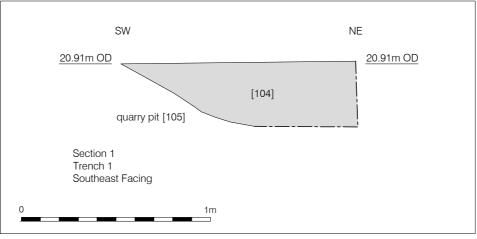
Figure 3 Trench 1 Plan & Section Plan 1:200, Section 1:20 at A4

- 5.2.1 Trench 1 contained an undated quarry pit in the southern end of the trench.
- 5.2.2 Pit [105] (Figures 2-3, Section 1) was located at the southern end of the trench. It extended out of the eastern and western limits of the trench. A 1.00m wide slot was excavated to a depth of 0.33m, to a total depth of 1.2m below ground level. The pit had moderately sloping sides and appeared to be cut from high up. It had a single fill (104) of mid-greyish brown silty sand.
- 5.2.3 This feature is likely to be a quarry pit for gravel, sand or chalk extraction. There were no finds from this feature.

TRENCH 1	Figures 2-3	Figures 2-3		Plates 1, 4	
Trench Alignment: N-S	Length: 30n	Length: 30m Leve		el of Natural (m OD): 21.08-22.	
Deposit		Contex	No.	Average De	epth (m)
				S End	N End
Made Ground		(103)		0.1m	N/A
Topsoil		(100)		0.35m	0.2m
Subsoil		(101)		0.4m	0.35m
Natural		(102)		0.75m+	0.35m+
Summary					
Trench 1 was located close	e to the western	boundar	y of the	e site.

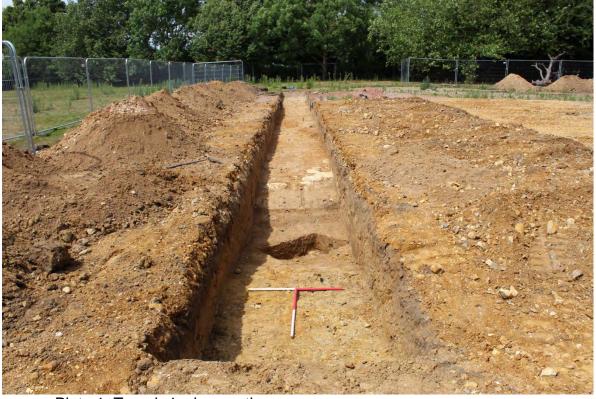
Plate 1: Trench 1, view north

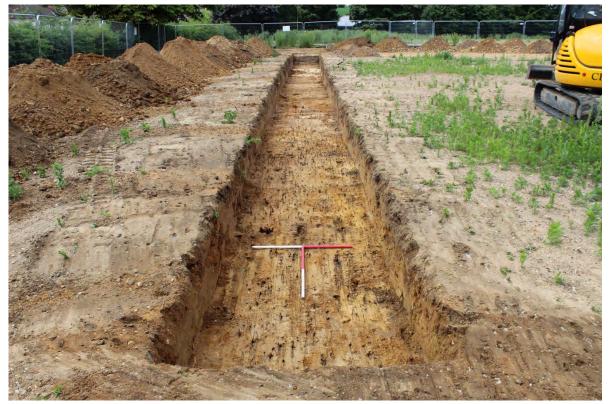
Plate 2: Trench 2, view west

TRENCH 2	Figure 2	Figure 2		Plate 2		
Trench Alignment: E-W	Length: 30r	Length: 30m Level		of Natural (m OD): 21.20-22.02n		
Deposit	I	Context No.		Average D	Average Depth (m)	
				W End	E End	
Topsoil		(100)		0.4m	0.3m	
Subsoil		(101)		0.6m	0.65m	
Natural		(102)		0.6m+	0.65m+	
Summary						
Trench 2 was located close	to the souther	n bounda	ry of th	e site.		
No archaeological features	were seen.

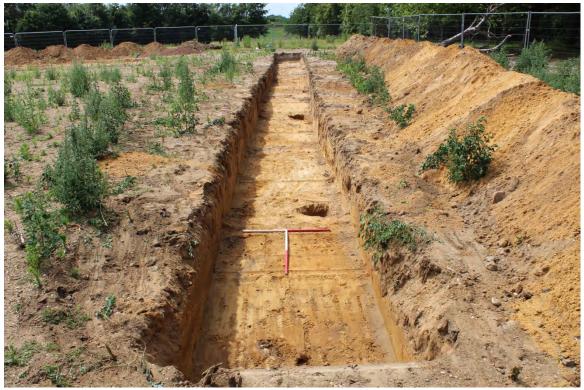
Plate 3: Trench 3, view north-west

5.4.1 The trench contained modern services associated with the former buildings on the site and two undated tree throws.

TRENCH 3	Figure 2			Plate 3		
Trench Alignment: NW-SE	Length: 30r	Length: 30m Lev		l of Natural (m OD): 21.79-22.2		
Deposit	Deposit		t No.	Average De	Average Depth (m)	
				SE End	NW End	
Topsoil		(100)		0.29m	0.26m	
Subsoil		(101)		0.79m	0.55m	
Natural		(102)		0.79m+	0.55m+	
Summary		1			I	
Trench 3 was located toward	Is the norther	n bounda	ry of th	e site.		
No archaeological features w	vere present i	n Trench	3.

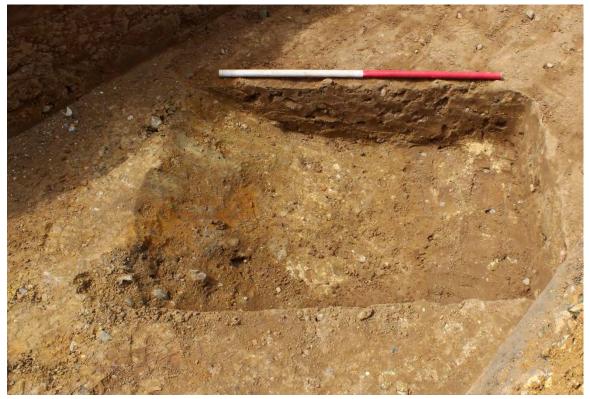
Plate 4: Pit [105], view north-west
