**ACTON GARDENS, PHASE 4,  
SOUTH ACTON ESTATE, ACTON**

**AN ARCHAEOLOGICAL  
EVALUATION**

**JULY 2015  
REPORT NO.12155**

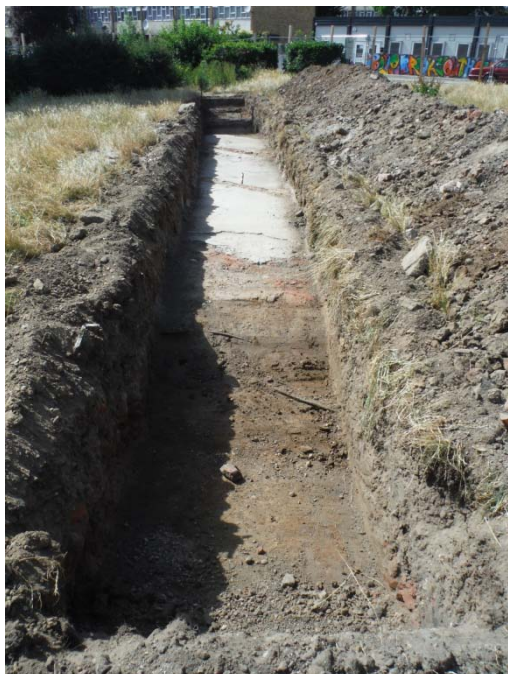
*Plate 1: Trench 1, looking north-west (1m scale)*

7.1.2 The earliest deposit recorded in the base of Trench 1 was a layer of naturally deposited firm mid yellow brown sandy silt [3]. It was encountered at a maximum height of 13.66mOD. This layer was cleaned and examined for any potential archaeological activity with no such evidence being observed.

7.1.3 Overlying the natural sandy silt [3] were two structural features, [4] and [5]. Structural feature [4] was located in the centre of the trench and comprised four wall foundations integrated into a concrete slab. The walls were orientated east-west and were composed of red frogged brick and concreted light grey cement in an English bond. Structure [4] encompassed an area of 9.70m north-west to south-east by 1.80m north-east to south-west and was 0.10m thick. It was encountered at a maximum height of 13.95m OD.

7.1.4 Structural Feature [5], located at the north-west end of the trench, was the truncated base of modern culvert constructed of unmortared red frogged brick in a north-south alignment. Culvert [5] measured 1.34m north-south by 0.28 east-west by 0.07m deep and was recorded at a maximum height of 13.89m OD.

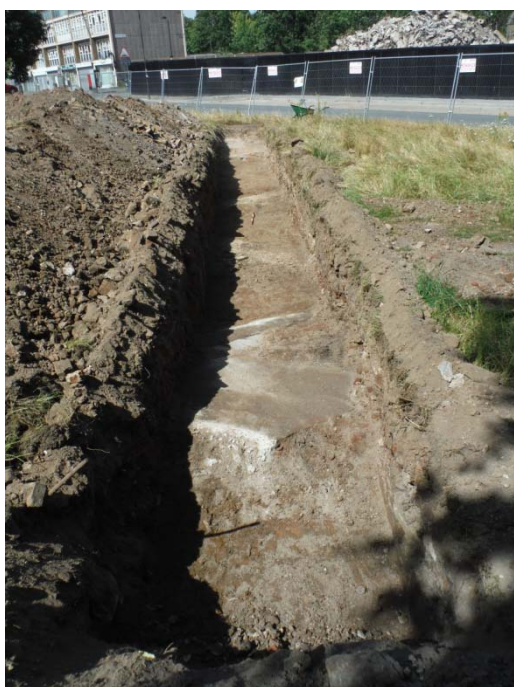
*Plate 2: Trench 2, looking north--east (1m scale)*

- 7.2.2 The earliest deposit encountered in Trench 2 comprised fairly firm mid orange brown silty sand [15] at heights that varied between 13.13-13.25m OD. This naturally deposited silty sand was cleaned and examined for any potential prehistoric or later archaeological activity with no such evidence being observed.

7.2.3 Several masonry and concrete structures were seen to rest on or truncate natural silty sand [15]. These included concrete slab [16], two concrete services [17] and [19] within construction cuts [18] and [20] respectively, and wall foundations [21] and [22]. The alignments and dimensions of these modern structures are summarized in the table below:

7.2.4 Wall foundations [21] and [22], located at the north-eastern end of the trench, were both constructed of purple blackened brick and concreted light brownish grey cement in a header bond and were likely to be part of the same structure.

7.2.5 Sealing all of the structures in Trench 2 was a 0.85m thick layer of modern made ground [14] of a similar description to that in Trench 1 that reached a maximum height of 14.00m OD. Made ground [14] was in turn overlain by a 0.22m thick layer of topsoil [12] that was seen at heights varying between 13.97-14.18m OD.

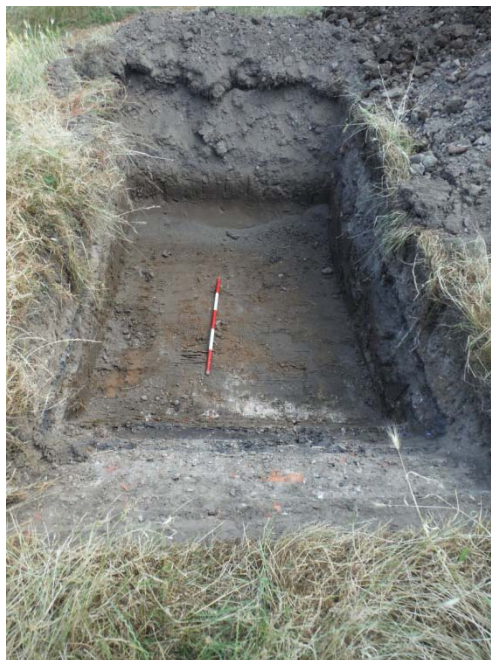
*Plate 3: Trench 3, looking south (1m scale)*

- 7.3.2 Natural silty sand [30] was recorded in Trench 3 at a maximum height of 13.71m OD. It was characterised as being fairly firm mid orange brown silty sand with occasional root activity. This layer was examined for any potential prehistoric or later activity with no such evidence observed.

- 7.3.3 No phase 2 activities were observed.

- 7.3.4 Sealing weathered natural silty sand [30] was a 0.54m thick layer of modern made ground composed of fairly firm but friable mottled mid grey brown with orange brown patches clay silt with moderate brick and concrete rubble, sub-rounded and rounded pebbles and occasional coal flecks and tarmac fragments [29]. It was recorded at a maximum height of 14.24m OD.
- 7.3.5 Modern made ground [29] was subsequently sealed by a 0.20m thick layer of topsoil [28] that was recorded at heights between 14.29-14.42m OD.

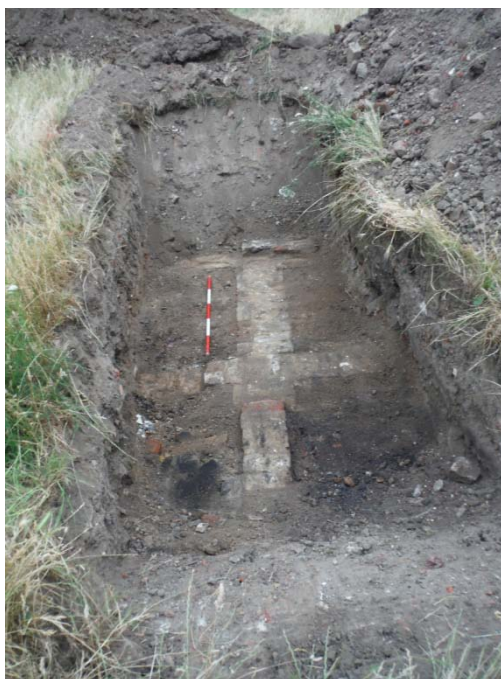
*Plate 4: Trench 4, looking west (1m scale)*

- 7.4.2 Natural firm, mid yellow brown sandy silt [11], was encountered at a maximum height of 13.48m OD in Trench 4. This layer was cleaned and examined for any potential archaeological activity with no such evidence being observed.

- 7.4.3 Truncating natural sandy silt [11] were two intersecting wall foundations composed of frogged red and yellow stock brick and light whitish grey cement, [9], which lay within construction cut [10]. One wall foundation was orientated east-west for 2.80m, while the other ran 1.80m north-south and both were 0.35m wide. Structure [9] was recorded at heights between 13.44-13.57m OD.
- 7.4.4 Abutting structure [9] was a floor surface fragment built of red and yellow frogged stock brick [12]. It measured 0.40m north-south by 0.50m east-west by 0.07m deep and was encountered at a maximum height of 13.53m OD.
- 7.4.5 As well as containing wall foundation structure [9] construction cut [10] was also backfilled by firm but friable dark grey brown silty sand with occasional CBM and mortar flecks. A copper alloy damaged naval button was recovered from this deposit.

- 7.4.6 All these structures were overlain by a 0.73m thick layer of modern made ground [7] of a similar description to Trenches 1 and 2 which reached a maximum height of 14.23m OD.

7.4.7 All deposits in Trench 4 were finally sealed by a 0.16m thick layer of topsoil [6] that was seen a heights varying between 14.35-14.45m OD.

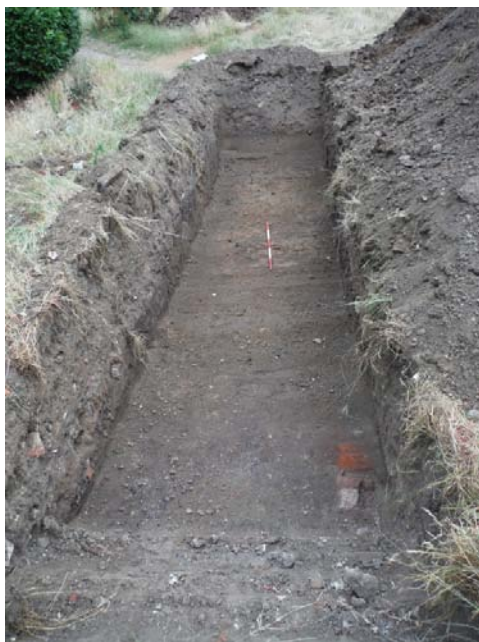
*Plate 5: Trench 5, looking north (1m scale)*

7.5.2 The earliest deposit encountered in Trench 5 was naturally deposited firm mid yellow brown sandy silt [27] that was recorded at a maximum height of 13.10m OD. This layer was cleaned and examined for any potential archaeological activity with no such evidence being observed.

7.5.3 In the south-eastern corner of the trench was a wall foundation composed of red frogged brick and light whitish grey cement [25] that lay within construction cut [26]. Foundation [25] was orientated north-south and measured 1.20m by 0.24m wide and was over 0.07m deep. It was recorded at a maximum height of 13.48m OD.

7.5.4 Structure [25] was subsequently sealed by a 0.90m thick layer of modern made ground [24] composed of firm but friable dark brown grey rubble and silt with occasional coal, concrete and slate flecks and fragments. This layer was recorded at a maximum height of 14.00m OD.

7.5.5 Made ground [24] was ultimately overlain by topsoil [23] which was encountered between 14.05-14.33m OD.
