**MARLBOROUGH ROAD,
ST JAMES' PALACE, SW1A 1BG**

**AN ARCHAEOLOGICAL WATCHING
BRIEF**

PCA REPORT NO: 12249

SITE CODE: MLB15

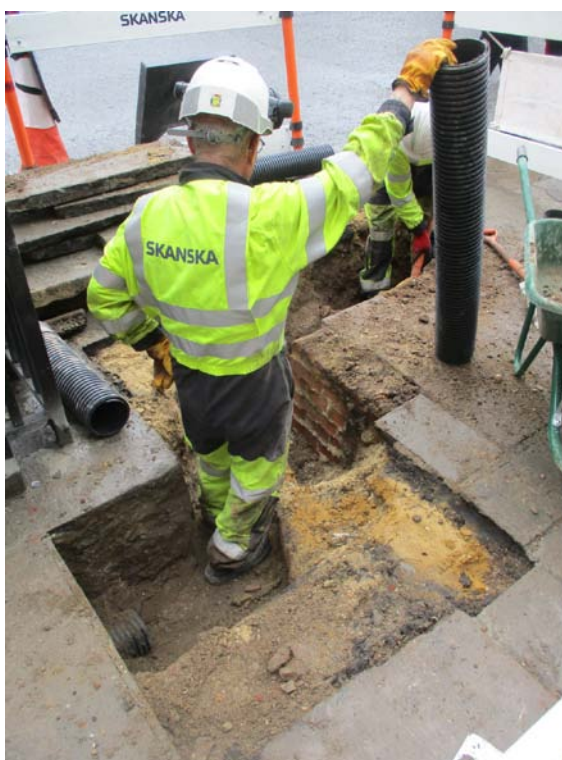
Plate 1: Trench excavation in progress

- 5.1 A cable trench measuring approximately 60m in length, 450 mm in depth and 450mm in width was excavated through the area of the site. The cable trench was excavated in a series of sections from a sub-station located immediately behind a rear driveway entrance to the Commonwealth Secretariat, along the pavement on the eastern side of Marlborough Road, by-passing the Queen's Chapel through the Palace gate and then eastwards along Pall Mall to the basement of a bank at no. 68 (Figure 2). The excavation of the cable trench was monitored by the attendant archaeologist under watching brief conditions.

- 5.2 The trench was hand excavated by hand under archaeological supervision until any archaeologically significant features were encountered, upon which these were cleaned and recorded.

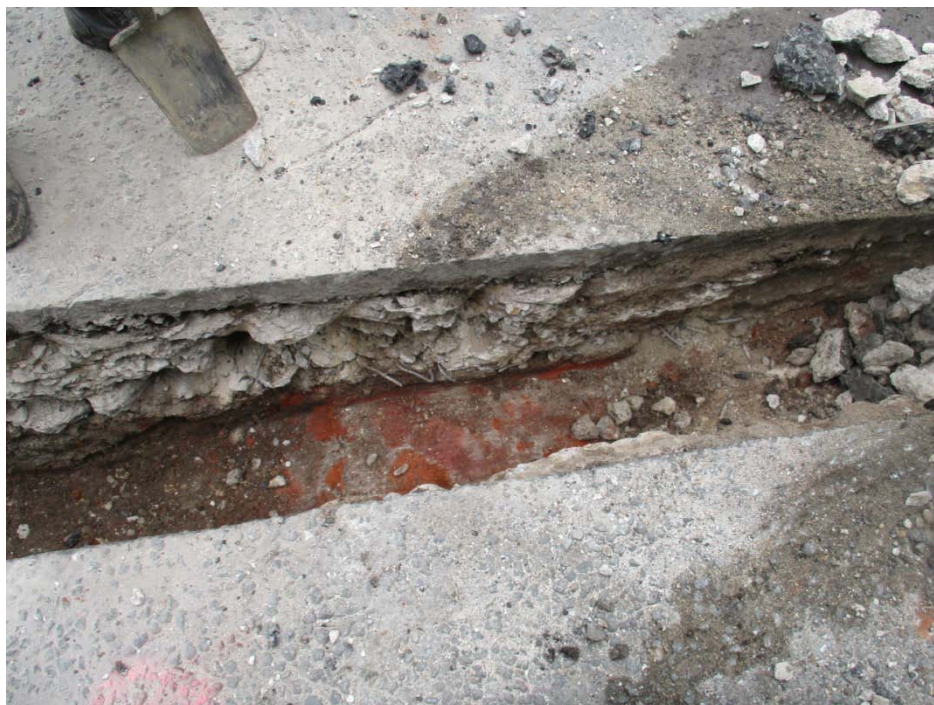
Plate 3: Conduit [18], looking northwest

- 6.2.6 A vaulted roof [18], probably forming the top of a drainage conduit, was recorded under the street in Pall Mall. It was partially revealed beneath a layer of demolition material.
- 6.2.7 The vault was formed of red stock brick, bonded with a hard greyish white lime mortar. The bricks were 100mm in width and 225mm in length. The masonry was observed to measure 0.9m in width, though it was undoubtedly wider than this at depth. It was orientated in a northwest- southeast direction, and most probably represented a drain or sewer that may still have been live. As such no brick samples were taken from it. The conduit was recorded at a depth of approximately 7.15m OD. This feature dated from the 1770's onwards as the narrow width of the brick is typical following government legislation brought in after 1776.

- 7.6 Part of a vaulted roof, probably forming the top of a northwest-southeast aligned drainage conduit, was recorded under the road level in Pall Mall. The conduit was formed of red stock brick, bonded with a hard greyish white lime mortar, and is considered to be at least late-18th century in date. This structure most probably represented a drain or sewer and as such may still have been live. It was found just below the concrete sub-base at a depth of 0.5m.

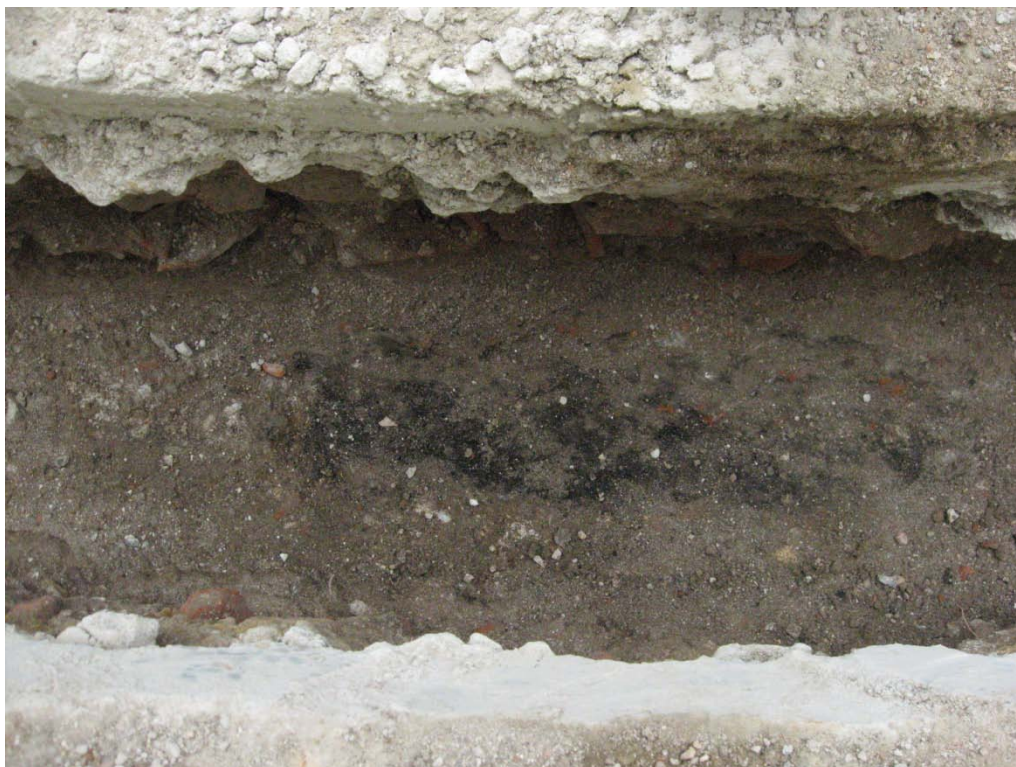
Plate 4: Deposit of burnt material [15], looking west

- 6.2.10 Two discrete areas of burnt material (contexts [14] & [15]) may represent evidence of the fire of 1809, though within the confines of the trench it could not be ascertained whether or not these were *in situ* deposits or re-deposited during the demolition of palace. Deposit [14] measured at least 0.66m by 0.2m extending beyond the limits of excavation, whilst deposit [15] measured at least 1.5m by 0.38m. They were observed at the formation level for the trench, approximately 7.15m OD.

- 7.7 Only limited evidence was found for deposits of archaeological significance pre-dating the creation of Marlborough Road. Two patches of burnt material, found at the base of the trench, may represent evidence of the fire of 1809, though it was not possible to ascertain whether or not these were *in situ* deposits or re-deposited during the demolition of palace.

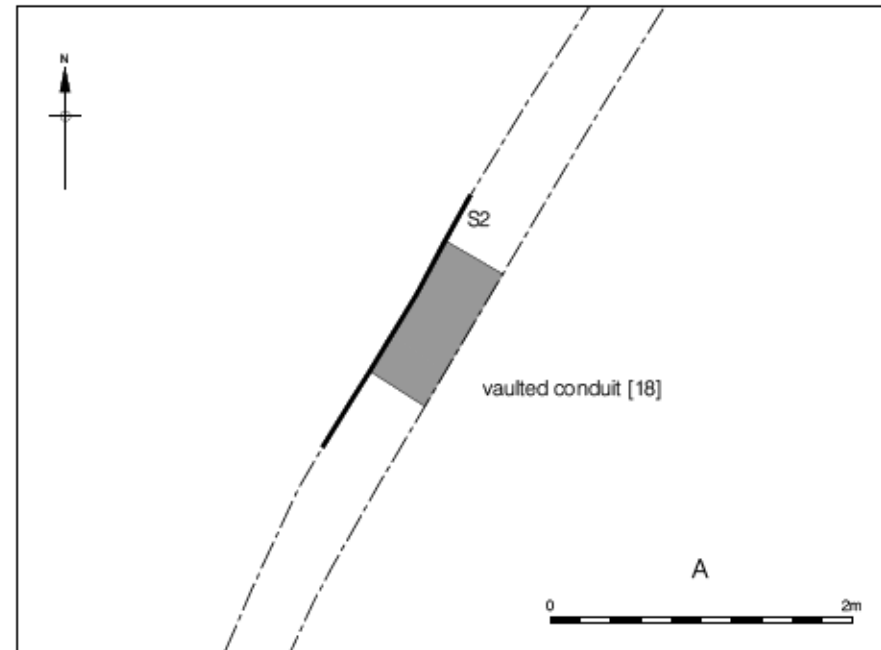
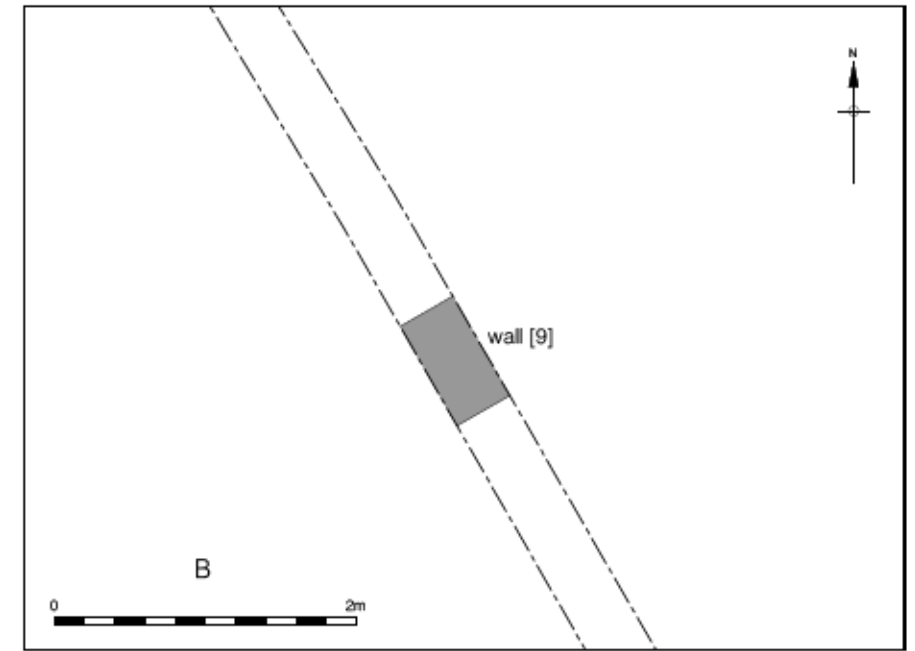
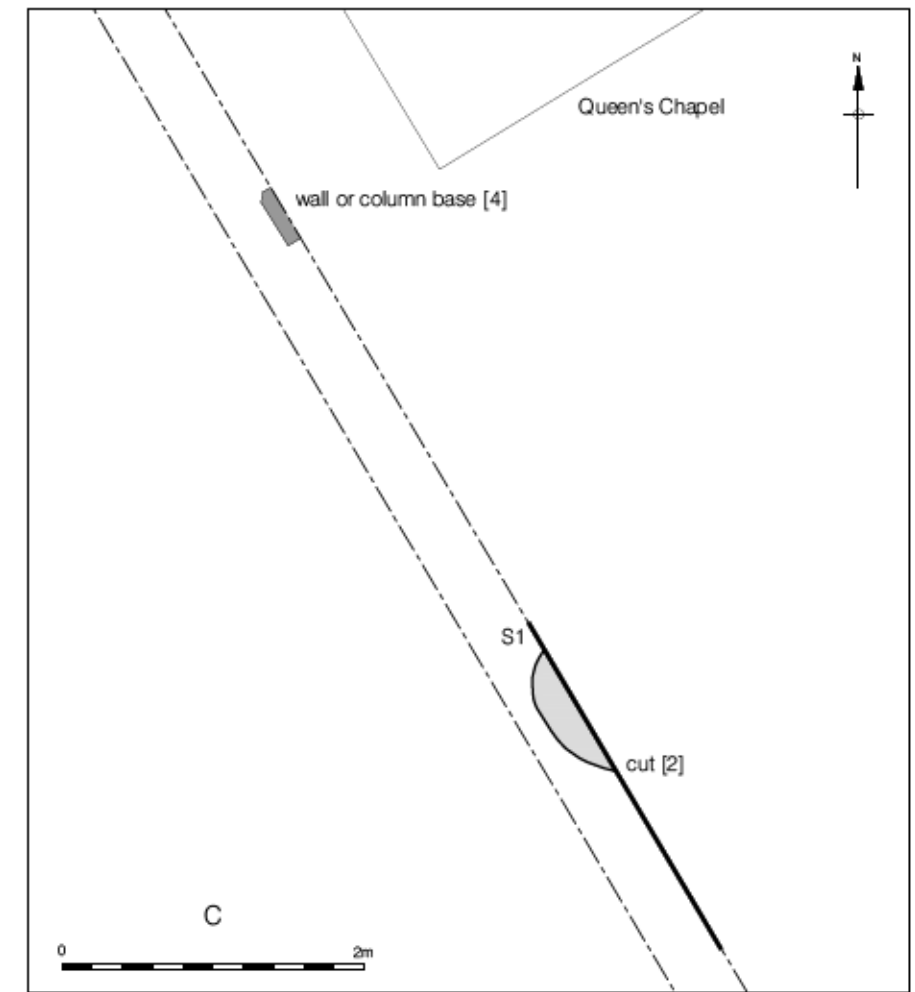
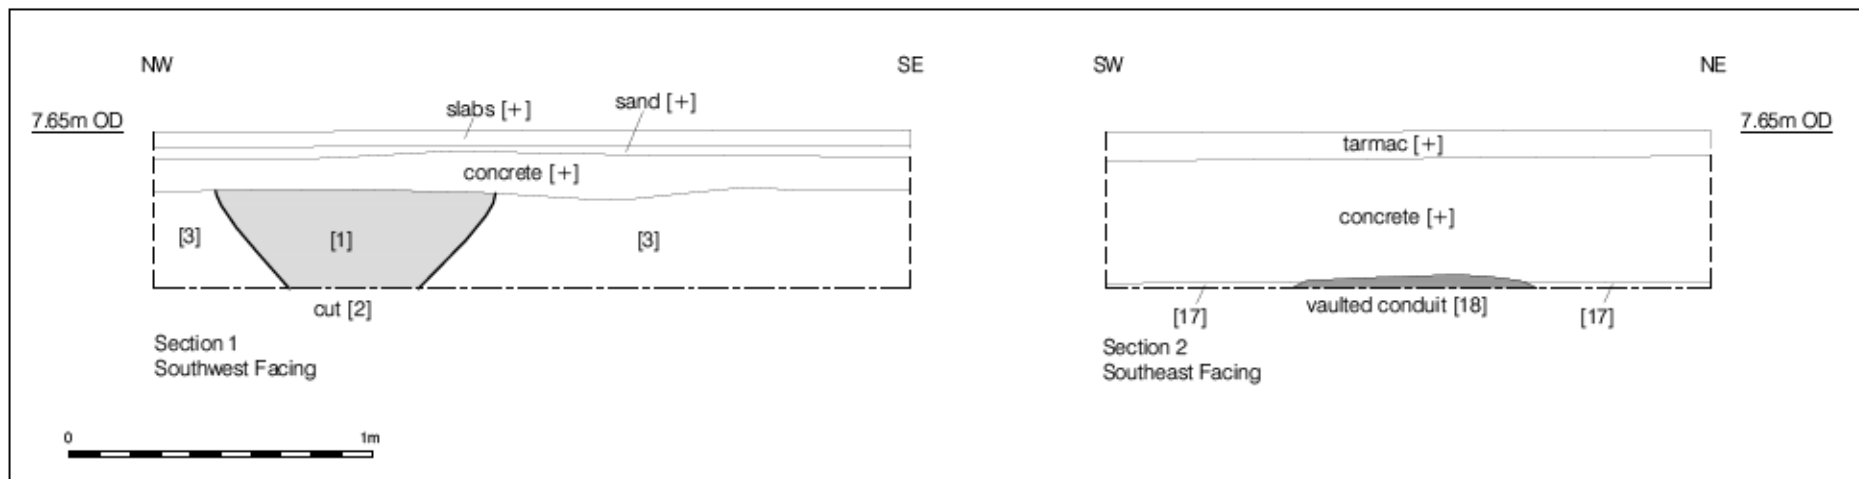
Figure 3
Trench Plan, Details and Sections
Plan: 1:500, Details 1:50, Sections: 1:25 at A3

- 5.3 All deposits were recorded on *pro forma* context sheets. The trench was planned at a scale of 1:20 and sections were drawn at a scale of 1:10 (Figure 3). The trench was located from ordnance survey plans of the locality. A full photographic record of the site was maintained. Finds, brick samples and environmental samples were collected according to standard retrieval methods as outlined in the Written Scheme of Investigation (Mayo 2015).

6.2.2 A masonry foundation [4] was recorded immediately in line with the southern wall of the Queens Chapel (Figures 2 & 3), which formerly formed the chapel for Marlborough House when it was still a functioning royal residence. This structure was observed in the eastern section of the trench.

6.2.3 Only a limited section of the foundation was exposed and observed, from which it appeared to be dressed and at least partly chamfered. No full blocks could be discerned, and as seen the remains measured 0.39m in length (north – south) by at least 70mm in height. Some hard grey lime mortar, flecked with brick and chalk stone inclusions, was observed associated with the foundation. It was located at a height of approximately 7.15m OD.

itself cut through demolition layer [3], located just below the pavement surface (Figure 3). Elsewhere was observed the edge of a modern telecoms cable trench [11], which was filled with a dark greyish brown, loose silty sand, containing frequent rubble fragments and charcoal flecks [10].
