**SOUTH-WEST ENTRANCE CAUSEWAY  
TOWER OF LONDON  
LB TOWER HAMLETS**

**ASSESSMENT OF AN  
ARCHAEOLOGICAL INVESTIGATION**

**TOL147  
OCTOBER 2015**

**An Assessment of an Archaeological Investigation at South-west  
Entrance Causeway Project, Tower of London, Tower Hill, London  
Borough of Tower Hamlets EC3N4AB**

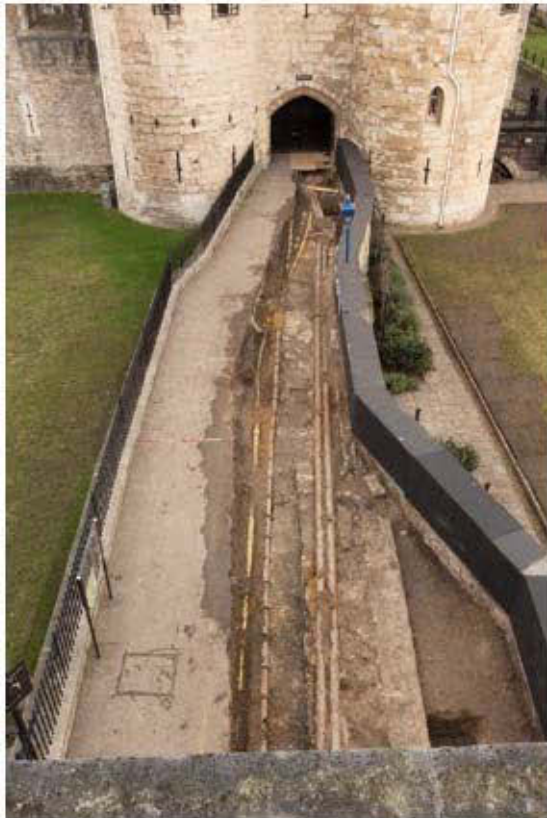
Plate 1: Causeway looking east towards Byward Tower, showing south wall [40/41], [43], [44] and foundation for road [39], with 2m scale.

7.2.4 Circa 1.37m to the north of and running parallel to [44] the inner face (north face) [40/41] was noted between 3.96m OD and 3.8m OD. Later truncations were noted impacting heavily upon this face. The masonry extended 6.5m from the 18th-century truncation (in the east) to where it was truncated by cast iron pipes in the west. A maximum width of 0.48m and height of 0.2m was recorded. The eastern portion of the masonry had an almost arch-like appearance, but this could be due to truncation. The fabric of [40/41] consisted of medieval yellow and pink/white bricks (fabrics TOL1; 3042nr303 1; 3101), which were comparable with Beauchamp Tower examples and were consistent with the known 1275-1285 date of structures, together with Reigate and Caenstone. These were bonded with a soft grey brown mortar.

- 7.2.7 Between [40/41] and [72] the masonry foundation of the entrance roadway [39] was seen rising from 3.76m OD (c. 3.5m to the east of the Middle Tower) to 3.83m OD (toward the centre of the causeway). It was unclear which type of stone or stones were used, but they did form a regular almost even surface. The road had also suffered heavily from later impacts which left the visible remains measuring 7.86m long by 0.84m wide. The thickness was not determined due to excavation limits.

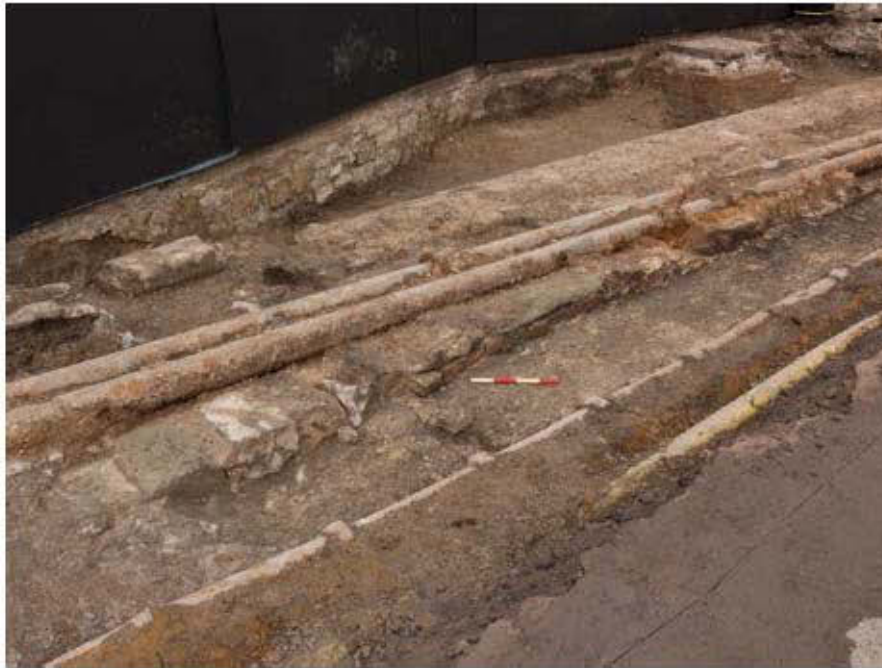
Plate 3: Southern causeway wall [40/41], [43], [44], road foundation [39] and present causeway wall [76] in background looking southwest, 0.4m scale.

7.2.5 The core [43] of the southern wall, which consisted of fragments of Kentish Ragstone and Reigate stone rubble, was seen between 3.86m OD and 3.76m OD. This measured 7.82m long by 1.2m wide (the base was not observed).

- 7.4.3 The southern causeway wall [76] was recorded at its highest points between 5.32m OD and 5.29m OD and ran from the Middle Tower to the Byward Tower. It had an irregular linear shape and an overall length of 33.06m with a width of 0.61m. The maximum height of the inner masonry was 1.68m, the outer height was not noted during these investigations. At its south-west extent the wall was located c. 1.6m to the south of [44], effectively widening the causeway in this area. The wall was seen to be comprised of ashlar blocks of Portland stone of varying sizes.

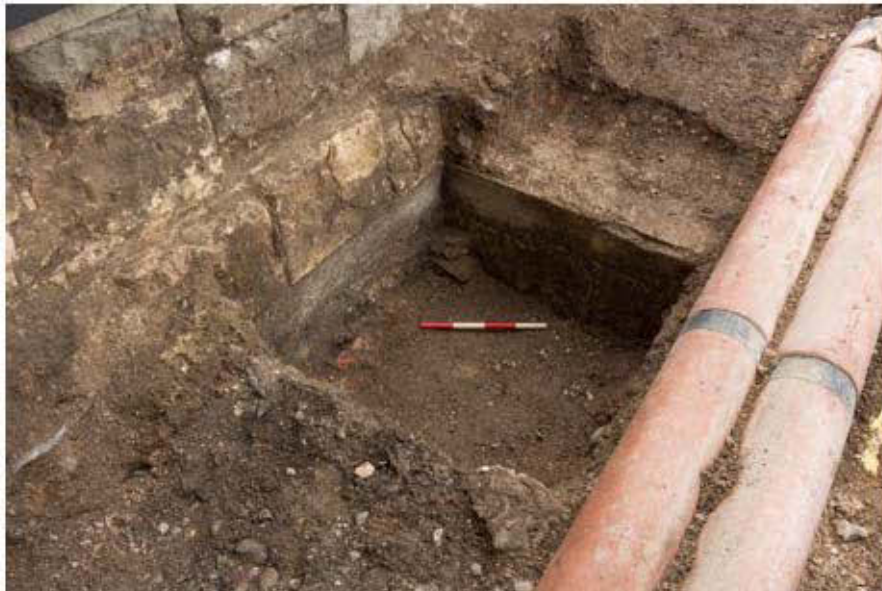
Plate 4: Southern and western walls [27] of drawbridge pit [8/27/65] under southern causeway wall [26], looking southwest, 0.4m scale

- 7.2.10 The drawbridge pit [8/27/65] was a rectangular defensive structure located in front of the Byward Tower measuring internally 6.1m (E-W) x 3.1m (N-S) (Fig. 7 Sections 9 & 10; Plates 4 & 5). All four sides of the pit were noted during the works. Three of the four inner faces (east, west and south) of the masonry were partially exposed during the excavations and the top of the fourth (north) was noted. The eastern side of the drawbridge pit was seen directly beneath the *in-situ* portcullis at the entrance of the Byward Tower. The highest recorded level was noted at 3.88m OD in the north and the lowest at 3.63m OD in the east. A 1m x 1m x 1m sondage (Sondage 2) was excavated in the south-west corner of the pit to a depth of 0.7m to investigate the fabric of the surviving masonry. This was seen to be comprised of ashlar blocks of Caen stone (0.6m x 0.8m), Purbeck marble (1.7m x 0.88m) and one large ashlar block of Tufa (seen on the south face near to the Byward Tower). The limited excavation revealed the upper course to be of Caen stone. Purbeck marble formed the course below and the next was Caen stone, giving the exposed masonry a two-tone appearance. It is unknown whether this banding continued further into the pit.

- 7.2.11 The southern causeway wall [9/26] was noted at 5.30m OD, above the drawbridge pit [8/27/65] (Sondage 2) (Fig. 7 Sections 5 & 9). This portion of the wall measured 4.59m in length by c. 1.66m high and was only visible between the drawbridge pit and the Byward

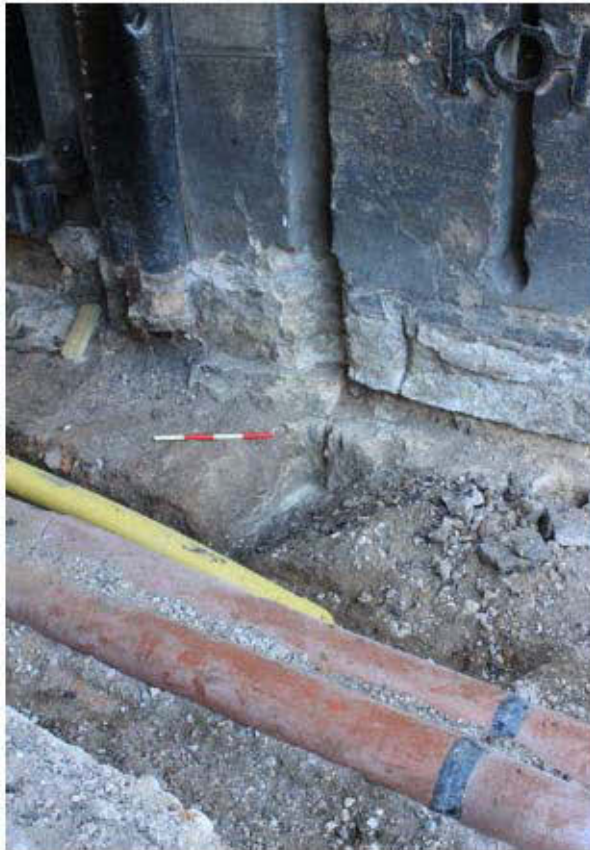
Plate 5: Eastern edge [8] of drawbridge pit [8/27/65] under outer port cullis slot, looking south east, 0.4m scale

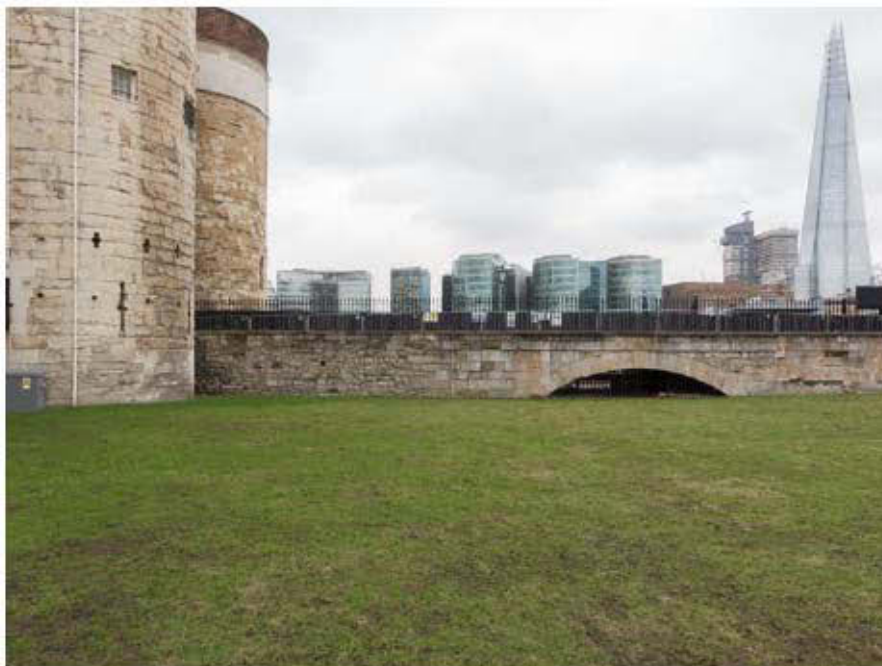
Plate 6: Central Arch of the Causeway with the Byward Tower looking south from within the moat, 2m scale.

- 7.4.6 A section of the central arch [36] was visible c. 0.84m to the north of [76] and c. 16.16m to the north-west of the Byward Tower entrance. This represented the upper portion of the western side of the arch. It was seen at a high point of 4.12m OD, toward the centre of the causeway, and sloped down to a low point of 3.85m OD (to the west). The exposed masonry measured 2.84m long by 0.86m wide; modern services and concrete had prevented further investigation. The fabric of the arch was seen to be ashlar blocks of Portland and Caen stone.

8.3.2 Only a small section of the central arch was seen during the excavations. This was a portion just to the west of the centre point, the rest of the arch was either covered or truncated by modern concrete and services. The construction cuts for the arch were seen in the east and west of the causeway truncating the earlier masonry.

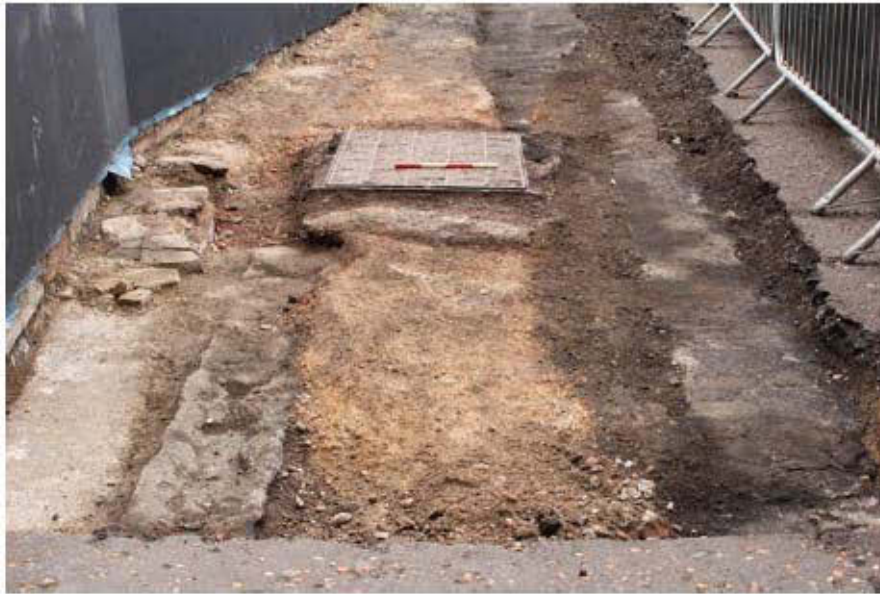
Plate 7: Concrete bedding for road [12], kerb [13], York Stone paving slabs [10] and bedding concrete [11], looking west, 0.4m scale

- 7.5.1 This period represents activities noted during the investigation dating from the 19th to 20th centuries.
- 7.5.2 This phase was dominated by the central concrete roadway [12] which was seen between the Middle and Byward Towers. The road was seen rising from a low point at 3.93m OD, near to the Byward Tower, to a high point of 4.16m OD, above the central arch, then falling to 4.04m OD at its western extent c. 3.0m from the Middle Tower. Modern pipe trenches and service ducts impacted heavily on [12]. The total length (E-W) of the road was 30.53m and the surviving width was c. 3.1m (N-S), the depth was 0.15m.

- 7.5.8 In the west of the study area a layer of demolition material [21] was seen between 4.04m OD and 4.03m OD measuring 1.m (N-S) x 3.2m (E-W) covering backfill deposit [46/48/52]. CBM recovered from this was spot dated 1700- 1900.
- 7.5.9 Late 20th- century deposits associated with the entrance road were recorded across the causeway and at the Byward Tower. At the Byward Tower a sequence of bedding and make up deposits [14], [15], [16] for the granite setts of the former roadway were recorded (Fig. 7 Section 7) .
- 7.5.10 Masonry including York Stone slabs [10], concrete foundation [11] , [14] and [15], a granite block [1], concrete kerbs [3] and [13] associated with the former footpath were noted in the south-east of the causeway (Plate 7) .
