**Land at Combined Colleges
Boathouse, Logans Way,
Cambridge CB4 1BL:
Archaeological Monitoring**

ARCHAEOLOGICAL MONITORING

Pre-Construct Archaeology Ltd	
Project Number	K3938
Report Number	R12178

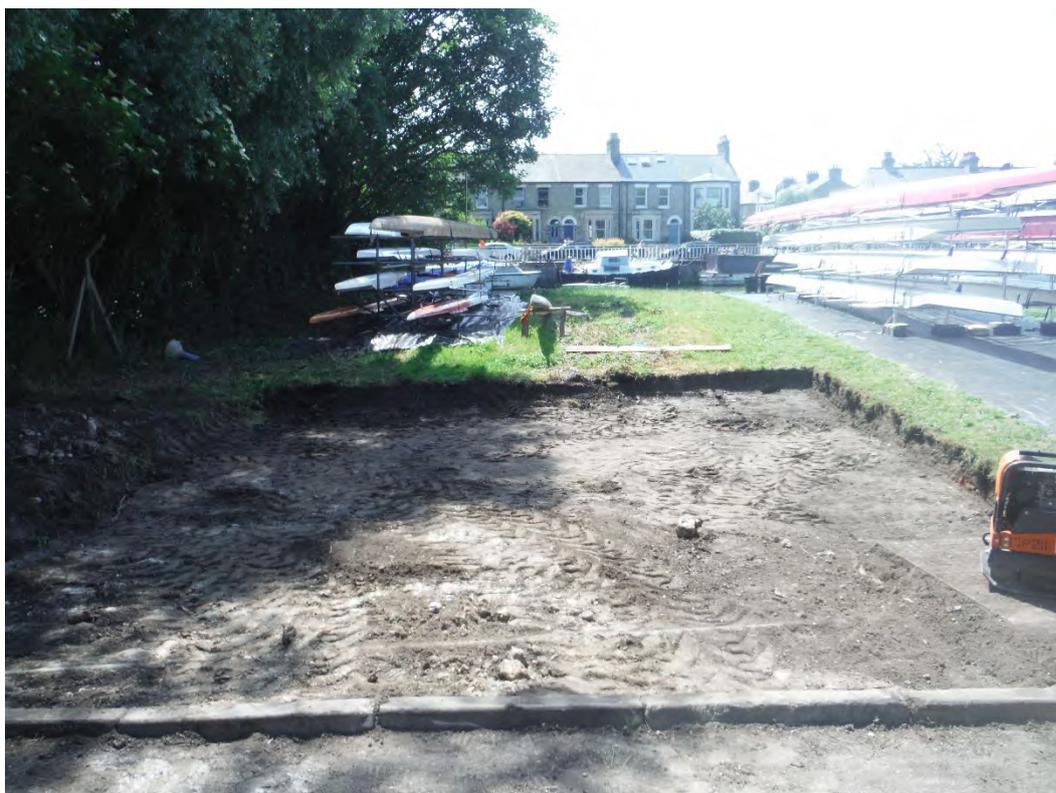
Plate 1: Topsoil strip monitored on 16th May, looking south

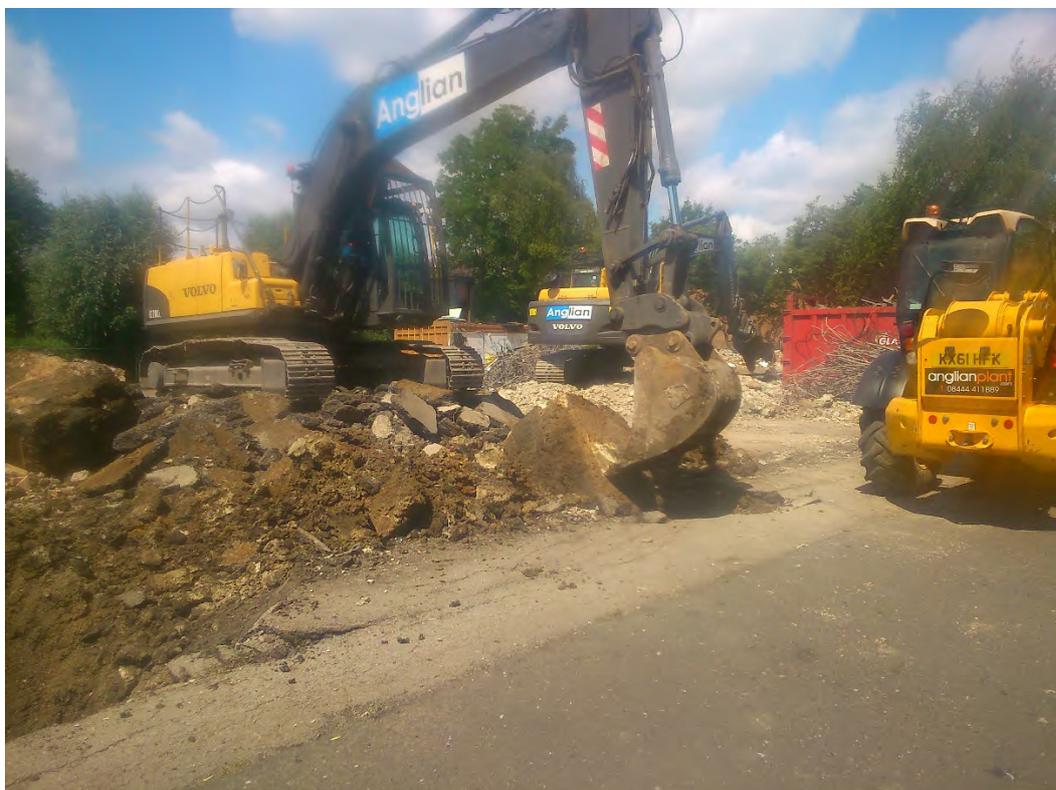
- 5.1.2 The removal of 16 concrete pads was monitored on the 6th July 2015. No archaeological features or deposits were encountered during this process. The removal of the foundations revealed a sequence of tarmac and concrete hardstanding overlying a thick made ground deposit comprising crushed brick and concrete. This in turn overlay the natural alluvium. These holes were then infilled with made ground and the site levelled.

Plate 2: Removal of concrete pads, 6th July

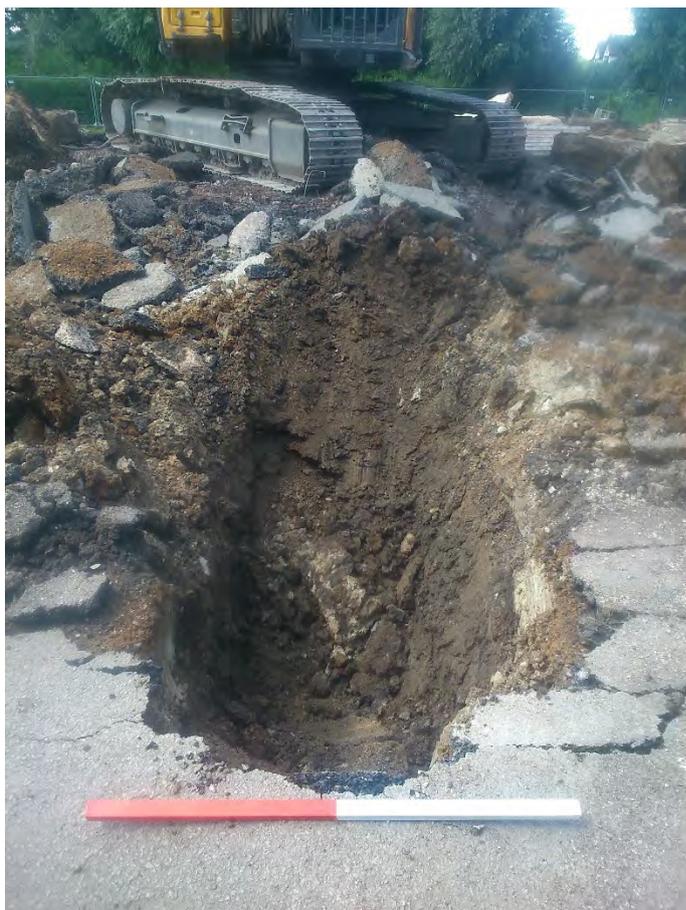
- 5.1.3 On average, the tarmac measured between 0.2m and 0.25m thick, with the made ground deposits measuring approximately 0.25m-0.3m. The concrete pads were each approximately 2m by 1m and 0.8m deep. The removal of these pads exposed a series of holes measuring between 1m and 1.25m in depth, where the top approximately 0.5m comprised modern layers sitting above the natural alluvium.

Plate 3: Made ground and alluvium revealed whilst removing concrete pads

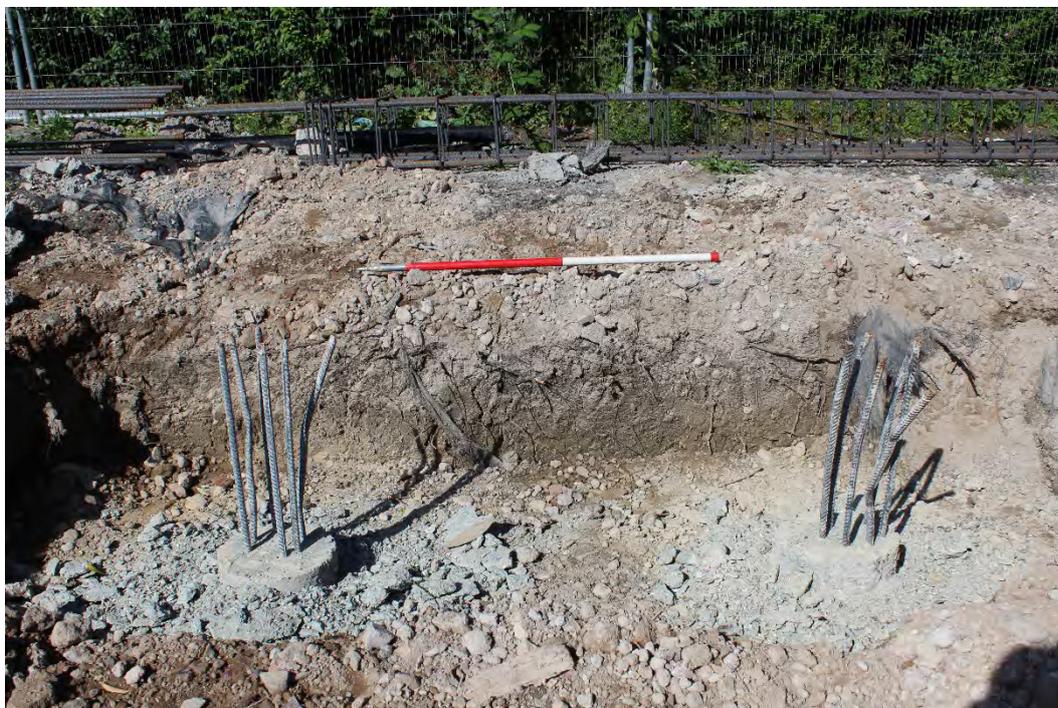
- 5.1.4 The digging of 17 holes for new concrete piling pads was monitored on 4th August 2015. These holes comprised 11 rectangular pits (approximately 3m by 1.5m and 0.6m deep), five triangular pits (approximately 3m by 3m by 3m by 0.6m deep) and a single narrow trench (approximately 2m by 0.5m and 0.6m deep). Most of the holes occupied the same locations as the former concrete foundation pads and hence only exposed the recent backfilled made ground. Within the 'new' holes, no archaeological features or deposits were seen and the sequence of deposits was as described above, with up to 0.3m of made ground overlying the alluvium.

Plate 4: The new foundation pits exposing recently backfilled made ground, the concrete pads and piles, looking west.

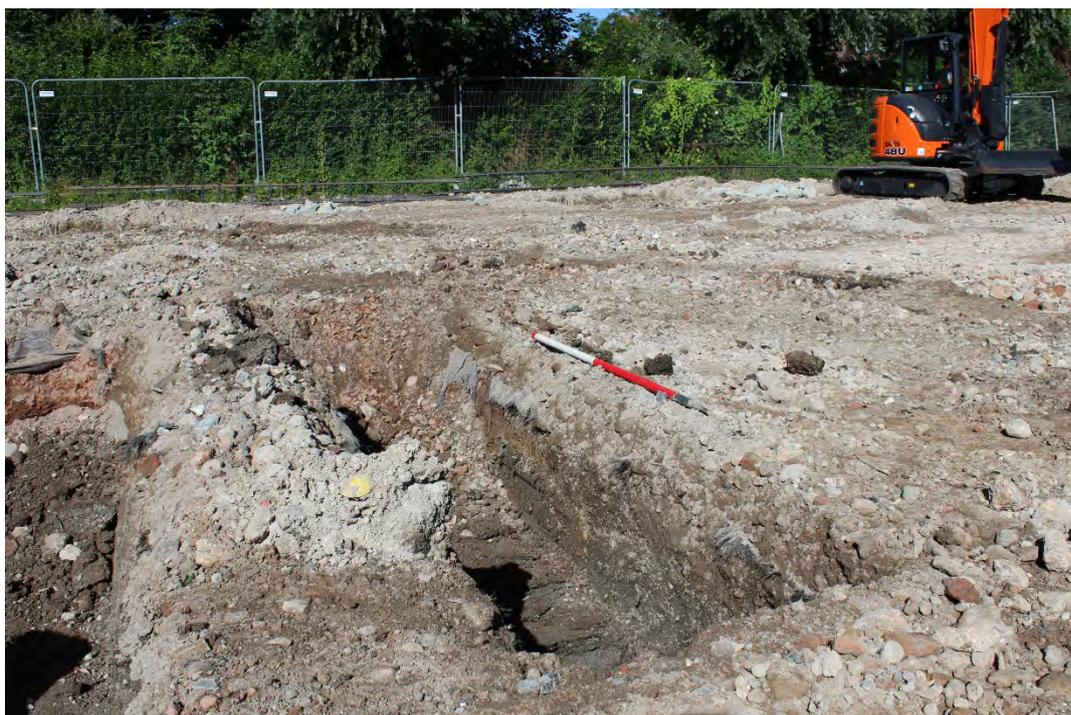
- 5.1.5 Within the narrow trench, located centrally within the development plot, a localised area of a more organic alluvium was noted but contained no archaeological material.

Plate 5: The narrow trench located centrally to the development plot exposing made ground overlying an organic-rich alluvium, looking northwest
