**THE ORANGERY YARD,
KENSINGTON PALACE**

**AN ARCHAEOLOGICAL
INVESTIGATION**

PCA REPORT NO: 12278

SITE CODE: KEN27

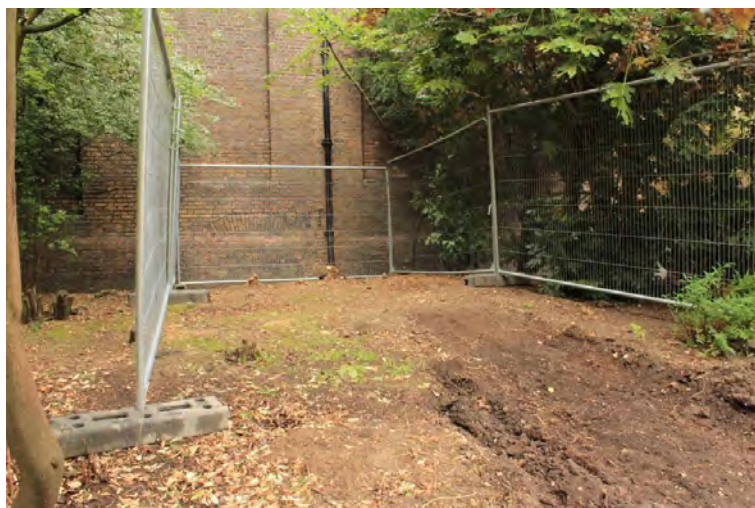
Plate 1: Trench 1 looking south, pre-excavation, showing earthen bank and the blind arch on the north wall of the Orangery

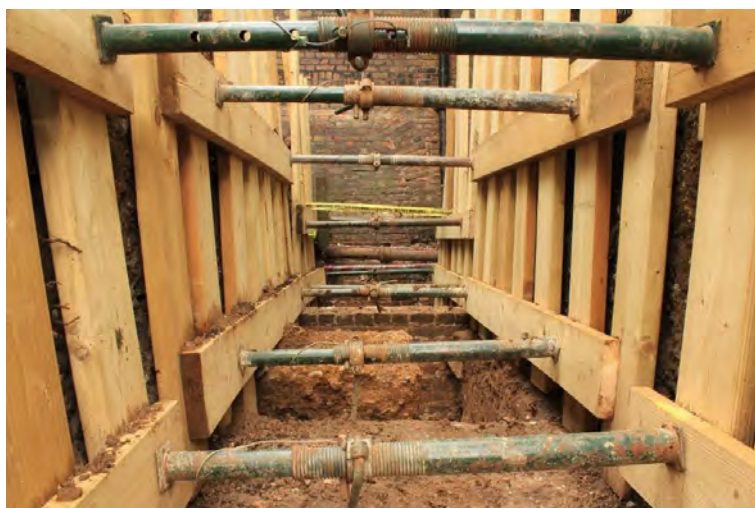
Plate 2: Trench 1, with shoring, looking south showing foundation pad [23], wall [41] and the partially obscured blind arch on the north Orangery wall.

- 6.4.17 The construction cut [24] for a compacted sand and gravel foundation pad [23] was seen cutting into layer [22] at 26.87m OD. The pad [23] was at least 0.8m (N-S) x 0.7m (E-W) and 0.58m deep as it extended beyond the eastern LOE (Figure 6, Plate 6). No evidence of an upper structure was apparent during the investigations.

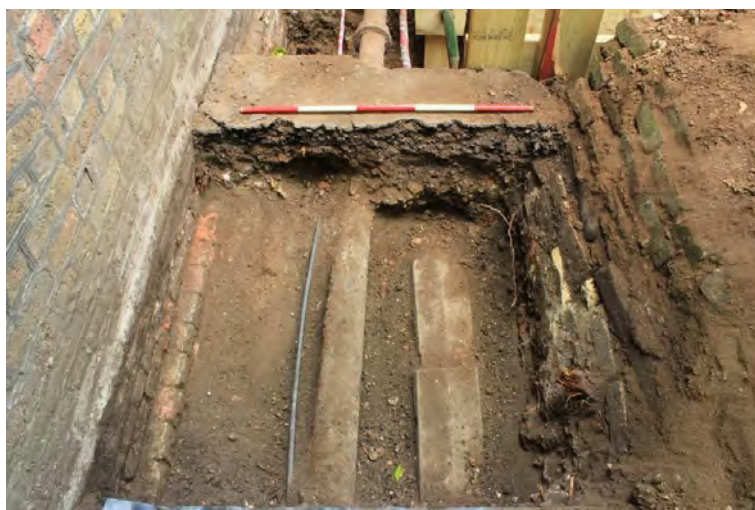
Plate 3: TP 3 looking west showing live services and Trench 1 in the background, 1.0m scale

- 5.4 The three test pits (TP2, TP3, and TP4) were hand excavated against the northern wall of the Orangery to ascertain the depth and form of the foundations (Figure 2). CAT scanning detected live services in all three test pits. TP2 was located to the east of TR1 and measured 1.6m (N-S) x 2.0m (E-W) with a finished depth of 1.25m. TP3 was located 0.4m to the east of TR1 and measured 1.5m x 1.5m and 0.4m deep. TP4 was located to the immediate east of TP2 and measured 2.0m x 1.9m x 2.45m deep. The foundations of the Orangery were encountered in TP4. In TP2 excavation ceased due to the presence of a late 18th-early 19th century culvert [55] and TP3 was abandoned because of the live services.

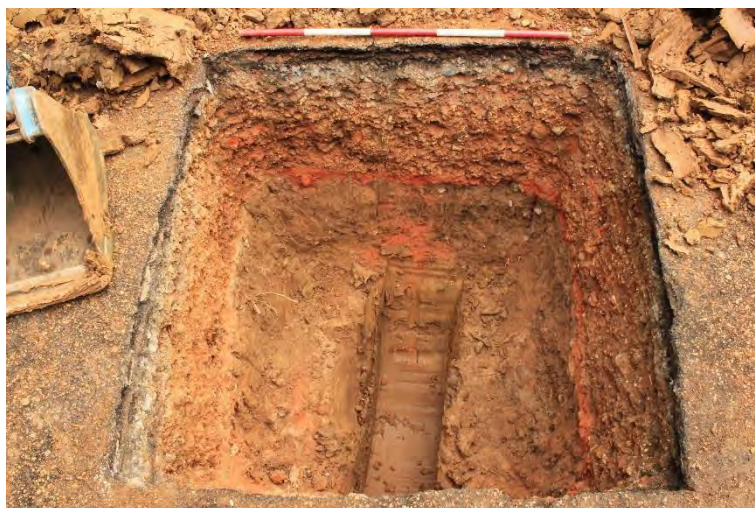
Plate 4: BH2 looking east showing natural clay [16] at the base of the test pit and crushed red brick layer [14], 0.4m scale.

- 6.1.1 The earliest deposits encountered during the excavations were layers of London Clay seen in BH 1, BH 2 and Trench 1. In BH 1 the clay [9] was a mid-brownish yellow colour seen at 26.16m OD with a thickness of c. 3.3m. As seen in BH 2 the clay [16] was a light-brownish yellow colour, noted at 26.11m OD to be 1.2m thick. In Trench 1 the clay [60] was a light brownish grey colour and was recorded at 26.45m OD with a thickness over 0.8m.

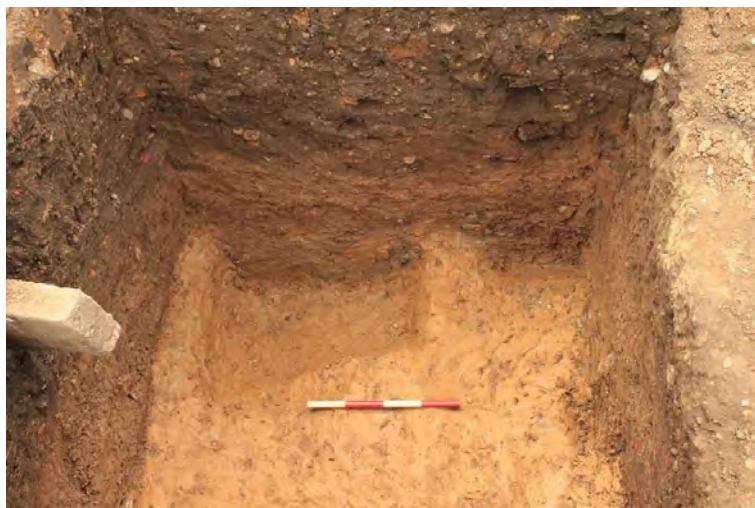
Plate 5: BH 1 looking south, showing shallow pits [6] and [8], 0.4m scale

- 6.3.1 Three shallow pit cuts [6] (fill [5]), [8] (fill [7]), [12] (fill [11]) were noted above the natural alluvial clay [9] in BH1 (Figure 3). No brickearth was encountered in this borehole or in Borehole 2. These have been interpreted here as possible early garden features and were filled with similar deposits of light brownish grey, clay with occasional charcoal flecks and CBM. Pit [12] was only seen in section, with a gradually sloping northern edge and an almost even base, at 26.16m OD with a depth of 0.2m. The portion of [6] which was seen in plan was recorded at 25.95m OD measuring 0.4m (N-S) x 0.6m (E-W) with a depth of 0.15m, the rest of the feature

lay beyond the southern LOE. The cut was described as sub-rectangular shaped with steeply sloping sides and a horizontal base. Circa 0.2m to the west of [6], pit [8] was seen extending into the western and southern LOE at 25.95m OD. Only a fraction of the north-eastern edge of the feature was evident in plan, having a slightly curved shape with shallow gently sloping sides, only 50mm deep. As exposed it had dimensions of 0.1m (N-S) by 0.3m (E-W).

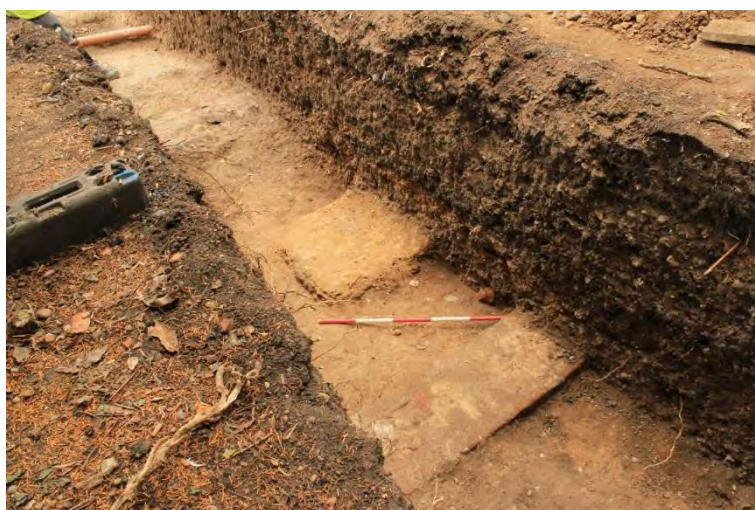
Plate 6: Trench 1 looking northeast showing foundation pad [23], wall [25] and the upper portions of section 4, 1.0m scale

- 6.4.4 Approximately 3.1m to the north of the southern edge of TR1 (the north wall of the Orangery) a segment of an east to west wall [25] was recorded at 26.84m OD extending beyond 1.15m into the east and west LOEs (Figure 5). The brickwork was 11 courses high (0.95m) and 0.58m wide and consisted of whole narrow post great fire unfrogged bricks (fabrics 3032, 3046), 220mm x 100mm x 60mm, with hard grey type gravel mortar. The construction cut [70] for wall [25] was seen in plan and section, at 26.36m OD, with gentle to steeply sloping sides. It was not possible to reach the base of cut, which also extended beyond the trench edges leaving the visible segment measuring 0.45m (N-S) x 1.2m (E-W) x 0.5m deep. Two construction backfill deposits were noted: a clay [72] lower fill and an upper redeposited brickearth fill [71].

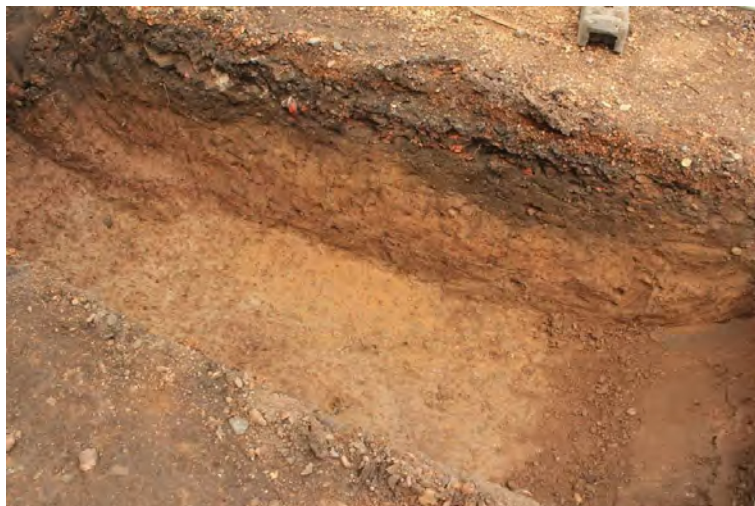
Plate 7: Trench 1 looking southwest showing section 5.

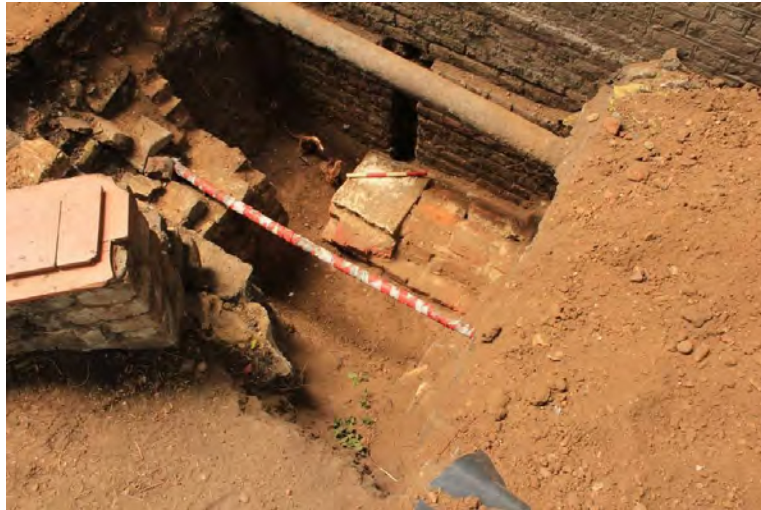
Plate 8: TP 2, post excavation, looking southeast showing culvert [55] with niche in the north wall of the Orangery and brick inspection chamber [27/56] in left of frame, 0.4m scale.

- 7.1.10 The brick culvert [41/55] noted in Trench 1 and TP 2 was most likely a rainwater drain. A niche noted in the Orangery brickwork in TP 2 suggests that a gutter downpipe fed into the culvert. The investigations showed a fall in level from west (Trench 1) to east (TP 2) and a possible termination in TP 2. Bricks from the culvert are dated from the late 18th century, and at least one brick displayed evidence of reuse (Appendix 3). This date fits extremely well with a recorded overhaul to the structure in 1781 which “took-in the roof, north wall, sashes, doors, wainscot, gutters and pipes” (Gregory 2015, 6). Due to the limited scope of the investigations it is uncertain whether the culvert fed into the void noted in the southeast of Trench 1, although this does remain a possibility.

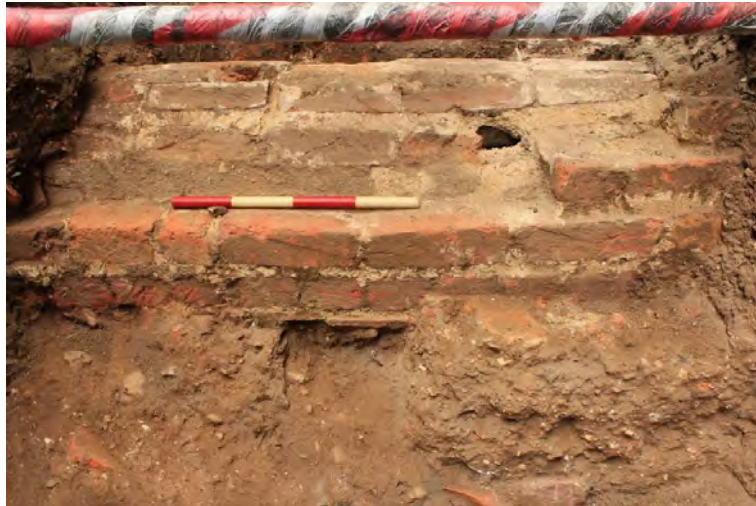
Plate 9: Trench 1 looking south showing culvert [41], 0.4m scale

- 6.4.21 Cut [35] was a linear N-S construction cut for a brick culvert [41] which ran parallel to and abutted the northern wall of the Orangery. The cut was seen in section at 26.97m OD and extended beyond the eastern and western trench edges. The visible segment was 1.12m wide (N-S) and 0.59m deep. Culvert [41] was noted at 26.88m OD and had a curved roof set on two courses of brick laid on a tile base. The bricks were whole post great fire brick (fabrics 3032 and 3046), 230mm x 100mm x 70mm, that were bonded in a gravel mortar. The brick fabrics imply a date from the late 18th century (Appendix 3), and a fragment of red post medieval brick in a brown mortar was also noted suggesting at least some of the bricks were re-used. To east of Trench 1 in TP 2 the culvert continued and was recorded as [55]. In this location it was encountered at 26.66m OD and appeared to terminate (Figure 7). A slab of stone covering a possible access point into the culvert was mortared into the brickwork. Also a vertical niche was noted in the brickwork of the Orangery, possibly for a downpipe into the culvert. In Trench1 it was agreed with Historic England that part of the culvert could be removed. This revealed the remains of a very dry infill deposit [47] which consisted of mid greyish brown silty clay with frequent mortar. Construction backfill deposits were recorded in both locations. In Trench 1 this was a light to mid greyish brown silty sand [34] and in TP2 the backfill [54] was a similar deposit which contained late 17th to early 18th century glass and pottery. Of note was a fragment of architectural cornice made of Ketton stone, also recovered from [54] (see Appendix 3).

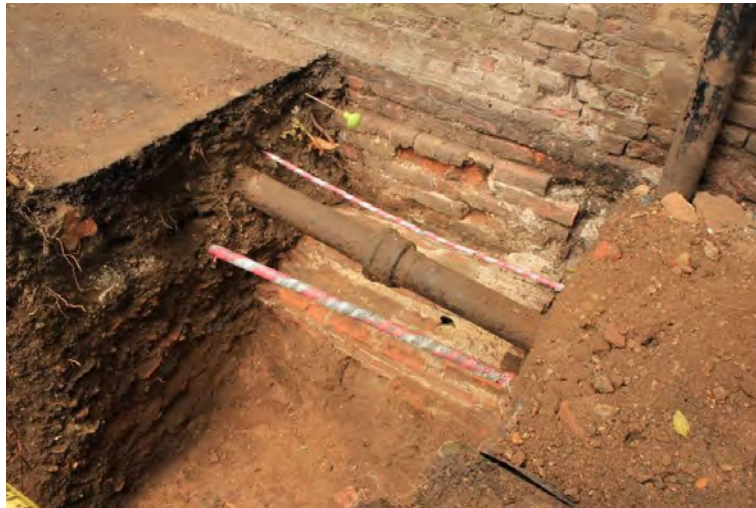
Plate 10: Trench 1 looking southeast showing the north wall of the Orangery and culvert [41] with live services above.

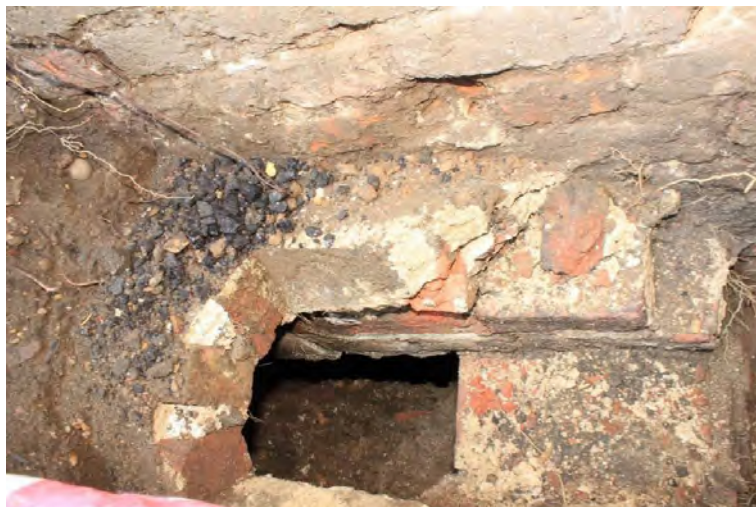
Plate 11: Culvert [41] looking southeast after partial excavation showing internal void

- 6.4.22 A large void was noted to the east and behind the culvert. This extended under the “blind arch” seen on the north wall of the Orangery. Despite the limited access to the void, it was possible to ascertain that it was to be over 4m deep with water at the bottom. Photographic records also show the interior to be a curved brick structure suggesting it was a well, still containing water at its base. Precise measurements could not be obtained, but it appeared to have an internal diameter of approximately 1m and a depth to water level of at least 3m. |

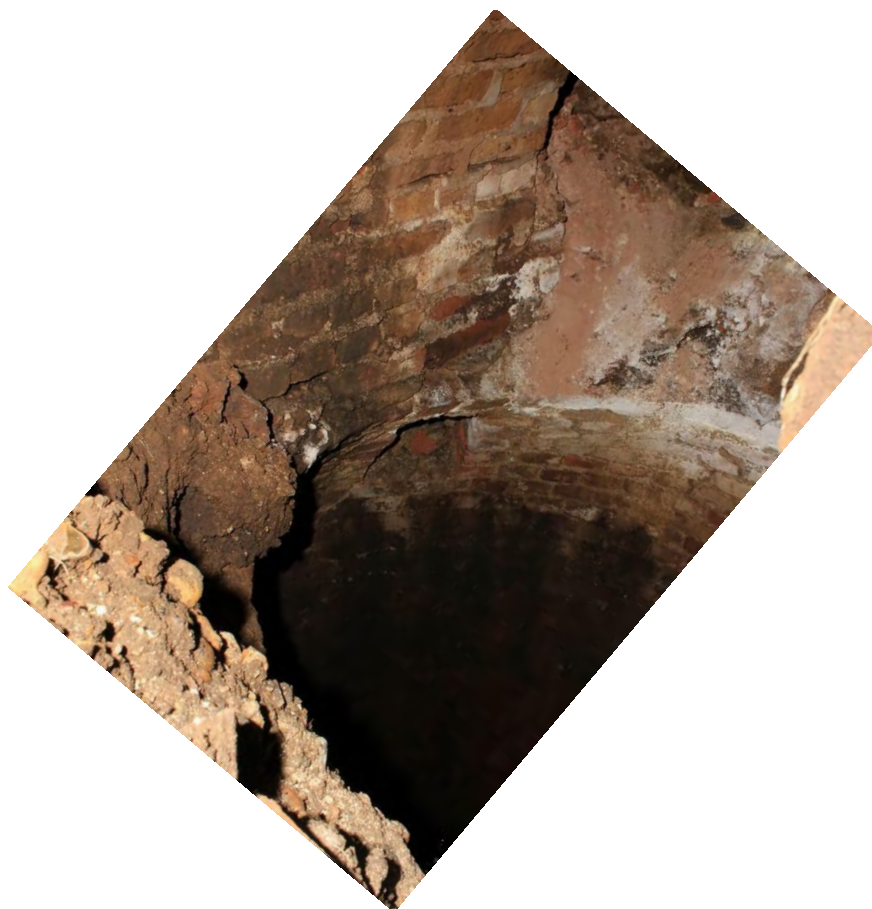
Plate 12: Trench 1 looking southeast showing well within the void

- 7.1.11 The void noted to the southeast of the culvert in Trench 1 and under the Orangery was a well shaft, with water extant within the structure. It is considered that the blind-arch built into the northern wall of the Orangery forms the above-ground superstructure to this well. Behind the blind-arch was a curved niche structure. Inspection of the well and the inside of the blind-arch was only possible by means of CCTV cameras and therefore the interpretation of them must remain subject to confirmation. It is uncertain if this feature is contemporary with, earlier to or later than the Orangery. How it was accessed when in use is also unclear as only a small portion was visible during the investigations.

- 7.2.7 The well shaft noted under and to the southeast of the culvert in Trench 1 extended under the main building of the Orangery in the area where a blind arch is seen in the brickwork of the northern wall. This is likely a well which acted as a water source for the plants kept in the building, or for the boilers thought to have existed in the yard behind. How this was accessed is uncertain, whether from inside the Orangery or from the building to the rear (boiler/store room). It is also uncertain if the culvert fed rainwater into it. The relationship between the well and the blind arch is unknown as only a tiny section was seen and this was obscured by the culvert.

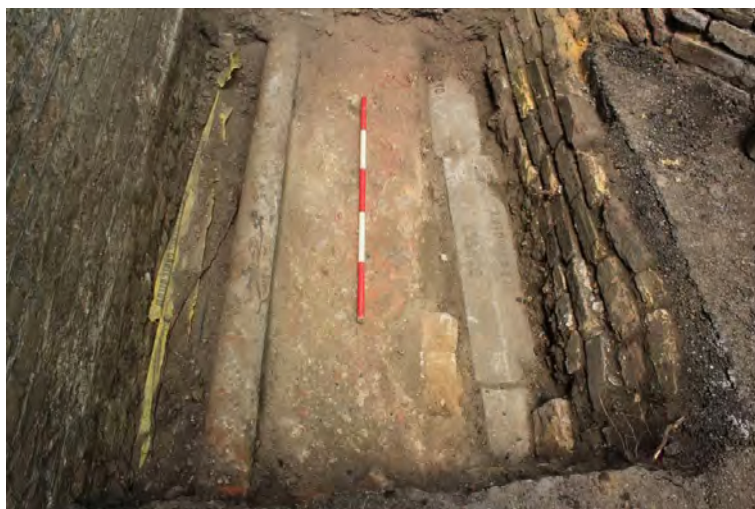
Plate 13: TP 2 looking west showing mortar surface/bedding deposit [26], 1.0m scale

- 6.4.25 The surface was also truncated by a brick inspection chamber [27/56] in the northeast corner of the test pit. The brick chamber continued into TP4 (recorded there as [77]) revealing the length of the outer edge of the brickwork to be 1.62m long with a width of 0.22m and an overall depth of 1.16m. It appeared to be square or rectangular shaped and extended beyond the northern edges of both test pits, making it over 1.12m in this direction. Re-used bricks, with shallow frogs, (probably sourced from elsewhere at the Palace) were used to build the chamber, these were bonded with a light yellowish brown sandy mortar. A high point of 27.34m OD was recorded in TP2 and a low point at 27.10m OD in TP4. The construction cut [79] and associated construction backfill [78] were visible in section in TP4 but were not apparent in TP2. In TP4 the cut was seen truncating the made ground [80] at 27.13m OD.

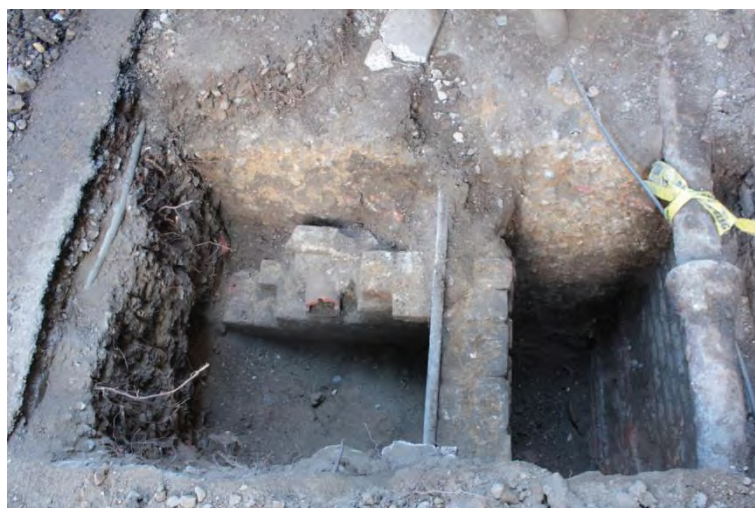
Plate 14: TP4 Looking east showing Orangery wall [86] in the right of the frame, Inspection chamber [27/56/77] in the bottom left and concrete pad [87] in the top

- 6.5.8 A large concrete foundation pad [87] was recorded to the immediate east of and truncating a clay drain pipe that fed into chamber [27/56/77] at 27.34m OD. This comprised sub-rounded gravels in a light yellow brown sand matrix and had an indurated compaction. The pad abutted the Orangery wall [86] and extended beyond the northern and eastern excavation limits, making the pad over 1.93m (N-S) by 1.02m (E-W) with a thickness of 1.2m.

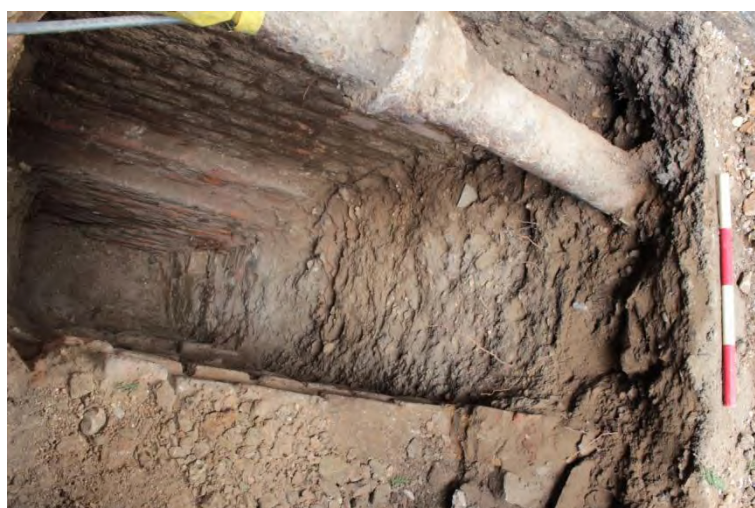
Plate 15: TP4 post-excavation looking southwest showing the north Orangery wall [86] and section 7 in the right of the frame, scale 0.4m

- 6.4.2 The section of the Orangery wall [86] that was revealed during the works in TP4 comprised a three step brick footing that descended 2.4m (27.64m OD) from the present ground level to the base of the brickwork (25.24m OD). Each step was 60mm wide giving a combined width of 0.18m (Plate 16). The basal course of bricks appeared to sit on a thin bed of sandy mortar. It was not practically or safely possible to obtain any further information on the bedding material. Two construction backfill deposits were noted: the primary fill was a very compact, mid-grey brown clay [83] with moderate inclusions of CBM and charcoal flecks. This was noted at 26.16m OD to be 0.9m thick. The upper fill [82] was a compact light to mid brown grey silty clay with occasional charcoal flecks, CBM and small sub-rounded gravels. It was seen at

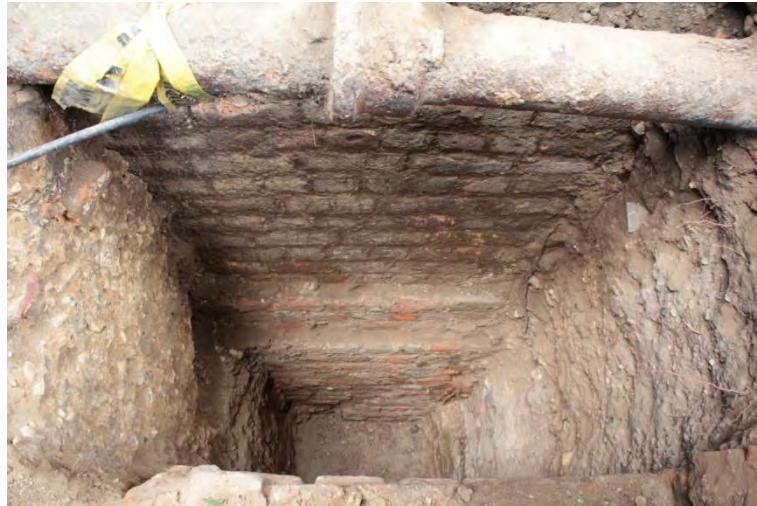
*Plate 16: TP4 post-excavation looking south, showing the base of the Orangery [86],
concrete pad [87]*
