**Former SEB Depot,  
Back of the Walls,  
Southampton, Hampshire  
Report on an  
Archaeological Watching  
Brief**

**May 2016**

Archaeological Watching Brief Report R12225

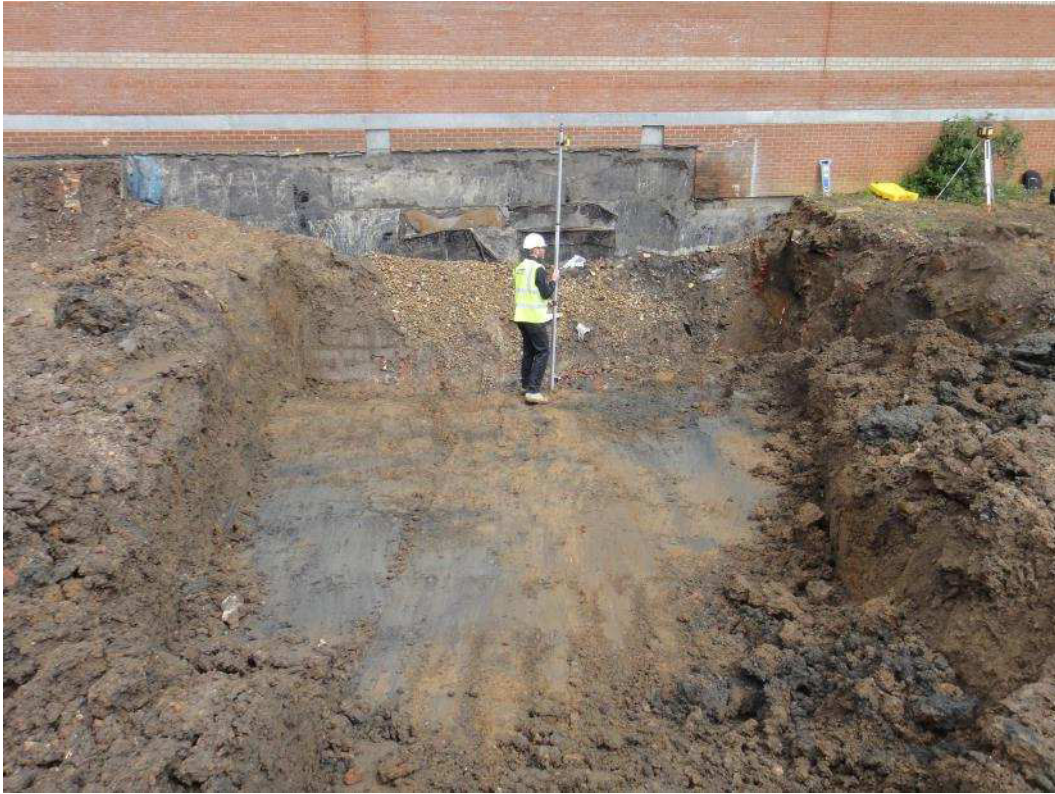
Plate 1. General view of base of northern end of Trench 6

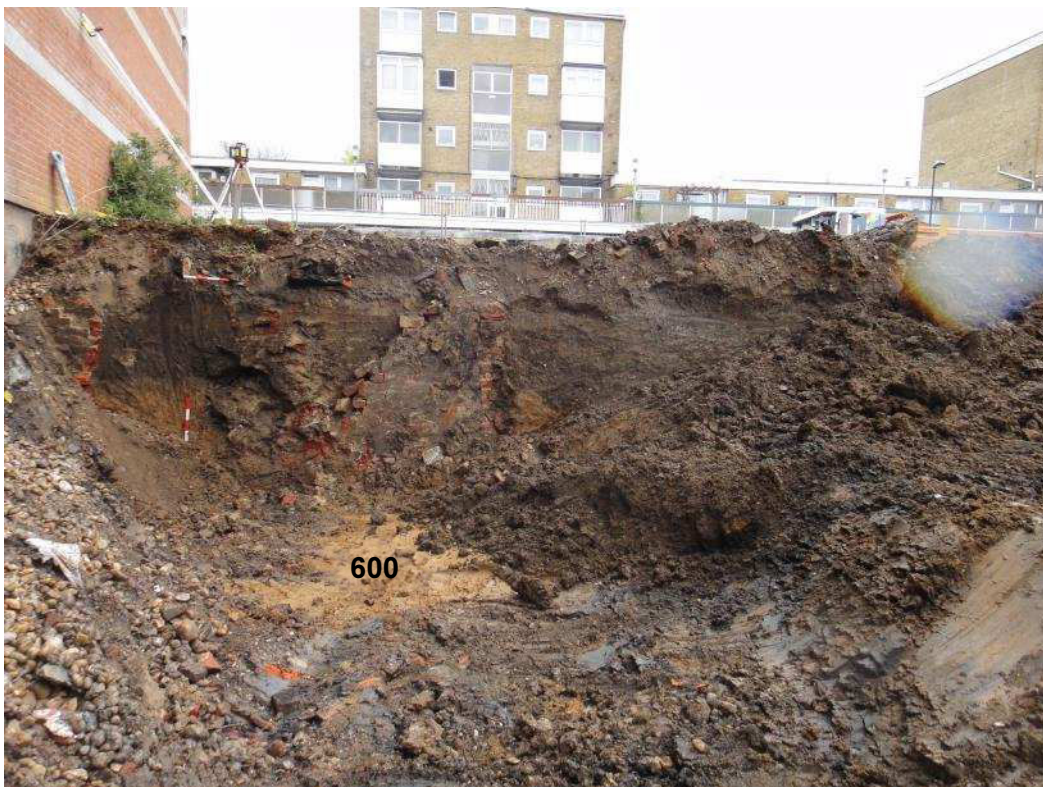
Plate 4. Northern end of west-facing section of Trench 6 showing hand-cleaned section and natural brickearth, **600**, at base of trench. Scales: 2 x 0.4m.

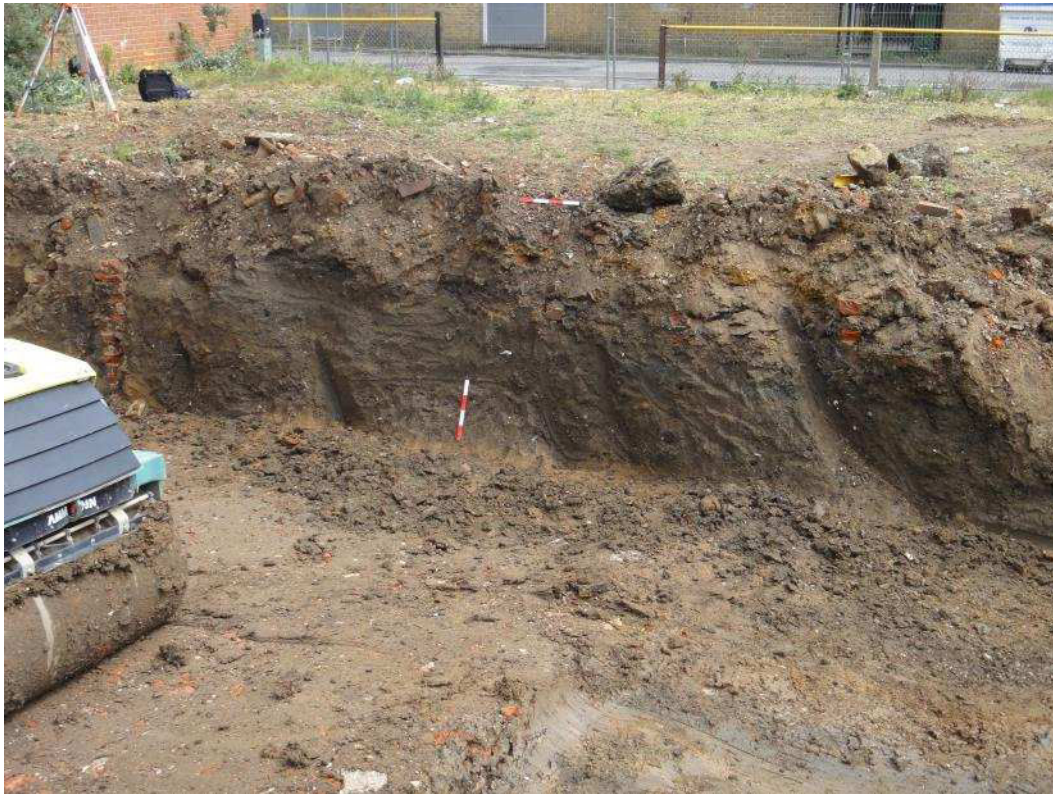
Plate 5. West-facing section of T6 south of brick cellar walls. Scales 2 x 0.4m.

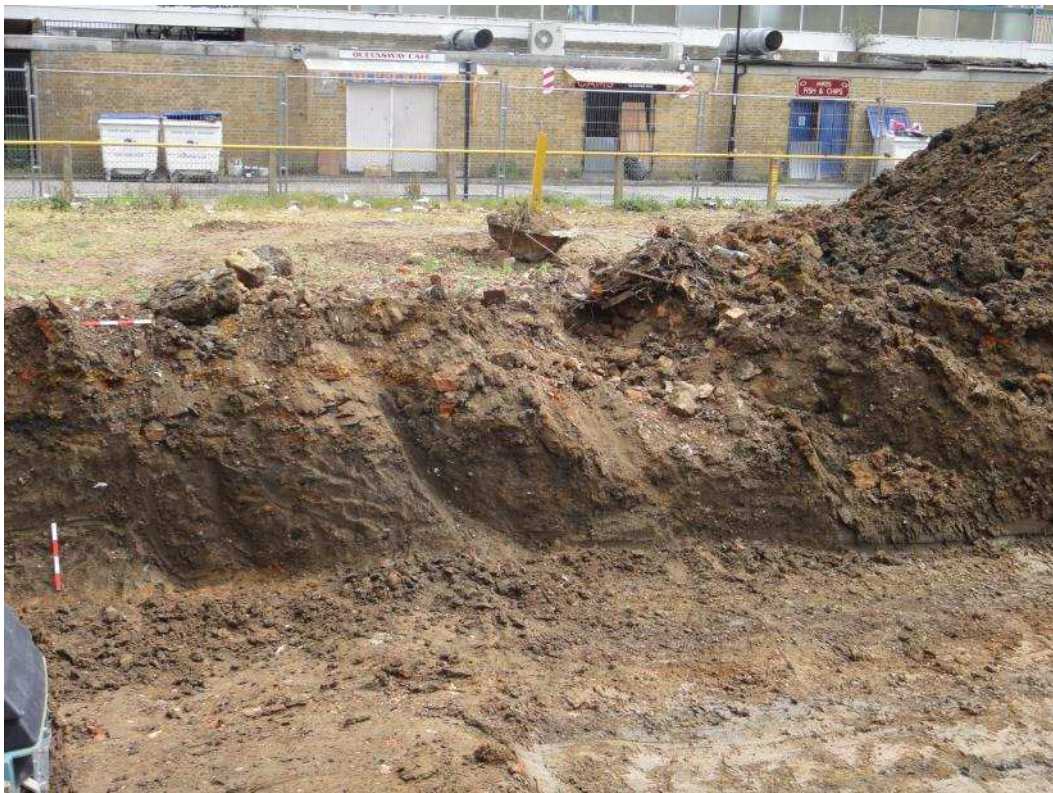
Plate 6. West-facing section of T6 to the south of Plate 5. Scales 2 x 0.4m.

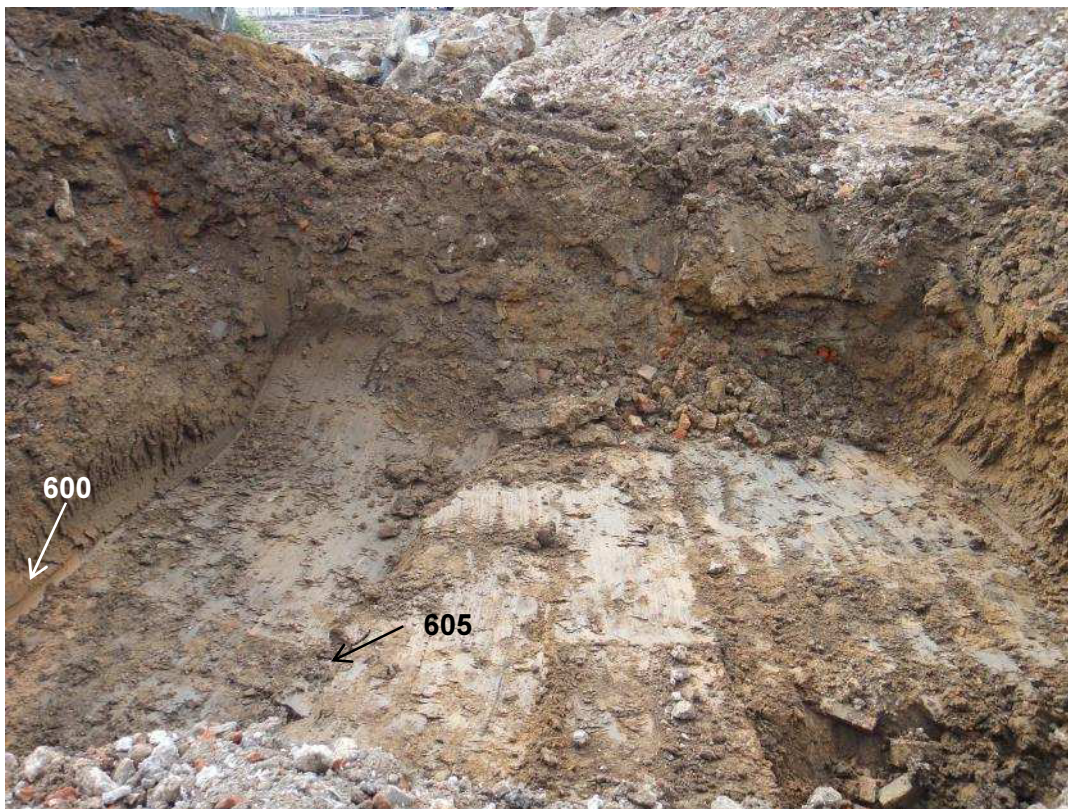
- 4.1.12 At the southern end of the trench **605** appeared to extend into the west-facing section of the trench (**Figure 7**; **Plate 7**) where it was recorded to a depth of approximately 0.5m cutting natural brickearth **600** and also appeared to extend into Trench 7 to the south and is possibly represented by deposits **716**, **717** and **718** in the east-facing section of Trench 7. If this interpretation is correct, then **605** appears to terminate within this trench as these deposits appear to be cut by **714** or overlain by deposit **715** and did not appear to extend into the north-facing section.

Plate 7. South-east corner of Trench 6, showing linear feature **605** running into section where it cuts natural? Brickearth **600** in west-facing section of trench, looking south. No scales.

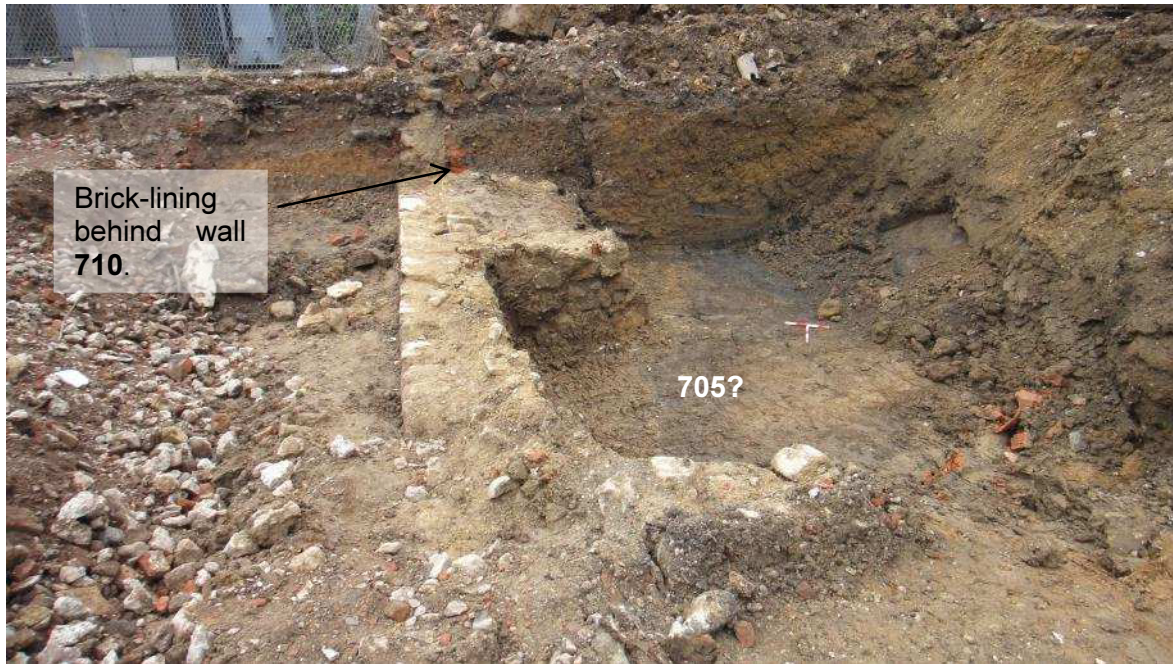
Plate 9. Trench 7 looking south showing north-south aligned limestone wall **710** and butresses and W-E sloping deposits in the north-facing section and, possibly, linear feature, **705**, in the base of the trench. Scales 2 x 0.4m.

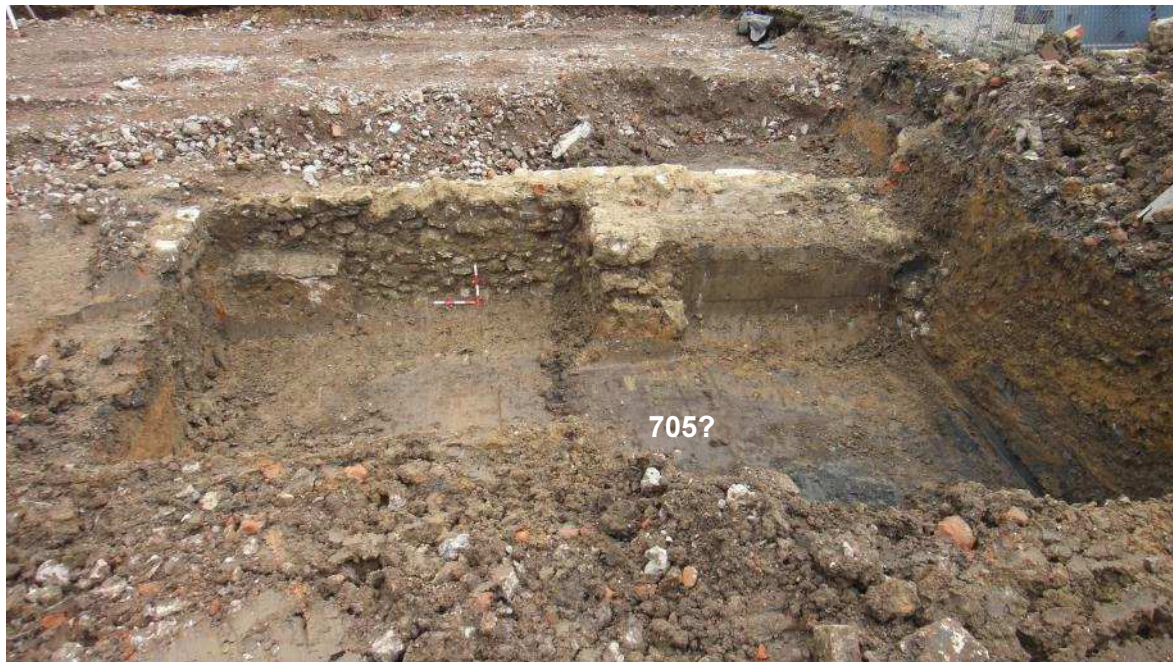
Plate 10. Trench 7 looking east, showing west-facing section of wall **710** after partially excavating abutting deposits, and north-facing section showing W-E sloping deposits. Scales 2 x 0.4m.

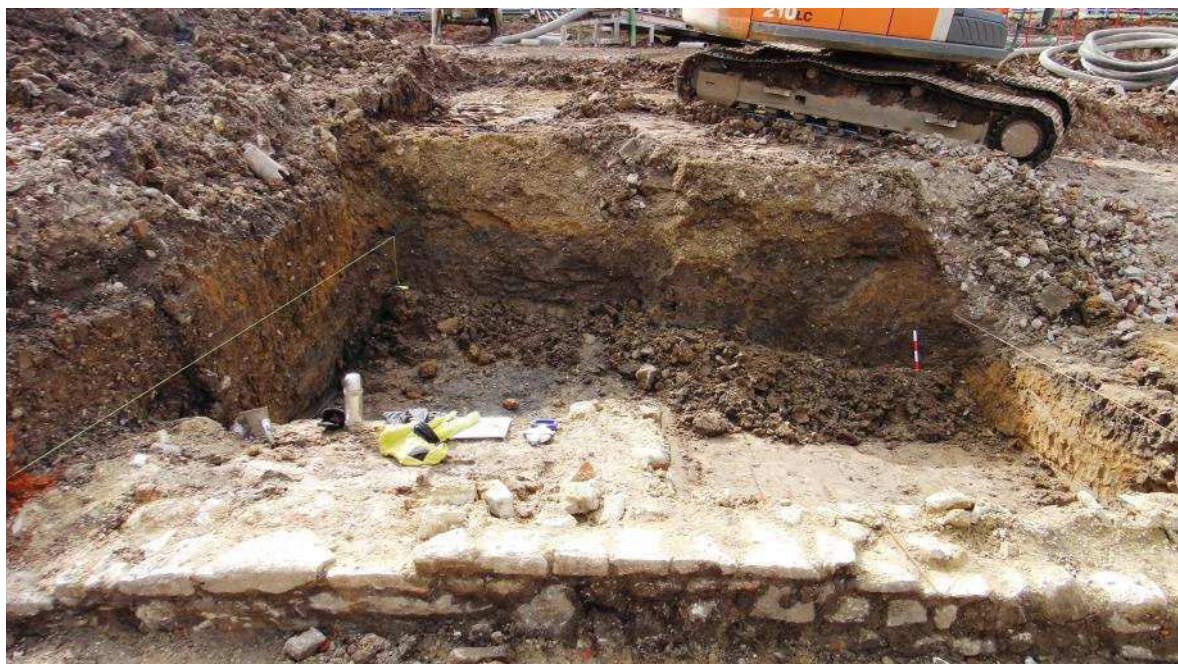
Plate 12. Trench 7 looking west showing wall **710** in the foreground and in the background the east-facing section of the trench after hand-cleaning. Scale 1 x 0.4m.

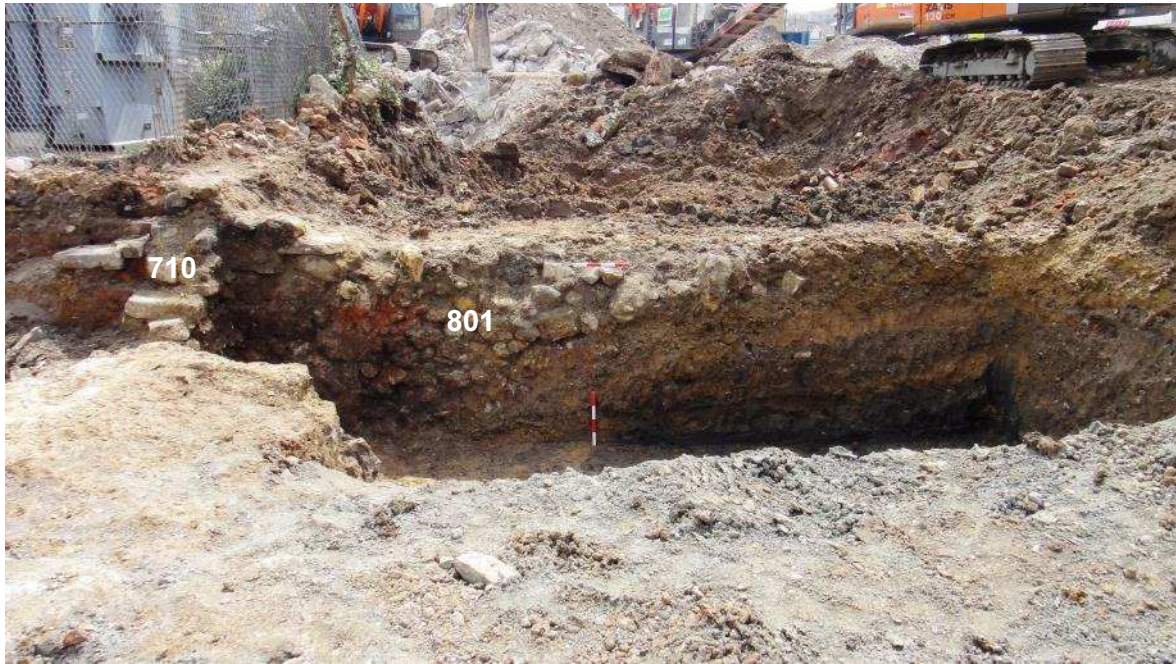
Plate 13. Trench 8, looking south showing return wall **801** on an E-W alignment and tapering over sloping deposits previously identified in Trench 7. Scales 2 x 0.4m.

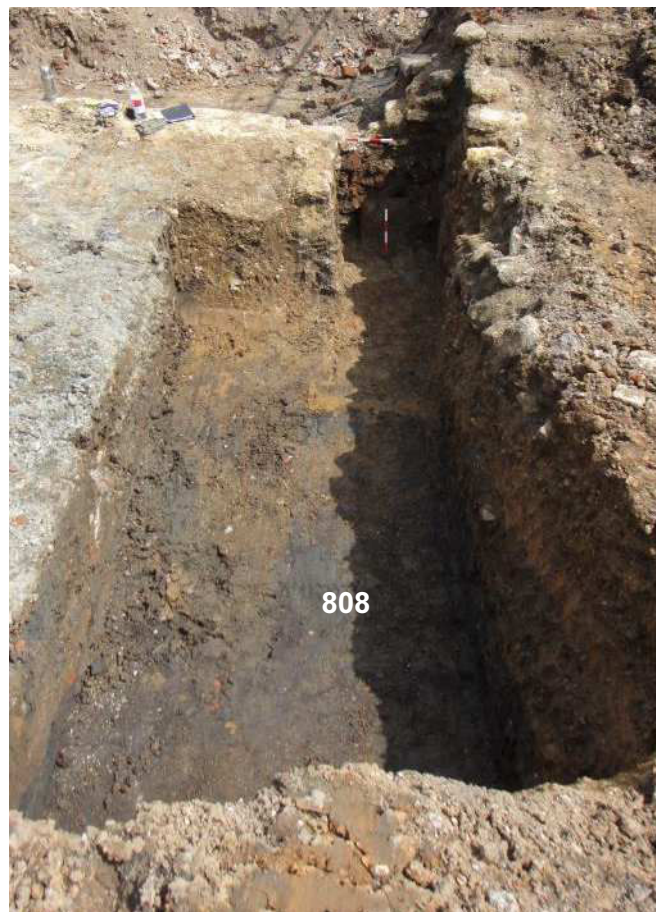
Plate 14. Trench 8, looking east showing blackish-blue gley at the base of the trench. Scales 2 x 0.4m.

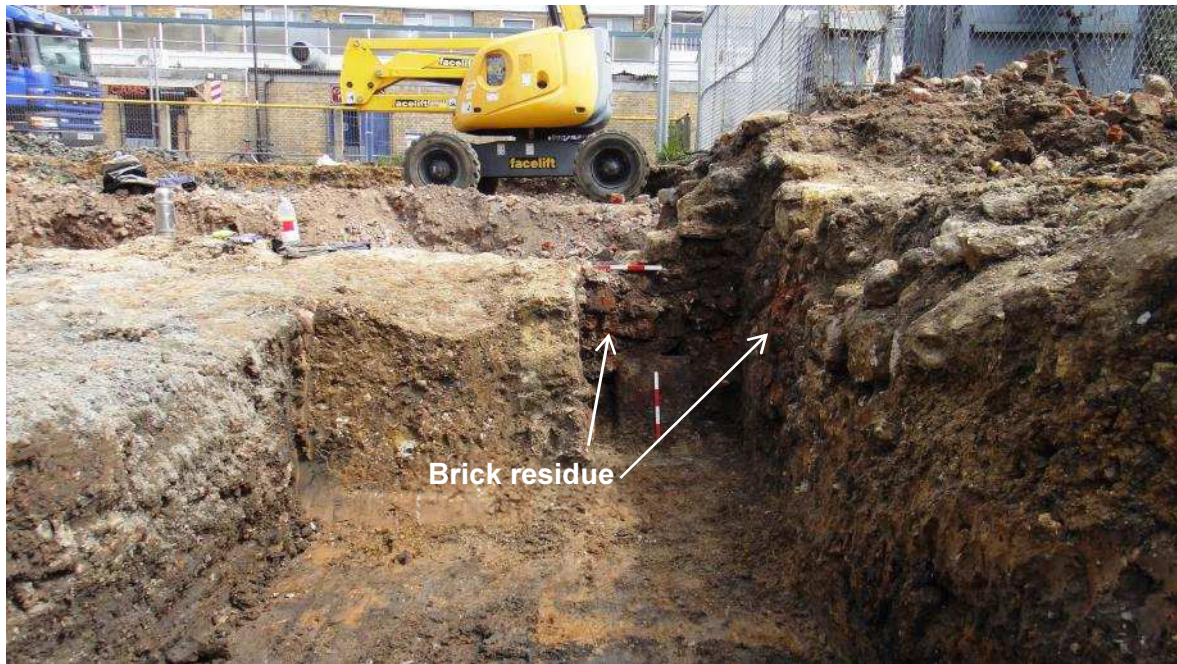
Plate 15. Close-up shot of west-facing section of Trench 8 showing residue from pre-existing brick lining on limestone walls. Scales 2 x 0.4m.

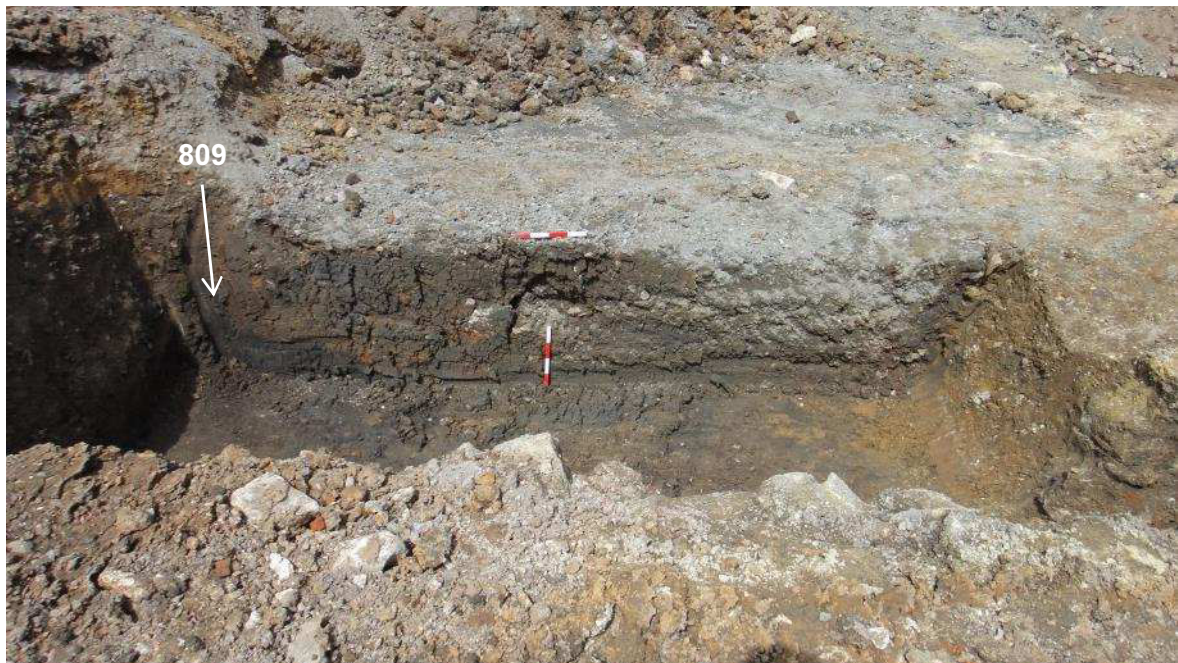
Plate 16. South-facing section of Trench 8 showing narrow cut, **809**, in-between Trench 8 and the north-facing section of Trench 7 which is probably a cut for the pre-existing modern E-W retaining wall of the NCP car park. Scales 2 x 0.4m.

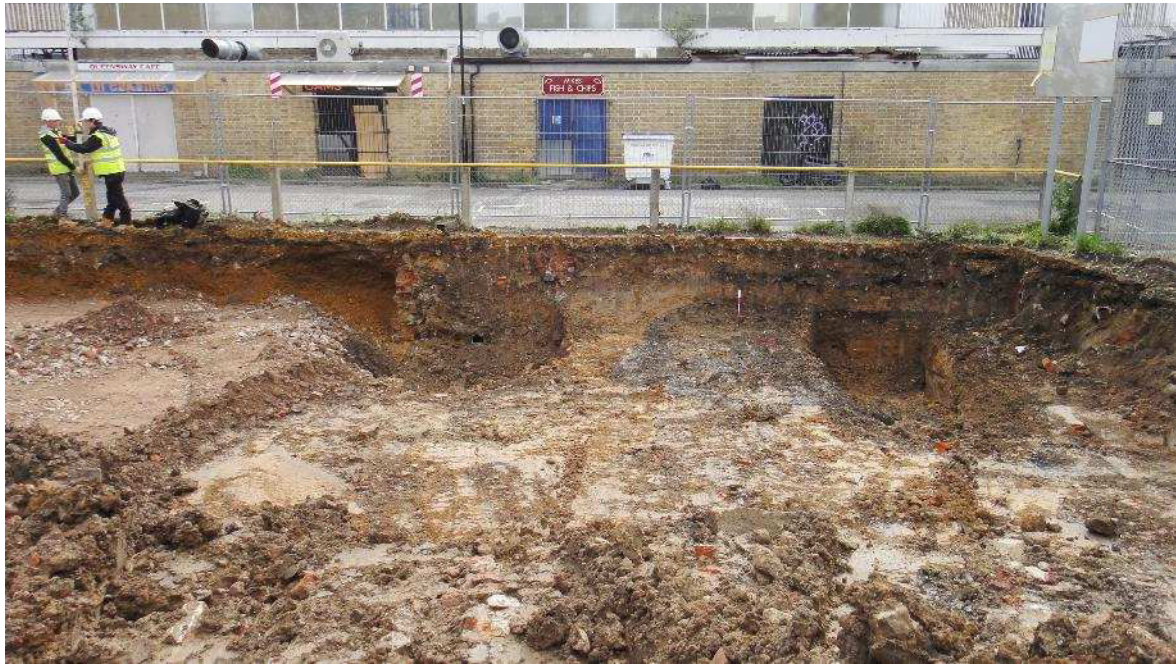
Plate 17. General shot of the area of the Site to west of Trench 7 and north of the Electricity Sub-Station showing strong brown gravel infilling in the section and extensive cuts in redeposited brickearth infilling of the canal in the base of the trench. Scales 2 x 0.4m.

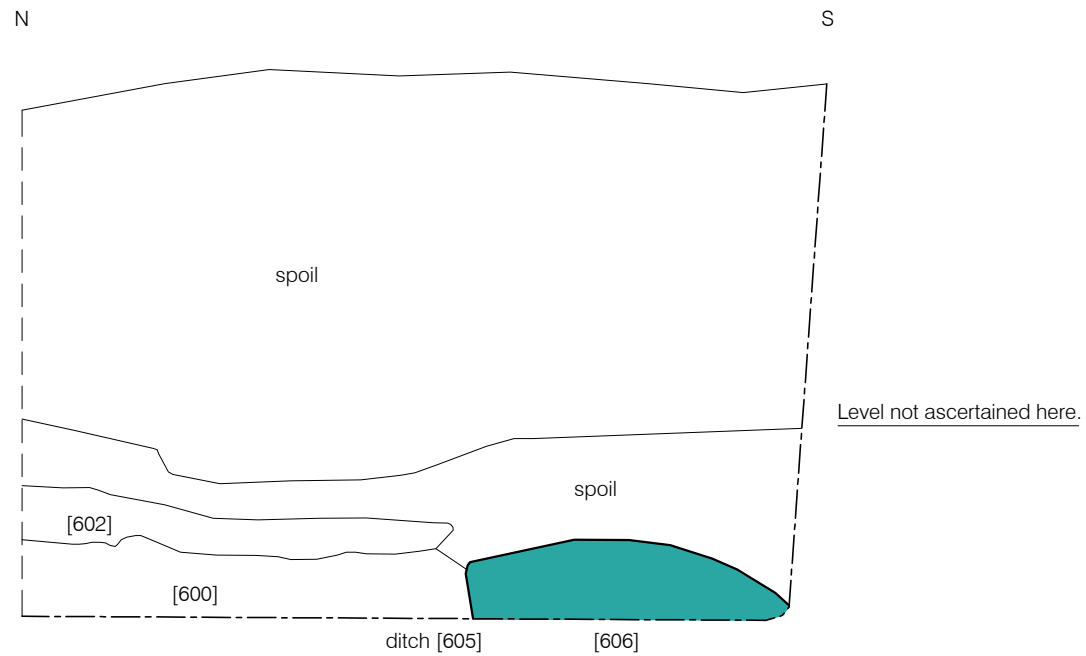
Figure 7  
Sections 32 from Trench 6  
1:50 at A4

the cutting process there. It's uncertain as to the extent and function of this possible feature as it was not clearly exposed in either section or plan. The material overlying the cut was a dark grey sandy clay loam with common flint inclusions but was indistinguishable, as a fill, from layer **602** in the section. The possible feature was assigned a cut number, **615**, and a fill number, **616**, and is annotated on the section drawing (**Figure 7**).
