**Ratcliffe House Farm, Ratcliffe
House Lane, Ratcliffe Culey,
Leicestershire**

**AN ARCHAEOLOGICAL TRIAL
TRENCH EVALUATION**

OCTOBER 2015

Commissioning Client: CgMs on behalf of Lightsource Renewable Energy Ltd

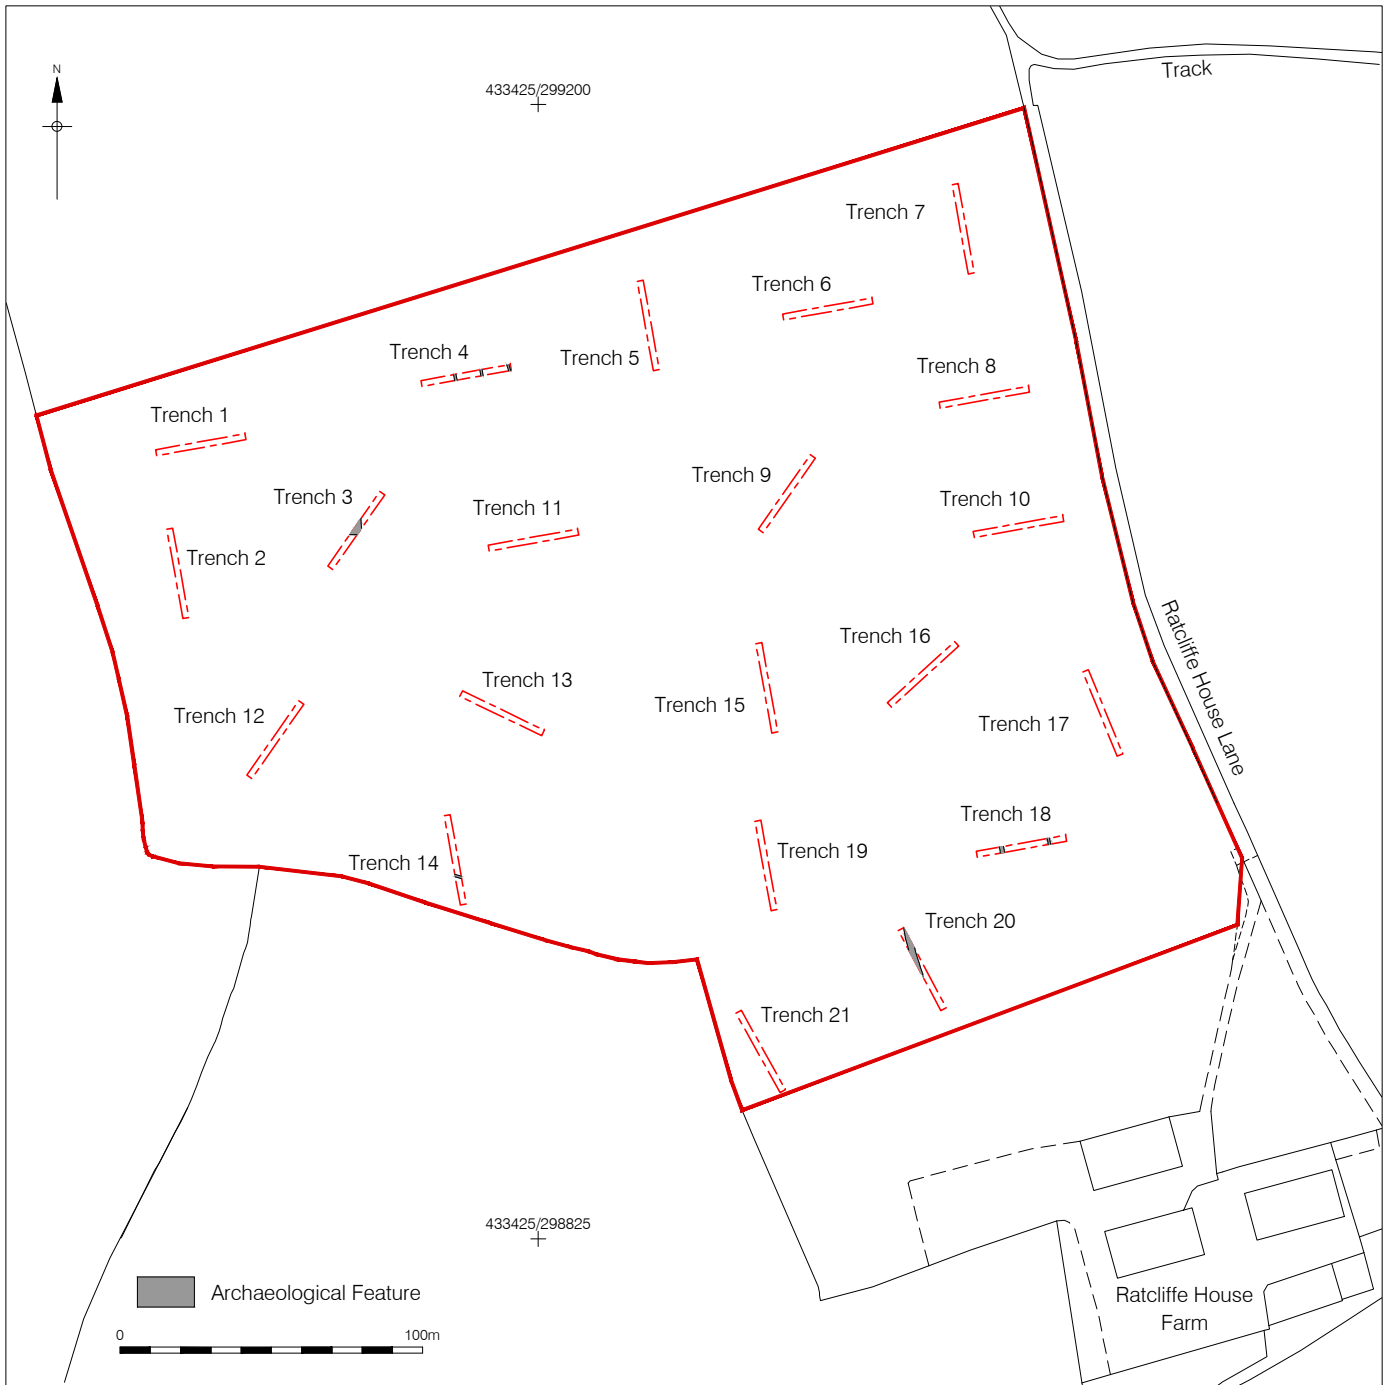
Figure 2
Trench Location
1:2,500 at A4

- 4.1.1 The Written Scheme of Investigation for the evaluation proposed the excavation of 21 trial trenches each measuring 30m in length, distributed across the site (Figure 2). A geophysical survey had been undertaken and was used to inform the location of the trial trenches.

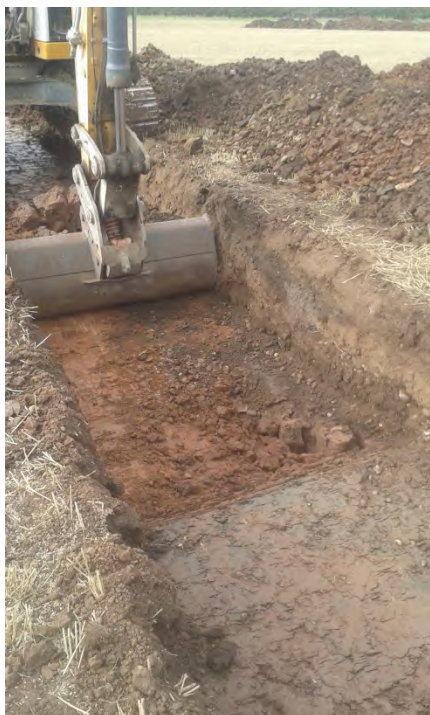
5.4.1 The trench was positioned to investigate potential archaeological features identified in the results of a geophysical survey (Fig. 3). It revealed the edge of a post-medieval pond, visible in 19th century mapping (Figure 5, Plates 1 & 2), but which had evidently been backfilled more recently as it contained very modern refuse.

Plate 1: Excavation of modern pond

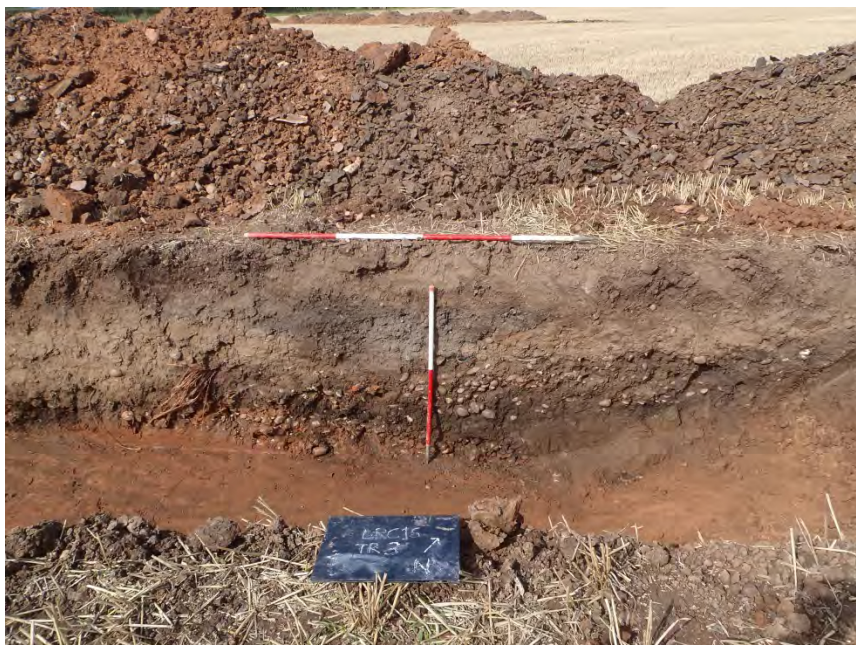
Plate 2: Section of pond, view north-west

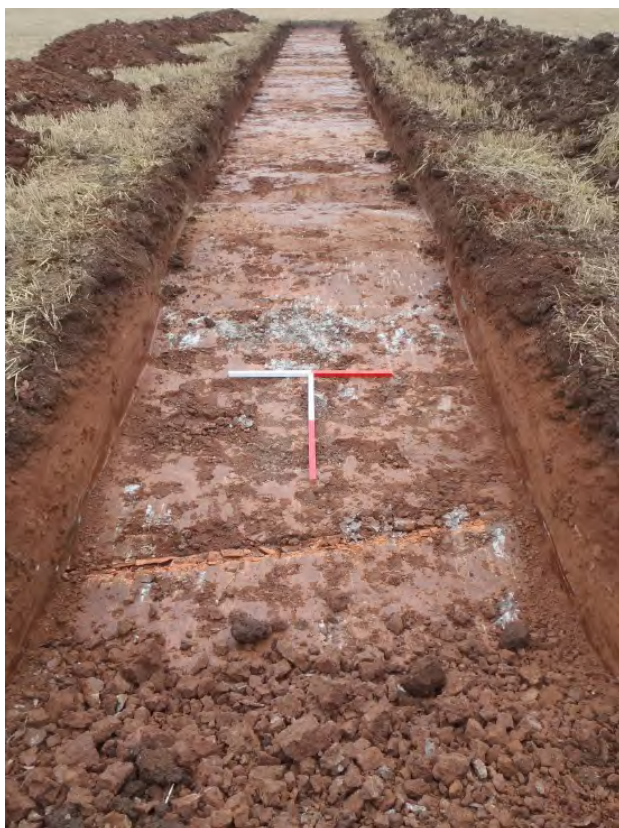
5.19.1 The trench contained two plough furrows on a north-west to south-east alignment. These were excavated to correctly identify them. They corresponded to the results of the geophysical survey (Fig. 3).

| TRENCH 18 | Figures 2, 3 & 4 | | Plate 4 | |
|---|---|---|---|--|
| The trench contained no archaeological features or deposits, although two plough furrows [103] and [105] were excavated and recorded. | | | | |

Plate 4: Trench 18, view north-east.
