**AN ARCHAEOLOGICAL  
WATCHING BRIEF AT MAYA  
HOUSE, 134-138 BOROUGH  
HIGH STREET, SOUTHWARK,  
SE1**

**REPORT NO: R12252**

**OCTOBER 2015**

**Site Code:** AYA 15

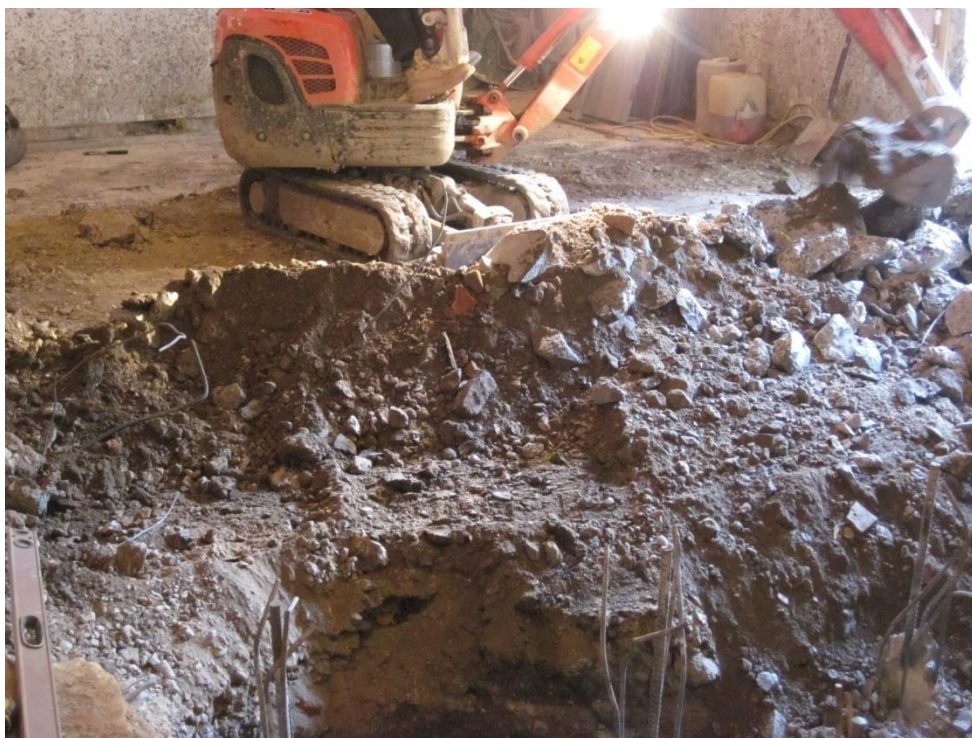
*Plate 1: North West Facing View of Modern Layers being removed in Trench 1*

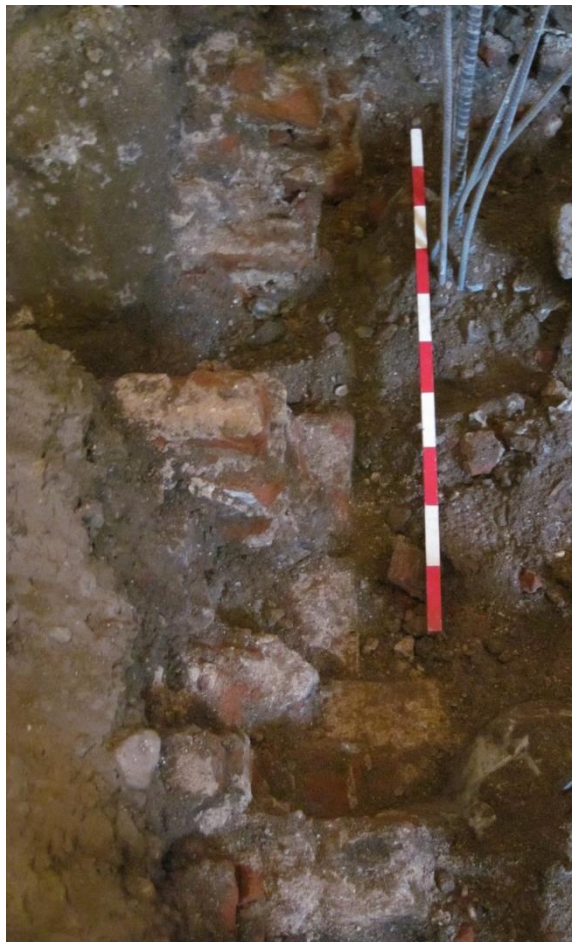
- 10.6 Brick wall foundation (context [001]; figure 3, plate 2 & 3).
- 10.6.1 In the very south-east corner of trench 1, the heavily truncated remains of masonry [001] was encountered. The top of this masonry was first observed 0.77m below the current concrete surface. It was recorded as 0.40m deep but continued below the foundation depth.

Plate 2: South Facing View of Post Medieval Wall Remains [001]

- 10.6.4 As a reasonably substantial, well-mortared and well-built brick wall, it is feasibly the wall foundation of a building. This would not be a particularly surprising interpretation considering the many post-medieval buildings which are known,

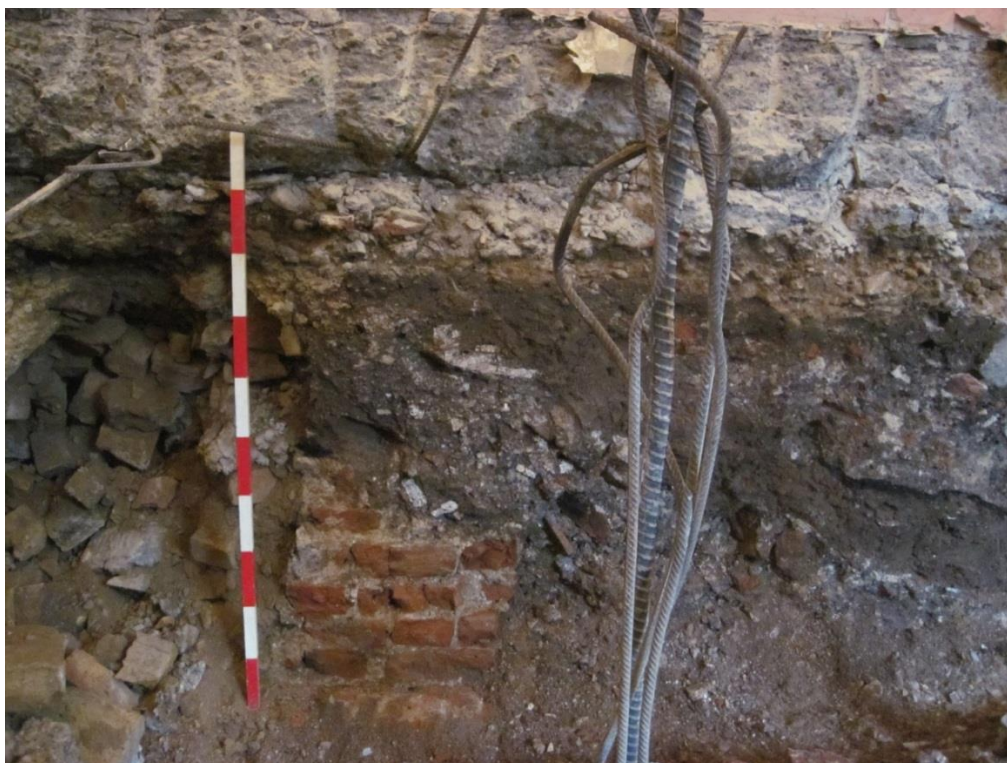
- 10.7 Construction cut (context [008], figure 3, plates 3 & 4).
- 10.7.1 Along most of the southern end of trench 1, a further large feature with vertical edges was observed in section, similarly truncating earlier layers (009) and (012). Only the western edge of this feature was observed, the eastern one having apparently been truncated by the construction cut for a modern basement wall.

Plate 3: South Facing View of Wall [001] in Section, Truncated by (+) to East and Overlain by Backfills of Construction Cut [008]

- 10.7.2 This cut feature was very substantial in extent, measuring at least 5.15m east-west. Its observed depth was 0.78m but it extended below the excavation limit.

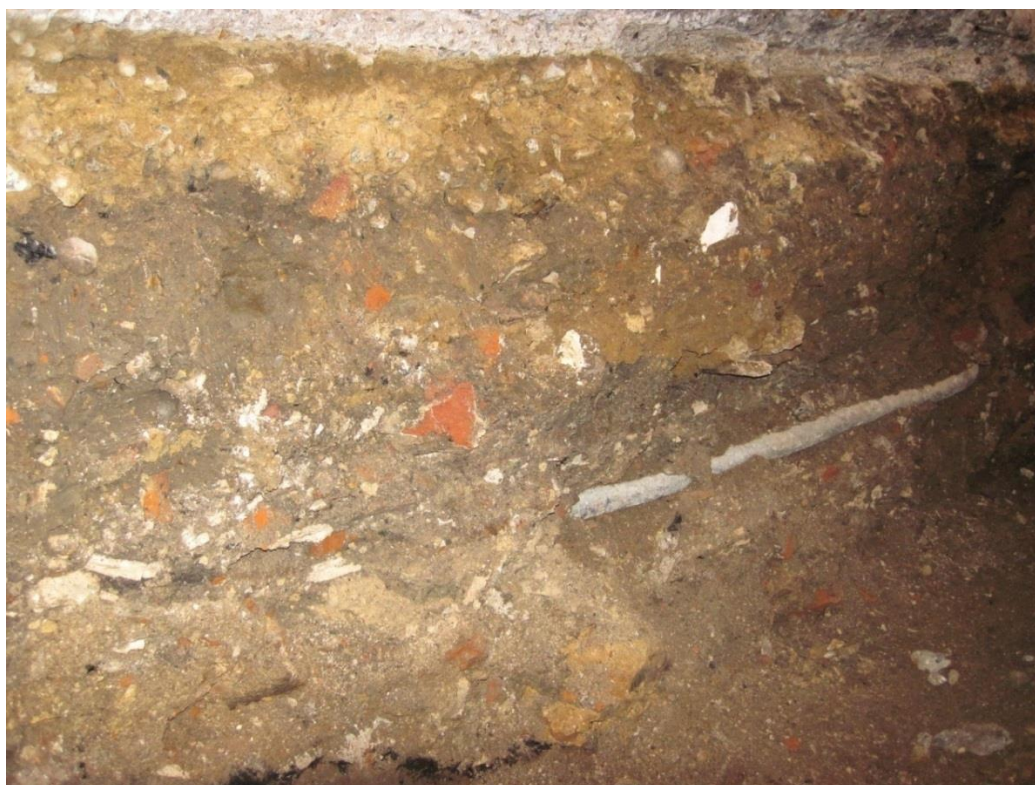
- 10.7.5 Within fill (004) an in-situ thin lead pipe was observed, probably also dating to the late 18th or 19th century. It would thus appear that feature [008] was a large construction cut for this lead water pipe and probably various other services too.

Plate 4: South West Facing View of In-Situ Lead Pipe in Backfilled Construction Cut [008]

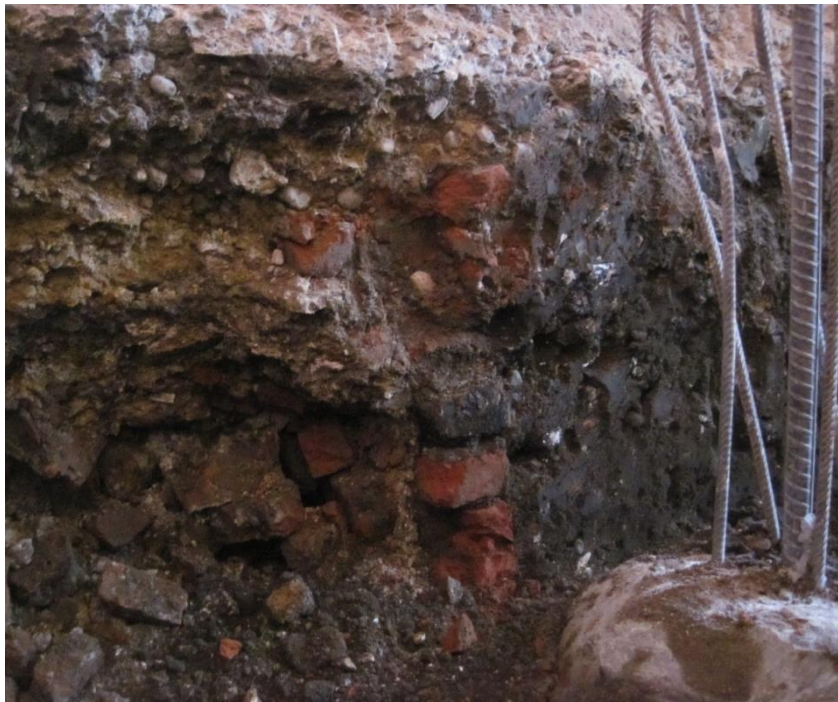
- 10.5 Brick-lined cess-pit (context [011]; figure 3, plate 5).
- 10.5.1 In the east-facing section of trench 1, a large cut feature [011] was observed. The feature had straight edges and was cut from immediately below the modern concrete surface and through earlier layers (009) and (012). A very sizeable feature, it measured 1.28m north-south and over 0.72m deep, continuing for an unknown extent below the foundation depth.

- 10.5.2 Feature [011] appears to have been at least partially brick-lined as a brick wall [013] was observed flush against the feature's northern side. The bricks comprising masonry [013] were rectangular, 110mm in width, slightly frogged and of orange fabric. They were bonded using a soft, sandy, light brownish-yellow mortar which contained frequent charcoal and small chalk flecks. A sample of this

Plate 5: West Facing View of Brick-Lined Cess Pit [011] Truncating Roman Dump Layer (009)

- 10.5.5 Feature [011] was filled with a very loose, rubble backfill (010) which – based on mortar and ceramic building material within it – probably also dates to the 18th or 19th century and comprises largely demolition debris, indicative of further demolition activity in the area during this time.

- 10.5.6 A row of piles driven into trench 1 immediately to the east of the west-facing section are responsible for the obliteration of feature [011] within the trench itself, and for the fact that it was not observed within the trench during the actual excavation but only later in section.

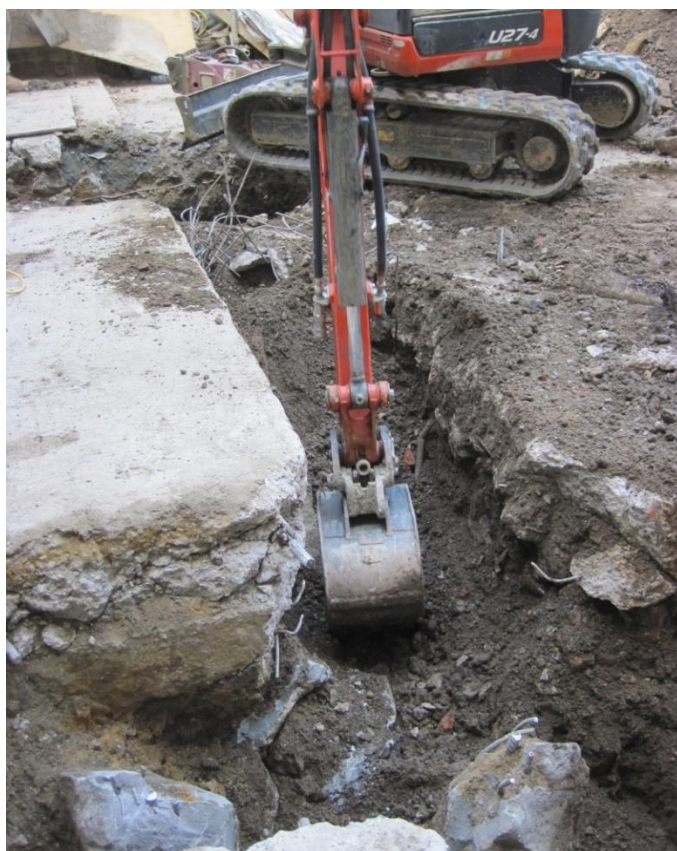
10.11.4 In trench 2, modern features were also present in the form of a backfilled construction cut for the current Maya House building and its associated basement. This cut was very large, occupying the entire eastern half of the trench down to foundation depth, and also contained some working services within the backfill.

Plate 6: North West Facing View of Modern Backfill being excavated in Trench 2

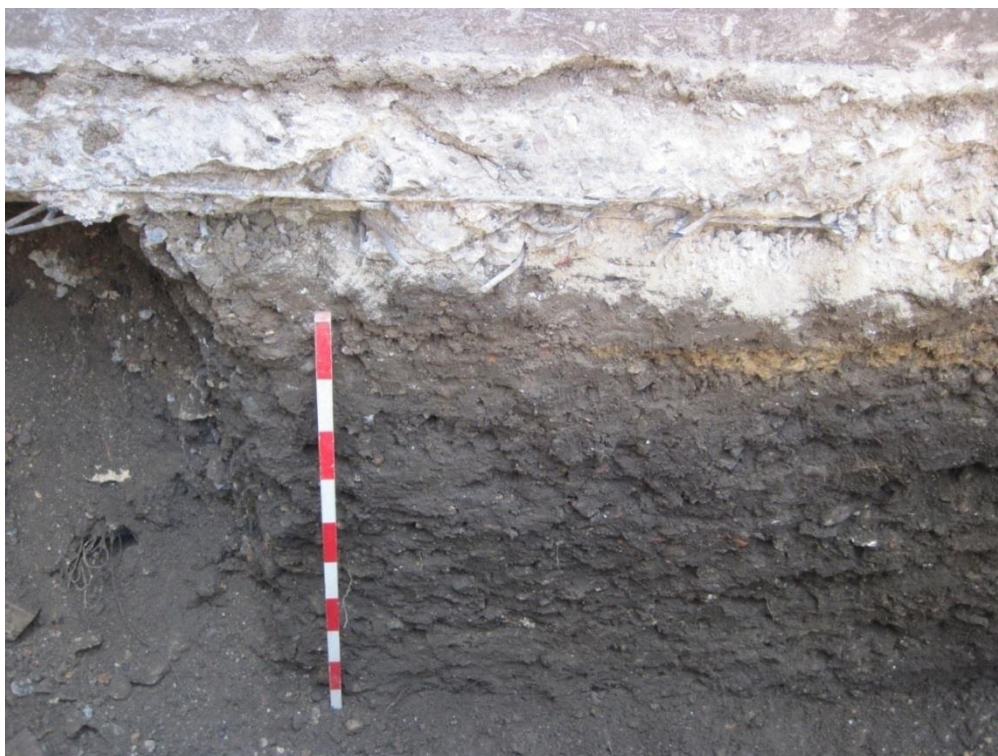
10.2.5 In trench 2, Roman dump deposit (014) also extended across the western half of the trench, but was truncated completely in the east by a modern construction cut relating to the construction of Maya House and its associated basement. The observed thickness of this deposit was 0.93m but it too continued below the foundation depth.

- 10.3.2 Above roman dump deposit (014) in trench 2, a thinner layer of soft, light greyish-brown clayey silt, with lenses of light brownish-orange gravel, was observed (context 015)). It too contained more cultural inclusions than (014) below, including charcoal, ceramic building material and oyster shell fragments, but no other finds. Like (014), this deposit was also truncated by the modern construction cut to the east.

Plate 7: South Facing View showing Roman Dump Layer (014) in Section being Truncated by Modern Construction Cut (+)

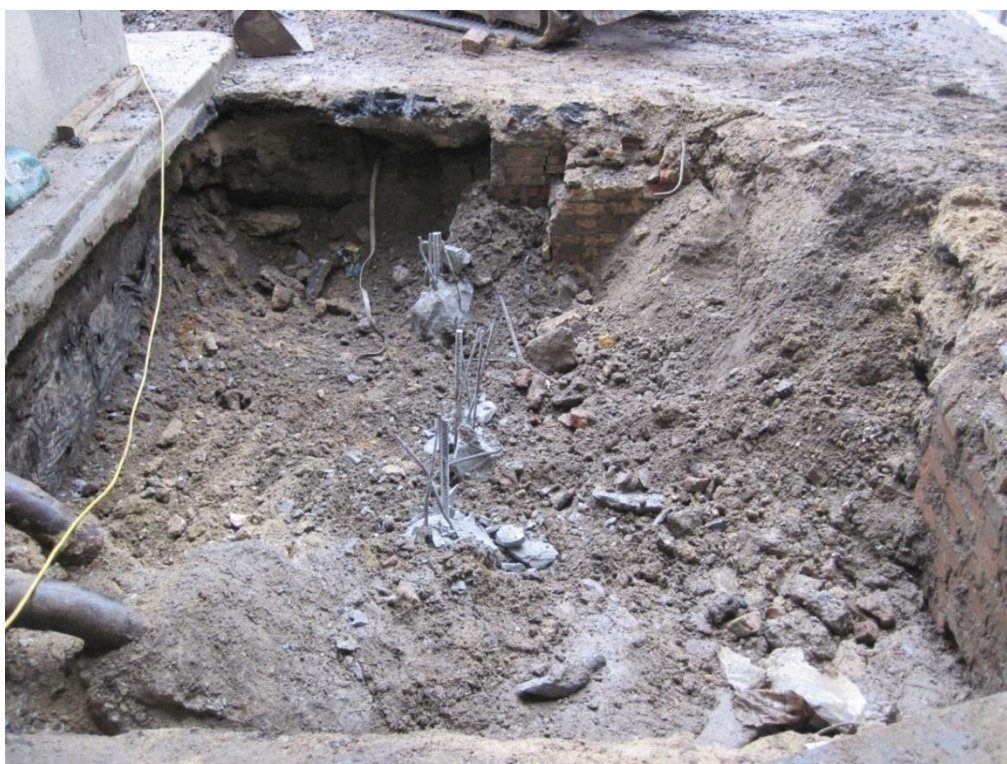
10.10.5 A clue to its function may however lie in the modern manhole wall which was observed just behind [016] to the west. The close proximity and almost identical alignment of this manhole wall make it possible that it was built to replace an earlier manhole structure on the same spot, part of which has survived in the form of wall remains [016].

Plate 8: West Facing View showing Modern Backfill in Trench 3, with Brick Manhole Walls (+) and Wall [016] Visible in Sections

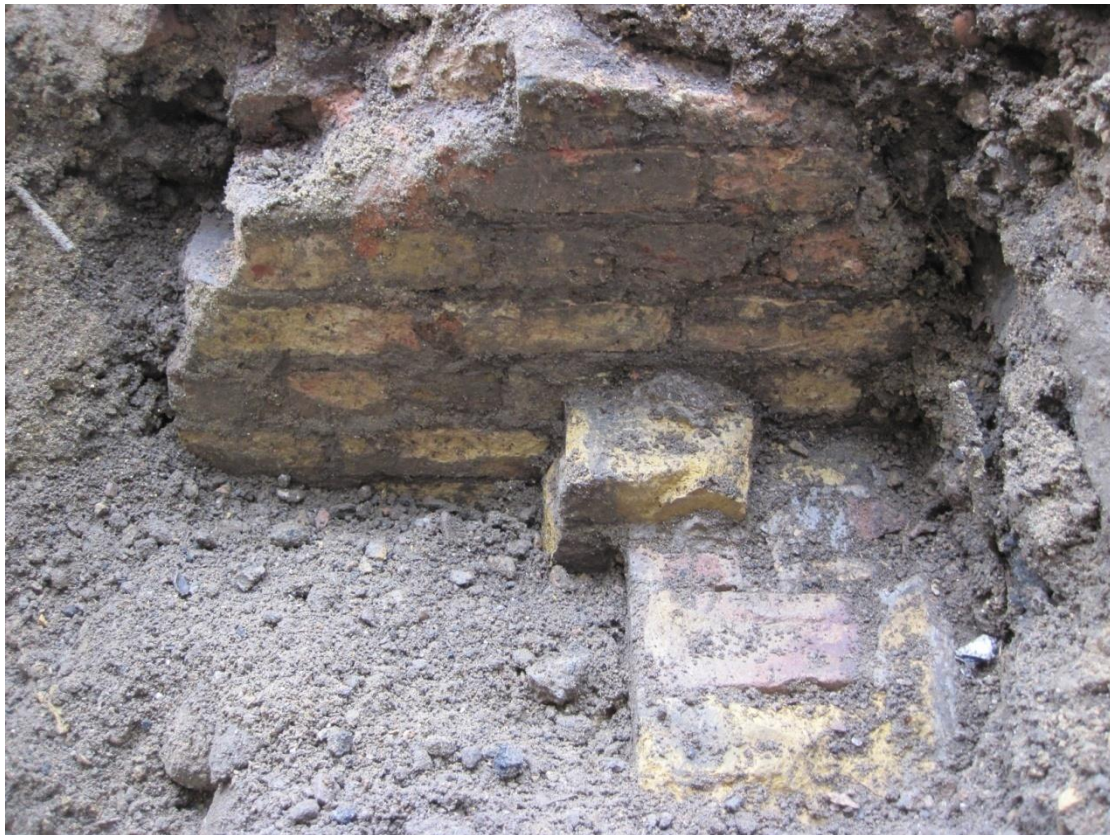
10.10.1 In the very north west of trench 3, the heavily truncated remains of a wall (context [016]) were observed. This masonry lay immediately below the modern concrete surface and had an observed depth of 0.66m, although it continued below the foundation depth.

10.10.4 The limited remains and truncated nature of masonry [016] make it hard to deduce its original function, although the main body of this wall was just one brick-width thick so seems unlikely to have been a foundation wall capable of supporting the weight of any kind of substantial upstanding structure.

*Plate 9: West Facing View of Truncated Remains of Wall [016]*

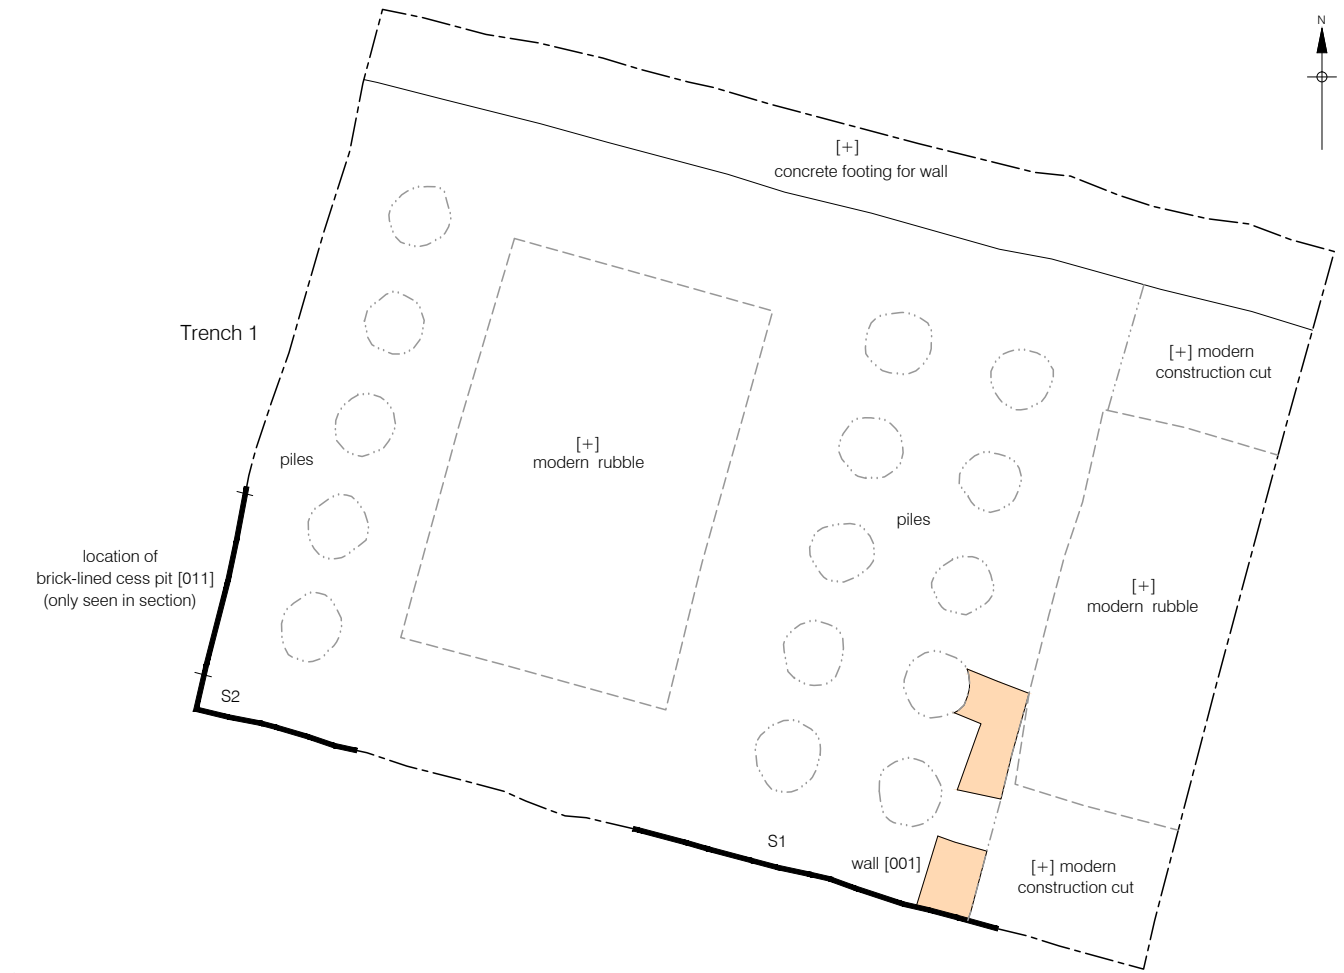
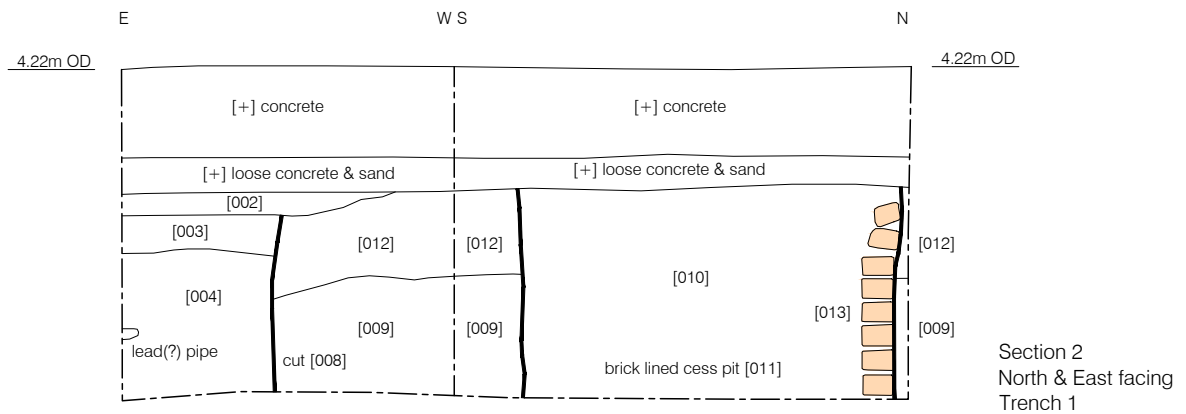
Figure 3  
 Plan of Trench 1 & Sections 1 & 2  
 1:50 & 1:25 at A4

10.2.4 In trench 1, roman dump deposit (009) extended across most of the western half of the trench, but was partially truncated by post medieval feature [011] and apparently completely removed by post medieval feature [008] to the east. The observed thickness of this deposit was 0.40m but it did also continue for an unknown extent below the foundation depth.

- 10.3 Deposits of unknown date (contexts (012) and (015); figures 3 & 4, plates 5 & 7)
- 10.3.1 Above roman dump deposit (009) in trench 1, a much thinner layer of soft, mid greyish-brown clayey silt was observed (context (012)). It contained more gravel and cultural inclusions than (009) below, including ceramic building material fragments and charcoal flecks, but no other finds. Like (009), this deposit was also truncated by later post-medieval features [008] and [011].

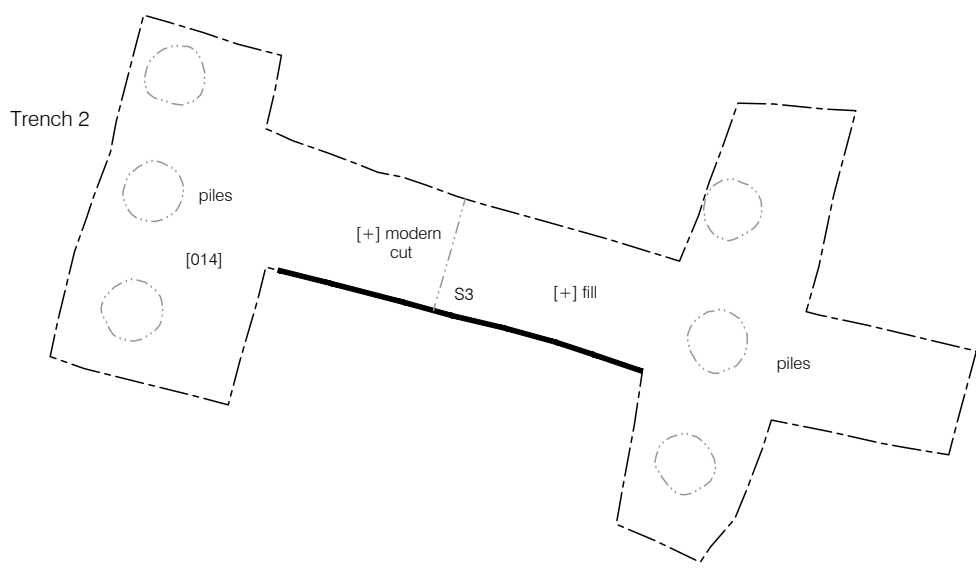
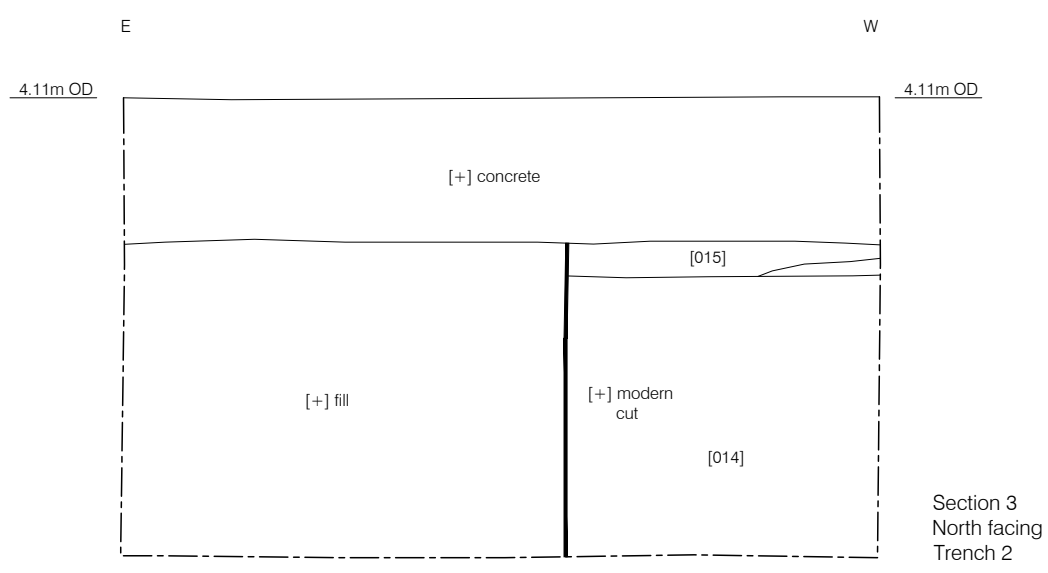
Figure 4  
Plan of Trench 2 & Section 3  
1:50 & 1:25 at A4

10.8.2 No post medieval features or deposits were observed within trench 2 (figure 4, plates 6 & 7).

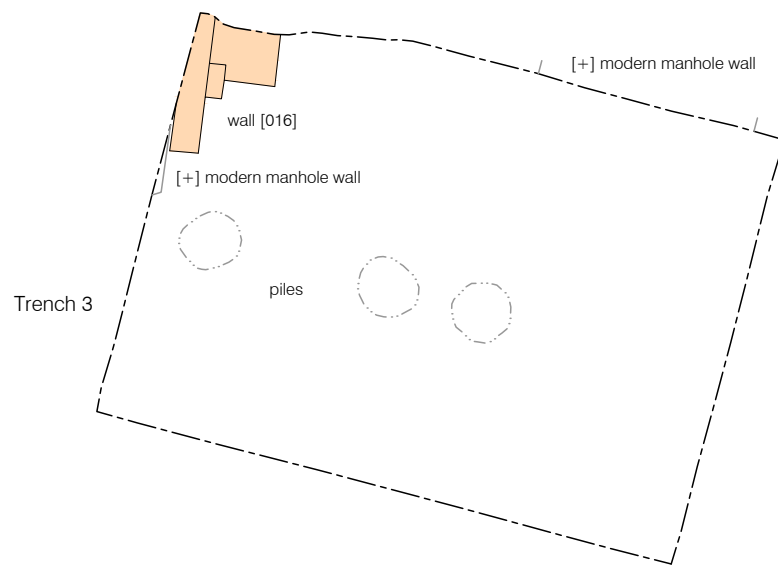
Figure 5  
Plan of Trench 3  
1:50 at A4

10.11.6 Excluding postmodern wall [016], the entire of trench 3 was filled by modern backfill and services, all once again relating to the construction and supply of the existing Maya House building and its associated basement.
