GEFFRYE MUSEUM, 136 KINGSLAND ROAD, E2 8EA

AN ARCHAEOLOGICAL
MONITORING OF GEOTECHNICAL
TEST PITS

PCA REPORT NO: 12253

SITE CODE: KLN 15

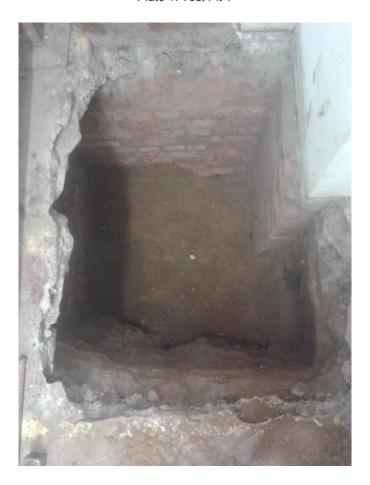
Plate 1: Test Pit 1

- 5.2 TP1 was located to the south west of the basement and measured 1.00m north-south x 1.00m east-west (Plate 1). The following sequence was observed:

- 0.15m thick concrete slab [30] overlying 0.07m of levelling layer of gravel and fragmented bricks [19].
 - Below this was 0.14m of loose, mid brown, sandy silty clay [20] (a second backfill of the brick foundation). After removing this context a surface measuring 0.05m thick was identified, comprised of CBM and lime mortar flecks and dust [21] this was interpreted as a construction layer.

- Beneath this construction activity was 0.58m of dark brownish grey silty clay with frequent flecks of charcoal and CBM [22]. This appears to be the first backfill associated with the brick foundation).

- The above deposit overlays the brick foundations [31] which were constructed on a mid-brownish yellow silty clay [24] identified as pre-1714 which was approximately 15.80m OD (not fully excavated).

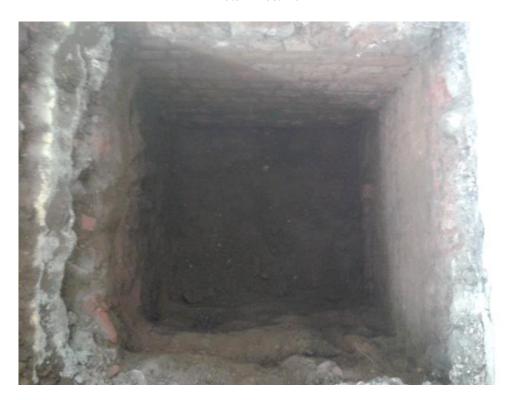
Plate 2: Test Pit 2

- 5.3 TP2 was located to the east of TP1, also at the south of the basement; the measurements were 1.00m north-south x 1.00m east-west (Plate 2). The following sequence was observed:

- 0.15m thick concrete slab [37] overlying 0.08m of levelling layer of gravel and fragmented bricks [6].
 - Below this was 0.20m of loose, mid brown, sandy silty clay [15] identified as a second backfill of the brick foundations. Beneath this, a layer, 0.04m thick of CBM and lime mortar flecks and dust [16] was interpreted as a construction surface.

- Below this was 0.53m of dark brownish grey silty clay with frequent flecks of charcoal and CBM [7], this constituted the first backfill of the brick foundations.

- Finally, the above deposit overlays the brick foundations [38], which were constructed on a mid-brownish yellow silty clay [17] identified as pre-1714 at approximately 15.79m OD (not fully excavated).

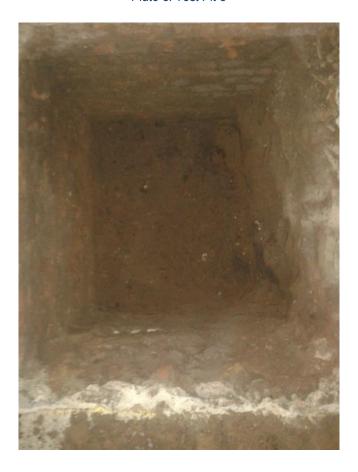
Plate 3: Test Pit 3

- 5.4 TP3 was located to the north of TP2, in the middle of the current museum basement and it measured 1.00m north-south x 1.00m east-west (Plate 3). The following sequence was observed:

- 0.18m thick concrete slab [32] overlying 0.05m of levelling layer of gravel and fragmented bricks [3].
 - Below this was 0.17m of loose, mid brown, sandy silty clay [25] interpreted as
 the second backfill of the brick foundations. Beneath this a layer, 0.03m thick,
 of CBM and lime mortar flecks and dust [26] was interpreted as a construction
 surface.

- Underneath, was 0.56m of dark brownish grey silty clay with frequent flecks of charcoal and CBM [5], this constituted the first backfill of the brick foundations.

- Finally, the above deposit overlays the brick foundations [33], which were constructed on a mid-brownish yellow silty clay [34] identified as pre-1714 at approximately 15.87m OD (not fully excavated).

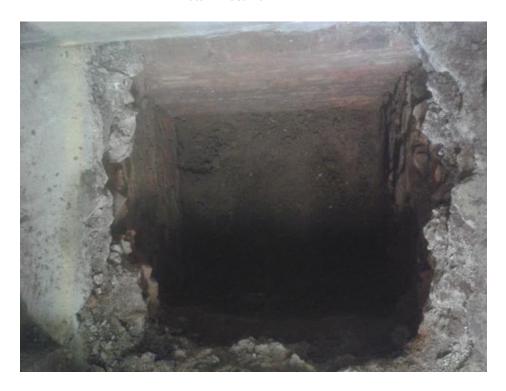
Plate 4: Test Pit 4

- 5.5 TP4 was located at the north of the basement and measured 0.90m north-south x 0.90m east-west (Plate 4). The following sequence was observed:
 - 0.20m thick concrete slab [28] overlying 0.18m of levelling layer of gravel and fragmented bricks [1].
 - Below this was 0.13m of loose, mid brown, sandy silty clay [2] interpreted as
 the second backfill of the brick foundations. Beneath this a layer, 0.03m thick,
 of CBM and lime mortar flecks and dust [13] was interpreted as a construction
 surface.
 - Underneath, was 0.51m of dark brownish grey silty clay with frequent flecks of charcoal and CBM [4], this constituted the first backfill of the brick foundations.
 - Finally, the above deposit overlays the bricks foundation [29], which were constructed on a mid-brownish yellow silty clay [8] identified as pre-1714 at approximately 15.78m OD (not fully excavated).

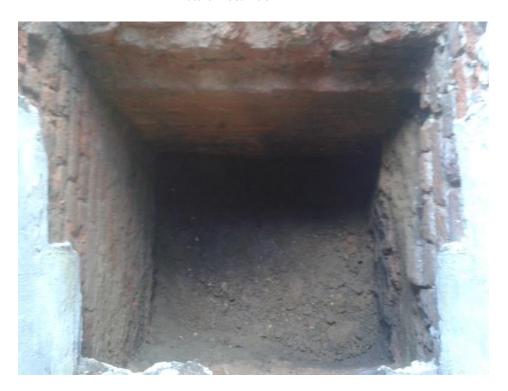
Plate 5: Test Pit 5

- 5.6 TP5 was located to the east of TP4, also at the north of the basement; the measurements were 0.85m north-south x 0.90m east-west (Plate 5). The following sequence was observed:

- 0.15m thick concrete slab [35] overlying 0.17m of levelling layer of gravel and fragmented bricks [10].
 - Below this was 0.21m of loose, mid brown, sandy silty clay [11] interpreted as
 the second backfill of the brick foundations. Beneath this a layer, 0.04m thick,
 of CBM and lime mortar flecks and dust [27] was interpreted as a construction
 surface. Underneath, was 0.49m of dark brownish grey silty clay with frequent
 flecks of charcoal and CBM [12], this constituted the first backfill of the brick
 foundations.

- Finally, the above deposit overlays the brick foundations [36], which were constructed on a mid-brownish yellow silty clay [14] identified as pre-1714 at approximately 15.77m OD (not fully excavated).

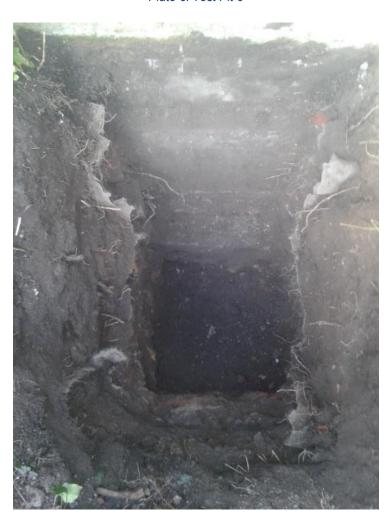
Plate 6: Test Pit 6

- 5.7 TP6 was located outside the museum, specifically, to the northeast of TP5, against the northern garden wall. The measurements were 1.00m north-south x 0.80m east-west x 1.03m depth (Plate 6). The following sequence was observed:
 - 0.50m of organic soil from the garden [9] overlying 0.93m of rubble backfill for the concrete foundation of the garden wall [18].
 - Below this, was a dark brownish silty clay layer which was not excavated [23].

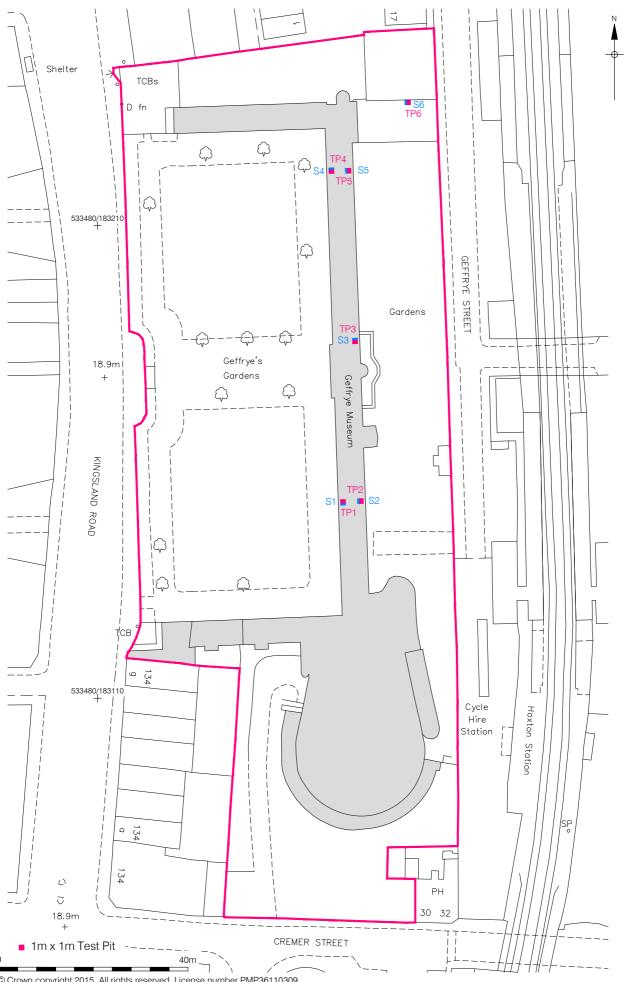
Figure 2 Test Pit Locations 1:800 at A4

- 2.3 The Watching Brief involved monitoring 6 trial pits in total, 5 within the basement of the Geffrye Museum and one more pit outside the building (Figure 2) in order to ascertain the depth and nature of any building foundations and their supporting sub-strata.

- 5.1 The work was carried out between 05/10/2015 and 07/10/2015 and the excavation of six pits measuring 1m² was monitored (Figure 2). The test pits were broken out by the contractor using a hand held breaker and then excavated using mattocks, shovels and trowels, all were monitored by an archaeologist on site. Ground level in the basement was located at approximately 16.80m OD.

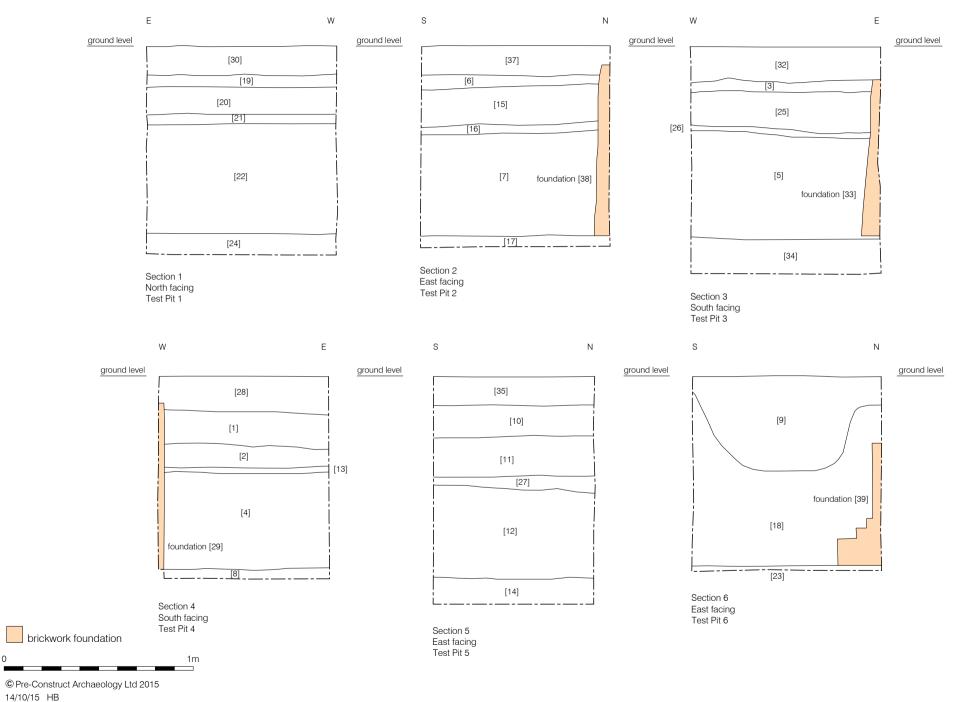
Figure 3 Sections 1-6 1:20 at A4

- 6.1 The sequence of TP6 shows a chronology for the late 20th century. However, the results obtained in the 5 test pits inside the museum's basement have the same archaeological sequence divided into three phases:

- Phase 1: Before 1714. This phase refers to deposits [8], [14], [17], [24] and [34]. These contexts form the layer on which the foundations of the current museum were built c.1714. They were not excavated and only observed in plan approximately 1m below current basement level. These are identified as constituting an archaeological horizon, of unknown depth, surviving under the current basement.

- Phase 2: 1714. The museum foundations [29], [31], [33], [36], [38] were built
 on the earlier archaeological layer and backfilled 0.60m. Above this backfill, a
 thin layer of crushed CBM and lime mortar evidenced the construction surface
 for the building. A second backfill for the foundations was then deposited over
 this.

- Phase 3: Basement Remodelling (Late 20th century). This phase relates to
 modern activity and the current basement with concrete floor which extends
 the whole length of the building.

- The excavation of these test pits only reached the depth of the wall foundations. Beneath these foundations the exposed layer appears to be pre-1714 deposit. The test pits did not reach natural so it is unclear what depth of these levels survive under the wall foundations and the extent of the basement.
