**ARCHAEOLOGICAL
EVALUATION AT LAND NORTH
OF BURY GREEN FARM AND
SOUTH OF NEW FEN ROAD
LANE, RAMSEY HEIGHTS,
CAMBRIDGESHIRE.**

**PRE-CONSTRUCT ARCHAEOLOGY
R12283**

AN ARCHAEOLOGICAL EVALUATION

Land North of Bury Green Farm & South of New Fen Road Lane, Ramsey Heights, Cambridgeshire: Archaeological Trial Trench Evaluation

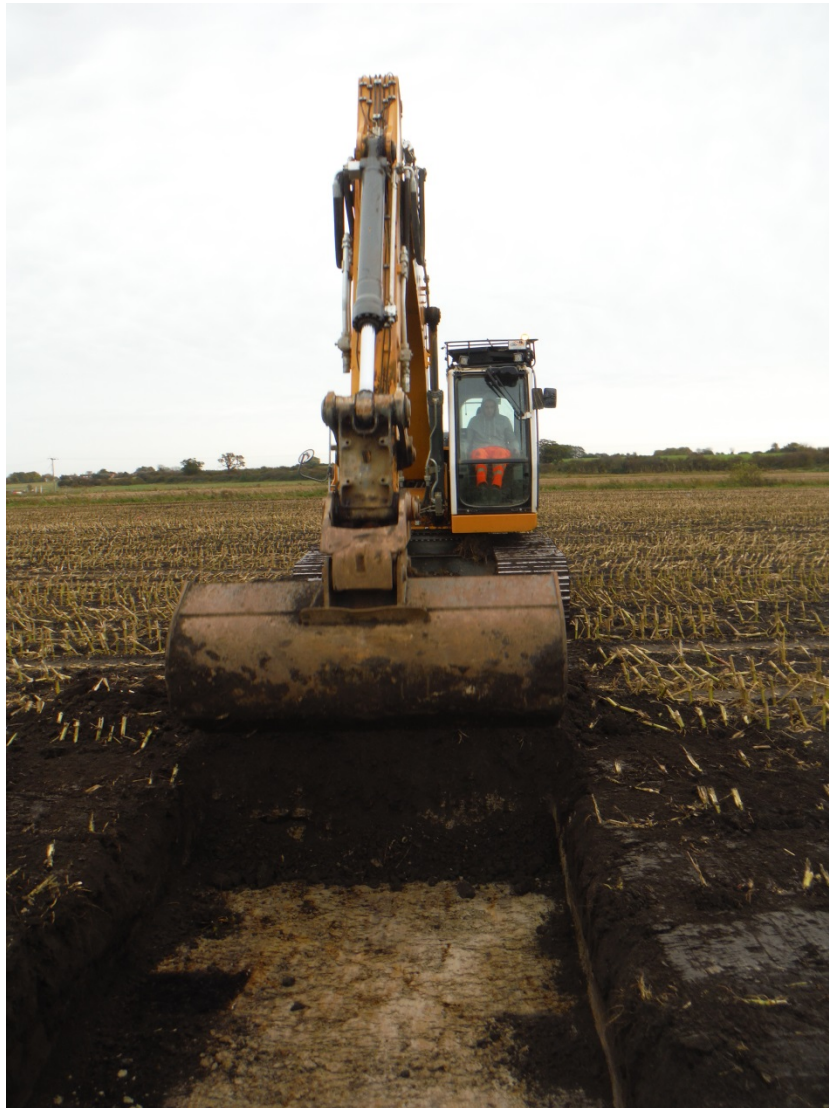
Plate 2: The site, machining

- 4.1.2 Ground reduction was carried out under archaeological supervision using a 21-ton tracked mechanical excavator fitted with a 1.8m-wide toothless ditching bucket (Plate 2). Topsoil deposits were removed in spits down to the level of the undisturbed natural geological deposits where potential archaeological features could be observed and recorded. Exposed surfaces were cleaned by trowel and hoe as appropriate and all further excavation was undertaken manually using hand tools. Overburden deposits were set aside beside each trench and examined visually and with a metal-detector for finds retrieval.

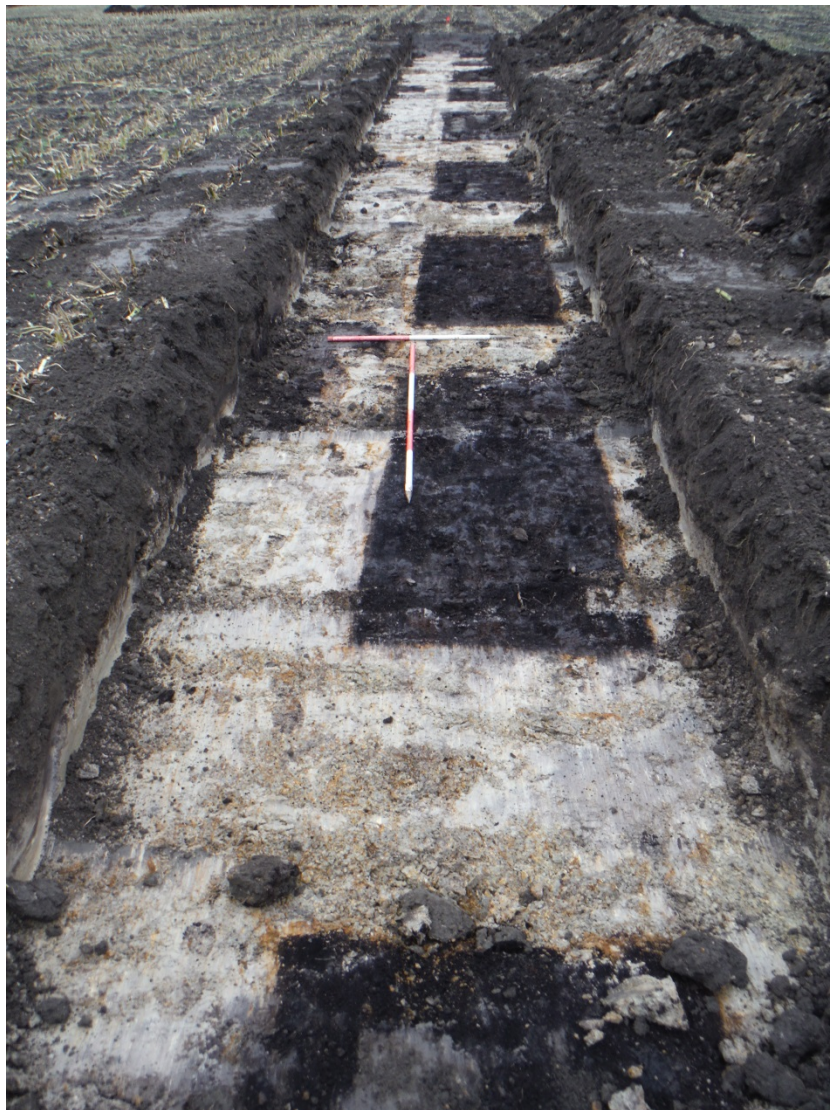
Plate 3: Trench 3, view south-east

TRENCH 3	Figure 2 and 3	Plate 3	
Trench Alignment: NW-SE	Length: 30m	Max Machine Depth (m OD): -0.9m Level of Natural (m OD): -0.85m	
Deposit	Context No.	Average Depth (m)	
		NW End	SE End
Topsoil	(100)	0.26m	0.36m
Natural (min depth)	(102)	0.40m	0.48m
Natural (max machined depth)	(102)	0.45+m	0.53+m
Summary			
Trench 3 was located along the northern boundary of the site.

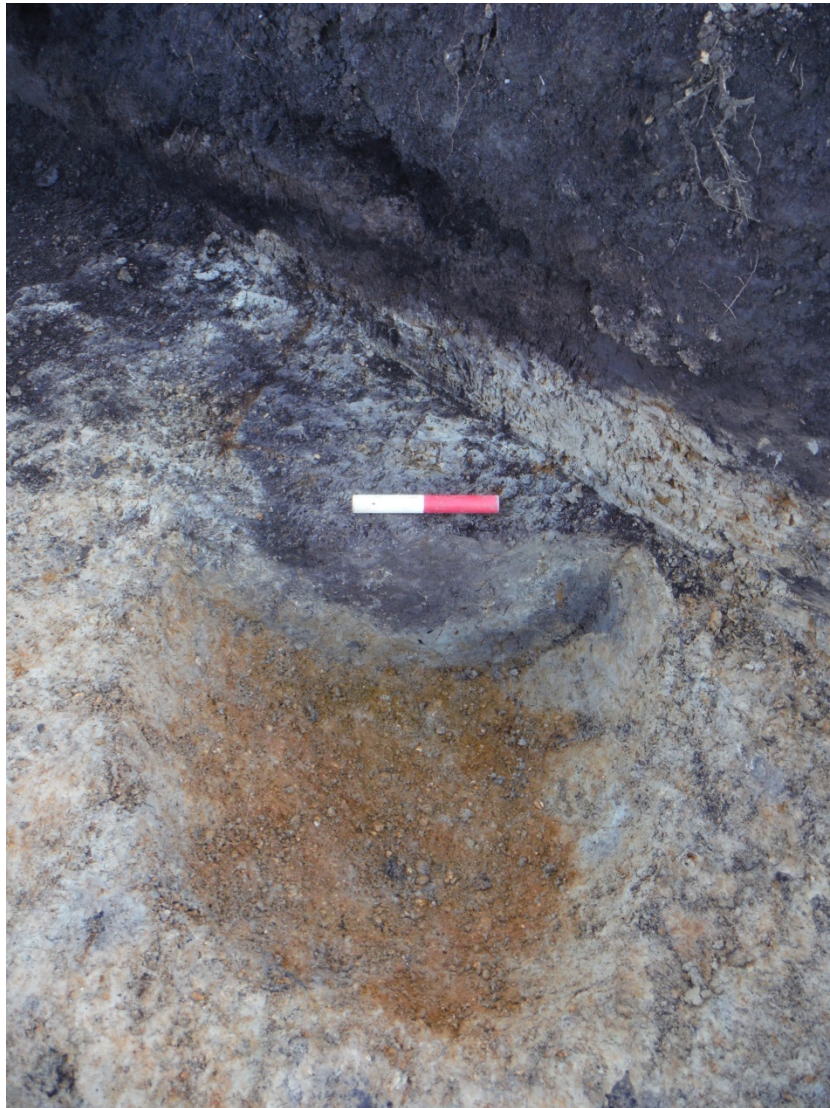
Plate 4: Ditch terminus [141], Trench 6, view north-east

5.7.2 Ditch terminus [141] (Plate 4) was located in the north-eastern part of the trench; it was aligned north-east to south-west and continued out of the eastern limit of excavation. It was 0.64m wide and 0.30m deep, with steeply-sloping sides and a concave base. It had a single fill of dark blue grey silty clay (140) which contained no finds.

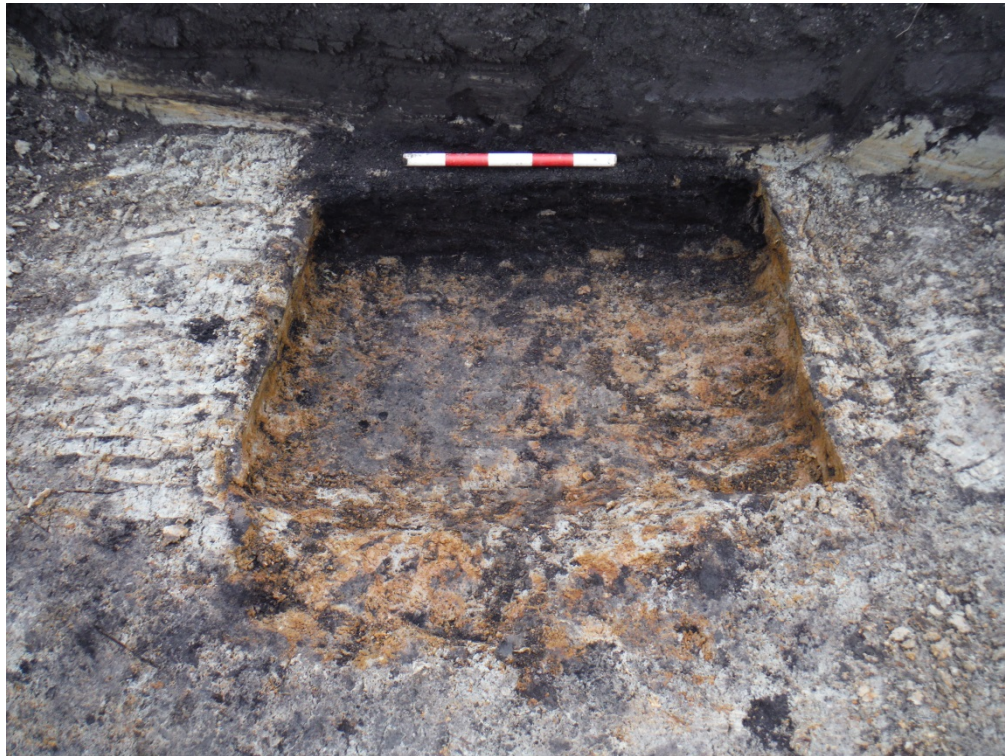
Plate 5: Clay marling ditch [115], Trench 12, view north

5.13.3 Clay marling ditch [115] (Plate 5) was located in the south-eastern part of the trench; it was sub rectangular in plan and continued out of the eastern limit of excavation. It had sub vertical-sloping sides and a flat base and measured 1.00+m by 1.00m and was 0.26m deep. It had a single fill of dark grey black silty peat (116) which contained no finds.

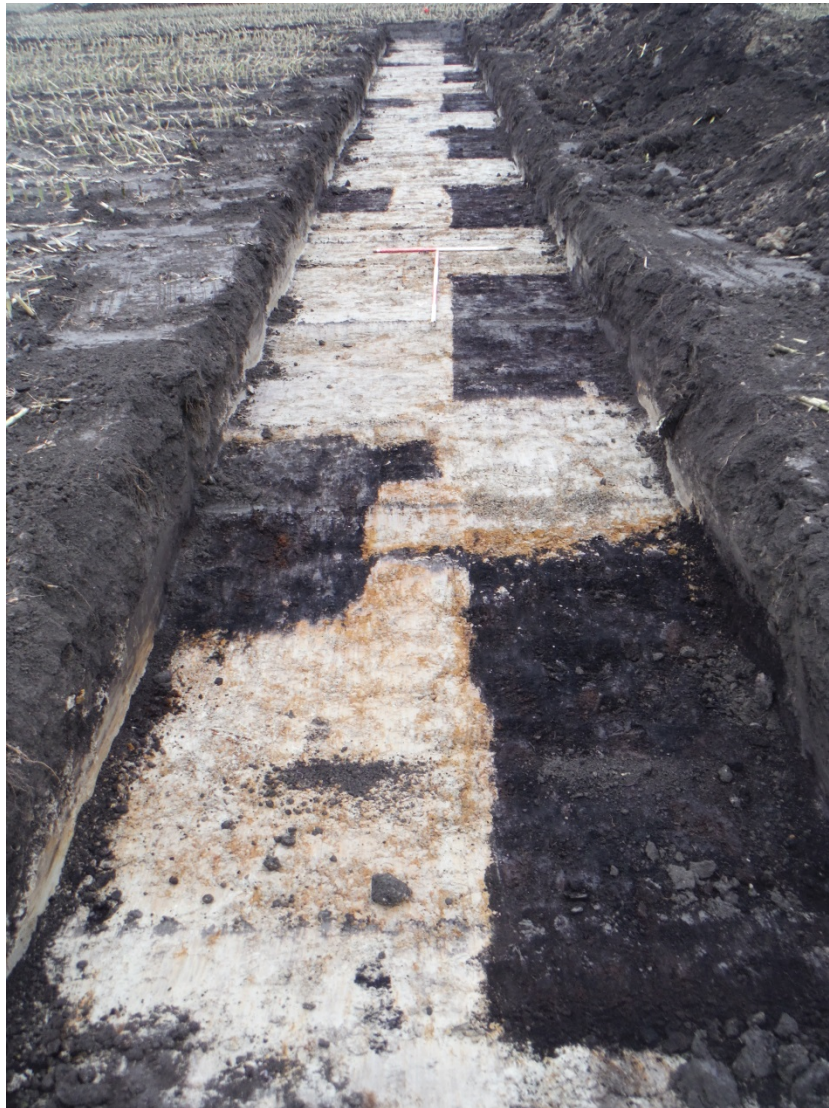
Plate 6: Trench 16, view north-west

TRENCH 16	Figure 2 and 3	Plate 6	
Trench Alignment: NW-SE	Length: 30m	Max Machine Depth (m OD): -0.78m Level of Natural (m OD): -0.71m	
Deposit	Context No.	Average Depth (m)	
		NW End	SE End
Topsoil	(100)	0.26m	0.22m
Natural (min depth)	(102)	0.39m	0.43m
Natural (max machined depth)	(102)	0.48+m	0.50+m
Summary			
Trench 16 was located in the north-western area of the site. The trench contained 12 clay marling ditches.
