**LAND AT UPWOOD AIRFIELD,
RAMSEY, CAMBRIDGESHIRE:
ARCHAEOLOGICAL TRIAL
TRENCH EVALUATION**

Pre-Construct Archaeology Ltd	
Project Number	K4202
Report Number	R12281

Land at Upwood Airfield, Ramsey, Cambridgeshire:

Archaeological Trial Trench Evaluation

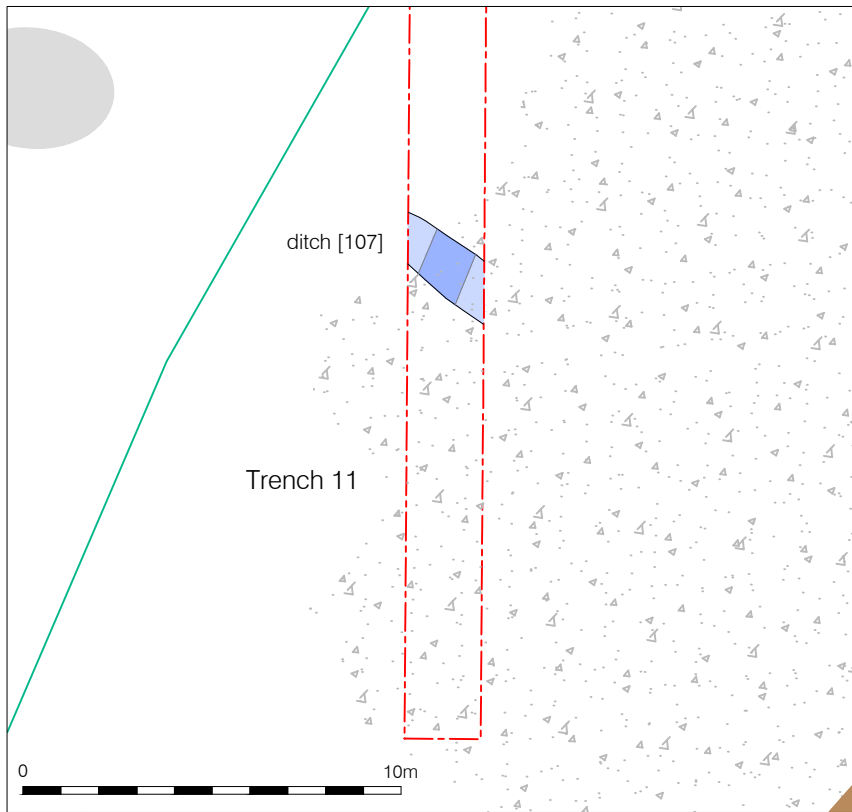
Figure 4
Trenches 4 and 11
1:200 at A4

5.5.2 Ditch [103] was located in the western part of the trench; it was aligned north-west to south-east and continued out of both limits of excavation. It was 0.47m wide and 0.17m deep with moderately-sloping sides and a concave base. It had a single fill (104) of mid grey brown silty clay which contained no finds.

5.12.2 Ditch [107] was located in the southern part of the trench; it was aligned north-west to south-east and continued out of both limits of excavation. It was 1.08m wide and 0.07m deep with very slightly-sloping sides and a concave base. It had a single fill (106) of mid grey brown sandy clay which contained no finds.

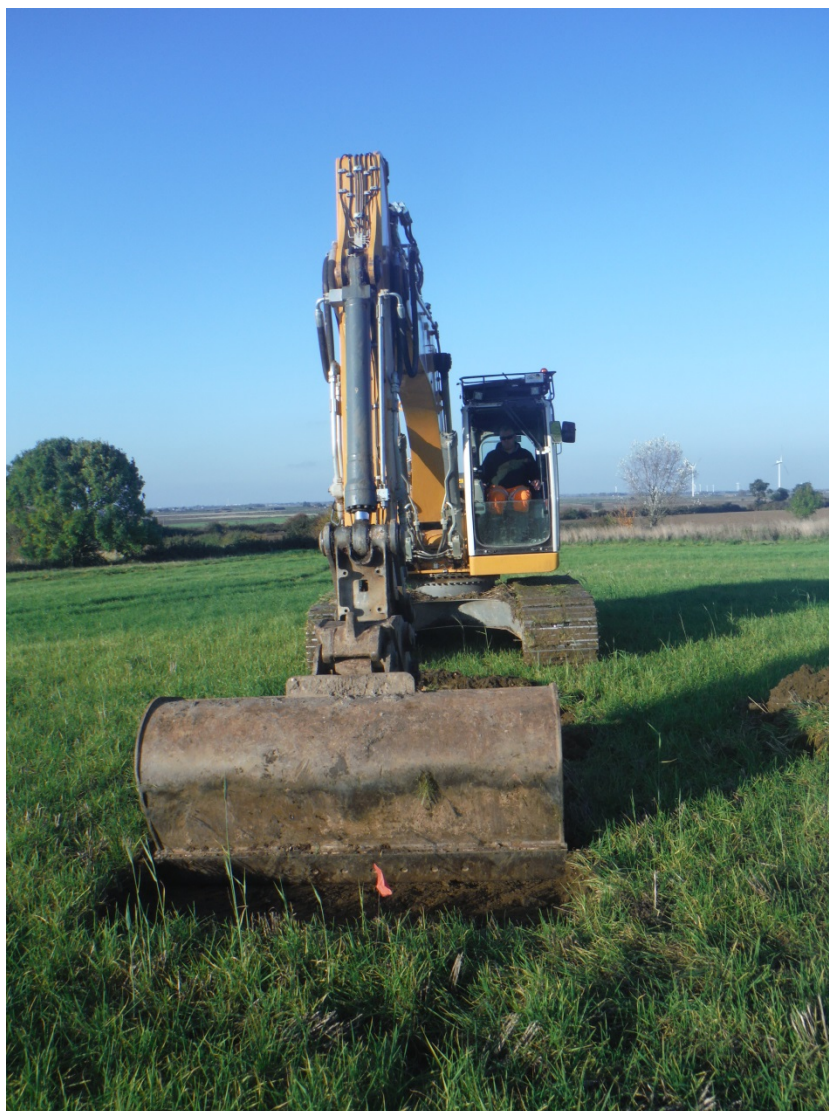
Plate 2: The site, machining, view north

4.1.2 Ground reduction was carried out under archaeological supervision using a 21-ton tracked mechanical excavator fitted with a 1.8m-wide toothless ditching bucket (Plate 2). Topsoil and subsoil deposits were removed in spits down to the level of the undisturbed natural geological deposits where potential archaeological features could be observed and recorded. Exposed surfaces were cleaned by trowel and hoe as appropriate and all further excavation was undertaken manually using hand tools. Overburden deposits were set aside beside each trench and examined visually and with a metal-detector for finds retrieval.

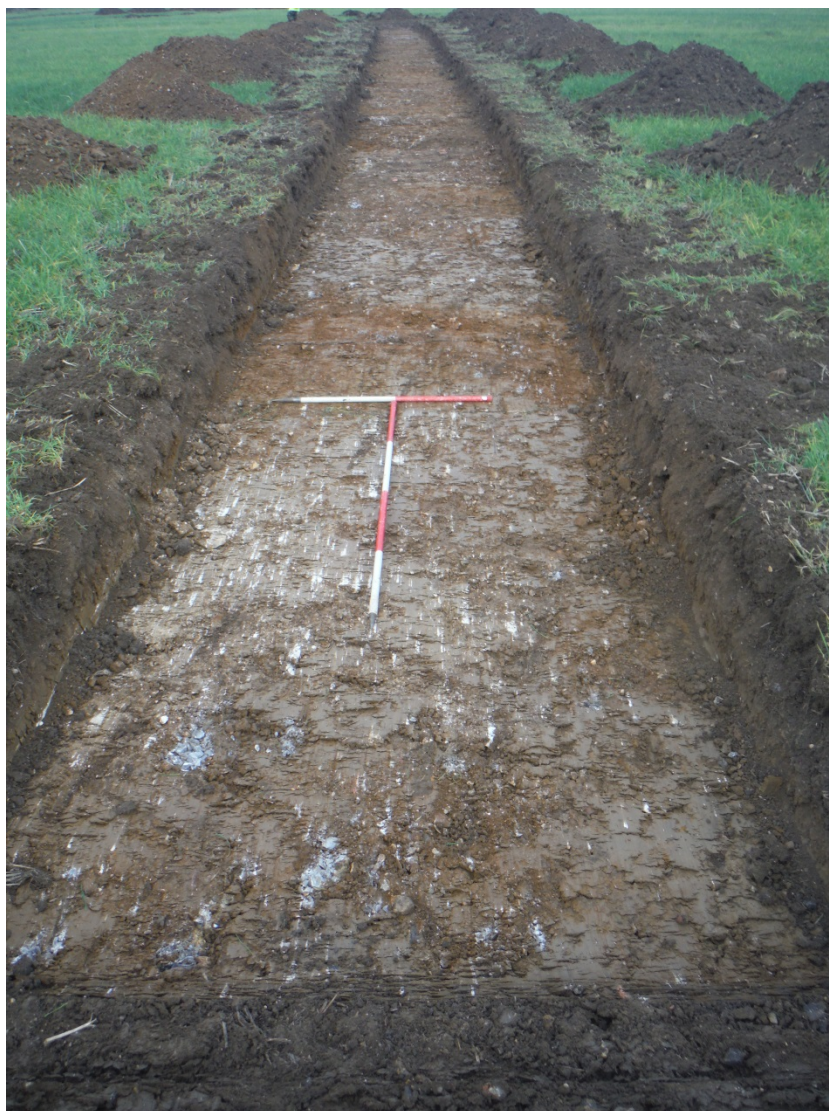
Plate 3: Trench 6, view north

TRENCH 6	Figures 2, 3		Plate 3	
Trench Alignment: N-S	Length: 50m	Max Machine Depth (m OD): 14.26 Level of Natural (m OD): 14.32		
Deposit	Context No.	Average Depth (m)		
		N End	S End	
Topsoil	(100)	0.20m	0.20m	
Subsoil	(101)	0.30m	0.30m	
Natural (max extent)	(102)	0.36+m	0.36+m	
Summary				
Trench 6 was located in the northern area of the site.				
The trench contained no archaeological features or deposits.

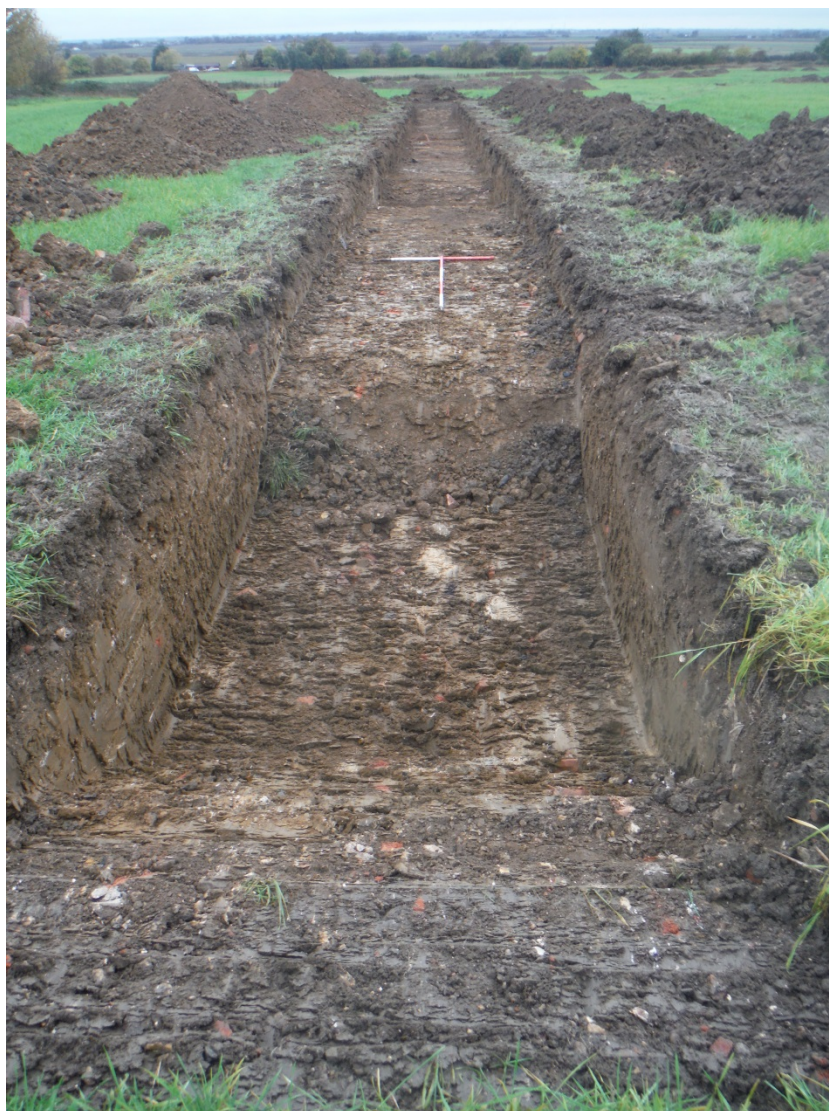
Plate 4: Trench 12, view north-west

TRENCH 12	Figures 2, 3		Plate 4	
Trench Alignment: NW-SE	Length: 50m	Max Machine Depth (m OD): 15.96 Level of Natural (m OD): 15.96		
Deposit	Context No.	Average Depth (m)		
		NW End	SE End	
Topsoil	(100)	0.21m	0.22m	
Made Up Ground	(105)	0.94m	1.20+m	
Natural (max extent)	(102)	0.94+m	-	
Summary				
Trench 12 was located in the central area of the site.				
The trench contained no archaeological features or deposits. The level of the natural was heavily truncated by modern made-up-ground deposits.
