**Worts Farm Granary and Barn,
High St, Landbeach,
Cambridgeshire : Historic
Building Recording**

HISTORIC BUILDING RECORDING

Pre-Construct Archaeology Ltd	
Project Number	K4227
Report Number	R12262

Planning Reference: S/2749/13/FUL & S/2750/13/LB/FUL

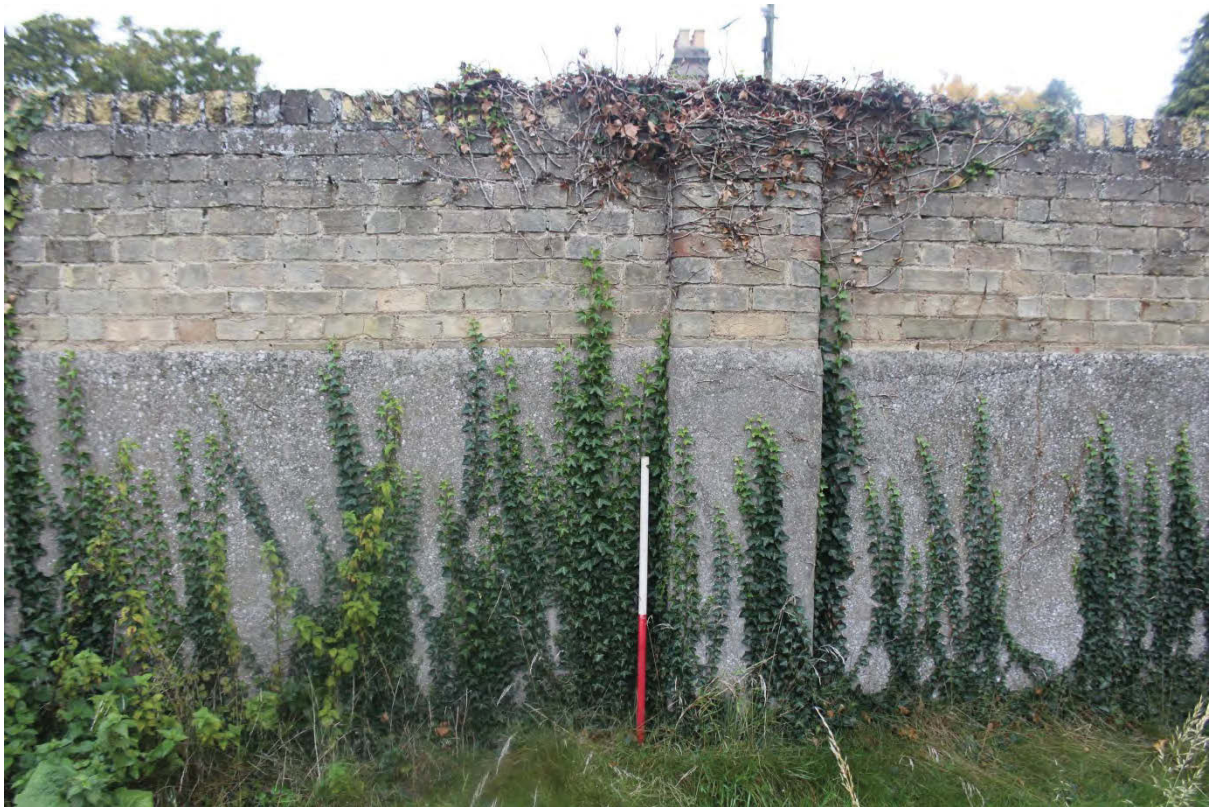
Plate 5. Farmyard wall with render on lower half

1.2.6 On entering the site from the High Street, the granary (Plate 1) is on the immediate left. The barn (Plate 2) is the next building, forming a courtyard along with a gault brick boundary wall along the High Street side and the walls of buildings in the adjoining property on the south-eastern side. The courtyard in the middle is now a grassed area (Plate 3). The historical farm has been divided into separate plots. On accessing from the High Street, the former farmhouse is on the right. On the south-west side of the surveyed barn, a second courtyard area, of a now separate property is still present, accessed via a large brick arch thought to be contemporary with most of the farm buildings present (Plate 4). The inside of boundary wall of the farmyard which fronts onto the High Street is rendered on the lower half (Plate 5).

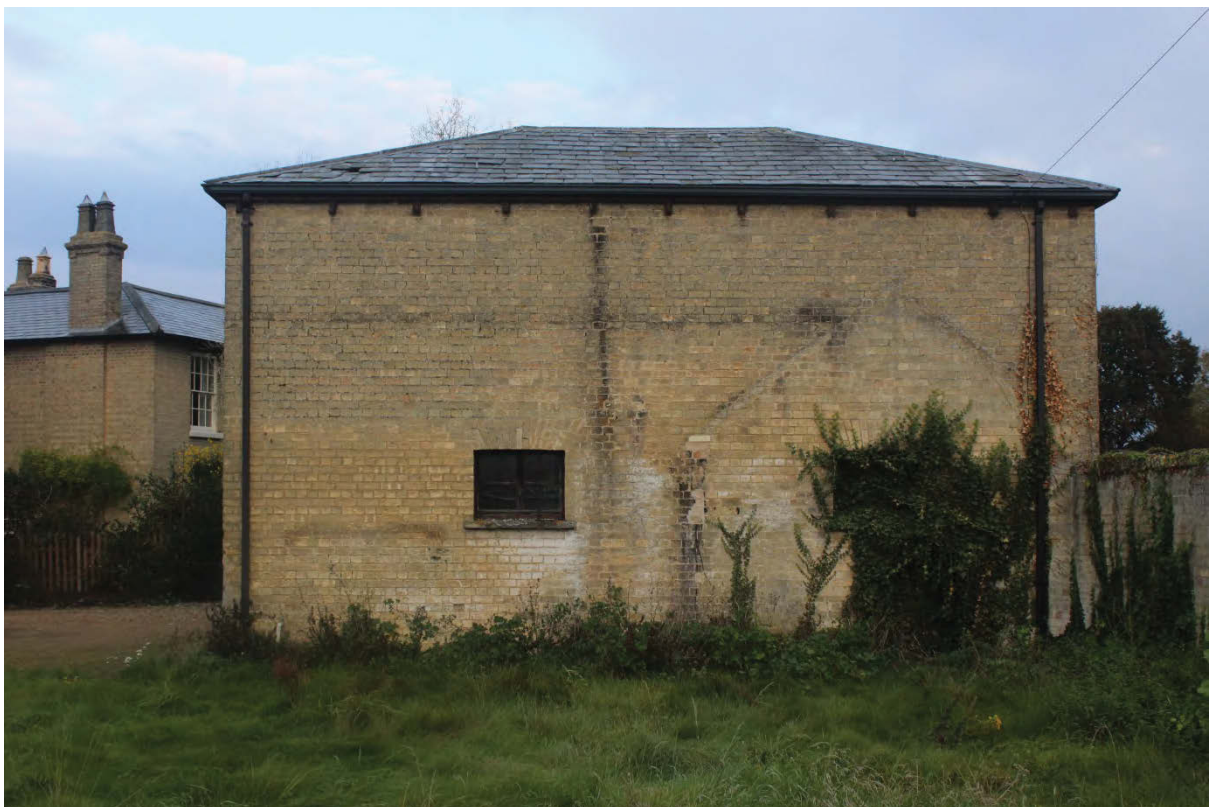
Plate 6. South-east facing elevation, The Granary

5.2.1 The south-east elevation (Plate 6) has two four-pane, wooden framed casement windows at ground floor level. These windows appear to be original and there is no evidence of their replacement visible in the surrounding brickwork. The windows have a stone cill and brick header arch above. Plastic downpipes and hoppers were located at each end of the wall.

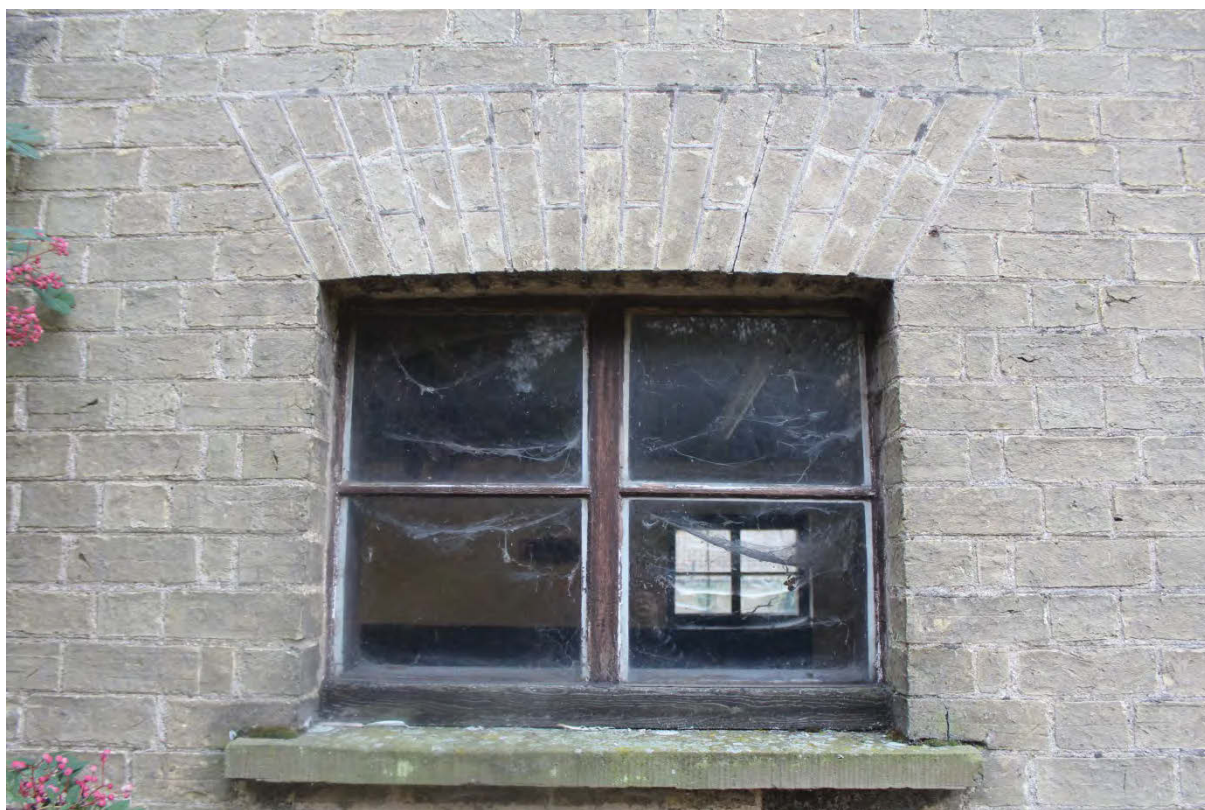
Plate 9. Casement window on the north-west facing elevation, The Granary

5.2.7 The fenestration on this elevation is the same as that noted on the opposite south eastern elevation, although this side has windows at first floor level (Plate 9).

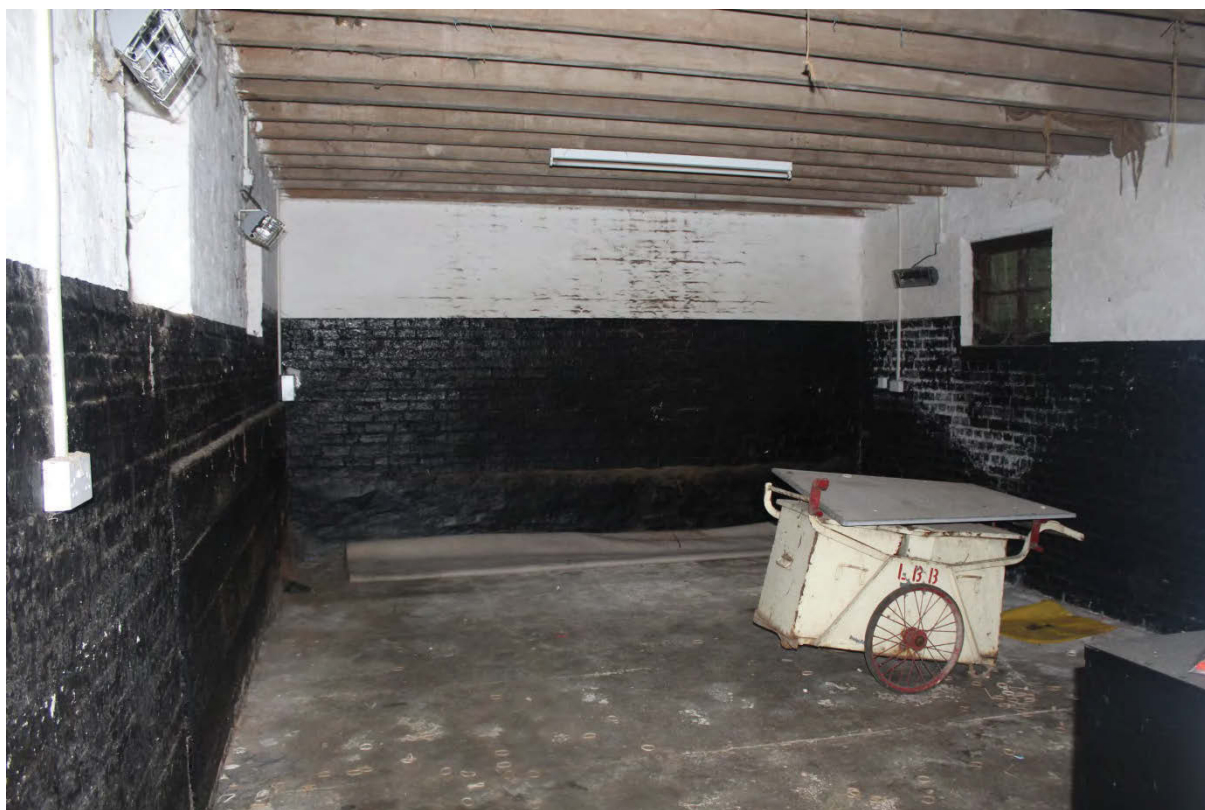
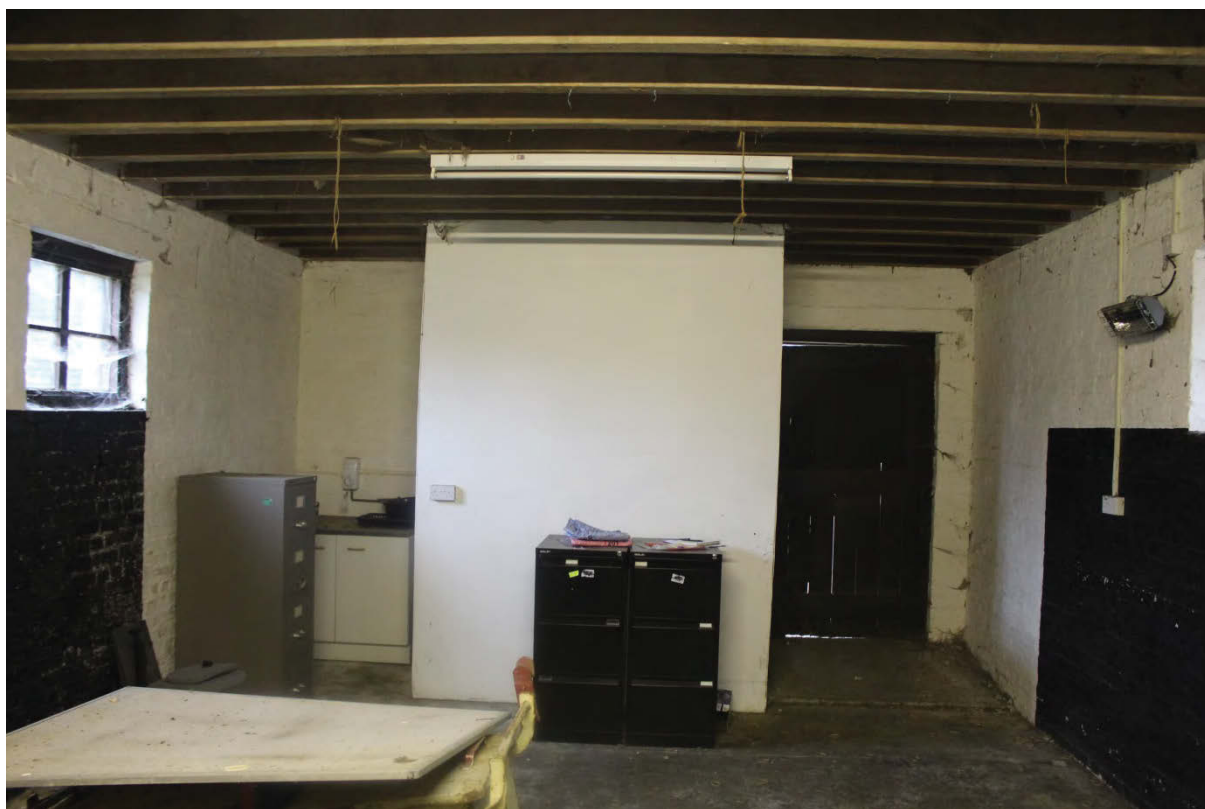
Plate 11. Ground floor storage area inside The Granary

5.3.3 The floor was covered with modern concrete and the ceiling joists are all exposed. Four rectangular holes were noted in the boards of the floor above, two of which had remnants of grain sacks attached.

6.1.7 The ground floor would have been used to store animal food would have been left in large sacks and to prevent damage from any damp, the walls were coated with a layer of tar to the height of the stored sacks. This tar is still visible in the granary as well as in two of the bays of the threshing barn.

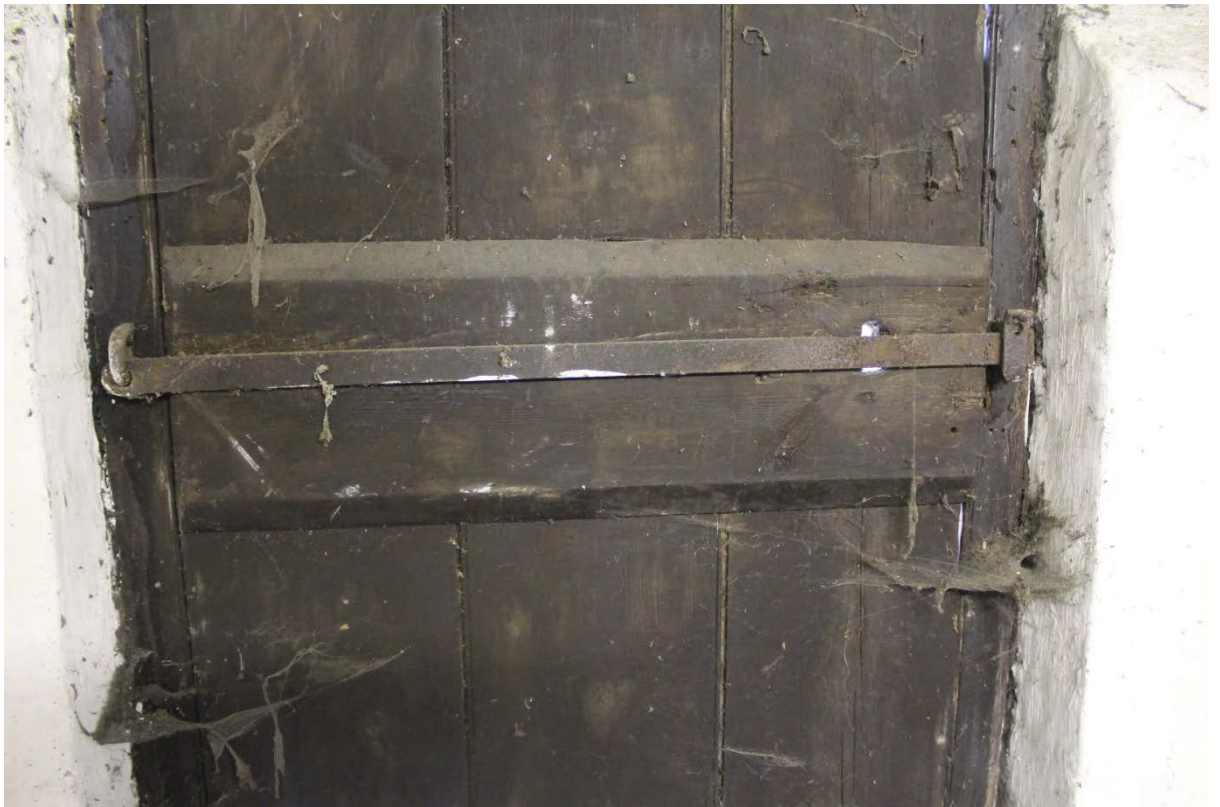
Plate 16. Detail of the loading door on the Granary first floor

5.3.10 The wooden loft door as noted on the external south-west facing elevation was recorded. A simple iron lever was used to secure the door which could only be opened and secured from the inside (Plate 16).

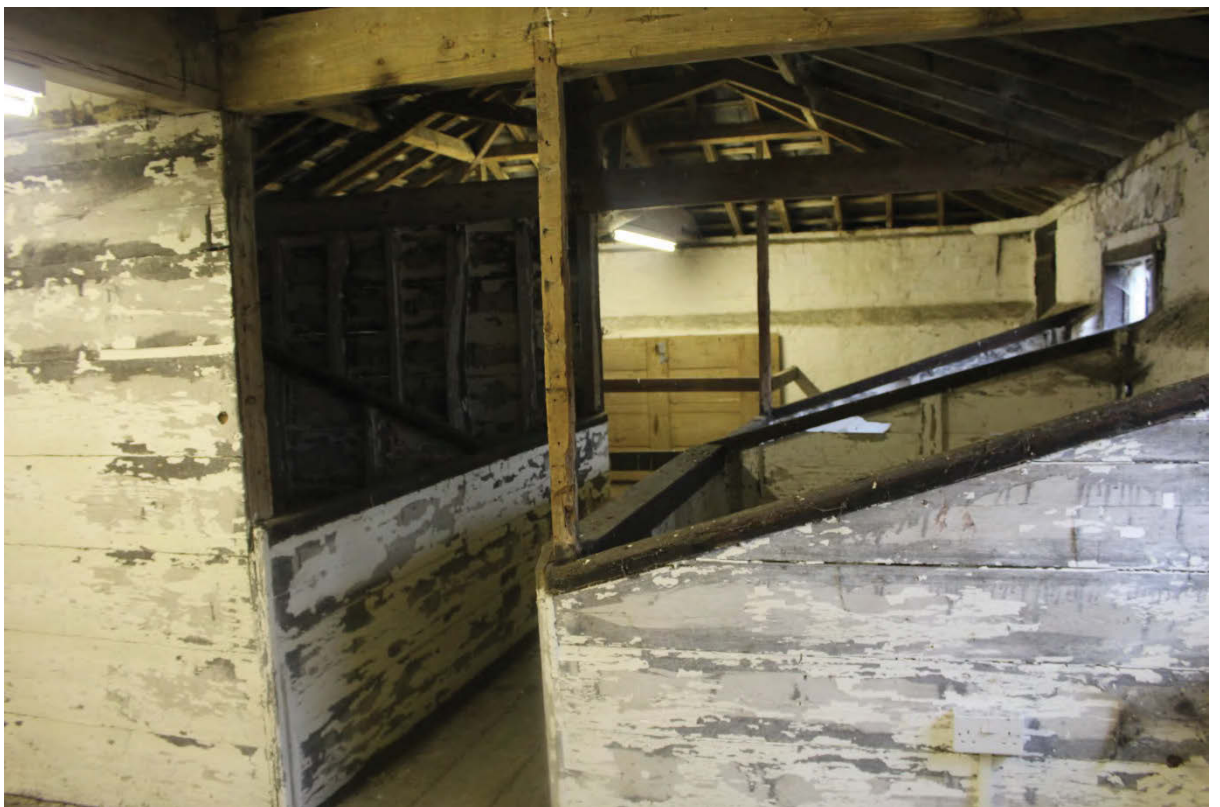
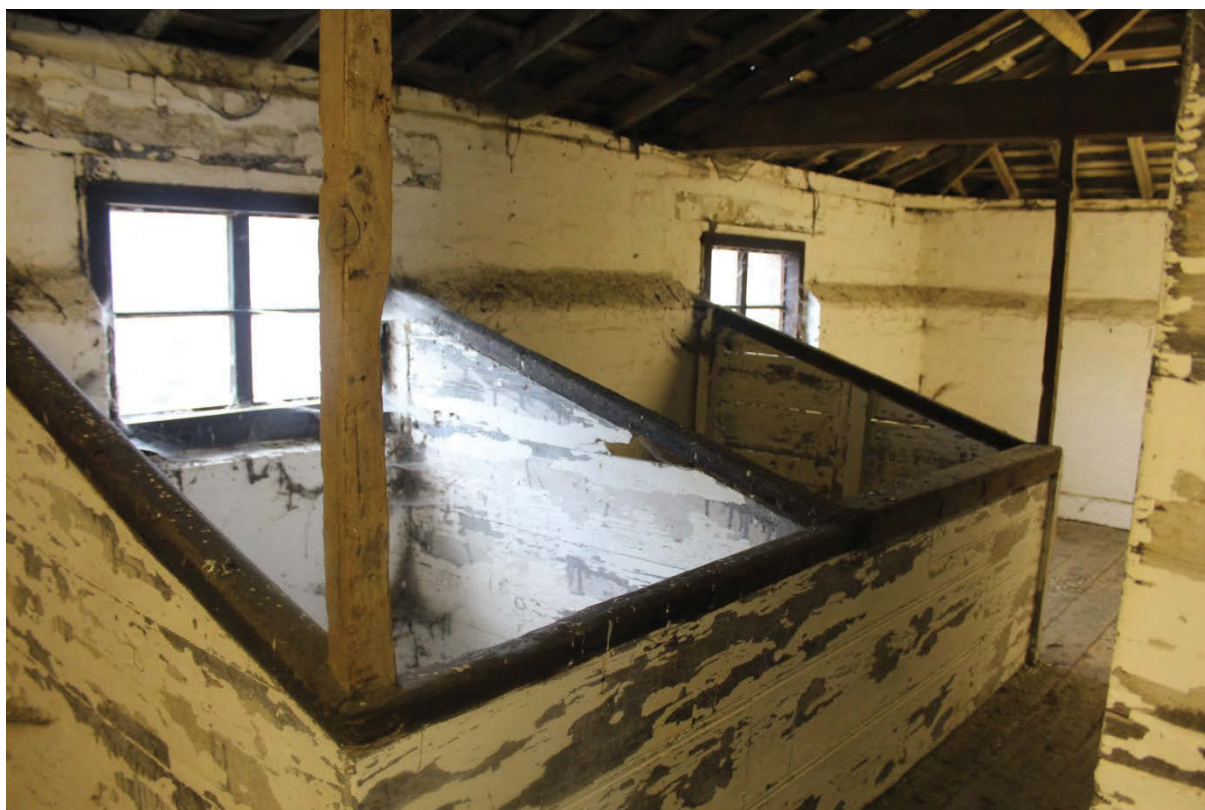
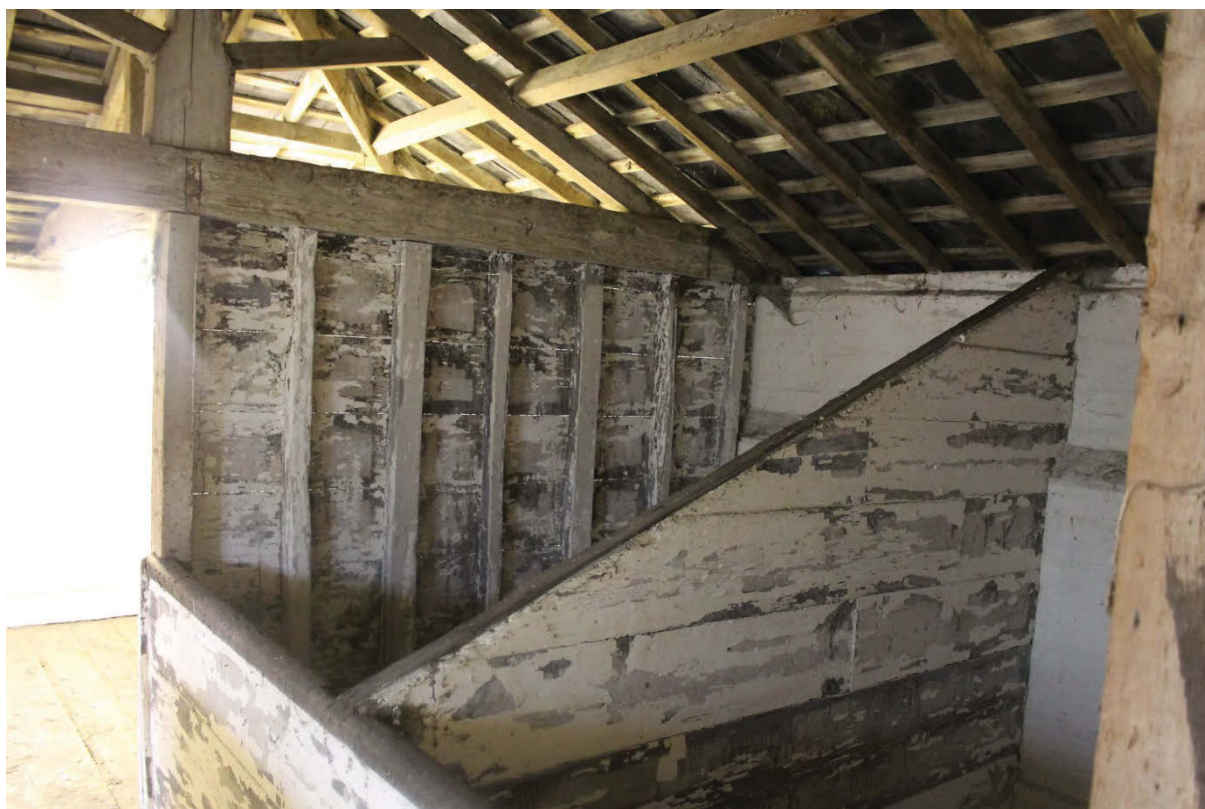
Plate 17. Grain stores on the first floor

storage and voids were noted in the base of each which correspond to the holes noted in the ceiling from below. The stores / bins had been constructed using wide timber boards which had all been painted white.

- 6.1.5 The grain could be transferred to the lower floor via the chutes noted in the floor of each bin. A canvas or sacking chute was attached, the end closed by a string tie. The stockman would untie the end of the chute from a particular
