**BLACKWATER TRADING ESTATE,
THE CAUSEWAY, MALDON, ESSEX**

ARCHAEOLOGICAL WATCHING BRIEF

PCA REPORT NO: R12302

DECEMBER 2015

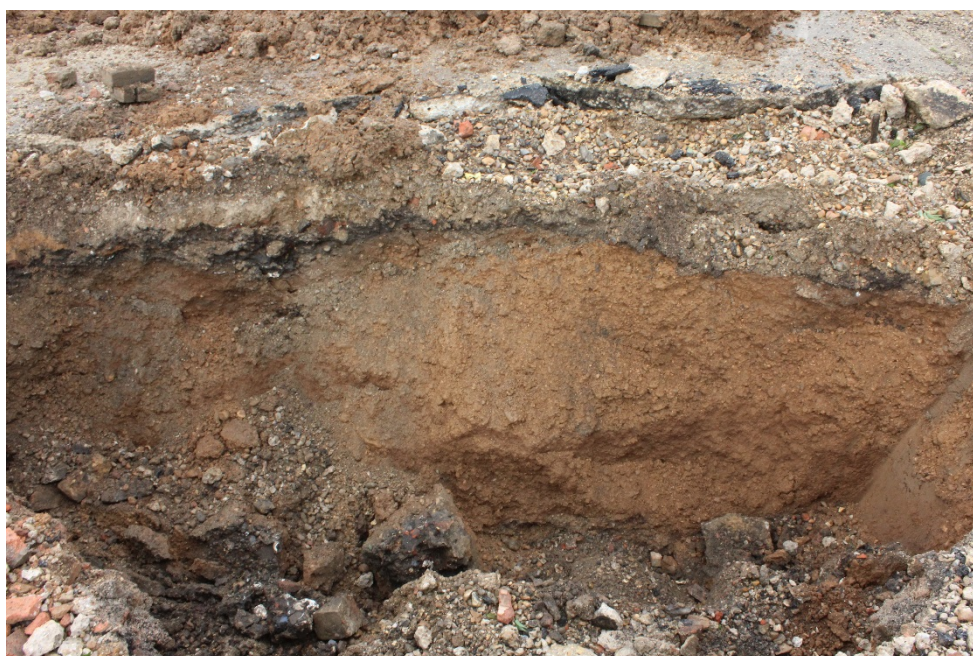
Plate 1: TP1, Looking SW

6.1.1 Trial Pit 1 was located at the north of the site. The earliest deposit encountered was natural gravel [3] at a depth of 0.50m below the current ground surface. Overlying the gravel was a levelling layer of crushed brick and gravel [2] which was in turn sealed by concrete slab [1] which formed the current ground surface.

Context No	Description	Depth	Thickness
1	Concrete Slab	0-0.20m	0.20m
2	Levelling Layer	0.20-0.50m	0.30m
3	Natural Gravels	0.50-1.5m+	1.00m+

- 7.1 It was apparent from Trial Pit 1 that within the northern area of the study site any potential archaeological horizon had been removed during the terracing and levelling of the site for the construction of the railway, causing widespread horizontal truncation of any potential archaeological resource.

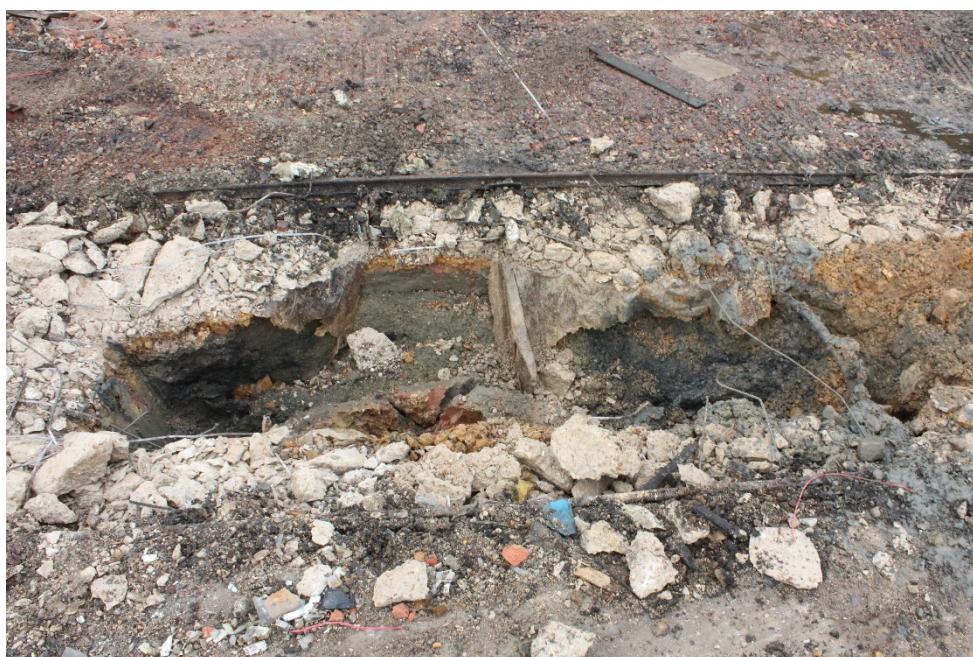
Plate 2: TP2, Looking SW

6.2.1 Trial Pit 2 was excavated in the north-west of the site. It was abandoned at a depth of 0.90m because of the presence of an electric cable. The earliest deposit recorded was alluvial gravel [5] which was in excess of 0.90m thick and was encountered at a depth of 0.60m below the current surface. Sealing the gravel was a levelling layer [4] which was capped by the concrete slab [1].

Context No	Description	Depth	Thickness
1	Concrete Slab	0-0.40m	0.40m
4	Levelling Layer	0.40-0.60m	0.20m
5	Alluvial Gravels	0.60-1.50m+	0.90m+

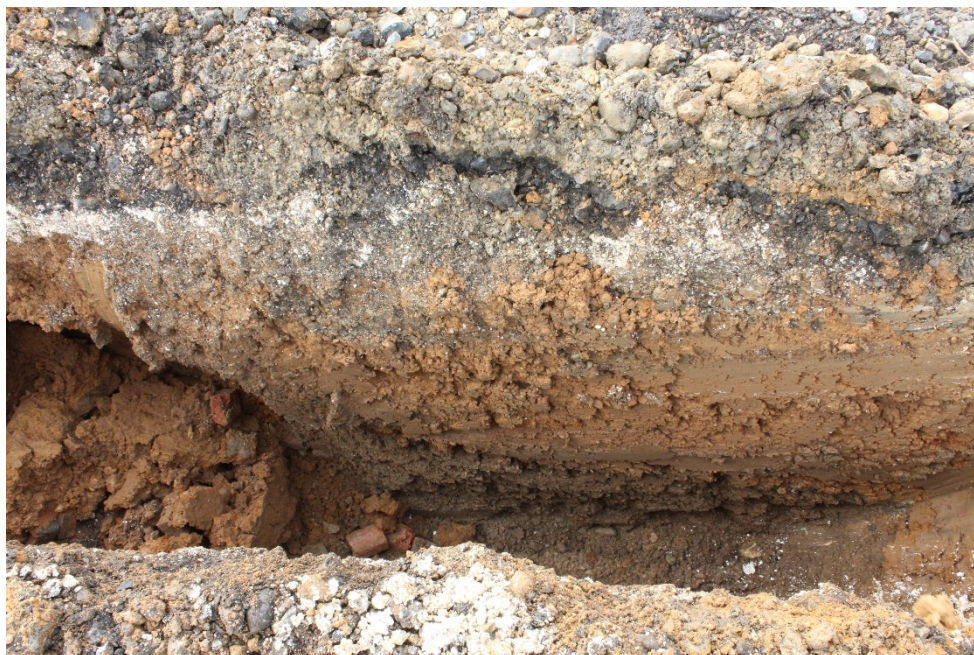
Plate 3: TP3, Looking SW

6.3.1 Trial Pit 3 was located at the northern end of the backfilled dock. The earliest deposit recorded was natural gravel [8] at a depth of 1.56m below the current ground surface, with a thickness of over 0.64m. The gravel was directly overlain by the backfill of the dock [7], a mid yellowish brown firmly compacted silty clay with brick fragments and clinker, which was located at 0.42m below ground level and was 1.24m thick. A 0.05m thick layer of chalk [6] overlay the backfill of the dock, which was in turn sealed by the concrete slab [1].

Context No	Description	Depth	Thickness
1	Concrete Slab	0-0.37m	0.37m
6	Chalk Layer	0.37-0.42m	0.05m
7	Dock Backfill	0.42-1.56m	1.24m
8	Natural Gravels	1.56-2.30m+	0.64m+

- 7.2 Trial Pits 3, 5 and 6 also showed truncation of the potential archaeological levels with the construction of the dock. However, whereas Trial Pit 6 showed total removal of any earlier deposits, Trial Pit 5, located on the edge of the dock, showed that the dock edge appeared to rise up gradually, and as a result a band of peat [16] was also recorded which could represent an ancient land surface.

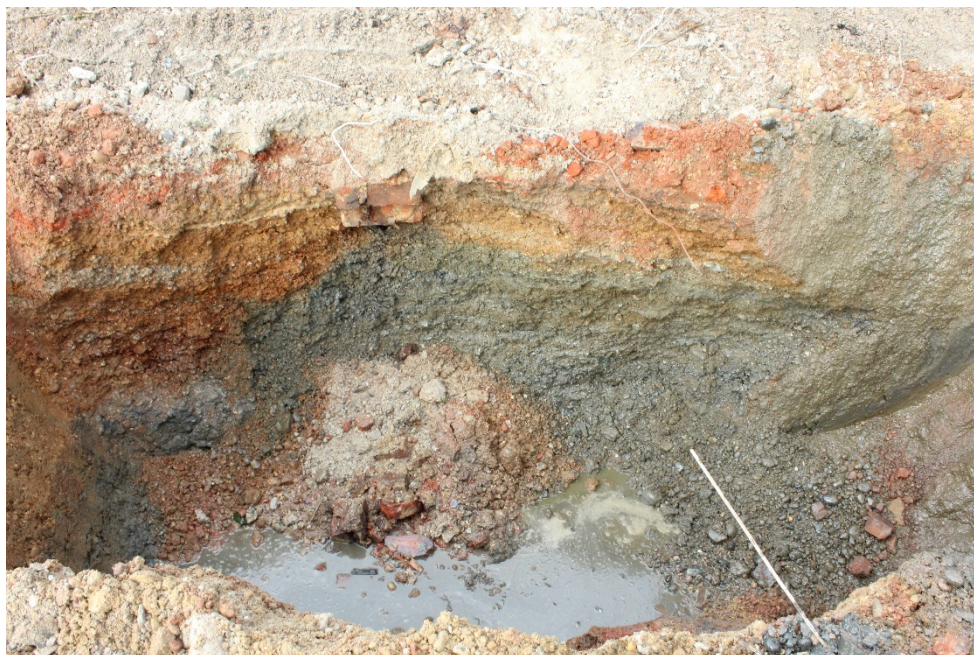
Plate 4: TP4, Looking SE

6.4.1 Trial Pit 4 was located along the western edge of the site. The earliest deposit encountered was the natural gravel [12], recorded at a depth of 1.58m below the current ground level and with a thickness in excess of 0.28m. Overlying the gravel at a depth of 1.50m below the current ground surface was a heavily weathered and fragmented peaty layer [11] with a thickness of 0.08m. Sealing the peat was a 1.00m thick layer of alluvial gravels [10] with a depth of 0.50m below ground level. This was in turn overlain by a 0.30m thick levelling layer [9] which was capped by the concrete slab [1].

Context No	Description	Depth	Thickness
1	Concrete Slab	0-0.20m	0.20m
9	Levelling Layer	0.20-0.50m	0.30
10	Alluvial Gravels	0.50-1.50m	1.00m
11	Weathered Peat Layer	1.50-1.58m	0.08m
12	Natural Gravels	1.58-1.80m+	0.28m+

- 7.3 Peat layers were also present within Trial Pits 4 and 7, recorded as [11] and [23] respectively. The presence of the peat is likely to indicate that the study site was periodically occupied by dry land, if only seasonally, with the temporary establishment of vegetation on the marginal land along the water's edge.

- 7.4 That the peat appears both above the alluvial gravels in Trial Pit 5 and below them in Trial Pits 4 and 7 implies that that there has been more than one episode of peat formation. This is typical of foreshores within an intertidal estuary.

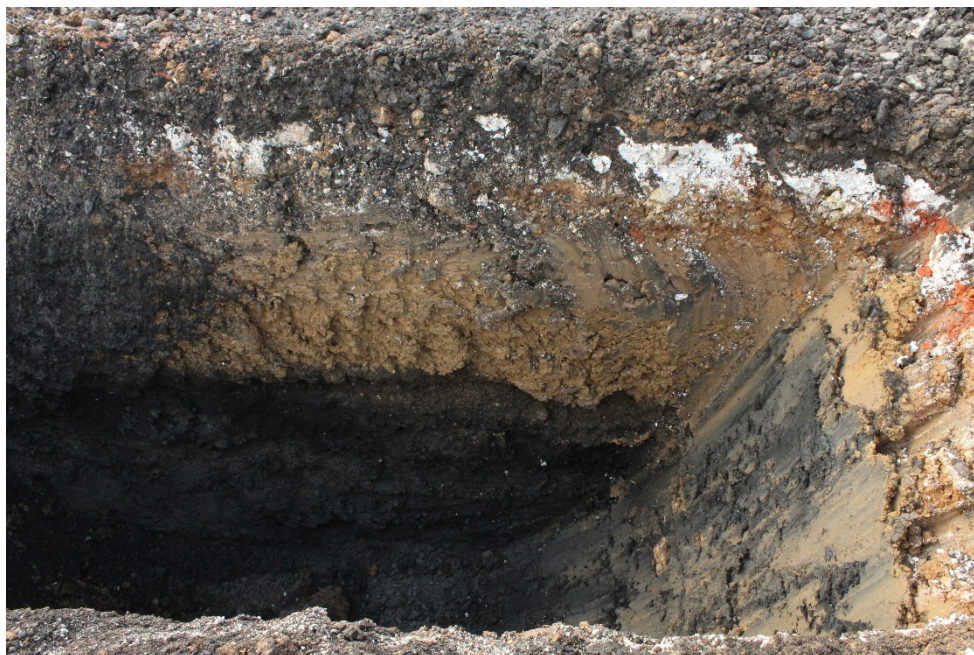
Plate 5: TP5, Looking SE

6.5.1 Trial Pit 5 was located along the western edge of the backfilled dock. The earliest deposit recorded was the natural gravel [18], recorded at a depth of 2.65m. This was overlain by alluvial gravel [17] located at 1.60m depth which had a thickness of 1.05m. Sealing the alluvial gravel was a 0.10m thick weathered and fragmented layer of peat [16], recorded at a depth of 1.50m. Overlying the peat at a depth of 0.35m was backfill from the dock, with a thickness of 1.15m. This was in turn sealed by a 0.05m thick chalk layer [14], above which was 0.05m thick levelling layer [13] for concrete slab [1].

Context No	Description	Depth	Thickness
1	Concrete	0-0.25	0.25m
13	Levelling Layer	0.25-0.30m	0.05m
14	Chalk Layer	0.30-0.35m	0.05m
15	Dock Backfill	0.35-1.50m	1.15m
16	Weathered Peat Layer	1.50-1.60m	0.10m
17	Alluvial Gravels	1.60-2.65m	1.05m
18	Natural Gravels	2.65m+	-

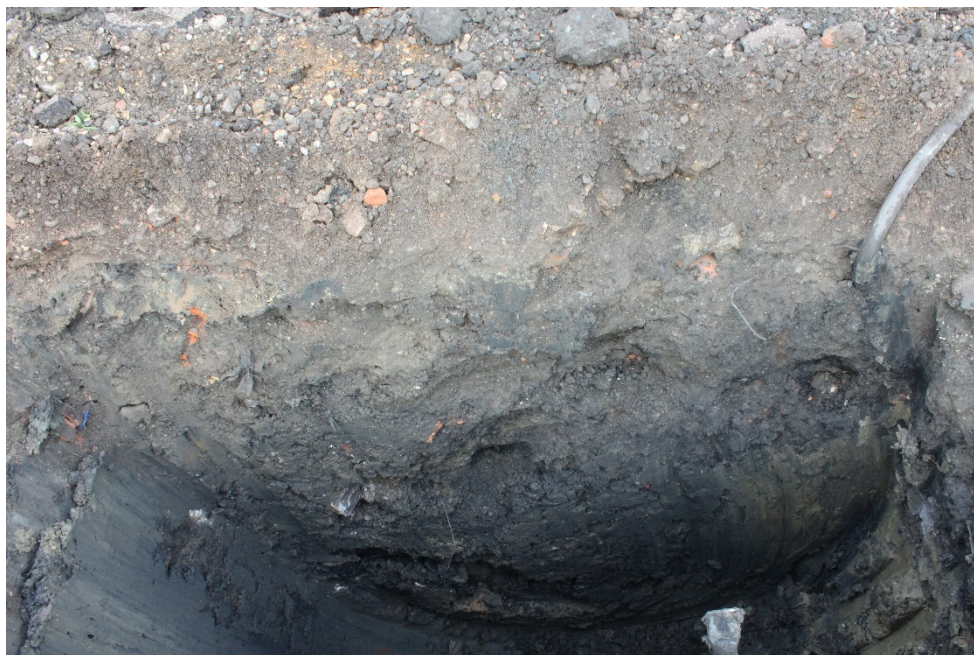
Plate 6: TP6, Looking SE

6.6 Trial Pit 6 was located to the east of the site, within the area of the backfilled dock. Natural gravels were not reached as they lay below the maximum depth that the machine arm could reach to. The earliest deposit encountered was the backfill of the dock [21], a dark grey firmly compacted silty clay with brick, clinker and wire, the top of which lay at 1.00m below the ground surface and was over 3m thick. Above the backfill was a 0.60m thick layer of made ground [20] which was sealed by levelling layer [19] which was capped by the concrete slab [1].

Context No	Description	Depth	Thickness
1	Concrete Slab	0-0.20m	0.20m
19	Levelling Layer	0.20-0.40m	0.20m
20	Made Ground	0.40-1.00	0.60m
21	Dock Backfill	1.00-4.00m+	3.00m+

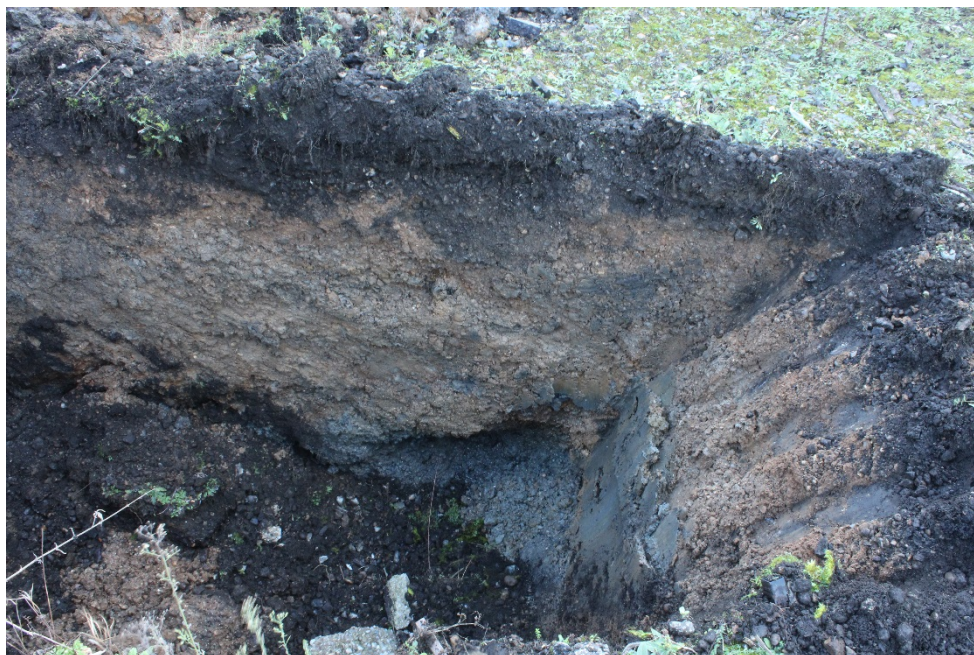
Plate 7: TP7, Looking SE

6.7.1 Trial Pit 7 was located towards the south of the site. The earliest deposit encountered was the natural gravel [24], recorded at a depth of 1.30m, with a thickness of over 1.40m. Above the gravel, at a depth of 1.25m, was a 0.05m thick layer of heavily weathered and fragmented peat [23]. The peat was sealed by a 0.95m thick layer of alluvial gravel [22] that had a maximum height of 0.30m. Sealing the test pit was the concrete slab [1].

Context No	Description	Depth	Thickness
1	Concrete Slab	0-0.30m	0.30m
22	Alluvial Gravels	0.30-1.25m	0.95m
23	Weathered Peat Layer	1.25-1.30m	0.05m
24	Natural Gravels	1.30-2.70m+	1.40m+
