**AN ARCHAEOLOGICAL WATCHING BRIEF:  
HEADLAND FIRE STATION, DURHAM STREET,  
HARTLEPOOL**

**JULY 2014**

<b>Pre-Construct Archaeology Limited Quality Control</b>	
<i>Project Number</i>	K3435
<i>Site Code</i>	DSH 14
<i>Report Number</i>	RN11046

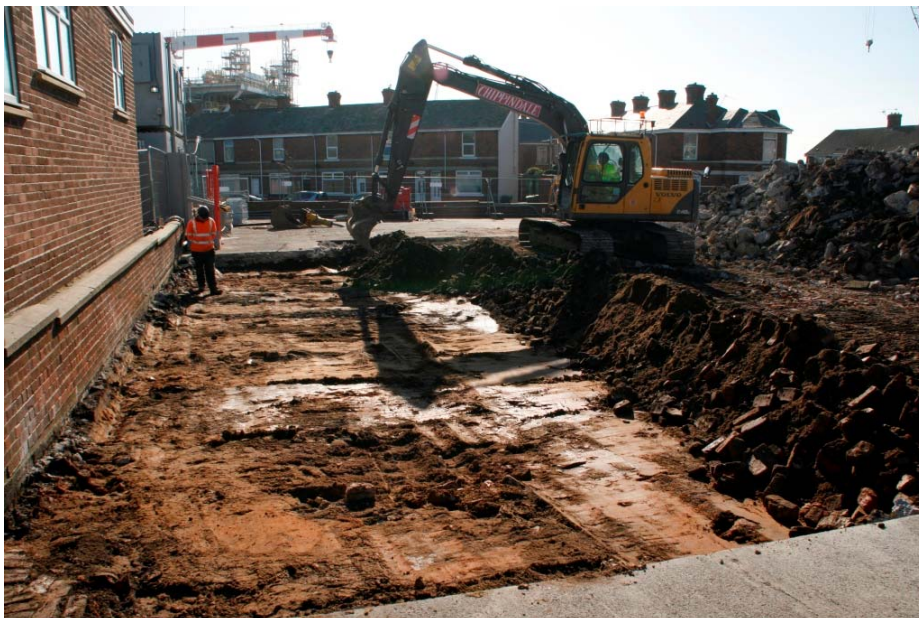
Plate 2. Area 1, general view, looking south

- 4.1.2 Monitoring took place during groundworks across four areas of the site (Figure 2). Area 1 was situated adjacent to the eastern boundary of the site and ground reduction took place across an area that measured c. 13m by 5m (Plate 2). Ground reduction also took place adjacent to the western boundary across an area that measured c. 16m by 6m (Area 2). An inspection pit located a short distance to the west of Area 1 was removed and ground reduction here took place across an area that measured 7m by 2.40m (Area 3). Area 4 comprised the strip foundation trenches for the new building, located across the central part of the site (Plate 7).

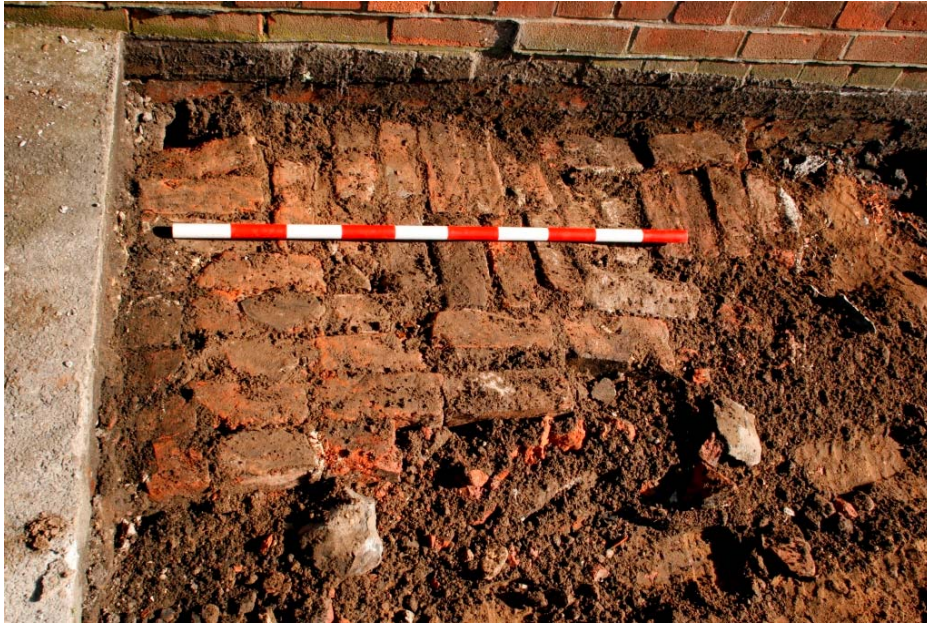
5.1.3 A brick surface, [2], was recorded across Area 1 for a maximum distance of 3.50m east-west and 20m north-south (Plate 3). The surface was constructed with red brick (230mm x 100mm x 80mm) and was dry bonded, bedded on a c. 0.10m thick dark grey sand, [3]. The brick surface was laid directly over the brick cistern and levelling deposit [4] and represents an earlier surface predating the current concrete slab.

Plate 3. Area 1, detail of brick surface [2], looking east (*scale 1m*)

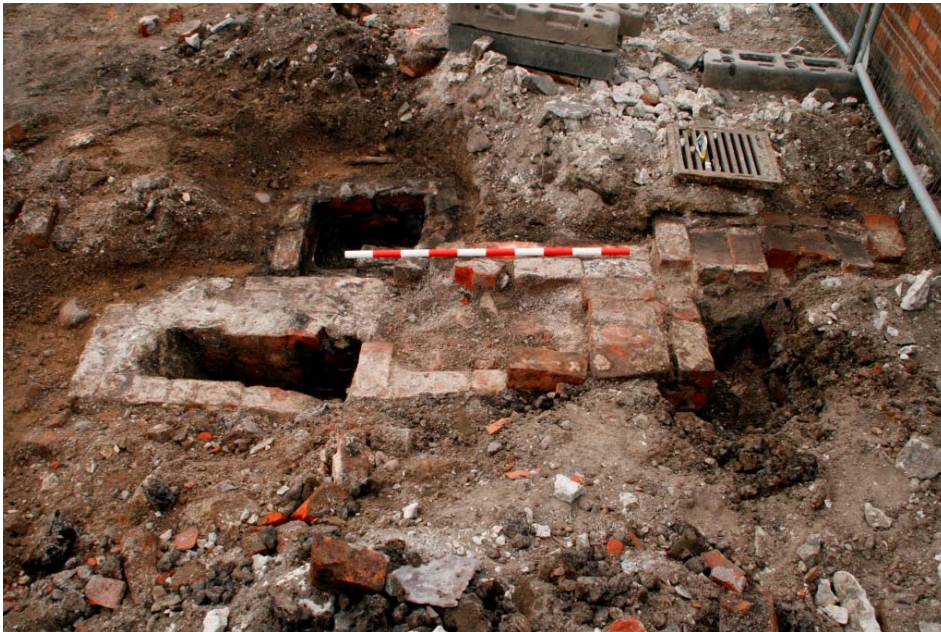
- 5.2.5 Located immediately to the south of the fireplace was a square drainage structure, [14], recorded within a narrow construction, [15] (Plates 4 and 5). This measured 0.71m by 0.68m and was at least 0.32m deep. The upper three courses were brick built (230mm x 110mm x 80mm) in stretcher bond and the lower course was built using two U-shaped adjoining salt glazed ceramic bricks (680mm x 340mm), all bonded with light grey lime mortar. No datable material was recovered from its mid grey silty sand backfill, [13].

Plate 4. Area 2, external cellar wall and fireplace [10] and drain [14], looking south (*scale 1m*)

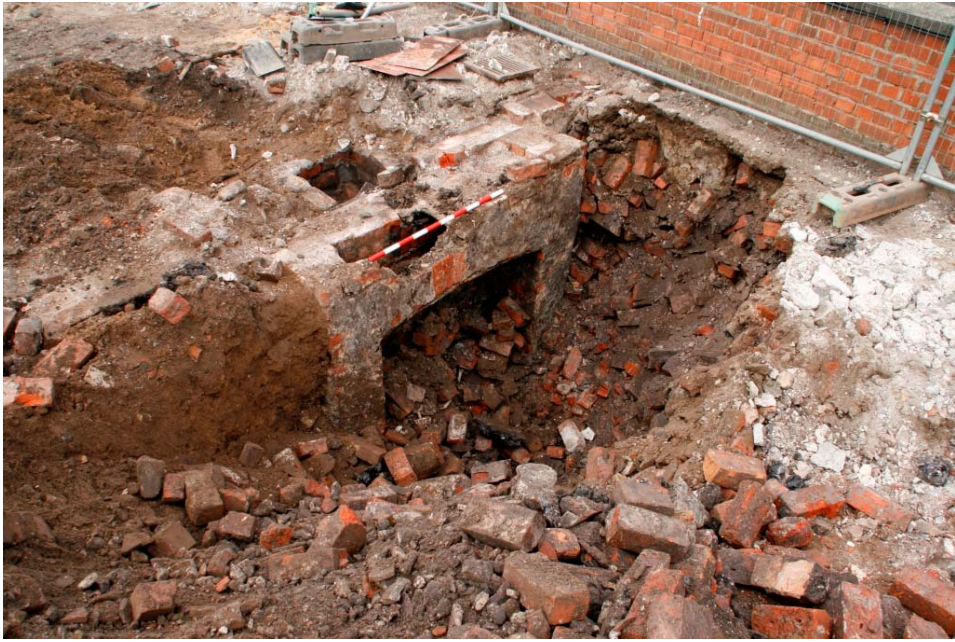
- 5.2.3 The southernmost basement element, [10], which represents the external wall of the building comprised an approximately NW-SE aligned rectangular fireplace with external dimensions of 2.07m NW-SE by 0.70m NE-SW (Figure 3; Plates 4 and 5). This was at least 1m high with a flue located to the south-east which measured 0.75m NW-SE by 0.25m NE-SW. Built of brick (230mm x 110mm x 80mm) it survived to at least 20 courses in both header and stretcher courses, bonded by light grey lime mortar, with the majority of the brick surface rendered with light grey lime mortar.

Plate 5. Area 2, fireplace [10], looking south-west (*scale 1m*)

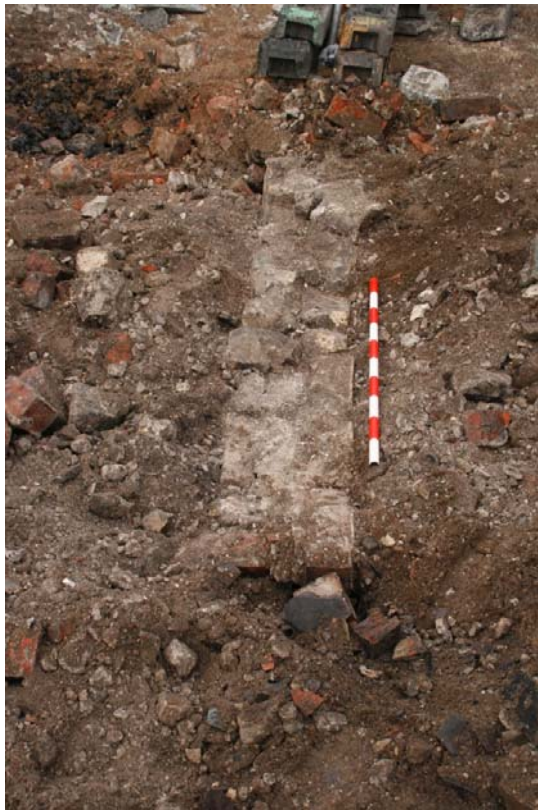
- 5.2.6 A short length of WNW-ESE aligned wall, [18], was exposed for a maximum distance of 2.10m c. 5m to the north of the fireplace and brick wall (Figure 3; Plate 6). This was 0.34m wide and at least 0.40m high. It was built principally of roughly hewn limestone blocks (minimum 110mm x 110mm x 100mm – maximum 210mm x 200mm x 200mm). At its eastern extent the wall was built using brick (230mm x 110mm x 80mm). The wall was exposed to at least four courses high and was bonded by light grey lime mortar. No construction cut was encountered for this wall. It may represent part of the same structure as wall [10], although was on a slightly different alignment and may represent an internal element. It is possible that the stone element of this structure may be of earlier origin and was incorporated into the 19th-century building as represented by the brick-built element.

Plate 6 Area 2, stone and brick wall [18], looking west (*scale 1m*)

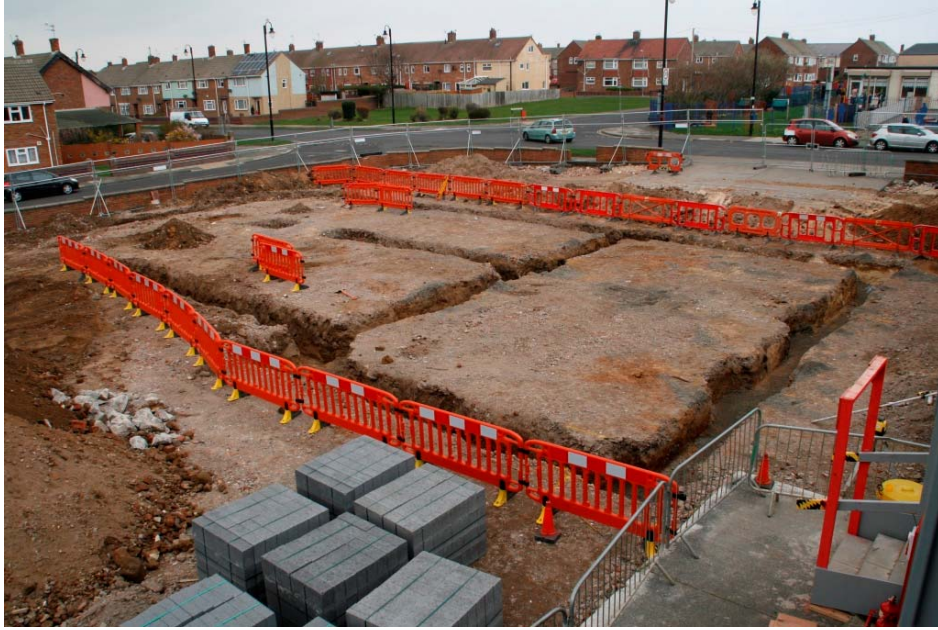
Plate 7. Area 4, general view of foundation trenches, looking north-west

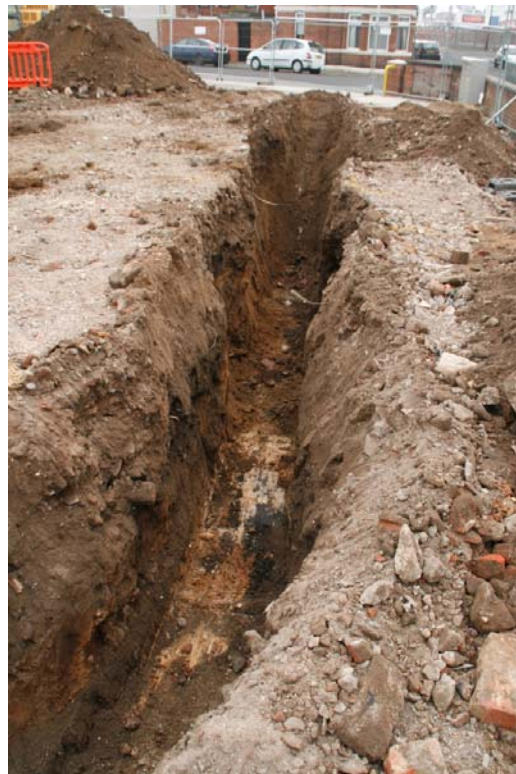
5.4.1 The earliest deposit encountered within the foundation trench comprised light grey limestone bedrock, [37] (Plate 8). This was encountered at various depths ranging from a minimum depth of 1m below present ground level in the north-eastern part of the trench sloping down to the south-west where bedrock was encountered at a maximum depth of 2.20m below present ground level. The bedrock was overlain by firm pinkish brown sandy clay, [36], representing boulder clay, which was up to 0.20m thick.

Plate 8. Area 4, detail of westernmost foundation trench with limestone bedrock exposed in base, looking south
