**AN ARCHAEOLOGICAL
EVALUATION ON LAND ADJACENT
TO WAGTAIL DRIVE,
HEYBRIDGE,
ESSEX
CM9 4UD**

SITE CODE: HYWD15

**FEBRUARY 2016
REPORT NO. R12333**

ARCHAEOLOGICAL EVALUATION

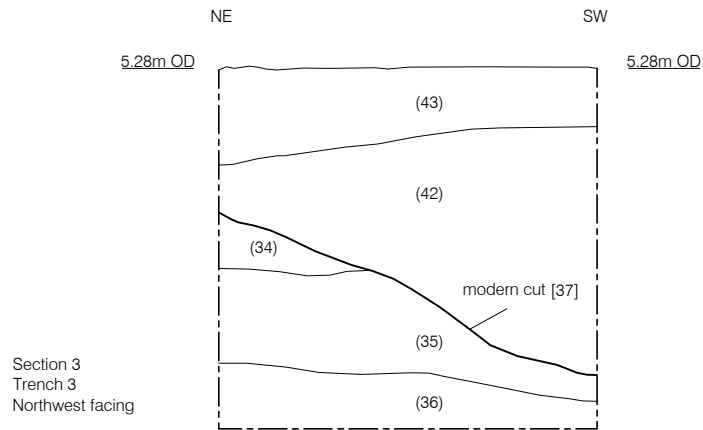
- 7.1.1 Natural geological deposits were encountered at the base of the sequence in both Trenches 3 and 4. In Trench 3, they comprised a number of layers of sandy gravels, each of which varied somewhat in colour and composition. The lowest layer consisted of a deposit of loose, light reddish-grey sandy gravel (36) which had an observed thickness of 0.35m. This lay beneath a 0.5m thick layer of loose, light bluish-grey clayey sandy gravels (35), which was in turn overlain by a layer of loose, dark reddish-brown sandy gravel (34) with an observed thickness of 0.3m (**Figure 3**).

- 7.1.2 Natural geological deposits in Trench 3 were only encountered at the very north-eastern end of the trench where they were observed to have been heavily truncated by a large cut filled with modern deposits (**Figure 3; Plates 1 and 2**). All natural geological deposits further west within the trench had been entirely removed by this truncation. Due to this heavy modern truncation, it is unknown at what level these natural gravels would have originally existed, nor whether any archaeological features of deposits had ever truncated, or been deposited upon, them.

- 7.1.3 In Trench 4, natural geological deposits appeared to consist of one thick, homogenous layer of loose, mid reddish-brown sandy gravel (33) (**Figure 3**). With an observed thickness of 1.08m, this deposit was recorded over an area measuring 3.25m (north-west to south-east) by 2m (north-east to south-west), at the very south-eastern end of the trench (**Plate 3**). Further to the north-west, the deposit had again been very heavily truncated by a large, near-vertical cut filled by modern deposits (**Figure 3; Plate 4**). This truncation had entirely removed all natural geological deposits across the remainder of the trench to the north-west (**Plate 3**).

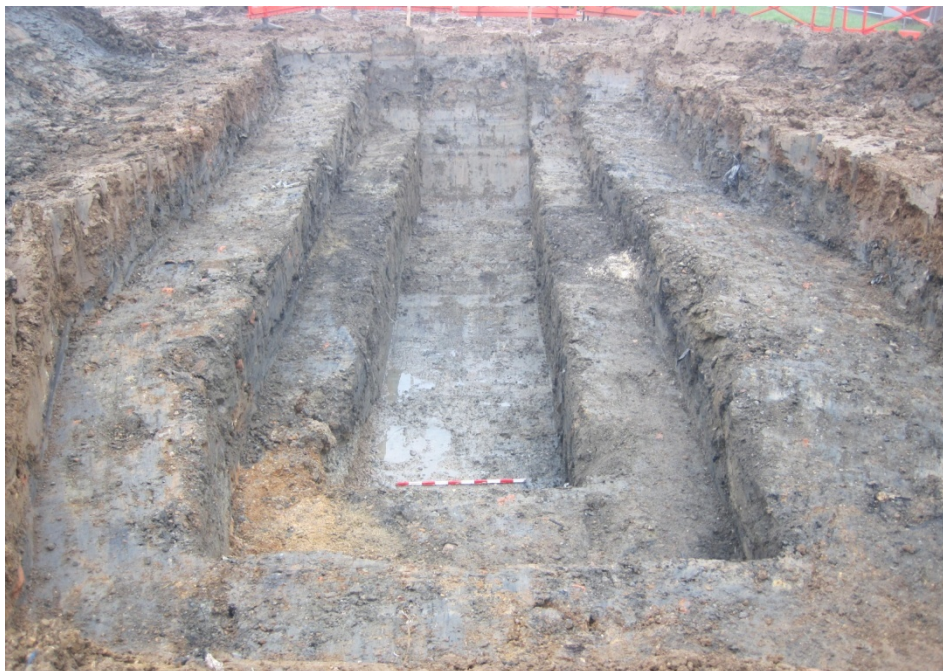
Plate 1: South-west view of Trench 3, showing mostly modern deposits with just one small patch of heavily truncated natural surviving in the north-east corner

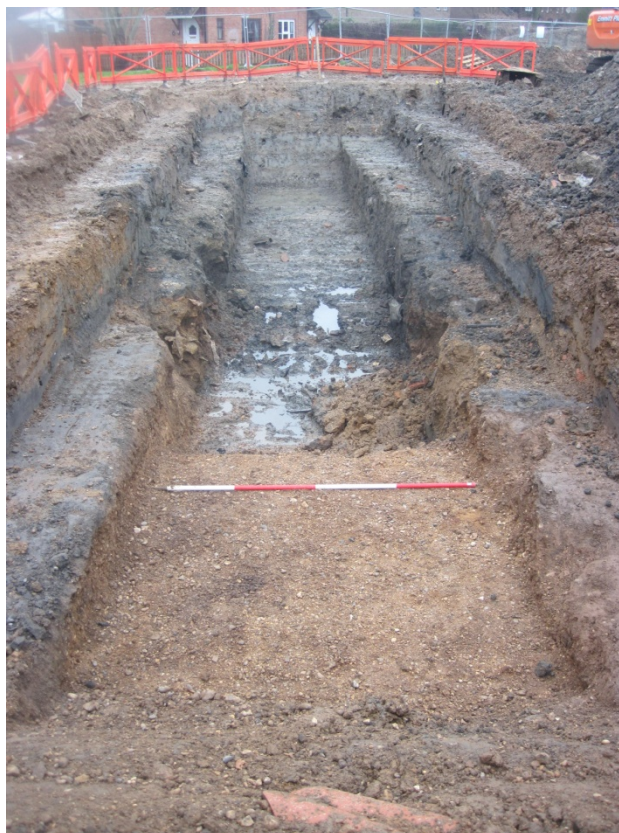
Plate 3: North-west view of Trench 4, showing natural geological deposits surviving at a high level in the south-east, but heavily truncated by modern cut and fills to the north-west

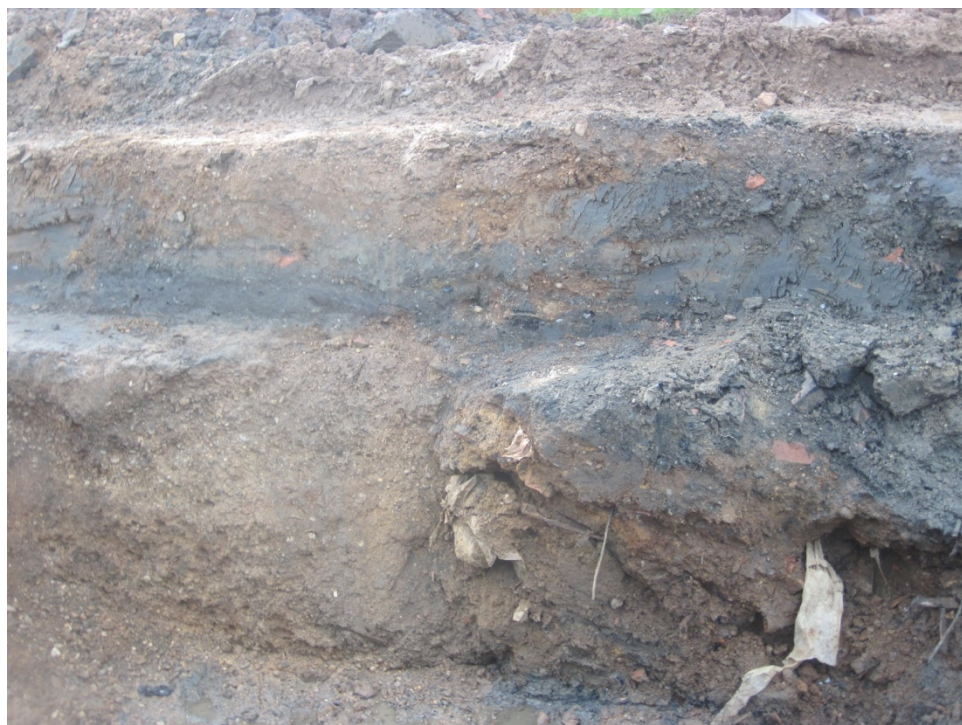
- 7.2.2 Both deposits comprised a roughly 0.4-0.5m thick layer of firm, silty clay, although deposit (31) was mid bluish-grey in colour, while (32) was more of a mid greyish-brown. Although generally quite 'clean' or sterile deposits, the layers did contain some inclusions of sub-angular flints (some burnt), coal fragments, and flecks of CBM (ceramic building material), chalk and charcoal, in varying frequencies. No closely datable artefacts were recovered from the deposits.

Plate 4: North-east facing section in Trench 4, showing natural gravel overlain by other deposits and truncated by modern cut and fills

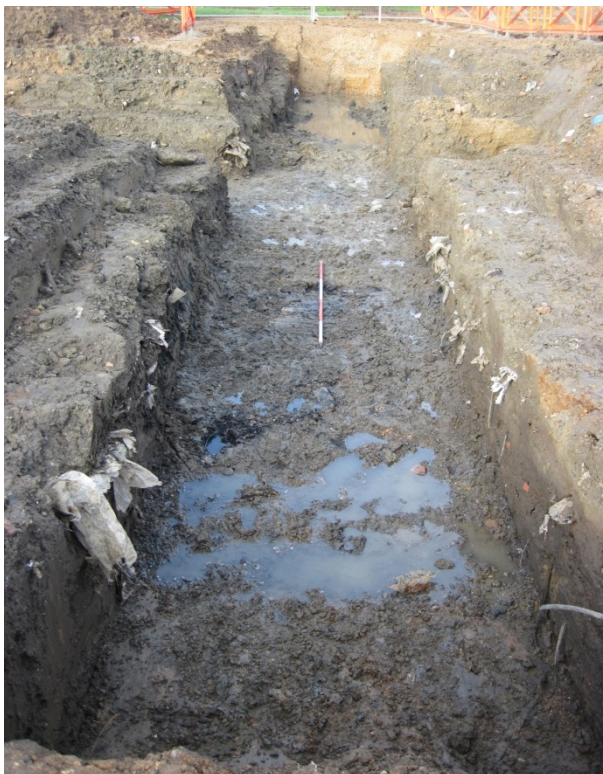
- 7.3 **Phase 3: Modern (Late 20th – Early 21st Century) Cut [37] and [38] and Deposits (39) to (44) (Trenches 1 to 4, Figure 3, Plates 1 to 7)**
- 7.3.1 Large, deep cuts [37] and [38] were observed to truncate natural geological deposits in both Trenches 3 and 4, respectively (**Figure 3; Plates 1 to 4**). Although only one cut edge was observable in each trench, both were filled by the same modern deposit (39), (40) and (42), suggesting they may be part of the same large feature. Indeed, this very substantial feature would appear to have occupied most of the area of the proposed attenuation ponds, as this same modern fill (44) and (45) was also observed to cover the entire area and depth of trenches 1 and 2 further north (**Figure 3; Plates 5 to 7**).

Plate 5: View of Trench 1, entirely filled by modern deposits of redeposited alluvium and modern waste, looking north-west

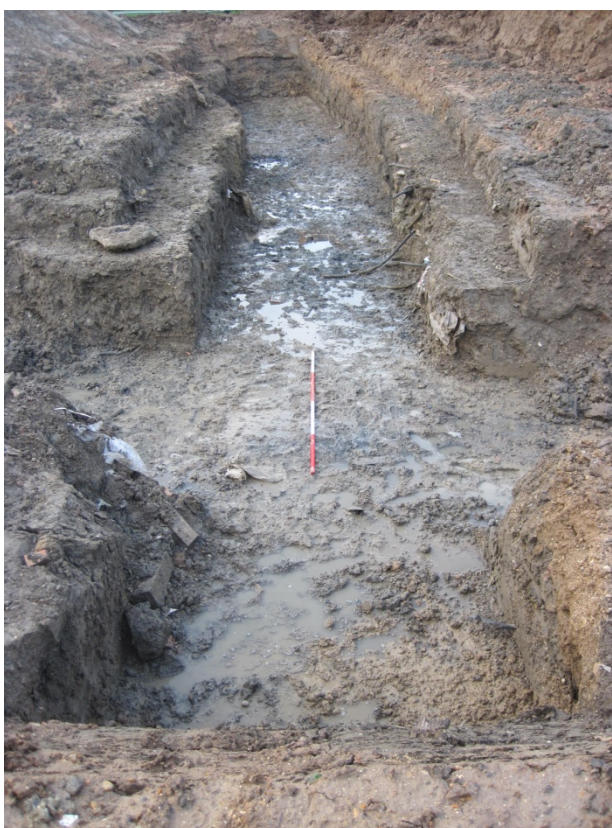
Plate 6: View of Trench 2, entirely filled by modern deposits of redeposited alluvium and modern waste, looking south-west

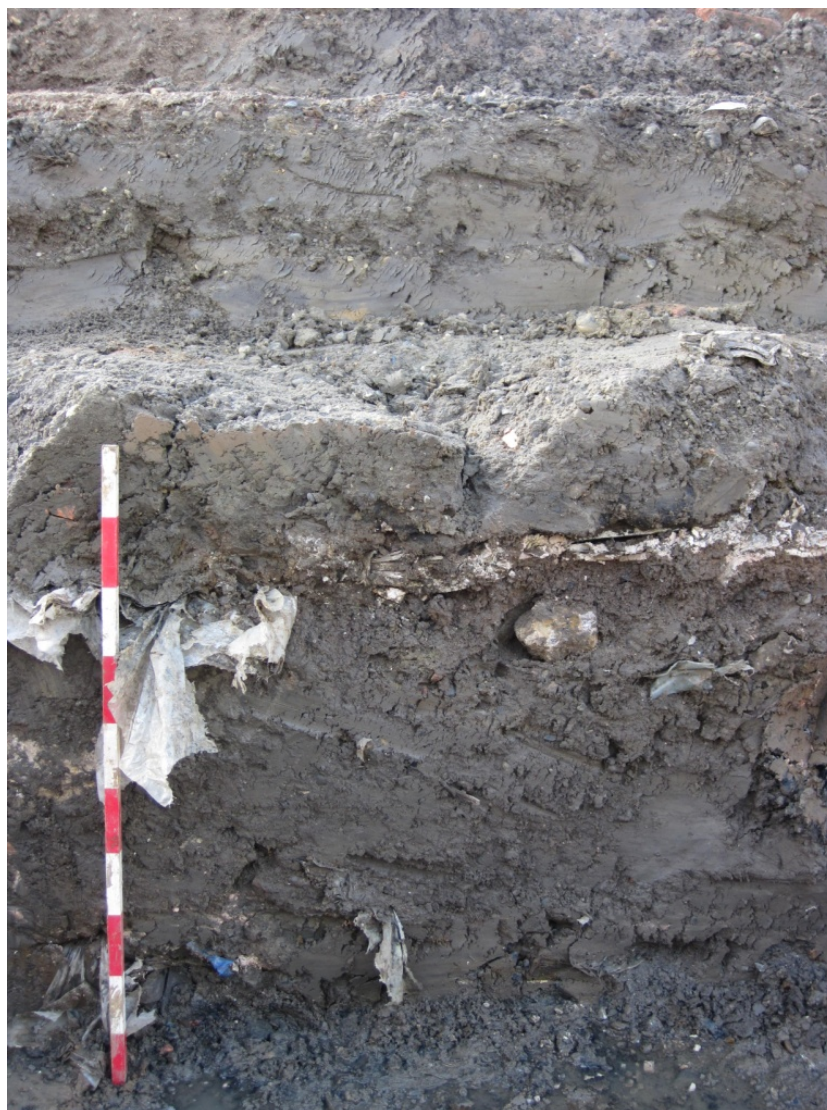
Plate 7: Representative section (north-east facing) for Trenches 1 and 2, showing the trench filled by exclusively modern deposits
