**AN ARCHAEOLOGICAL EXCAVATION AT  
SANDS ROAD, SWALWELL,  
GATESHEAD, TYNE AND WEAR**

**Post-Excavation Assessment Report**

**Central National Grid Reference: NZ 2020 6225**

**Site Code: SRS 05**

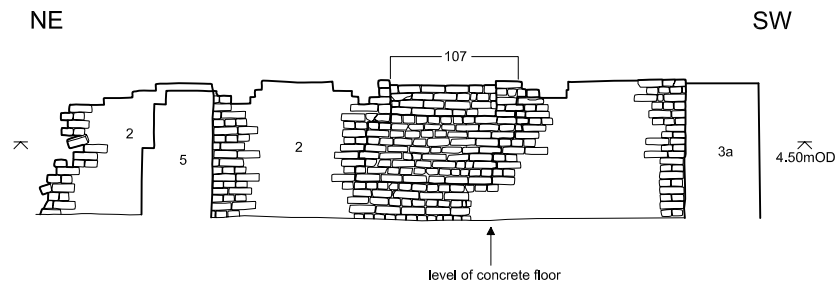
Figure 4. Wharf Building. Wall [2], elevations  
Scale 1:75

Wharf Building. North-west elevation, internal face. Wall [2].

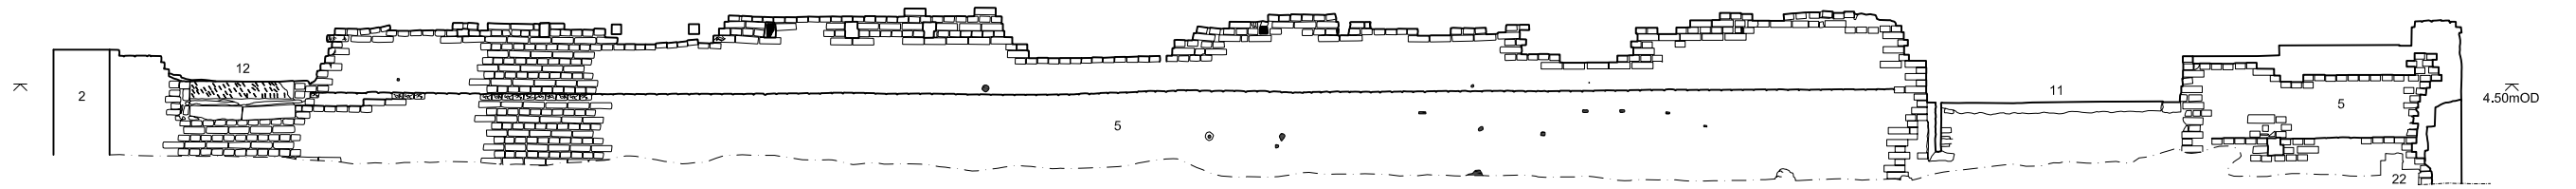
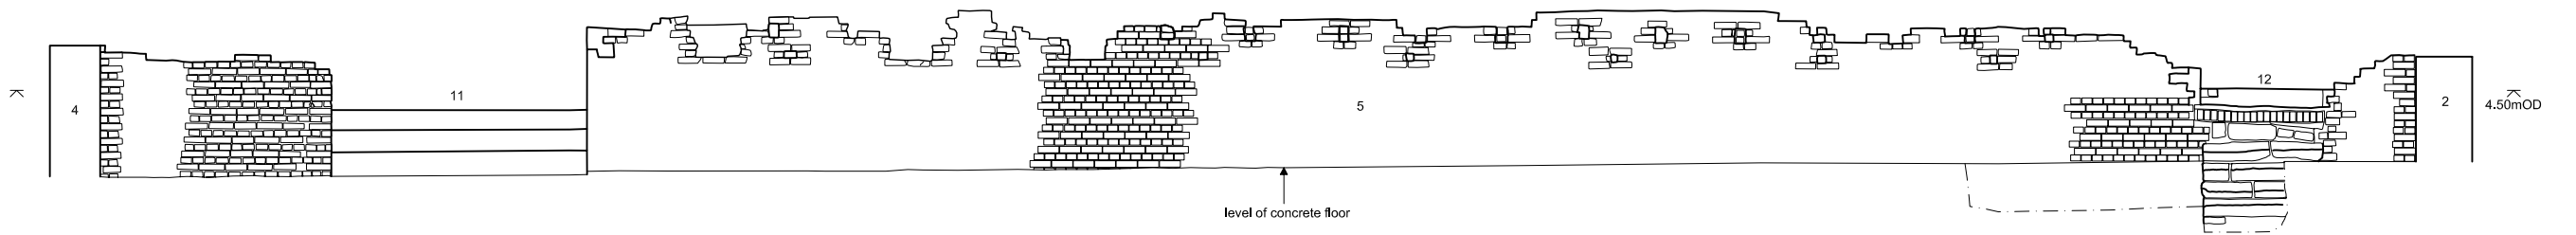
Figure 7. Wharf Building. Wall [5], elevations  
Scale 1:75

Wharf Building. North-east elevation, external face. Wall [5].

Wharf Building. South-west elevation, internal face. Wall [5].

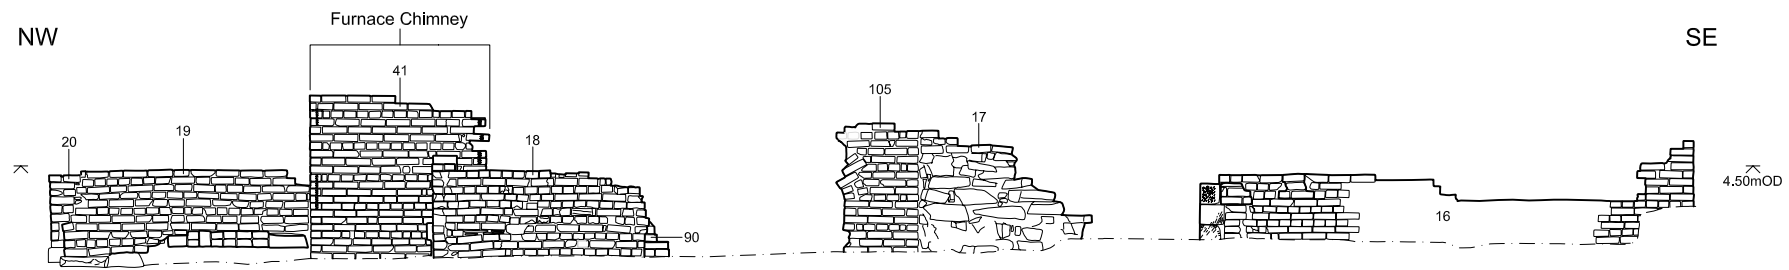
Figure 9. Half Forge and Forge Buildings. South-west wall, elevations  
Scale 1:75

Half Forge and Forge Buildings. South-west elevation, external face.

Half Forge and Forge Buildings. North-east elevation, internal face.

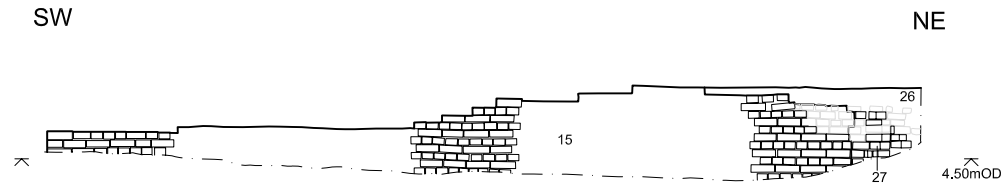
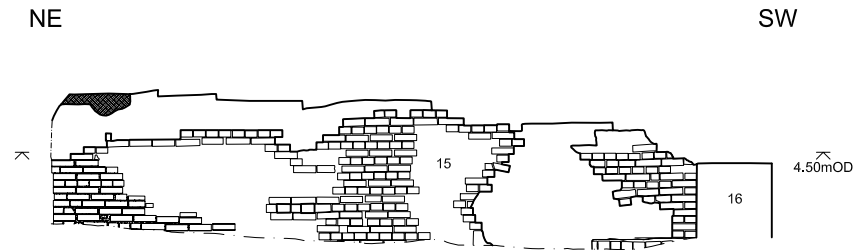
Figure 10. Half Forge and Forge Buildings. Wall [15], elevations  
Scale 1:75

Half Forge and Forge Buildings. South-east elevation, external face. Wall [15].

Half Forge and Forge Buildings. North-west elevation, internal face. Wall [15].

- 5.2.2.3 Wall [15] formed a right-angled return from the southern end of wall [16] and these walls were keyed into each other (Figure 3). Wall [15] was of very similar construction to wall [16] with the same materials and bonding utilised (Figure 10). It extended 7.85m NE-SW in length and was 0.64m wide, with a maximum surviving height of 1.43m, the lowermost portion not being revealed. Later repairs utilising yellow firebricks were also evident within this wall.

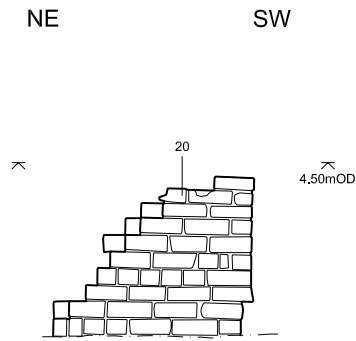
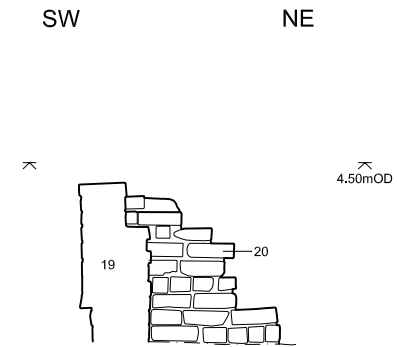
Figure 11. Half Forge and Forge Buildings. Wall [20], elevations  
Scale 1:40

Half Forge and Forge Buildings.  
North-west elevation, external face. Wall [20].

Half Forge and Forge Buildings.  
South-east elevation, internal face. Wall [20].

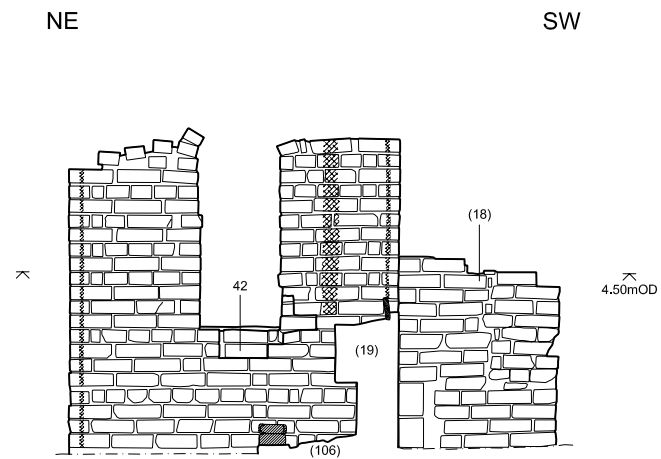
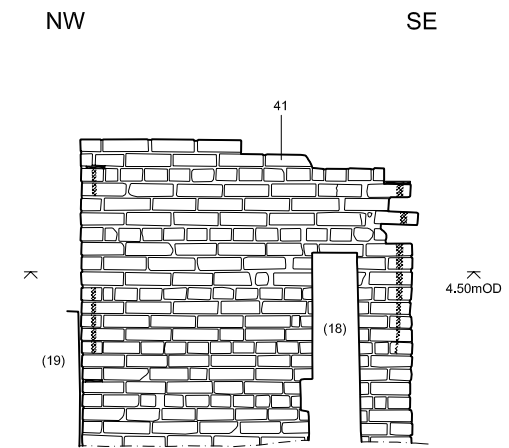
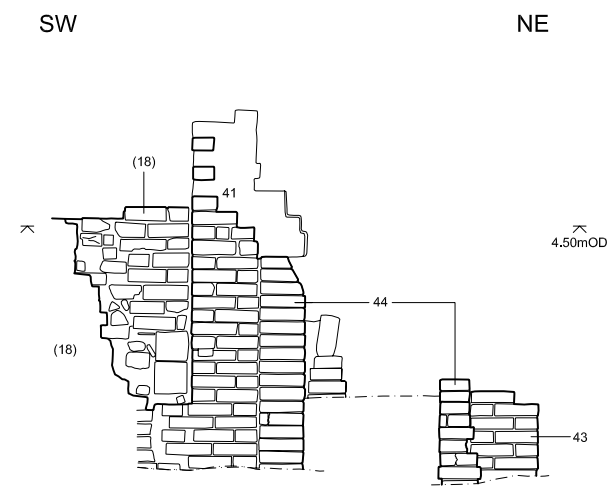
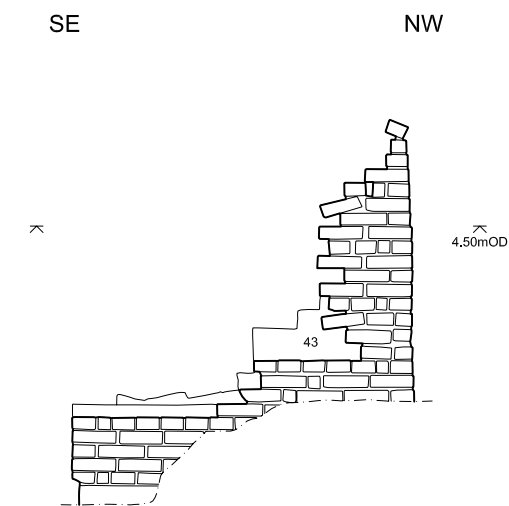
Figure 13. Furnace Chimney, external elevations  
Scale 1:40

Furnace Chimney. North-west facing elevation.

Furnace Chimney. South-west facing elevation.

Furnace Chimney. South-east facing elevation.

Furnace Chimney. North-east facing elevation.

5.7.2.3 All three walls of the Furnace Chimney were built with yellow firebricks of varying dimensions, with very occasional reused handmade red bricks also noted. The majority of the brickwork was laid in English garden wall bond, although there were also areas in irregular bonding patterns. Open to the south (Plate 4), the chimney had internal dimensions of c. 1.40m NW-SE x 1.10m NE-SW and external dimensions of 1.80m square. The highest surviving level of the structure was 5.22m OD and the lowest that could be reached was 3.23m OD, this on the putative sandstone foundation of the east wall. Iron fittings were noted on the external face of the structure along with iron staining which may have marked the position of removed iron brackets which would have supported the structure during heat expansion. Several stamped firebricks were recovered from the structure and these date from the second half of the 19th century.

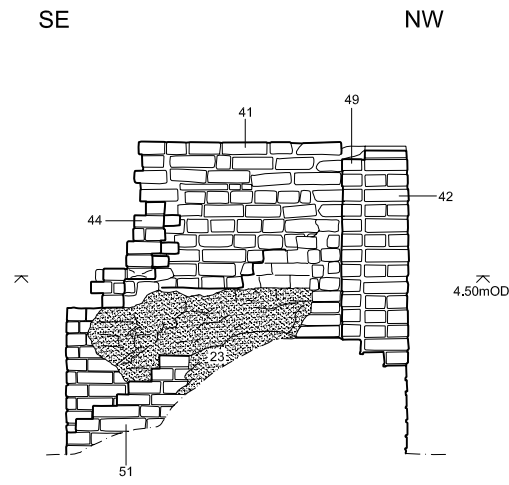
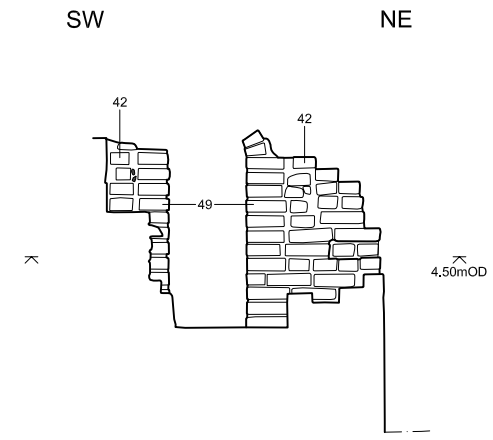
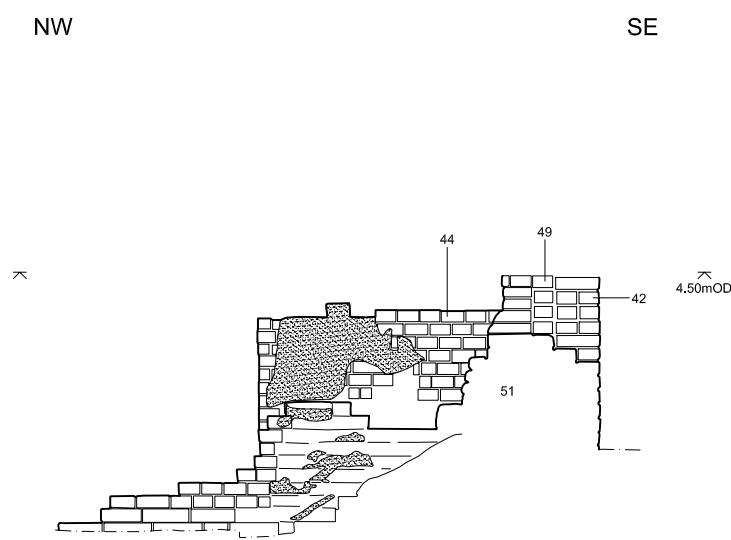
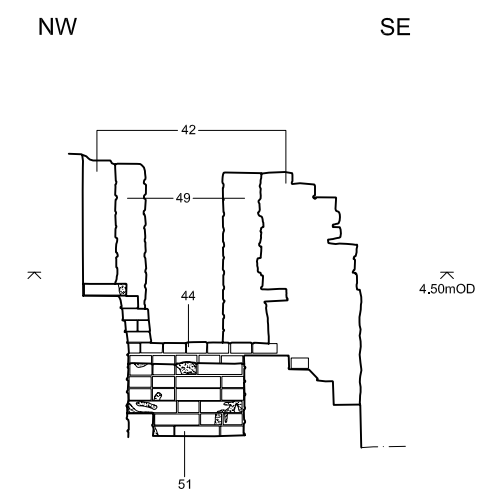
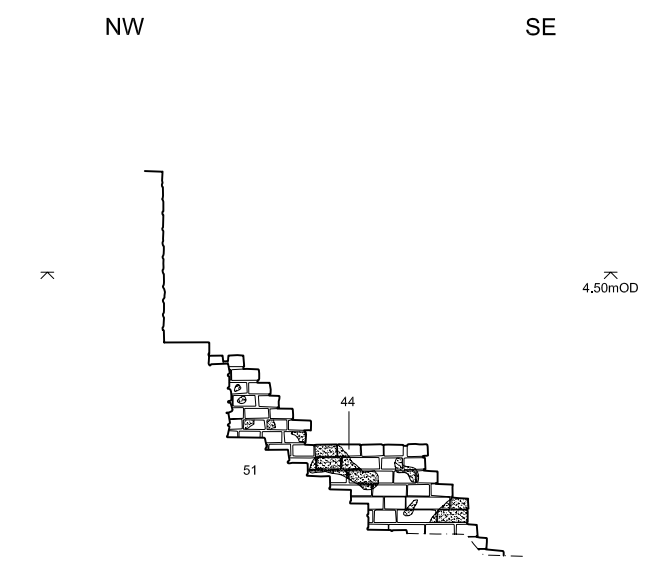
Figure 14. Furnace Chimney, internal elevations  
Scale 1:40

Furnace Chimney. North-east facing internal elevation.

Furnace Chimney. South-east facing internal elevation.

Furnace Chimney. North-east facing internal elevation, after further excavation.

Furnace Chimney. South-east facing internal elevation, after further excavation.

Furnace Chimney. South-west facing internal elevation, after further excavation.

5.7.4.3 Within the chimney, the tertiary skin was exposed for a maximum height of 0.58m and the highest level at which it survived was 4.10m OD. The bonding pattern in the brickwork could not be identified due to a covering of iron slag residue, [23], as well as the partial collapse of the upper part of the structure. As with the secondary skin of brickwork, there was greater degradation by heat damage on the eastern side.

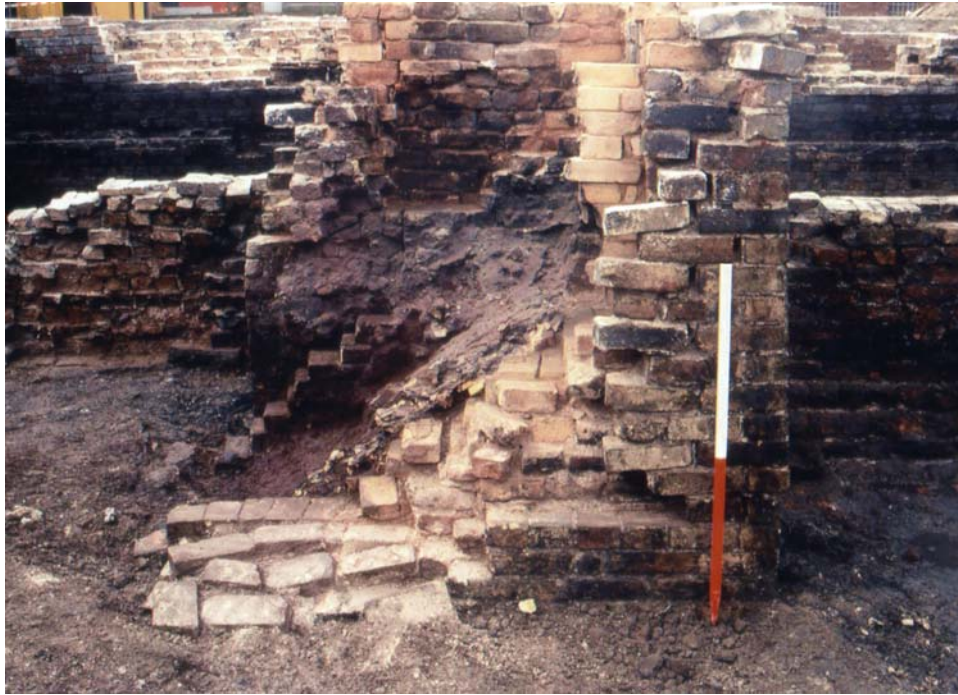
Plate 3. Furnace Chimney, during excavation, looking south-west (*1m scale*).

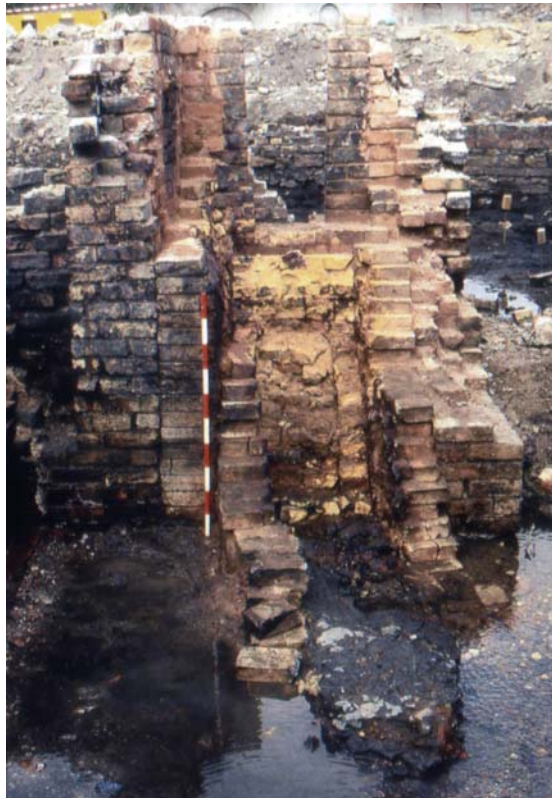
Plate 4. Furnace Chimney, after excavation, looking north-west (*1m scale*).

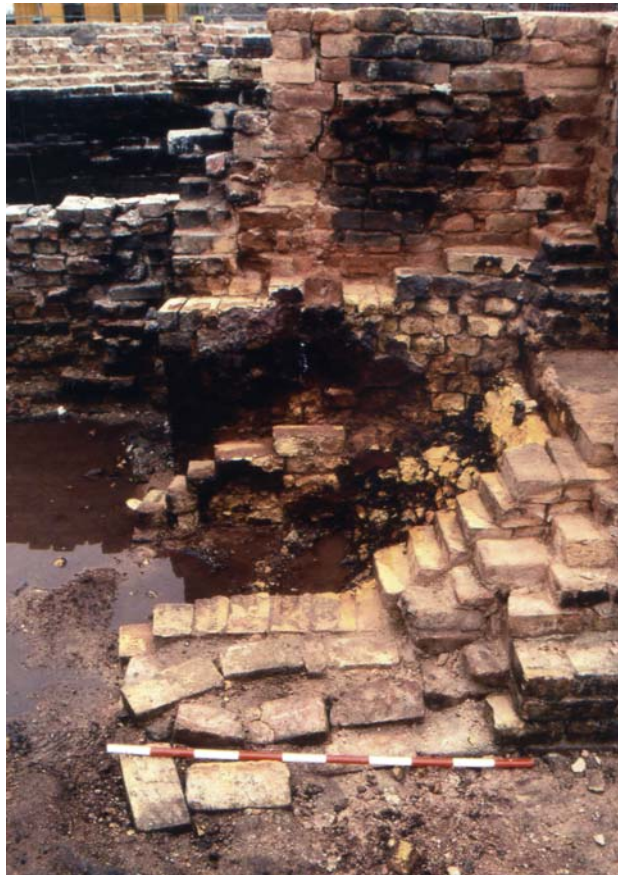
Plate 6. Furnace Chimney, after removal of deposit [23], looking south-west (1m scale).

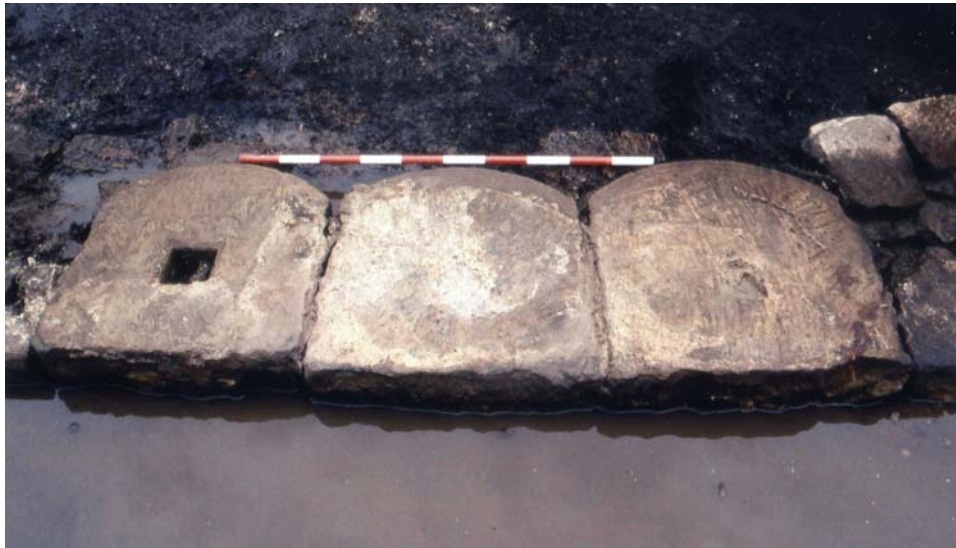
Plate 10. Retaining Wall (western end). Wall [22], with reused grinding stones SFs 8-10, looking south (*1m scale*).

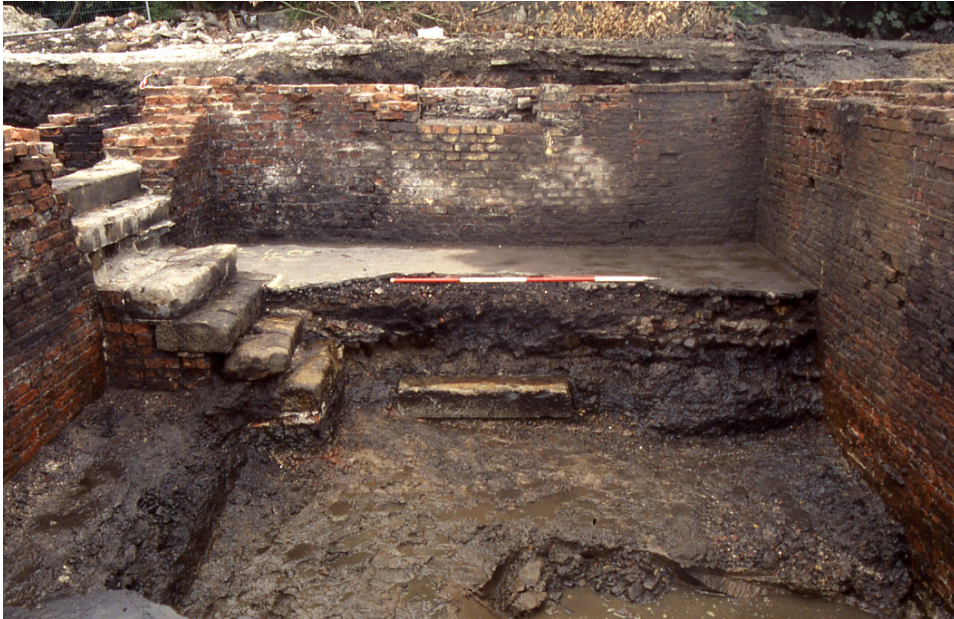
Plate 11. Test Pit 1, north-west facing section (2m scale).

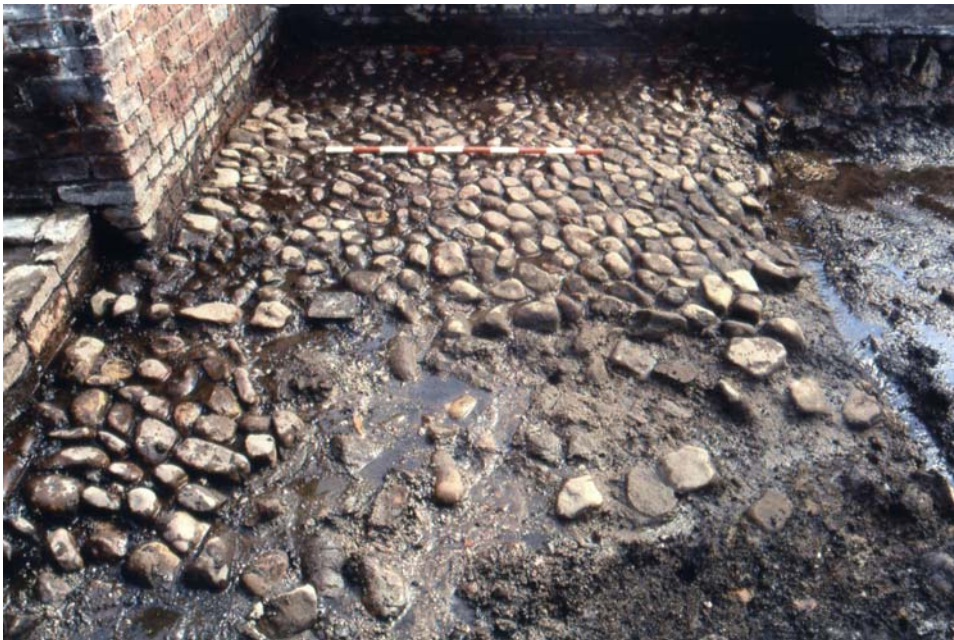
Plate 12. Wharf Building. Cobbled surface [40], looking north-east (1m scale).

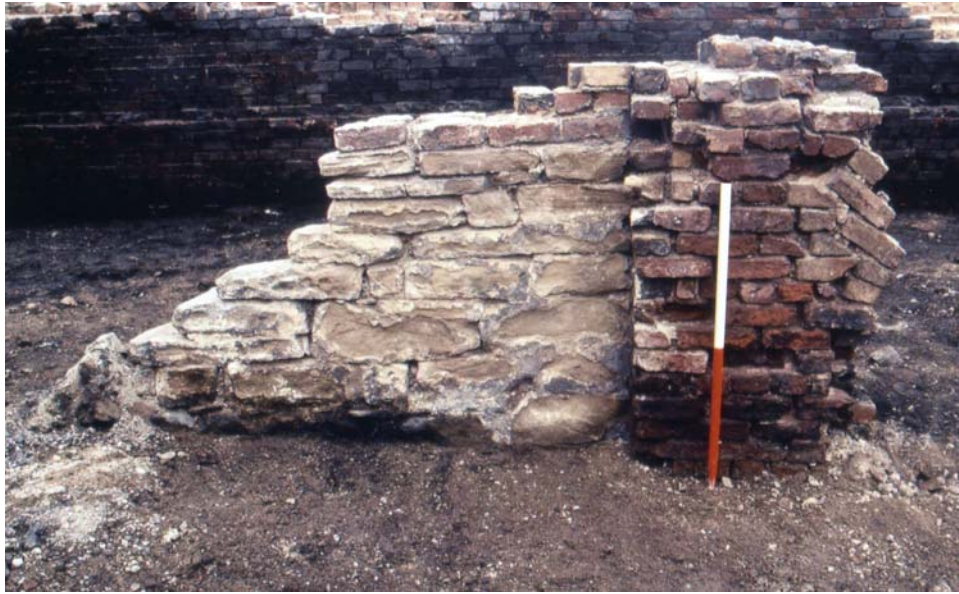
Plate 13. Half Forge and Forge Buildings. Walls [17] and [105], looking south-west (1m scale).

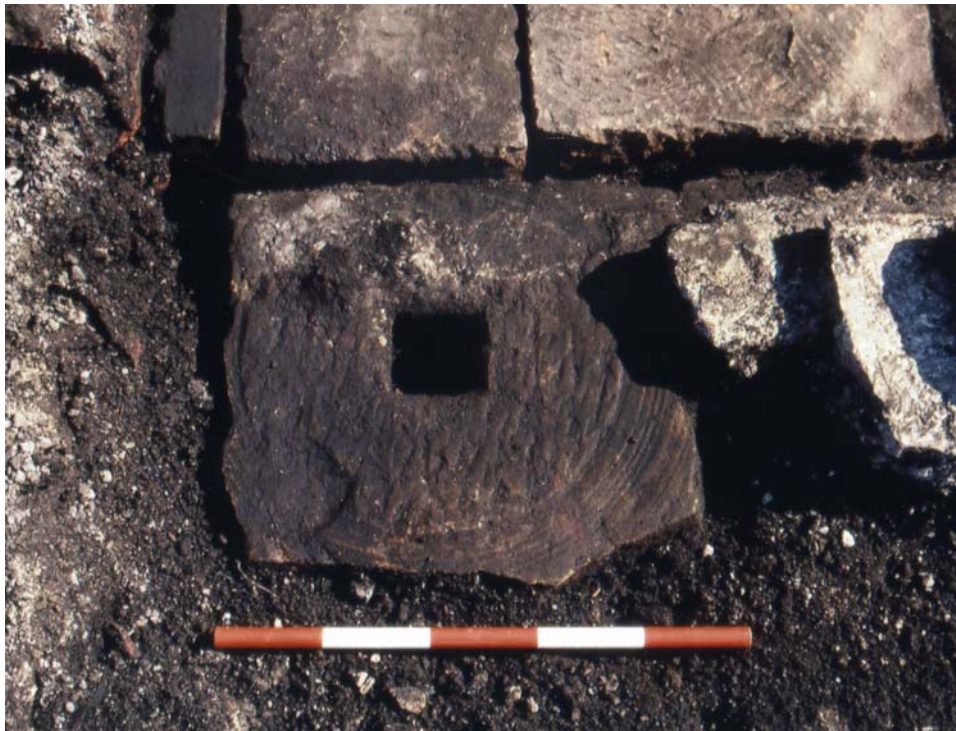
Plate 14. Reused grinding stone SF 30 in Well [94] (0.5m scale).
