**ASSESSMENT REPORT ON THE  
ARCHAEOLOGICAL BUILDING  
RECORDING (INCLUDING  
PETROGRAPHIC SURVEY) AND  
WATCHING BRIEF AT THE  
BELL TOWER AND ADJACENT  
INNER CURTAIN WALL,  
HM TOWER OF LONDON,  
LONDON BOROUGH OF TOWER  
HAMLETS**

**SITE CODE: TOL149**

**FEBRUARY 2016**

**REPORT NO. R12359**

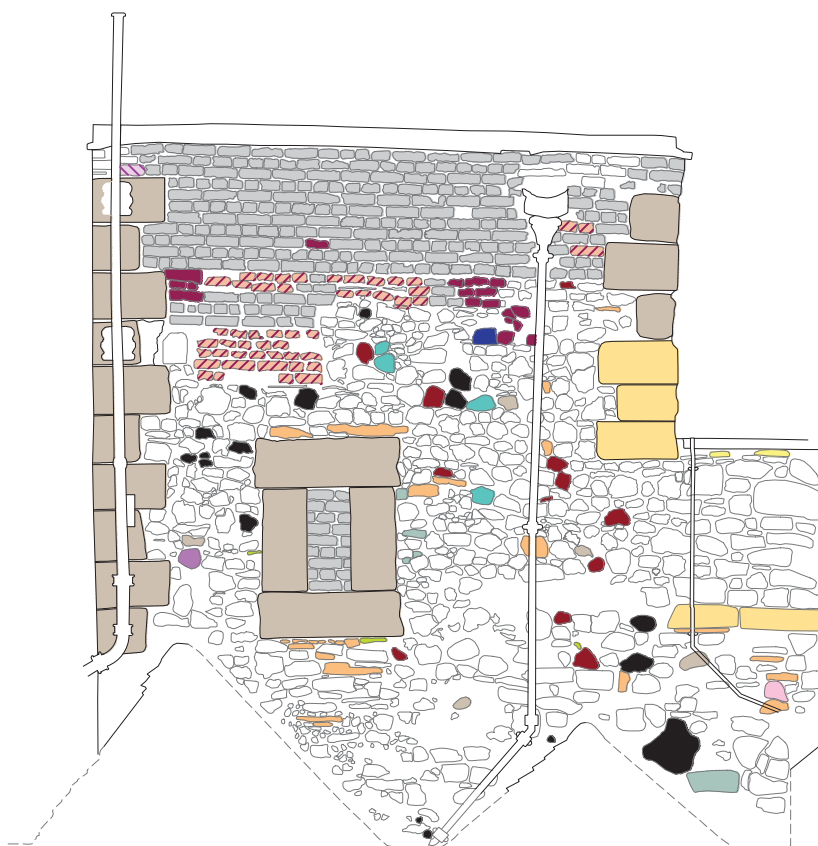
Figure 22  
Stone and brick types in the North Elevation B of the  
Stair Turret to the Bell Tower  
Elevation - 1:50 and Inset - 1:500 at A4

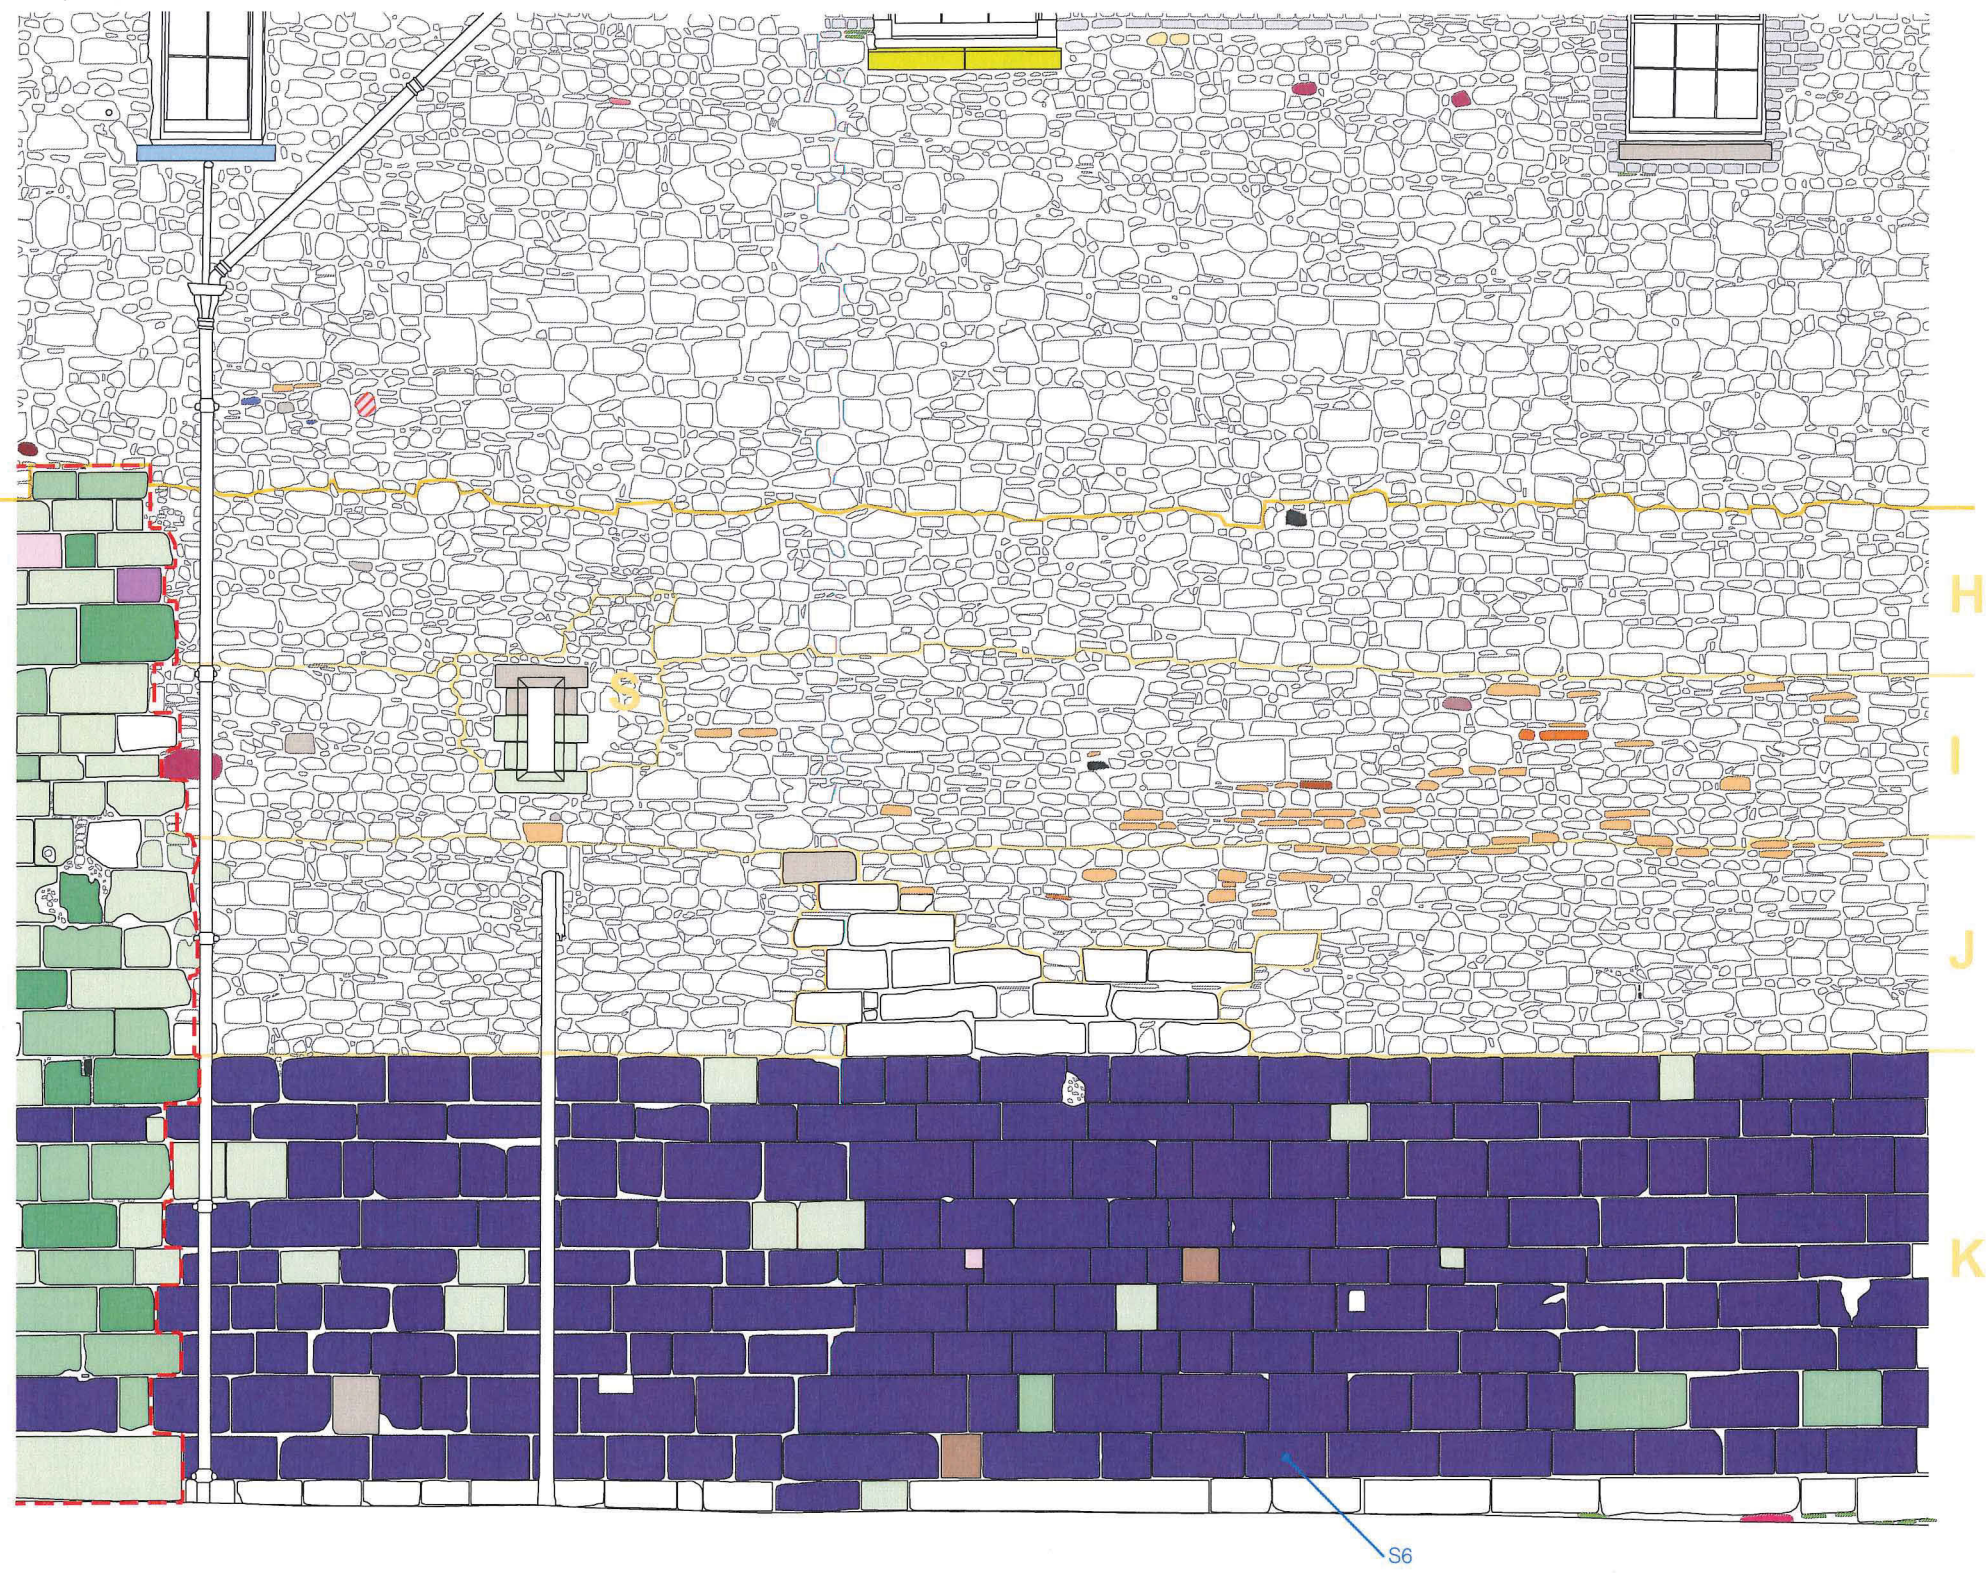
Figure 31  
Stone and brick types in the lower eastern section of the surveyed Curtain Wall  
Elevation - 1:50 and Inset - 1:500 at A3

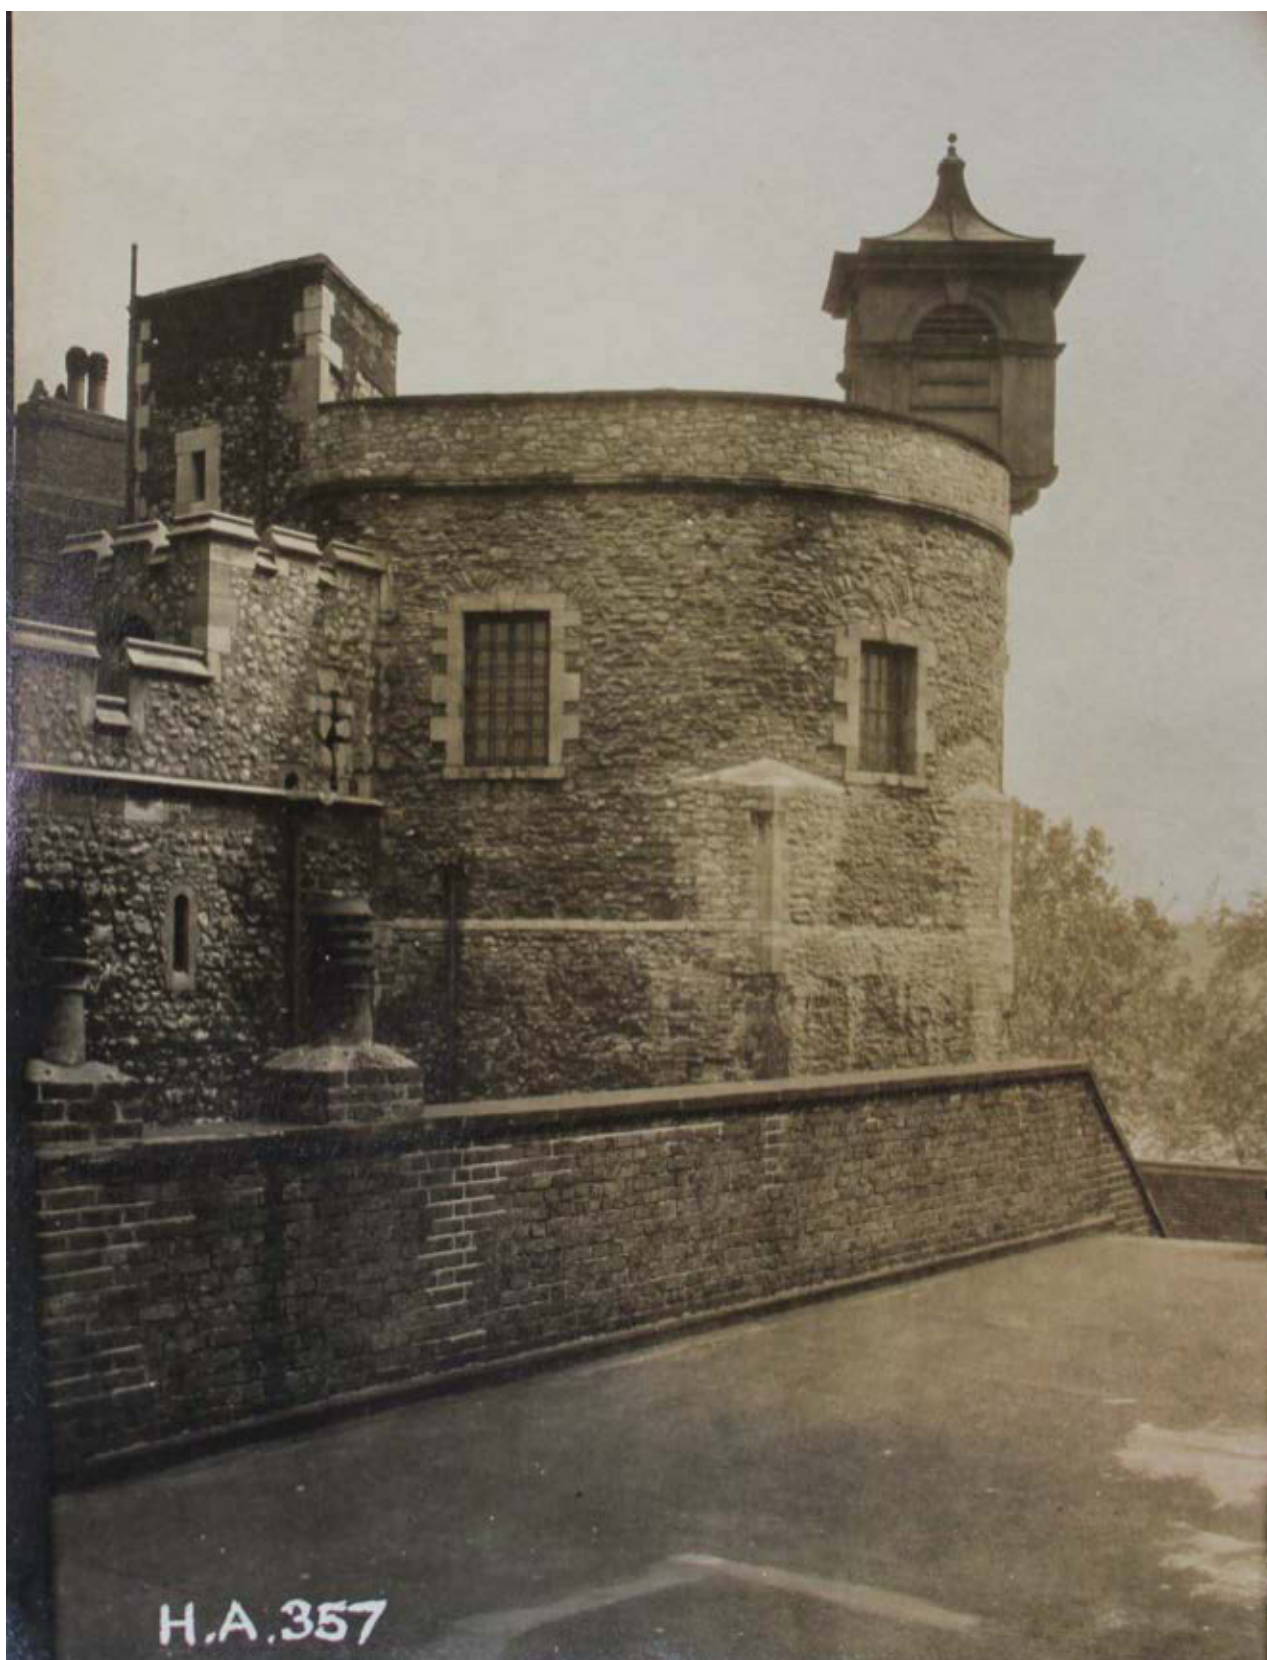
Plate Q: Photograph taken 13<sup>th</sup> June 1924 of the Bell Tower, looking south-east (© Historic England NMR Ref. Red Box File No. 3596: BB75/7715)

4.3.19 A set of photographs of the Bell Tower taken in June and July 1924 show that by this time the brick exterior of the parapet had been replaced with stone and the cement roughcast/pebbledash render had been removed (**Plates Q to V**). Other changes included the removal of the large drainpipe on the north side of the parapet (compare **Plates L and Q**), the removal of a chimneystack on the east side of the Bell Tower (compare **Figure 8; Plates E, H, I, J and R**). The earlier photographs (**Plates E, H and I**) show this chimneystack with a distinctive chimney pot, which had been removed in the early 20<sup>th</sup> century (**Plate J**). By June 1924 the brick chimney stack added to the south elevation of the Queen's House had been lowered to the level of the parapet (compare **Plates A to C, E, H to K, R, U and W**). It has since been totally removed (**Plates 8 and 9**). The June and July 1924 photographs suggest that the Inner Curtain Wall was still covered with pebbledash cement render under the prolific vegetation (Virginia Creeper) growing up the wall (**Plates R, U and W**). It has since been removed along with the cement render to the brick string course and to the head of the large window with a balcony (**Plates 8 and 9**). Ashlar quoins missing in the 1924 photographs have since been added to the angles of the Bell Tower (compare **Plates Q, S with 1; T with 3, 6 and 7**).

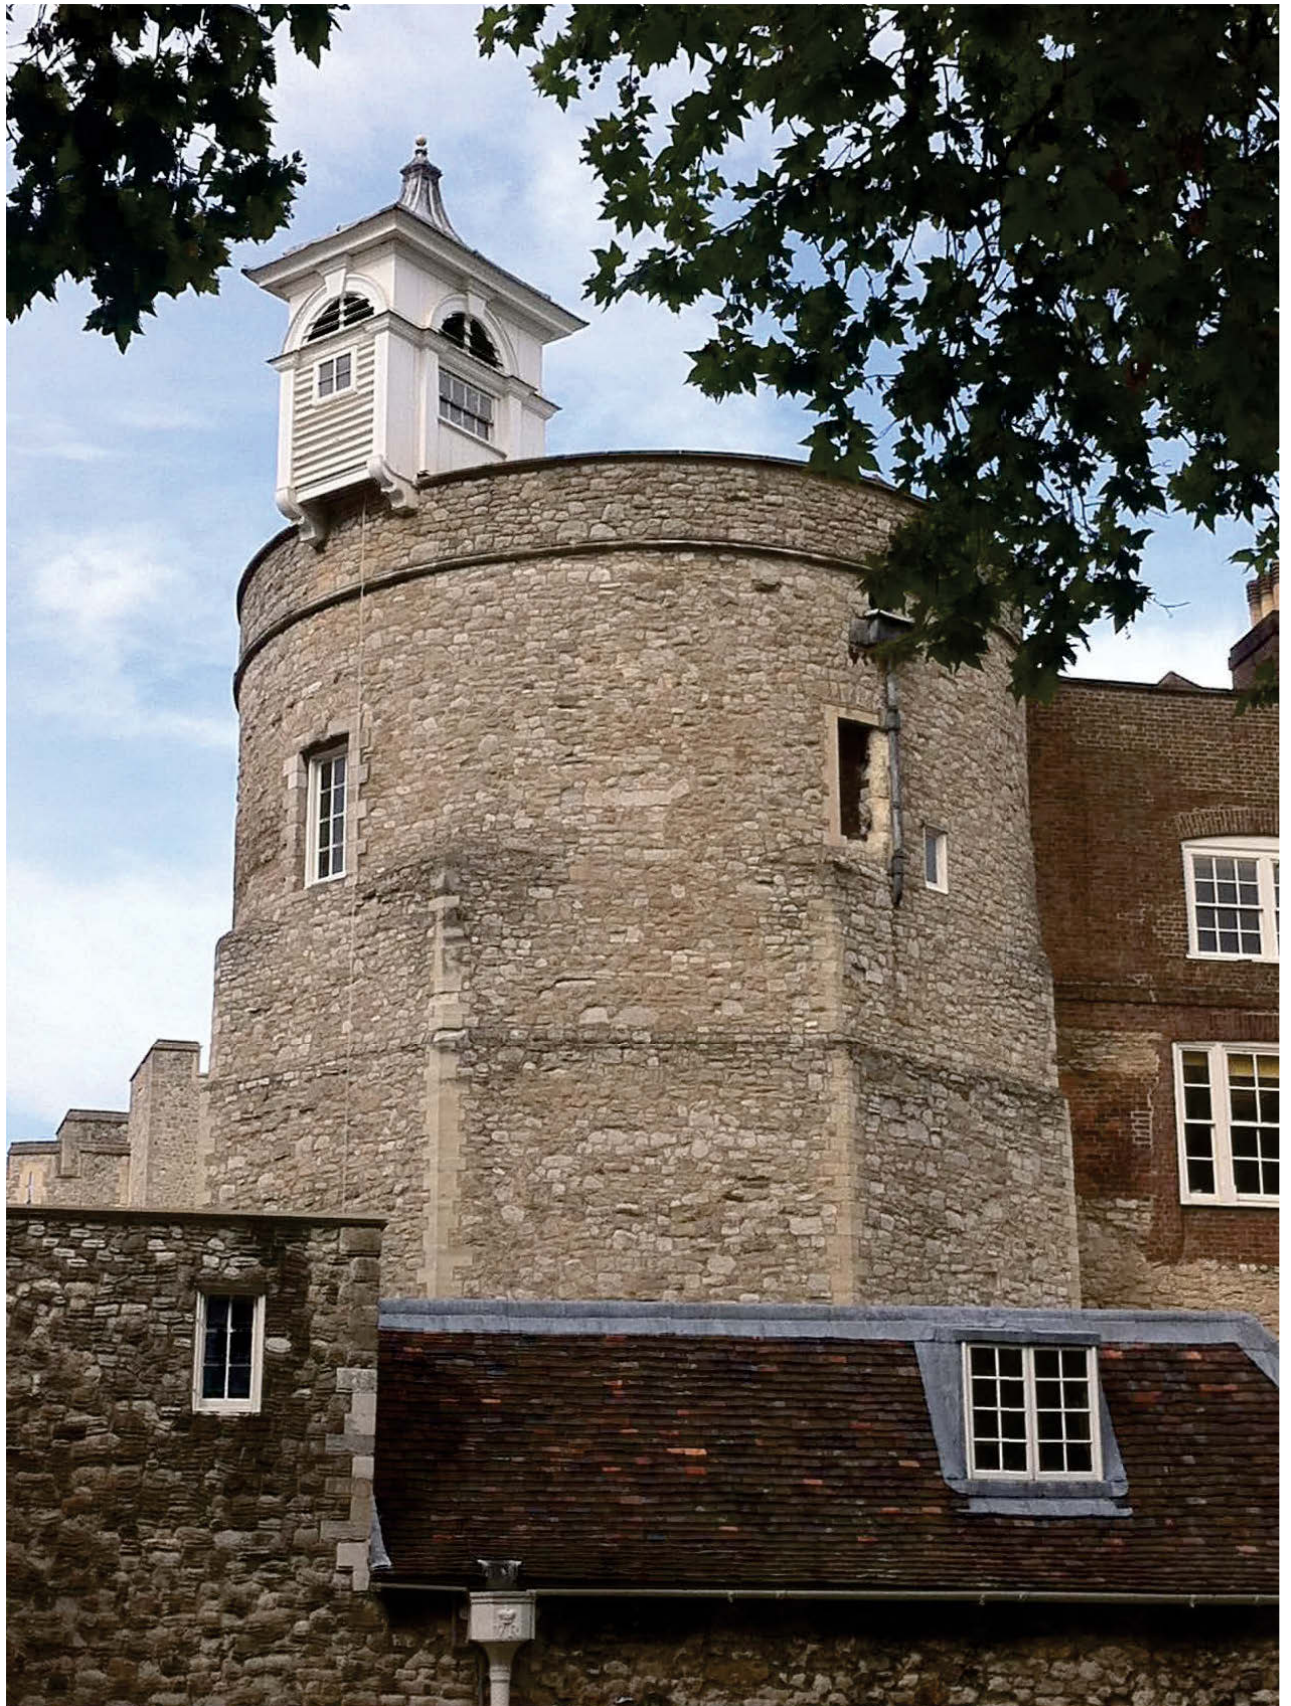
Plate 7: South side of the Bell Tower and adjacent Inner Curtain Wall, looking north (photograph provided by HRP)

5.2.1 The external elevations of the Bell Tower can broadly be subdivided into four major components. The lowermost 4 to 6 metres is dominated by mainly replaced regular sized ashlar and quoin blocks of freestone (**Figure 14; Plates 1 to 5**). Above, 11 metres or so of Kentish Ragstone rubble make up the medieval core of the tower. The freestone used in the window jambs and quoins make up another component. Above the rubble core, the former external brickwork of the parapet was replaced between c.1904 and c.1924 with larger Kentish Ragstone topped with Yorkstone paving (**Plates 6 and 7**).

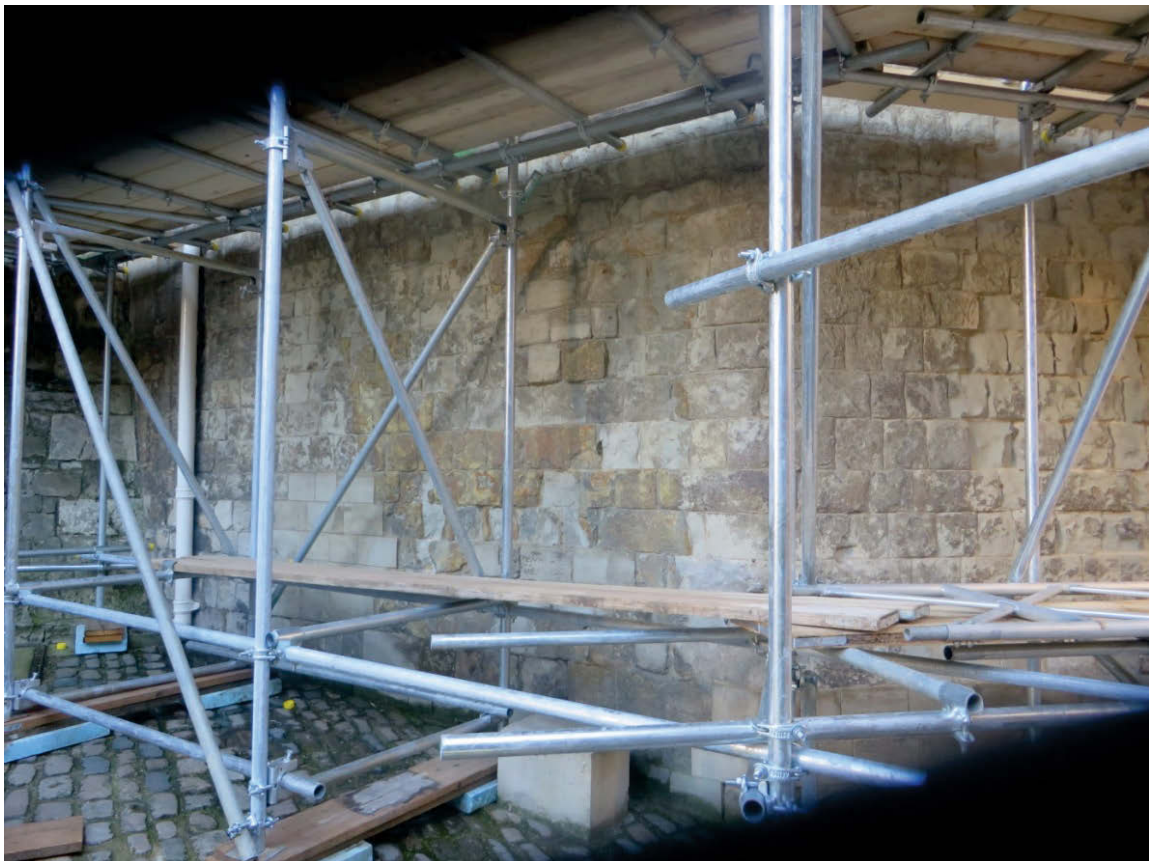
Plate 10: Elevation A: lower basal course 2m replacement of Kentish Ragstone ashlar

5.2.3 **Elevation A:** The ashlar base of the north elevation (A) is about 4 metres in height and comprises regular-sized 25cm square and rectangular shaped blocks of freestone (**Figure 15; Plates 1 and 10**). The ashlar base is distinct from the Kentish Ragstone rubble above. Most of the original Reigate Stone ashlar survives with one block of original Taynton Stone. Some ashlar blocks have been replaced by a small group of crisply dressed olive green Chilmark Stones from courses 1 to 7 (up from ground surface), probably 19th or 20th century repairs.

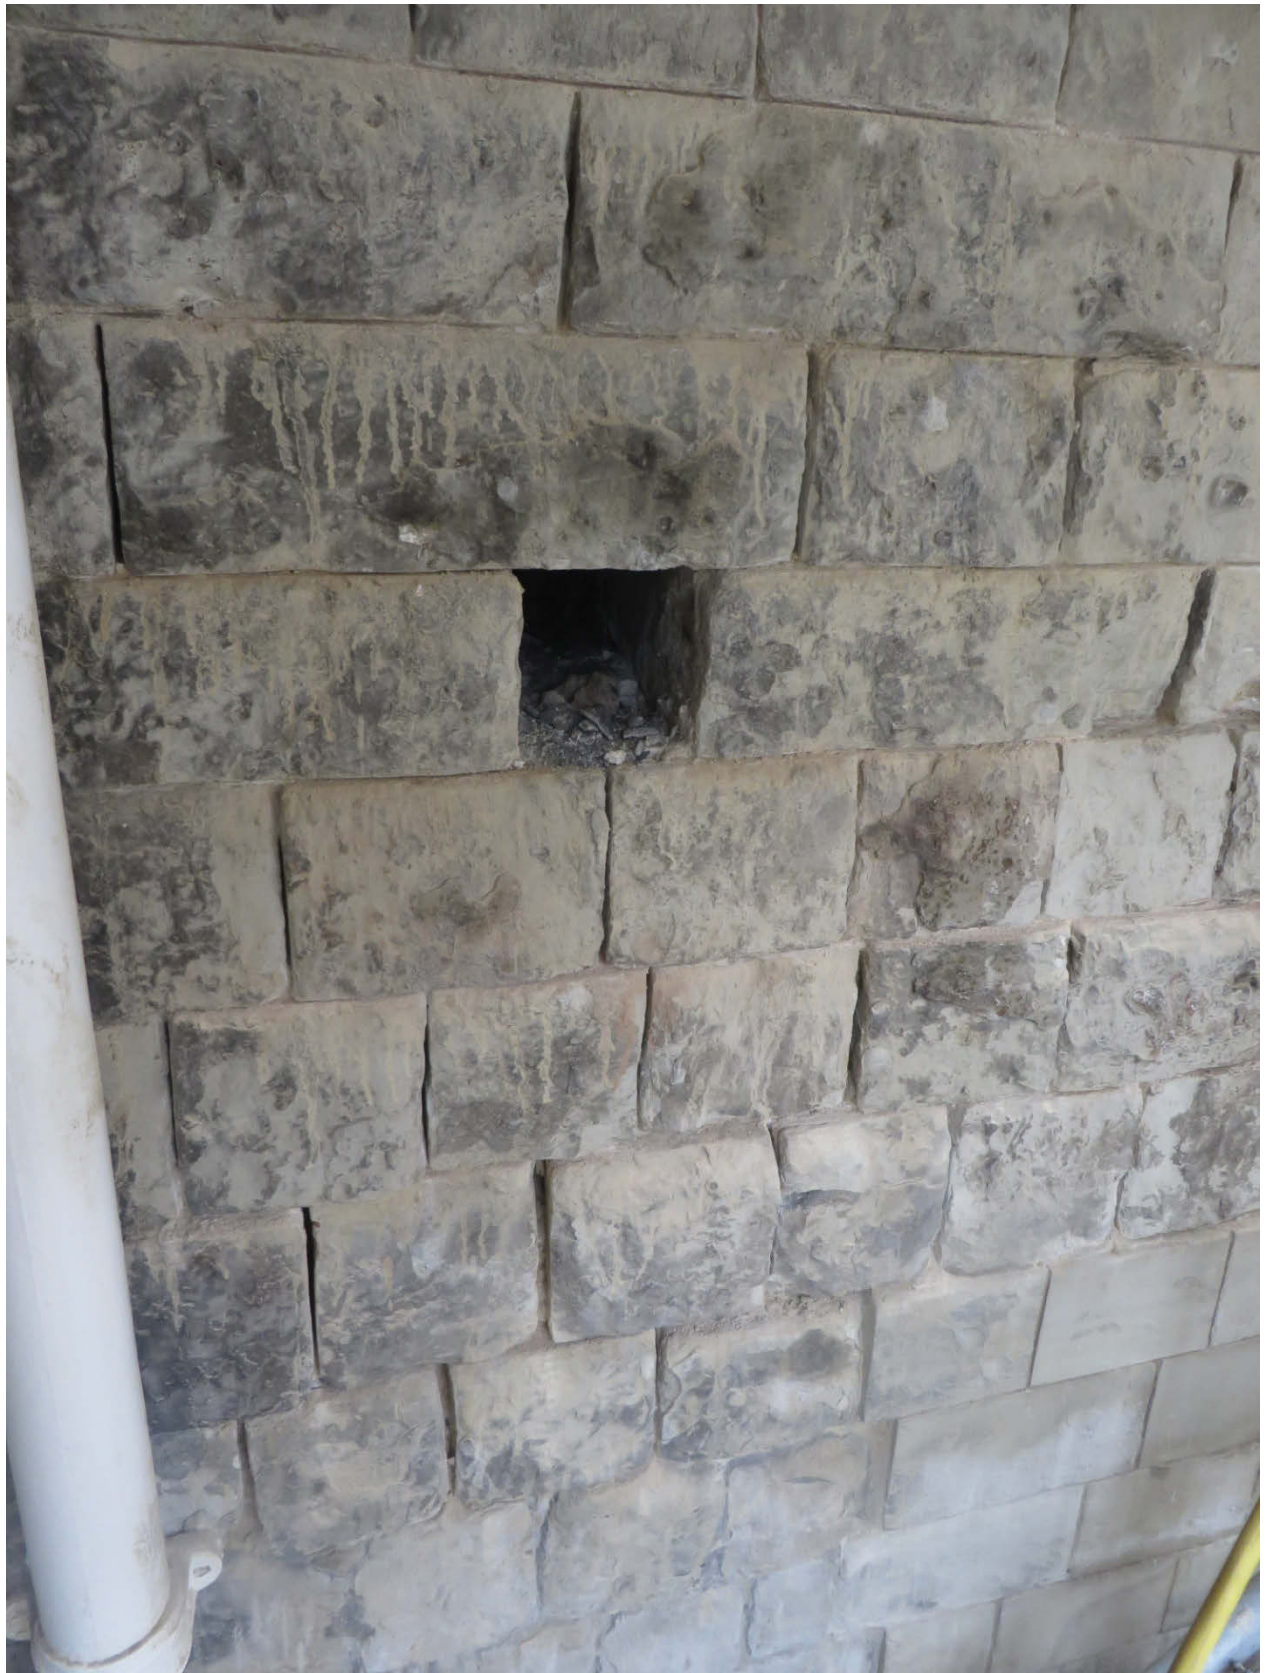
Plate 20: Putlog 4 in Elevation A, looking south

- 5.2.9 Putlog Hole 4 was uncovered on 20<sup>th</sup> July 2015. It is situated below Putlog 1, some 10 rows up from the ground surface (**Figure 15; Plates 19 and 20**). The void was blackened internally with evidence of scorch marks and burning (**Plate 21**). A sample of medieval mortar (M2) was obtained for thin section analysis.

- 5.2.11 These putlog holes were used to receive the ends of wooden scaffolding poles or beams. After the scaffolding was taken down, the ashlar block was inserted in the putlog void in order to prevent any water damage.

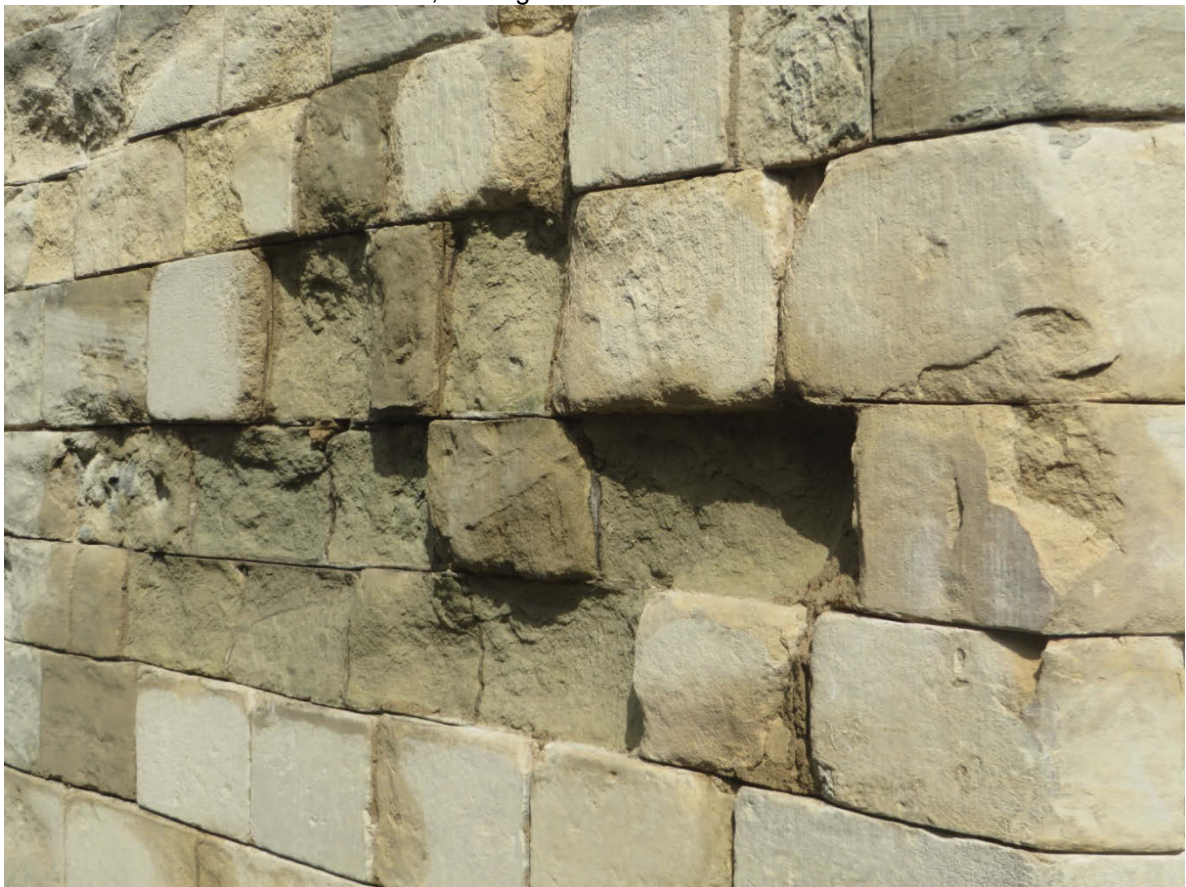
Plate 28: Weathered primary Reigate ashlar, replacement Magnesian limestone and soft Kentish Ragstone in the base of Elevation D, looking north-west

5.2.18 **Elevation D:** The petrological character of the basal ashlar of Elevation D differs in a number of ways from Elevations A to C. Firstly, the remnant medieval Reigate Stone is limited to the lowest 8 courses and about half of it has been replaced during various post-medieval repairs by a variety of materials including small ashlar blocks of poor quality Kentish Ragstone, Ketton Stone, laminated, oolitic, pale cream and yellow Magnesian Limestone (**Figure 18**).

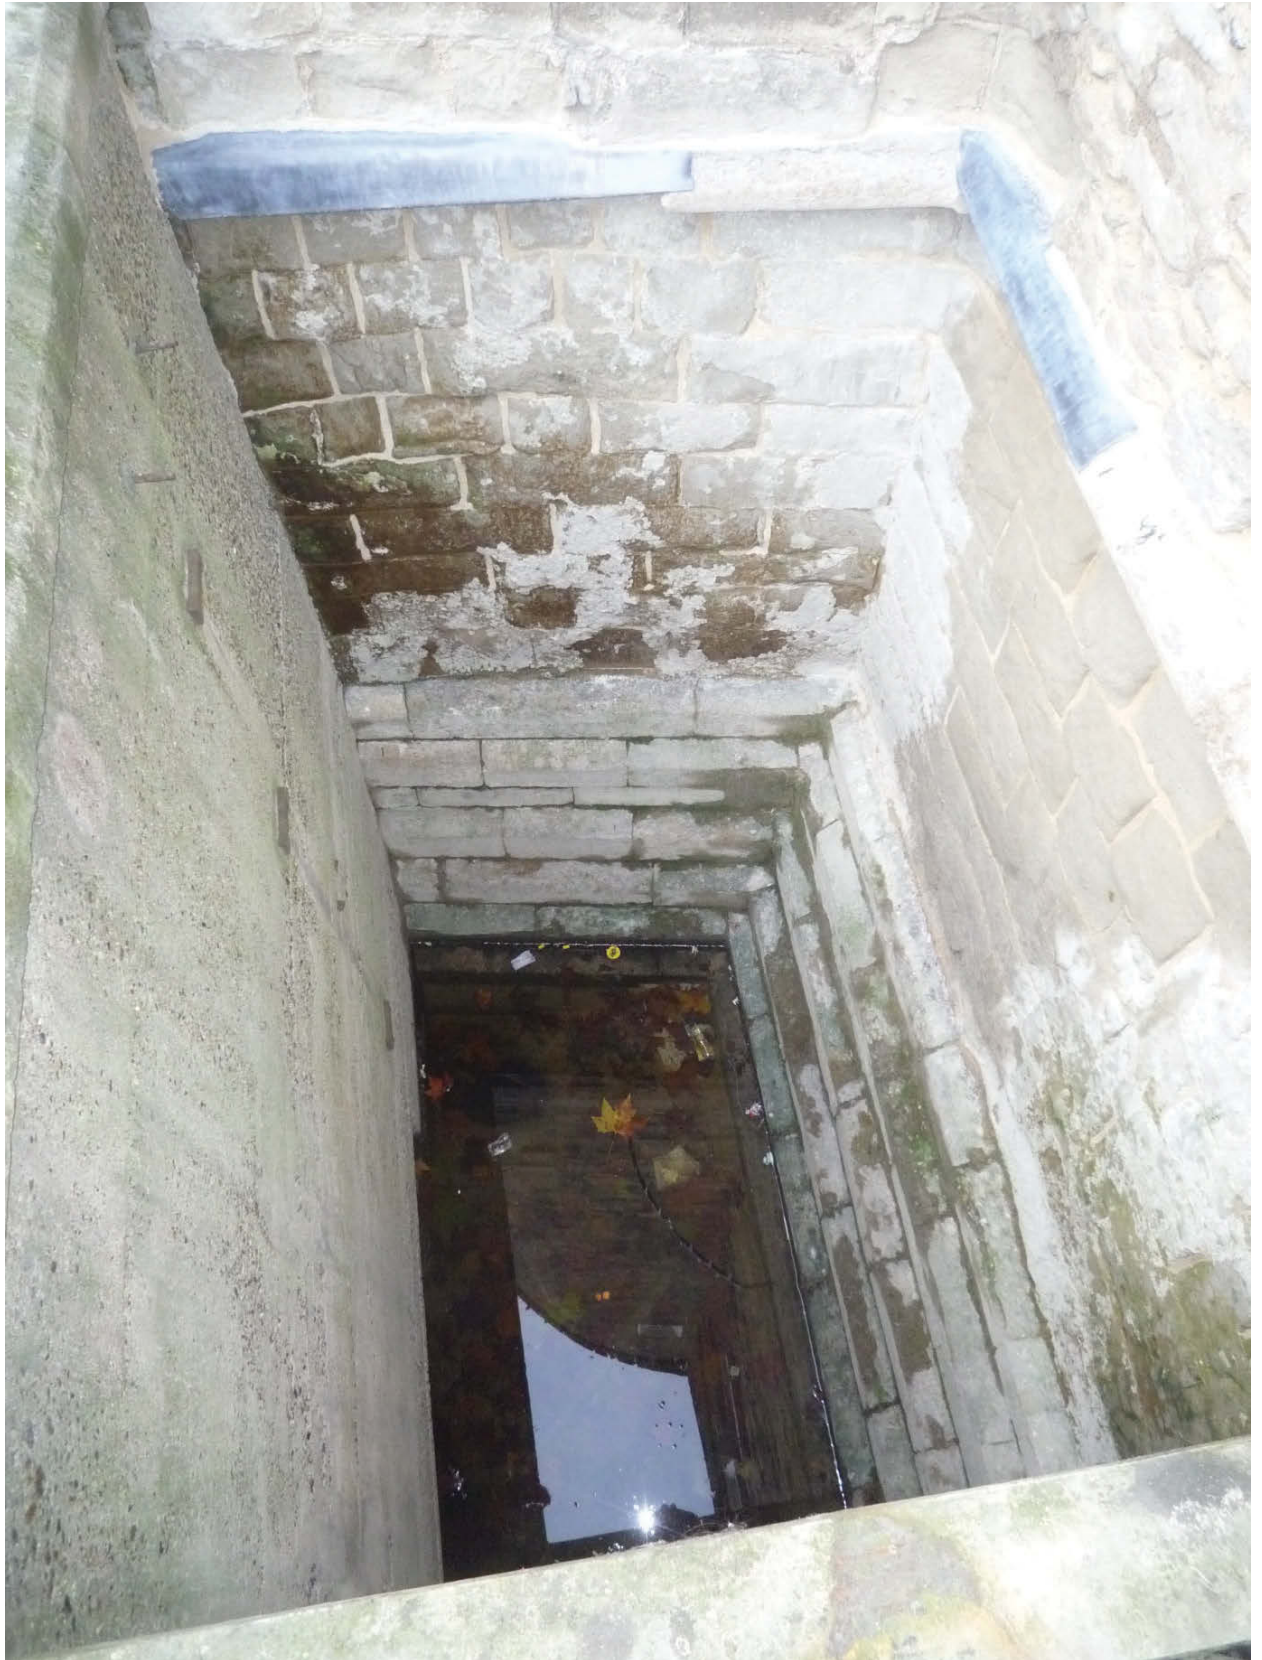
Plate 29: Viewing pit excavated in 1928 exposing the (now) below ground foundations of the Bell Tower (ahead) and Inner Curtain Wall/south elevation of the Queen's House (right), looking west

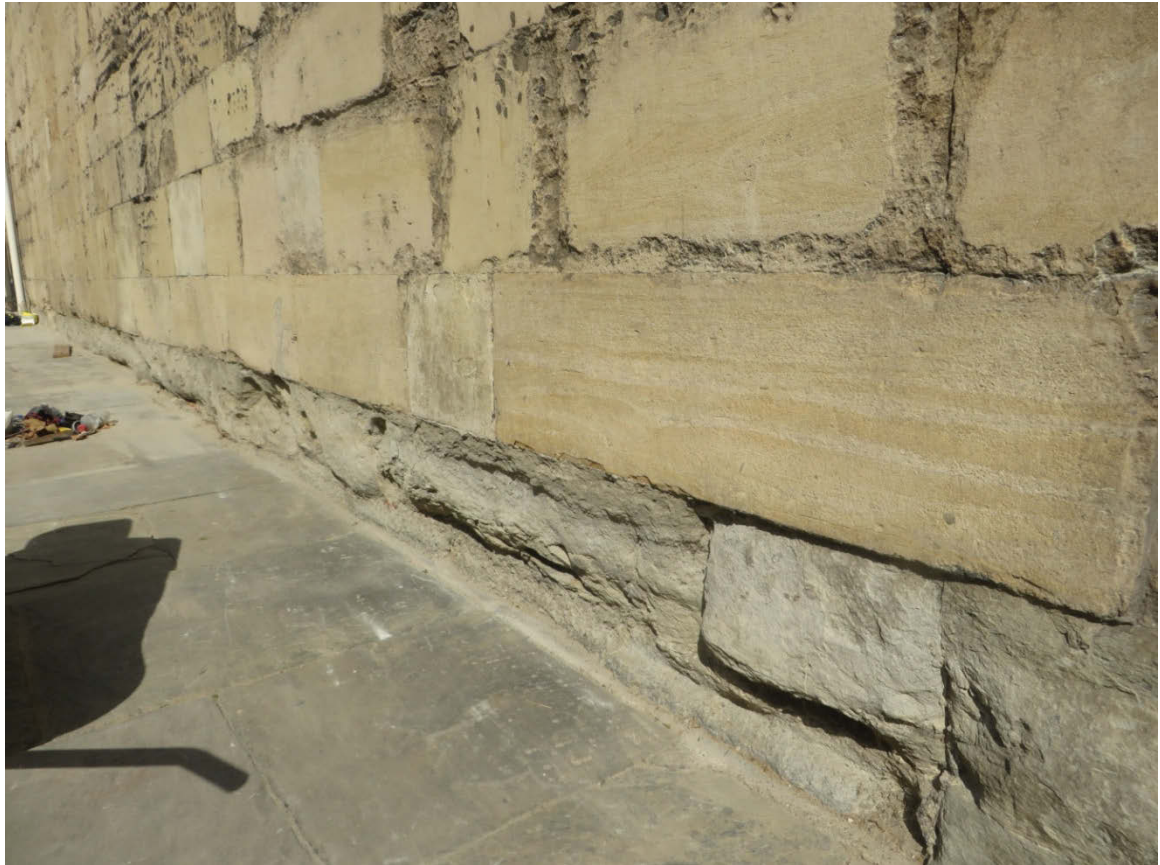
Plate 30: Base of the Inner Curtain Wall with emerging medieval Sussex Marble and Kentish Ragstone, above the ashlar has all been replaced, looking north-west

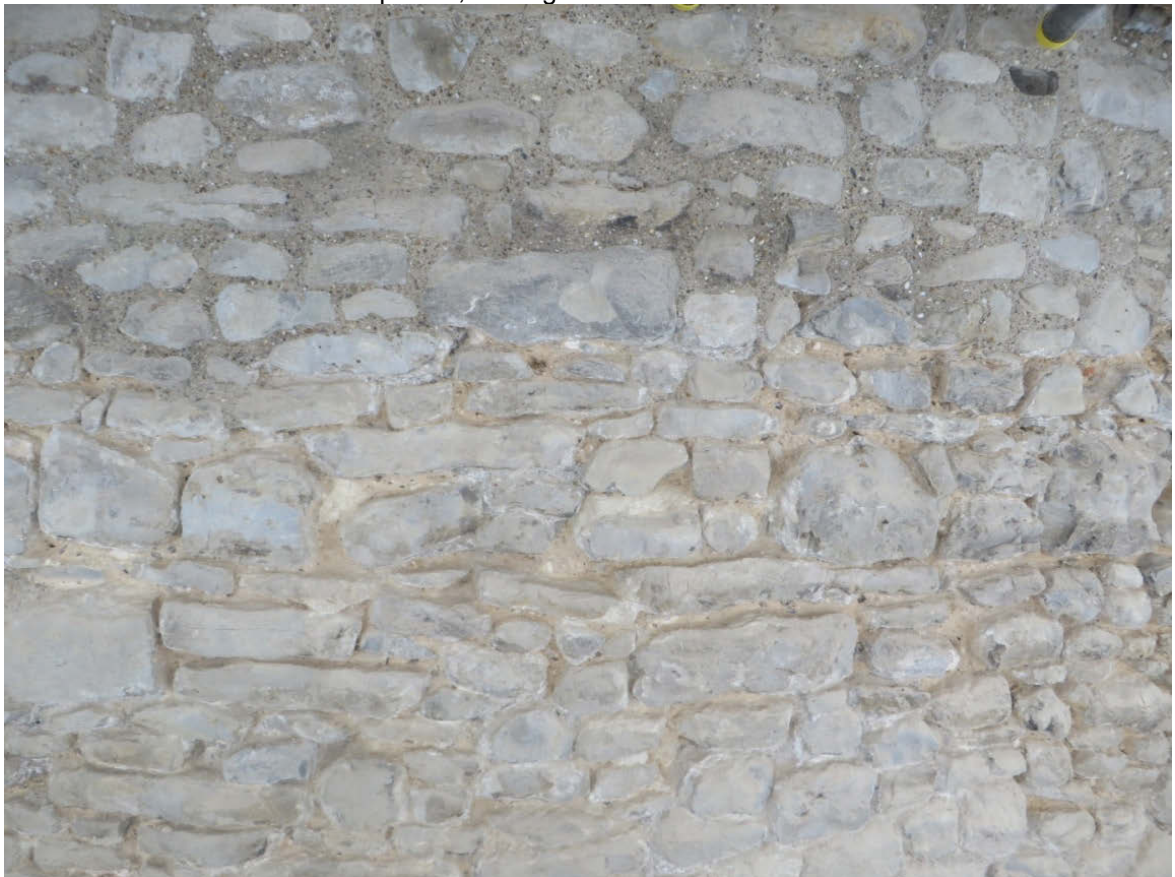
Plate 31: Section of Kentish Ragstone rubble wall in the Bell Tower showing underlying brown medieval mortar during re-pointing of Elevation B, looking south-east

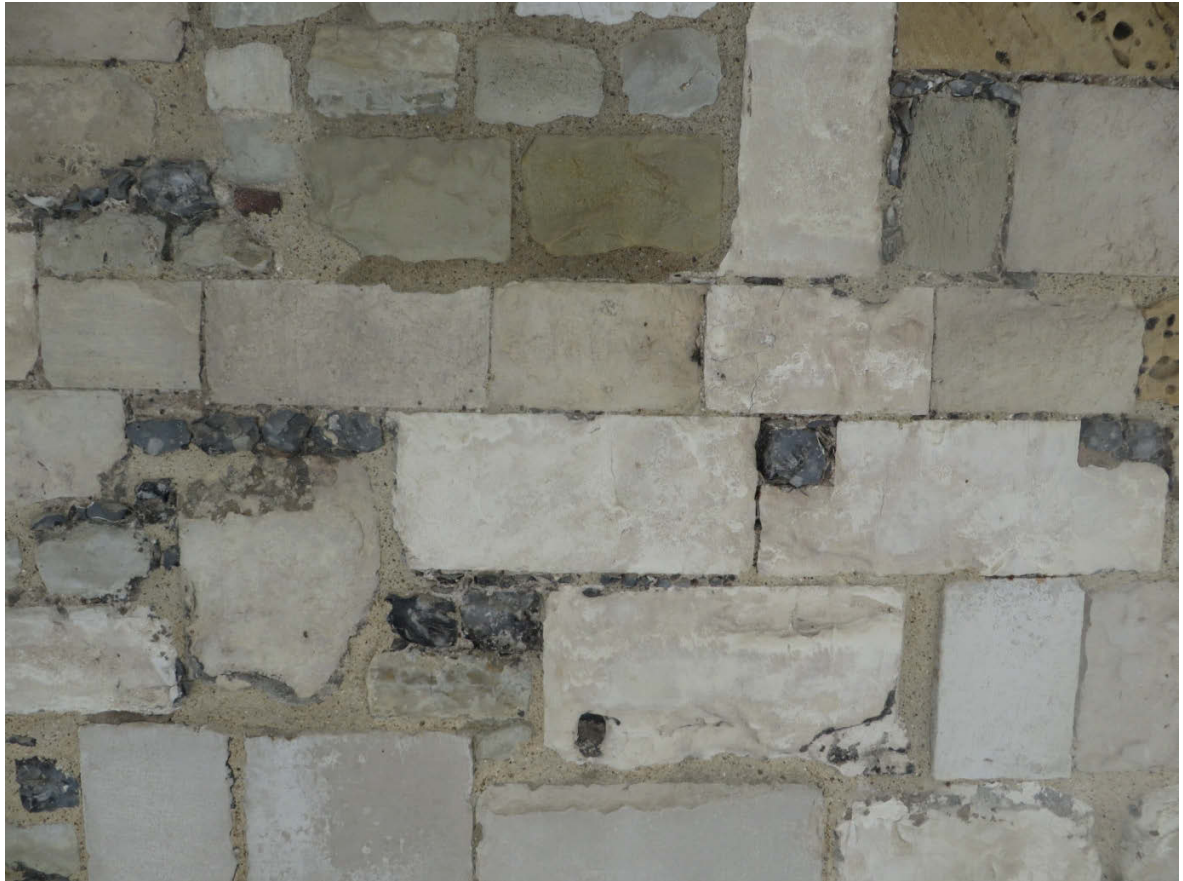
Plate 35: Flint galetting in amongst the mid 19<sup>th</sup> century replacement Magnesian Limestone at the west end of the Inner Curtain Wall

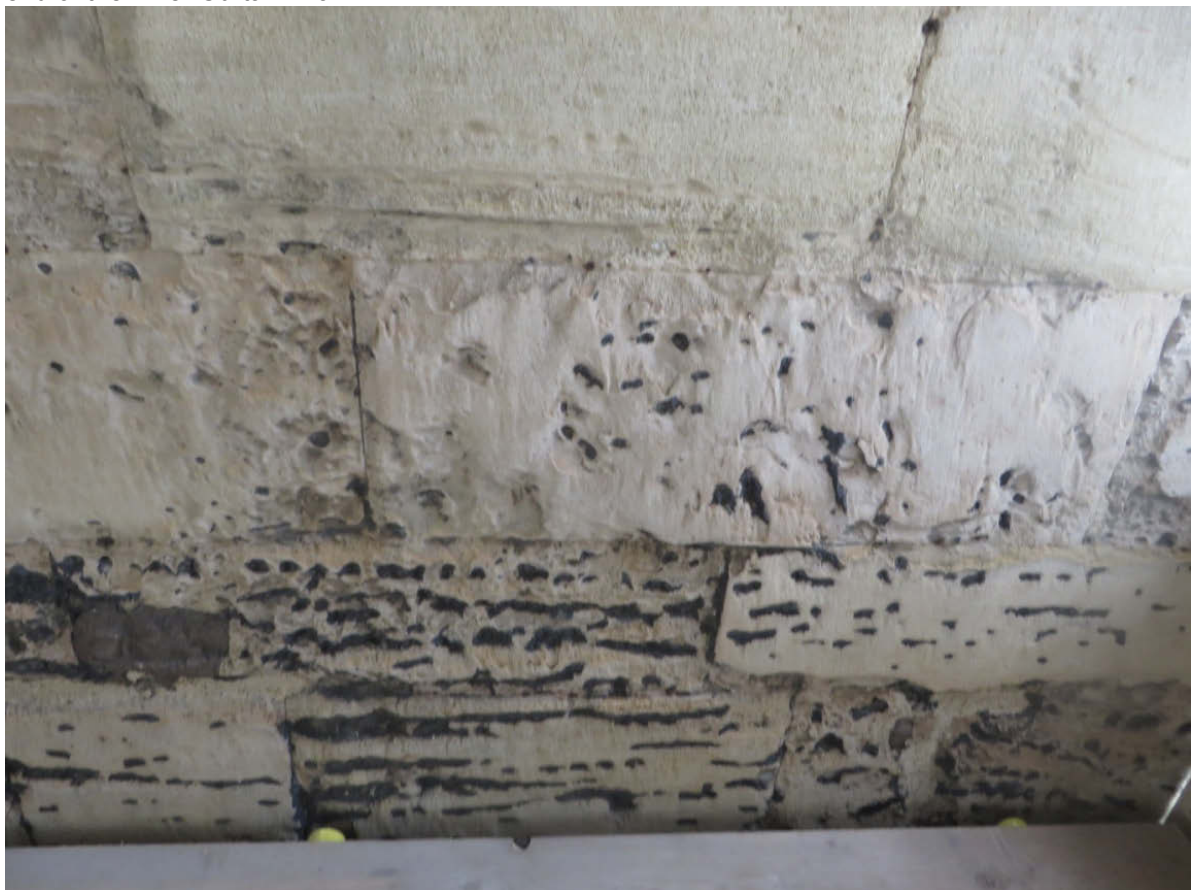
Plate 36: Weathering of Ancaster Freestone in the eastern part of the recorded Inner Curtain Wall
