**LAND OFF MANOR ROAD,
CLAYBROOKE,
ULLESTHORPE,
LEICESTERSHIRE:**

**AN ARCHAEOLOGICAL
OBSERVATION**

February 2016

**PRE-CONSTRUCT ARCHAEOLOGY LTD
R12381**

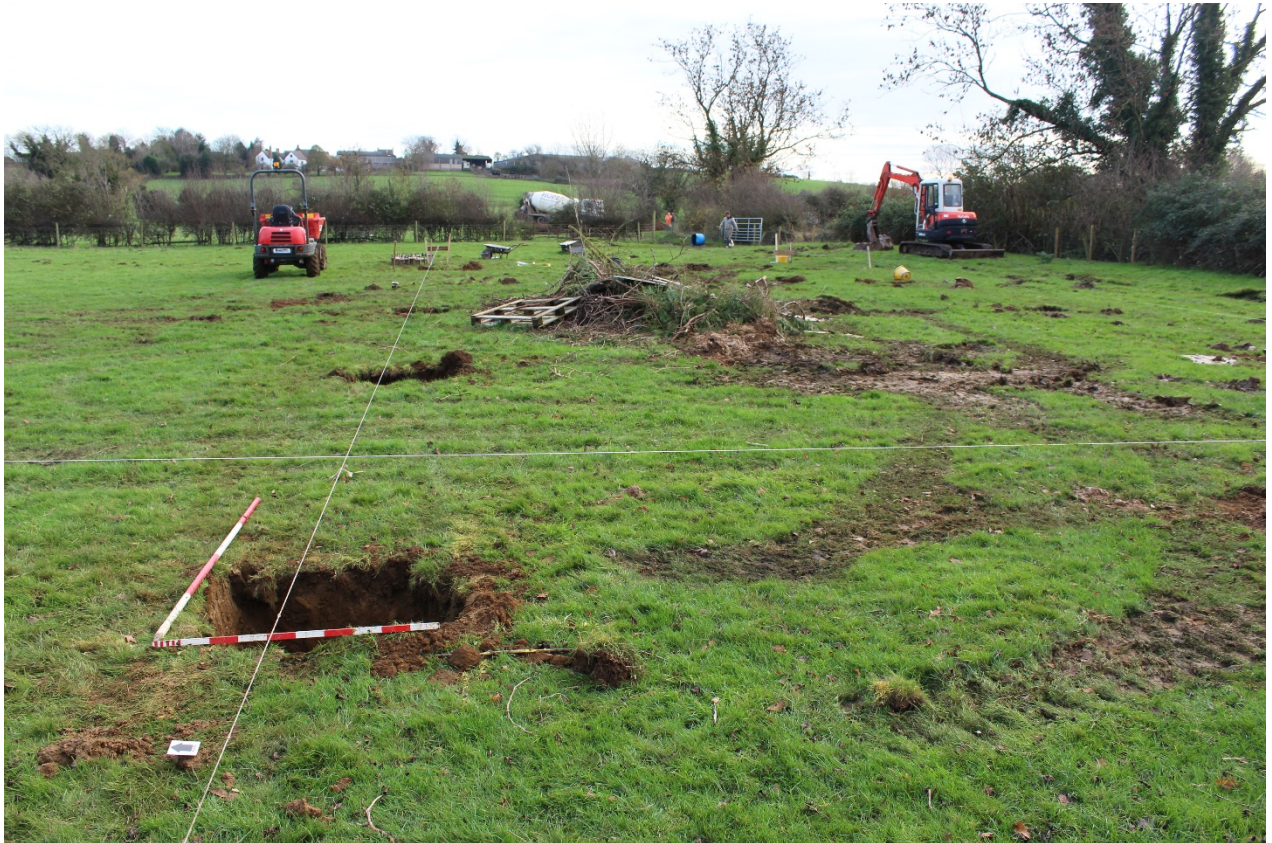
Plate 1: East facing shot across barn footings area.

- 3.1.1 Between 1st-2nd of January 2015, archaeological supervision took place during the excavation of twelve footings required in the preparation of land for the construction of a barn at land off Manor Road, Claybrooke, Ullesthorpe, Leicestershire (**Plate 1**). Additional supervision took place during the groundworks associated with the new access required for this building (**Plate 2**).

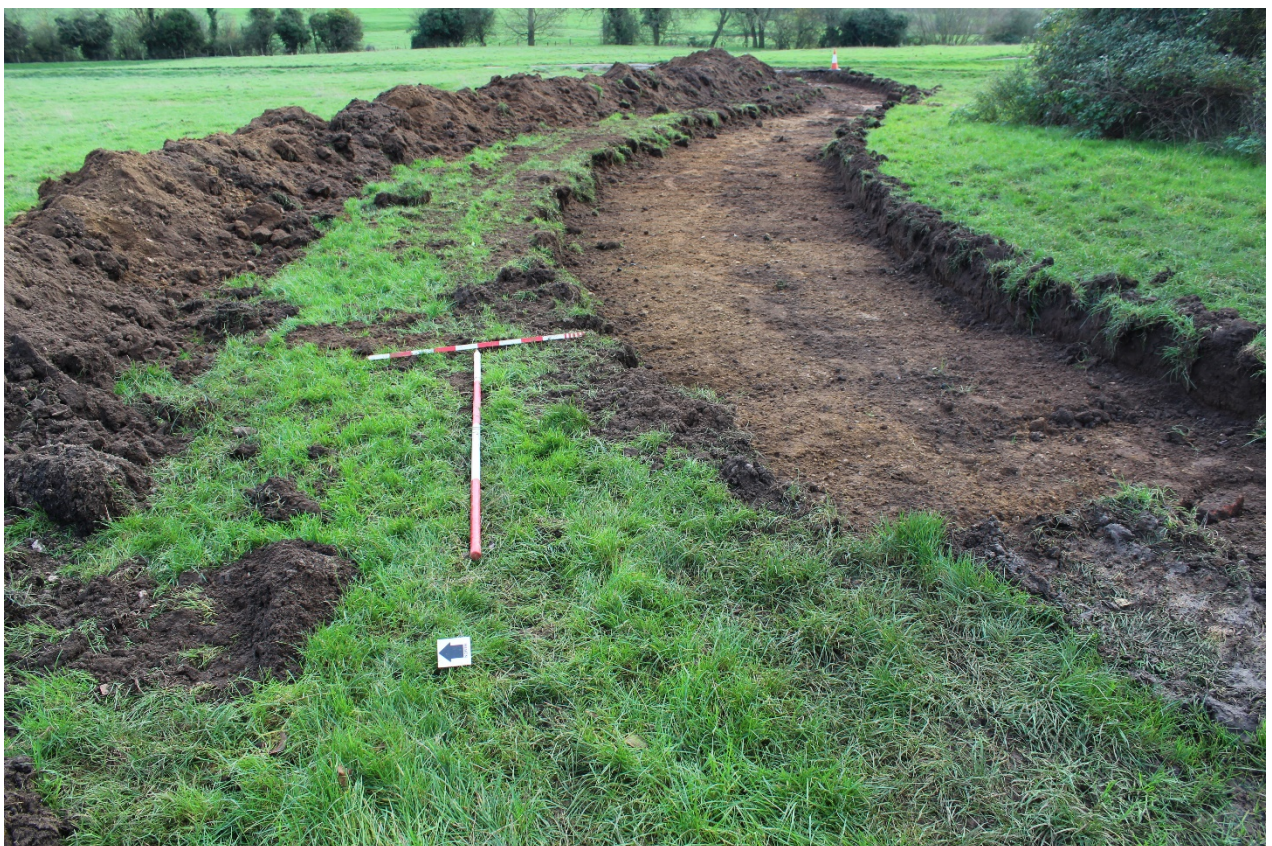
Plate 2: East facing shot of stripped road area.

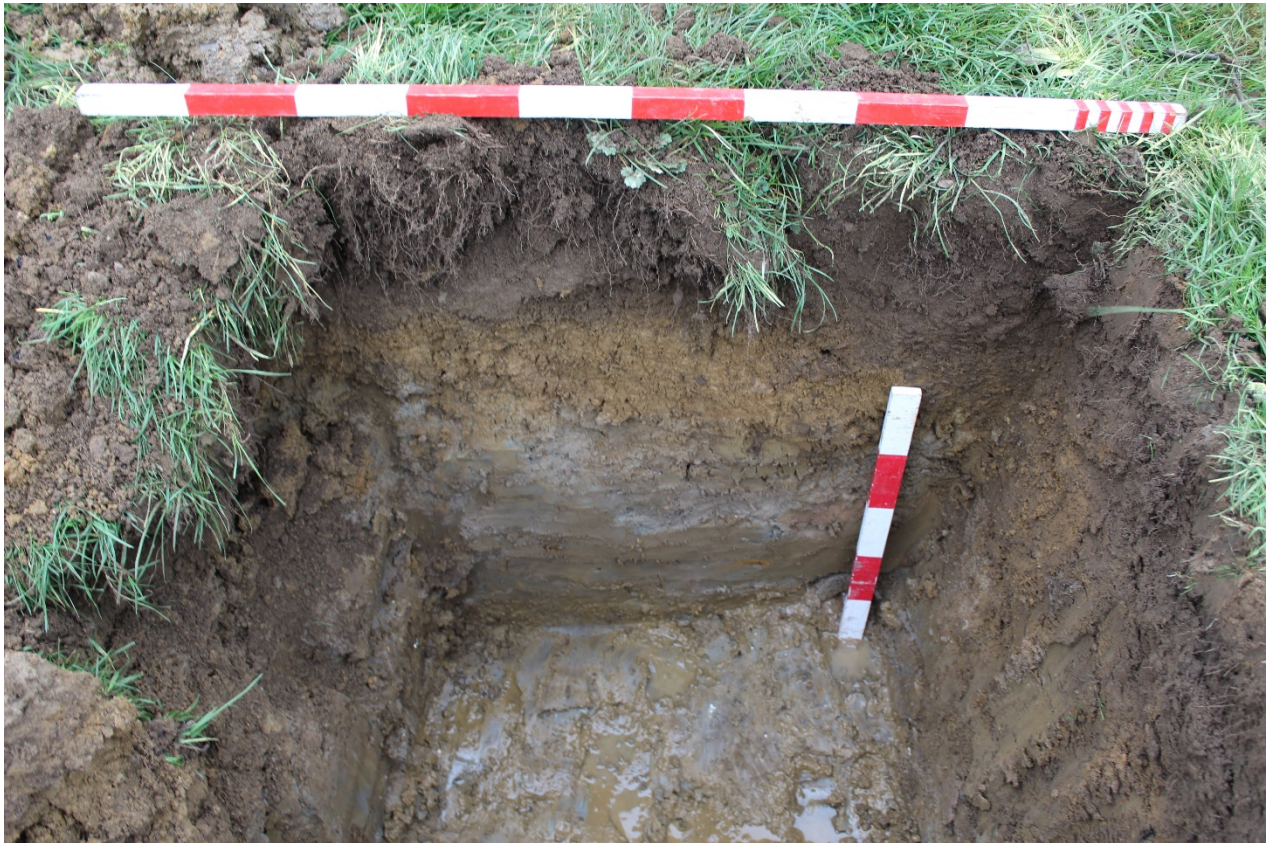
Plate 3: West facing shot of Section 2 – showing contexts 01, 02, 03.

- 4.1.1 The non-archaeological deposits encountered during the observation (see **Plates 3, 4 and 6**) consisted of a mid-dark brownish grey top soil containing occasional small, sub-rounded stones and occasional modern material such as machine made brick (dating to the 20th century) and later 20th century glass fragments (context **01**). Underlying this, a subsoil of mid-light reddish orange sand, that was increasingly grey towards the east of the site, was encountered (context **02**). The subsoil contained a fragment of handmade brick dating to the 18th to mid-20th century as well as a sherd from an iron-glazed bowl which dated to the mid-17th/18th century and additional 19th-mid-20th pottery fragments (see **APPENDIX 2**).

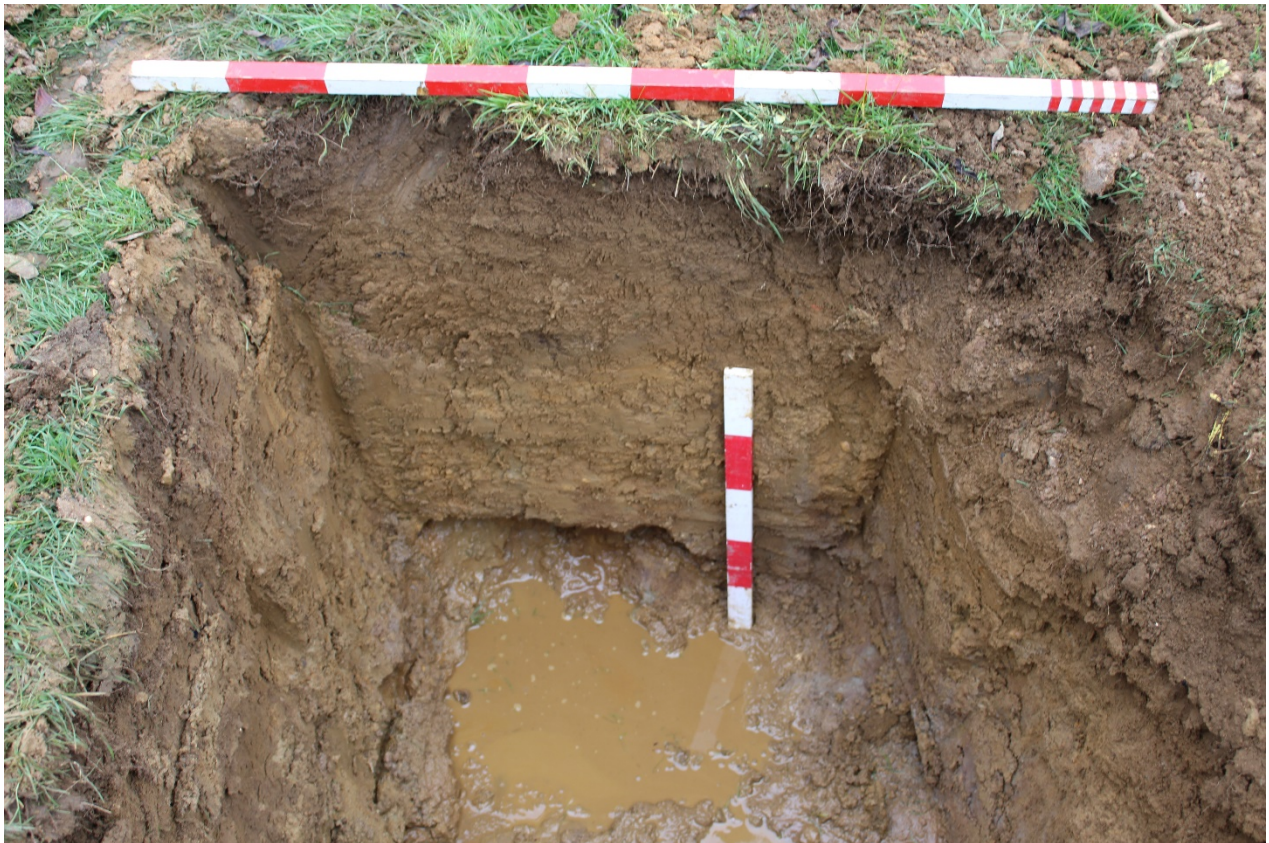
Plate 4: North facing shot of Section 6 – showing contexts 01, 02 and 03.

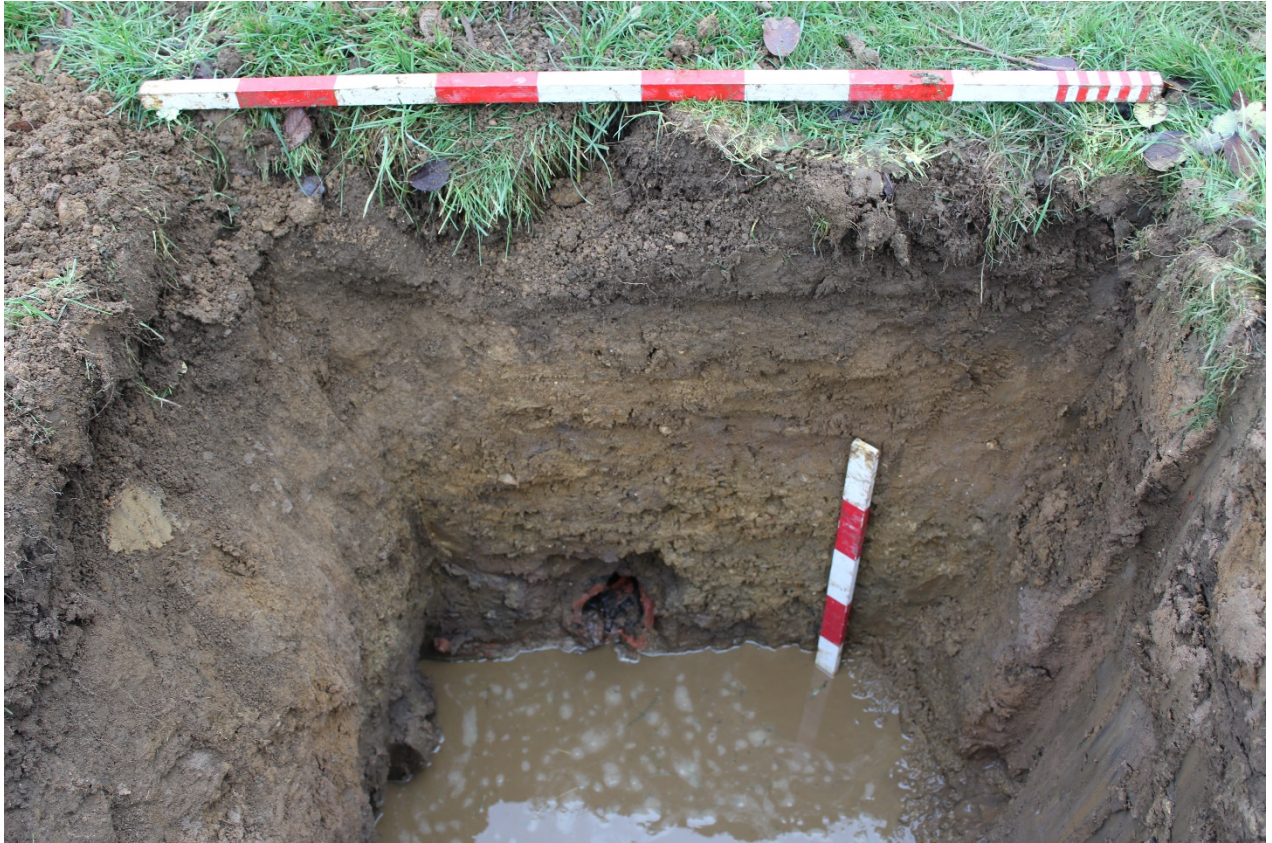
Plate 5: East facing shot of Section 8, including field drain – showing contexts **01**, **[04]**, **(05)** and **03**.

- 4.2.1 Two modern field drains were encountered during the archaeological observations (**Figure 3**). The first (allocated cut number [**04**]) ran on an east-west alignment and was encountered in one of the southern footings of the barn. It contained a ceramic pipe c.0.12m x 0.12m and the cut was infilled with mixed orange sand and grey clay (**05**) which was redeposited subsoil and natural (**Plate 5**). The second field drain, ascribed cut number [**06**], contained a similar pipe and was encountered in the southern portion of the road area on a north-south alignment. It contained a fill of light/mid orangey grey sand which was allocated context number (**07**) and made up of redeposited subsoil (**Plate 7**).

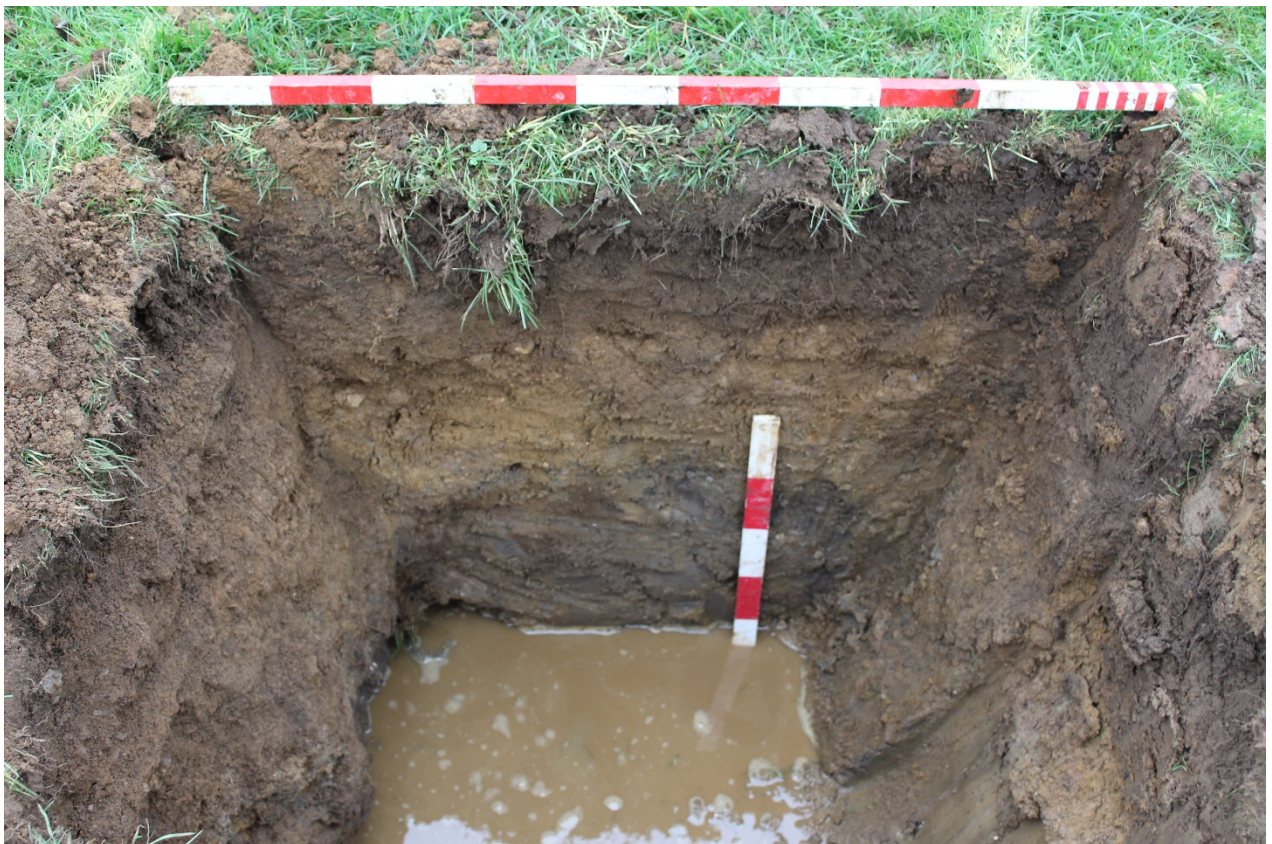
Plate 6: East facing shot of Section 10 – showing contexts **01**, **02** and **03**.

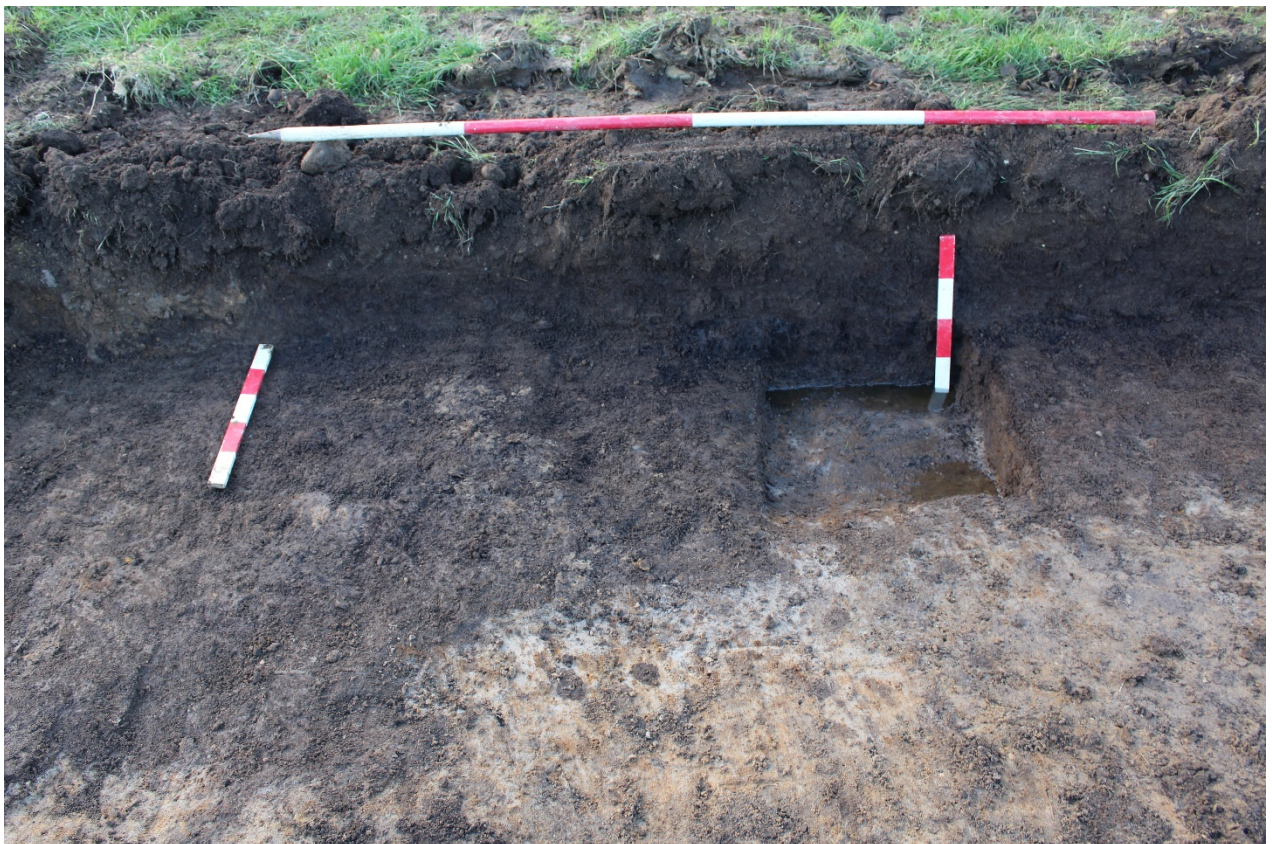
Plate 8: South facing shot of Section 14, including unidentified feature – showing contexts **01, 02, [08]** and **(09)**.

- 4.3.1 A single possible feature was identified to the east of the second field drain, in the observed road area (**Plate 8**). This consisted of an irregular, roughly rectangular shaped feature with an irregular base and sides. It was allocated cut number [**08**] and contained a fill of mid grey brown sandy silt with orangey inclusion (**09**). The fill held no finds but was replete with fine roots which compacted the otherwise loose material. Because of the irregular nature of the feature, lack of finds and heavy rooting, it is possible that this feature is organic rather than archaeological.

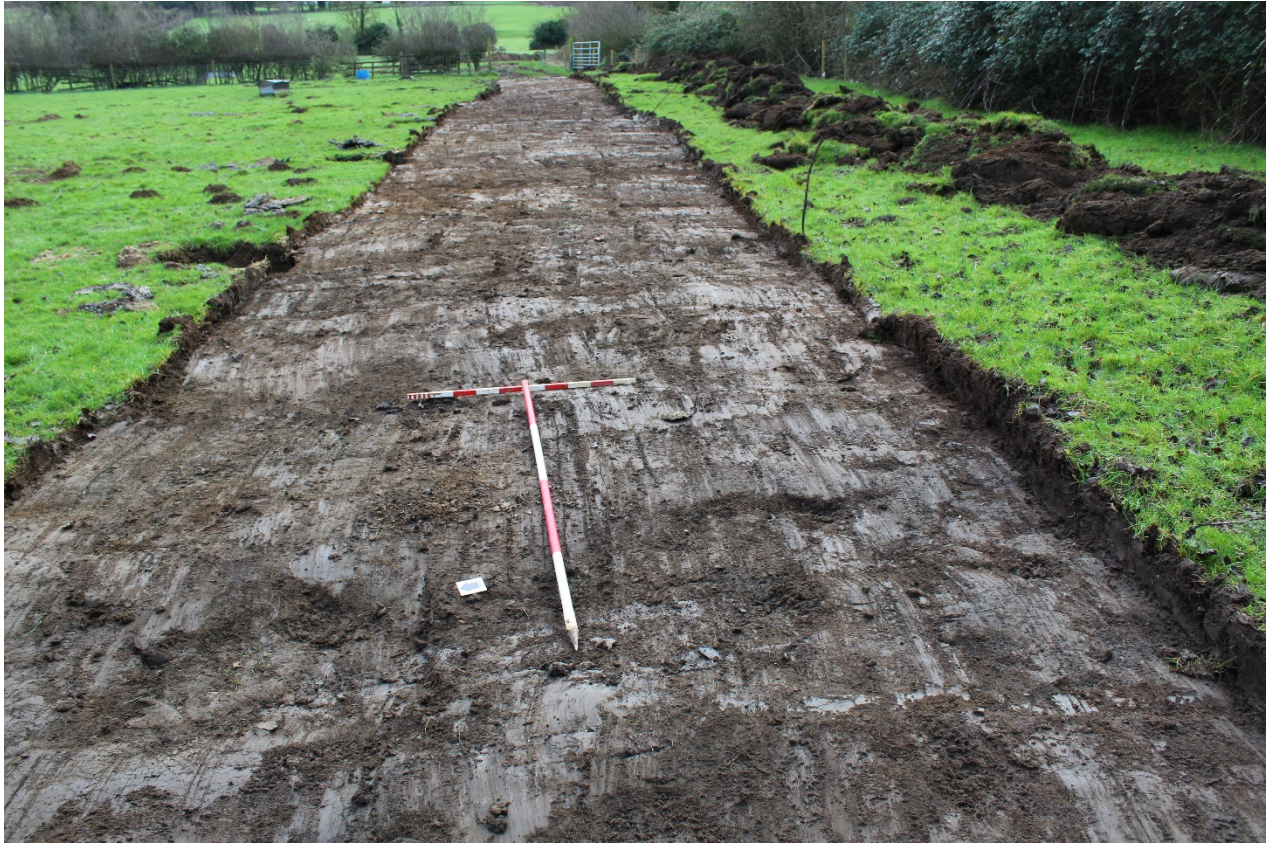
Plate 9: East-southeast facing shot of stripped road area adjacent to barn footings. Only the topsoil (context 01) has been revealed.

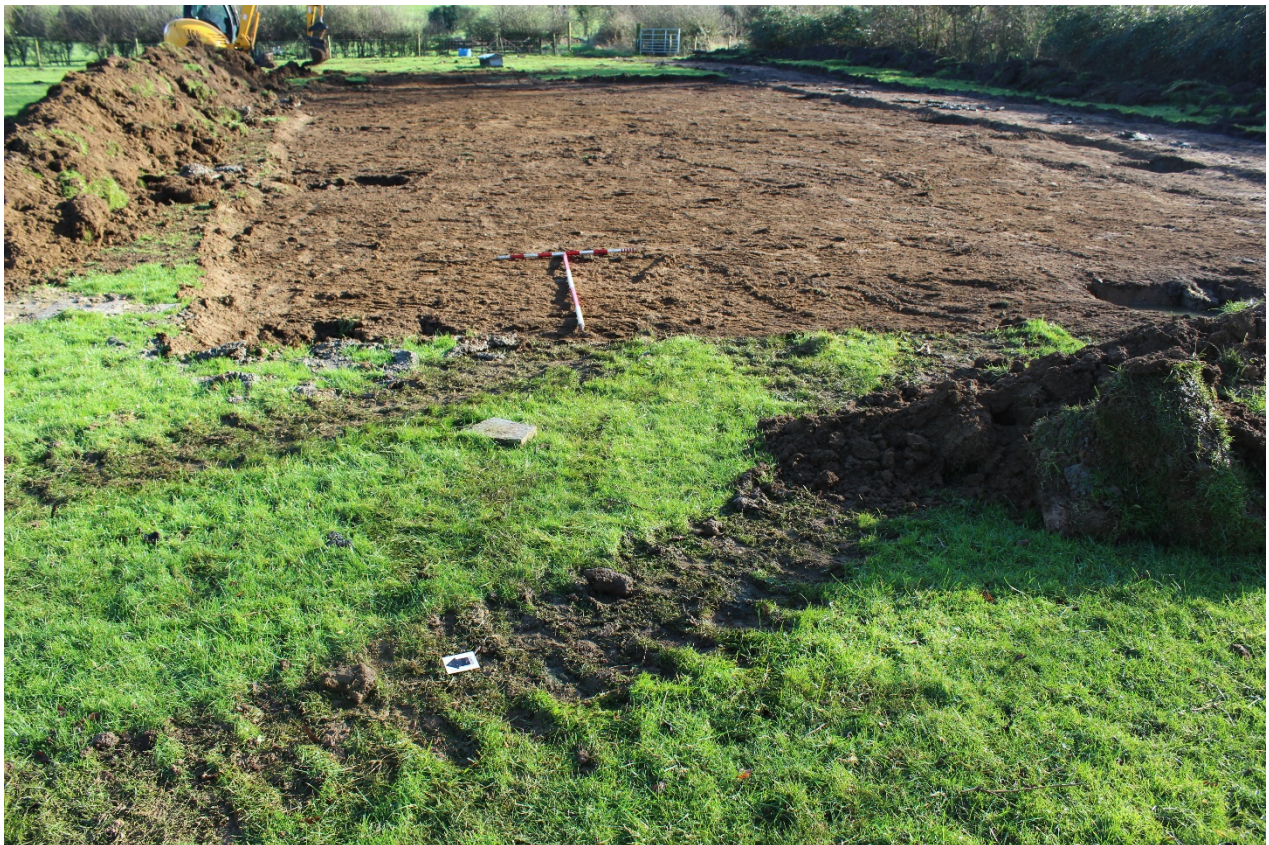
Plate 10: East-southeast facing shot of stripped barn and road area adjacent to barn footings. The subsoil (context 02) has been revealed in the barn footings area and topsoil (context 01) in the road area.
