Archaeological
Monitoring at the Church
of the Holy Trinity,
Chrishall, Essex

March 2016

ARCHAEOLOGICAL MONITORING

Pre-Construct Archaeology Ltd	
Project Number	K4201
Report Number	R12326

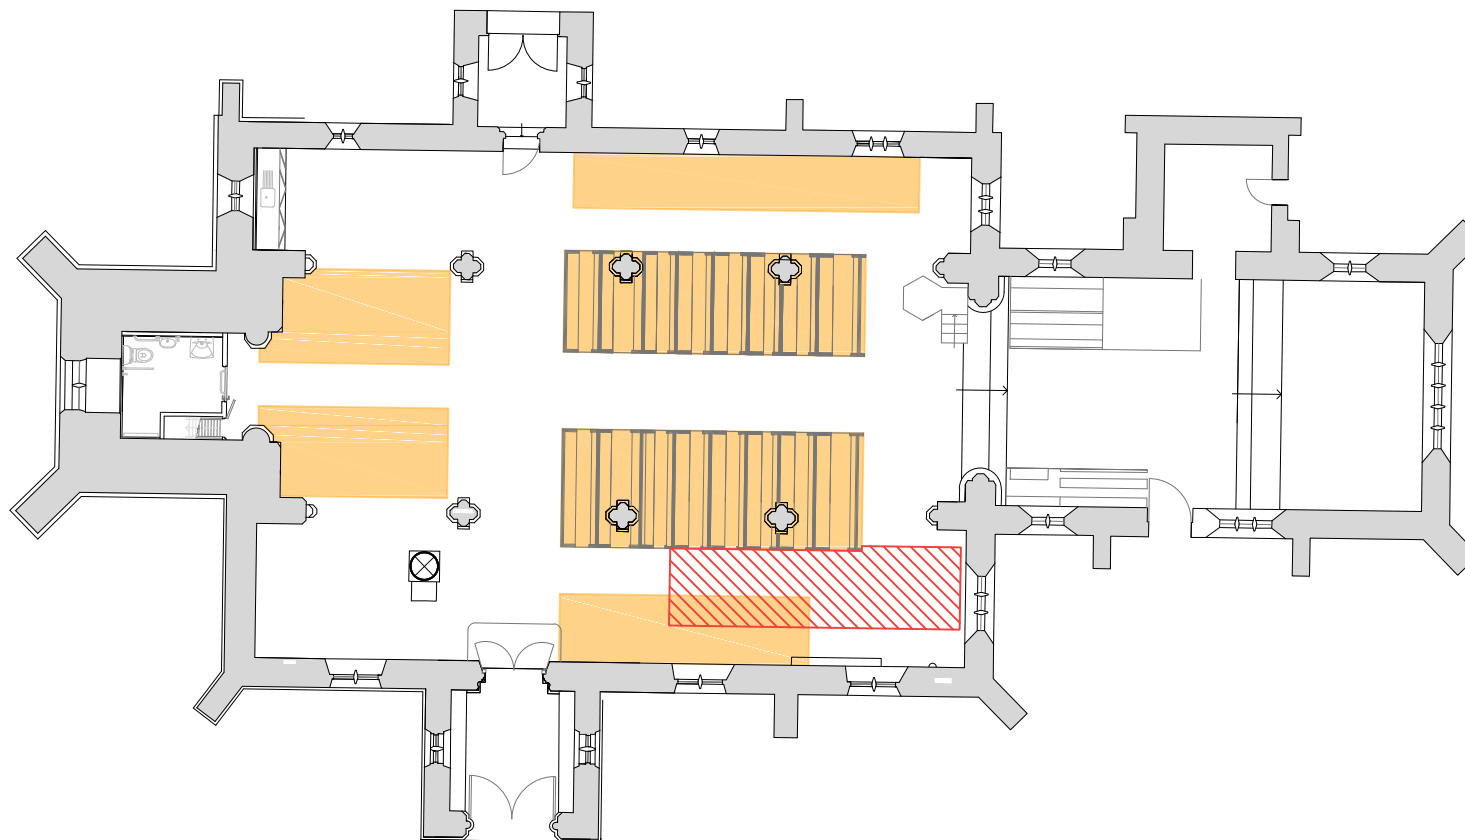
Figure 3
Plan of Holy Trinity Church indicating areas of archaeological monitoring
1:200 at A4

- 4.1.1 The archaeological monitoring comprised two components : the recording of the area where pews were removed and the reduction of the floor in the south aisle (Figure 3).

- 5.1.2 Pews were removed from the western end of the nave, main aisle and north and south aisles (Figure 3) (Plates 1, 2 and 3).
- 5.1.3 There were two types of pews noted prior to removal; these were photographed during a pre-works visit. There were plain pews located in the western end of the nave and against the walls of the north and south aisles (Plate 2) and more decorative ones with carved brackets on the ends located in the main aisle (Plate 3). The last two pews at the rear on either side of the main aisle of the nave had decorative carved ends depicting kneeling figures at prayer (Plates 4a and 4b).

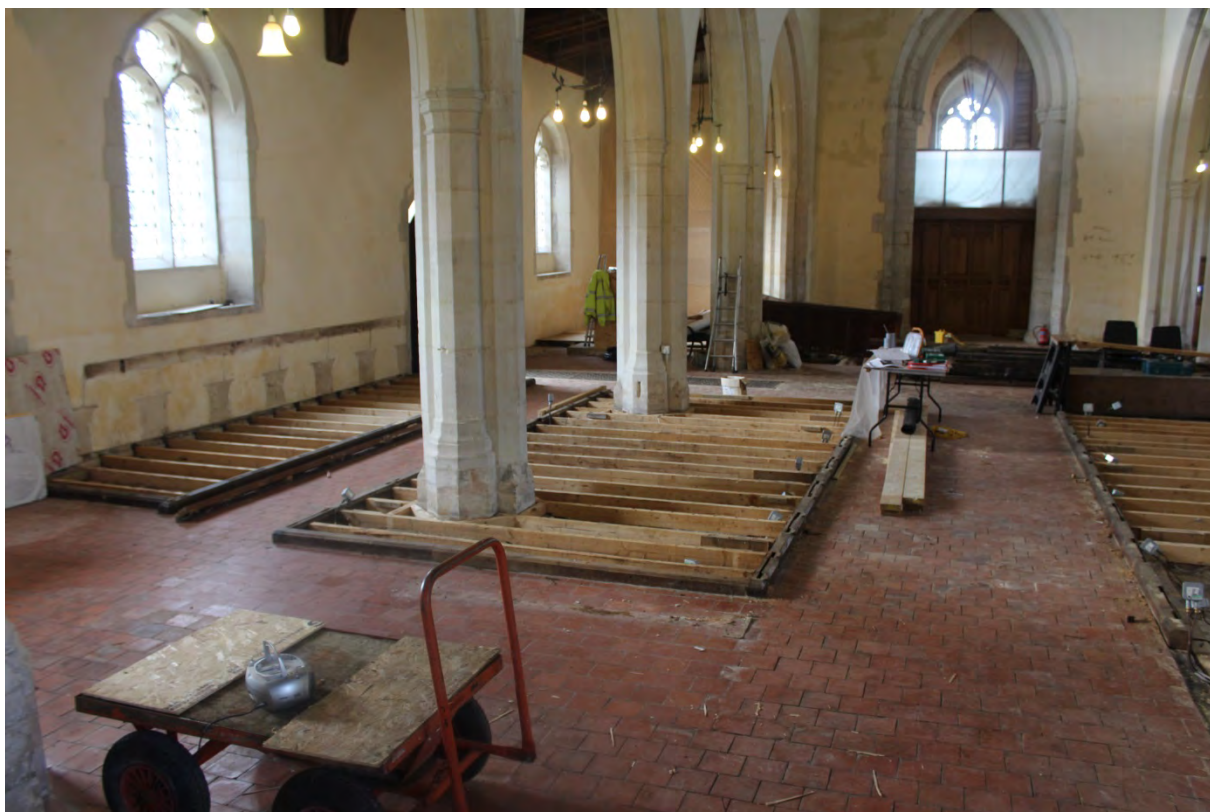
Plate 5: Main and South Aisle during pew removal

- 5.1.4 On arrival of the first day of monitoring, the pews had been removed from all locations, in most places leaving the supporting beams and plinths into which the pews slotted in place. (Plate 5). The ground level below each pew was lower in all locations at approximately 300mm. As this was to be the final floor level no further reduction was required in these area.

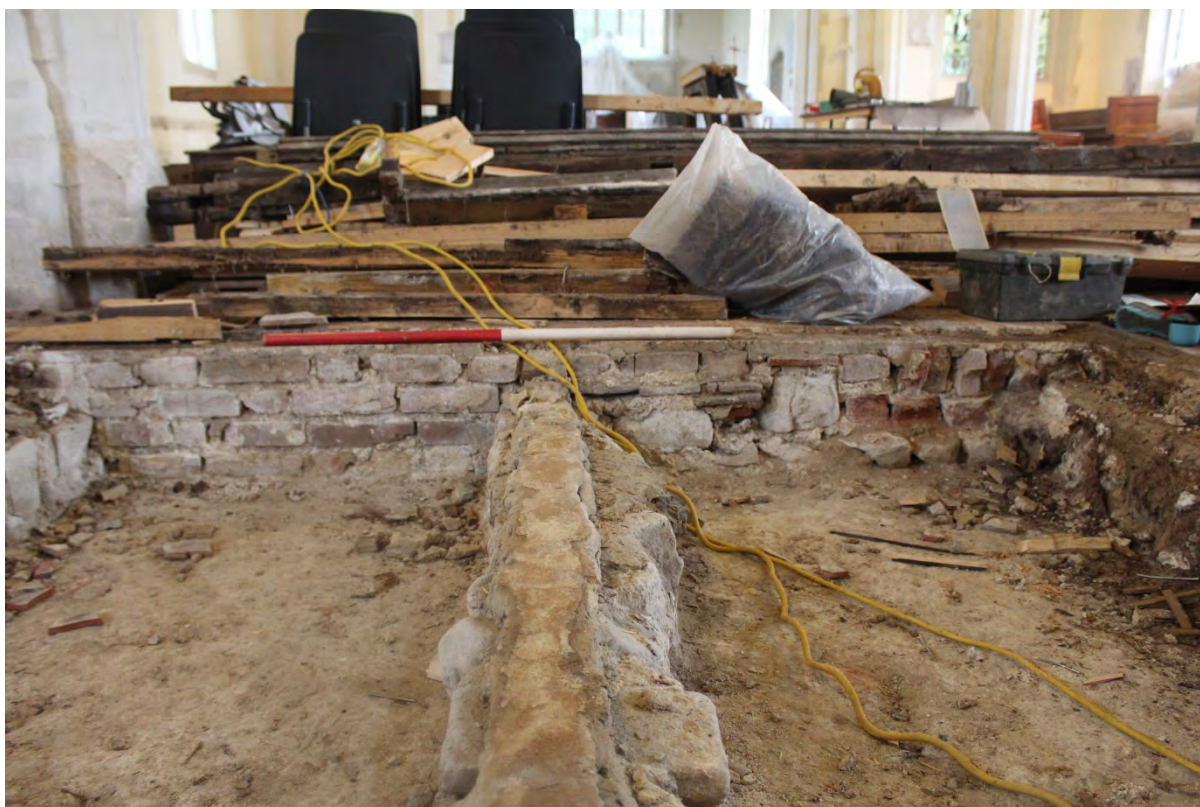
were created from blocks excavated to create the void to add support beneath the softwood pew bases. Bricks had been used in the northern edge of the excavated void located the western end of the nave, on the north side of the tower entrance (Figure 3) (Plate 6). Although it was not possible to remove a sample for dating or examination, average dimensions of the bricks were noted : 23cm x 6cm x 9cm. These bricks may have been used to support the pew plinths.

Plate 6: Area recorded following pew removal in the western end of the nave (north side of tower entrance)

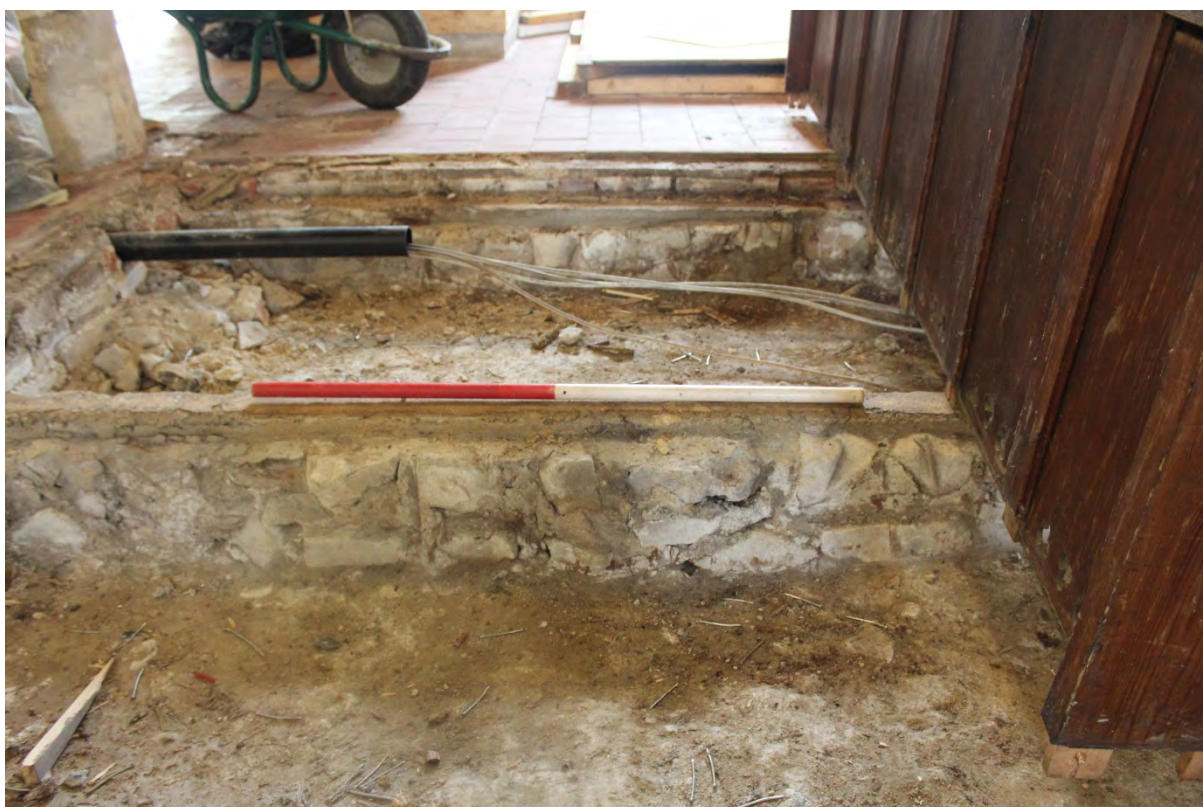
Plate 7: Area recorded following pew removal in the western end of the nave (south side of tower entrance)

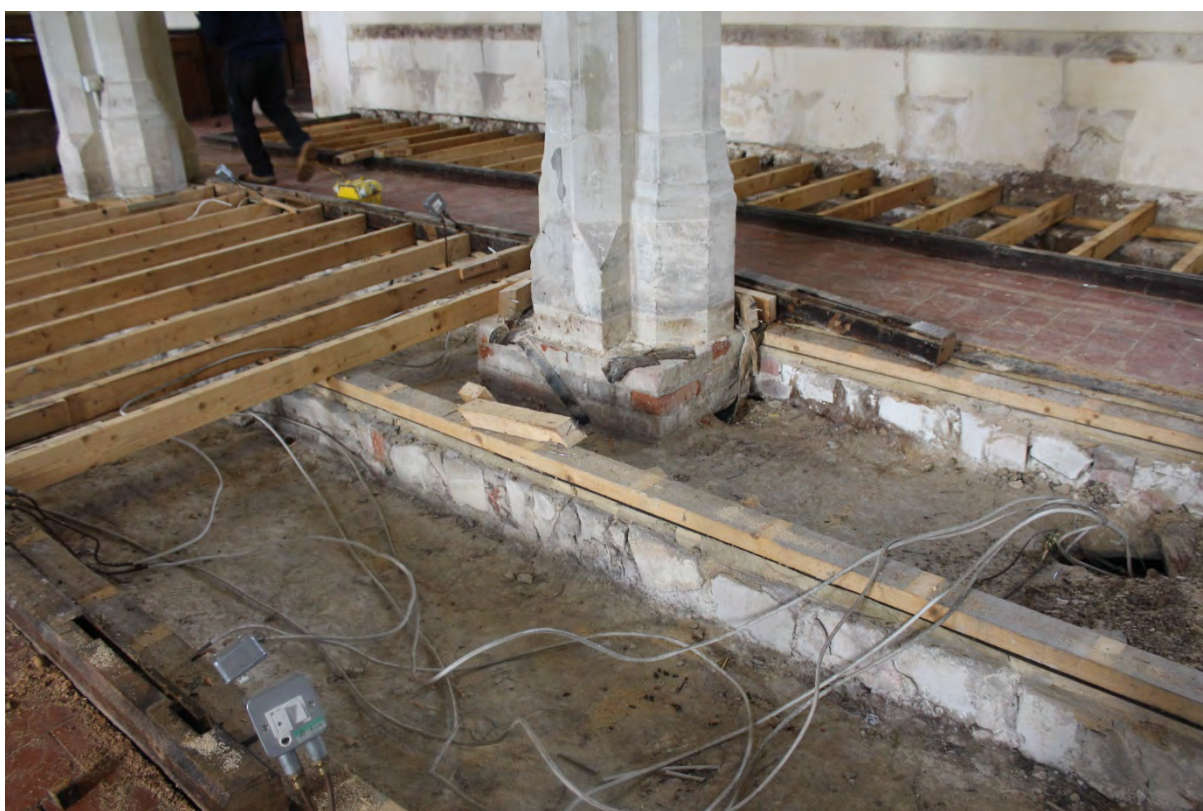
Plate 8: Area recorded following pew removal on north side of the nave

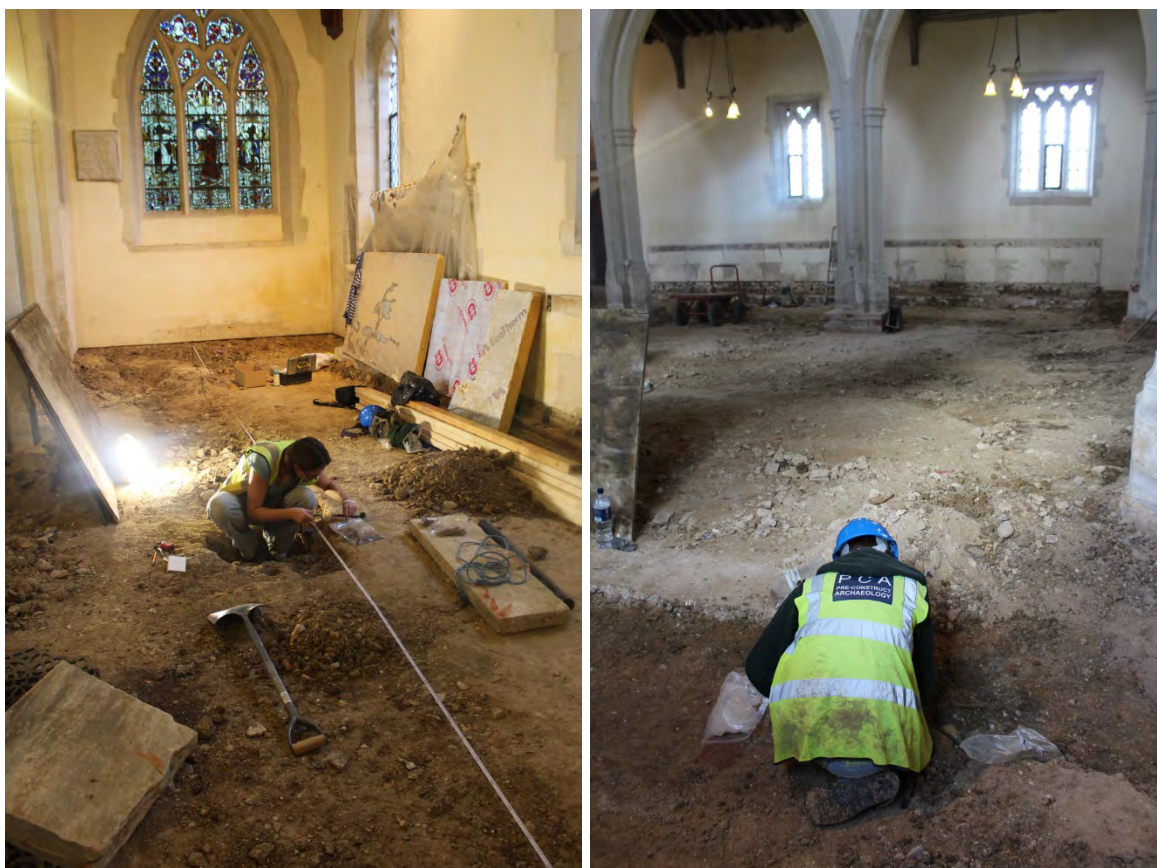
5.2.1 Monitoring of the reduction of the floor level in the south aisle was undertaken in November 2015. Articulated human bone was noted as the mechanical excavator began to reduce the ground level. Mechanical excavation was immediately suspended in this area to allow archaeological investigation using hand tools only (Plate 9).

Plate 9: Working Shots during excavation of Sk1 and Sk 3 in south aisle

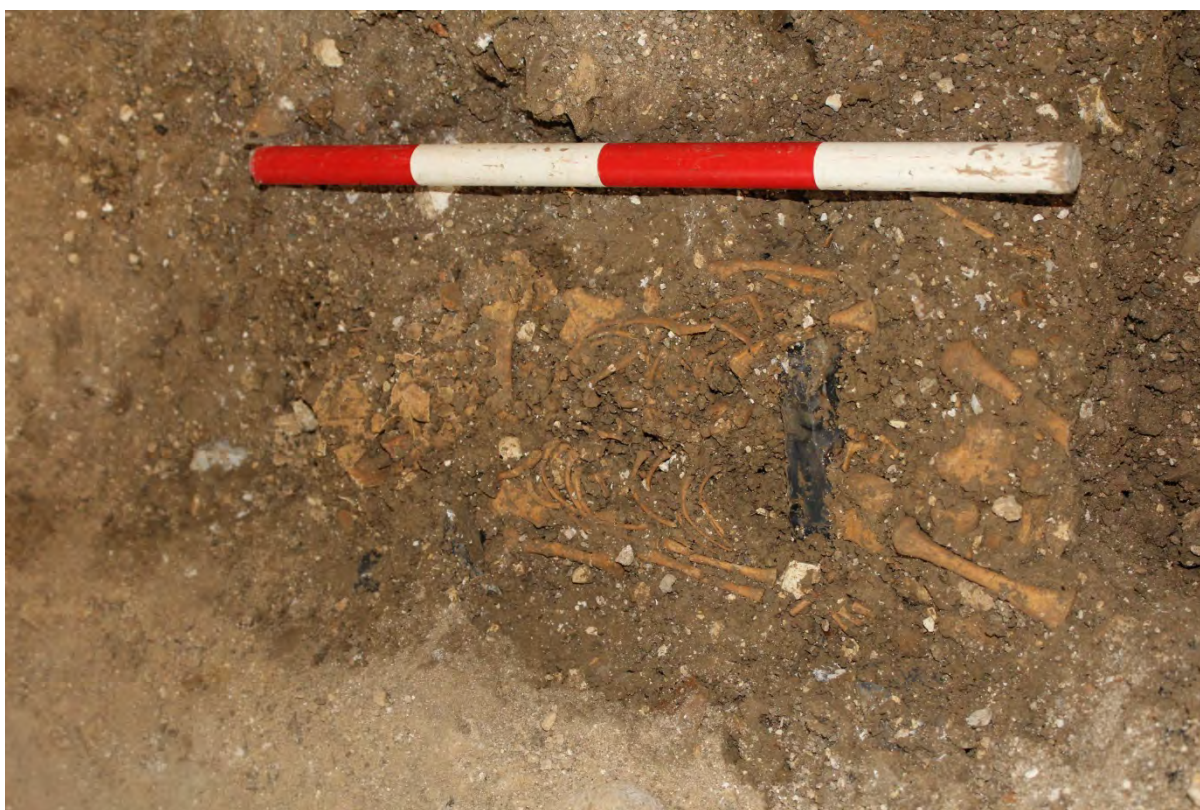
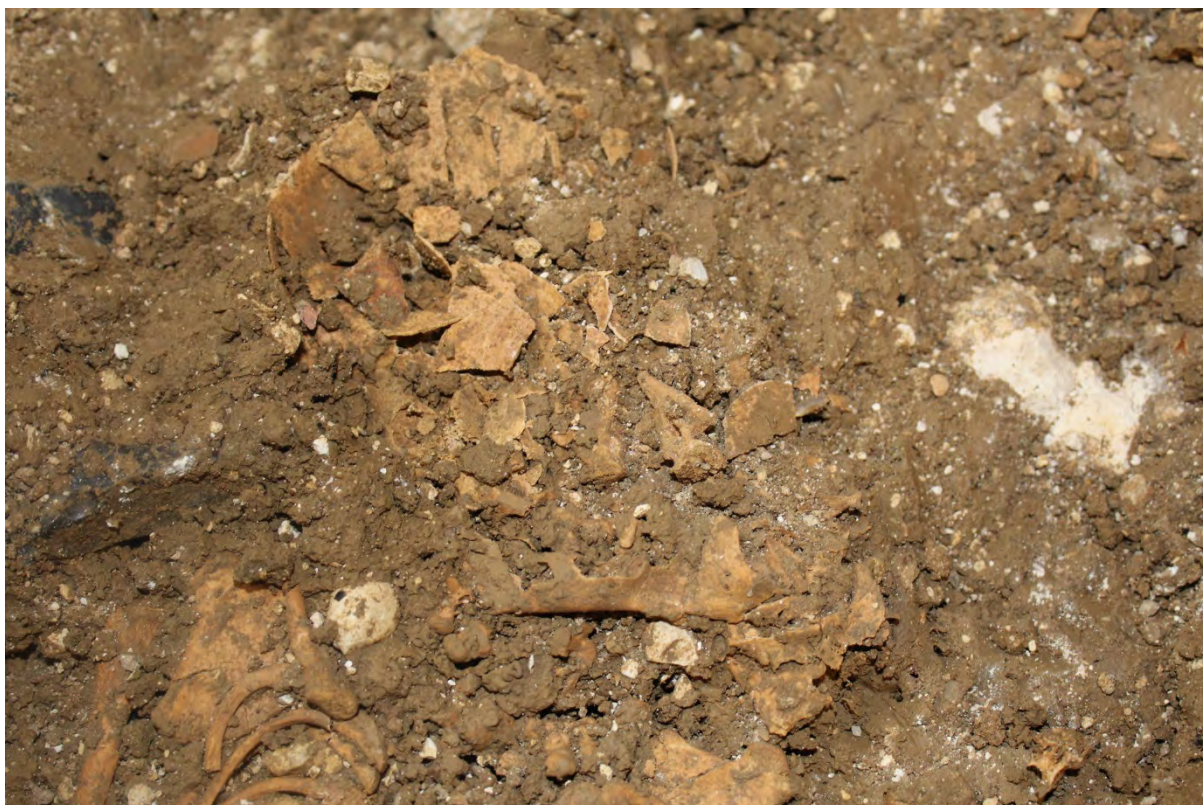
Plate 10: Sk 1

5.2.6 This infant was located c. 6.4m from the east wall of the south aisle and c. 2m from the south wall of the south aisle. It appears to be an isolated burial at this level. It was on a west - east orientation, extended supine with head turned north and both arms by its side. The grave has been truncated, evidenced by the truncated left femur. This individual was very well preserved with smaller skeletal elements such as hand phalanges surviving. Metrical data of the petrous portion of the temporal and the femur has aged this individual as an infant (more precisely a neonate between 40 prenatal weeks (full term) and 1.5 months).

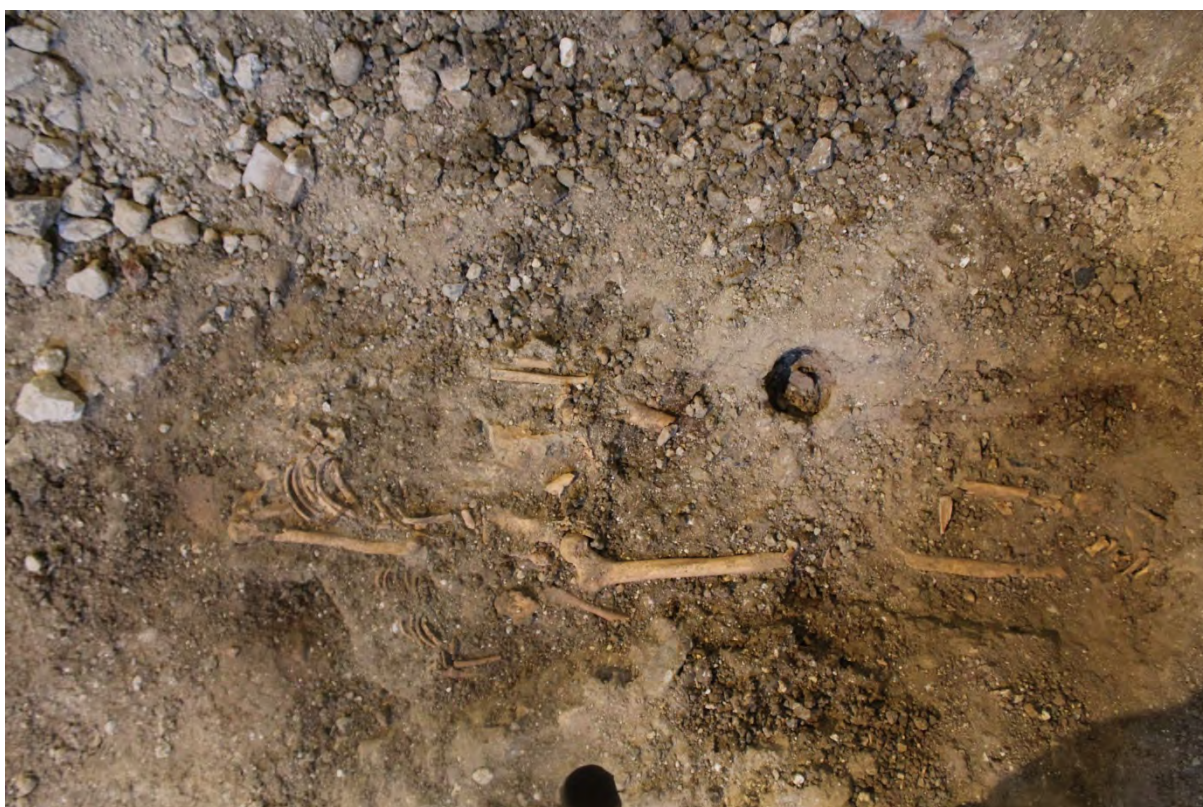
Plate 12: SK2 and 3

5.2.7 This adult female was located c. 0.5m from the east wall of the south aisle and c. 2.5m from the south wall of the south aisle. It was on a west - east orientation, extended supine with both arms originally by its side. This individual was well preserved. Observations of epiphyseal fusion and general size have aged this individual as adult, but due to the lack of any degenerative changes on the bone, a narrower age category cannot be assigned. The greater sciatic notch scored 2/3 (?F/??), while a potentially associated fragment of occipital resulted in a nuchal crest scoring of 2 (?F); both of which suggest possible female. This was a large individual with

- 5.2.8 This infant was located c. 0.75m from the east wall of the south aisle and c. 2m from the south wall of the south aisle. It was on a west - east orientation, extended supine with both arms originally by its side. This individual has been buried in a coffin as evidenced by the nine iron nails which were found in a row by its feet. This individual was very well preserved with the smaller skeletal elements such as hand phalanges surviving. Metrical data of the ulna, tibia and fibula has aged this individual as an infant (more precisely between 2.5 and 3 years).

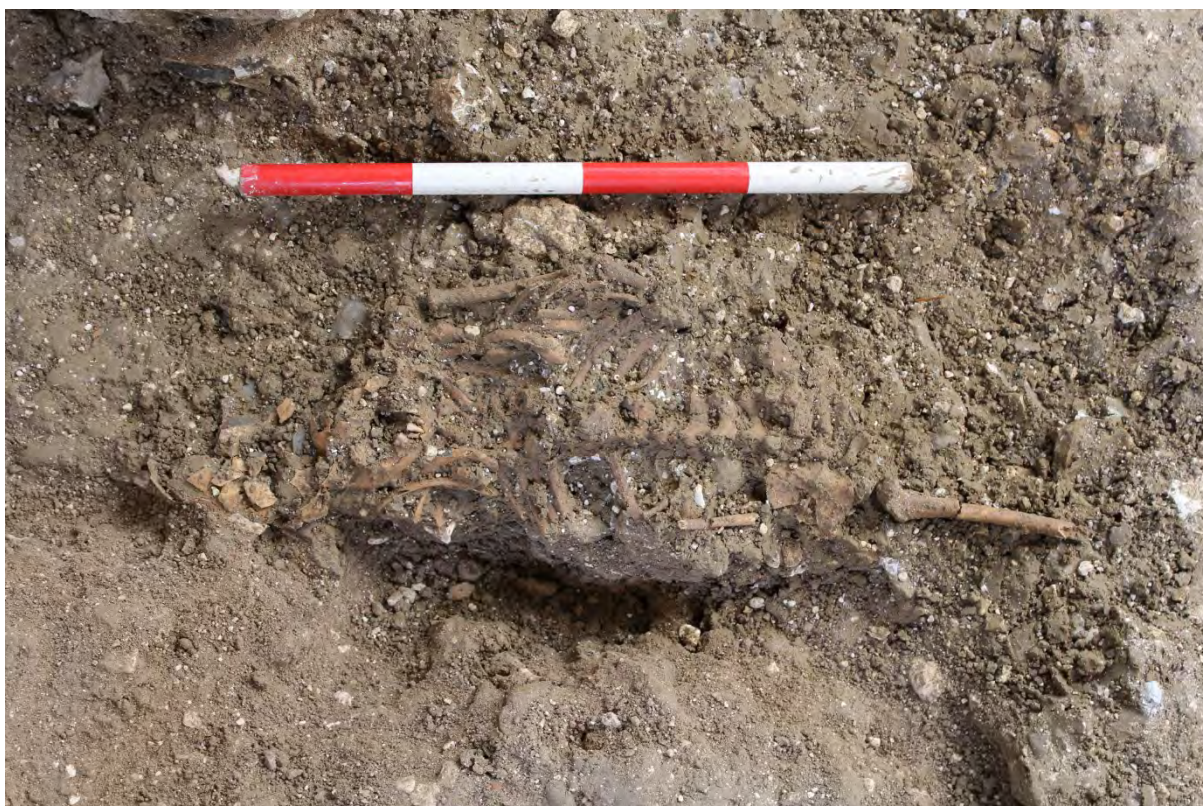
Plate 14: Sk 4

- 5.2.9 This infant was located c. 2.5m from the east wall of the south aisle and c. 2.5m from the south wall of the south aisle. It was on a west - east orientation, extended supine with head turned north and both arms by its side. This individual was buried in a coffin as evidenced by two iron nails found with the body. The grave appears to have been truncated to the south (by SK2) and to the east by modern disturbances. Despite this, this individual was very well preserved with smaller skeletal elements such as teeth and hand phalanges surviving. Metrical data of the humerus, in addition to dental eruption data, has aged this individual as an infant (more precisely between 1 - 1.5 years).

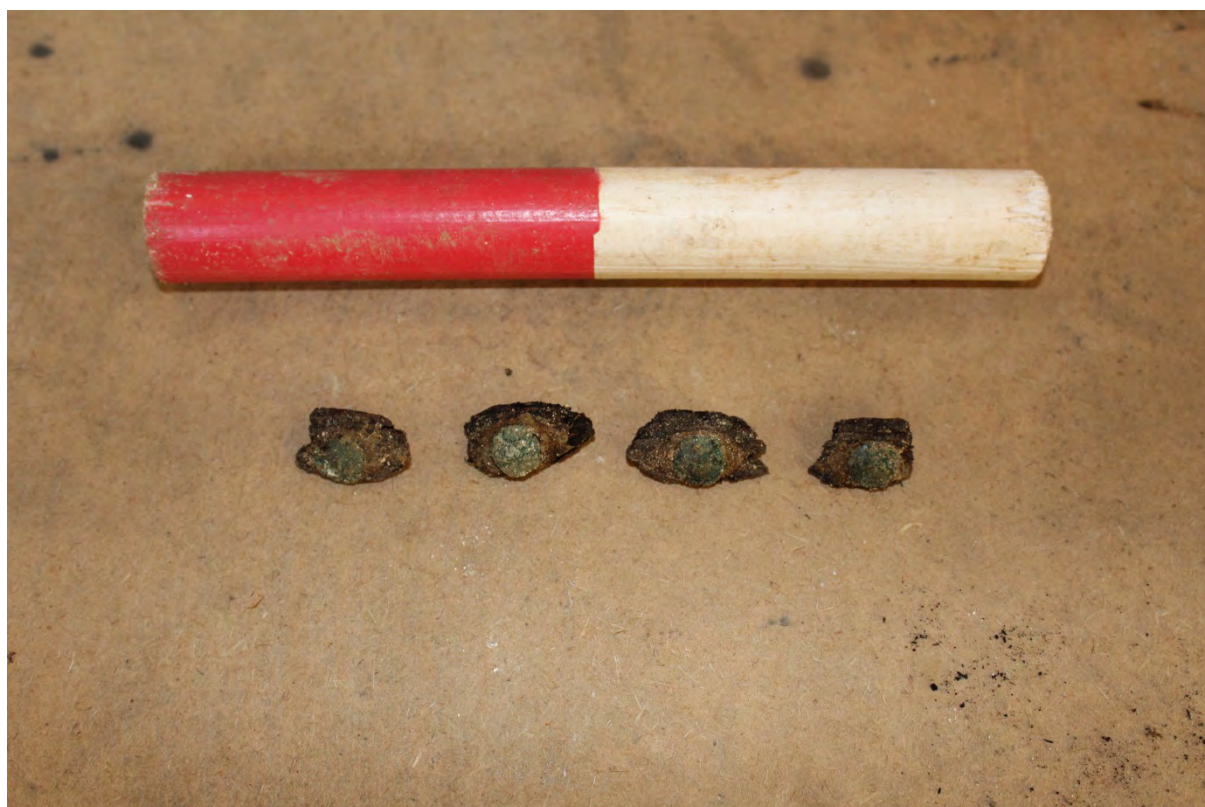
- 5.2.11 Two tibias, one fibula and an associated partial femur were allocated a skeleton number due to their partial articulation. They were found on a south - north alignment with a number potential coffin fittings, c. 5m from the east wall of the south aisle and c. 2.75m from the south wall of the south aisle. It appears that this grave may have been disturbed while the body was still partially fleshed, or indeed while the coffin still survived, with the most likely original alignment being west - east. This theory is supported by the coffin

fittings which were alongside this individual's legs (Plate 15). Observations of epiphyseal fusion and general size have aged this individual as adult, but due to the lack of any degenerative changes on the bone and the small quantity of bone recovered, a narrower age category cannot be assigned. Evidence of osteomyelitis was noted on the right tibia and fibula. Osteomyelitis is an inflammation caused by pus producing bacteria which can occur following a fracture which may have been the case with this individual. This infection and the resulting swelling has affected both the distal tibia and fibula causing them to fuse.

Plate 15: Coffin Nails, Sk 6

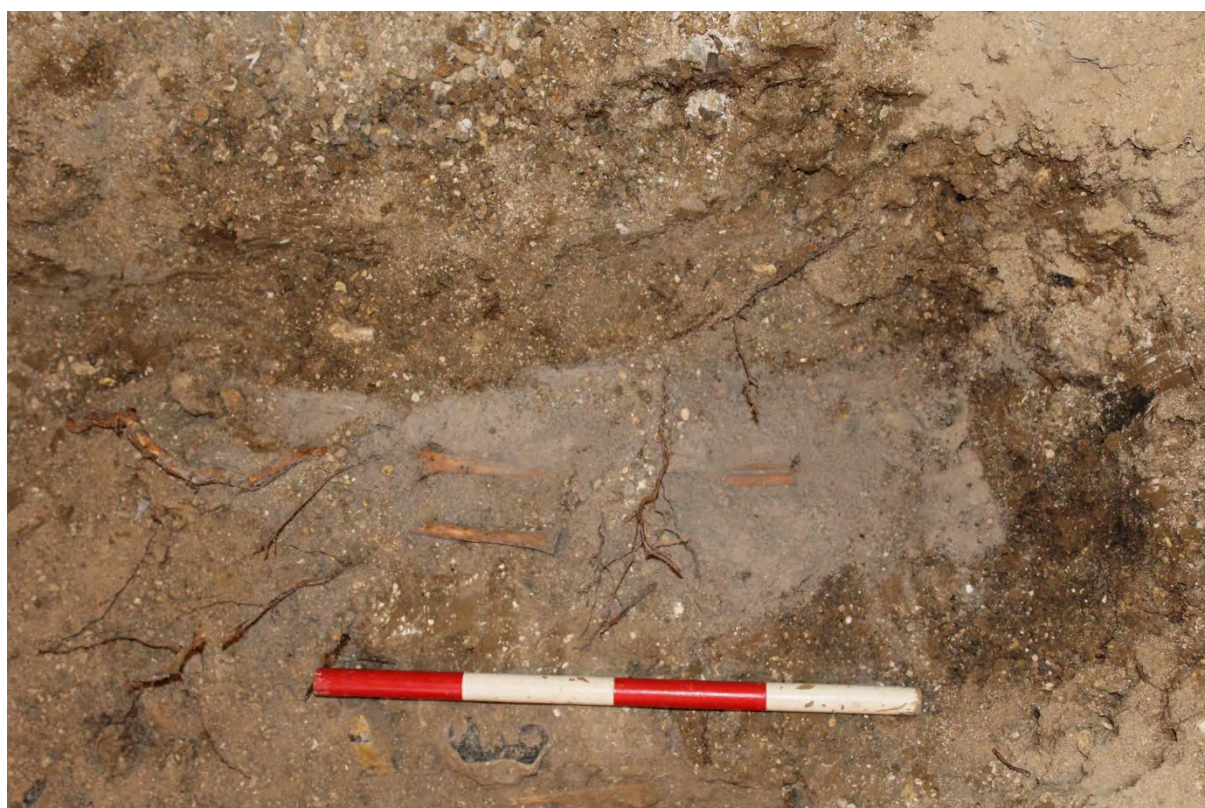
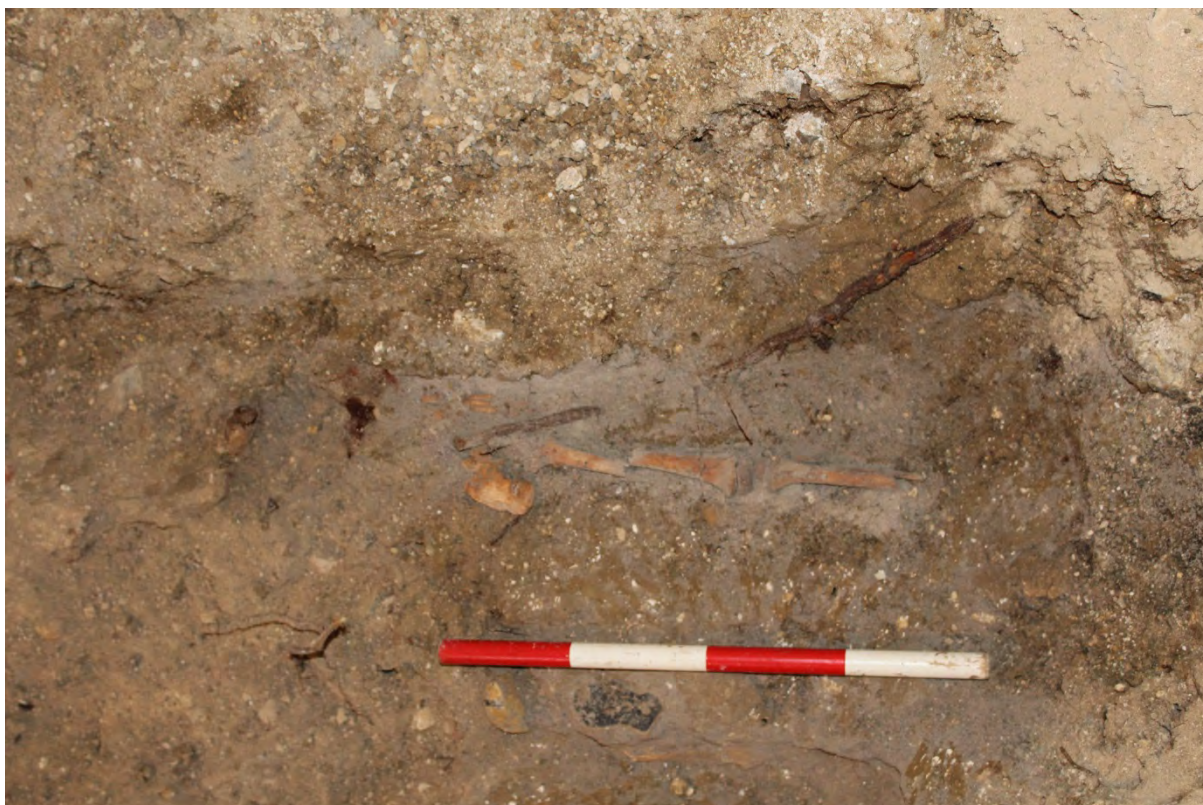
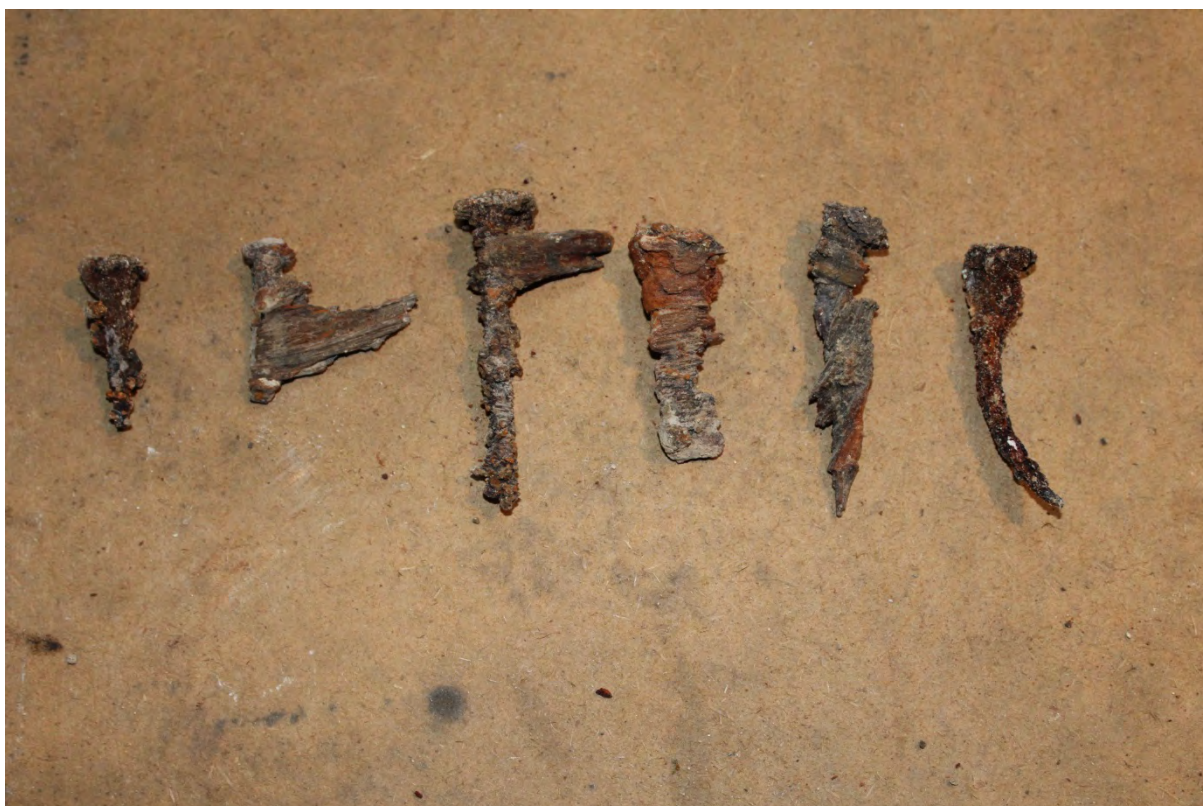
5.2.12 This infant was located c. 0.5m from the east wall of the south aisle and c. 2.75m from the south wall of the south aisle. It was on a west - east orientation, assumed extended supine. This individual was buried in a coffin as evidenced by the ten nails (with preserved wood attached) associated with it in addition to a very clear coffin edge made clearer by the grey coffin fill. The grave has been truncated by Skeleton 2 which was just above it as evidenced by a truncated left radius. As a result only the partial left radius, left hand, pelvis and legs remain. This individual was very well preserved with the smaller skeletal elements of the hand surviving. Metrical data of the femur and fibula has aged this individual as an infant (more precisely between 1 - 1.5 years).

5.2.13 It has been suggested that the grey coffin fill is lime or a variant of lime. Previously believed to destroy bone, it is now known that lime has been used to prevent the spread of disease but also to prevent the putrefaction which creates the odour. As the bones were perfectly skeletonised, this may not be a solid theory and further opinions may need to be sought.

Plate 16: Pre-excitation shot of Sk 7 showing degraded lime (?)

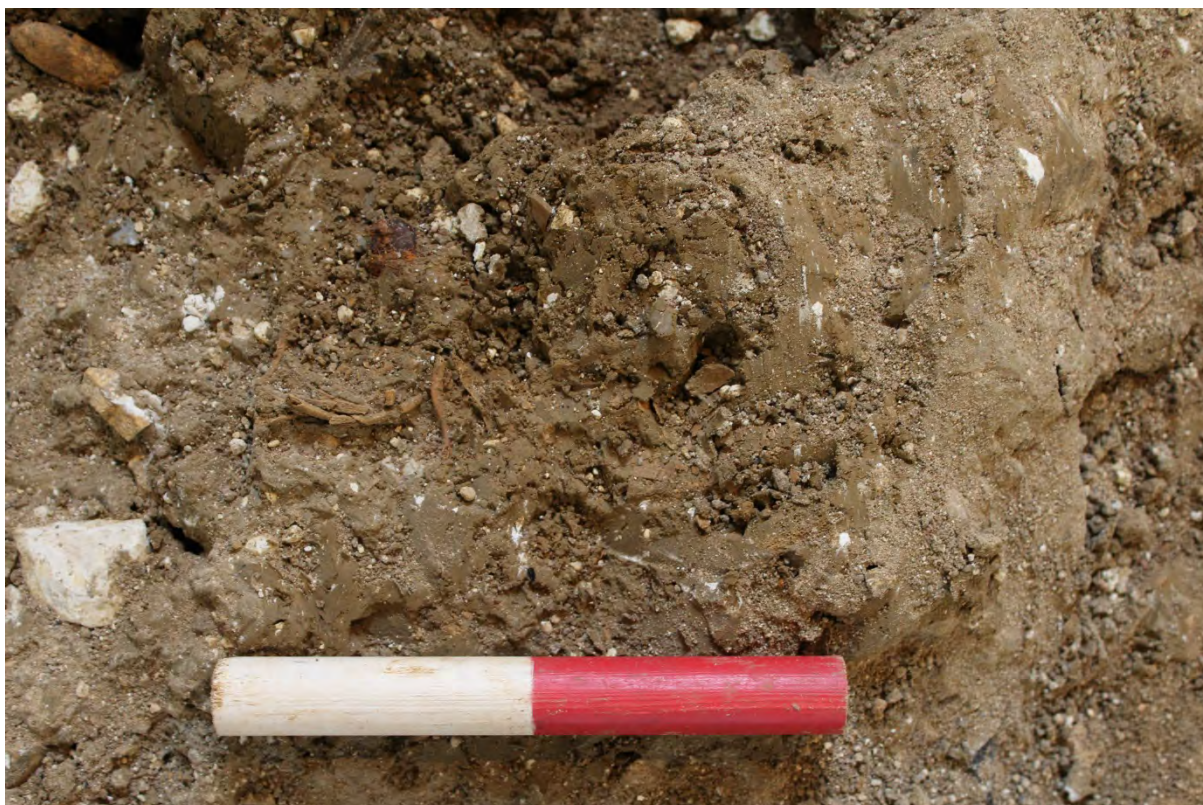
Plate 19: Sk 8

5.2.14 This infant was located c. 1m from the east wall of the south aisle and c. 2m from the south wall of the south aisle. It was on a west - east orientation, assumed extended supine. The grave has been truncated by Skeleton 9 and as a result only a very fragmentary skull, left clavicle and left ribs remain. Metrical data of the clavicle has aged this individual as an infant

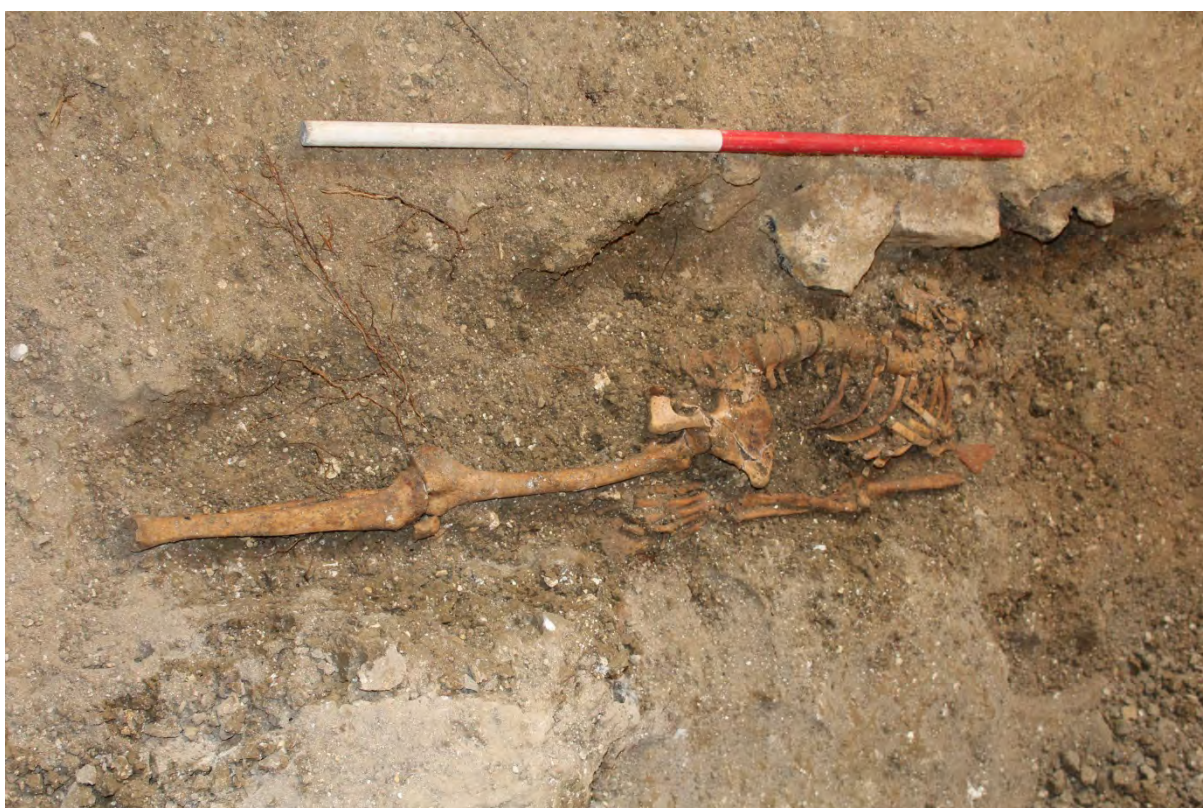
Plate 20: Sk 9

5.2.15 This young adult female was located c. 0.5m from the east wall of the south aisle and c. 1.75m from the south wall of the south aisle. It was on a west - east orientation, extended supine with both arms originally by its side. The individual may have been buried in a coffin as two nails were retrieved from the fill. This individual was very well preserved although truncated. This truncation has resulted in the loss of this individual's right arm, right pelvis and right leg. Her right ribs have been disturbed and her lumbar vertebrae and distal tibia damaged. A separate truncation, which also affected Skeleton 3 and Skeleton 12, has resulted in the loss of her skull and has damaged her left scapula and left proximal humerus.

5.2.16 Observations of epiphyseal fusion and general size have aged this individual as a young adult. The greater sciatic notch scored 1 (F). A number of Schmorl's nodes were noted on thoracic and lumbar vertebrae, occurring on both superior and inferior endplates. Whilst normally an occurrence in the elderly, as part of degenerative disc disease, the occurrence in young adults can be as a result of a fall from a height, heavy lifting or trauma during physical exercise.

5.2.17 This individual's left hand appeared to be resting on a piece of infant skull, but following the lifting of this young adult, another infant (SK13) was discovered directly beneath. The skull appeared to have been disturbed, presumably by the excavators who buried Skeleton 9, but the skull was placed back with the remainder of its body before deposition of this young adult.

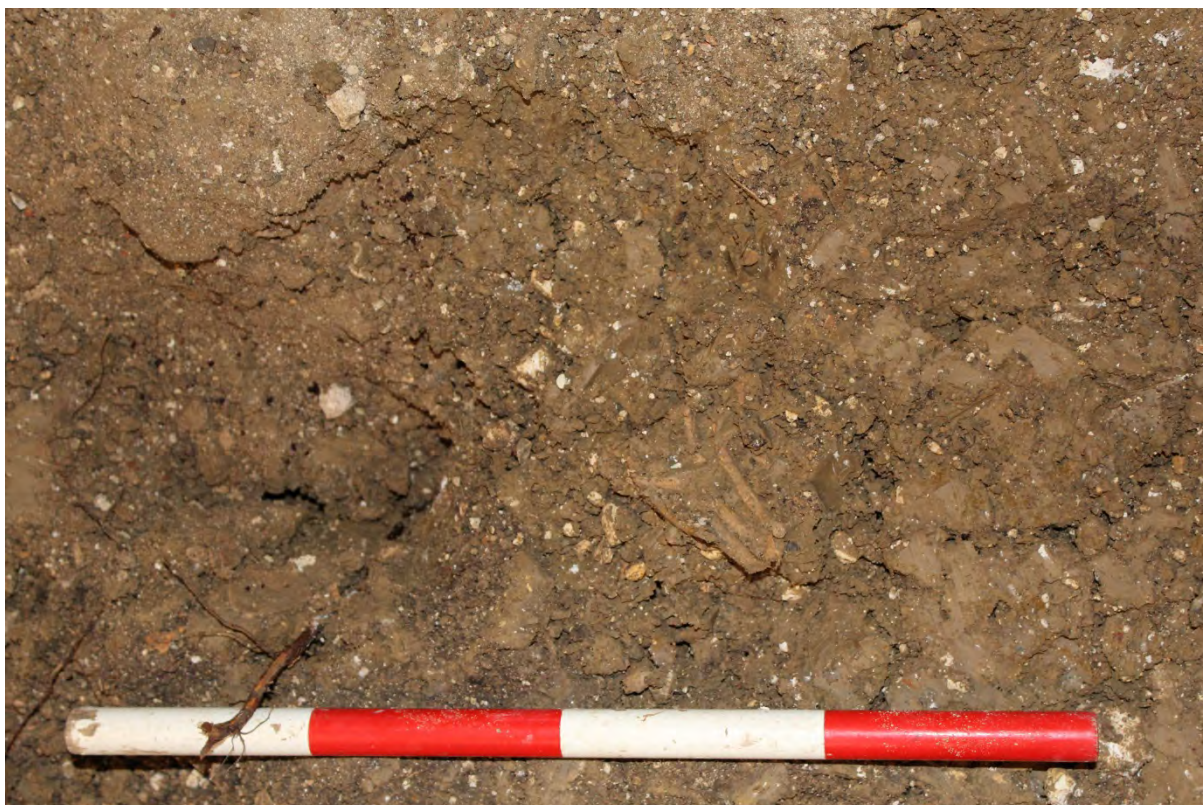
Plate 21: Sk 10

5.2.18 This infant was located c. 1m from the east wall of the south aisle and c. 1.6m from the south wall of the south aisle. It was on a west - east orientation, assumed extended supine. The grave is highly truncated, evidenced by the survival of only the left ribs and skull fragments. Judging by the size of the ribs and the thin nature of the skull fragments, this

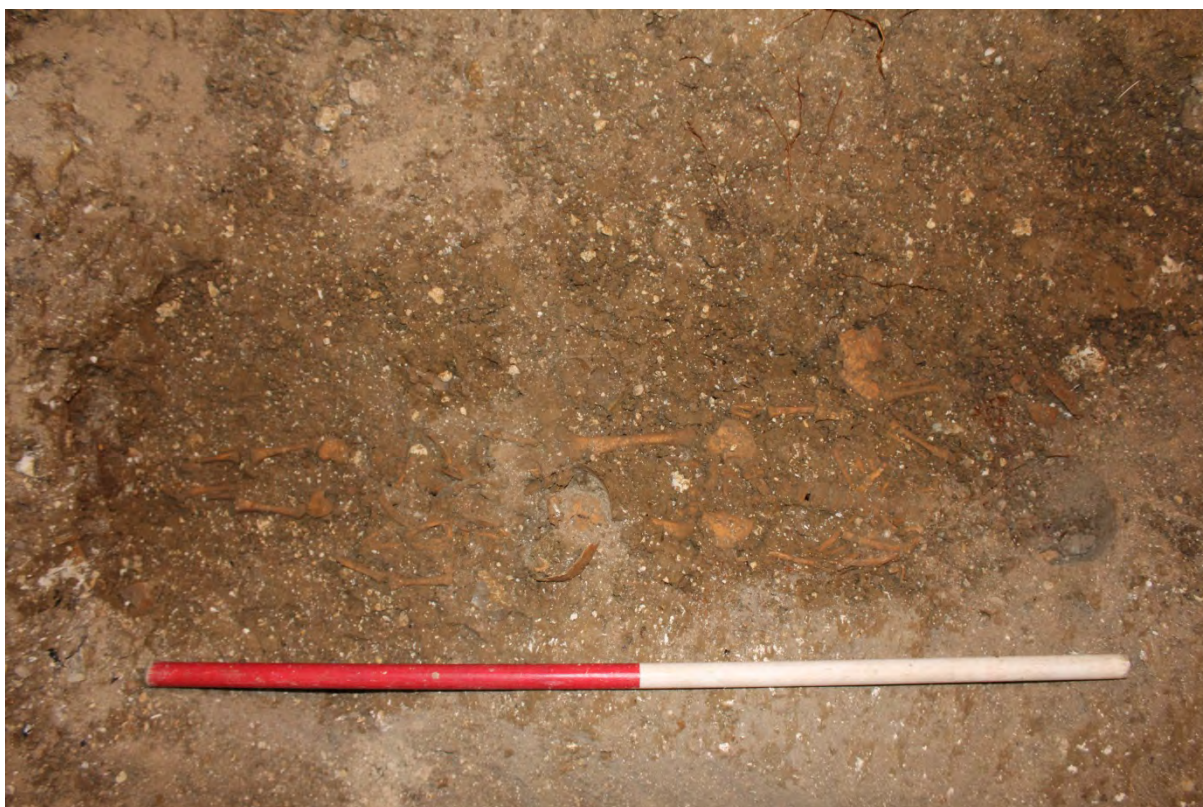
5.2.19 This infant was located c. 0.5m from the east wall of the south aisle and c. 2.25m from the south wall of the south aisle. It was on a west - east orientation, extended supine with head facing up and it's left arm by its side with the right lower arm across the body. The grave is undisturbed but cuts through the grave of Skeleton 12 to the west. This individual was very well preserved. Metrical data of the clavicle, scapula, humerus, pelvis and femur has aged this individual as an infant (more precisely between 36 - 40 prenatal weeks (full term)).

5.2.20 This infant was located c. 0.75m from the east wall of the south aisle and c. 2m from the south wall of the south aisle. It was on a west - east orientation, extended supine and both arm by its side. This grave suffers truncation both to the east by Skeleton 11, to the west by Skeleton 13 and to the south by Skeleton 9. This individual was very well preserved. Metrical data of the femur has aged this individual as an infant (more precisely between 1 - 1.5 years).

5.2.21 This infant was located c. 1m from the east wall of the south aisle and c. 2m from the south wall of the south aisle. It was on a west - east orientation, extended supine. Having been disturbed by the excavators of the grave for Skeleton 9, the skull of this infant was replaced on top of it's body. The borehole to the north may have also truncated this grave to some extent. The grave cuts through the grave of Skeleton 12 to the east. This individual was very well preserved. Metrical data of the tibia has aged this individual as an infant (more precisely between 0 - 3 months).

Plate 22: Sk 11, Sk 12 and Sk13
