**HISTORIC BUILDING
RECORDING OF
SCOCLES MANOR COURT,
SCOCLES ROAD,
MINSTER-ON-SEA,
KENT
ME12 3RU**

PCA REPORT NO. R12427

**Historic Building Recording of Scocles Manor Court, Scocles Road, Minster-On-Sea,
Kent ME12 3RU**

HISTORIC BUILDING RECORDING

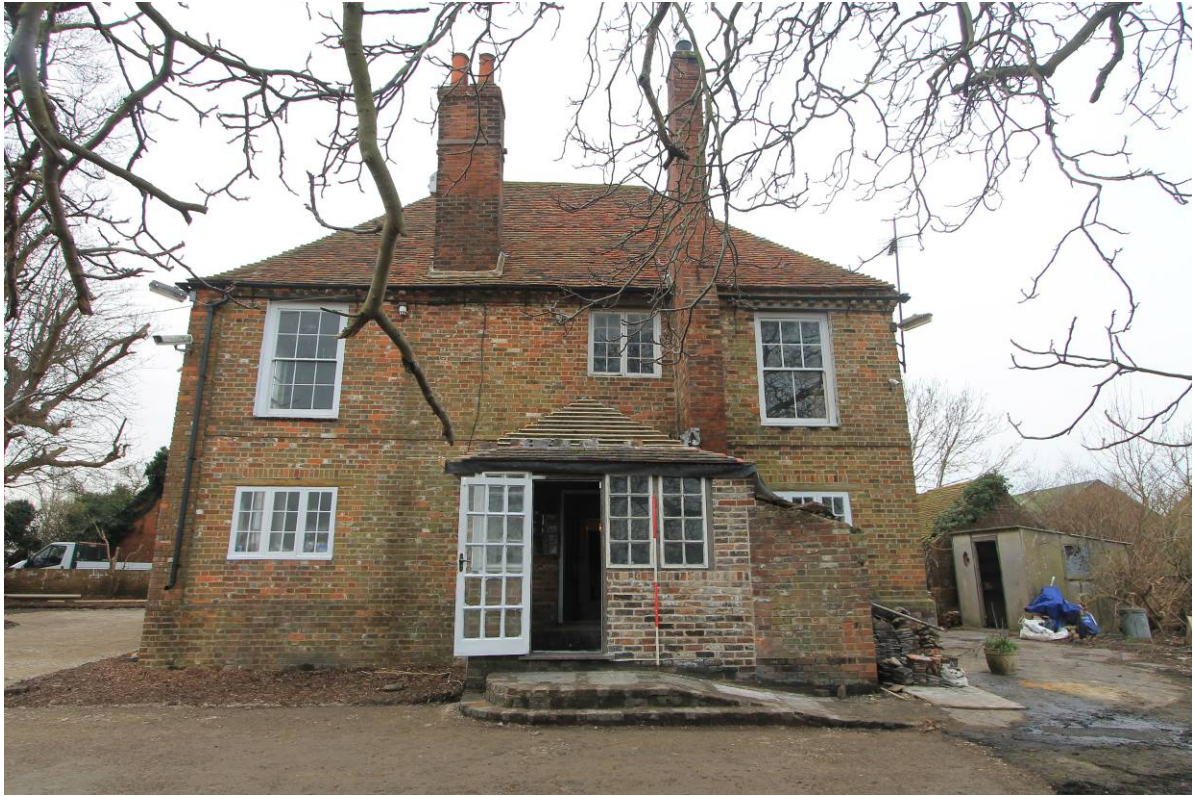
Plate 4 North-east elevation looking south-west

- 6.3.1 The north-east elevation had been the subject of much more attention, represented by the addition of a hipped roof porch and adjoining coal store (**Plate 4**). The porch had been placed roughly centrally to the elevation. These changes had caused the insertion/replacement of ground floor windows. The brickwork of this rear elevation lacked the refinement of the front facade and included more bricks with kiss marks and burnt headers. The brickwork was in a less regular bond. This may have been accentuated by the quality of its re-pointing. The bricks were the same dimension and bond but showed features including diagonal pressure marks and scoring to the brick face. This elevation unlike the front facade included a simple wall plinth and quoin to the east angle (only). It also included a raised three course brick first floor band and an eaves dentil course.

- 6.3.4 The other chimneystack biased to the north-east front was an original feature, whose upper courses had also had been part re-built and repaired. The chimneystack was clearly leaning out, addressed, historically by an iron band and strap tied back into the roof structure (**Plate 4**).

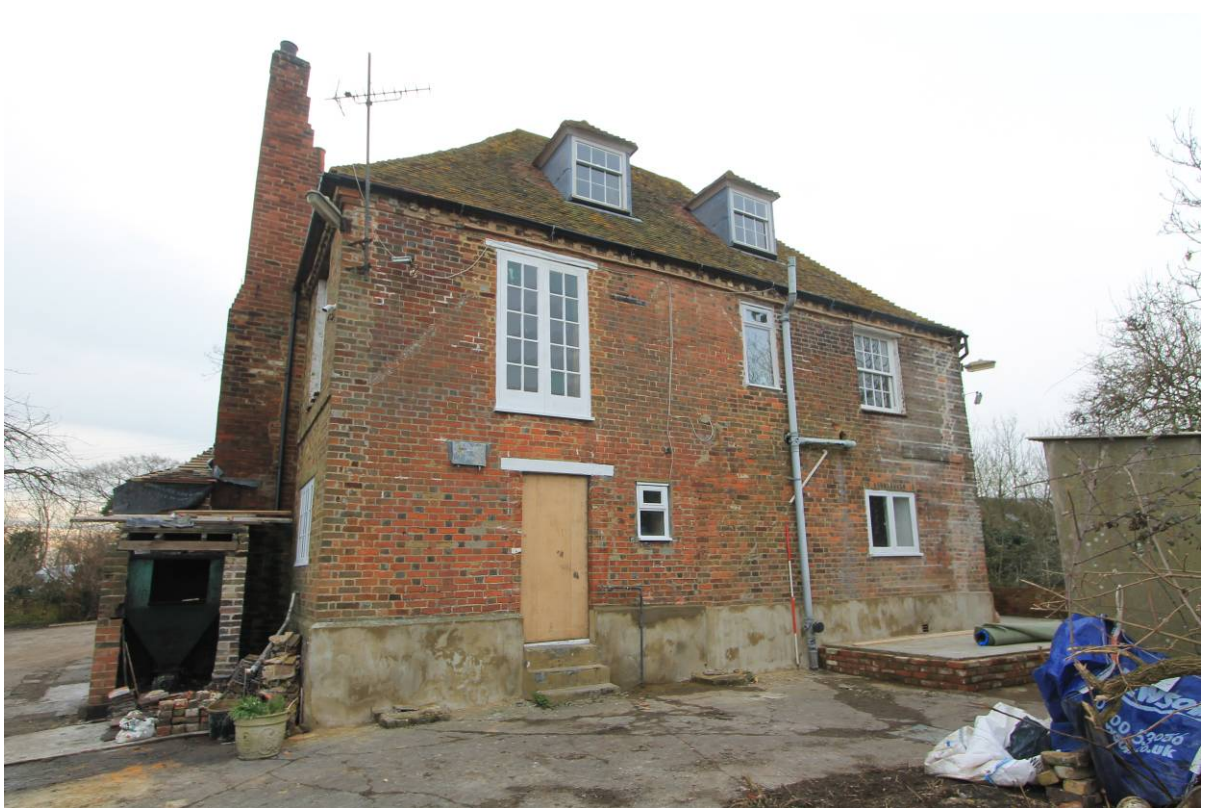
Plate 7 North-west (rear) elevation looking south-east

- 6.4.2 Generally the brickwork in the north-west elevation is poorly executed and it is mainly built in Flemish bond (**Plate 7**). It includes areas towards the west corner that uses burnt headers to decorative effect, areas which incorporate narrower ?Tudor/Stuart (16th/17th century) bricks (220mm x 45mm x ?) and brickwork that matches that in the adjacent north-east elevation. A brick wall plinth (rendered along the north-east elevation) continues along the south-west (side; **Plate 9**) and north-east (side; **Plates 4 to 6**) elevations. A short length of first floor band survives towards the western corner (**Plate 7**). Whilst the eaves dentil course remains, a later tile course has been inserted below it, which extends along most of the length of the elevation.

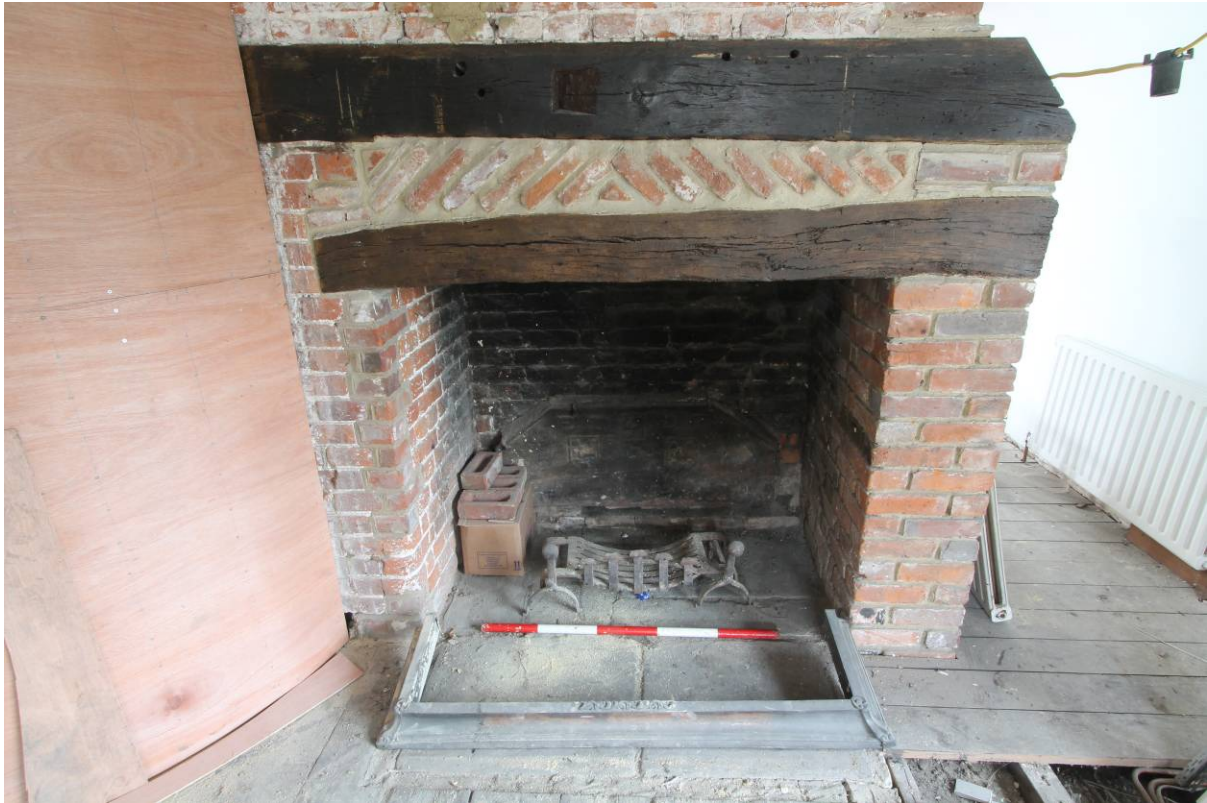
Plate 12 Open hearth fireplace in GF1 showing rebuilding, looking south-east

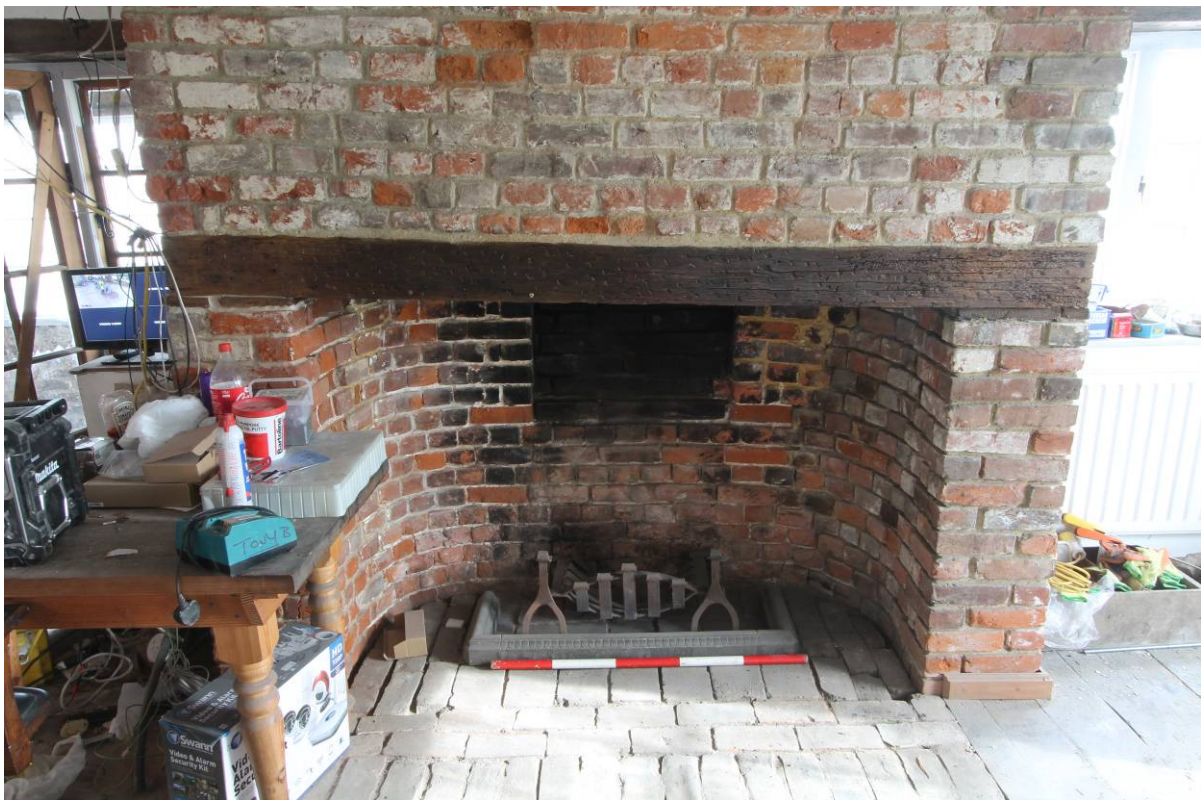
Plate 21 Inglebrook fireplace in GF4 showing rebuilt south-east side, looking north-east

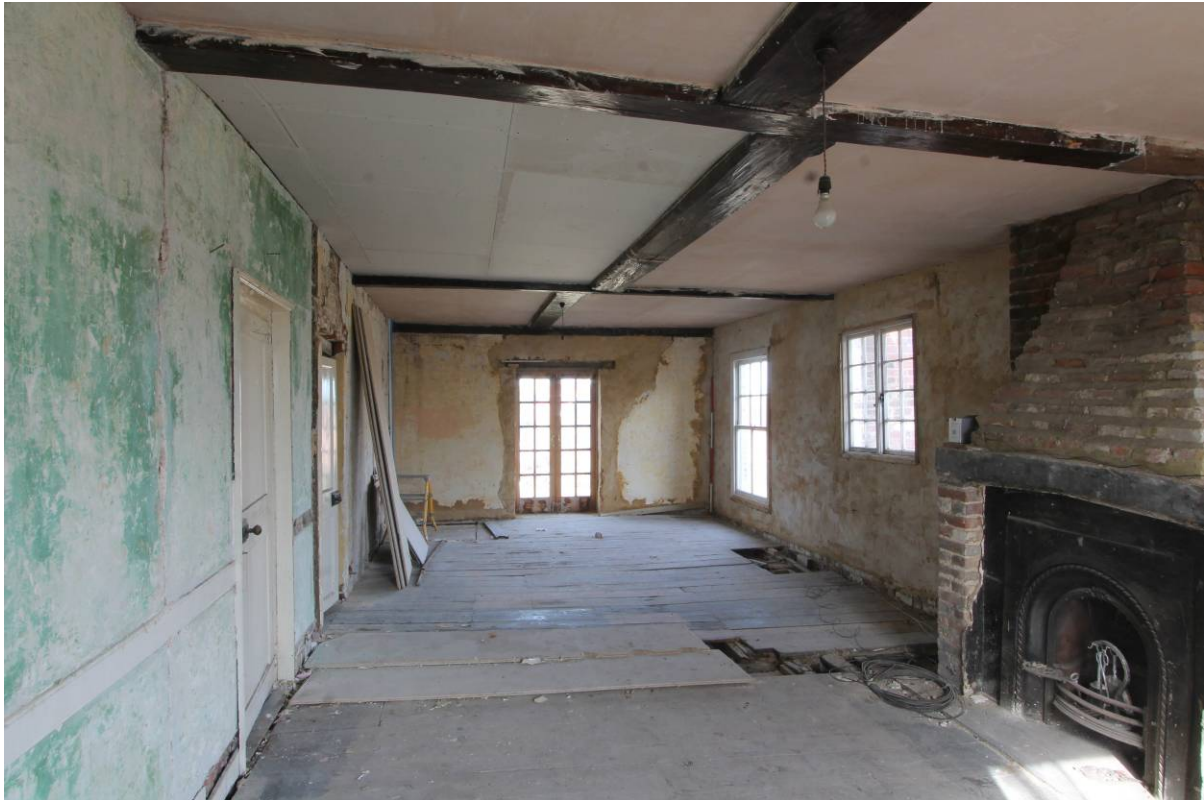
Plate 25 Rooms FF1 and FF2, looking north-west

6.6.24 The plaster ceilings to both FF1 and FF2 had latterly been replaced with modern plaster ceilings, although the heavy scantling 7½ inch binding and bridging joists, dividing the ceiling into three bays remained visible (**Plate 25**). These joists, in common with those at ground floor level, were meant to be visible from the outset, with the bridging joists (north-west to south-east) stopped at their junction with the binding joists (north-east to south-west). They were clearly not machine-cut but 'squared up' using an axe or adze, as seen by slight corrugation along the soffits and were formed from either soft or hard wood.

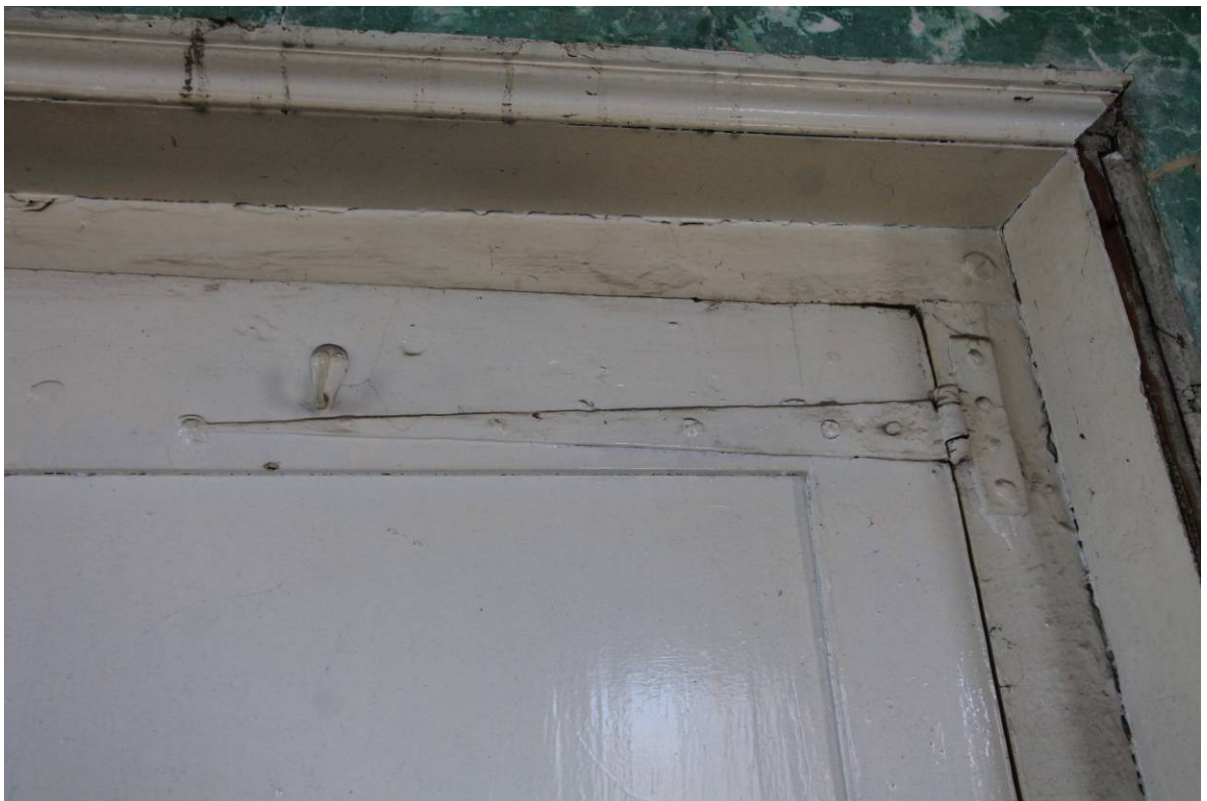
Plate 28 Eighteenth century strap (T) hinge on door to FF1, looking south-west

6.6.23 This contrasts with the door to FF1 which retains an 18th century two panel door hung off contemporary wrought iron strap hinges (**Plate 28**). The architrave is also original and is pegged at the corners. The axial wall is one brick thick and is built using bricks measuring 220x60x95-100mm covered with horse-hair plaster. Whilst the plaster was generally in a poor condition, a beaded dado rail and a plain skirting board survived (in part) within FF1.

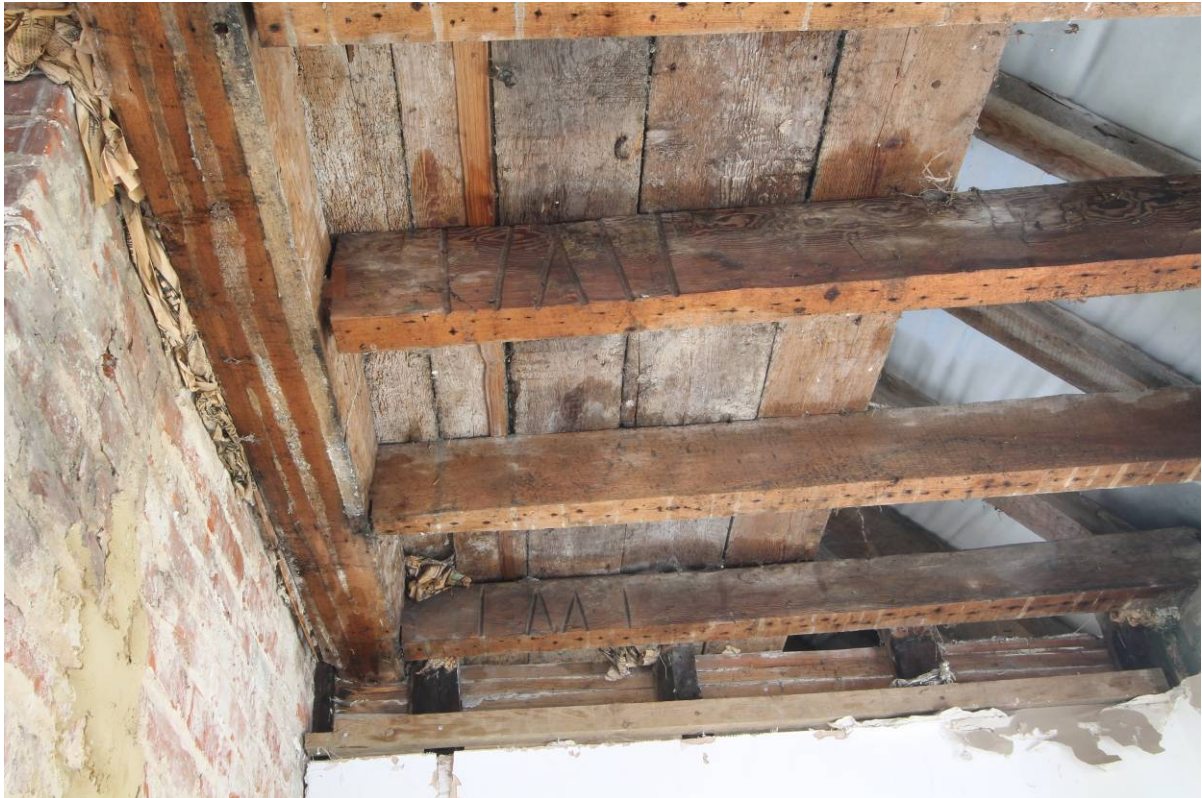
Plate 34 Heavy ceiling joists with Baltic marks over Room FF4, looking south-east

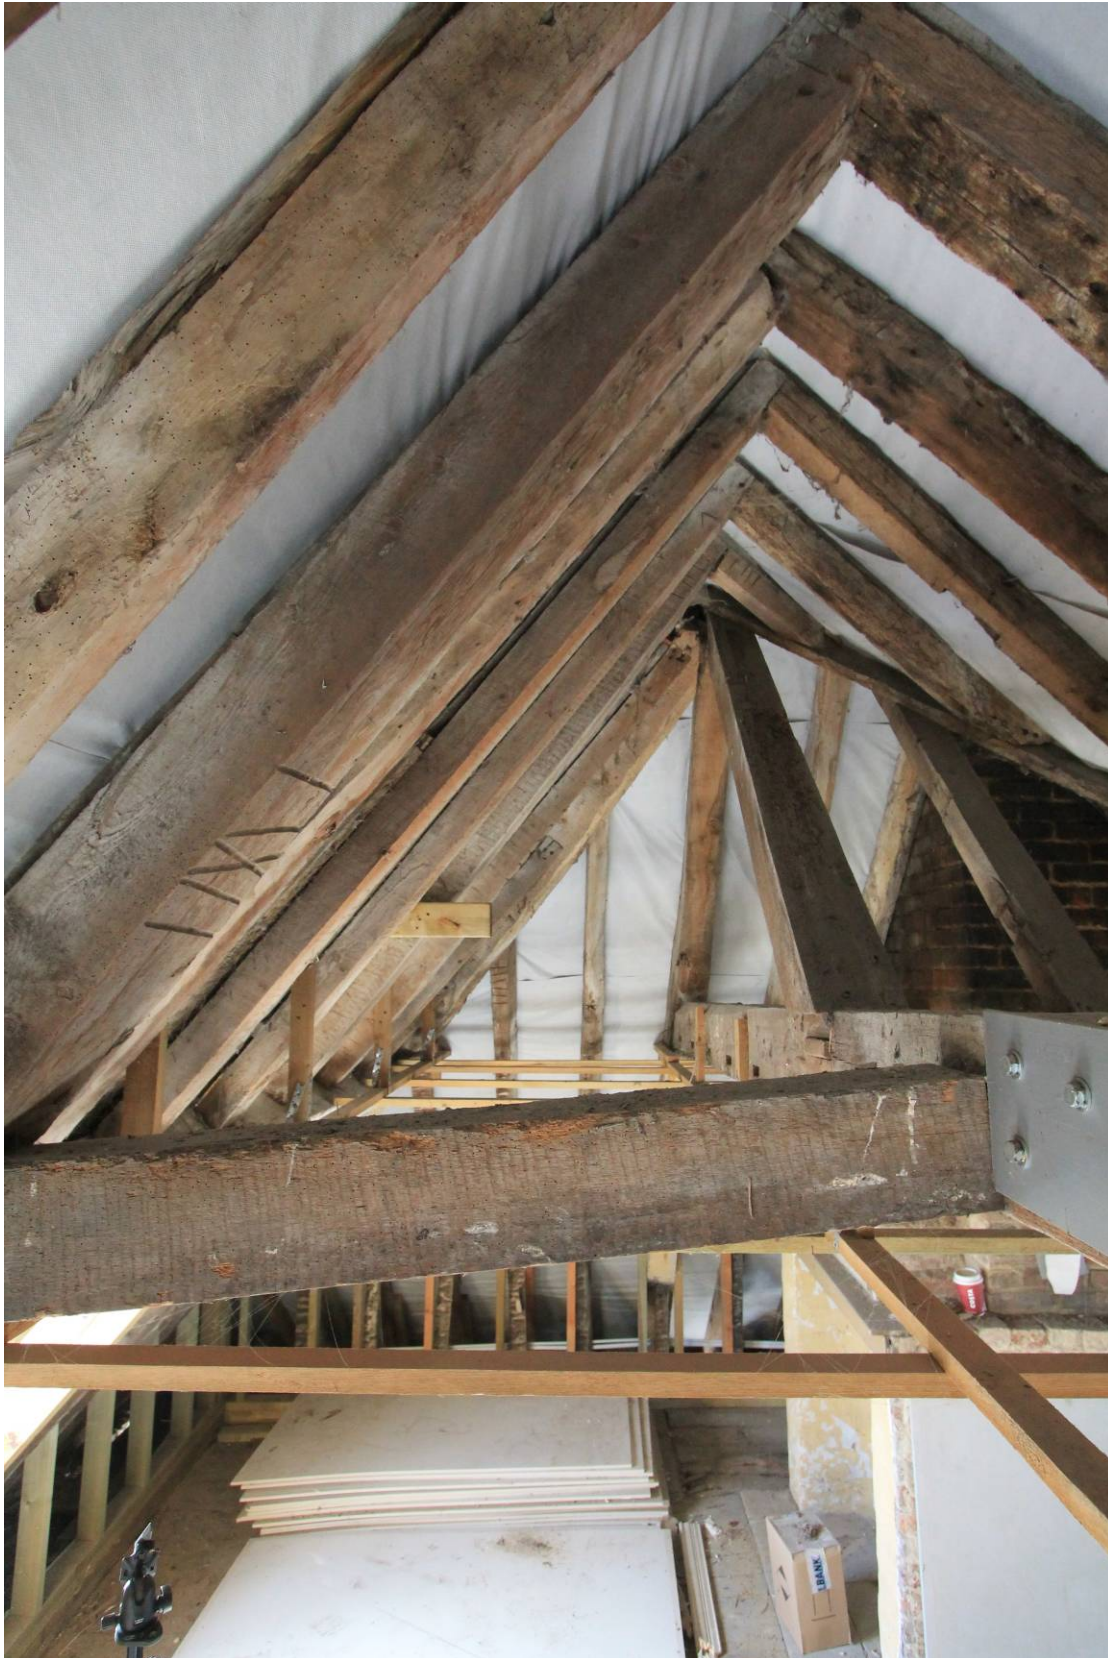
6.7.1 The roof structure was a mixture of both hardwood (oak) and softwood imported from the Baltic regions. The principal components including the four principal hip rafters, the butt purlins and principal rafters were mainly oak while the joists that supported the central valley and the tiebeams were in softwood. The common rafters were a mixture of both softwood and hardwood and included some modern replacement and bolstering. A number of the main roof timbers, particularly some of the principal rafters and butt purlins showed distinctive bracking marks associated with Baltic timber (**Plate 41**), which was increasingly imported from the Baltic regions from the 17th century due to a depletion in native woods and a shortage in timber as a consequence of the rebuilding of London following the Great Fire in 1666.

Plate 41 South-eastern roof pitch showing Baltic marks with the central well to the right, looking south-west

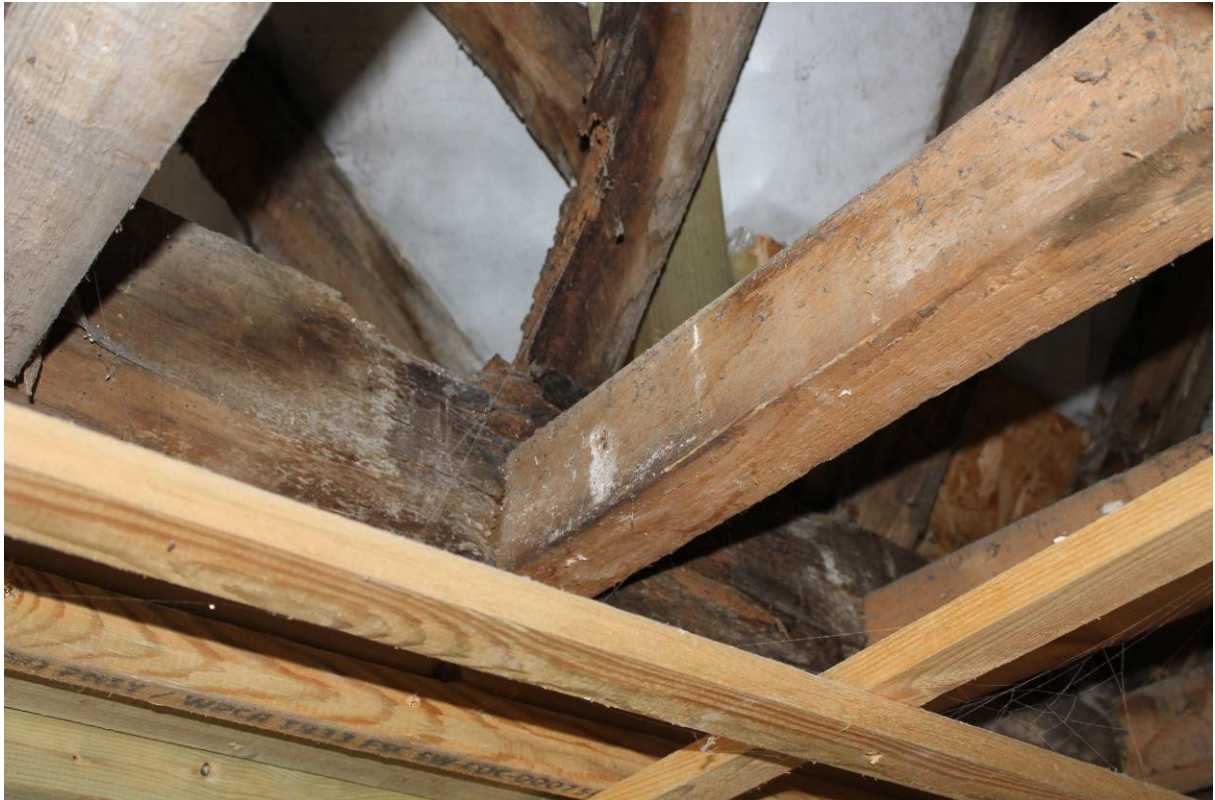
Plate 44 Decay from leaking central well, looking west

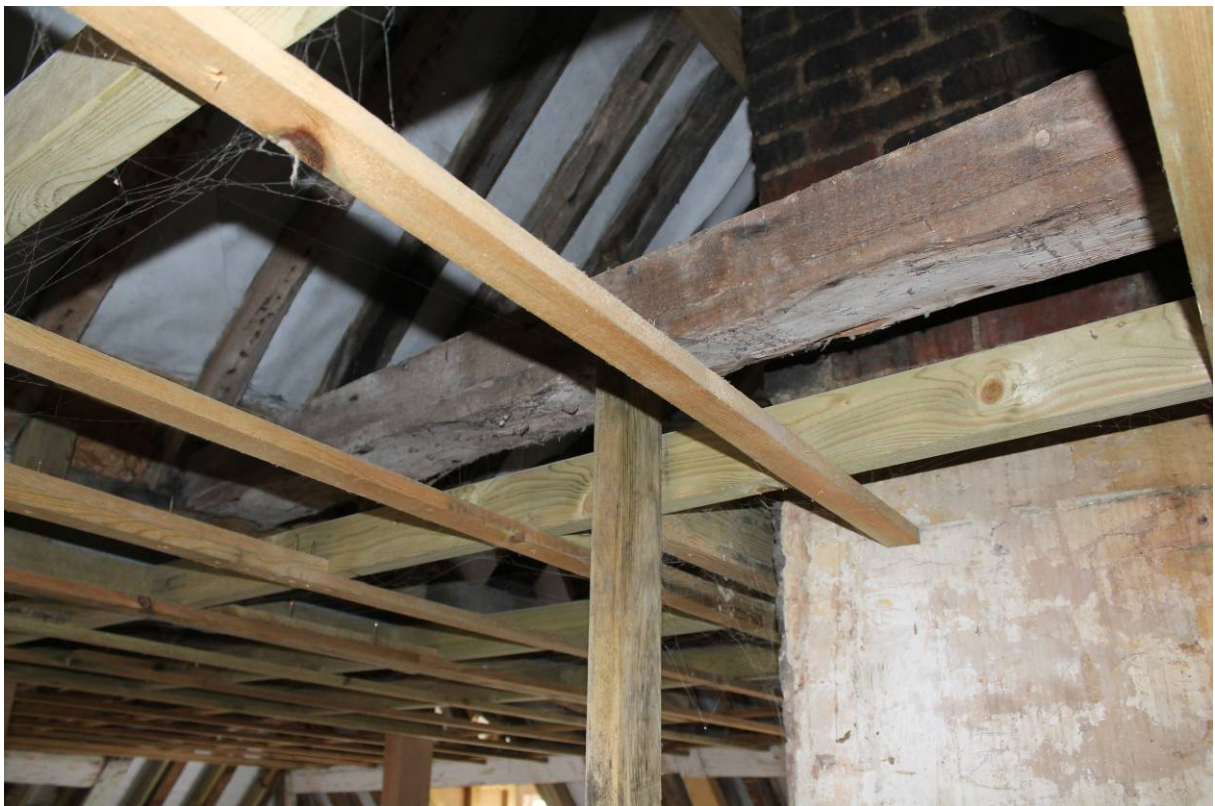
- 6.1.4 Given its square plan form the roof appears to be simply hipped, but in fact comprises four inter-connecting pitched roofs (hipped at the angles), which together form a central 'well', drained via a conduit which passes through the southern roof attic space. The roof is covered with red clay plain tiles and the south-eastern and north-western roof pitches are interrupted by paired hipped-roofed dormer windows (**Plates 1, 2 and 7**). The fenestration is a mixture of original and repaired sash windows and modern casement insertions. The front façade has a formal portico with fluted columns (**Plates 1 and 2**), while a much more utilitarian reconstructed brick-built porch has been added to the north-eastern elevation (**Plate 4**). A large square section chimneystack rises through the building to pierce the roof south-west of the central well (**Plate 8**) while a corresponding but smaller in-wall chimneystack rises up from the north-east elevation (**Plate 4**). It is shadowed to the west by an external brick chimneystack, which rises from within the northern porch.

Plate 45 Timber conduit holding drainage pipe from central roof well, looking south-east
