**HIGHGATE CEMETERY,
HIGHGATE N6 6PJ**

**SUMMARY OF AN
ARCHAEOLOGICAL EVALUATION**

SITE CODE: HGG16

PCA REPORT NO: R12389

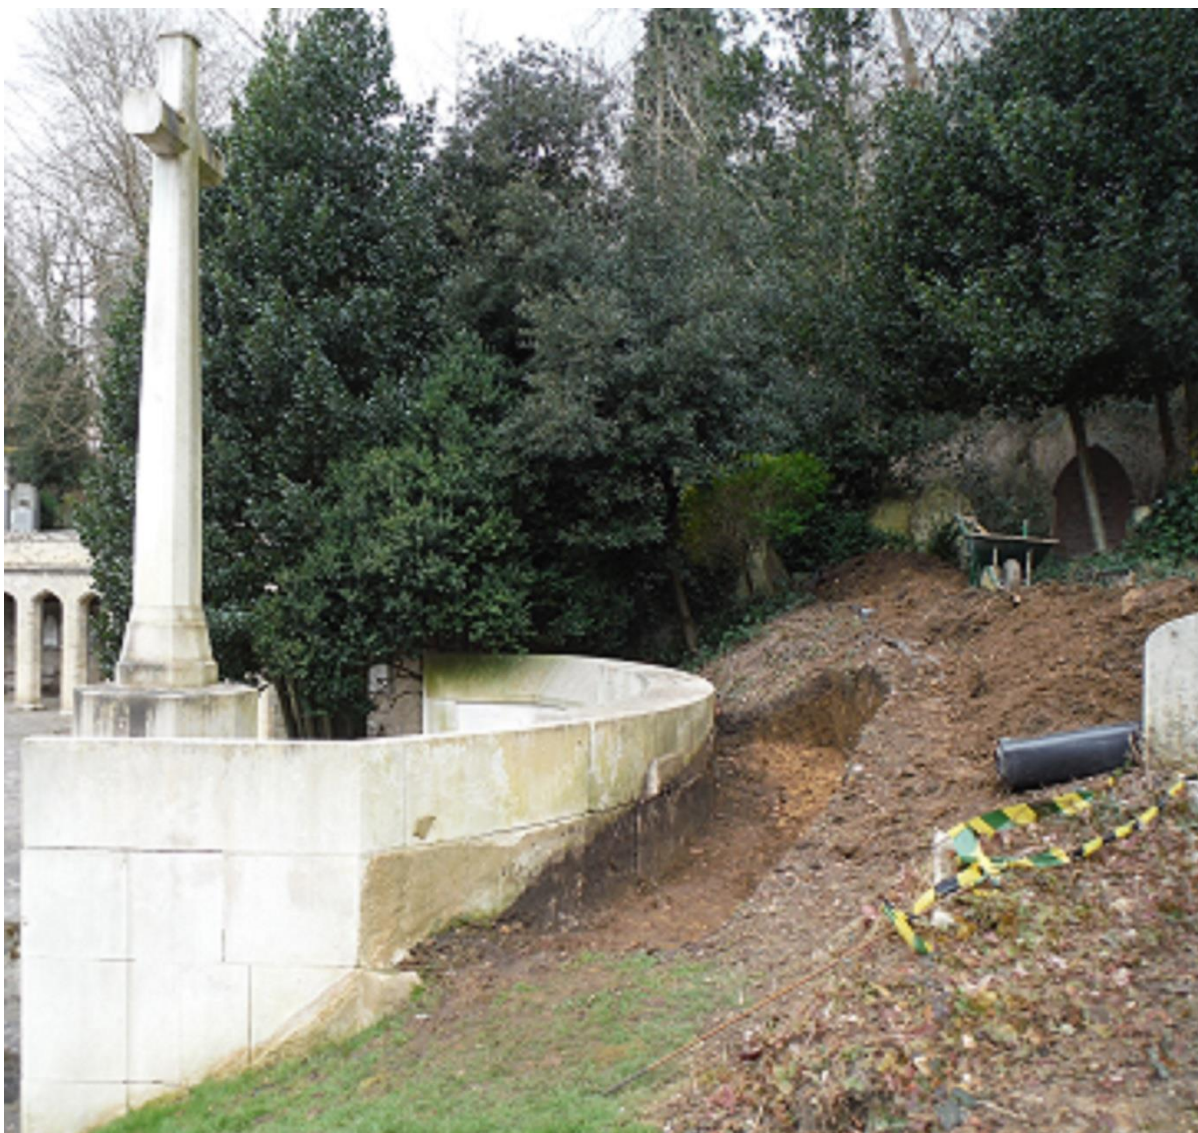
Plate 1: West view of war memorial and test trench (no scale)

- 1.1 Pre-Construct Archaeology Limited was commissioned on behalf of the Commonwealth War Graves Commission by Ramboll UK Ltd to excavate an archaeological test trench to the immediate rear of the screen wall war memorial within Highgate Cemetery, Highgate, London Borough of Camden, N6 6PJ (Figure 1 & Plate 1). The memorial is located just inside the west cemetery main entrance at central National Grid Reference TQ 28533 86989 and is curated by the Commonwealth War Graves Commission.

- 1.2 The war memorial was originally constructed in the 1920s, upon a flat terrace which involved cutting into the hill to its rear, the ground behind being retained by a stone and cement screen wall.

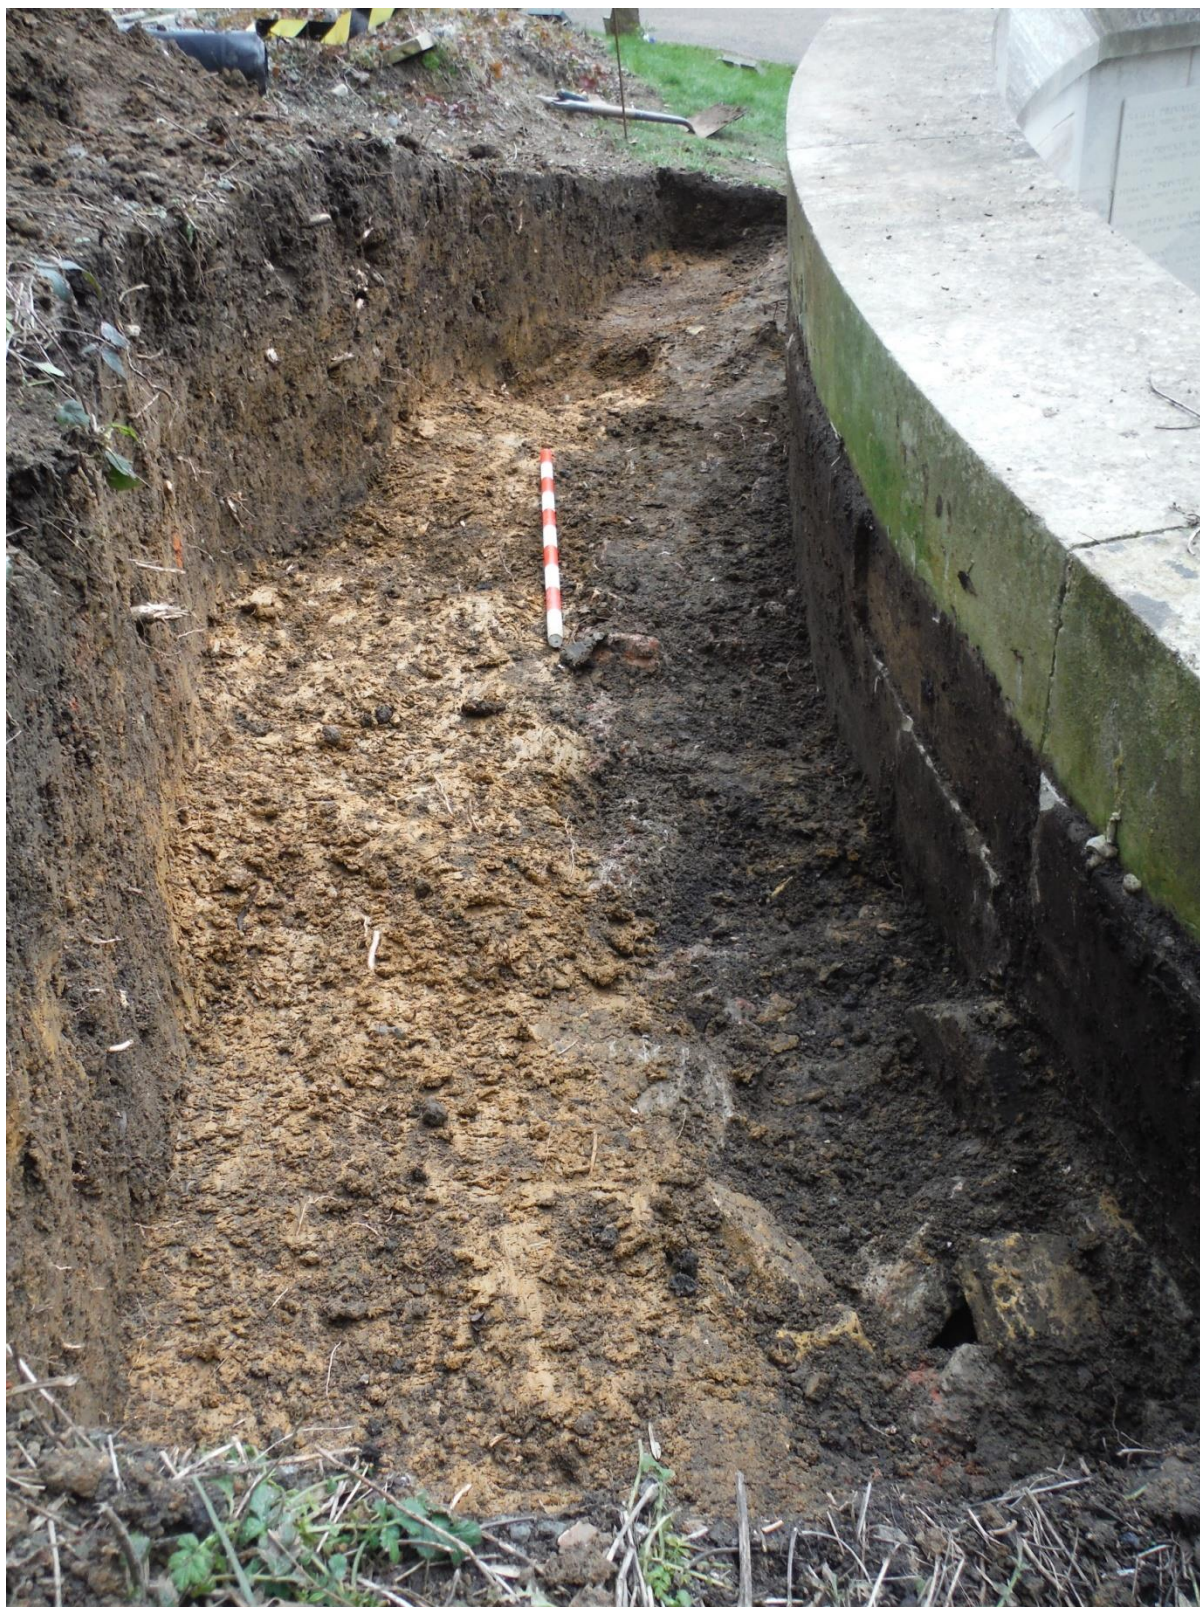
Plate 2: East view of test trench (1m scale)

3.1.1 The earliest deposit encountered within the test trench was firm-compact light-mid orange brown naturally deposited clay [8] (Plates 2, 3, 4 & 5). This deposit was encountered at a maximum height of 90.87m OD at the western end of the test trench and at a minimum height of 90.08m OD in the eastern part of the trench.

3.2.3 Also truncating natural clay [8] were a series of planter beds [5], [7] and [10] (Plates 2, 3 & 4) and the construction cut for the screen wall of the war memorial [3] (Plates 2, 3, 4, 5 & 6).

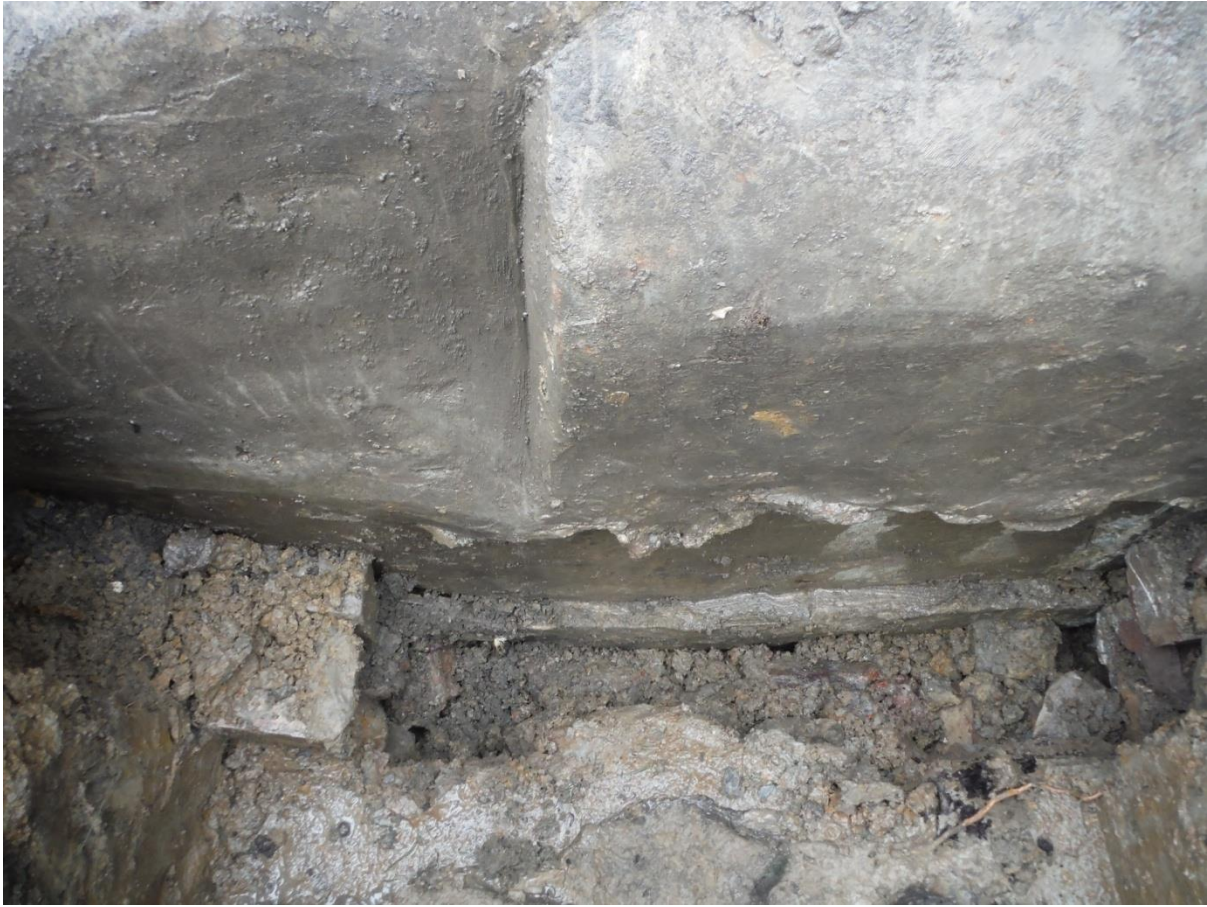
Plate 6: South view of exposed screen wall in sondage (no scale)

- 4.4 The excavation of the construction cut [3] revealed details of both the form and the current state of preservation of the northern face of the screen wall. Within the sondage the flat face of the northern aspect of the screen wall was seen to have been subject to modification below the penultimate course of masonry (Plates 4, 5 & 6). A thick render of cement had been applied to the northern face of the wall and had been poured in vertical sections, apparently serving the dual functions of waterproofing and consolidating the stonework. The render was cracked and, in parts, missing entirely (Plate 7), exposing the masonry to damp penetration. Given that the render was absent rather than flaking away from the wall during the excavation of the test trench, this could be indicative of previous groundworks having been performed against the northern face of the screen wall; perhaps a previous attempt at re-pointing or re-setting the stonework.
