**AN EVALUATION ON LAND
AT HELIPORT HOUSE, 38
LOMBARD ROAD, LONDON
BOROUGH OF
WANDSWORTH, SW11 3RP**

REPORT NO: R12438

An Archaeological Evaluation on land at Heliport House, 38 Lombard Road, London Borough of Wandsworth, SW11 3RP

**Type of project
ARCHAEOLOGICAL EVALUATION
Quality Control**

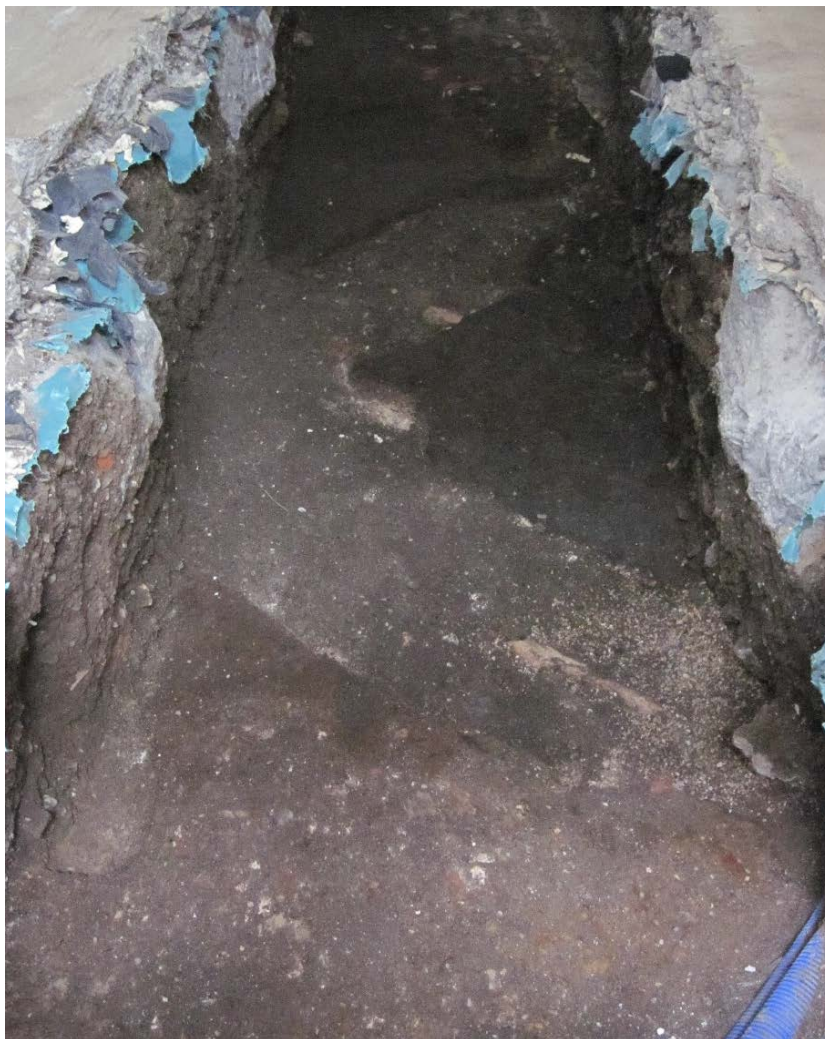
Plate 1: Post-medieval deposits heavily truncated by [+] in the south-west of Trench 1 (looking north-east)

- 7.6 **Made Ground/Dump Deposits [1], [6], [8], [9]: Mid 19th – Mid 20th Century** (Figure 4, Plates 1 & 3)
- 7.6.1 Overlying the sequence of industrial surfaces in the north-west, and extending across the remainder of the trench, were further deposits of late post-medieval made ground (contexts [1], [6], [8] and [9]). These deposits included sandy clays, sandy silts and clayey silts (with some lenses of crushed CBM and cinder) and were generally loose and mid-light brownish-grey in colour. Inclusions within the deposits comprised largely building and industrial waste, and included (in varying proportions) gravel, mortar, charcoal, coal, CBM, coal, metal, slag and wood. An industrial character was also indicated by these deposits' glass and pottery assemblages, which included a notable proportion of vessels which are known to have often held toxic substances, chemicals or other products used in industry.

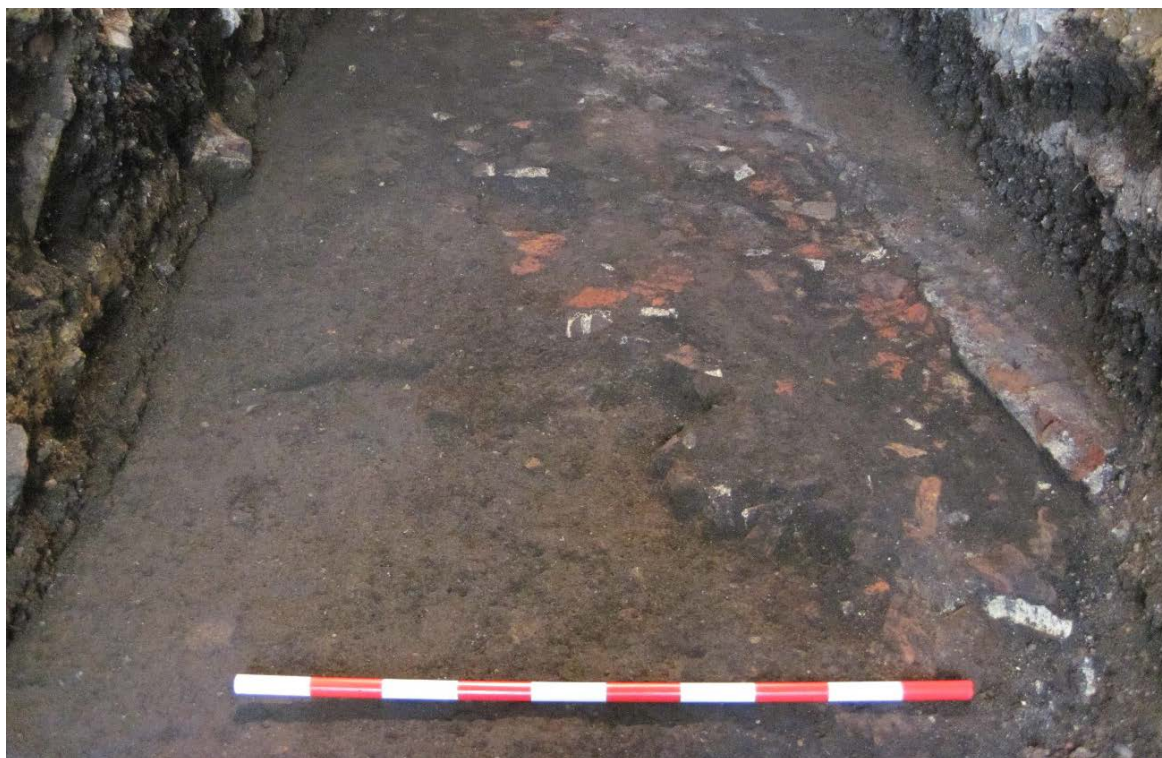
Plate 2: Succession of industrial surfaces [3], [4] & [5] surviving in the north-east of Trench 1

(looking north-east)

- 7.5.2 Lying immediately above surfaces [2] and [3] was a further industrial surface [4]. Similarly compact and a light brownish-black in colour, it too had been constructed using industrial waste materials; small fragments of coal, slag, scrap metal and larger, irregular fragments of (mostly burnt) brick. Apparently more heavily truncated than the surface below it, it extended across only the most north-eastern third of the trench and also showed a slope downwards, from 3.50m OD in the north-east to 3.35m in the south-west. The deposit was 0.09m thick.

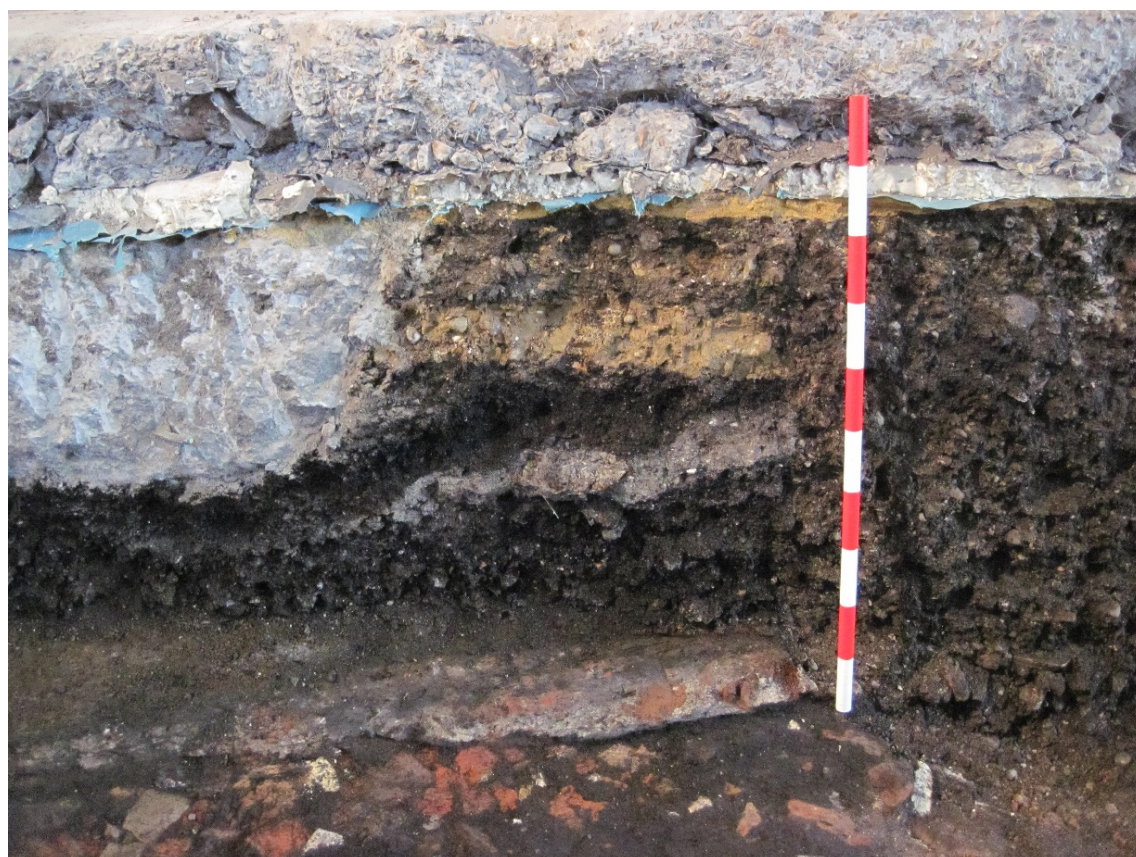
Plate 3: NW facing section showing industrial surfaces [4] & [5] overlain by post-medieval dumping [6], and truncated by modern intrusions.

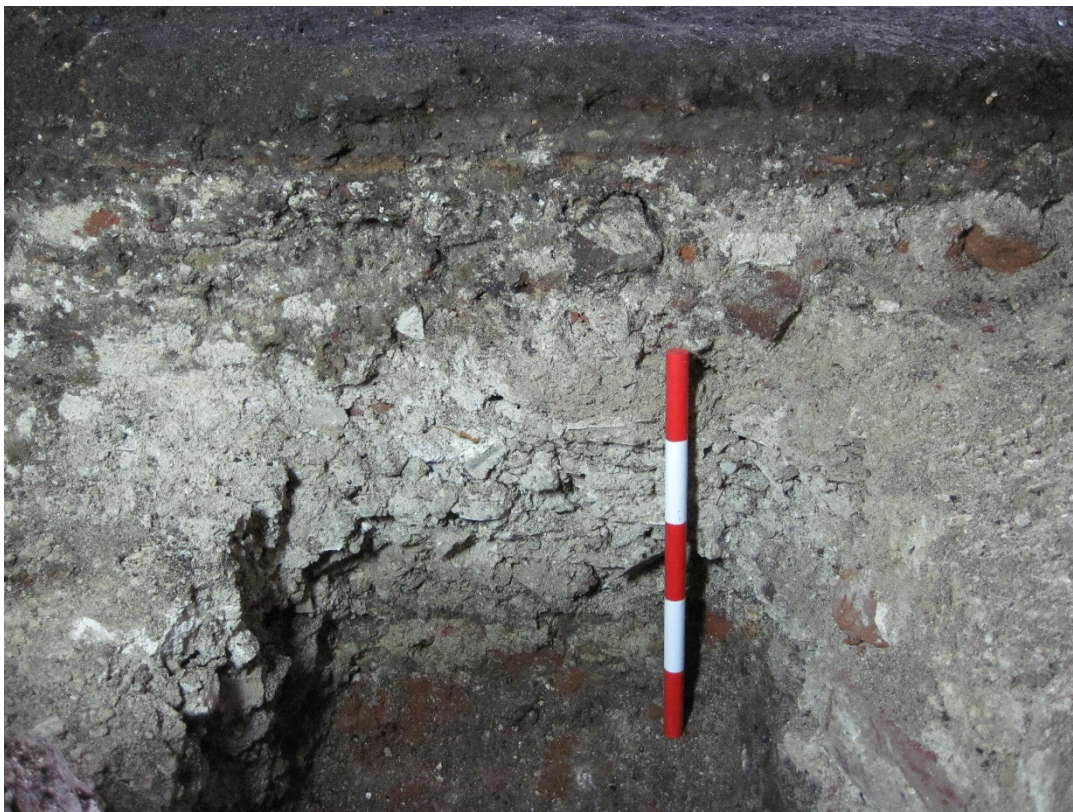
Plate 4: North facing section in hand-excavated sondage, showing demolition layers [10], [11] & [12] underlying industrial surface [2].

7.4.2 By far the most substantial deposit encountered however was a thick layer of loose, light whitish-grey chalky mortar [11]. Extending across at least the north-eastern half of the trench, this deposit was first encountered at 3.13m OD and was 0.54m thick. In addition to mortar lumps, the deposit also contained moderate fragments of brick and slate (including some slate peg tiles), and frequent white wall plaster pieces, one of which was painted yellow.
