**HISTORIC BUILDING
RECORDING OF
THE MOUNT,
NO. 4 NORTH AVENUE,
ASHBOURNE,
DERBYSHIRE,
DE6 1EZ**

PCA REPORT NO. R12441

Report by Adam Garwood

HISTORIC BUILDING RECORDING

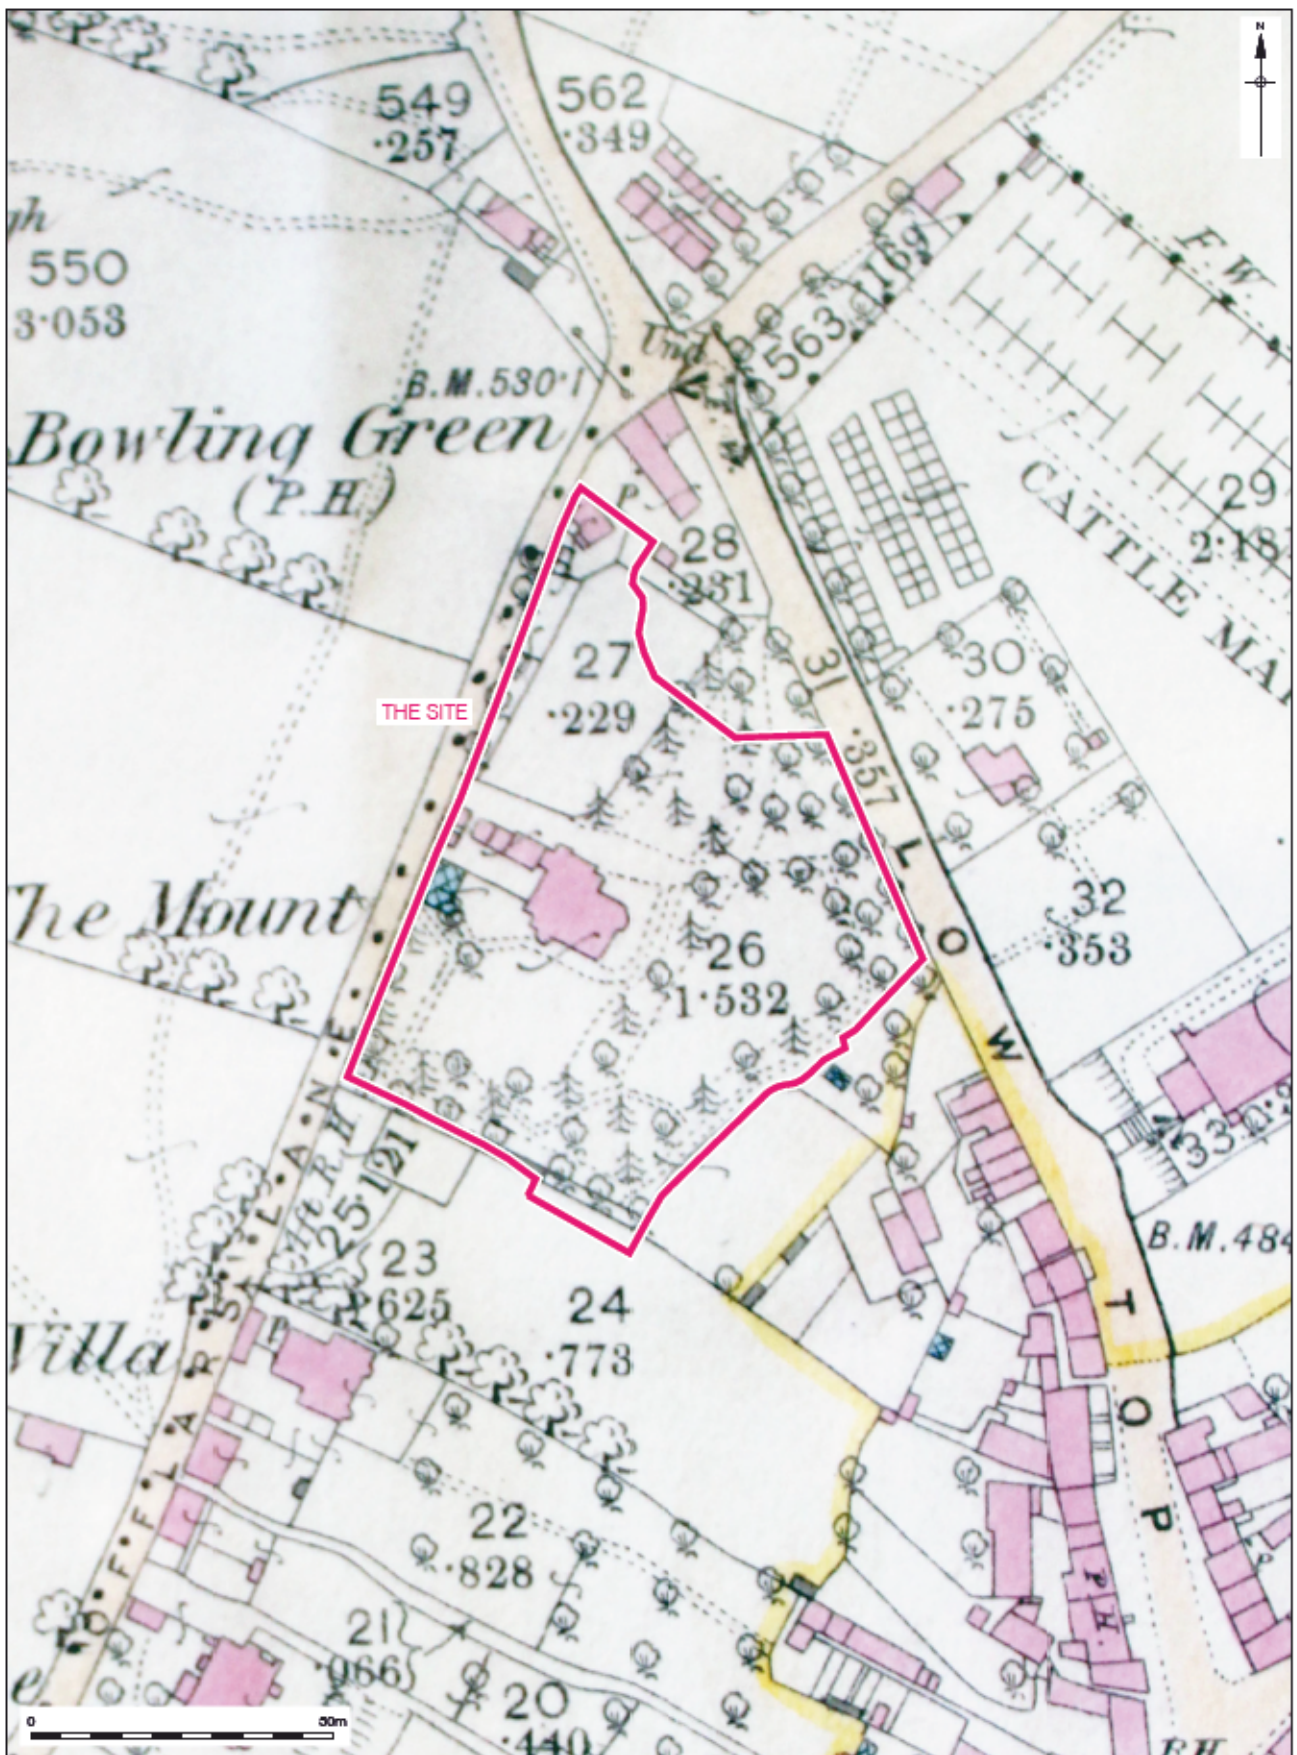
Figure 5
 First Edition Ordnance Survey, 1880
 1:1,250 at A4

- 6.2.1 The northern principal elevation overlooks the formal circular drive and approach to the house from North Avenue. This drive was replaced the former bowling green between 1880 and 1900 (**Figures 5 and 6**). The north elevation has an un-balanced asymmetrical appearance and can be broadly divided down the centre (divided between GF5 and GF9 on **Figure 8**), with the eastern half relating to the main house and the western half forming the service range.

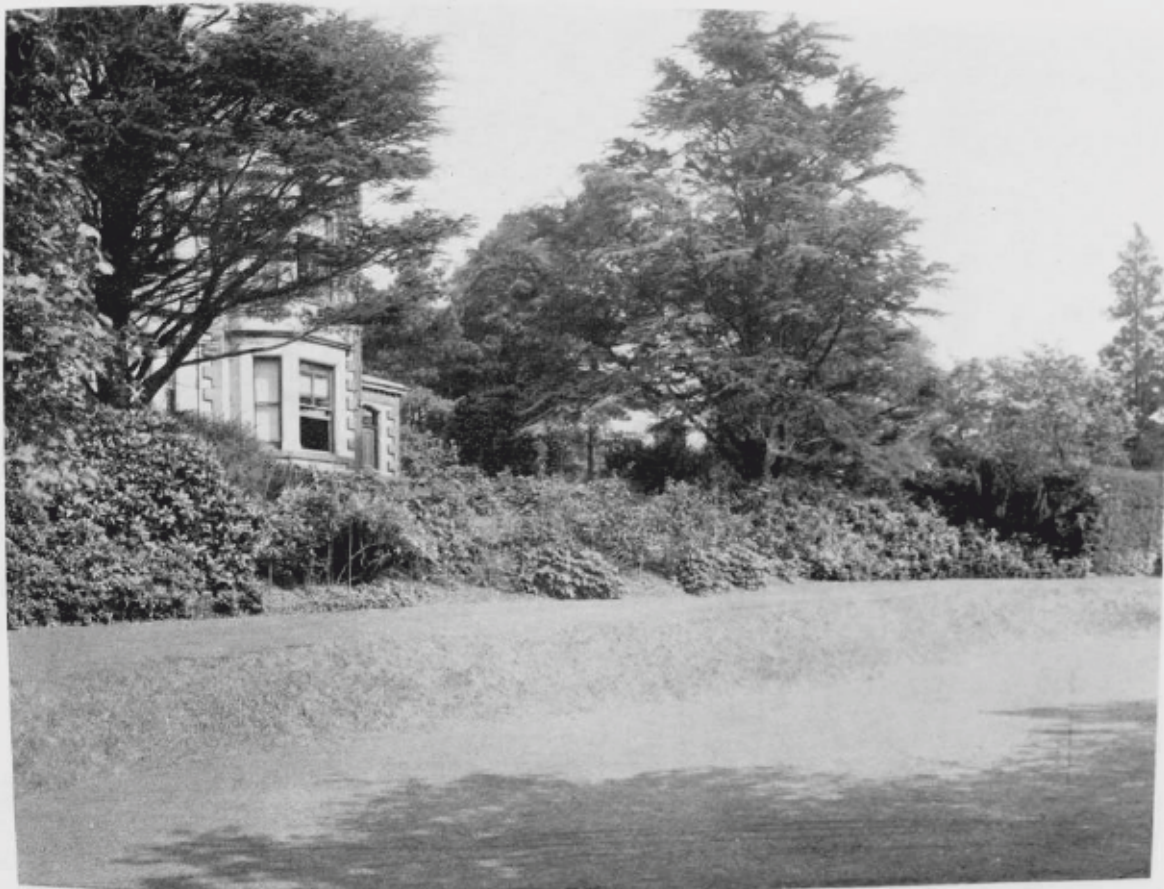
Historic Plate 3 Photograph of the Mount included in the 1926 Sales Particulars, viewed from eastern terrace garden looking north-west

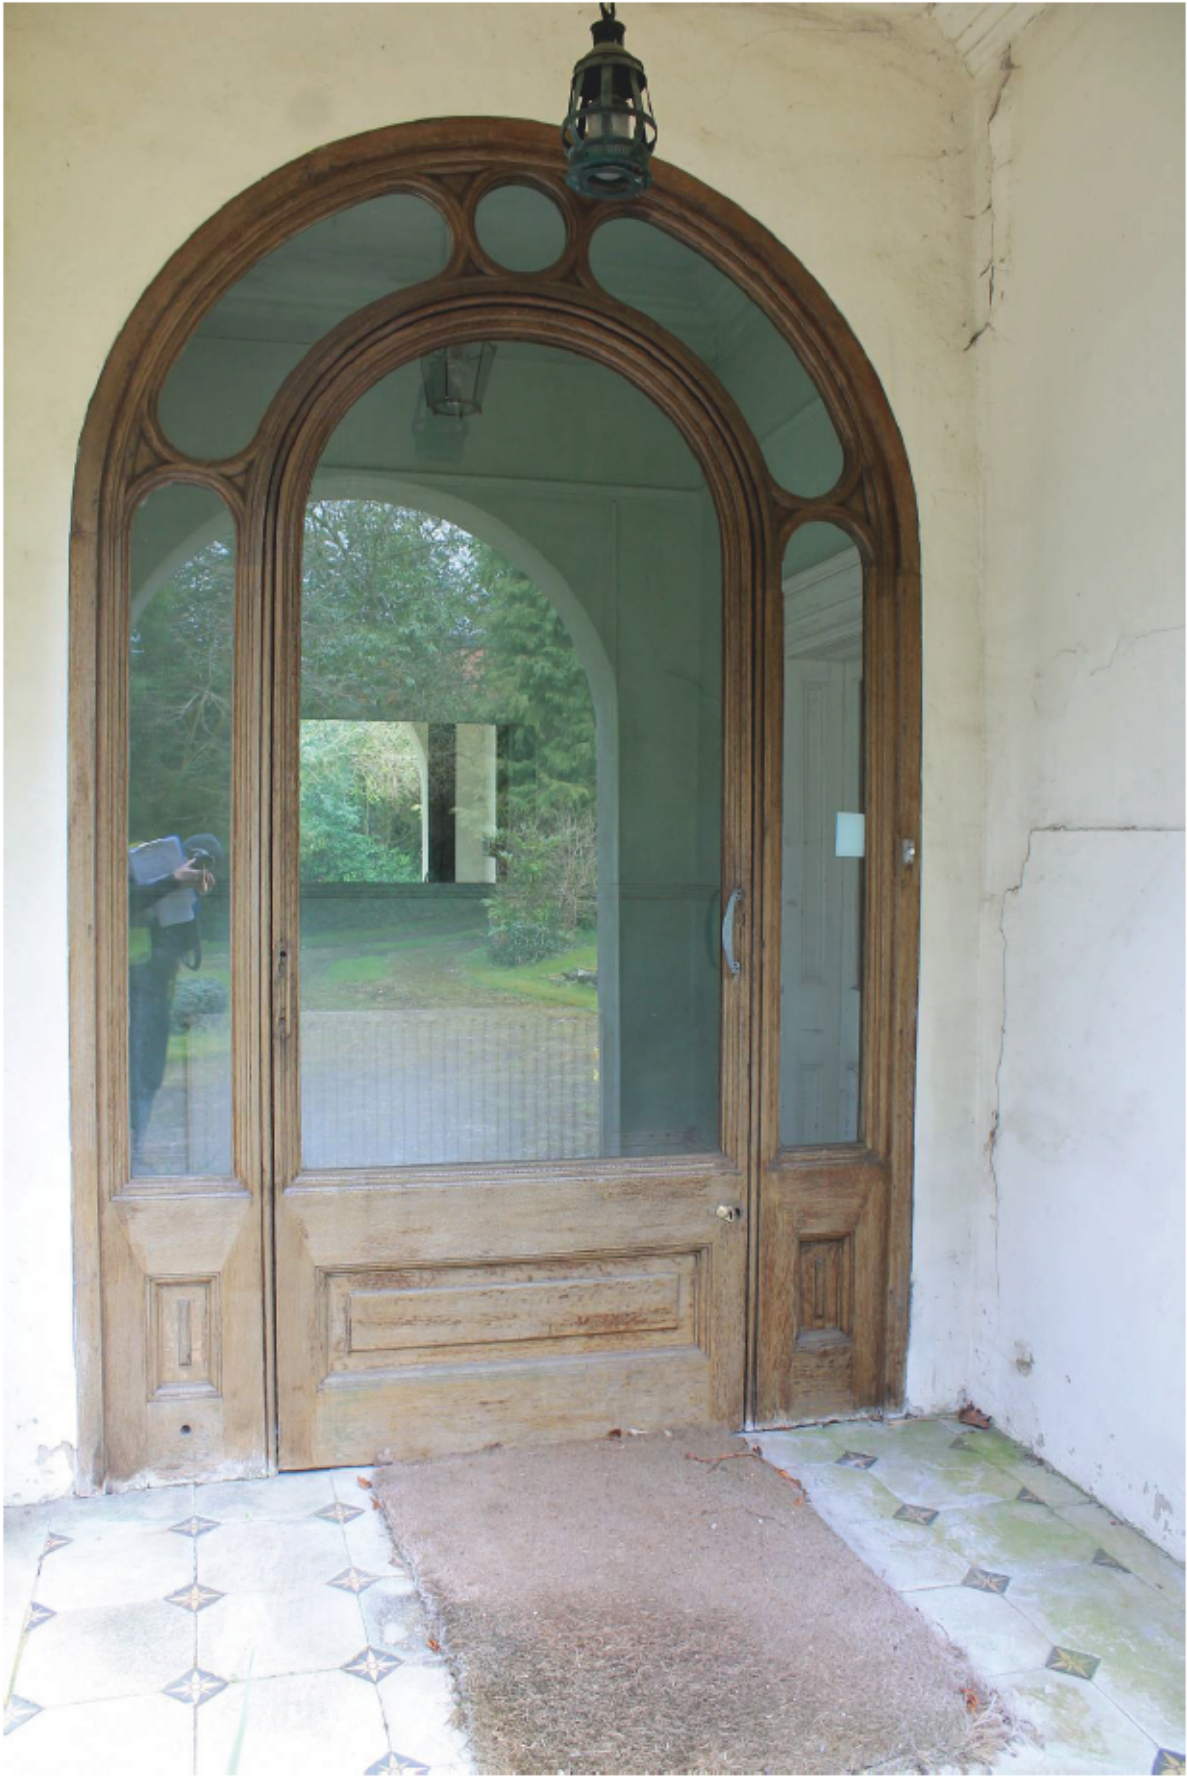
Plate 7 Art Nouveau style glazed entrance to outer hall, looking south

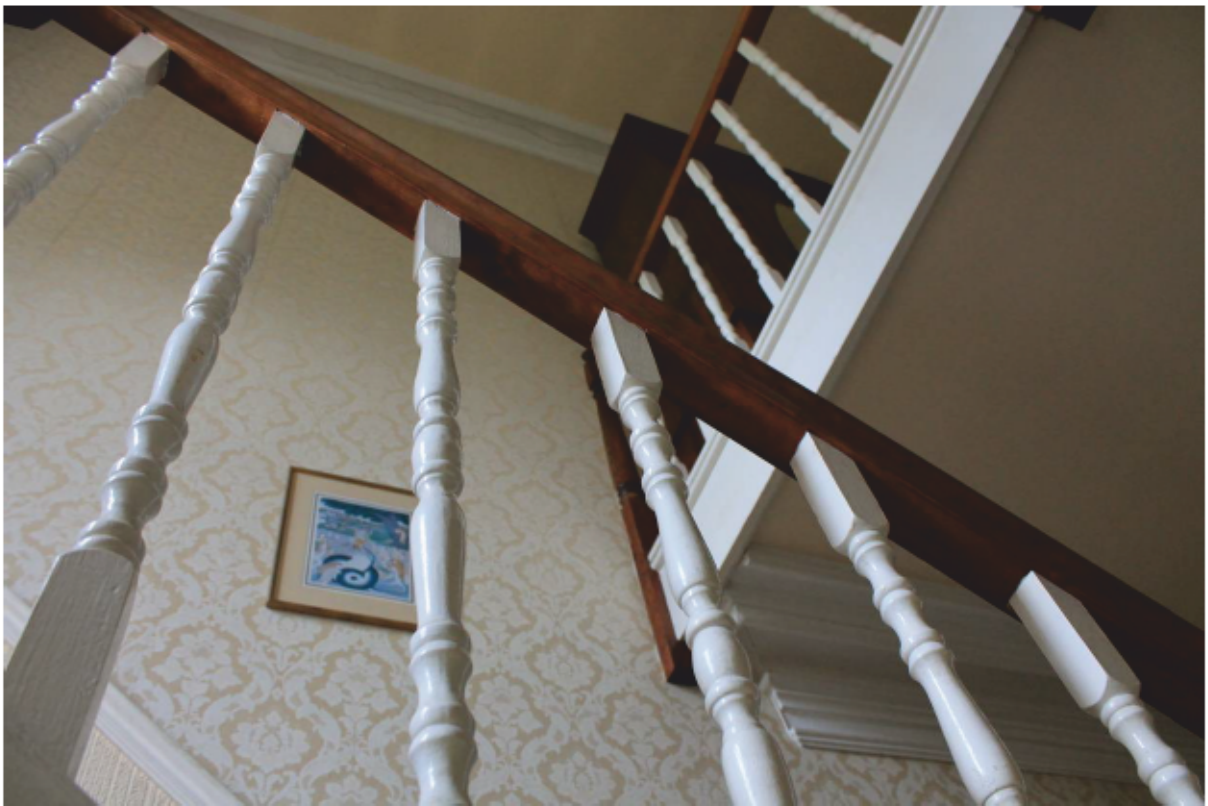
- 6.6.4 The principal stair within the hall is an open-well stair built with simple turned balusters, a moulded oak hand rail and a plain undecorated string (**Plates 16 and 18**). The newel posts were also simply moulded and topped with ball finials. The design of this stair does not match that described in the 1926 and 1952 Sales Particulars with their 'massive mahogany pillars and balustrade', suggesting it is a replacement stair.

Plate 18 Detail of Balustrade in (GF1), looking west

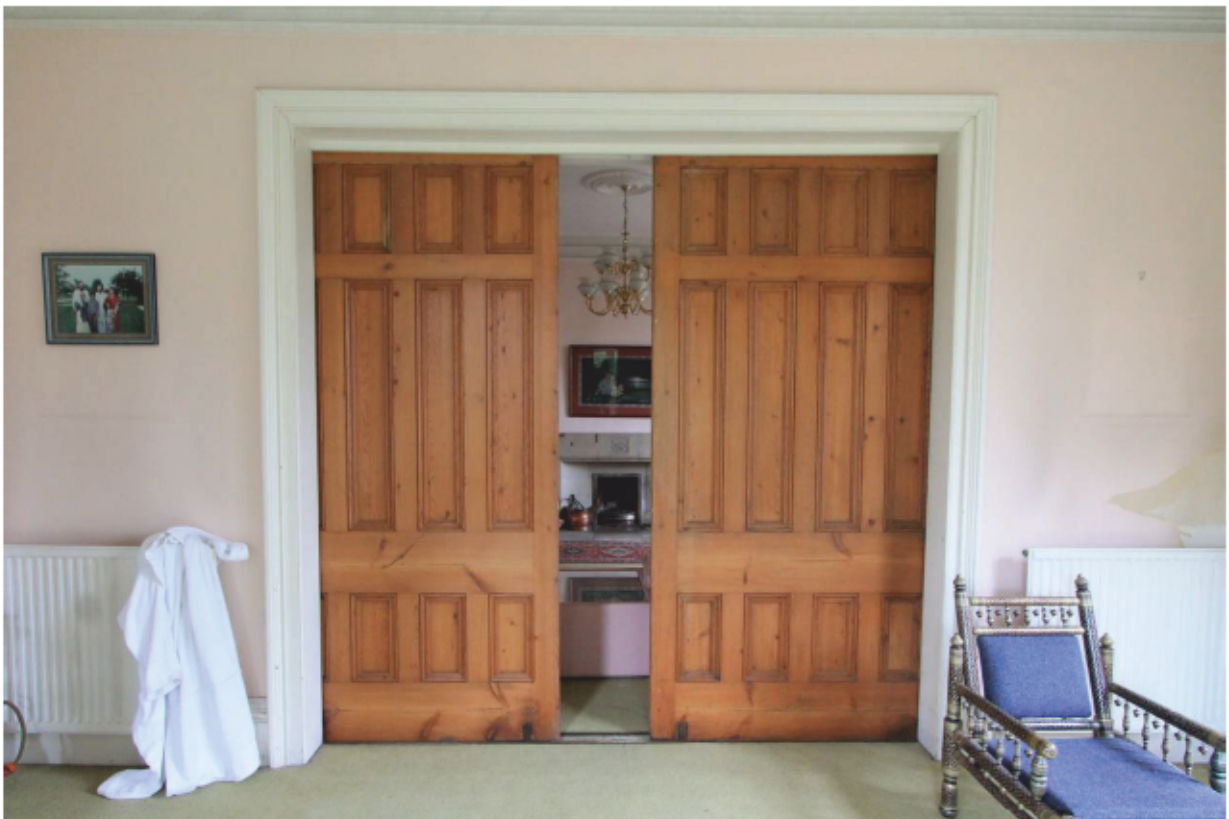
Plate 22 Double Drawing Room, showing internal sliding screen, looking north from (GF2) to (GF3)

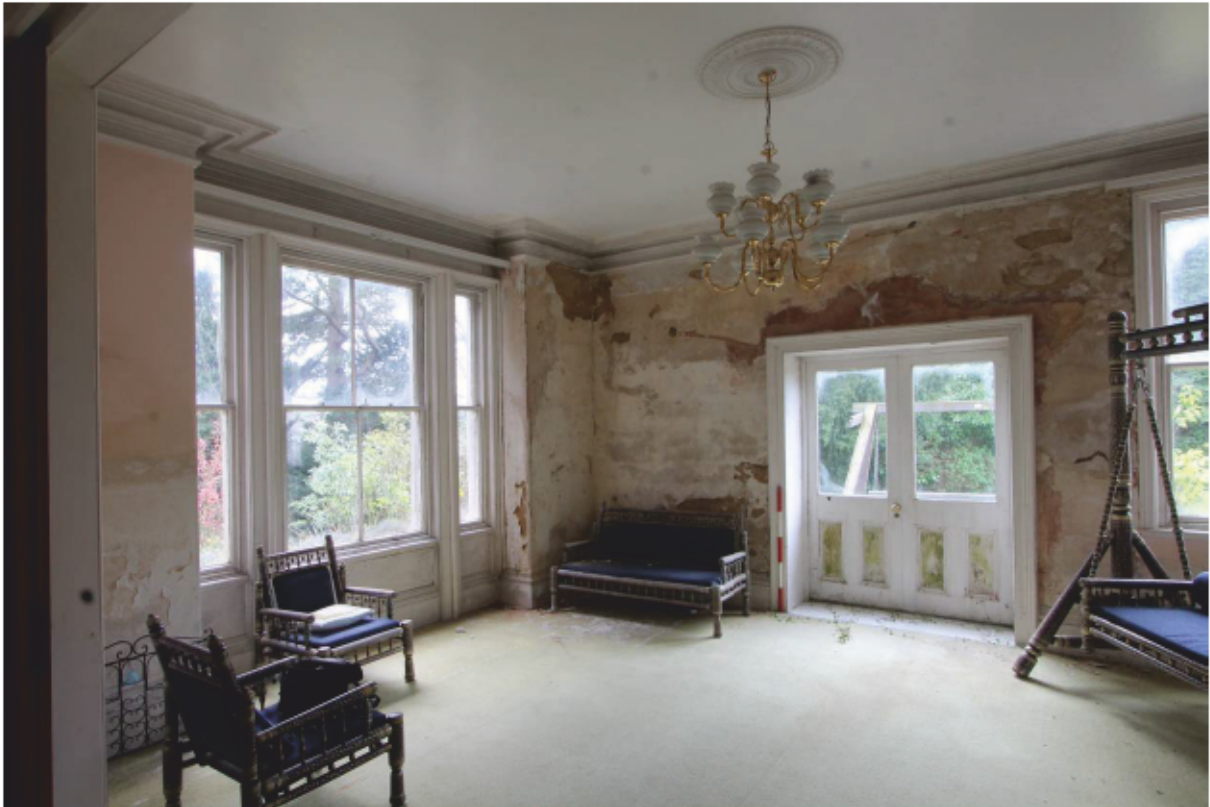
- 6.6.6 After 1952, the chimney breast and fireplace in the south wall of (GF2) were replaced by a pair of French doors (**Plate 23**). It is possible that this fireplace was moved to Study (GF5; **Plate 28**) at the same time since it matches that in GF3 (compare **Plates 25 and 28**). In addition, the Morning Room (former Study) fireplace is described in the 1952 Sales particulars as a 'modern Devon grate' suggesting it was different to the 'Hopton Stone grates' in the Double Drawing Room.

- 6.6.7 Room (GF2) has historically suffered from damp issues, with areas of wall plaster and decoration deteriorating (**Plate 23**). The room has typical decoration for the house with tall 12 inch high moulded skirting boards and a deeply moulded plaster cornice. The ceiling included a central plaster ceiling rose with foliate designs and a modern chandelier (**Plate 23**), a feature repeated in (GF3; **Plate 24**). The inserted French doors to the south wall were part-glazed and panelled, which together with the architrave, were designed to be sympathetic with the doors, although the panelling (to the door surround) was not repeated (**Plate 23**). The insertion of these doors clearly raised light levels within the room which was formerly lit by a narrow box sash and a large mullioned window in the east wall. The latter comprised a large central 2 over 2 horned box sash (on chords) flanked by a pair of tall narrow 1 over 1 box sashes, all with relatively fine glazing bars with a lambs tongue detail. This arrangement was repeated within the bay window in GF3, as was the detailing to the window surround, which were heavily moulded and used a Bolection-style detail (**Plate 24**). The cornice was deeply moulded but more angular in its form, contrasting with that used in the adjacent (GF3) which was similar to that used in the hall.

Plate 23 Double Drawing Room (GF2), looking south-east

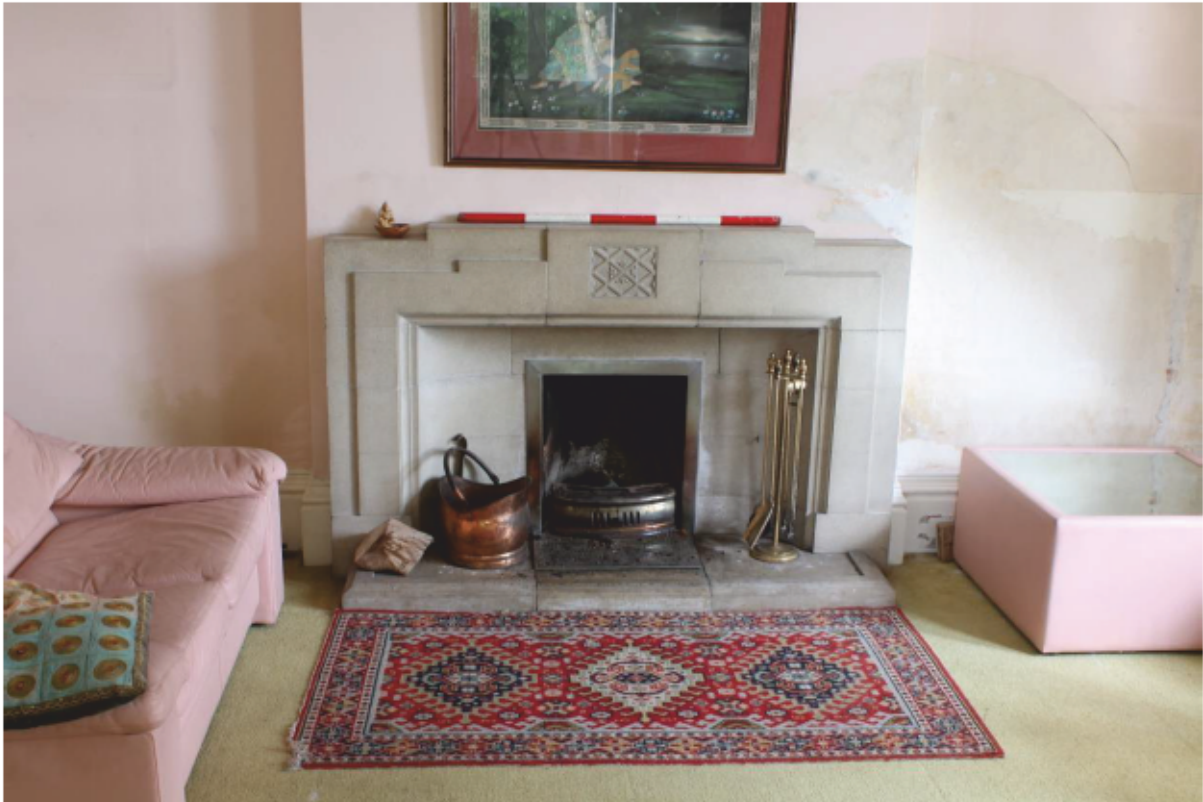
- 6.6.12 The fireplace was exactly the same in size and design as the fireplace described in Double Drawing Room GF3 (**Plates 25 and 28**). It may have been installed in Double Drawing Room GF2 between 1926 and 1952 and then moved to the Study (GF5) after 1952 when the chimney breast in GF2 was replaced with French Doors. The fireplace in Study (GF5) now accommodates a modern gas appliance.

Plate 25 Fireplace in (GF3) inserted by the Bagshaws between 1926 and 1952, looking north

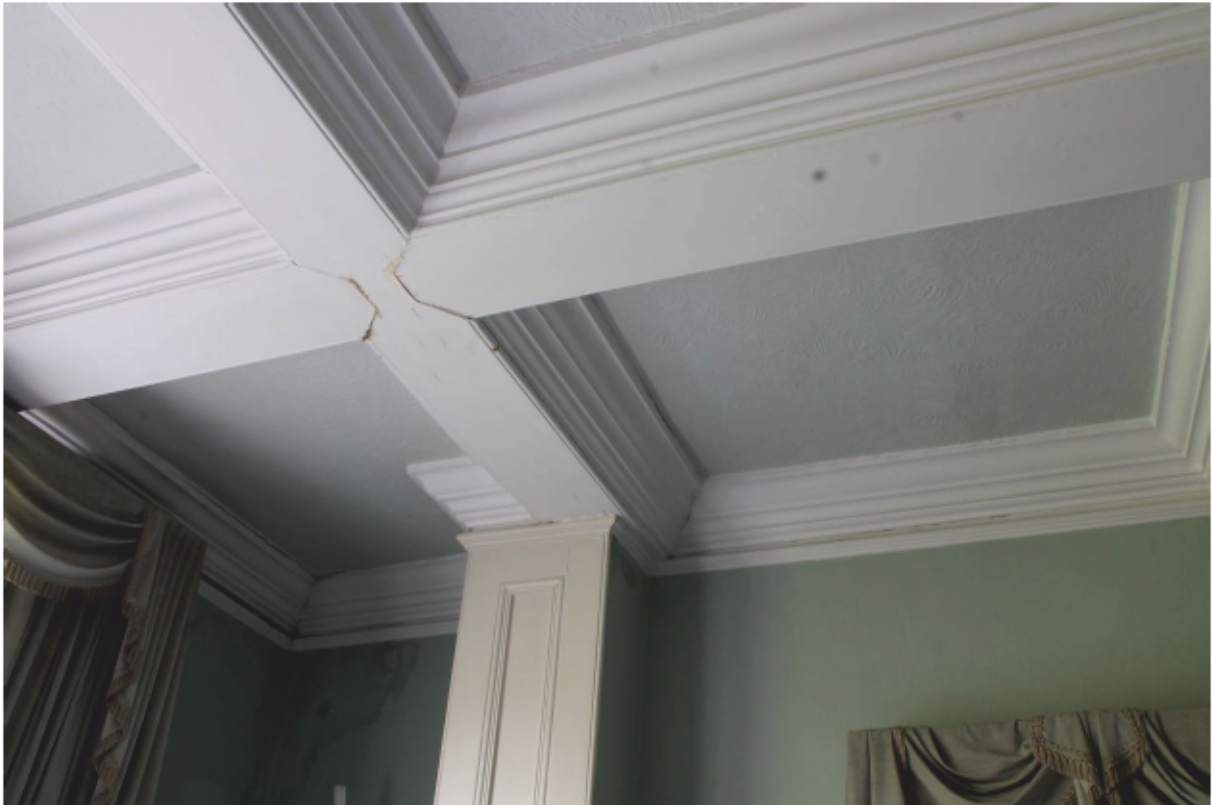
Plate 29 Detail of coffered ceiling in Study (GF5), looking north-east

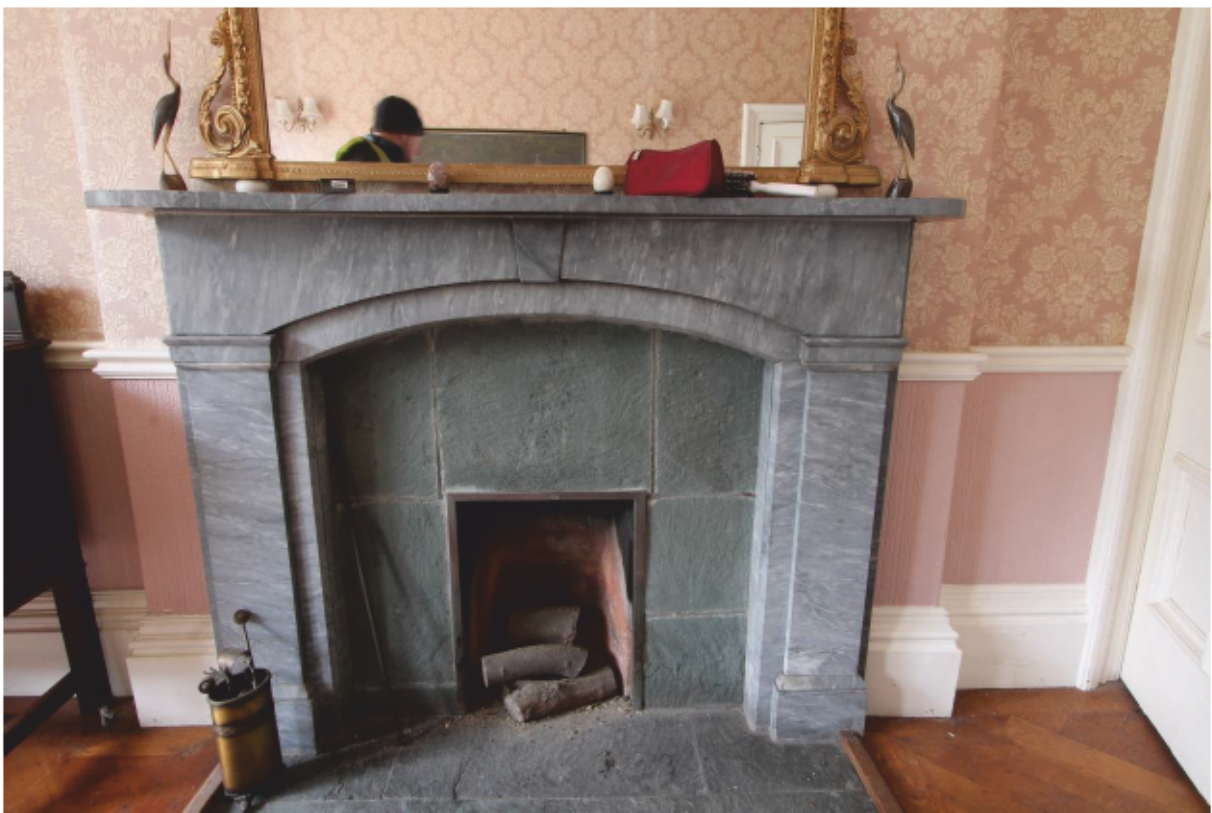
Plate 33 Fireplace in Dining Room (GF7) inserted by the Bagshaws between 1926 and 1952, looking west

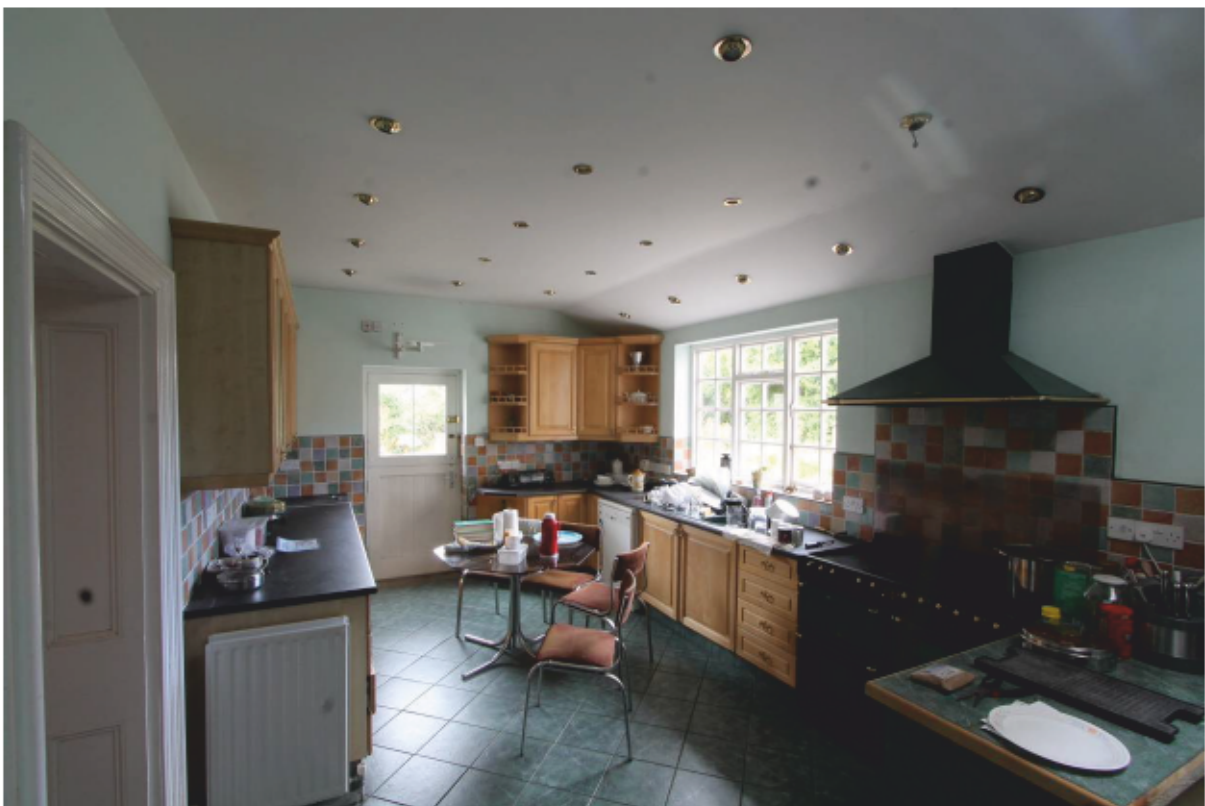
- 6.6.15 Kitchen (GF8) was a modern addition built up against the west side of the dining room (GF7) and superseding (functionally) the former kitchen which was originally located with (GF10) (**Figure 8**). It most likely replaced a small link building/passage, evidenced by a change in floor levels/step within the present kitchen, which connected the dining room (GF7) and pantry (GF6) with the service range and back stairs. All fixtures, fittings, decoration and fenestration in kitchen (GF8) were modern. To the north of the kitchen (GF8) were the service stairs to the first floor which was of dog leg construction

Plate 35 Kitchen (GF8) looking south-west

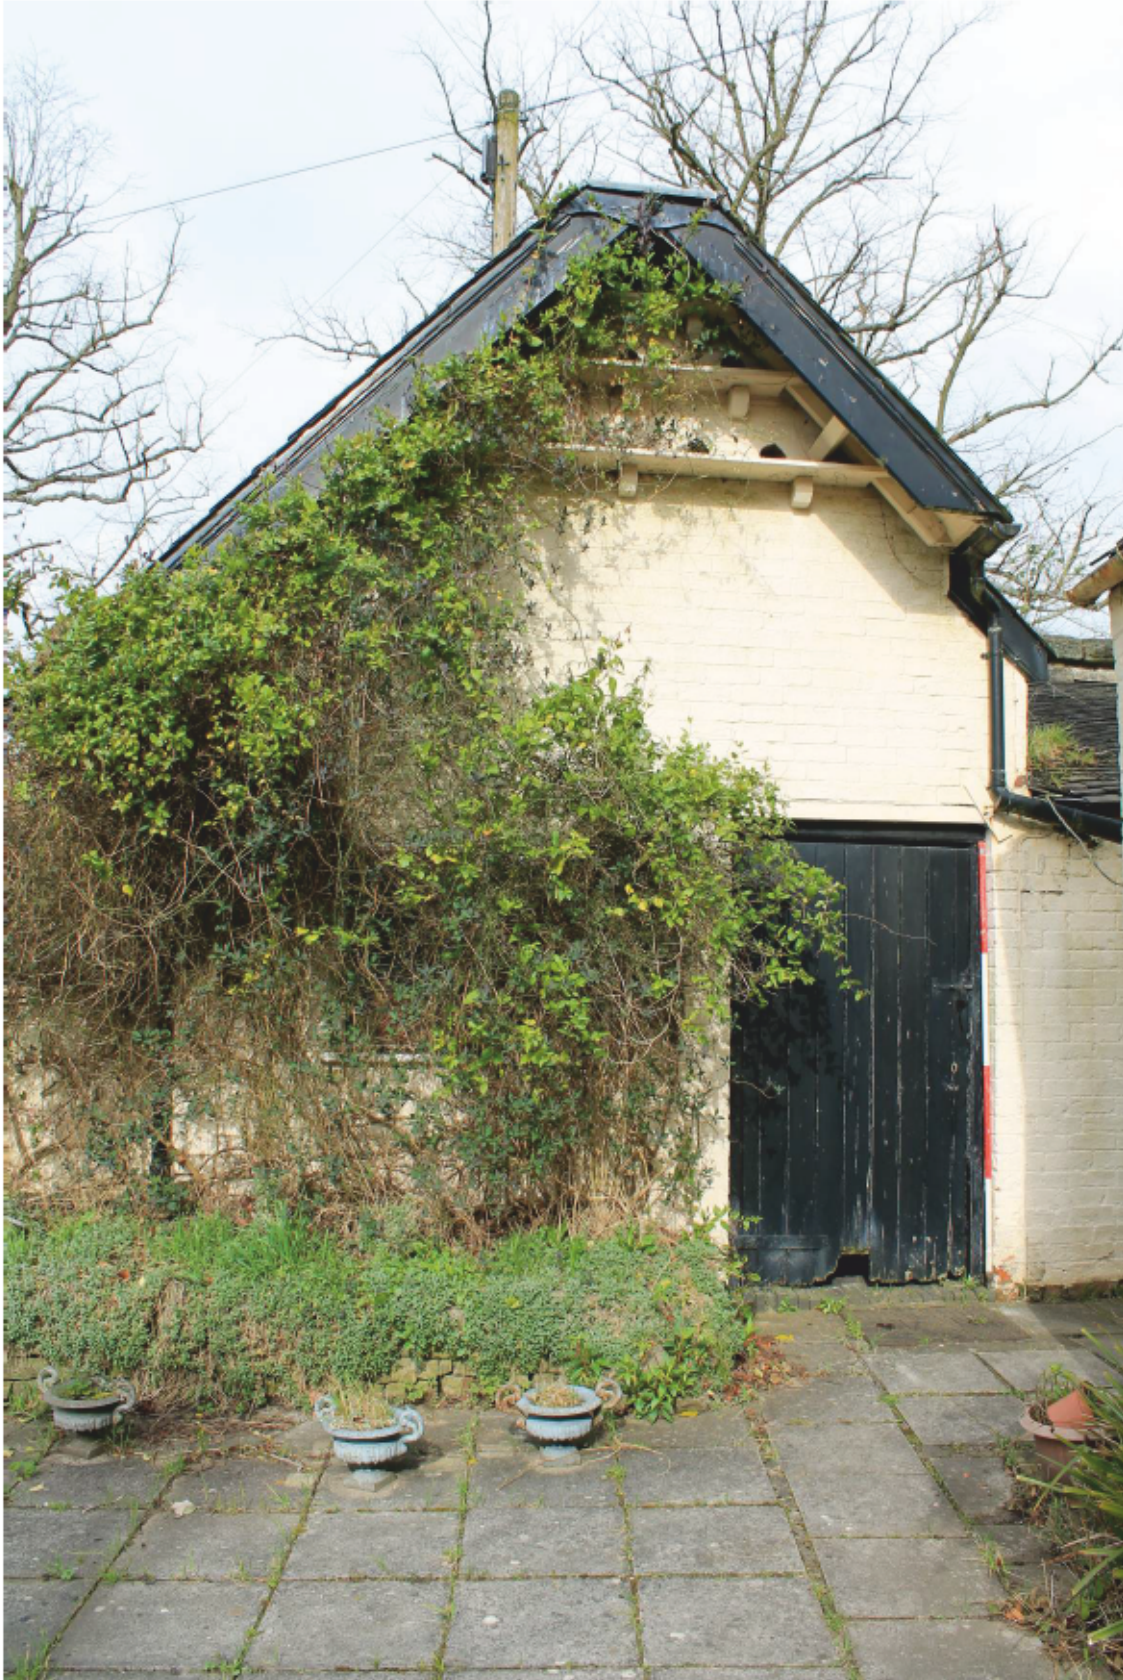
6.7.1 A brick-built utility store, with a dovecote built into its gable end (**Plate 62**) and a lean-to garage building (**Plate 61**), were situated to the west of the house and service range. The outbuilding was built backing onto the brick boundary wall (**Figures 2 and 8**). They were both built in brick in an irregular bond. The garage was built in brick of the same type as the boundary wall up to eaves level, and rebuilt above (**Plate 61**). Internally, both had a brick or sett floor. The internal north wall of the dovecote building had been replaced with an RSJ. The first floor structure to the dovecote buildings was extensively constructed of re-used roof rafters, which had presumably been sourced from the main house after the 1944 aeroplane crash.

Plate 62 Outbuilding with dovecote looking west
