**AN ARCHAEOLOGICAL WATCHING
BRIEF (2015–2016)
FORMER SWAN HUNTER SHIPYARD,
STATION ROAD, WALLSEND
NORTH TYNESIDE, TYNE AND WEAR**

**An Archaeological Watching Brief:
Former Swan Hunter Site, Station Road,
Wallsend, North Tyneside, Tyne and Wear**

WATCHING BRIEF (2015–2016) REPORT

Pre-Construct Archaeology Limited Quality Control	
<i>Project Number</i>	K4248
<i>Site Code</i>	SRN15
<i>Report Number</i>	RN11070

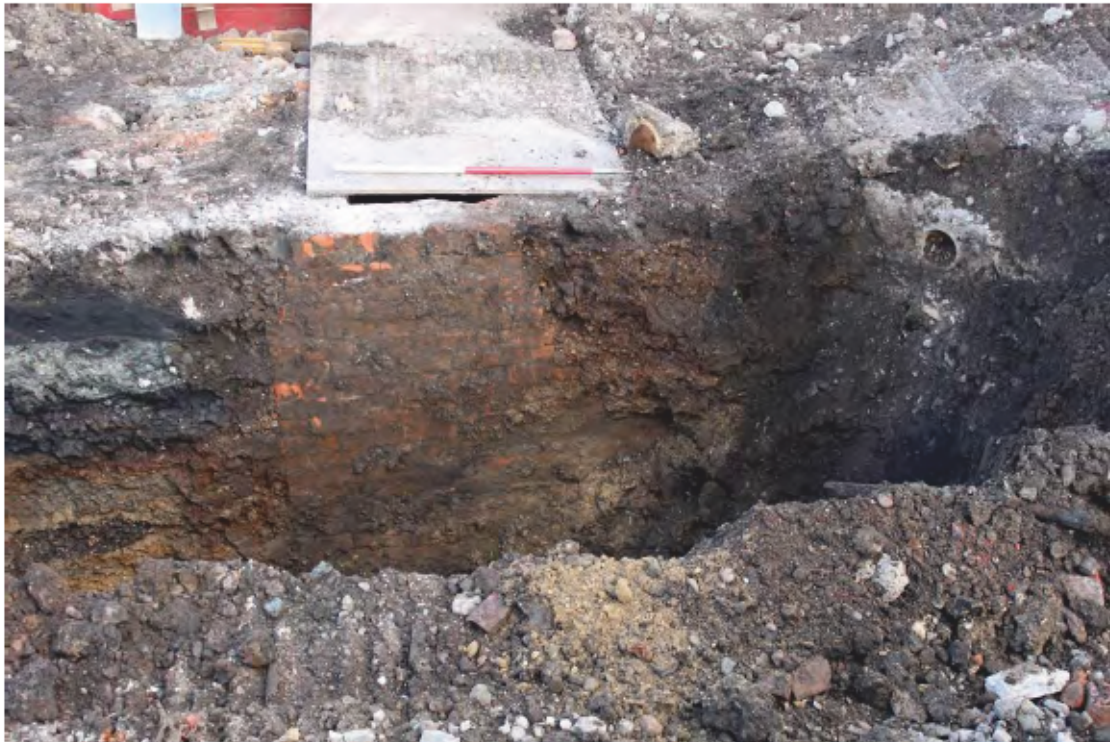
Plate 1: Trench 1, North section of SW facing section, showing brick culvert drain [244] (scale 1m)

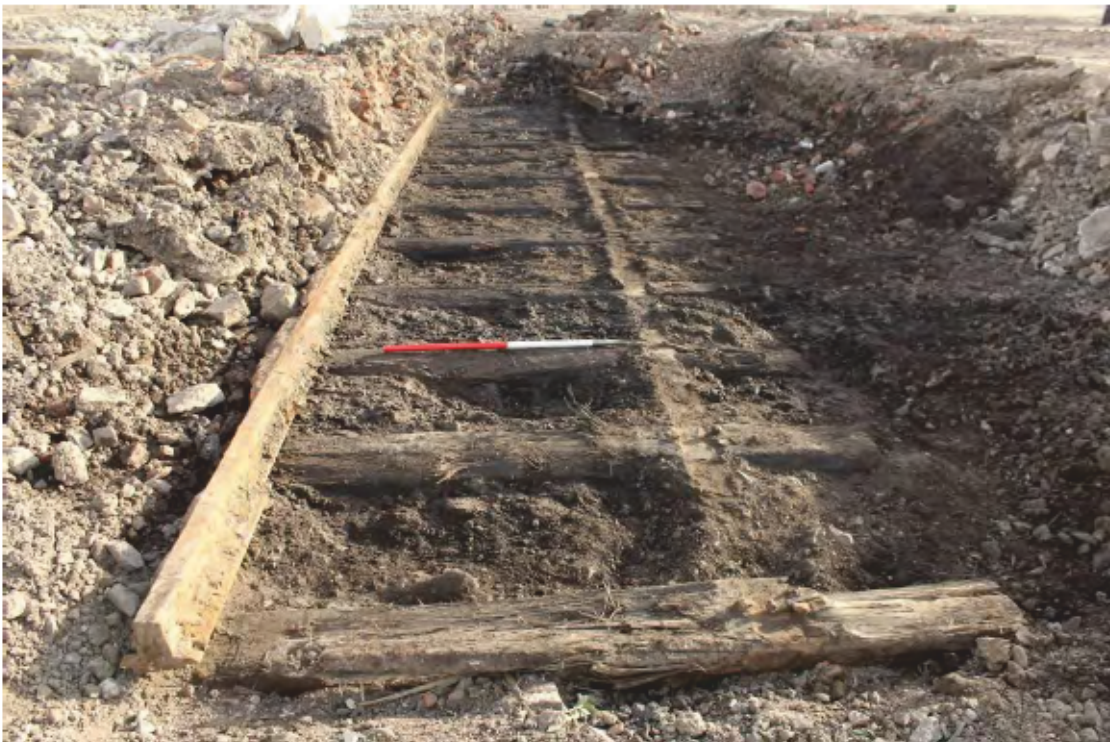
Plate 2: South-east facing view of timber sleepers [124] and vignole rails [125] in central portion of Trench 1 (scale 1m)

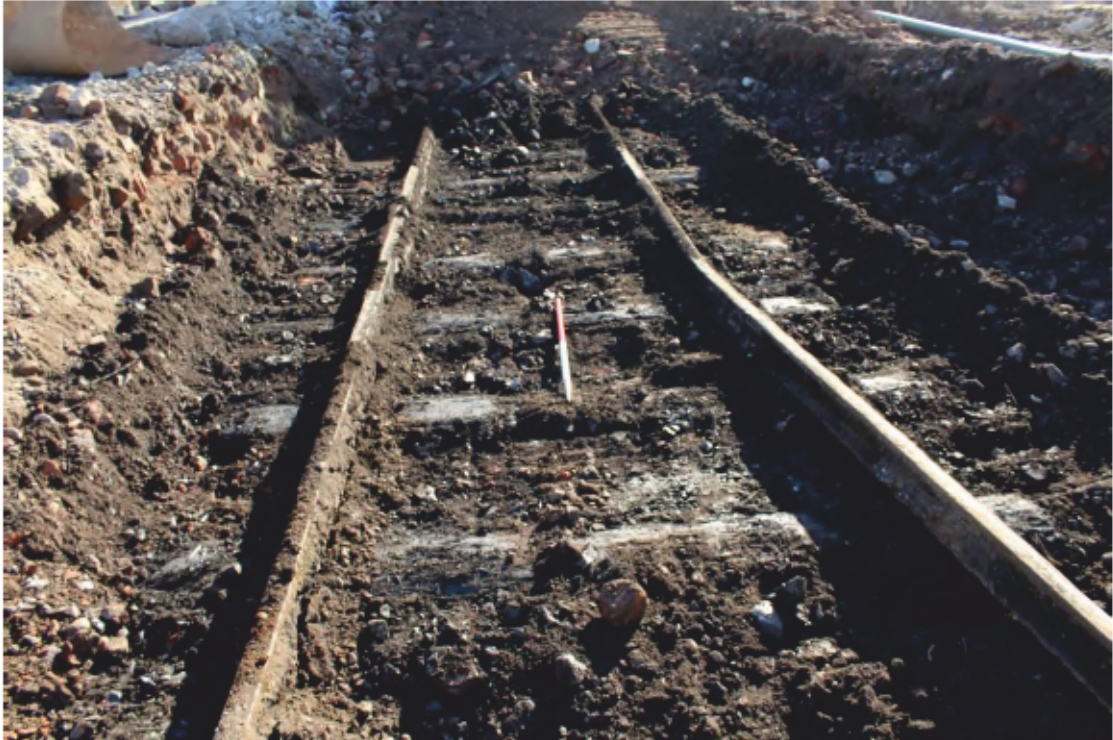
Plate 3: South-east facing view of timber sleepers [124] and vignole rails [125] in central portion of Trench 1 (scale 1m)

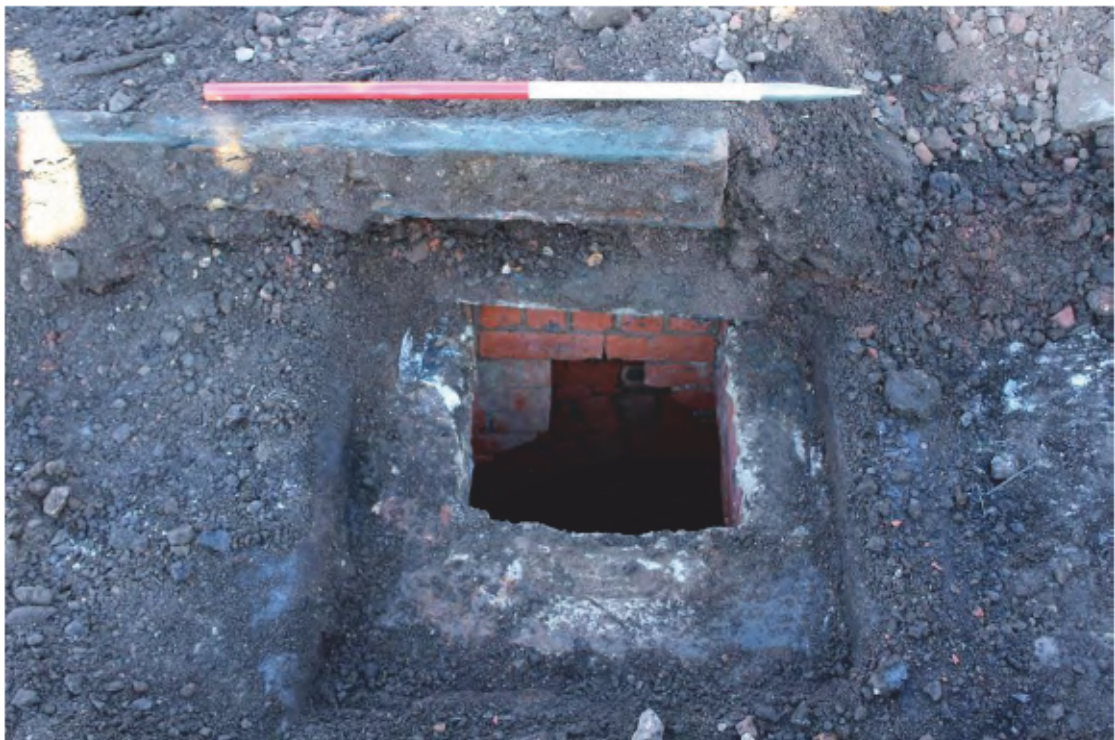
Plate 4: Trench 1, north-east facing view of brick culvert [146] (scale 1m)

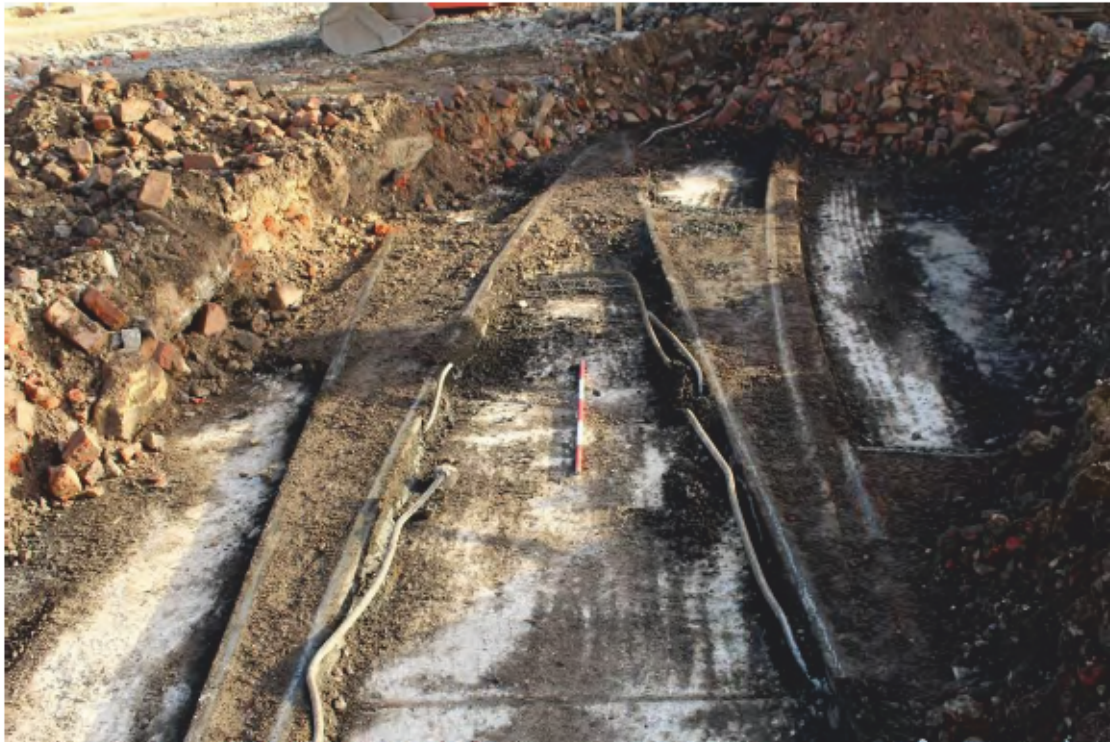
Plate 5: SSE facing view of 20th-century rails [113] imbedded in concrete in the central portion of Trench 1 (scale 1m)

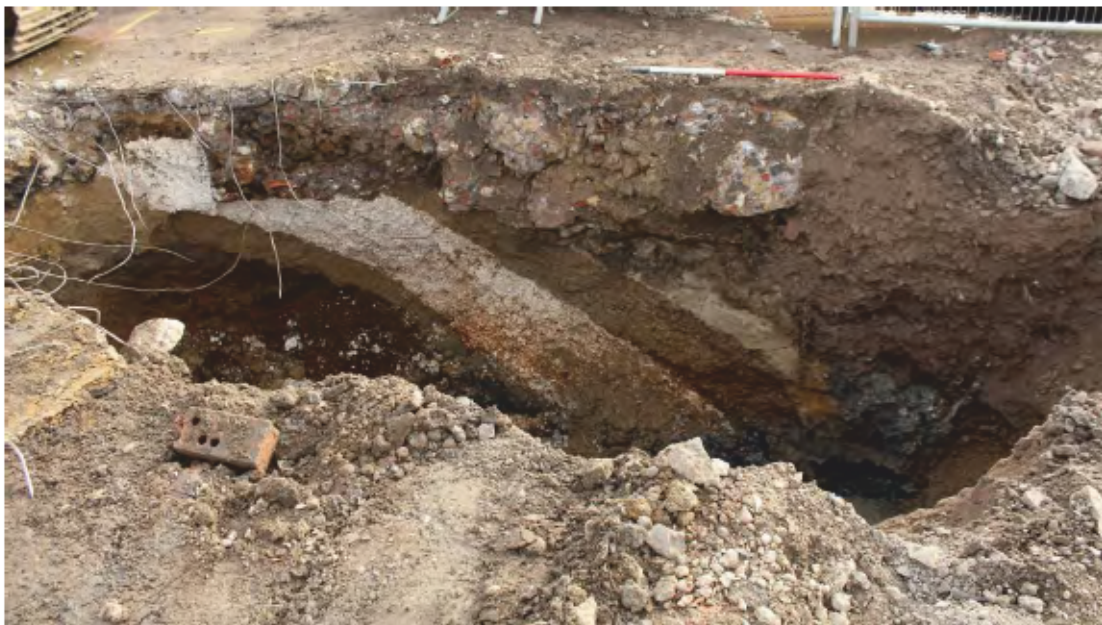
Plate 6: Trench 2, north-west facing section of Trench 2, southern portion, showing deposit tip lines (scale 1m)

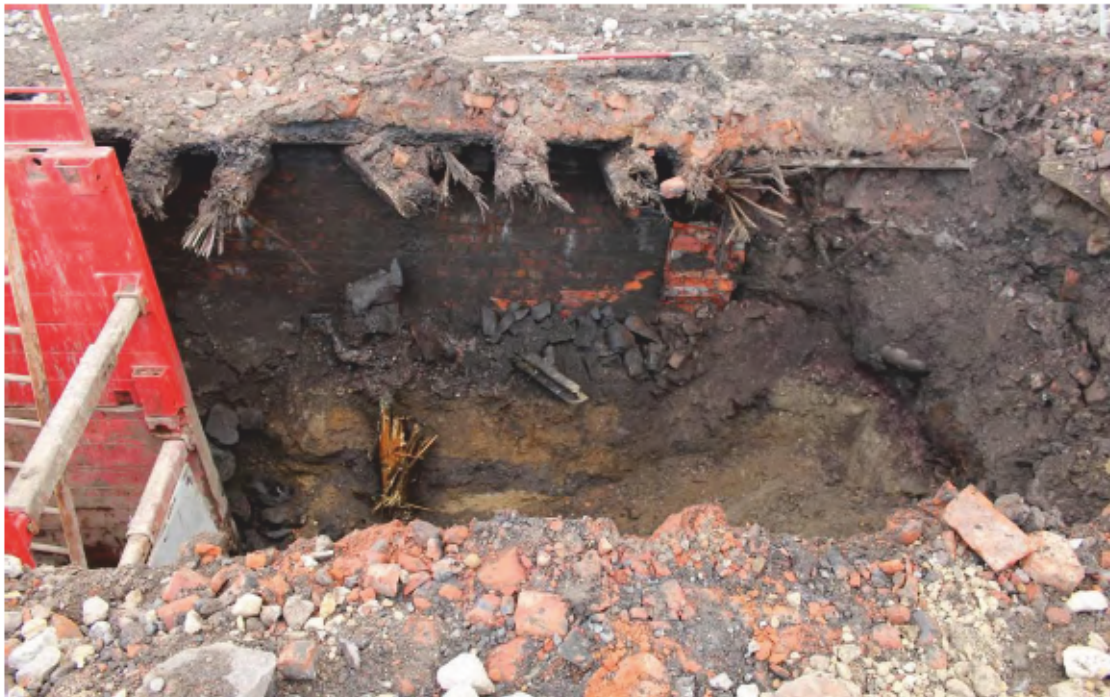
backfilled with loose 'winston' stone [267]. Wall [264] was also built from red brick (c. 230mm x 105mm x 80mm) and concrete mortar exposed for a distance of c. 2.90m NE-SW and depth of c. 1.30m (Plates 7-9). The wall is likely to have been part of one of the many buildings that once occupied Swan Hunter shipyard as depicted on various Ordnance Survey maps of the 20th-century. The construction cut [265] was backfilled with loose yellow sand [266] c. 0.80m thick.

Plate 7: Trench 2, south-west facing section view of concrete floor and rails structure [263] and walls [261] and [264] and rails with timbers [289] and [259] (scale 1m)

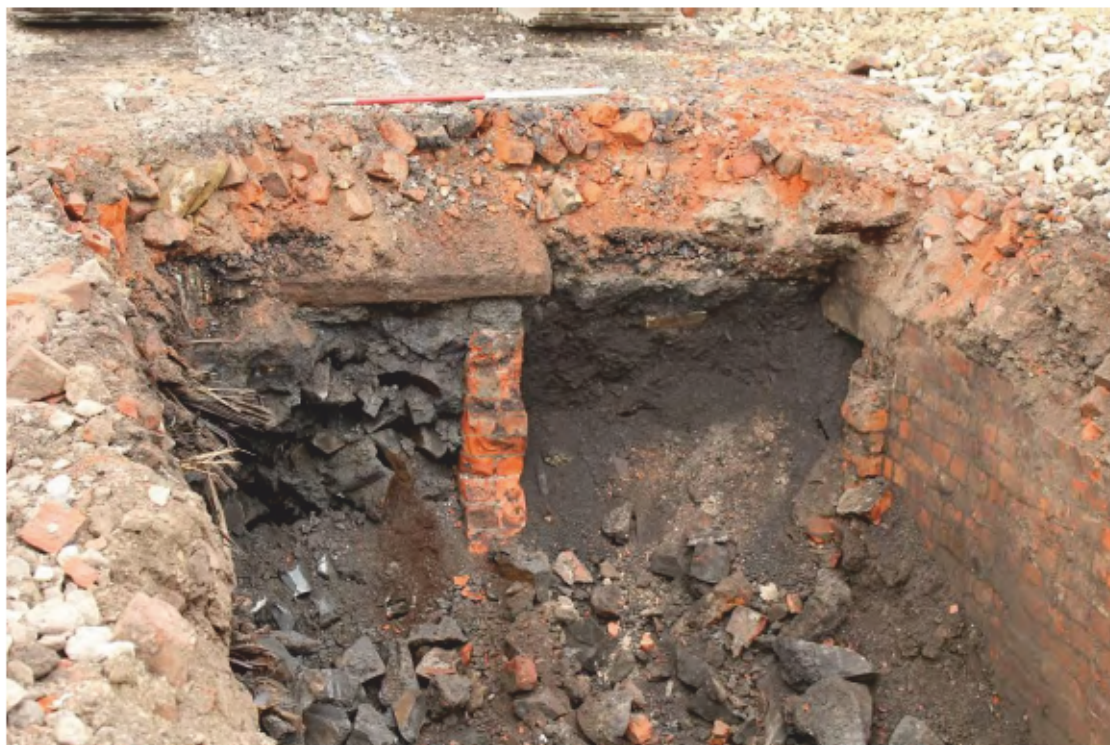
Plate 8: Trench 2, NNW view of walls [261] and [264] with 'Winston' stone backfill [267] (scale 1m)

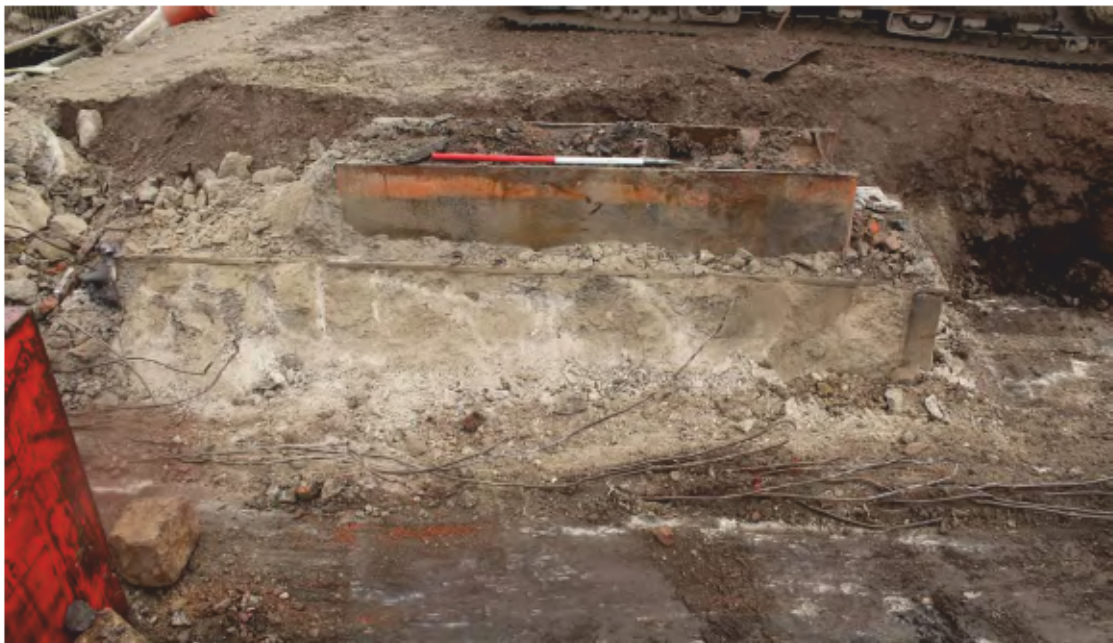
- 5.2.8 A concrete and metal structure [290] was recorded within construction cut [291] for a distance of c. 6.90m and exposed depth of c. 3.10m in the northern portion of Trench 2 (Plates 10-11). This concrete and metal structure is interpreted as a footing for a building foundation. Buildings are visible within this area on OS maps dating from the 20th-century.

Plate 10: North-west facing view of 20th-century building footing structure [290] in the northern section of Trench 2 (scale 1m)

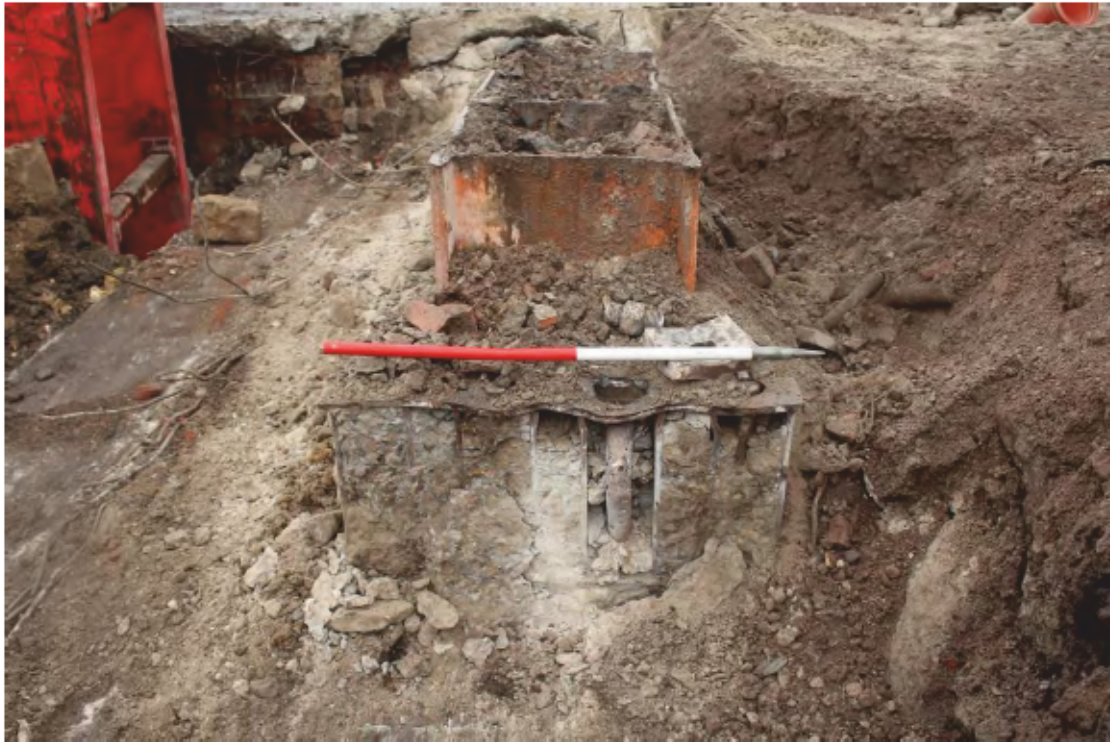
Plate 11: North-west facing view of 20th-century building footing structure [290] in the northern portion of Trench 2 (scale 1m)

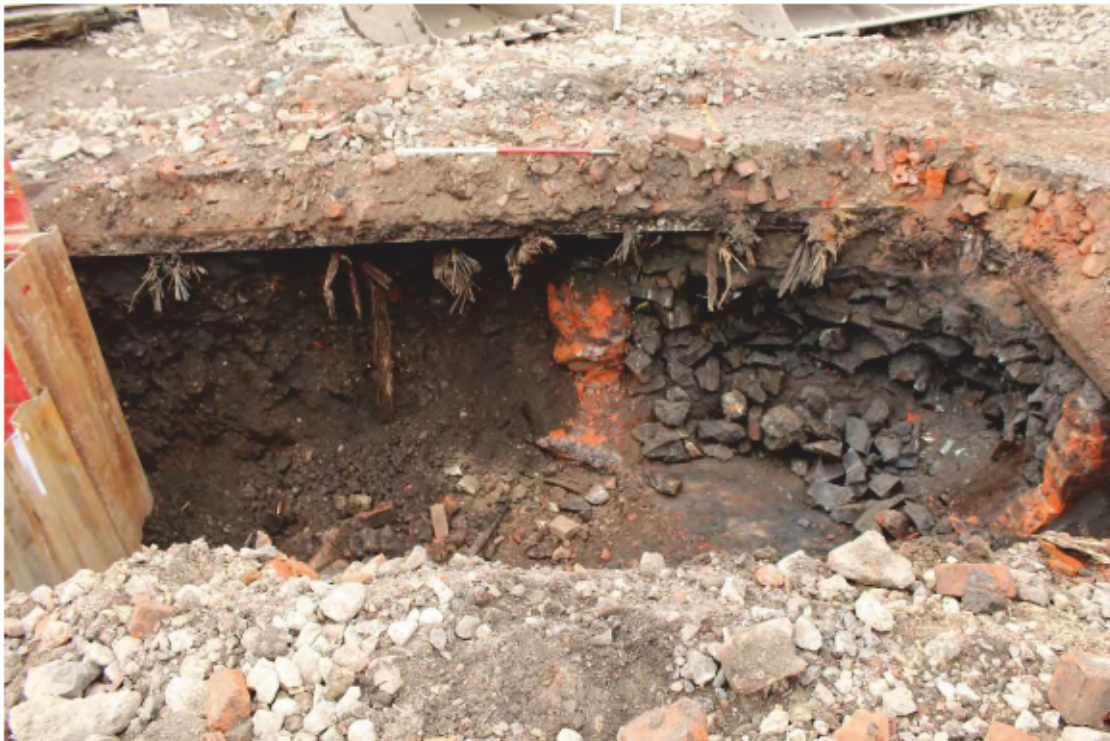
Plate 12: South-west facing view of 20th-century vignole rails [258] and timbers [259] in the northern extent of Trench 2 (scale 1m)

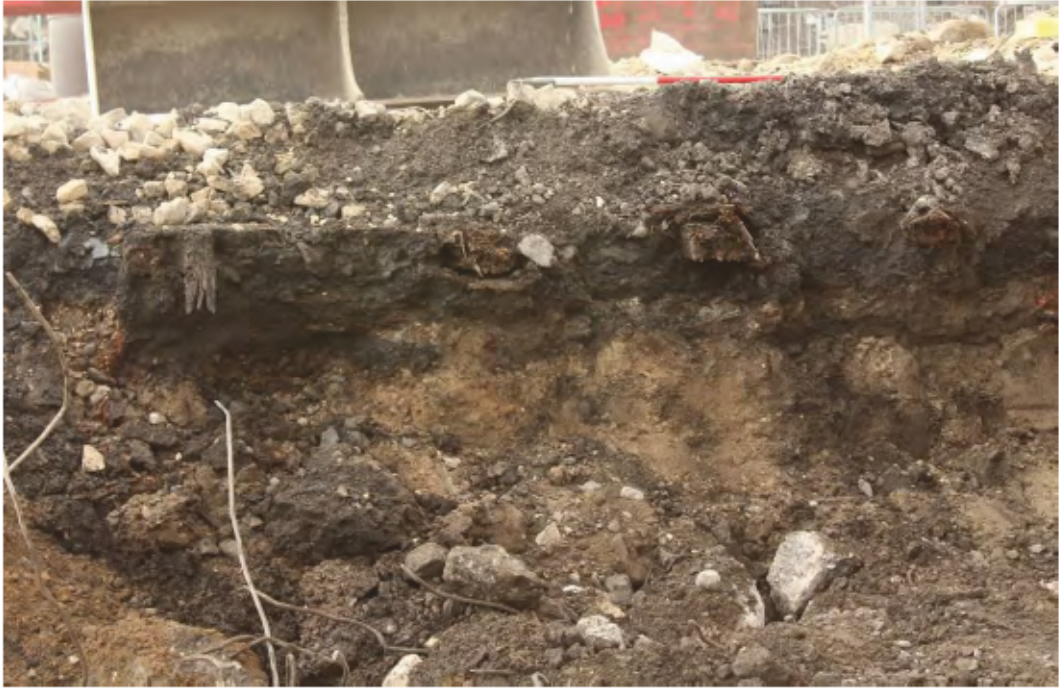
Plate 13: South-west facing section showing timber sleepers [245] in the central part of Trench 2 (scale 1m)

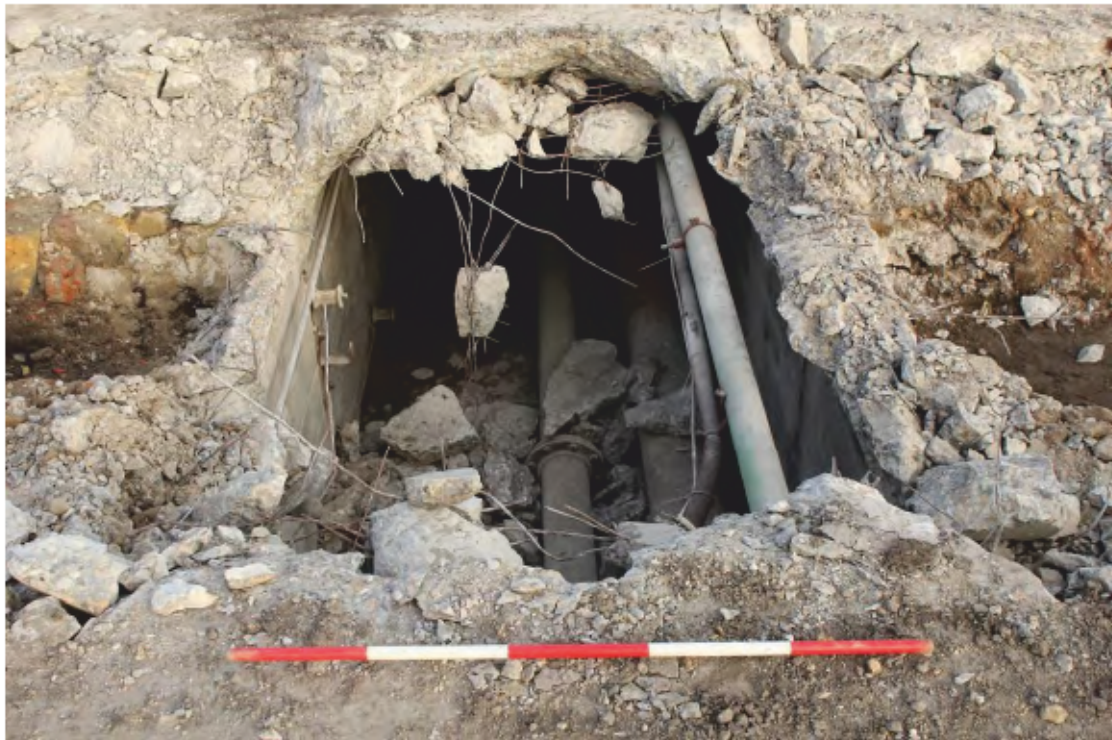
Plate 14: North-east facing view of concrete pipe housing in the northern extent of Trench 3 (scale 1m)

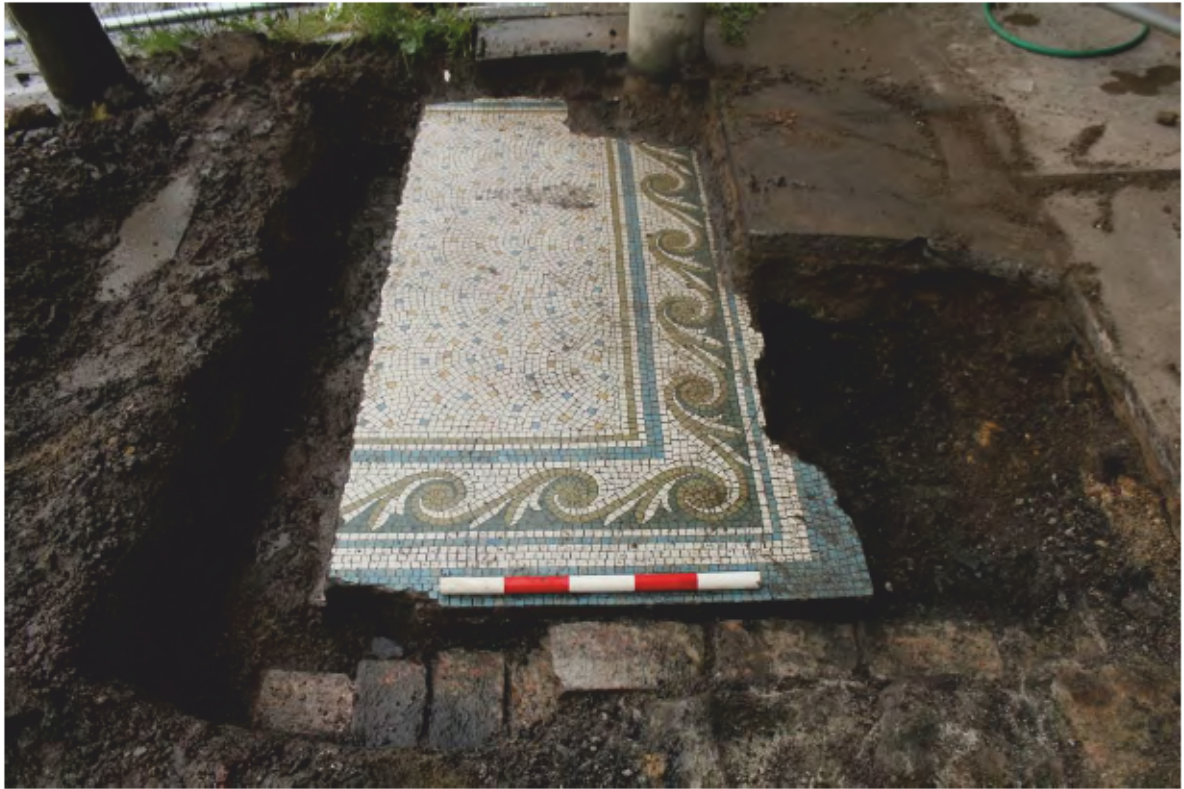
Plate 15: WSW facing view of 20th-century mosaic tile floor entranceway [416] and wall [417] in Trench 4 (scale 0.5m)
