**FULHAM PALACE,
BISHOPS AVENUE, FULHAM,
LONDON SW6 6EA**

**NEW FRUIT TREES:
AN ARCHAEOLOGICAL WATCHING
BRIEF**

PCA REPORT NO: R12472

SITE CODE: FUP14

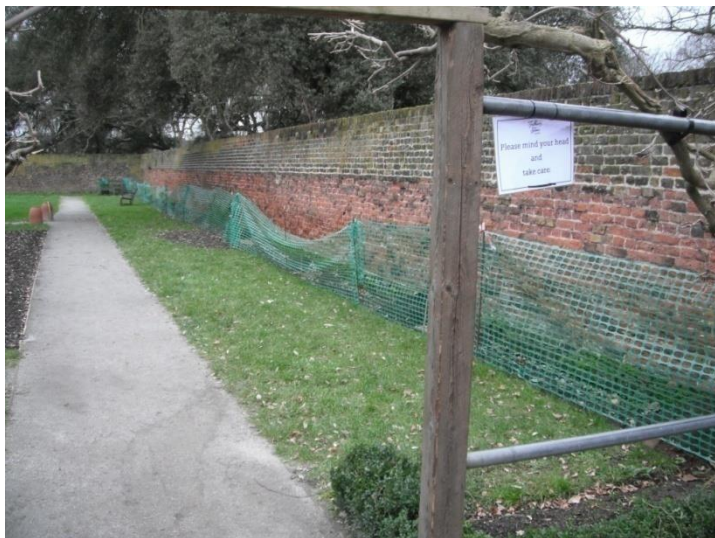
Plate 1: Baseline 1, looking West.

- 3.1.1 Along the Tudor wall were 11 trenches numbered Tr. 50 through to Tr. 60. All of these trenches contained two distinct layers, the uppermost was a loose mid to dark brown humic silt [300] *et al*, and the lower a layer of firm mid brown yellow sandy silt [301] *et al* (see Table 1).

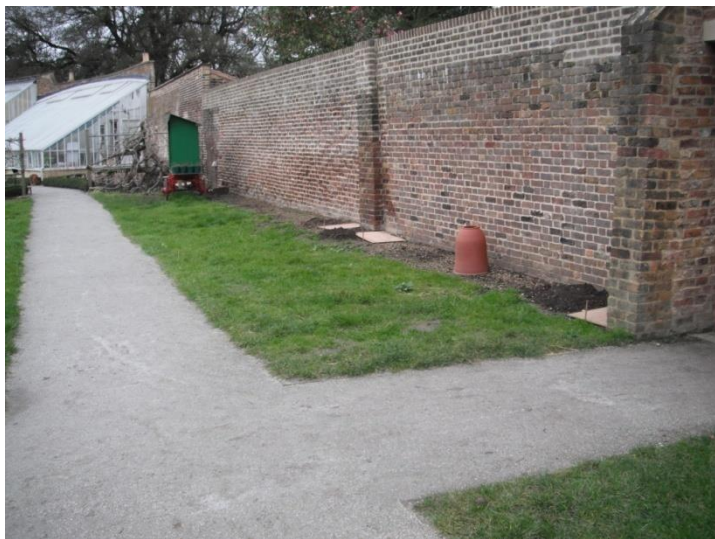
Plate 2: Baseline 3, looking North.

3.2.1 Along this stretch of Georgian wall [331] from the Tudor gate to the western side of the Vinery (baseline 2) were three trenches, Tr. 61, Tr. 62 and Tr. 63 (Plate 6), and from the eastern side of the Vinery to the wisteria (baseline 3) were an additional three trenches, Tr. 64 (Plate 7), Tr. 65 and Tr. 66. All six contained a layer of loose dark black brown silty clay loam, [332] *et al* (see Table 2). With the exception of Tr. 63, they all also contained a firm dark grey brown sandy clay silt layer [333] *et al*.

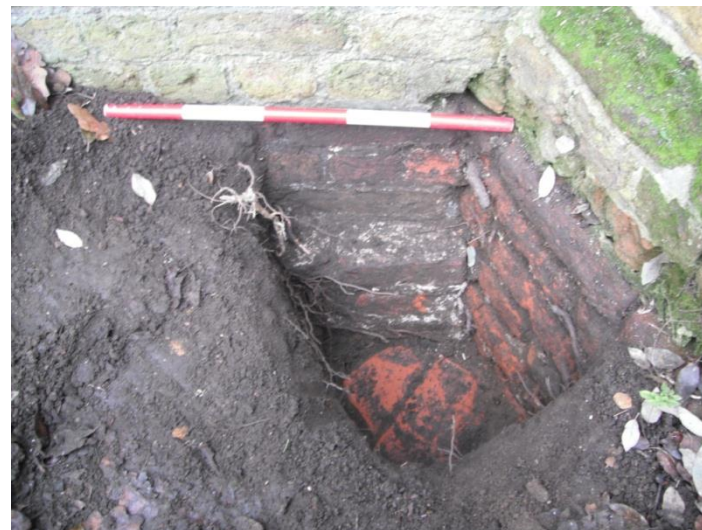
Plate 3: Tr. 50, looking South West.

- 3.1.4 Within Tr. 50 (Plate 3) and Tr. 52 (Plate 4) there was additional masonry, [302] and [307] respectively. This was in the form of bricks visible at the limit of excavation. These bricks appeared to be reused, suggested by the presence of mortar on the upper face. The measurements of the one wholly visible brick, 0.24m by 0.11m meant it was consistent in size with the Tudor masonry wall [330]; this was further supported by the brick's colour. The purpose of these bricks [302] is uncertain but it is possible that it could have been a construction surface for the wall.

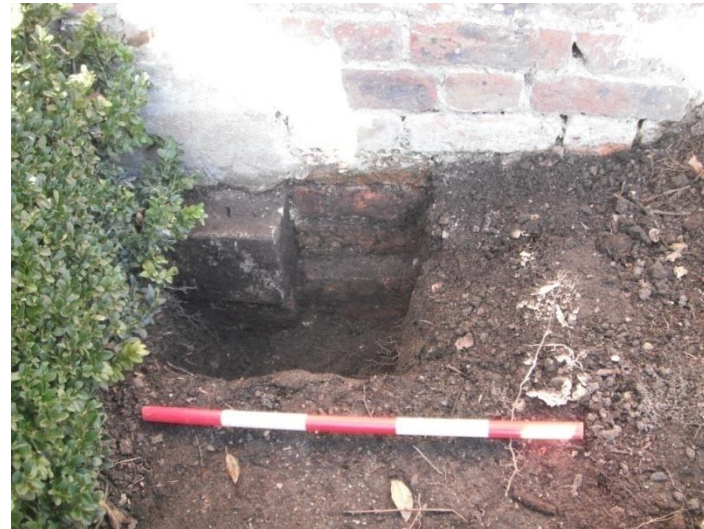
Plate 7: Tr. 64, looking North East.

3.2.3 The lower layer [333] was a more compacted layer of garden soil. It contained frequent twigs and small fragments of building material. It continued below the limit of excavation, in excess of 0.19m thick.

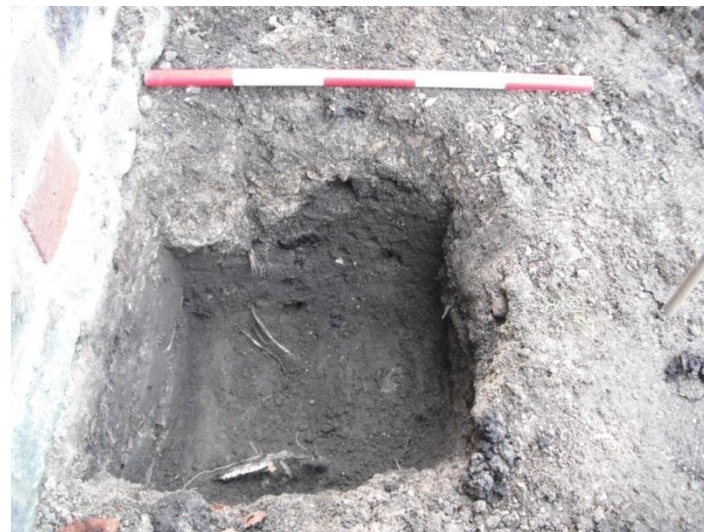
Plate 8: Tr. 67, looking South East.

3.3.1 Along the Georgian wall [331] from the wisteria to the north eastern gate were 4 trenches numbered Tr. 67 through to Tr. 70 (Plate 9). Within Tr. 67 (Plate 8) and Tr. 69 was a layer of mottled pale yellow mortar [344] and [347]. Below this all four trenches contained a layer of loose mid brown grey sandy silt [345], [346], [348] and [349]. Below layer [349] within Tr. 70 was evidence of repair to the north eastern gate [350].

3.3.2 Within Tr. 67 (Plate 8) and Tr. 69 a layer mottled pale yellow mortar [344] and [347] lay on top of the garden soil layers [345] and [348] respectively. This was most probably as a result of

recent repairs to the Georgian wall [331] making it a very modern deposit.

- 3.3.3 The layer of garden soil [345], [346], [348] and [349] had been heavily disturbed by bioturbation as it had been a planted border as recently as 2014 (pers comm Fulham Palace gardeners). Continuing beyond the limit of excavation in all four trenches, this layer was in excess of 0.31m thick. The layer post-dated the concrete [350] (Plate 8) and brickwork repair to the north eastern gate in Tr. 70.

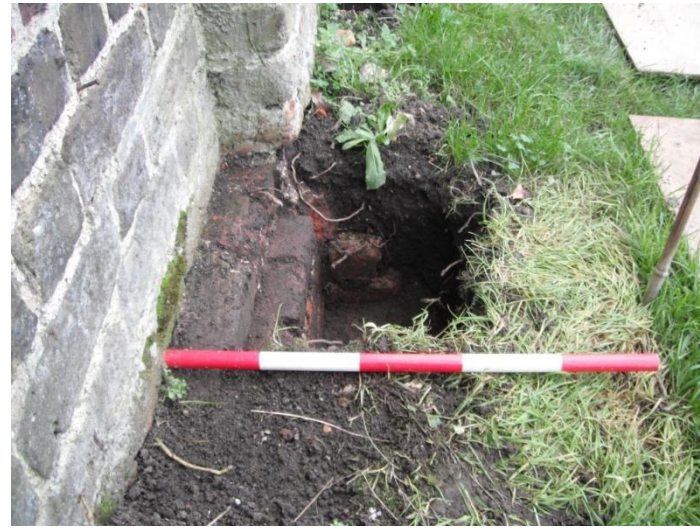
Plate 11: Tr. 79, looking South West.

- 3.5.1 Along the Georgian wall [331] from the eastern corner to the south eastern gate were six trenches numbered Tr. 78 through to Tr. 83. All of these trenches contained one layer, a loose mid grey brown loamy silt [363], [364], [365], [366], [367] and [368].
- 3.5.2 This layer appeared the same as [352] (see Table 3) found in all trenches along baseline 5. It comprised of garden soil topped with turf and contained frequent fine roots, charcoal flecking and small gravels. It at least 0.37m thick, continuing beyond the limit of excavation. In Tr. 81 (Plate 12), layer [366] was only 0.15m thick as it overlaid [369] an iron post set in concrete. This

- 3.5.3 The lower portion of the Georgian wall [331] was stepped along its south-eastern section, visible within Tr.78 to Tr. 83. This differed from elsewhere within the walled garden where wall [331] was vertically faced as far as the limit of excavation.

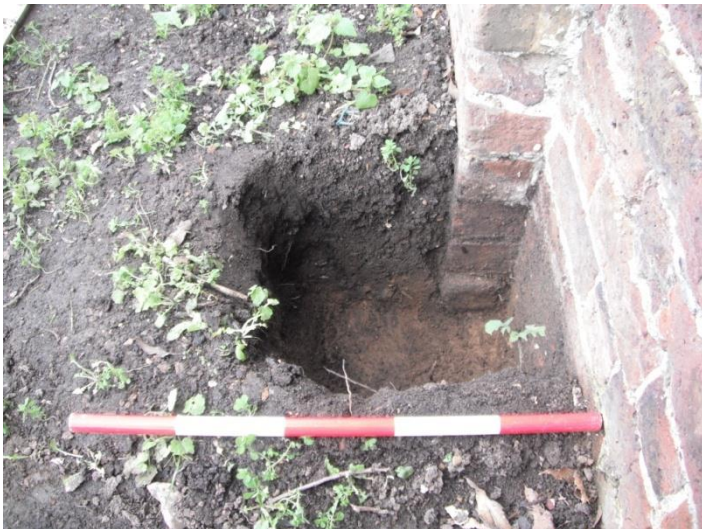
Plate 10: Tr. 73, looking North West.

- 3.4.1 From the southern edge of the north eastern gate to the eastern corner of the walled garden (baseline 5) were seven trenches Tr. 71 through to Tr. 77. All seven contained a layer of loose mid grey brown loamy silt, [352] (see Table 3). Tr. 72, Tr. 73 (Plate 9), Tr. 74 and Tr. 76 also contained a layer of firm mid yellow orange sandy silt [354] (see Table 3). Below layer [352] within Tr. 71 (as seen in Tr. 70), evidence of repair [351] to the north eastern gate was seen.

- 3.4.3 The lower deposit [354] (see Table 3) was very similar to that seen in Tr. 50 [301] measuring at least 70mm to the limit of excavation. This deposit most probably represents the construction cut backfill for the Georgian wall [331].

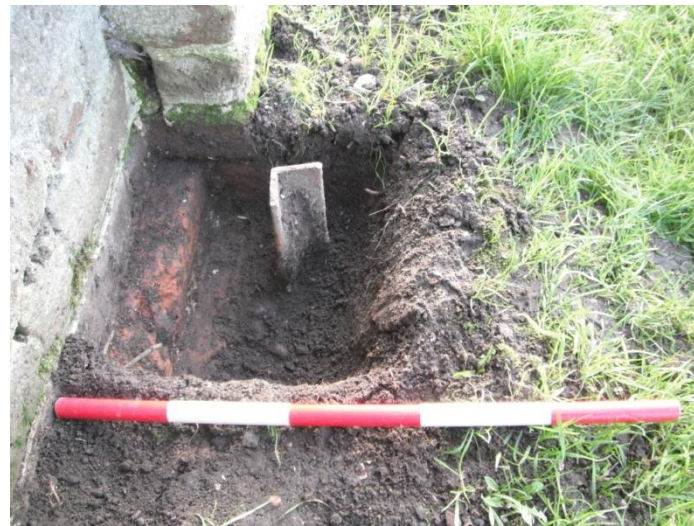
Plate 12: Tr. 81, looking South West

post had supported a chain link fence which had been erected prior to 1976 when the area within the moat of Fulham Palace became a Scheduled Ancient Monument and was in use until the Georgian wall [331] was repaired (pers comm Fulham Palace gardeners).
